PNNL-18645

Summary of TPH Monitoring Conducted at 100-NR-2 During CY 2008 and 2009

August 2009

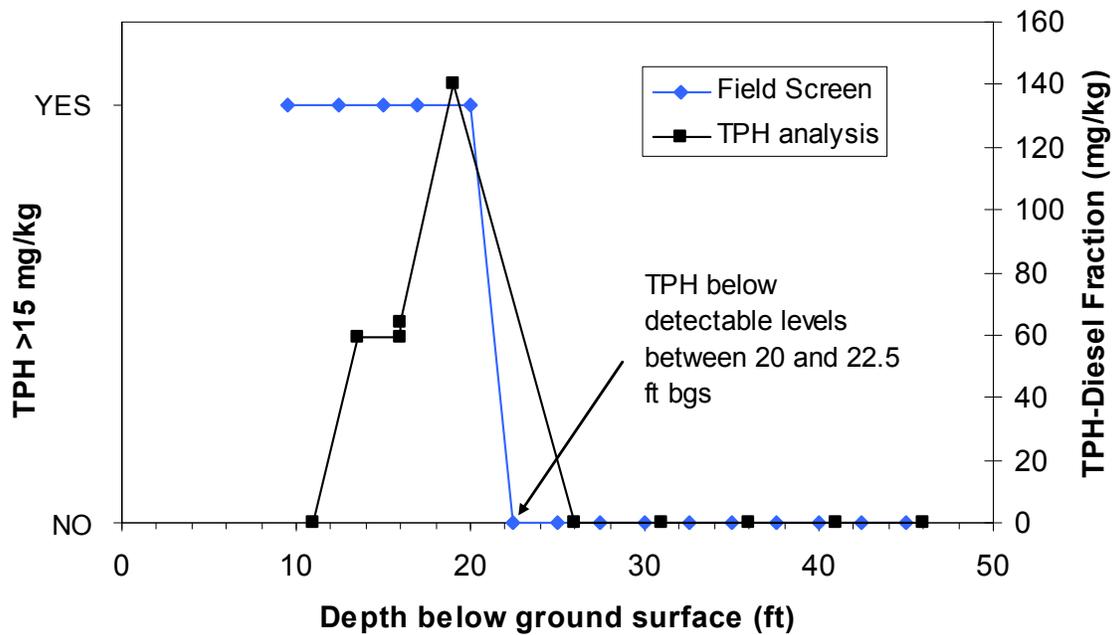
Figure 1. Concentrations and Screening Results for TPH Measured in Samples Collected During Drilling of Monitoring Well 199-N-173

The field screening for TPH indicated the presence of diesel contamination between 9.5 and 20 feet bgs at concentrations exceeding 15 mg/kg. This was consistent with the results from the core samples (Figure 1). The core sample results indicate that the concentrations increased with depth up to 20 feet bgs. Below 20 feet bgs, the TPH concentrations in sediment were below detectable concentrations (~4 mg/kg). The metals concentrations observed in core samples collected from 199-N-173 appeared to vary some with depth; however, the variation was probably associated with lithological changes rather than the presence of contaminants (Appendix C). Core samples were analyzed for 99 organic compounds; only 7 were measured at detectable concentrations in any of the core samples (Table 5, Appendix B). These concentrations were at or below the MTCA Method A soil cleanup levels for unrestricted use (Table 740-1, WAC 173-340-740) for the detectable compounds. It should be emphasized that the data presented here is for a handful of samples collected from a single location; further sampling from boreholes in this area may reveal different information.

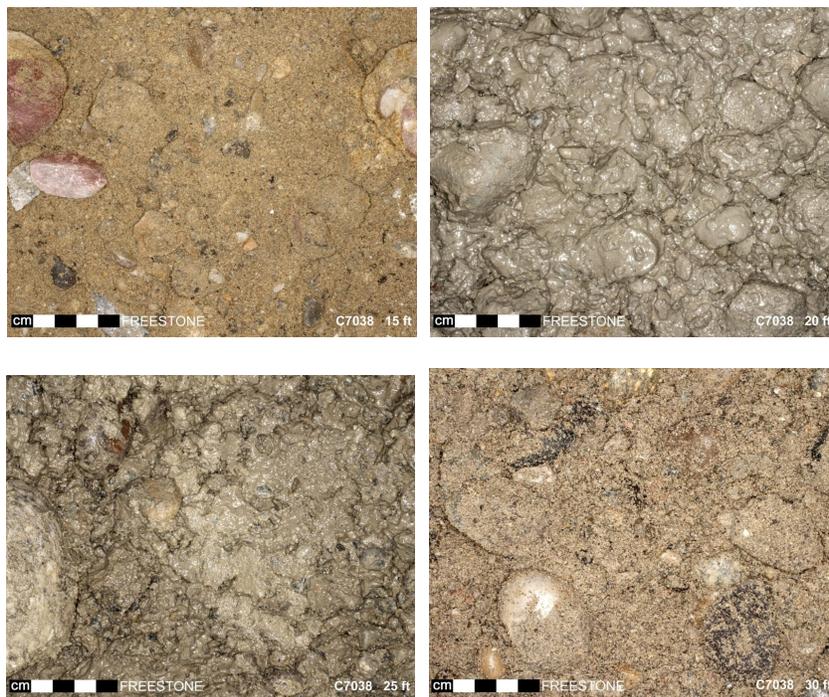
Figure 2. Pictures of core samples collected during drilling of 199-N-173

Pictures of the core samples indicated some irregularities at 20 feet bgs. Primarily, the color of the soil became grey and had a slimy appearance (Figure 2). However, the grain size distribution did not appear significantly different. This same grey color was observed in several soil samples collected along the shoreline. During drilling, there was a diesel odor noticed at the 20 foot depth (Appendix C). This was consistent with diesel odor associated with grey discoloration noted in samples collected along the Columbia River shoreline.

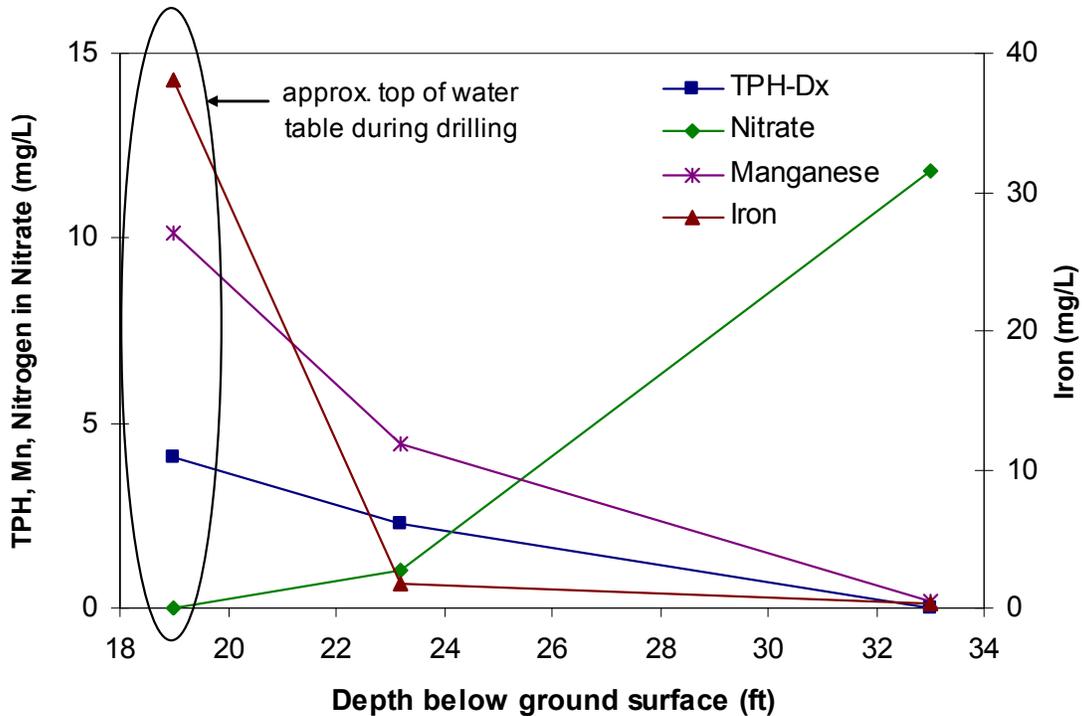
Figure 3. Concentrations of Selected Compounds Measured in Water Samples Collected During Drilling of Monitoring Well 199-N-173

Five aqueous samples were collected during drilling activities. These samples were collected from the top of the water table (2 samples), and then at various depths (Appendix B). For evaluation, results from three depths were evaluated; results from the two samples at the top of the aquifer were averaged into a single result, and the sample at the bottom of the well was from a different lithologic material, and was not considered representative. In general, chemical analysis of samples collected from the top of the aquifer identified the presence of TPH and provided evidence of microbial activity, and deeper samples indicated a decrease of TPH contamination with depth (Figure 3). At the top of the aquifer, TPH, iron, and manganese were elevated relative to the lower portion of the aquifer. The high iron and manganese concentrations are indicative of microbial activity; aqueous iron concentrations increase as bacteria use Fe(III) as an electron acceptor and reduce it to Fe(II), which is soluble in water. Manganese can be reduced in a similar manner, but is not present in sediment at the same quantity as iron. Microbial use of iron and manganese as an electron acceptor is not as thermodynamically favorable as the use of oxygen and nitrate. Dissolved oxygen levels in groundwater have been shown to be quite low (see section 3.3). Similarly, nitrate concentrations were very low at the top of the aquifer, and increased with depth. These data all indicate that bacteria are actively using the TPH contamination near the top of the aquifer as a carbon source. As the TPH concentrations decrease, the microbial activity also decreases, as evidenced by higher measured nitrate concentrations, and lower iron and manganese concentrations with increasing depth. Microbial activity and TPH degradation were confirmed by slurry reactor tests (see Section 3.4).

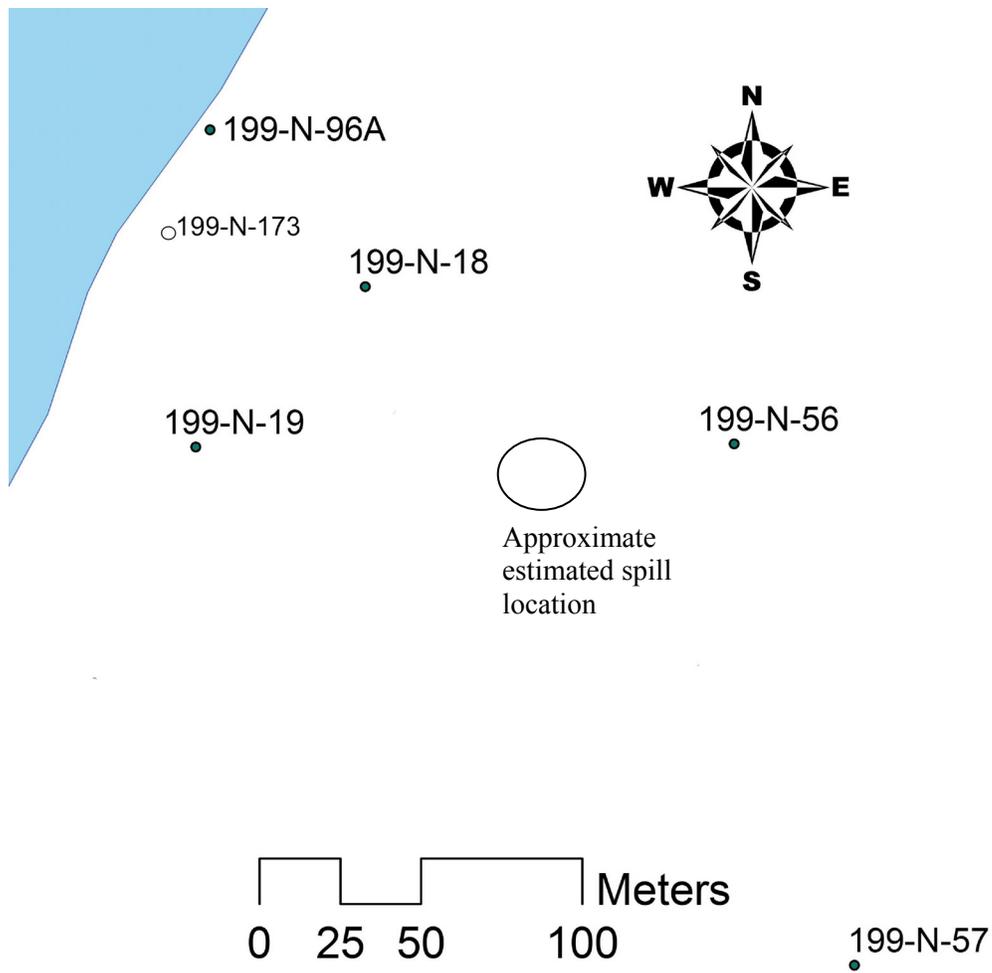
Figure 4. Locations with Water Level Monitoring Instrumentation Installed in 2008 (199-N-173 shown for reference only; water level monitoring began summer 2009).

Five groundwater wells in the vicinity of the TPH contaminant plume were instrumented with water level sensors (Figure 4). This was done to gain a better understanding of the groundwater gradient in this portion of the 100-N Area, and to evaluate the influence of fluctuating river stage at various distances away from the river. The instruments were PT2X temperature/pressure sensors housed within a self-contained data logger (Instrumentation Northwest, Kirkland, WA). Measurements were recorded every 15 minutes, beginning in early January 2009. Water depth was converted to head elevation by collecting periodic depth to water readings from vertically controlled points (top-of-casing). Hourly river stage elevation measurements were obtained from the Hanford Site Virtual Library. The data indicate that the water head elevation in all of the wells responded to changes in river stage, even 330 meters inland from the river (199-N-56). As expected, the wells closer to the river responded very rapidly to changes in river stage, while wells farther from the river responded slower, and with a dampened response (Figure 5).

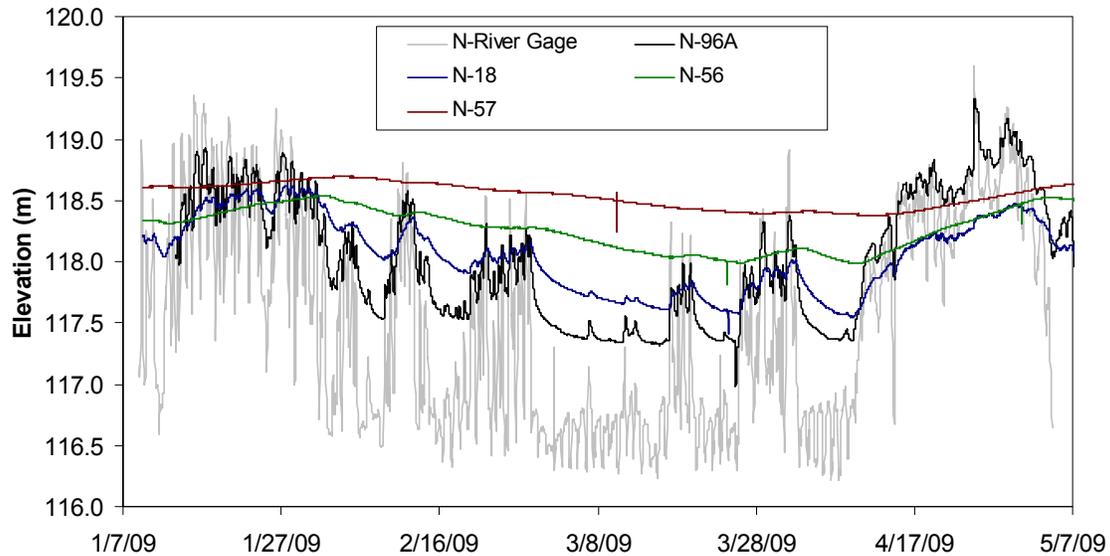
Figure 5. Groundwater Head Elevation Measured in the Vicinity of the Diesel Contamination Plume. Data from 199-N-19 not shown as it was nearly identical to data from 199-N-18.

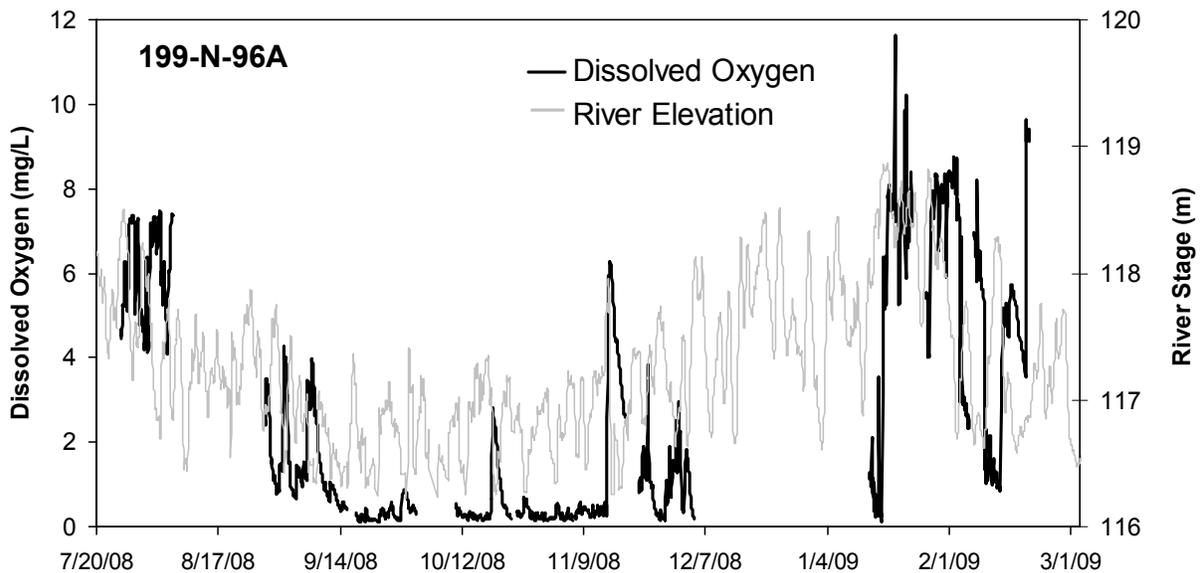
Figure 6. Dissolved Oxygen Concentrations Measured in 199-N-96

In 199-N-96A it is evident that the dissolved oxygen concentrations are impacted by seasonal river stage conditions as well as hourly river stage conditions (Figure 6). During the late summer, when the river stage is beginning to descend from the yearly high, dissolved oxygen concentrations were moderately high, indicating intrusion of oxygenated river water. This is supported by the lower specific conductance observed during this time. As the river stage decreased, the specific conductance increased, indicating a higher groundwater to river water mixing ratio. During this time, the dissolved oxygen concentration decreased below 1 mg/L. Although the seasonal pattern of dissolved oxygen response to river stage is typical (high river stage = high dissolved oxygen), the hourly fluctuations of dissolved oxygen are inversely proportional. When river stage increases, the dissolved oxygen concentration decreases.

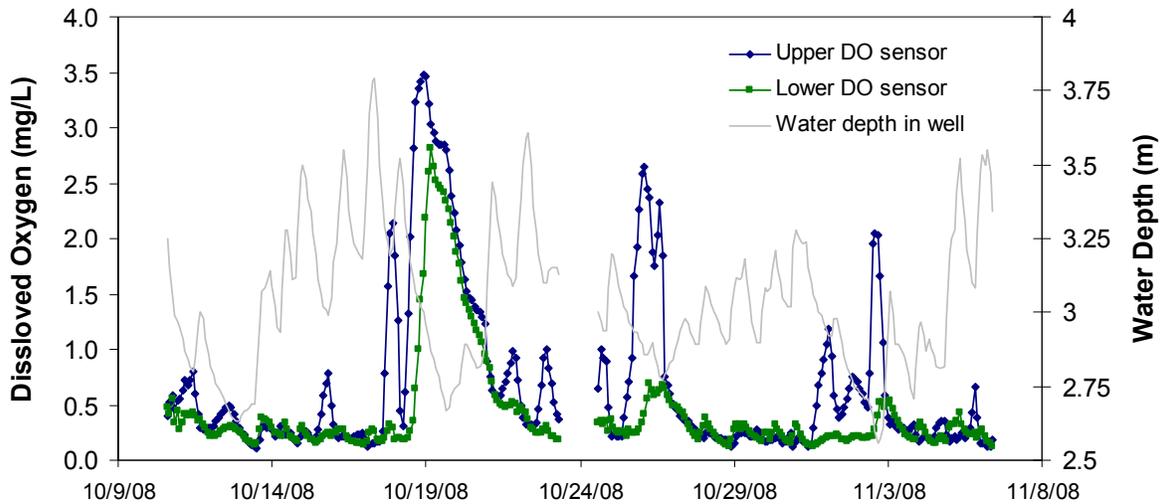
Figure 7. Dissolved Oxygen Measured at Two Locations in 199-N-96A; Near the Top and Bottom of the Screened Interval

This unusual pattern was further investigated by installing a pair of dissolved oxygen sensors in 199-N-96A; one near the bottom of the screen, and one near the top of the water table. During most time periods, the dissolved oxygen concentration was the same at the top and bottom of the screened interval (Figure 7). During some periods of rapid decrease in river stage, the top sensor measured an increase in dissolved oxygen concentration. The bottom sensor only measured a significant change in dissolved oxygen concentration a couple of times. One possible explanation for this unusual behavior is that 199 N-96A is on the very edge of the diesel contamination plume. During stable hydraulic conditions, microbial activity results in low dissolved oxygen concentrations. During rapid decreases in river stage, the hydraulic gradient changes such that water from outside of the diesel contamination plume (higher dissolved oxygen) moves into the well, primarily near the top of the water table.

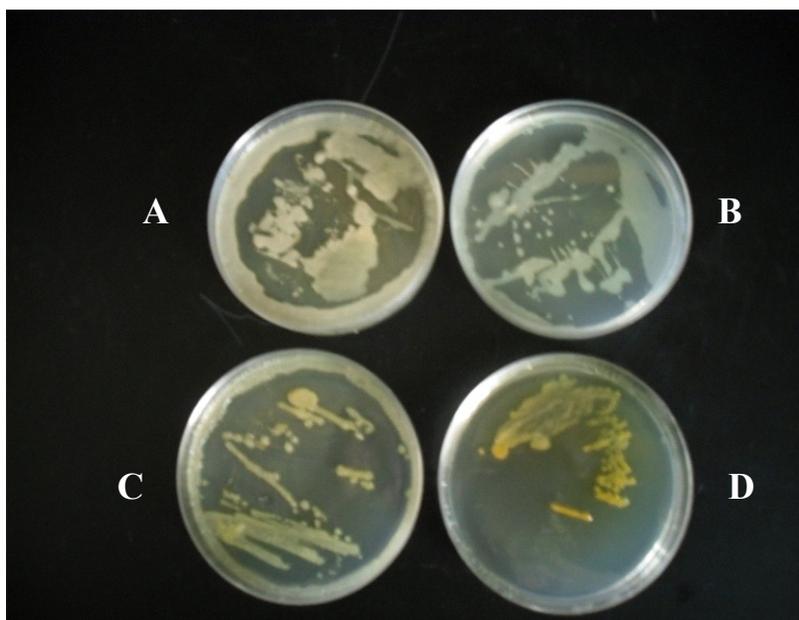
Figure 8. Agar Plates with Bacteria Growing on Them. Diesel fuel was the sole carbon source; sediment from: A-35 ft bgs, B- 17 ft, C- 15 ft, D- 17.5 to 20 ft.

In order to gain a better understanding of the morphology of the bacteria, regular agar plates were used to grow the bacteria. All bacteria were grown in the presence of diesel fuel (0.05 g per plate). The plates were inoculated with a sediment suspension from each of the monitoring well samples and allowed to dry. Diesel fuel was then spread thinly over the agar plate to act as a carbon and energy source. The diesel fuel was obtained from a local gas station. The plates were then incubated for approximately 30 days at 30° C under aerobic conditions. After completion of the incubation, the agar plates were assessed for positive results. Numerous plates indicated the presence of bacteria (Figure 8). The upper left plate is bacteria grown from the 35 ft bgs sediment, upper right is from sediment collected 17 ft bgs, lower left was inoculated with sediment from 15 ft bgs, and the lower right sample used sediment from 17.5-20 ft bgs. Clearing zones appeared around all the colonies indicating diesel degradation had occurred (Figure 8). The white bacteria growth on plates A and B (Figure 8) demonstrate the production of rhamnolipids, which are natural surfactants produced by some bacteria to aid in the mobilization of organics. The rhamnolipids make the organic compounds more readily available for biodegradation by the bacteria. The presence of rhamnolipid producing bacteria also likely explains the foamy water observed purging of well 199-N-173 (Appendix C).

The two tests indicated that bacteria, capable of using diesel as the sole carbon source, are present in the soil. The use of the mini-plate was meant to enumerate all diesel degrading species that may have been present while the larger agar plate provides a qualitative indication of the types of bacteria present.

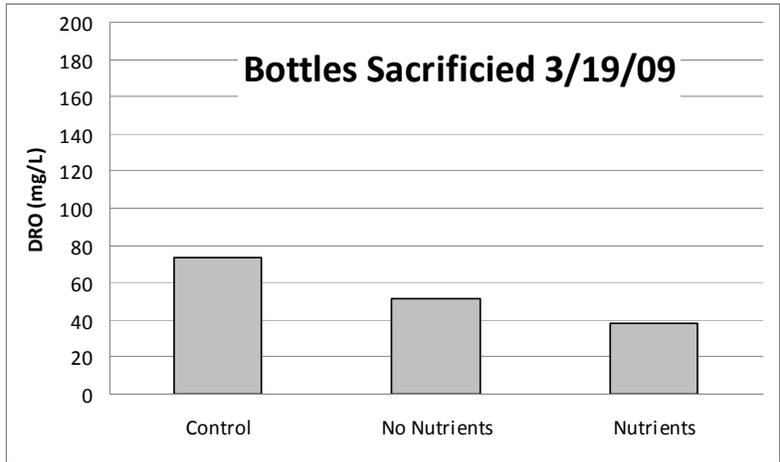
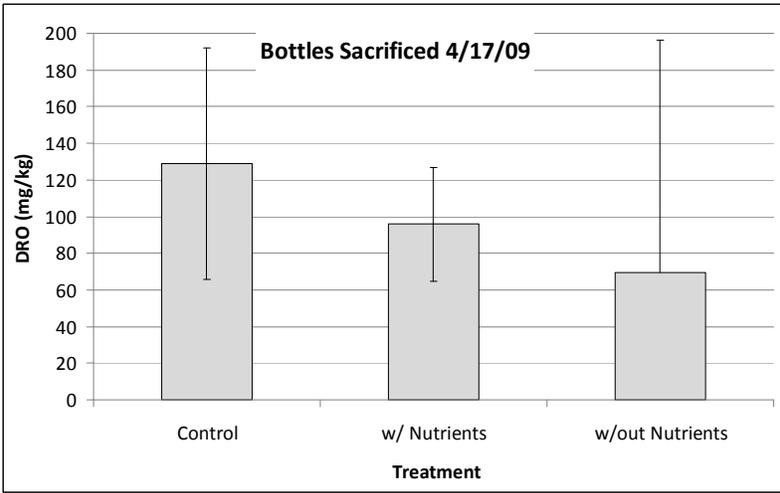
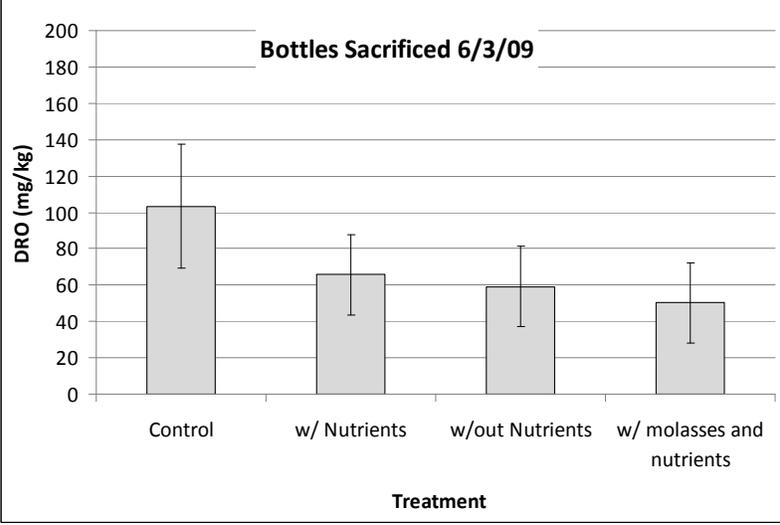
Figure 9. Results for Multiple Sets of Slurry Reactor Tests

After 17 days of incubation, the reactors were analyzed for diesel concentrations. The DRO concentrations were compared to the DRO concentrations in the sterile control reactors (Figure 9). Initial results demonstrate a reduction in diesel concentration for the reactors with nutrient addition relative to the control and the no-nutrient amendment. Repeat analysis reactors showed that the small apparent benefit of nutrient addition was not statistically significant relative to the no-nutrient tests. However, all of the slurry reactors demonstrated a statistically significant decrease in diesel concentration relative to the control. This indicates that natural attenuation of the diesel by microbial activity is occurring within the soil, enhancement or stimulation of the degradation process with the nutrients tried here would not be successful.

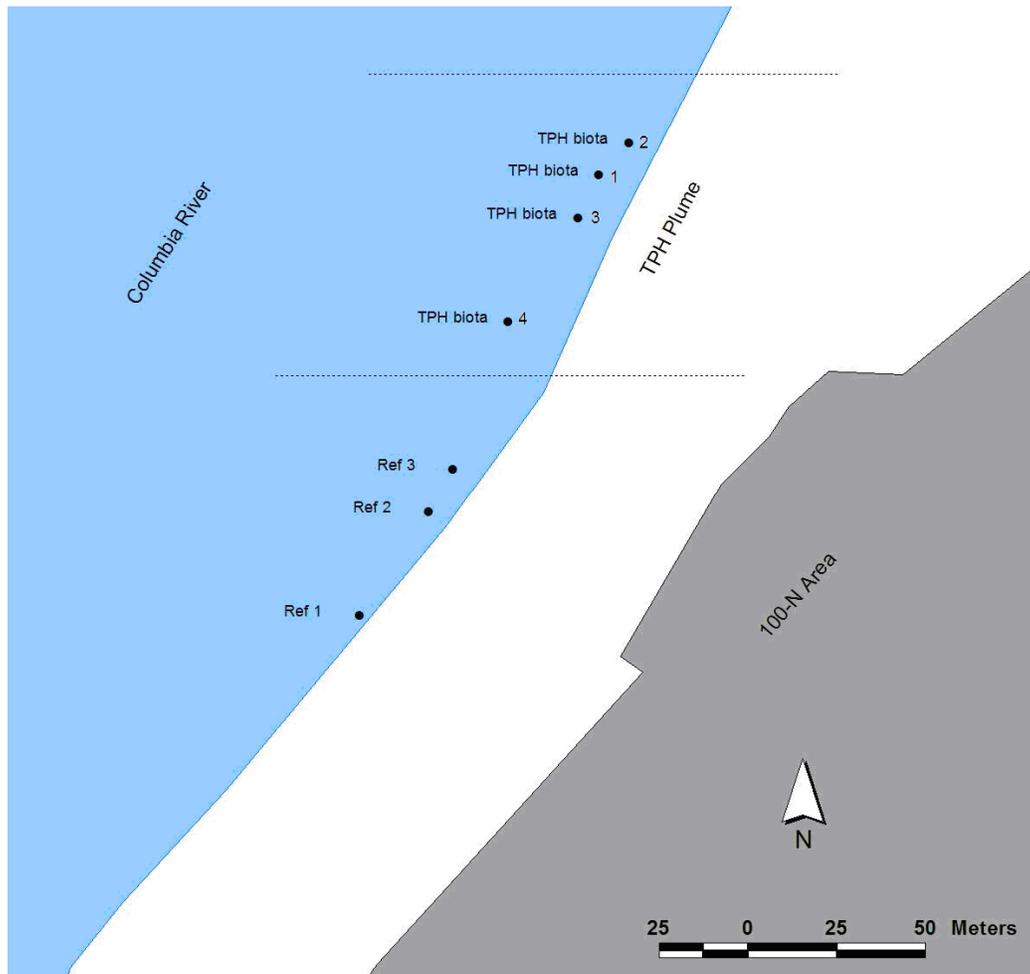
Figure 10. Periphyton and Clam Sampling Locations – September 2008

Periphyton and clam samples were collected from four locations along the 100-N shoreline within the perceived TPH plume discharge boundary. Three periphyton and three clam samples were also collected at a reference location directly upstream of the plume (Figure 10). All samples were collected at the same river depth at the green line. The green line is the minimum river stage elevation along this stretch of the Columbia River (nominally 117 m). The rocks on which the periphyton grow are always submerged, making for a high biological productivity area. The periphyton were scraped from the rocks immediately after the rocks were removed from the river. Clam samples were collected by plucking clams from the river bed. All samples were placed on ice after collection. The soft body tissues from 15-20 clams from each sampling location were removed from their shells in the laboratory within 6 hours of collection.

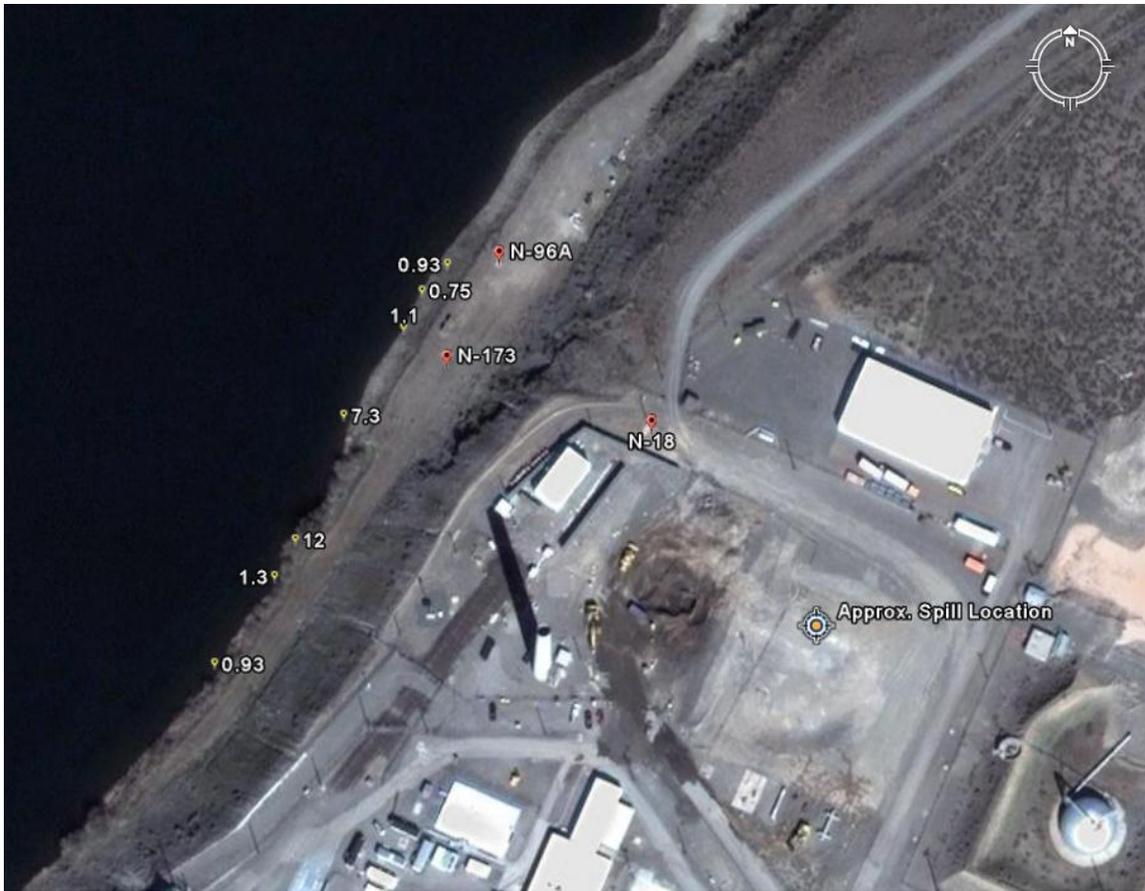
Figure 11. Fluorathene Concentrations Measured in Periphyton Samples Collected Along the 100-N Shoreline. Trend was similar for other PAHs.

Three periphyton samples from the upstream reference location and four from the TPH plume were analyzed for PAHs. In most cases, results for individual PAHs were below detection (0.5 ug/kg). In all cases, average concentration results from the upstream reference area were the same as or higher than the average concentrations measured in periphyton samples collected from the suspected TPH plume discharge area (Table 8). This appears to be a result of the reference samples not being collected far enough upstream. For most of the periphyton results, the PAH concentrations reported at TPH location 4 and Reference location 1 were significantly higher than concentrations reported at the other five sampling locations. For example, fluoranthene concentrations at these two locations were approximately 10 times higher than the concentration measured at the other five sampling locations (Figure 11). This trend was similar for all the PAHs measured at detectable concentrations.

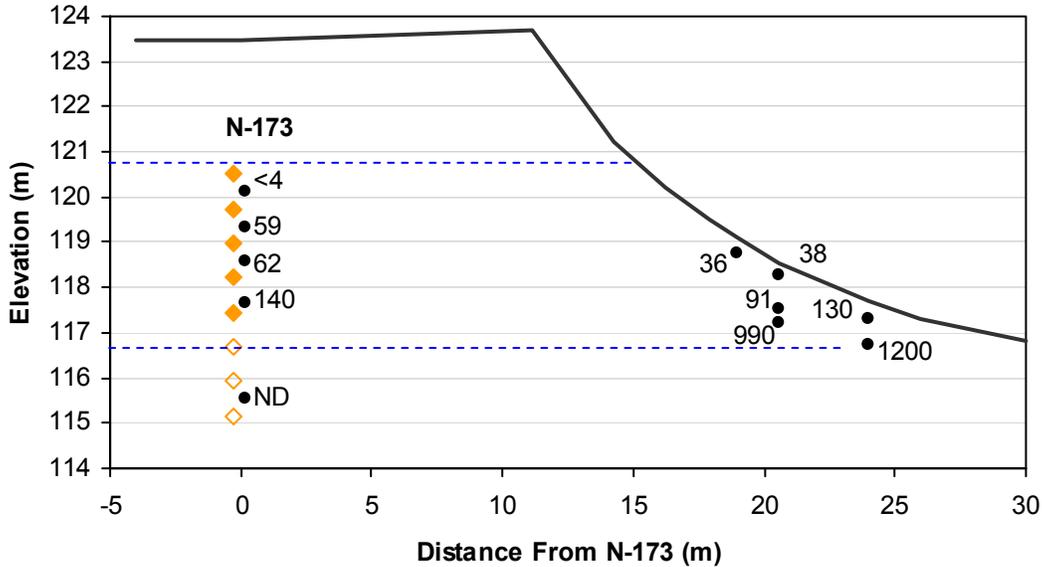
Figure 12. Concentrations of TPH-Dx measured in Sediment Samples Collected during Drilling of 199-N-173 and Along the Shoreline. Orange diamonds indicate where screening samples were collected (solid= detected, hollow= undetected). The blue lines represent nominal high and low water table elevations.

The concentrations of diesel in sediment measured in core samples from N-173 were compared against the concentrations measured along the shoreline. When compared spatially, the concentrations are relatively consistent at the two locations (Figure 12). The concentrations typically increase at lower elevations. The highest concentration measured at 199-N-173 was 140 mg/kg and occurred between 118.1 and 117.4 meters elevation. The two shoreline cores collected within this elevation range had measured diesel concentrations of 91 and 130 mg/kg. However, TPH results from the shoreline core samples and from the well are not necessarily directly comparable. The well samples were bulk material, whereas the samples collected from shoreline cores were size selective; material larger than ~5 mm was removed from the sample prior to analysis. For gravelly sediment, this could have biased the results from shoreline samples high.

Based on the field screening, the diesel concentration dropped below 15 mg/kg below 116.6 m elevation. The maximum sediment contamination may have been missed in 199-N-173 between 116.6 and 117.4 meters. This is the elevation range where the maximum TPH concentrations were measured in the shoreline core samples. However, the water sample collected at 116.4 m had lower measured diesel concentrations than the sample collected at 117.7 m. It is also worth noting that 116.6 m is at approximately the 5th percentile river state elevation; in other words, in the vicinity of 100-N, the river elevation only drops below 116.6 meters elevation about 5% of the time.

When all of these results are evaluated together, it would appear to indicate that the diesel contamination is confined to the ‘smear zone’, or that portion of the vadose zone that is occasionally saturated. This is not too surprising since diesel has a lower specific gravity than water. It would tend to float on top of the water table, making it less likely for sorption onto sediment to occur below the low water table elevation. It is important to note that the water samples collected along the shoreline were collected at elevations ranging between 116 and 117 meters, or likely near the bottom edge of the vertical extent of diesel contamination.

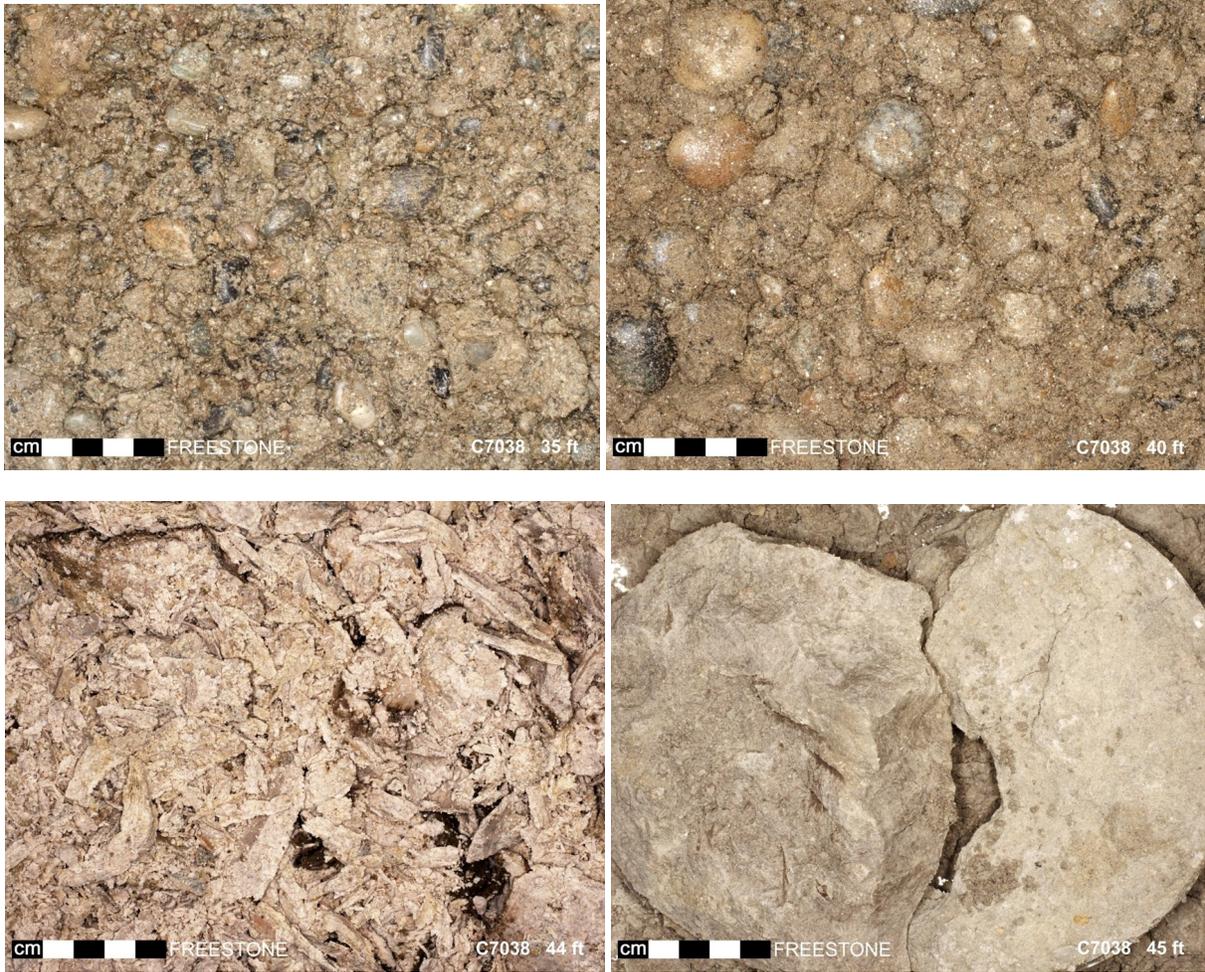
Figure C.2. Additional Pictures of Core Samples Collected From Monitoring Well 199-N-173

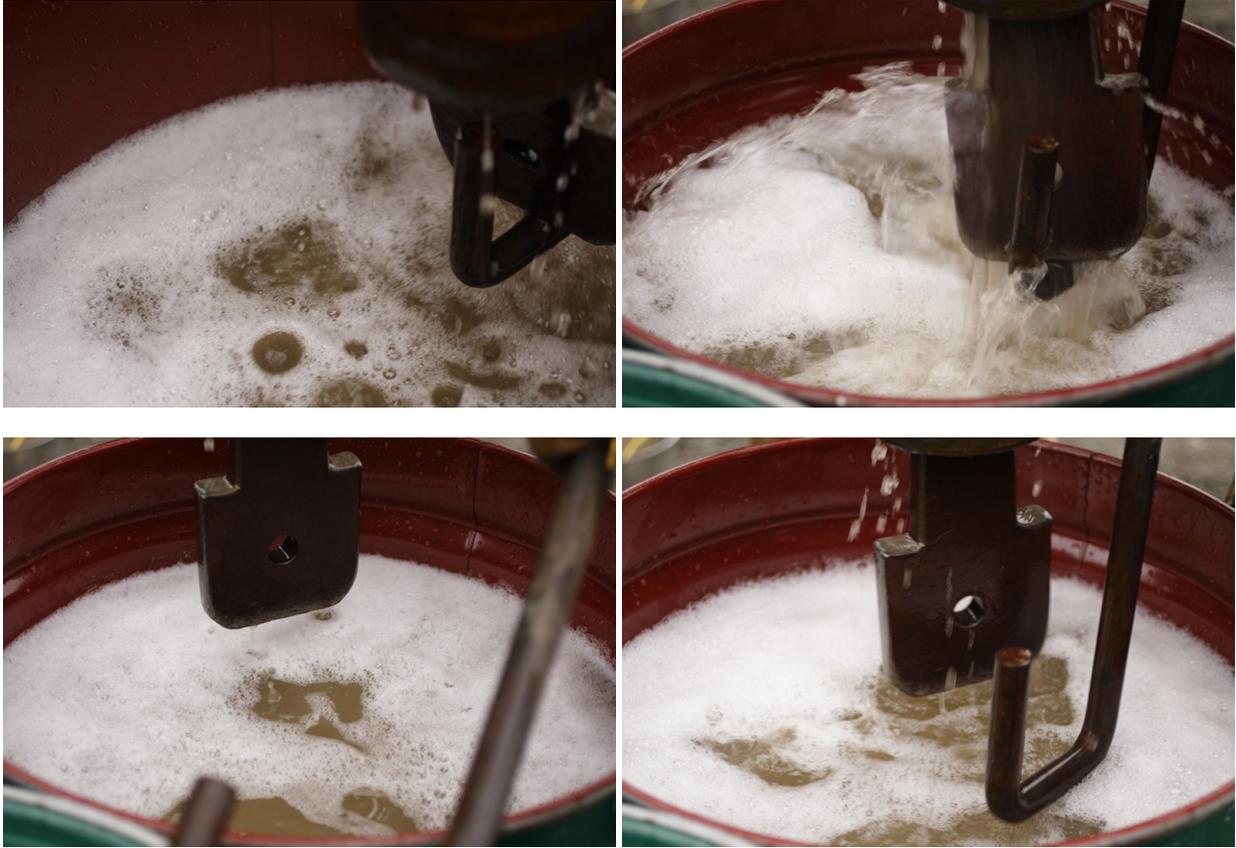
Figure C.3. Examples of the Unusual Foamy Water Observed During Drilling and Development of Monitoring Well 199-N-173
