U.S. DEPARTMENT OF
ENERGY

PNNL-18645, Rev.1

Summary of TPH Monitoring Conducted at 100-NR-2- 2008 through 2010

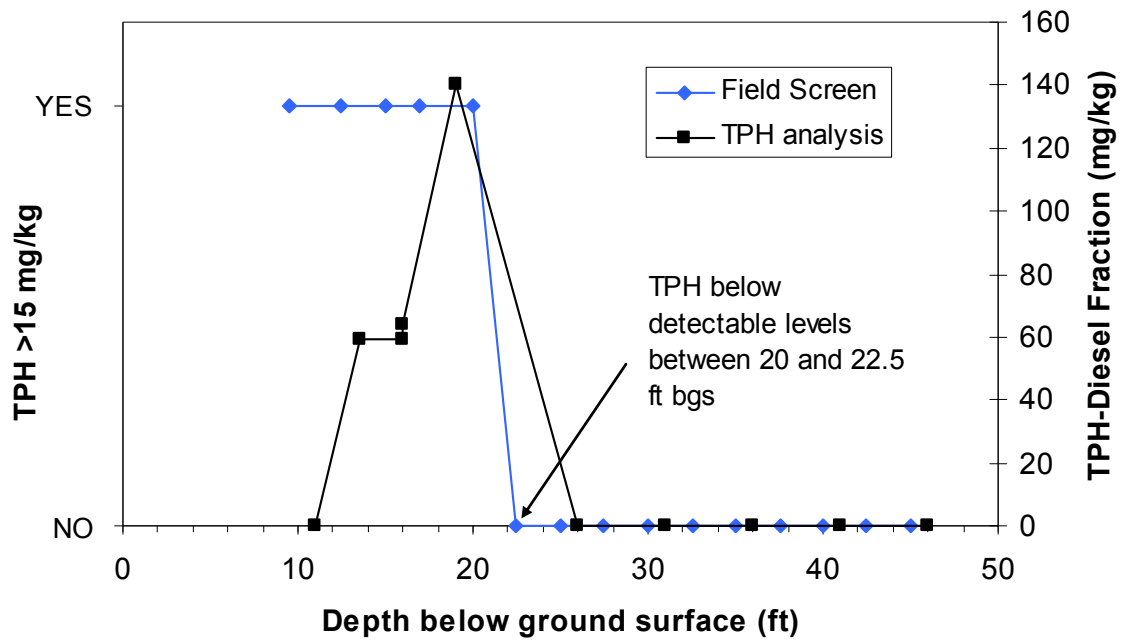
Figure 1. Concentrations and Screening Results for TPH Measured in Samples Collected During Drilling of Monitoring Well 199-N-173

The field screening for TPH indicated the presence of diesel contamination between 9.5 and 20 feet bgs at concentrations exceeding 15 mg/kg. This was consistent with the results from the core samples (Figure 1). The core sample results indicate that the concentrations increased with depth up to 20 feet bgs. Below 20 feet bgs, the TPH concentrations in sediment were below detectable concentrations (~4 mg/kg). The metals concentrations observed in core samples collected from 199-N-173 appeared to vary some with depth; however, the variation was probably associated with lithological changes rather than the presence of contaminants (Appendix C). Core samples were analyzed for 99 organic compounds; only 7 were measured at detectable concentrations in any of the core samples (Table 5, Appendix B). These concentrations were at or below the MTCA Method A soil cleanup levels for unrestricted use (Table 740-1, WAC 173-340-740) for the detectable compounds. It should be emphasized that the data presented here is for a handful of samples collected from a single location; further sampling from boreholes in this area may reveal different information.

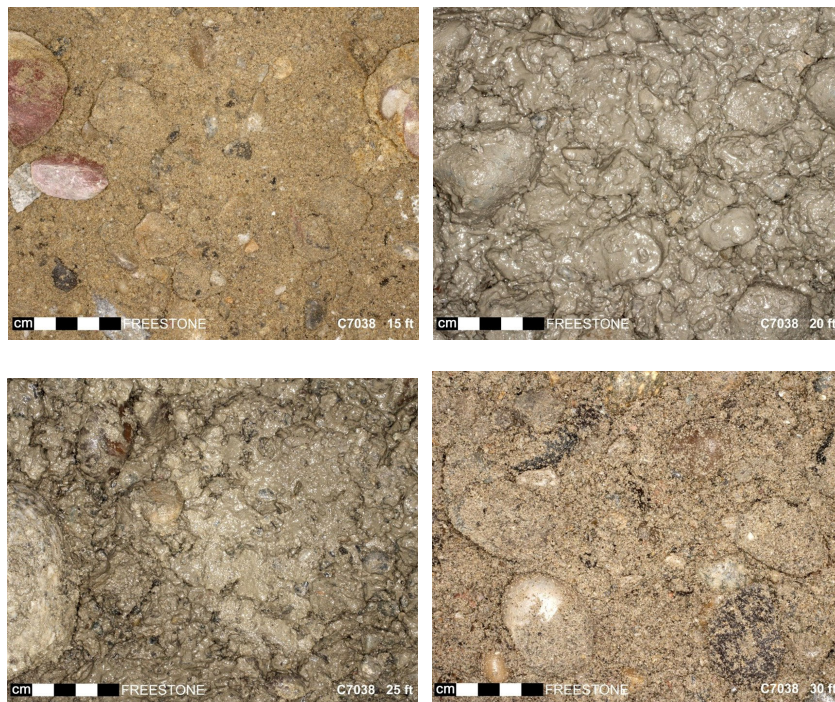
Figure 2. Pictures of core samples collected during drilling of 199-N-173

Pictures of the core samples indicated some irregularities at 20 feet bgs. Primarily, the color of the soil became grey and had a slimy appearance (Figure 2). However, the grain size distribution did not appear significantly different. This same grey color was observed in several soil samples collected along the shoreline. During drilling, there was a diesel odor noticed at the 20 foot depth (Appendix C). This was consistent with diesel odor associated with grey discoloration noted in samples collected along the Columbia River shoreline.

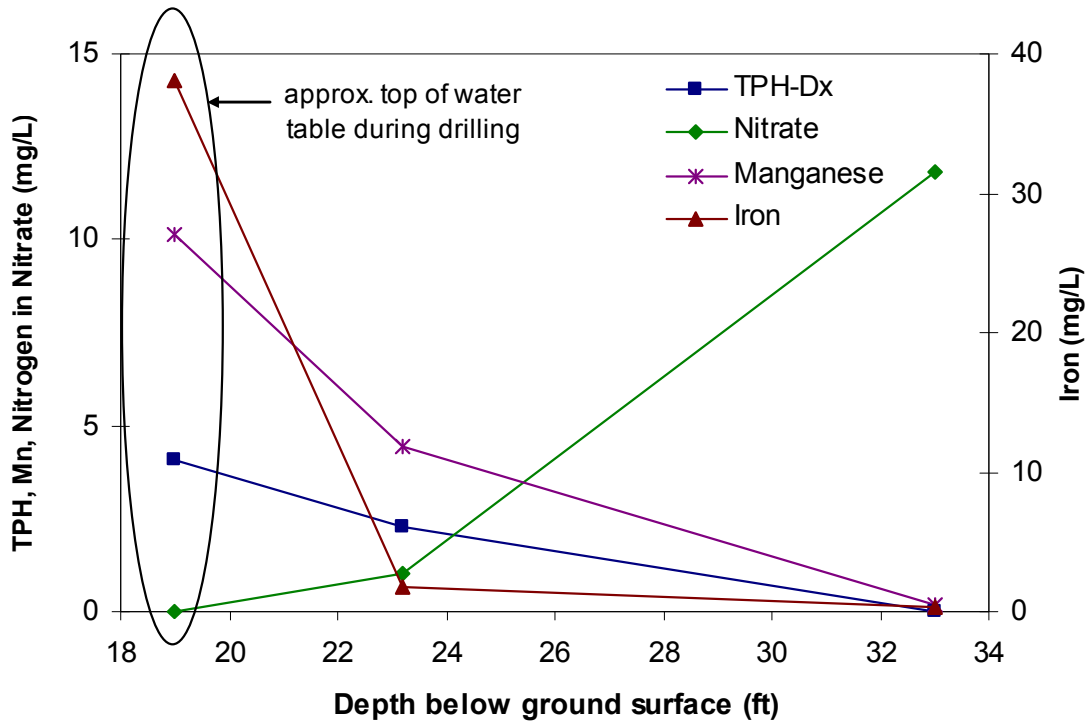
Figure 3. Concentrations of Selected Compounds Measured in Water Samples Collected During Drilling of Monitoring Well 199-N-173

Five aqueous samples were collected during drilling activities. These samples were collected from the top of the water table (2 samples), and then at various depths (Appendix B). For evaluation, results from three depths were evaluated; results from the two samples at the top of the aquifer were averaged into a single result, and the sample at the bottom of the well was from a different lithologic material, and was not considered representative. In general, chemical analysis of samples collected from the top of the aquifer identified the presence of TPH and provided evidence of microbial activity, and deeper samples indicated a decrease of TPH contamination with depth (Figure 3). At the top of the aquifer, TPH, iron, and manganese were elevated relative to the lower portion of the aquifer. The high iron and manganese concentrations are indicative of microbial activity; aqueous iron concentrations increase as bacteria use Fe(III) as an electron acceptor and reduce it to Fe(II), which is soluble in water. Manganese can be reduced in a similar manner, but is not present in sediment at the same quantity as iron. Microbial use of iron and manganese as an electron acceptor is not as thermodynamically favorable as the use of oxygen and nitrate. Dissolved oxygen levels in groundwater have been shown to be quite low (see section 3.3). Similarly, nitrate concentrations were very low at the top of the aquifer, and increased with depth. These data all indicate that bacteria are actively using the TPH contamination near the top of the aquifer as a carbon source. As the TPH concentrations decrease, the microbial activity also decreases, as evidenced by higher measured nitrate concentrations, and lower iron and manganese concentrations with increasing depth. Microbial activity and TPH degradation were confirmed by slurry reactor tests (see Section 3.4).

Other contaminants were also detected in aqueous samples collected from 199-N-173 during drilling. Several of these contaminants were detected at concentrations that approach or exceed the Groundwater Quality Criteria or Drinking Water Standards established by the WAC Code (173-200-040 and 246-290-310, respectively) (Table 6). Several of these contaminants do not originate from the diesel fuel spill (nitrate, sulfate, specific conductance, strontium-90), and iron is likely only high because of microbial activity (this iron would be insoluble in oxygenated water). It is also important to note that

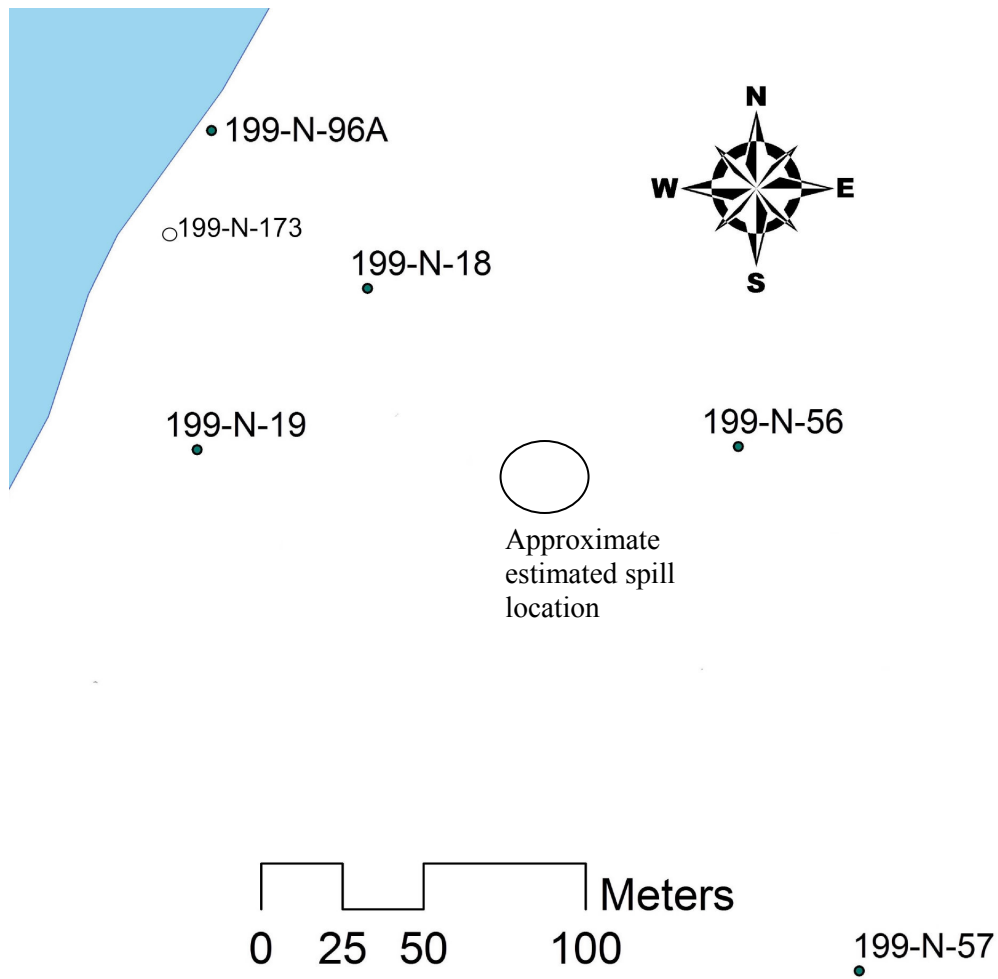
Figure 4. Locations with Water Level Monitoring Instrumentation Installed in 2008 (199-N-173 shown for reference only; water level monitoring began summer 2009).

Five groundwater wells in the vicinity of the TPH contaminant plume were instrumented with water level sensors (Figure 4). This was done to gain a better understanding of the groundwater gradient in this portion of the 100-N Area, and to evaluate the influence of fluctuating river stage at various distances away from the river. The instruments were PT2X temperature/pressure sensors housed within a self-contained data logger (Instrumentation Northwest, Kirkland, WA). Measurements were recorded every 15 minutes, beginning in early January 2009. Water depth was converted to head elevation by collecting periodic depth to water readings from vertically controlled points (top-of-casing). Hourly river stage elevation measurements were obtained from the Hanford Site Virtual Library. The data indicate that the water head elevation in all of the wells responded to changes in river stage, even 330 meters inland from the river (199-N-56). As expected, the wells closer to the river responded very rapidly to changes in river stage, while wells farther from the river responded slower, and with a dampened response (Figure 5).

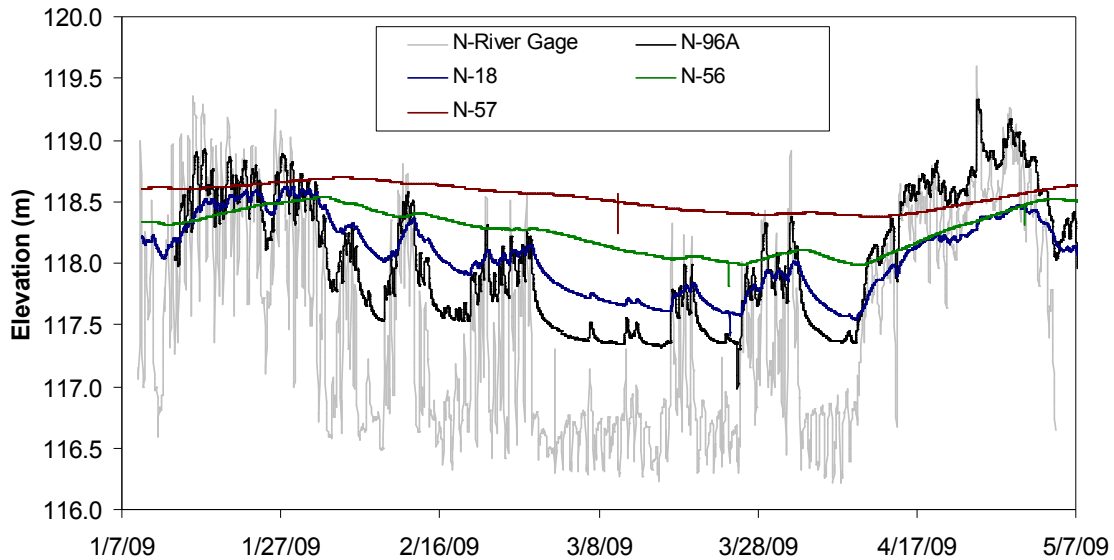
Figure 5. Groundwater Head Elevation Measured in the Vicinity of the Diesel Contamination Plume. Data from 199-N-19 not shown as it was nearly identical to data from 199-N-18.

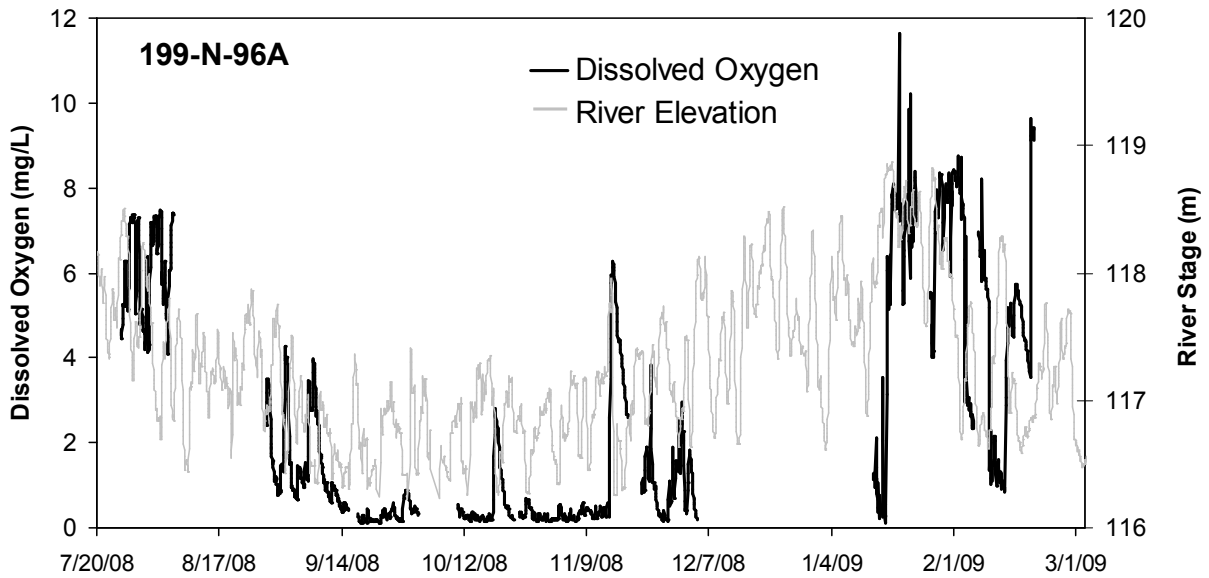
Figure 6. Dissolved Oxygen Concentrations Measured in 199-N-96

In 199-N-96A it is evident that the dissolved oxygen concentrations are impacted by seasonal river stage conditions as well as hourly river stage conditions (Figure 6). During the late summer, when the river stage is beginning to descend from the yearly high, dissolved oxygen concentrations were moderately high, indicating intrusion of oxygenated river water. This is supported by the lower specific conductance observed during this time. As the river stage decreased, the specific conductance increased, indicating a higher groundwater to river water mixing ratio. During this time, the dissolved oxygen concentration decreased below 1 mg/L. Although the seasonal pattern of dissolved oxygen response to river stage is typical (high river stage = high dissolved oxygen), the hourly fluctuations of dissolved oxygen are inversely proportional. When river stage increases, the dissolved oxygen concentration decreases.

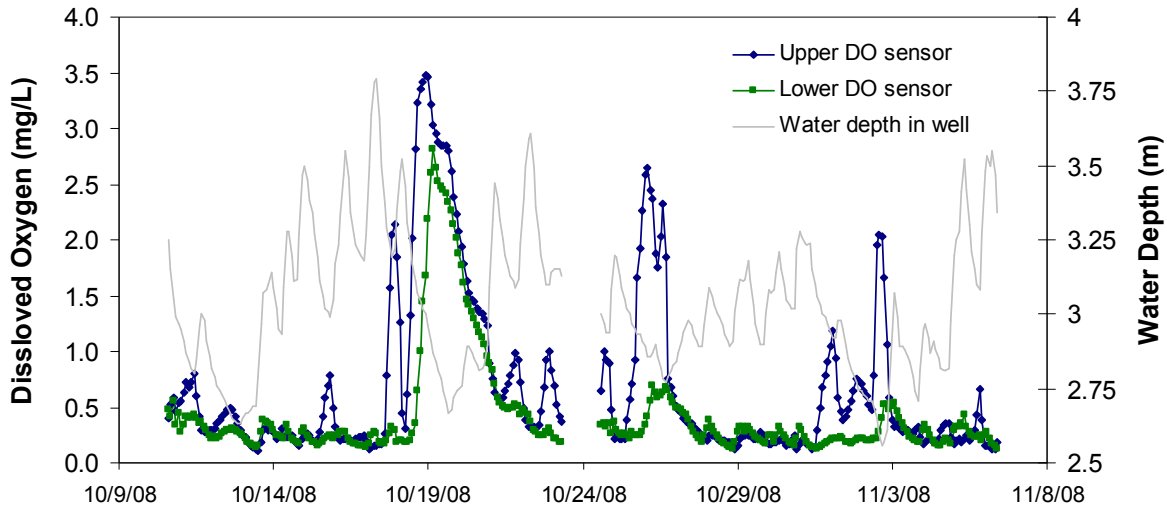
Figure 7. Dissolved Oxygen Measured at Two Locations in 199-N-96A; Near the Top and Bottom of the Screened Interval

This unusual pattern was further investigated by installing a pair of dissolved oxygen sensors in 199-N-96A; one near the bottom of the screen, and one near the top of the water table. During most time periods, the dissolved oxygen concentration was the same at the top and bottom of the screened interval (Figure 7). During some periods of rapid decrease in river stage, the top sensor measured an increase in dissolved oxygen concentration. The bottom sensor only measured a significant change in dissolved oxygen concentration a couple of times. One possible explanation for this unusual behavior is that 199 N-96A is on the very edge of the diesel contamination plume. During stable hydraulic conditions, microbial activity results in low dissolved oxygen concentrations. During rapid decreases in river stage, the hydraulic gradient changes such that water from outside of the diesel contamination plume (higher dissolved oxygen) moves into the well, primarily near the top of the water table.

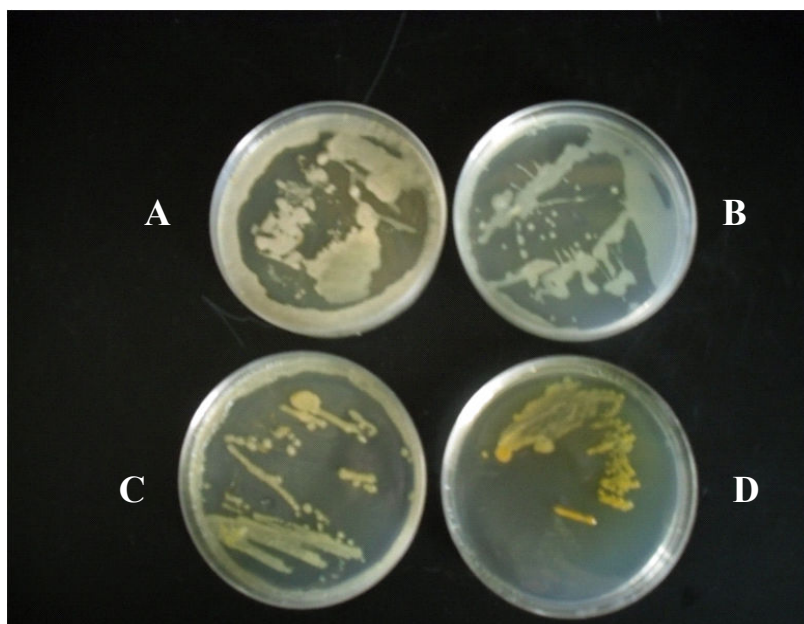
Figure 8. Agar Plates with Bacteria Growing on Them. Diesel fuel was the sole carbon source; sediment from: A-35 ft bgs, B- 17 ft, C- 15 ft, D- 17.5 to 20 ft.

In order to gain a better understanding of the morphology of the bacteria, regular agar plates were used to grow the bacteria. All bacteria were grown in the presence of diesel fuel (0.05 g per plate). The plates were inoculated with a sediment suspension from each of the monitoring well samples and allowed to dry. Diesel fuel was then spread thinly over the agar plate to act as a carbon and energy source. The diesel fuel was obtained from a local gas station. The plates were then incubated for approximately 30 days at 30° C under aerobic conditions. After completion of the incubation, the agar plates were assessed for positive results. Numerous plates indicated the presence of bacteria (Figure 8). The upper left plate is bacteria grown from the 35 ft bgs sediment, upper right is from sediment collected 17 ft bgs, lower left was inoculated with sediment from 15 ft bgs, and the lower right sample used sediment from 17.5-20 ft bgs. Clearing zones appeared around all the colonies indicating diesel degradation had occurred (Figure 8). The white bacteria growth on plates A and B (Figure 8) demonstrate the production of rhamnolipids, which are natural surfactants produced by some bacteria to aid in the mobilization of organics. The rhamnolipids make the organic compounds more readily available for biodegradation by the bacteria. The presence of rhamnolipid producing bacteria also likely explains the foamy water observed purging of well 199-N-173 (Appendix C).

The two tests indicated that bacteria, capable of using diesel as the sole carbon source, are present in the soil. The use of the mini-plate was meant to enumerate all diesel degrading species that may have been present while the larger agar plate provides a qualitative indication of the types of bacteria present.

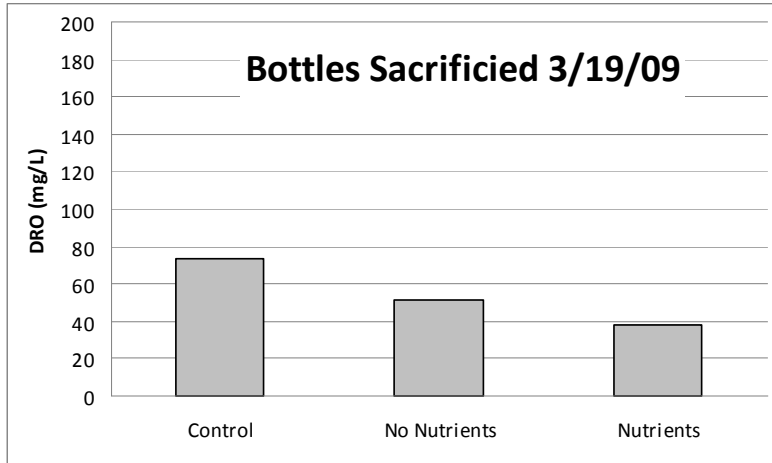
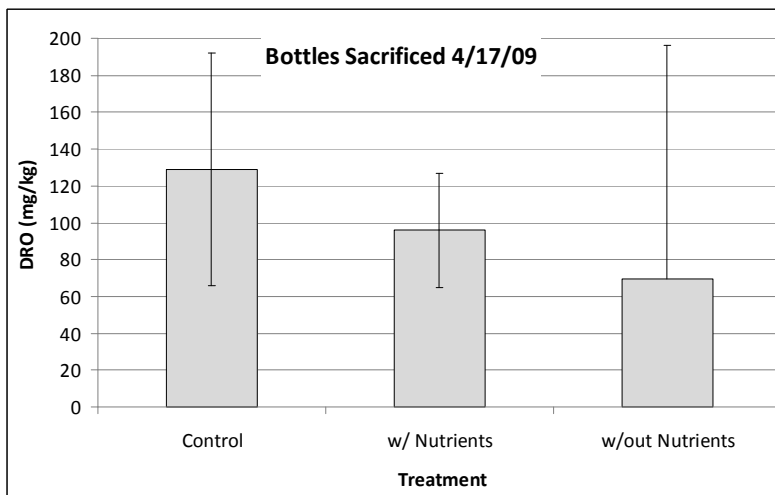
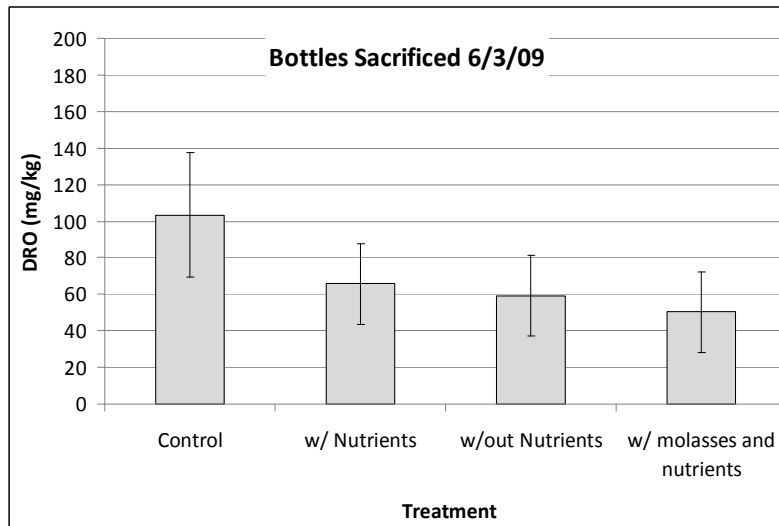
Figure 9. Results for Multiple Sets of Slurry Reactor Tests

Slurry reactors were used to determine the rate at which the bacteria could degrade diesel. Sediment from the 20 ft bgs sample was used. Seven grams of soil (wet weight) and 110 mL of sterile (autoclaved) tap water were added to the reactors. A number of reactors were prepared and separated into different groups. The first group was used as a control; phosphate and ammonia (0.62mM and 3.8 mM

respectively) were added along with 0.1 M sodium azide to prevent bacterial growth. Other groups of reactors were prepared with nutrients (ammonia and phosphate), with nutrients and an additional carbon source (ammonia, phosphate and 500 mg/L molasses) and without nutrients. Reactors from different groups were sacrificed and total concentration of soil-phase diesel range organics (DRO) were determined by extraction/concentration in methylene chloride with quantification by gas chromatography/flame ionization detector (FID). The control and ammonia/phosphate reactors were prepared on March 2, 2009. Ammonia levels were maintained at constant levels throughout the experiment by monitoring ammonia concentrations and adding additional mass to maintain the target concentration.

After 17 days of incubation, the reactors were analyzed for diesel concentrations. The DRO concentrations were compared to the DRO concentrations in the sterile control reactors (Figure 9). Initial results demonstrate a reduction in diesel concentration for the reactors with nutrient addition relative to the control and the no-nutrient amendment. Repeat analysis reactors showed that the small apparent benefit of nutrient addition was not statistically significant relative to the no-nutrient tests. However, all of the slurry reactors demonstrated a statistically significant decrease in diesel concentration relative to the control. This indicates that natural attenuation of the diesel by microbial activity is occurring within the soil, enhancement or stimulation of the degradation process with the nutrients tried here would not be successful.

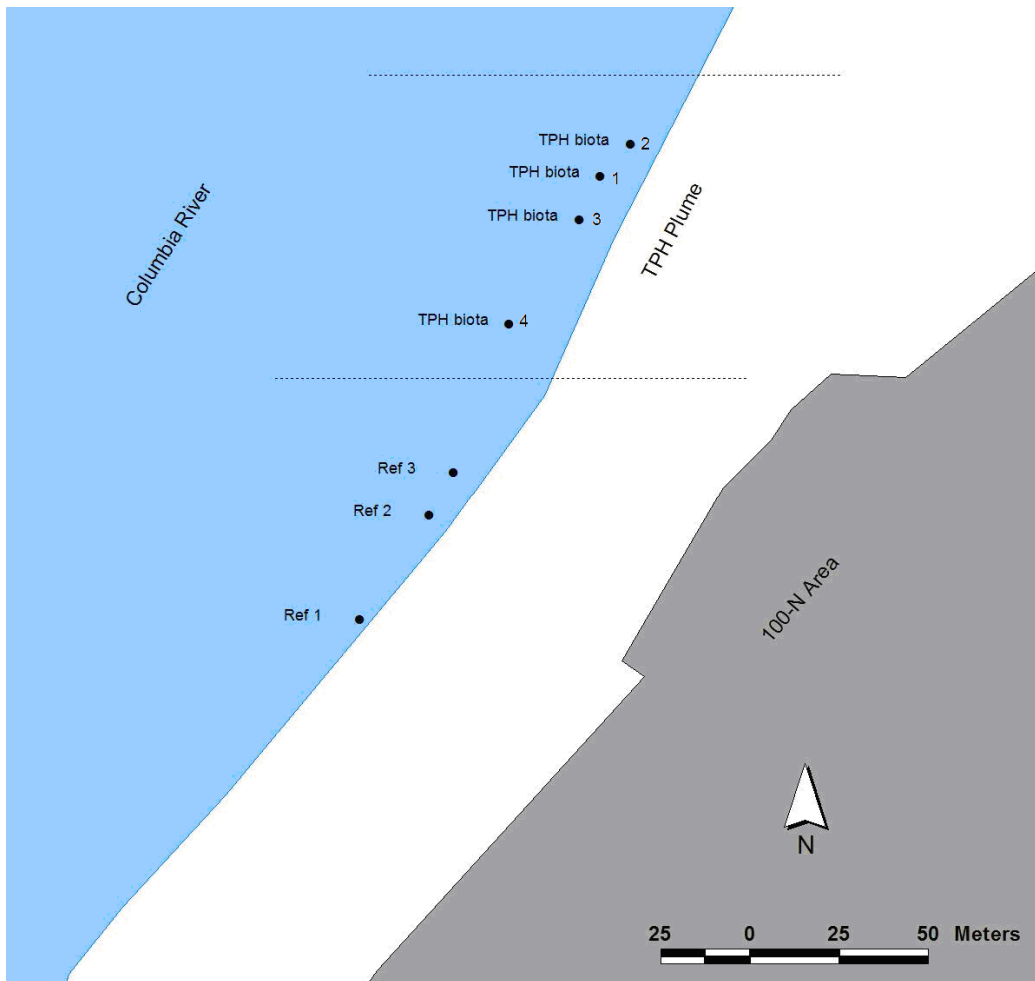
Figure 10. Periphyton and Clam Sampling Locations – September 2008

Periphyton and clam samples were collected from four locations along the 100-N shoreline within the perceived TPH plume discharge boundary. Three periphyton and three clam samples were also collected at a reference location directly upstream of the plume (Figure 10). All samples were collected at the same river depth at the green line. The green line is the minimum river stage elevation along this stretch of the Columbia River (nominally 117 m). The rocks on which the periphyton grow are always submerged, making for a high biological productivity area. The periphyton were scraped from the rocks immediately after the rocks were removed from the river. Clam samples were collected by plucking clams from the river bed. All samples were placed on ice after collection. The soft body tissues from 15-20 clams from each sampling location were removed from their shells in the laboratory within 6 hours of collection.

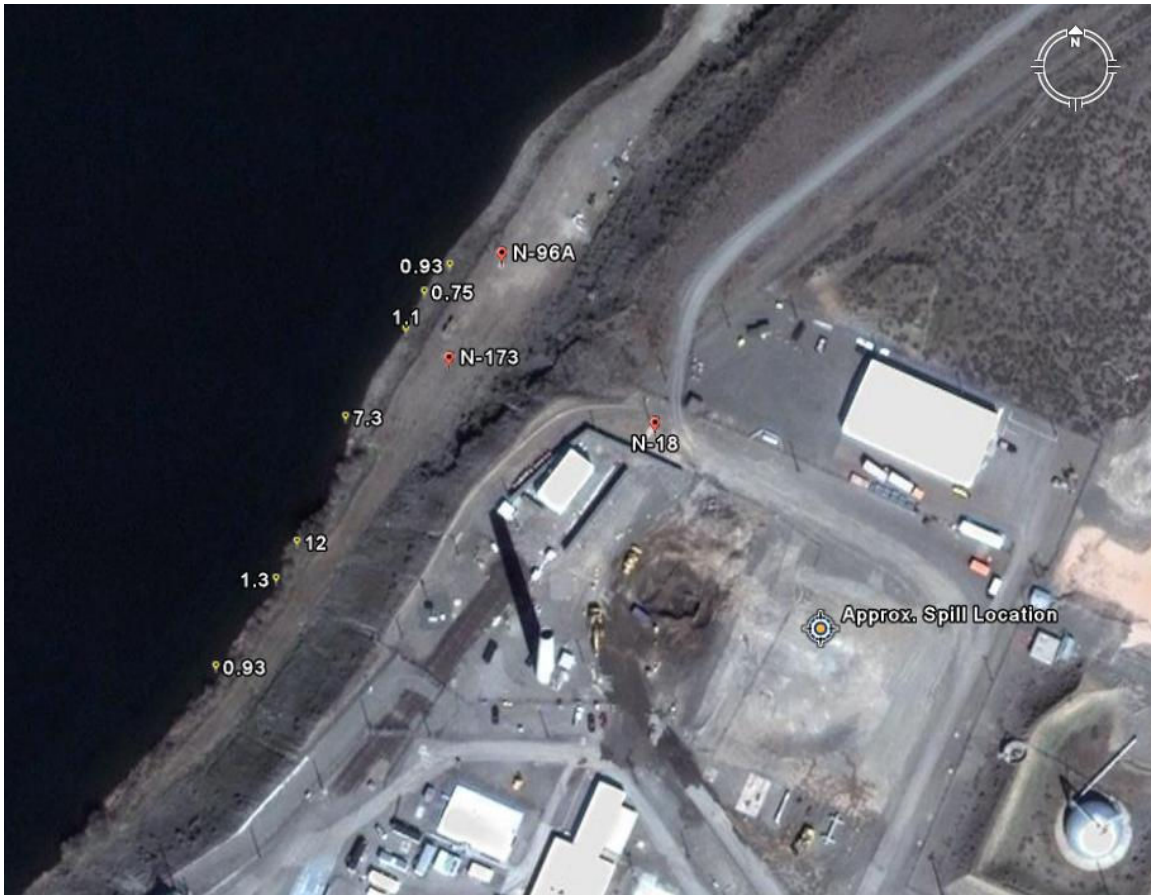
Figure 11. Fluorathene Concentrations Measured in Periphyton Samples Collected Along the 100-N Shoreline. Trend was similar for other PAHs.

Three periphyton samples from the upstream reference location and four from the TPH plume were analyzed for PAHs. In most cases, results for individual PAHs were below detection (0.5 ug/kg). In all cases, average concentration results from the upstream reference area were the same as or higher than the average concentrations measured in periphyton samples collected from the suspected TPH plume discharge area (Table 8). This appears to be a result of the reference samples not being collected far enough upstream. For most of the periphyton results, the PAH concentrations reported at TPH location 4 and Reference location 1 were significantly higher than concentrations reported at the other five sampling locations. For example, fluoranthene concentrations at these two locations were approximately 10 times higher than the concentration measured at the other five sampling locations (Figure 11). This trend was similar for all the PAHs measured at detectable concentrations.

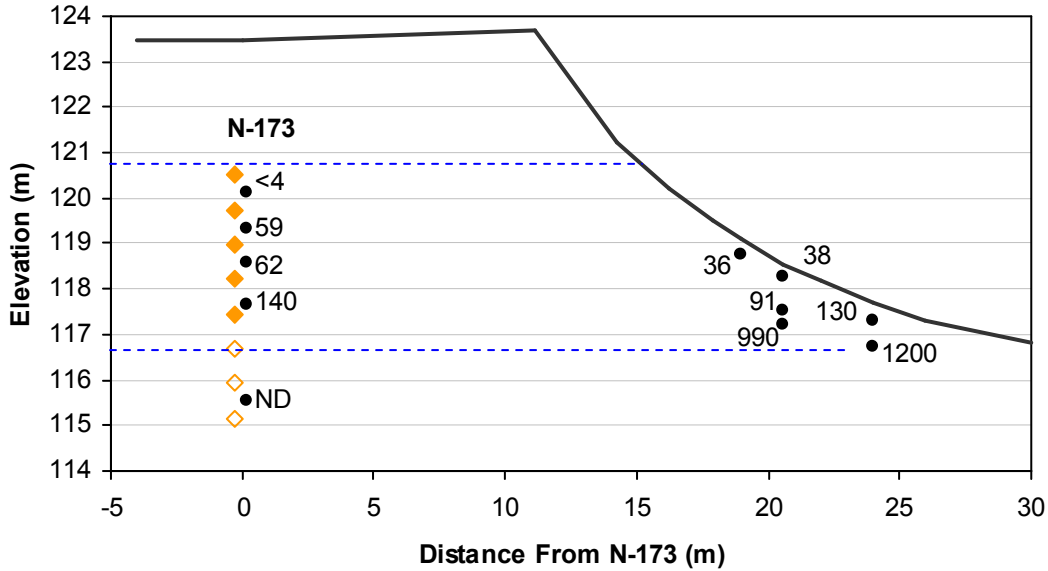
Figure 12. Concentrations of TPH-Dx measured in Sediment Samples Collected during Drilling of 199-N-173 and Along the Shoreline. Orange diamonds indicate where screening samples were collected (solid= detected, hollow= undetected). The blue lines represent nominal high and low water table elevations.

The concentrations of diesel in sediment measured in core samples from N-173 were compared against the concentrations measured along the shoreline. When compared spatially, the concentrations are relatively consistent at the two locations (Figure 12). The concentrations typically increase at lower elevations. The highest concentration measured at 199-N-173 was 140 mg/kg and occurred between 118.1 and 117.4 meters elevation. The two shoreline cores collected within this elevation range had measured diesel concentrations of 91 and 130 mg/kg. However, TPH results from the shoreline core samples and from the well are not necessarily directly comparable. The well samples were bulk material, whereas the samples collected from shoreline cores were size selective; material larger than ~5 mm was removed from the sample prior to analysis. For gravelly sediment, this could have biased the results from shoreline samples high.

Based on the field screening, the diesel concentration dropped below 15 mg/kg below 116.6 m elevation. The maximum sediment contamination may have been missed in 199-N-173 between 116.6 and 117.4 meters. This is the elevation range where the maximum TPH concentrations were measured in the shoreline core samples. However, the water sample collected at 116.4 m had lower measured diesel concentrations than the sample collected at 117.7 m. It is also worth noting that 116.6 m is at approximately the 5th percentile river state elevation; in other words, in the vicinity of 100-N, the river elevation only drops below 116.6 meters elevation about 5% of the time.

When all of these results are evaluated together, it would appear to indicate that the diesel contamination is confined to the ‘smear zone’, or that portion of the vadose zone that is occasionally saturated. This is not too surprising since diesel has a lower specific gravity than water. It would tend to float on top of the water table, making it less likely for sorption onto sediment to occur below the low water table elevation. It is important to note that the water samples collected along the shoreline were collected at elevations ranging between 116 and 117 meters, or likely near the bottom edge of the vertical extent of diesel contamination.

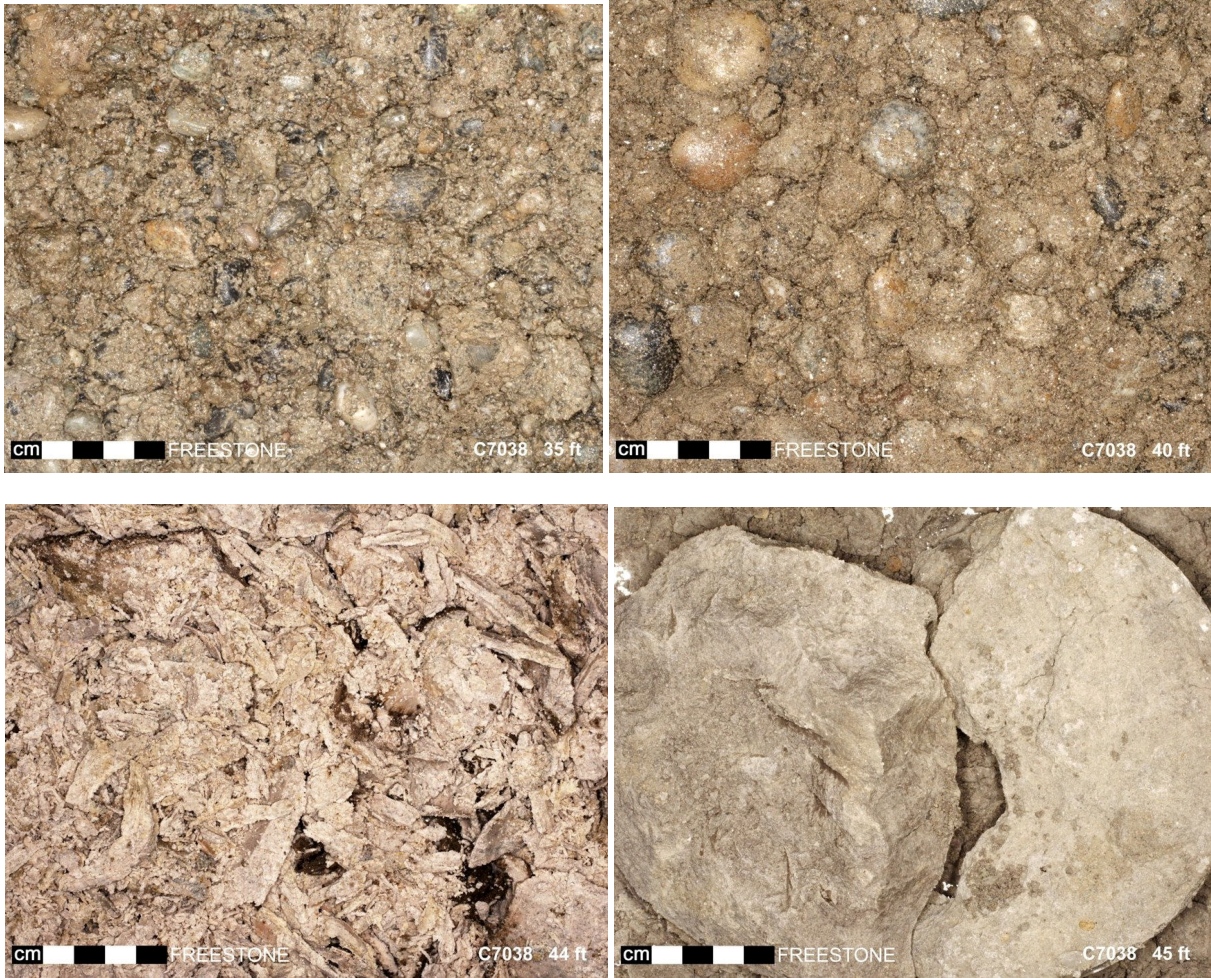
Figure C.2. Additional Pictures of Core Samples Collected From Monitoring Well 199-N-173

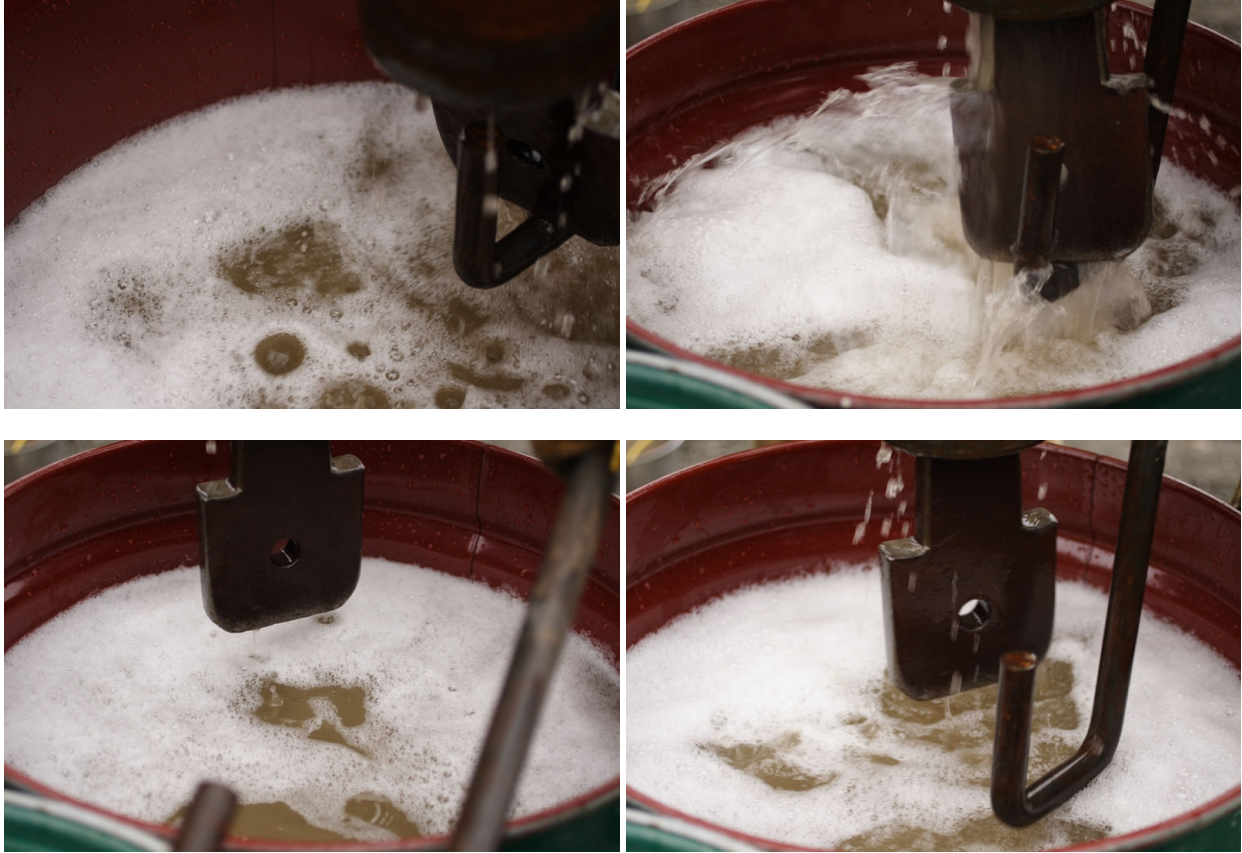
Figure C.3. Examples of the Unusual Foamy Water Observed During Drilling and Development of Monitoring Well 199-N-173
