PNNL- 18985

Program for the Inspection of Nickel Alloy Components

Report from the Program's Steering Committee: Inspection of Bottom- Mounted Instrumentation Nozzles Round Robin

November 2009

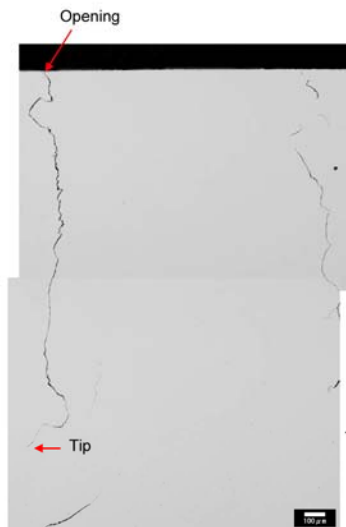
Micro. photo of cross section

Position		(9)
Depth (mm)	d	2.0
Opening (µm)		2
Tilt (deg) (°)		3
Position of surf. opening (mm)	y	150.3
	X	-0.9
	Y	145.9
	Z	29.6
Position of crack tip (mm)	X	-1.0
	Y	147.6
	Z	28.7

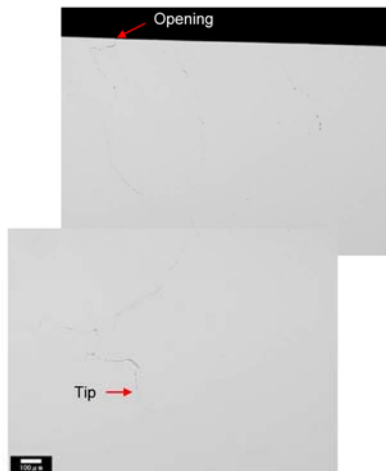
Micro. photo of cross section

Position		(4)
Depth (mm)	d	1.8
Opening (µm)		2
Tilt (deg) (°)		-5
Position of surf. opening (mm)	y	153.3
	X	-0.2
	Y	147.7
	Z	32.7
Position of crack tip (mm)	X	-0.1
	Y	149.3
	Z	31.9

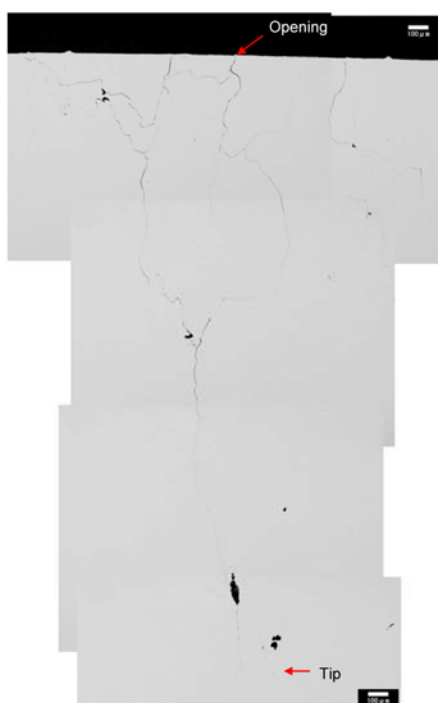
Micro. photo of cross section

Position		(8)
Depth (mm)	d	3.3
Opening (µm)		2
Tilt (deg) (°)		-7
Position of surf. opening (mm)	y	150.0
	X	-0.4
	Y	146.1
	Z	29.5
Position of crack tip (mm)	X	0.0
	Y	149.1
	Z	28.0
