PNNL-20408

Characterization of Fish Passage Conditions through a Francis Turbine and Regulating Outlet at Cougar Dam, Oregon, Using Sensor Fish, 2009–2010

Final Report

May 2011

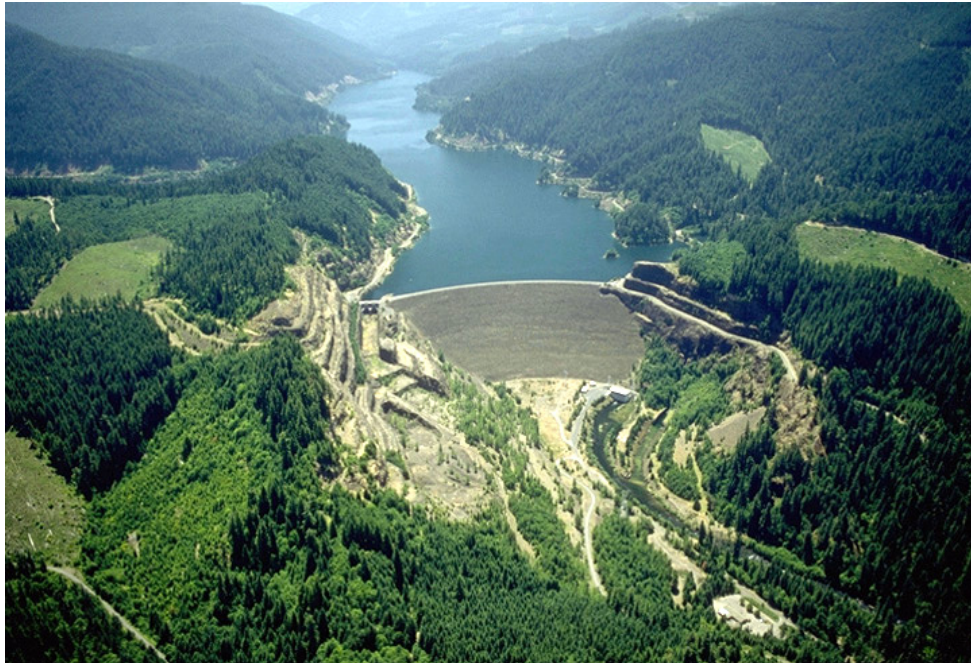
Figure 2.1. Cougar Dam, Oregon.

Cougar Dam is located on the South Fork of the McKenzie River in Lane County, Oregon, approximately 4 mi upstream of the confluence of the mainstem McKenzie River, at river kilometer 406 of the Willamette River (Figure 2.1). It is a storage dam used for flood control, power generation, irrigation, navigation, and recreation. The dam, a rock-fill embankment approximately 452 ft tall and 1500 ft long, has two ROs and an opening leading to the penstock that distributes water to a powerhouse containing two Francis turbine units. The turbines have a hydraulic capacity of 1050 cubic feet per second (cfs) and a total capacity of 25 megawatts (MW) (Figure 2.2). Full pool is 1699.0 ft above mean sea level (MSL); minimum pool is 1532.0 ft MSL. A gated spillway with two spillbays, currently nonoperational, is available for flood control. Downstream fish passage is possible only through the turbines or ROs.

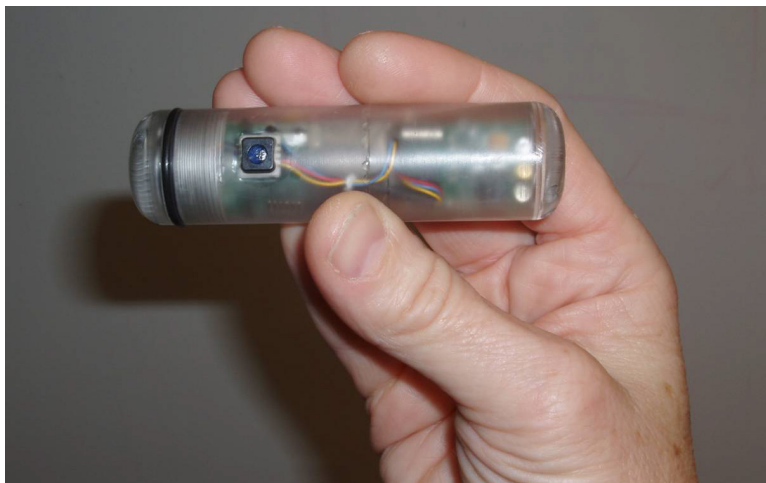
Figure 2.4. Six-degree-of-freedom Sensor Fish device.

The Sensor Fish housing is constructed of clear polycarbonate plastic (Figure 2.4). It is 24.5 mm in diameter and 90 mm long and weighs 43 g. The Sensor Fish is nearly neutrally buoyant in fresh water. The Sensor Fish measures the three components of linear acceleration, the three components of angular velocity (these together comprise the six degrees of freedom), absolute pressure, and temperature, at a sampling frequency of 2000 Hz per sensor channel over a recording time of about 4 min.

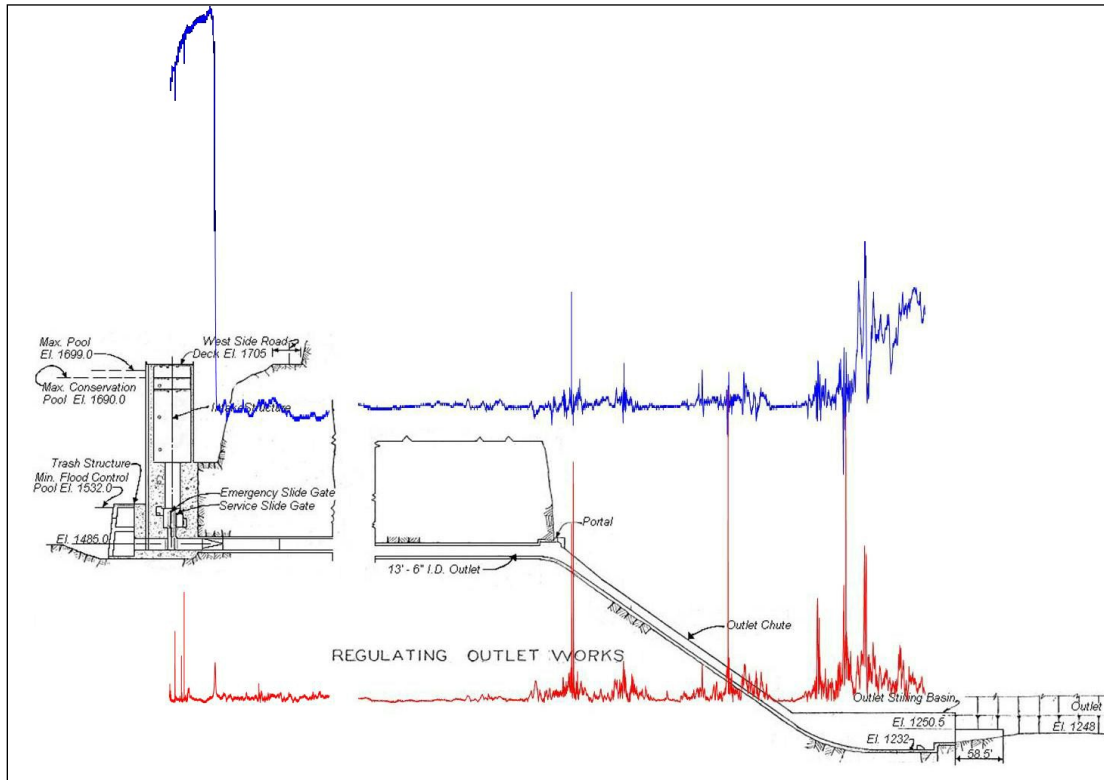
Figure 3.1. Representative Sensor Fish data overlaid on a cross section of the Cougar Dam regulating outlet showing the approximate locations of selected major timing marks. The blue line is pressure; the red line is acceleration vector magnitude in g.

Examples of pressure timing marks used for the RO study are shown in Figure 3.1. Pressure is highest as the sensor exits the induction pipe and approaches the RO gate. A rapid decrease in pressure (shown by the blue line) occurs as the Sensor Fish passes through the RO gate; pressure is nearly

atmospheric during passage through the outlet and down the outlet chute. Pressure increases as the Sensor Fish descends into the stilling basin, then decreases as the sensor rises to the surface in the tailrace. During passage through the 1.5-ft gate opening, one Sensor Fish was observed to have experienced a shear event at the gate and then became caught or trapped for approximately 0.1 s before continuing passage. Passage times from the gate to the stilling basin averaged 41.8 s and 32.6 s for the 1.5-ft and 3.7-ft gate openings, respectively.

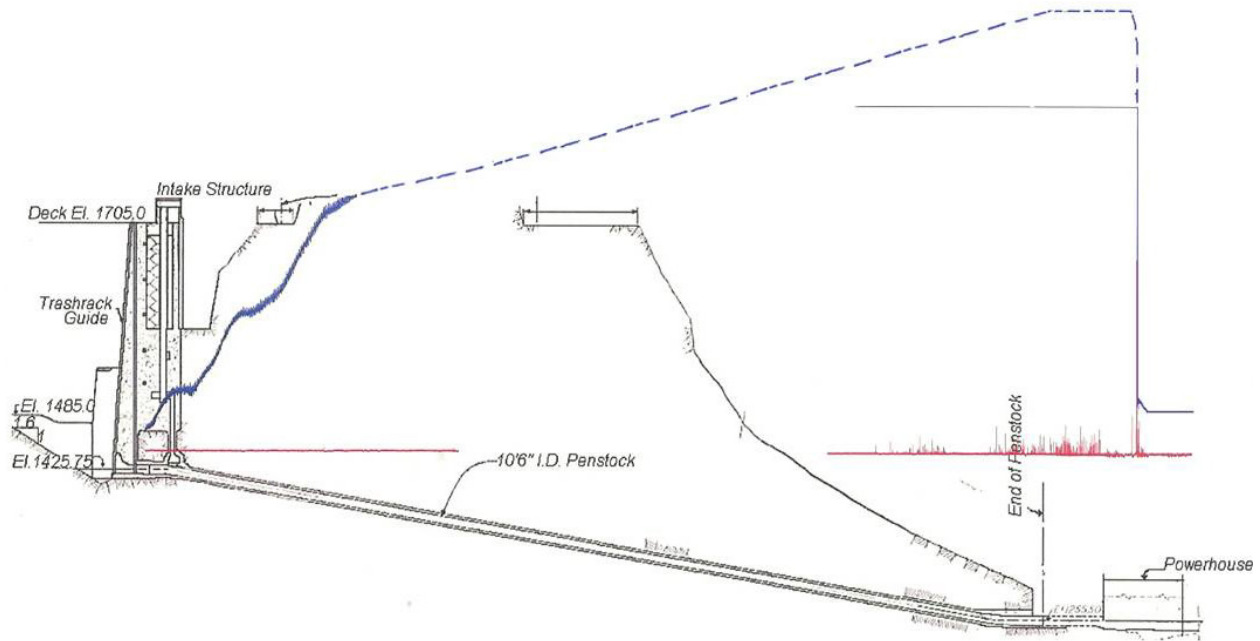
Figure 3.2. Representative Sensor Fish data overlaid on a cross section of the Cougar Dam penstock and turbine region showing the approximate locations of selected major timing marks. The blue line is pressure; the red line is acceleration vector magnitude in g .

Examples of pressure timing marks used for the turbine study are shown in Figure 3.2. The pressure transducer on the Sensor Fish has a measurement range of 0 to 100 pounds per square inch absolute (psia). The hydraulic head at Cougar Dam was nearly 300 ft during the study period, which when converted to pressure is approximately 132 psia, exceeding the pressure sensor measurement range. At pressures higher than 100 psi, the pressure sensor does not show the actual pressure but reports its maximum value of 100 psia. As the pressure acting on the sensor drops below 100 psi, actual pressures are once again reported by the sensor. However, except where water velocities become high, pressure values can be inferred (as shown on the dotted line in Figure 3.2) by noting the likely time-dependent elevation of the sensor relative to the level of water in the dam forebay.

Pressure rises as the Sensor Fish passes down the induction pipe to the point of injection into the penstock, gradually increasing as the sensor is carried with penstock flow through decreasing elevation of the penstock. As the flow approaches the turbine, a flow transition occurs as the penstock bends, and the pressure remains constant during scroll case passage on approach to the turbine wicket gates. As the Sensor Fish passes through the turbine runner, there is a rapid decrease in pressure. Pressure reaches its lowest point, its nadir, during transit of the suction side of the turbine runner. Following passage through the turbine runner, the Sensor Fish is carried with flow through the turbine draft tube and into the powerhouse tailrace.

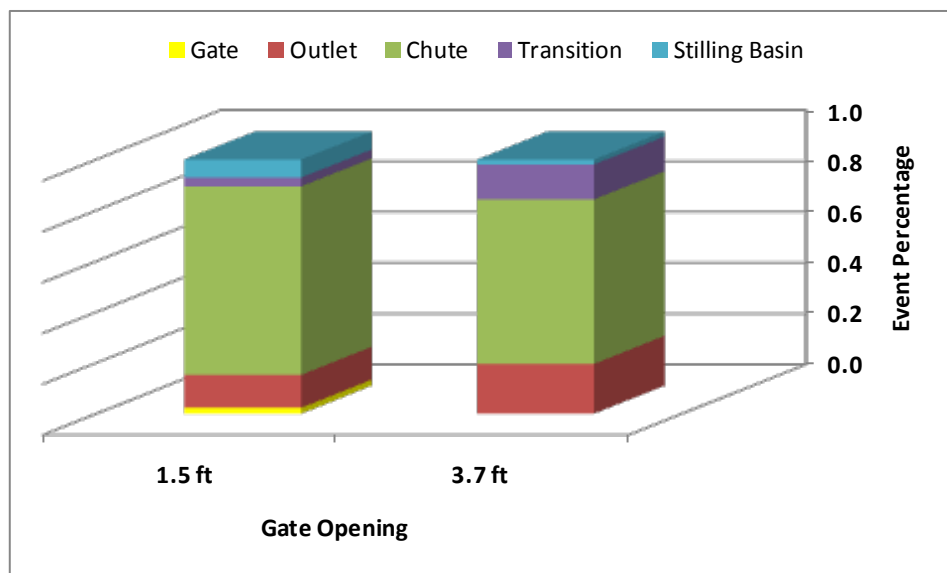
Figure 3.3. Location of all Sensor Fish significant events by passage region.

Significant events were observed most frequently on the outlet chute (Figure 3.3). There were no significant events at the gate for Sensor Fish passing through the 3.7-ft gate opening; two significant events were observed at the 1.5-ft opening. Significant event occurrence during passage through the RO outlet passageway and at the flow transition from the outlet chute to the stilling basin was more frequent for Sensor Fish passing through the 3.7-ft gate opening. Sensor Fish passing through the 1.5-ft gate opening experienced a greater percentage of events on the outlet chute and in the stilling basin, presumably due to a more shallow flow depth.

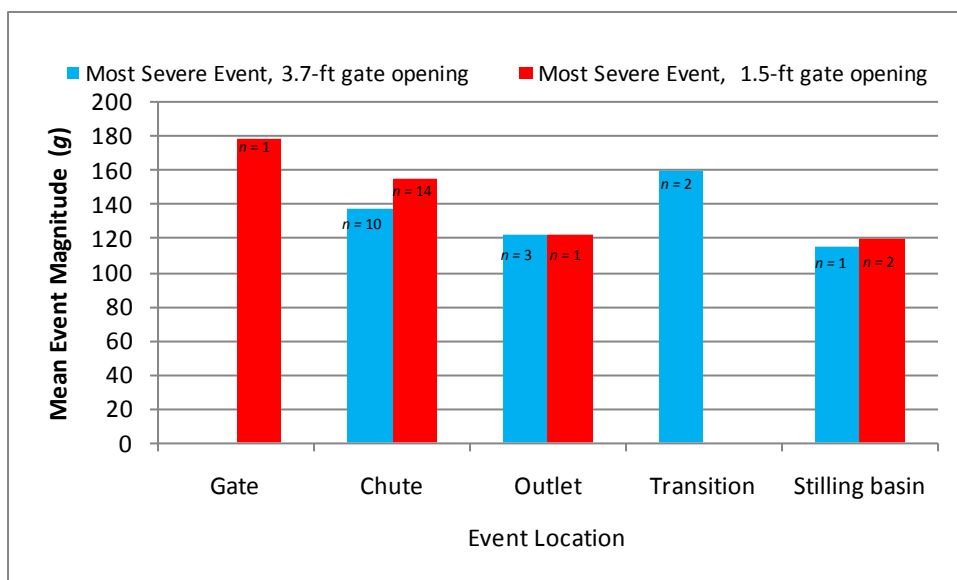
Figure 3.5. Location of the most severe significant events experienced by Sensor Fish during regulating outlet passage.

The mean acceleration magnitude values for the most severe event per release by event location are shown in Figure 3.5. The highest magnitude was observed for a shear event during Sensor Fish passage under the 1.5-ft gate opening. There were also high magnitude events at the transition of flow from the outlet chute to the stilling basin during passage through the 3.7-ft gate opening. Significant events on the outlet chute, especially at the 1.5-ft gate opening, were frequent due to depth of flow and the resultant distance from structure. The mean acceleration magnitude values for all Sensor Fish significant events by event location are shown in Figure 3.6.

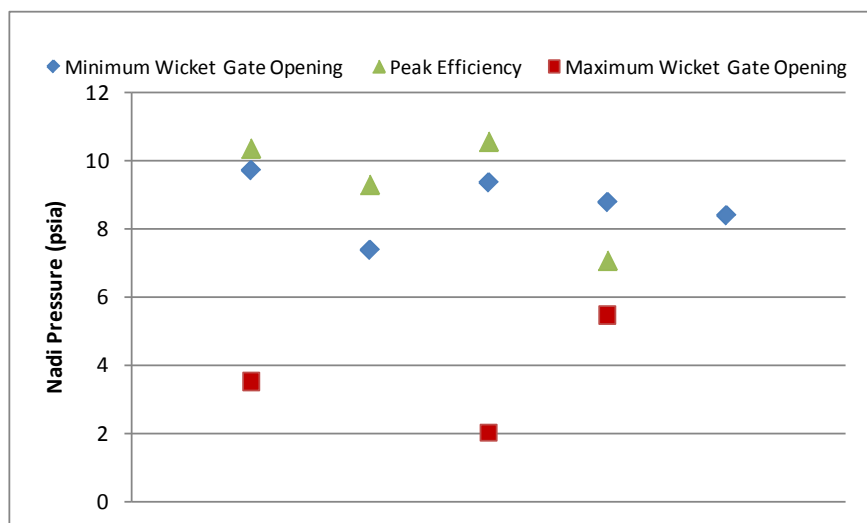
Figure 3.7. Nadir pressure observed during passage through turbine unit 2 as measured by Sensor Fish.

A rapid pressure decrease occurs during passage through the turbine runner region as the sensor is carried with flow from the pressure to suction sides of the turbine runner. The lowest pressure (nadir) observed during turbine passage occurs as flow passes under the runner blade prior to draft tube entry. The lowest nadir occurred during maximum wicket gate opening, averaging 3.66 psia. Average nadir was highest during peak efficiency operations (9.31 psia); the minimum wicket gate opening averaged 8.74 psia (Figure 3.7).

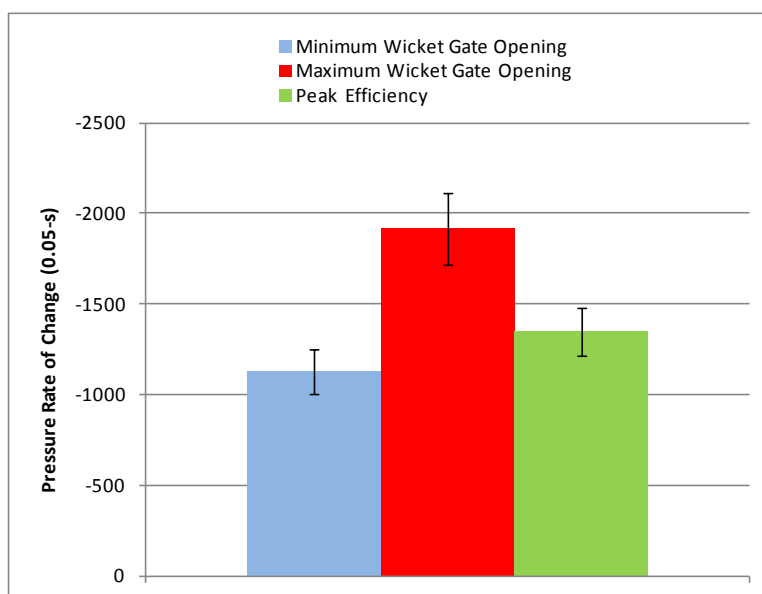
Figure 3.8. Average pressure rate of change for the three passage operations through Cougar Dam turbine unit 2. Error bars represent standard error of the mean.

Pressure rate of change differences among turbine operation treatments were associated with turbine flow; i.e., the greater the discharge, the higher the observed pressure rate of change. The average pressure rate of change was greatest for high wicket gate opening releases (-1916.7 psia/s [maximum = -2297 ; minimum = -1637]). Pressure rate of change during peak efficiency operation was -1348.9 (maximum = -1666 ; minimum = -1041). Pressure rate of change during passage through the minimum wicket gate opening was -1126.8 (maximum = -1423 ; minimum = -803) (Figure 3.8). Rapid decompression has been shown to injure or kill fish acclimated to depth (Brown et al. 2007, 2009; Carlson et al. 2010).

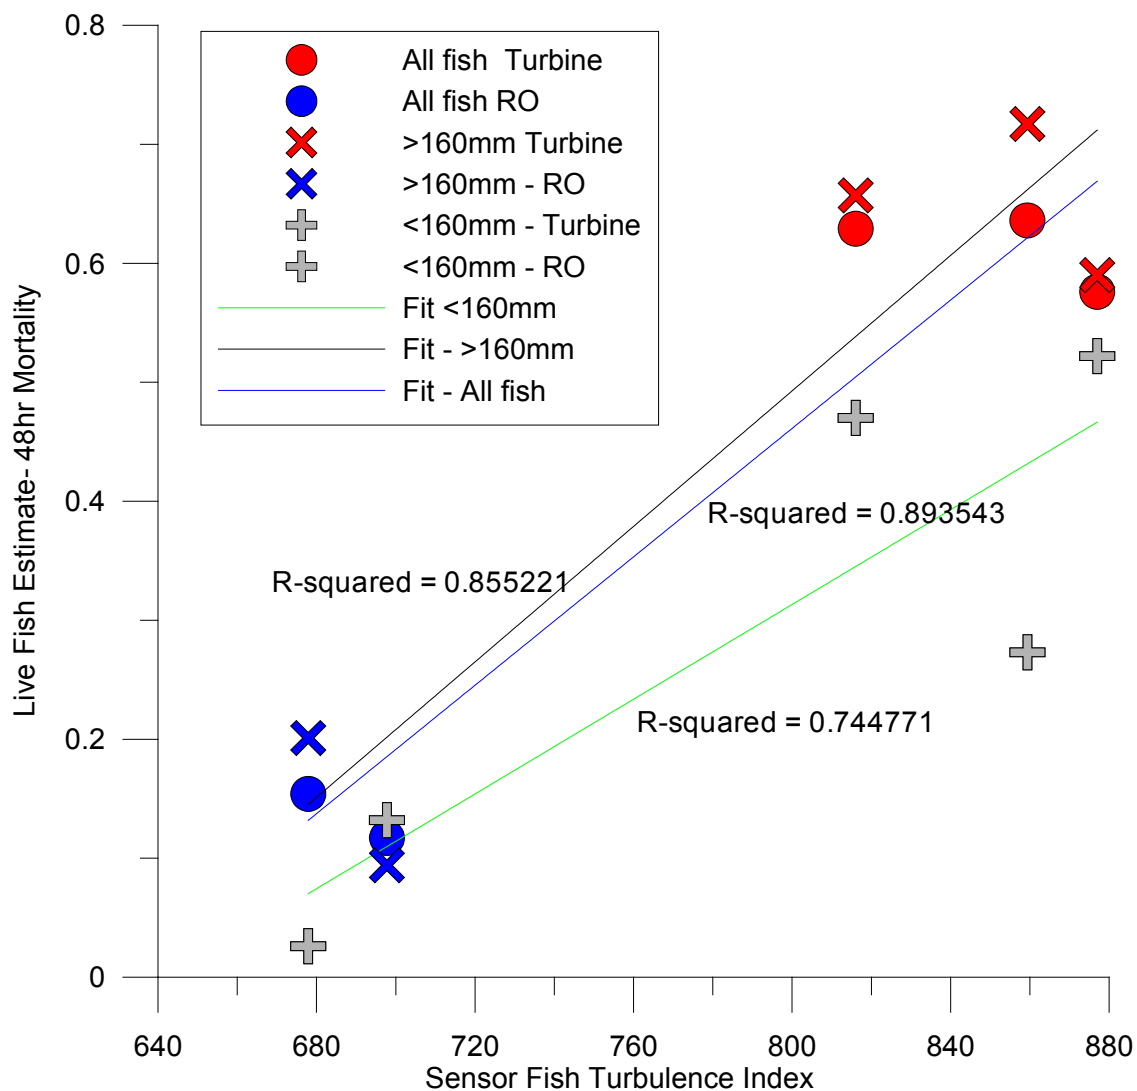
Figure 3.11. Fit of linear model between live-fish estimated 48-hr mortality rate and Sensor Fish turbulence index based on length.

Turbulence Index (Adj) Vs. 48-Hr Mortality <160mm
(green line)

$$Y = 0.001990538814 * X - 1.279219046$$

R-squared = 0.893543

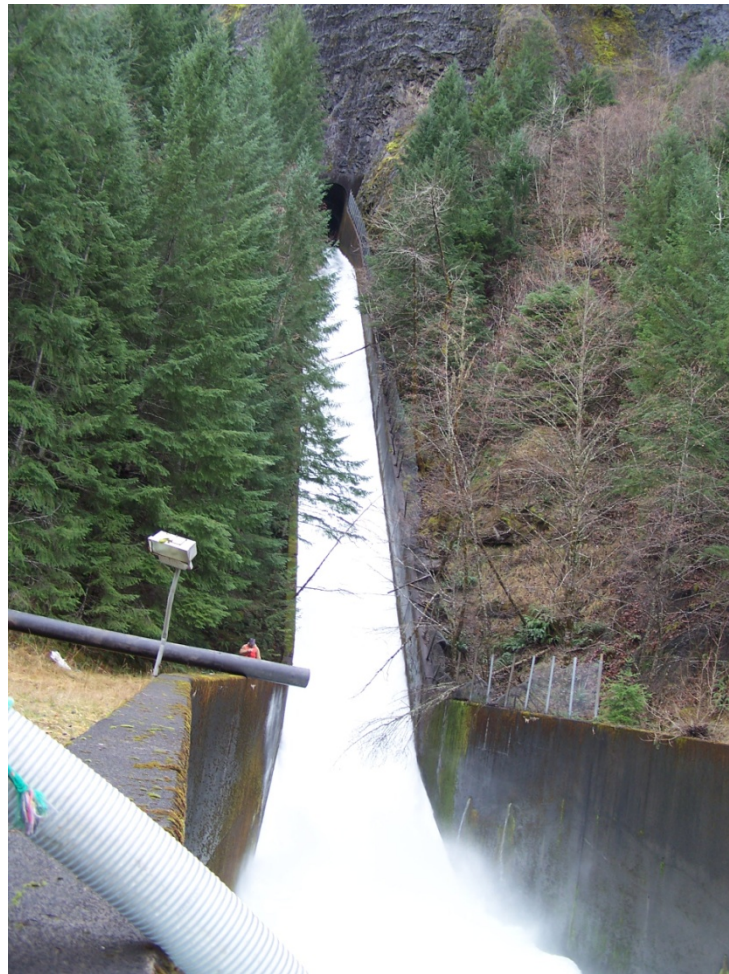
Figure 4.1. Regulating outlet flow discharge exits down a concrete chute into the stilling basin.

Sensor Fish were used to evaluate the RO at two gate openings, 1.5 ft and 3.7 ft, corresponding to discharge flow rates of 440 cfs and 1040 cfs, respectively, at an approximate forebay elevation of 1533 ft MSL. The RO is a gravity-fed passageway controlled by a hydraulic gate. The 1000-ft-long passageway runs through the dam and rock formations before exiting down a concrete chute with guidewalls into a concrete-enclosed stilling basin (Figure 4.1). The velocity of the RO discharge jet at entry into the stilling basin was estimated to be approximately 125 fps.

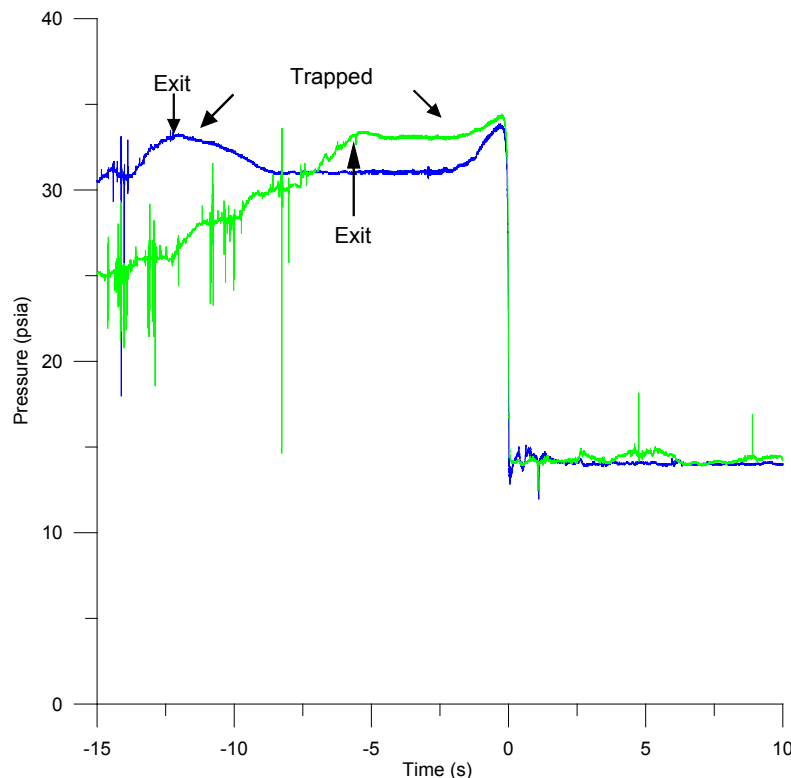
Figure 4.2. Pressure time histories for two Sensor Fish from injection pipe exit to regulating outlet passageway showing one sensor trapped prior to the gate at the 1.5-ft gate opening.

During passage at the 1.5-ft gate opening, one Sensor Fish experienced a significant shear event; a second had a collision with the gate. None of the Sensor Fish passing through the 3.7-ft gate opening collided with the gate or experienced significant shear during passage under the gate. The average acceleration magnitude of the Sensor Fish during passage under the control gate at an opening of 1.5 ft was nearly 3 times that observed during passage when the gate was open 3.7 ft. At least one Sensor Fish was caught behind the gate during passage at the 1.5-ft gate opening (Figure 4.2). More than 12 s were required for the trapped Sensor Fish to pass from the pipe exit to the gate, compared to an average time of less than 6 s.

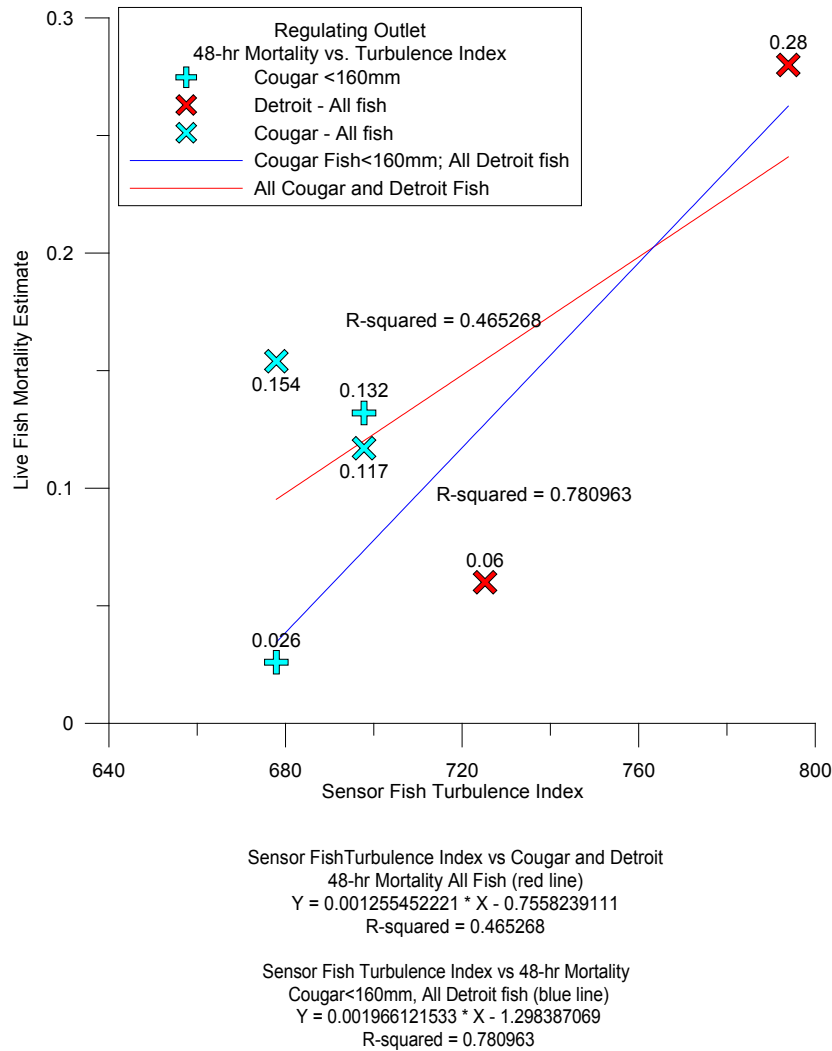
Figure 4.3. Fit of linear model between live fish estimated 48-hr mortality and Sensor Fish turbulence index for Cougar and Detroit regulating outlet evaluations based on fish length.

A linear model fit to the live-fish 48-hr mortality estimates and Sensor Fish turbulence index values for turbine passage at Cougar and Detroit dams based on fish length showed that for operating conditions tested, the turbulence index is a fairly good predictor for 48-hr mortality for fish less than 160 mm in length (Figure 4.3).

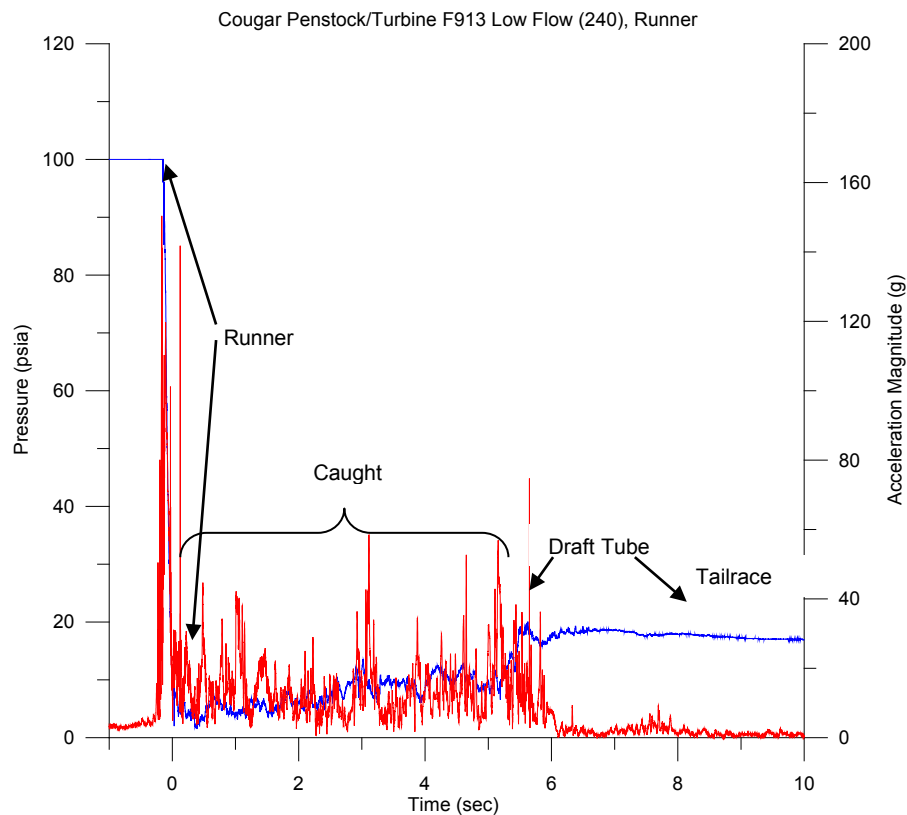
Figure 4.4. Pressure and acceleration magnitude time histories for passage through the runner, draft tube, and into the tailrace. Sensor Fish were caught under the runner for more than 5 s.

Transport time through the penstock into the turbine was longer than observed at other projects—more than 6 min for minimum wicket gate opening flows, approximately 5 min for peak efficiency flows, and over 4 min for maximum wicket gate opening flows. HI-Z balloon tags typically begin inflation approximately 4 min after injection. During the low-flow treatment scenario, 80% of the Sensor Fish were observed to be “caught” either under the runner or at the draft tube entrance. These fish were apparently temporarily hung up in an eddy area or became caught on some structure within the passage region prior to draft tube exit (Figure 4.4). Data indicate that the Sensor Fish did not become stationary but were in motion. This phenomenon was also observed in 25% of the peak efficiency treatment but for a shorter time increment. Inflation of the HI-Z tags likely contributed to this period of entrapment and could potentially contribute to injury and/or mortality if fish are exposed to high extreme flows or collide repeatedly with structure while caught. Figure 4.5 shows typical passage for comparison.

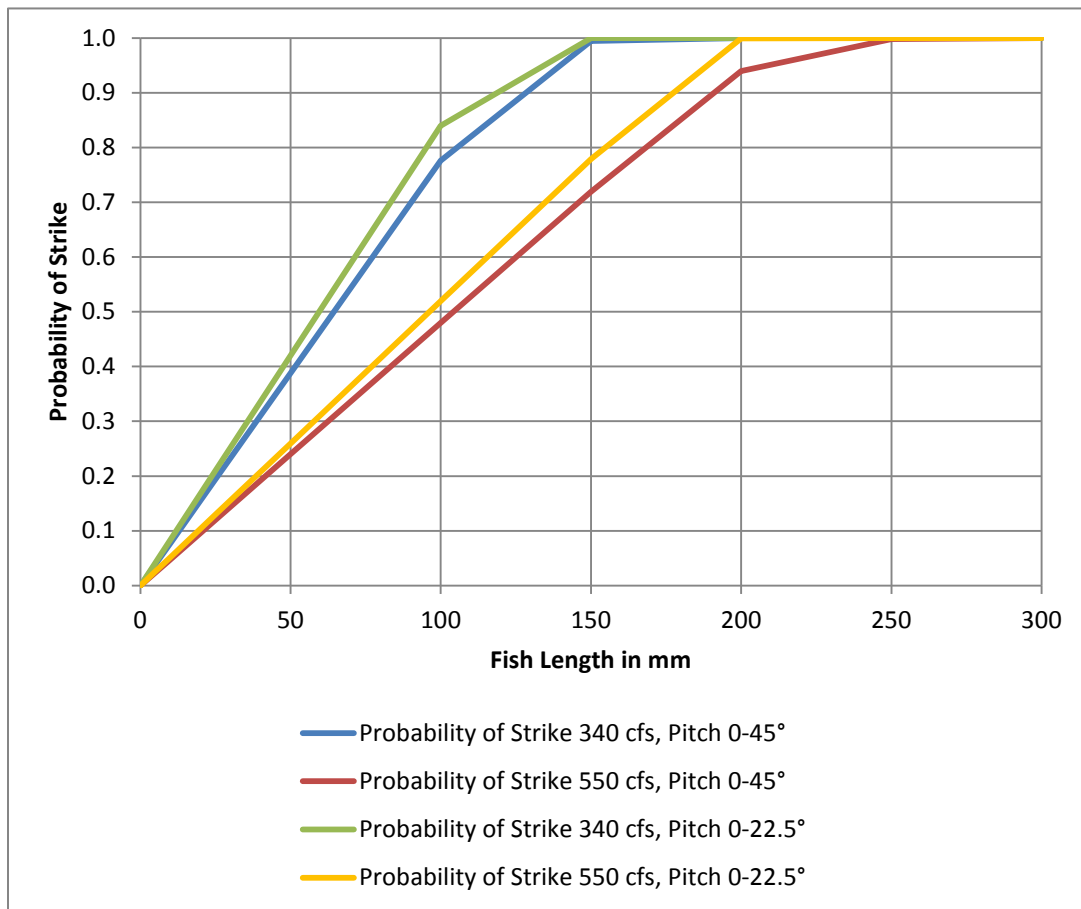
Figure 4.6. Probability of blade strike based on fish length, discharge, and blade pitch.

Two pitch ranges, 0° to $\pm 22.5^\circ$ and 0° to $\pm 45^\circ$, and two turbine discharges, 340 cfs and 550 cfs, were modeled. The pitch range distributions were assumed to be uniform. The analysis model was stochastic and was performed using @RISK¹ spreadsheet overlay software. The discharges modeled were the lowest and highest evaluated during the Sensor Fish and live-fish study.

The estimates of probability of blade strike for fish over the size range from 5 to 300 mm for the two discharges, and pitch angle ranges are shown in Figure 4.6 and Table 4.1. As expected, the probability of blade strike increased with fish size, with a greater rate of increase for the lower discharge and for the 0° to $\pm 22.5^\circ$ pitch range. Because the radial velocity of the runner is constant with discharge, at higher discharge the fish are carried with flow more rapidly into the runner past the periphery of the runner blades, therefore experiencing a lesser probability of blade strike. The lower probability of blade strike with increasing pitch range results from the shorter effective length of fish (the projection of the fish length onto the horizontal axis) as pitch angle increases.
