# USED FUEL DISPOSITION CAMPAIGN

## *Optimization of Hydride Rim Formation in Unirradiated Zr-4 Cladding*

*Prepared for  
U.S. Department of Energy  
Used Fuel Disposition  
Campaign*

FCRD-UFD-2013-000379

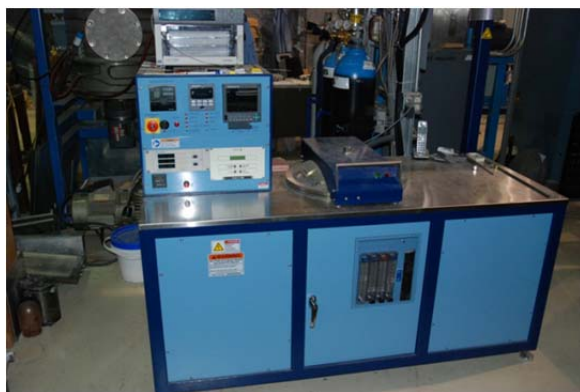
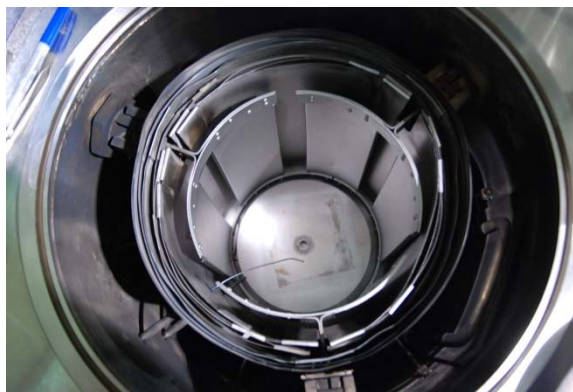
Figure 3.1 CAMCo Hydrogen/Inert gas furnace.

The cold wall furnace (see Figure 3.1) is manufactured by CAMCo Incorporated (San Carlos, CA) and is capable of high vacuum or flowing either hydrogen or argon at 100%, or mixed with each other, during the heat cycle at atmospheric pressure. The furnace is capable of higher heat treatments ( $2400^{\circ}\text{C}$ ), but is capable of heating samples between  $200$ - $350^{\circ}\text{C}$ . Gas enters the retort through a diffusion plate on the bottom of furnace and exits through a flame arrestor that burns the hydrogen discharge. Gas flow is controlled by manual rotometers with a 30 standard cubic feet per minute (scfm) maximum readout. The furnace is capable of profiling its heating and cooling ramps with a digital controller, as well as electronically recording additional survey thermocouples inside the furnace. Typically, samples between 40-50 mm long were placed in a stainless steel pan in the bottom of the furnace or hung at an elevated height during the heat treatment with a thermocouple nearby to confirm the temperature.

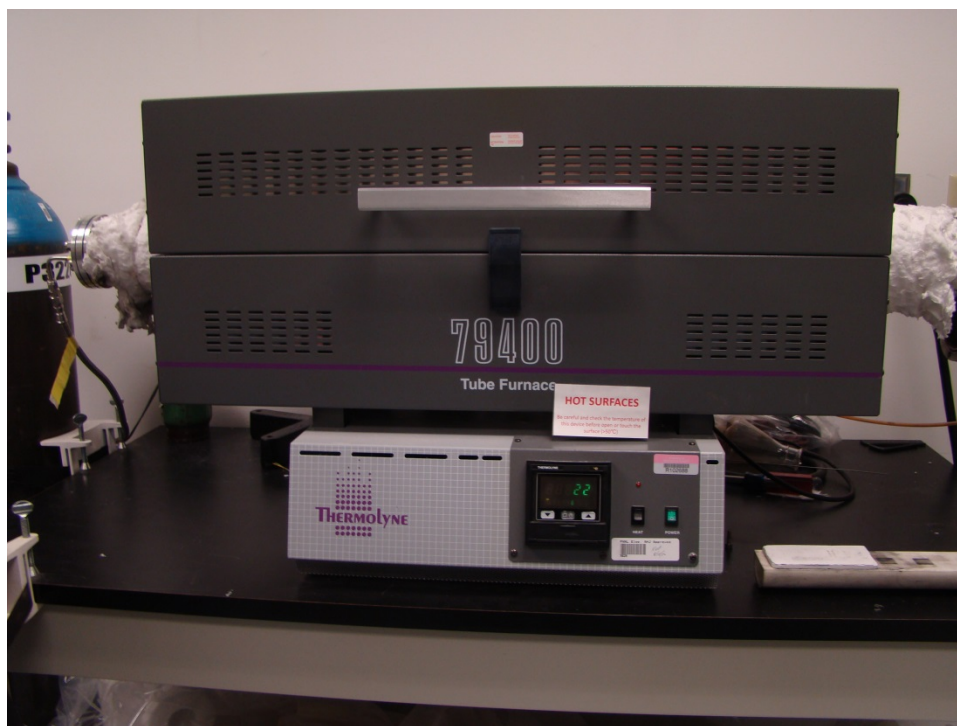
Figure 3.2 Thermolyne Model 79400 Tube Furnace

The tube furnace (see Figure 3.2) used was a 24" Thermolyne tube furnace (Model 79400) that also was setup to run with both 100% hydrogen or argon into the annealing chamber continuously during operation. Samples were placed on a ceramic block inside the tube furnace that could place 2" samples vertically (upright) or horizontally into the heat zone of the furnace. The differences between the two furnaces are:

- The CAMCo furnace chamber was a larger diameter furnace designed to reduce materials in a hydrogen gas environment.
- The Thermolyne furnace was smaller, but has a tighter control on the heat zone ( $\pm 1-2^{\circ}\text{C}$ ), and better control of gas flow.

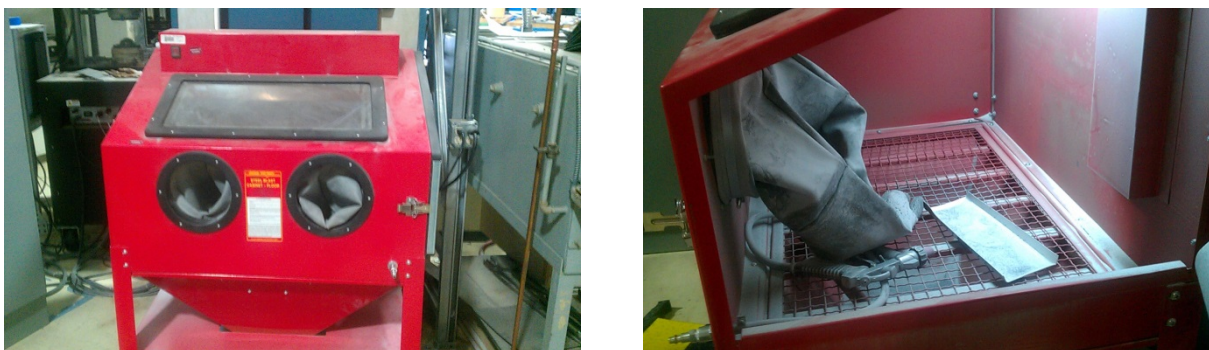
Figure 3.3 Grit Blasting Box used to Condition Cladding Surfaces

For all the work done in this document, the outside diameter of the Zr-4 cladding was blasted prior to heat treatment to strip the oxide layer off the surface to increase the flux of hydrogen into the outside wall of the cladding faster. Samples were finished on the outer wall using a grit blasting box (Figure 3.3) using glass frit beads. Samples were placed into the furnace either within an hour of conditioning or after waiting 24 hours. Oxide layer growth can form in air immediately after finishing, so the impact on the time period between conditioning and pre-hydriding was of interest.

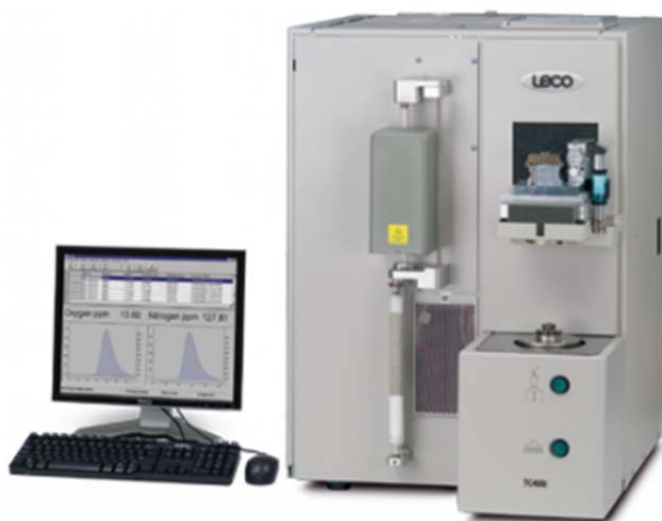
Figure 3.5 LECO Series 400 inert gas fusion analyzer.

Cut radial samples were destructively analyzed for the total hydrogen content in the Zircaloy samples by inert gas fusion, using an analyzer (Figure 3.5) made by the LECO Corporation (St. Joseph, MI). Analyses were performed both at PNNL and at ATI Wah Chang Analytical Services (Albany, OR). Instruments were calibrated prior to each analysis using manufacturer-supplied standards. Cut samples were divided again either into 2 or 4 additional samples to produce analytical duplicates or to verify the uniformity of the hydrogen concentration around the circumference.

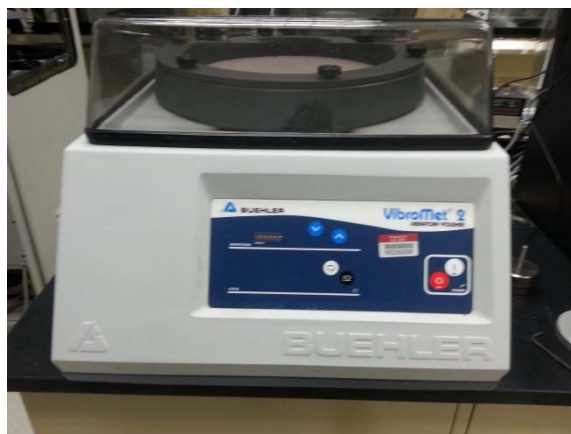
Figure 3.6 Metallographic polishing equipment used.

(b) Buehler Vibratory Polisher

Samples were also examined in the radial direction by metallographic optical microscopy to confirm the results of the gas fusion analysis and qualitatively assess how the hydrides were deposited on the samples. Samples were placed in epoxy circular mounts and wet-polished using a metallographic polisher (Figure 3.6). Silicon carbide (SiC) grit paper with DI water was used, starting with 400 grit and repeating with ever finer grit sizes up to 1200. The number of polishes required varied depending on how scratches were removed during polishing. In some cases, a vibratory polisher was used instead. After polishing, hydrides should be visible but can be difficult to discern from the metal (Figure 3.7). After polishing was completed, a hydrofluoric-nitric acid etch polish was used to preferentially etch the hydrides over the metal. The hydrides appear as dark crevices in the metal surface in an etched sample. This metallographic etch is typically performed while rubbing the mount onto a cotton swab that contains the etchant and is quickly rinsed afterwards. Most of the literature discusses using higher concentrations (4-5 wt%) of hydrofluoric than what was used on this task. However, samples were easily over-etched at this concentration making discerning the hydride present difficult. It was discovered that lowering the hydrofluoric concentration to between 0.5 – 1 wt% was a more robust etching solution and minimized over-etching of samples afterwards.

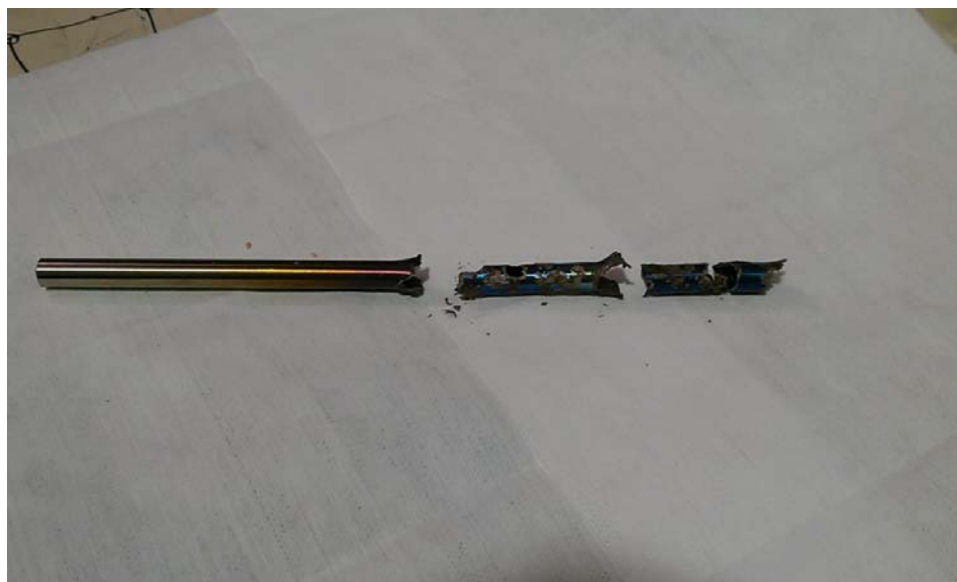
Figure 4.1 Cladding sample (11 inches) hung vertically in CAMCo for 24hr in 100% Hydrogen

Upon completion of the M2 milestone testing (Hanson et al. 2013), the capability of the CAMCo to pre-hydrate longer samples was tested. A cladding sample eleven inch long (furnace depth of 12 inches) was run at a control temperature of 280°C for 24 hours in 100% hydrogen, with no surface conditioning preparations, to see how it would behave. Upon opening of the furnace, the sample was discovered to be overly hydrided on one end and sitting in the bottom of the furnace (Figure 4.1). Examination of the tube showed that the end that was hanging from the top of the furnace was the end that was overly hydrided and had fallen off the hanging wire.

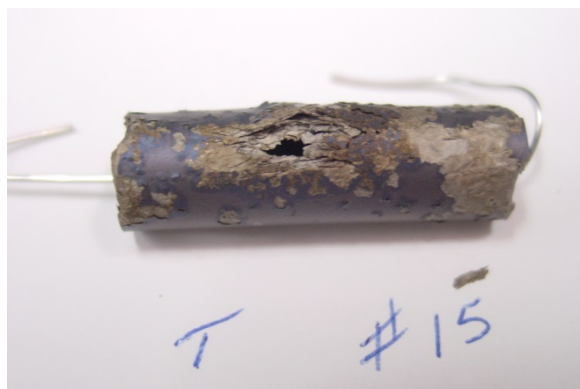
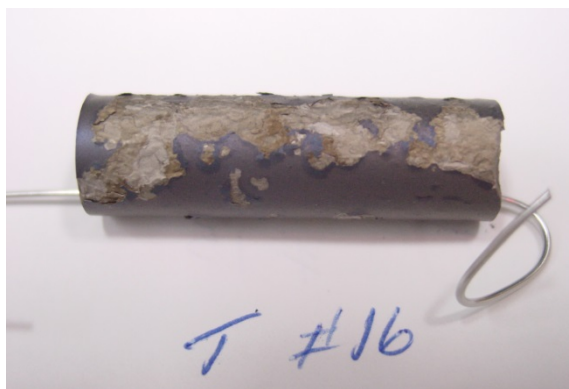
Figure 4.11 Images of Sample 15 and 16 after Pre-hydriding

Images of Samples 15 and 16 after pre-hydriding are shown in Figure 4.11. The samples were heavily hydrided with a great deal of loss of mechanical integrity. The increase in temperature and likely gas flow from hanging in the center of the furnace versus sitting at the bottom were the likely cause for the increase in reaction rate. Hydrogen analysis and metallography were not performed.

(a) Sample 15

(b) Sample 16

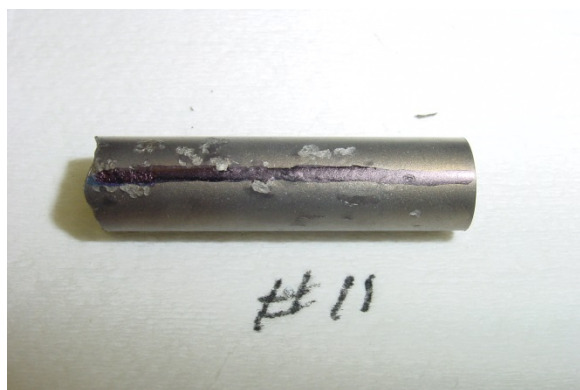
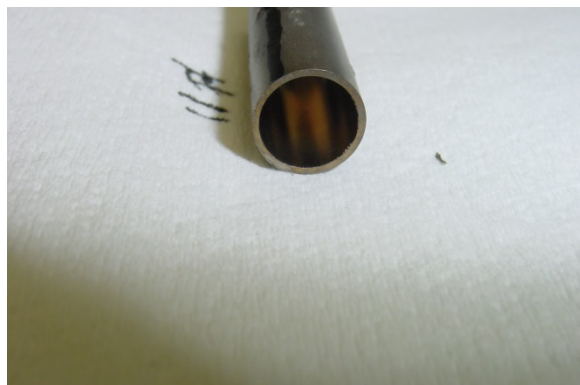
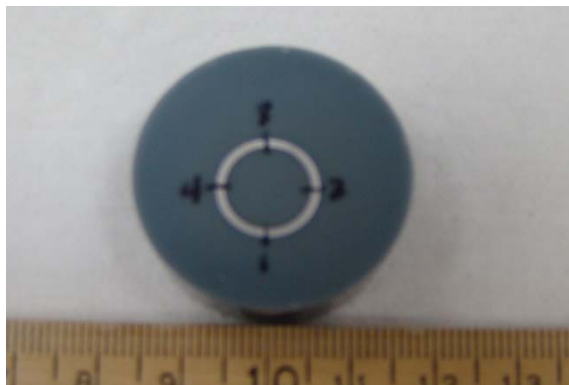
Images of Sample 11 After Hydriding and Mounted in Epoxy

Optical examination of Samples 11 and 12 are shown in Figure 4.5 and Figure 4.6. While the pictures all show a significant hydride rim forming on all the samples, variation circumferentially is seen that confirms the results seen from the hydrogen analysis. In some cases, regions became overly hydrided producing a hydride blister (Quadrant 1 of Sample 11 in Figure 4.5) which cause radial hydrides to branch out through the tube wall. Such a formation for this program is very undesirable for a final surrogate, so total hydrogen concentrations need to be lower.

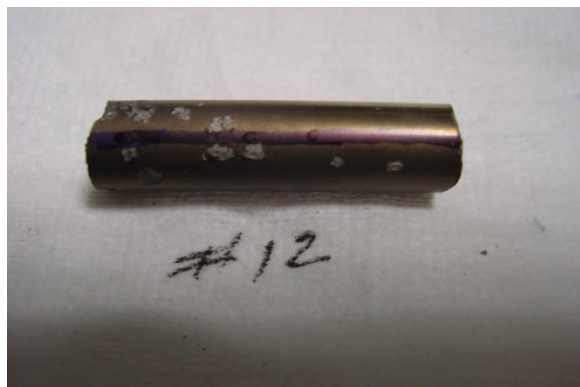
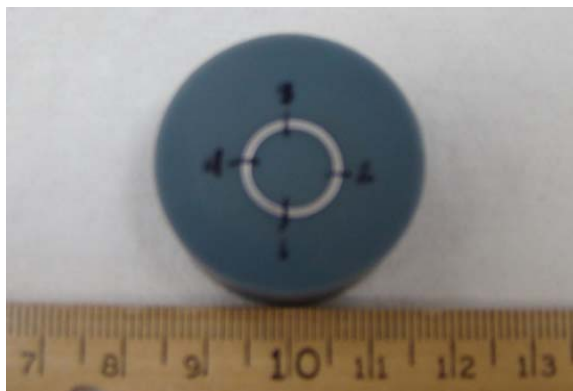
Images of Sample 12 After Hydriding and Mounted in Epoxy

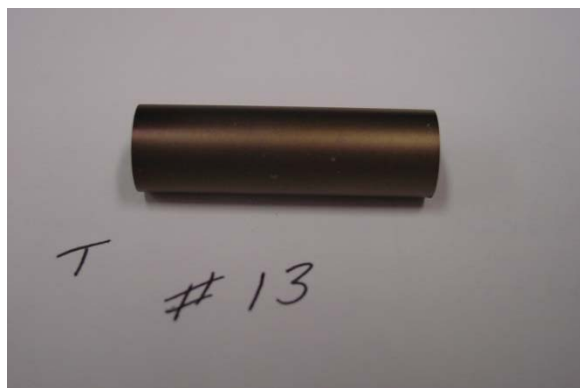
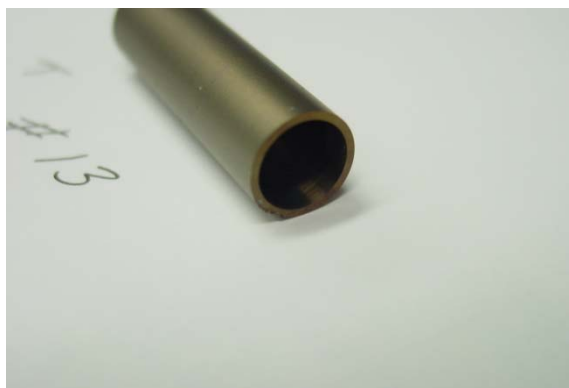
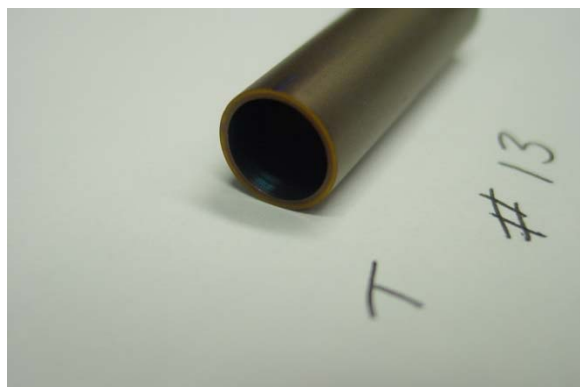
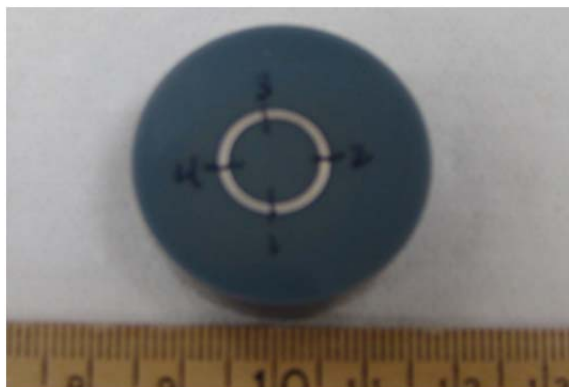
Images of Sample 13 After Hydriding and Mounted in Epoxy

Optical examination of Samples 13 and 14 are shown in Figure 4.7 and Figure 4.8. The decrease in rim thickness observed in these samples correlate well with the decrease in the hydrogen concentrations measured. Also, variability visually observed in the rim thickness also correlates well to the relative deviation measured in the hydrogen analysis in Table 4.2, showing it to be a useful tool to delineate variability in the rim thickness.

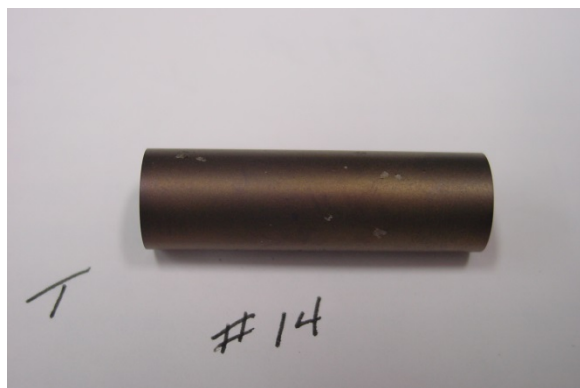
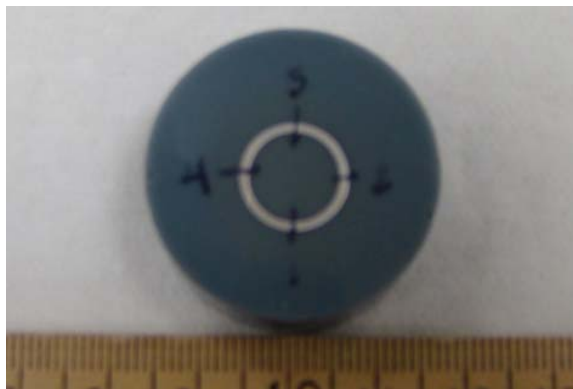
Images of Sample 14 After Hydriding and Mounted in Epoxy

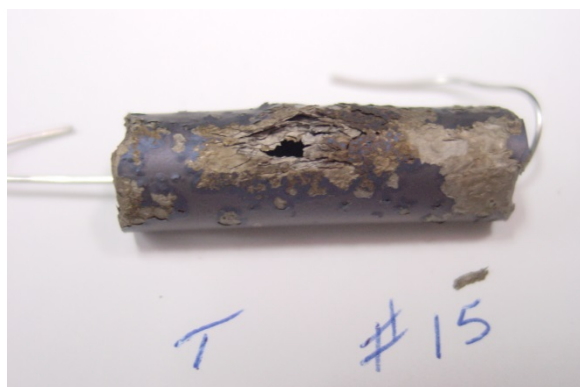
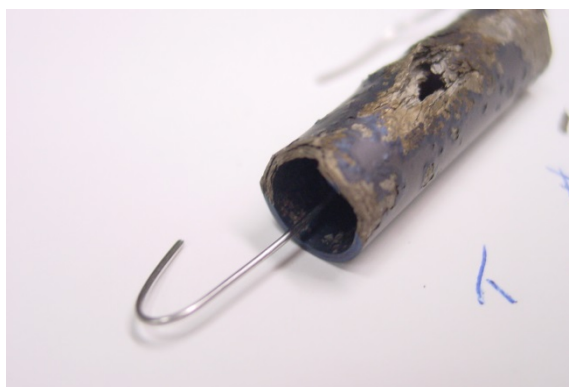
Furnace: CAMCo  
Location: Hung  
Temperature: 300°C  
OD Surface: Blasted, 24 Hr Hold in Air  
Outside Diameter: 0.451 in (11.5 mm)  
Wall Thickness: 0.036 in (0.90mm)

Images of Sample 15 After Hydriding; No metallography or hydrogen analysis performed.

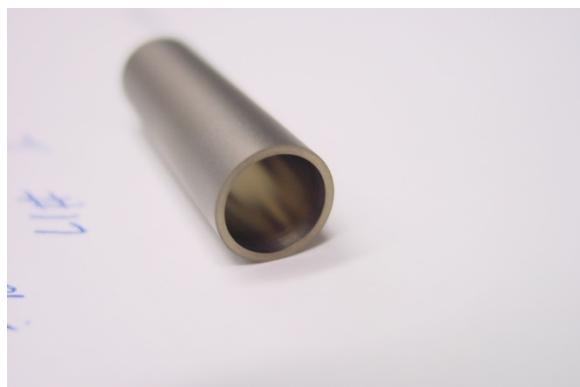
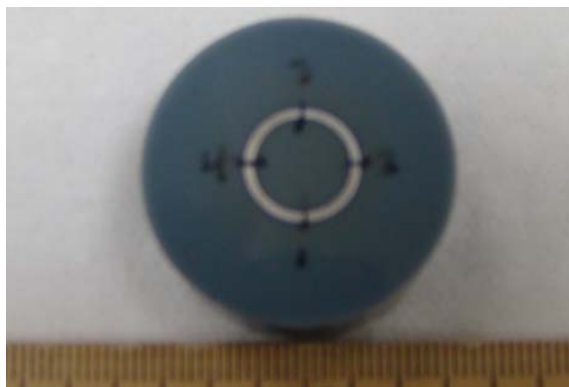
Images of Sample 17 After Hydriding and Mounted in Epoxy

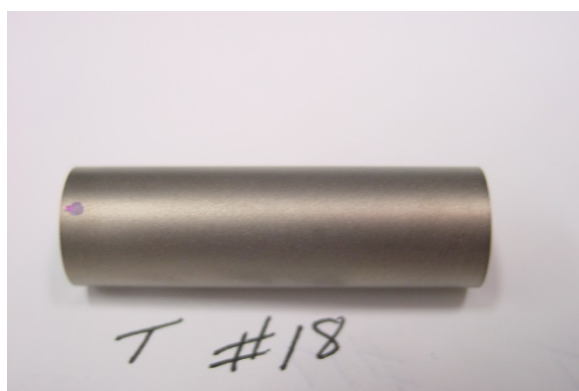
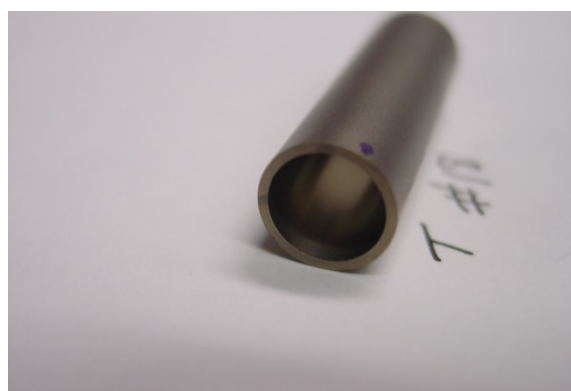
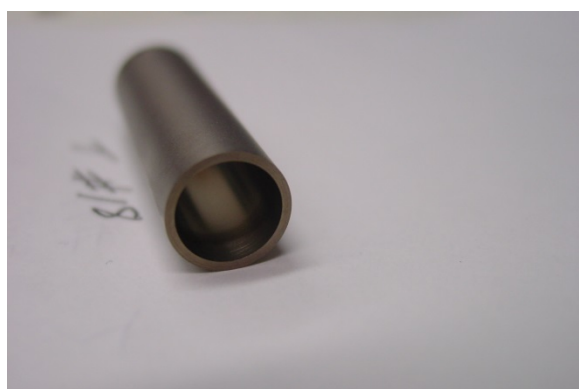
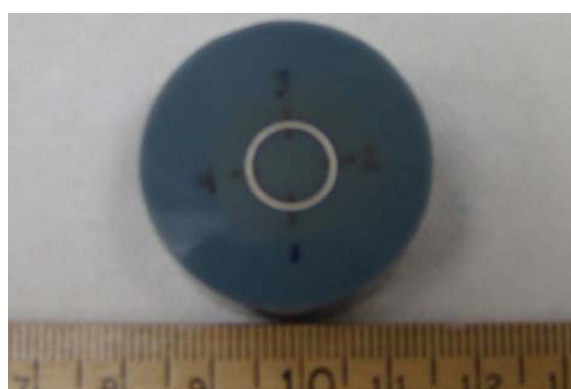
Images of Sample 18 After Hydriding and Mounted in Epoxy

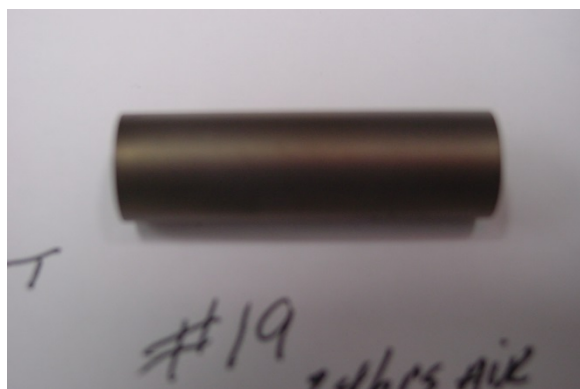
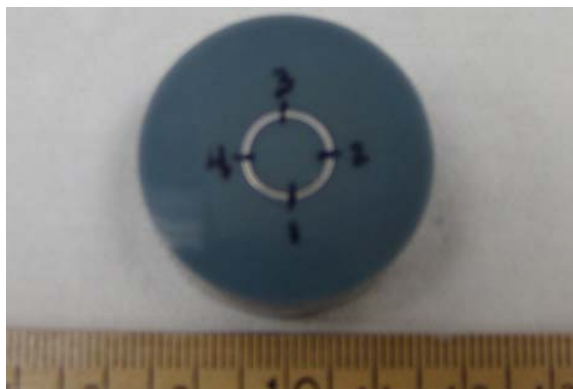
Images of Sample 19 After Hydriding and Mounted in Epoxy

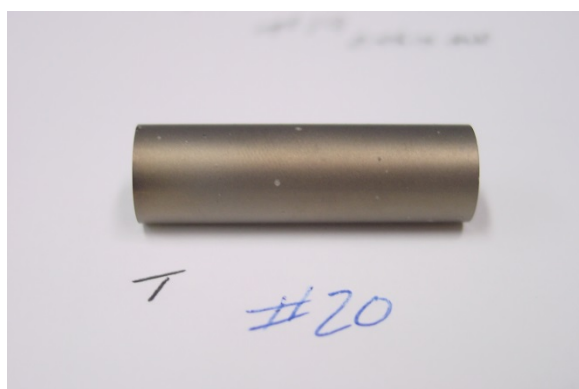
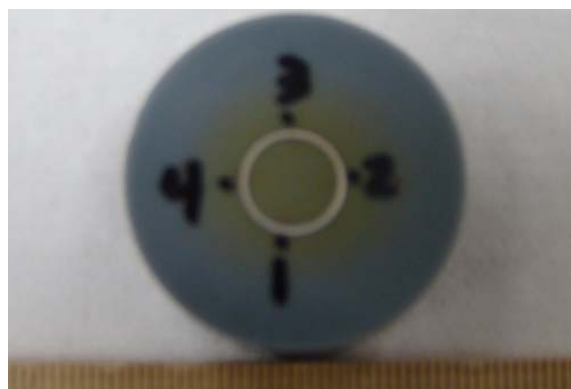
Images of Sample 20 After Hydriding and Mounted in Epoxy

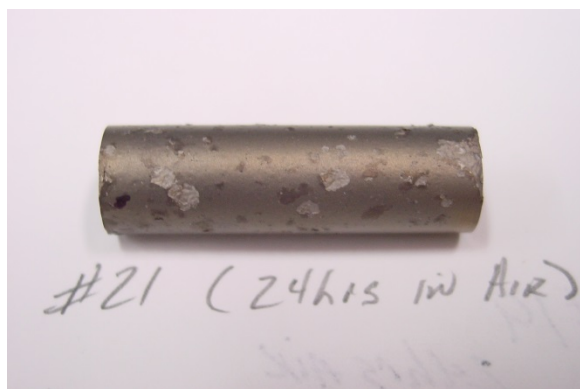
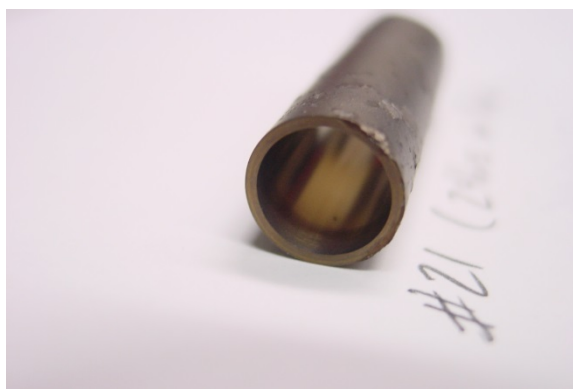
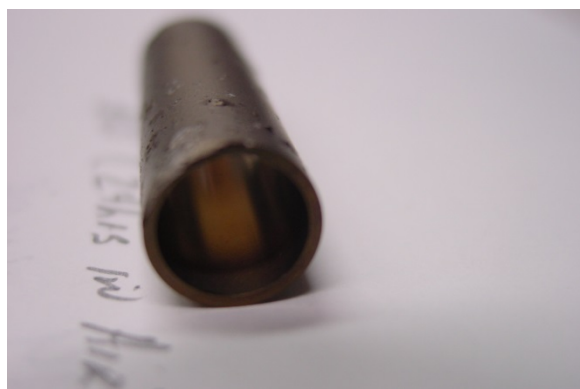
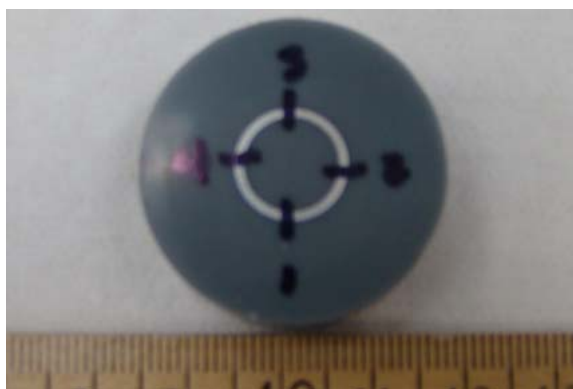
Images of Sample 21 After Hydriding and Mounted in Epoxy

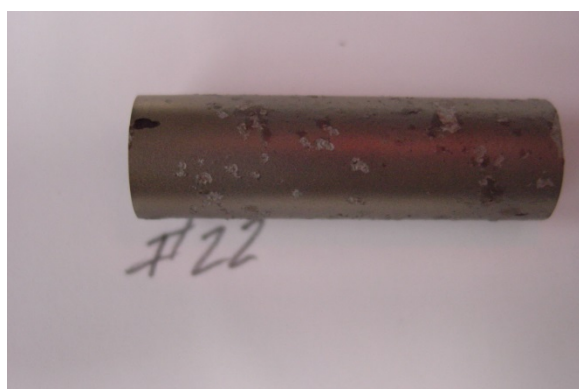
Images of Sample 22 After Hydriding and Mounted in Epoxy

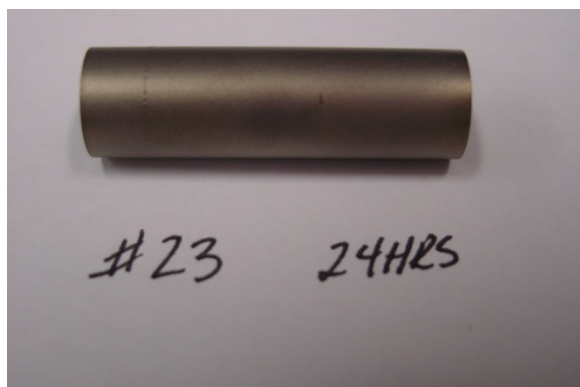
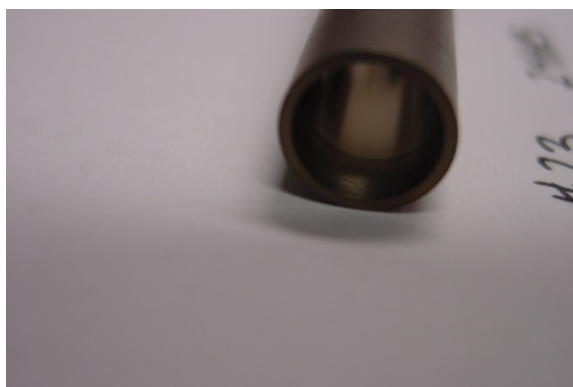
Furnace: Thermolyne  
Location: Upright – tipped over  
Temperature: 270°C  
OD Surface: Blasted, 24 hr Wait in Air  
Outside Diameter: 0.451 in (11.5 mm)  
Wall Thickness: 0.036 in (0.90mm)

Images of Sample 23 After Hydriding; No metallography or hydrogen analysis performed.
