# ASSESSING GREEN BUILDING PERFORMANCE

A Post Occupancy Evaluation of 14 Air Force Buildings

**June 2014**

Prepared for  
the U.S. Air Force  
under Contract DE-AC05-76RL01830

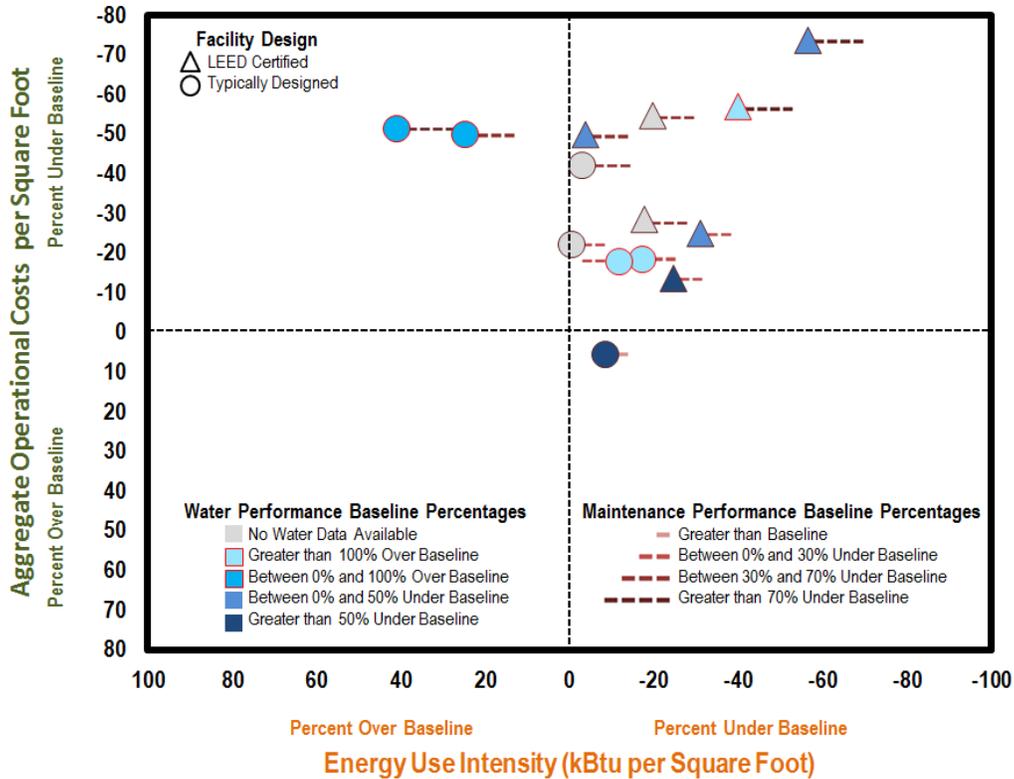
Figure S1 represents the energy, water, maintenance, and aggregate operational costs for each of the fourteen buildings investigated (six office buildings, four academic facilities, two fire stations and two fitness centers). All of the energy use intensity values for the LEED certified Air Force buildings were better than their industry baseline and outperformed their matched-pair. The top six buildings in the energy metric and four out of five of the buildings in the water metric were LEED certified. Thirteen of the fourteen buildings in this study had aggregate maintenance costs that were better than the industry baseline. The top two buildings in the maintenance cost metric were LEED-Gold certified. The buildings performing the best in all categories are shaded dark blue and located in the top-right quadrant.

**Figure S1.** Energy and maintenance performance is better than the baseline for all of the LEED certified buildings.

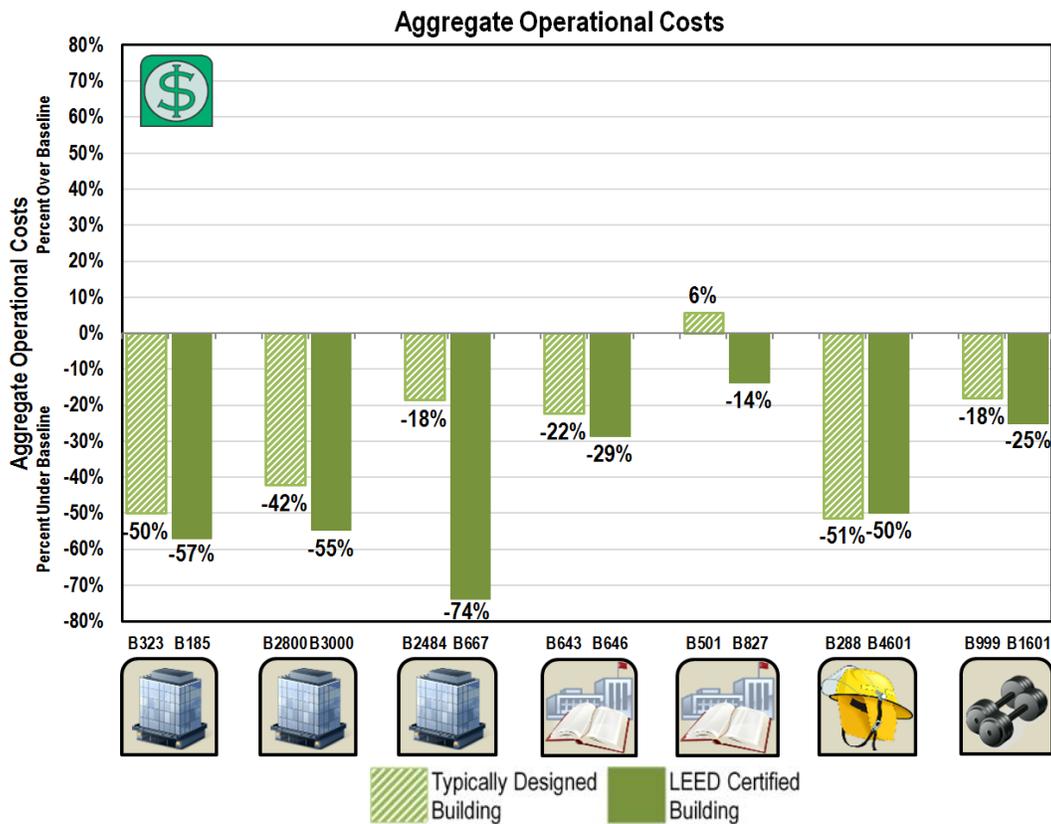
The “aggregate operating cost” metric includes water utilities, energy utilities, general maintenance, grounds maintenance, and janitorial costs. Thirteen of the fourteen Air Force buildings performed better than the industry baseline, with one having an aggregate operating cost 6% higher baseline largely because of the building’s general maintenance performance. On average, the seven LEED certified buildings have an aggregate operational cost 43% lower than industry average and 15% lower than the matched-pairs. Six of the seven buildings cost less than their respective pair as shown in Figure S3. The 1% difference in that matched-pair was due to higher total maintenance costs despite having lower energy and water costs.

Figure S3. Aggregate operational costs are lower for most buildings.

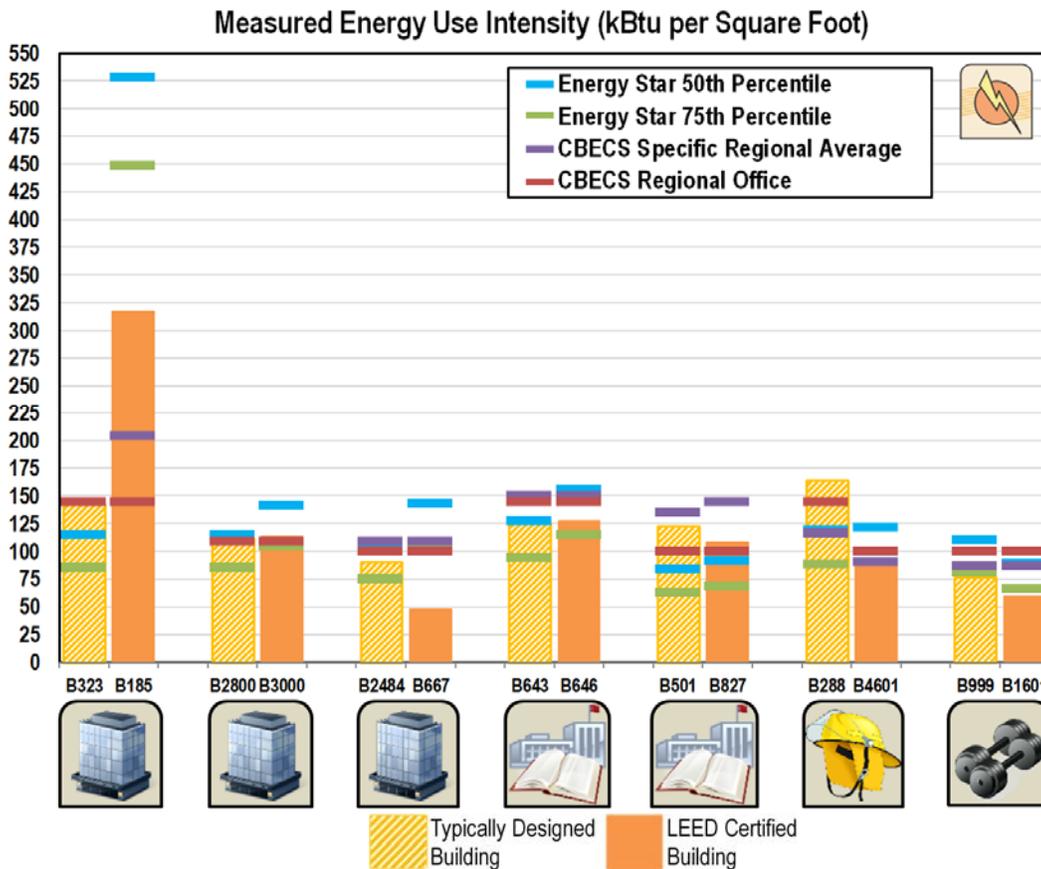
The buildings' energy use intensity (EUI) was compared to multiple different baselines (Figure S4), with the most commonly referenced baselines being from the Commercial Building Energy Consumption Survey (CBECS) and EPA's Energy Star<sup>®</sup> 50<sup>th</sup> percentile for office buildings. In addition to comparing to industry standards, the sustainably designed buildings were also compared to their matched-pair's respective performance. The energy performance of the sustainably designed buildings in the study was on average 28% better than industry baselines and 28% better than their matched-pairs. The industry baselines included CBECS specific regional average and EPA's Energy Star 50<sup>th</sup> percentile depending on the characteristics of the buildings. More information on energy and other baselines is located in the body of the report.

**Figure S4.** Energy performance of Air Force buildings is strong when compared to industry averages and typically designed Air Force buildings.

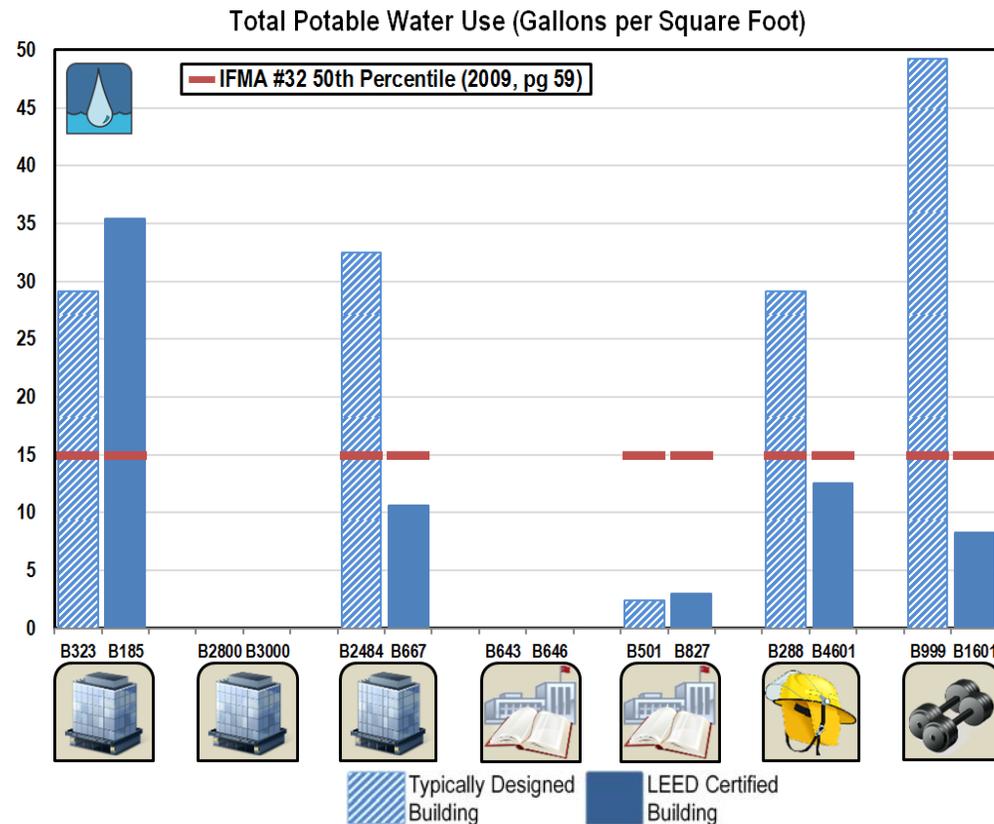
The common metric for assessing the water use of buildings is water use per gross square foot, also known as water use intensity (WUI). Five matched-pairs in this assessment had quality water data that could be used for this analysis. The WUI metric that four of the five sustainably designed buildings in this study use less water than the IFMA baseline (Figure S5) with the average water use 7% below the industry baseline. Of the five sustainably designed buildings with water data, three of the buildings largely outperformed their matched-pairs with two using slightly more water per square foot. The only sustainably designed building that is using more water per square foot than the industry baseline and its matched-pair has approximately 900 occupants, a two cell cooling tower with a below grade concrete basin, a coffee/sandwich shop in the foyer, and several large data centers areas with a non-typical operating schedule. The combination of these factors is assumed to contribute to the higher water use for that building. On average the sustainably designed buildings in this study use 32% less water per square foot than their matched-pairs.

**Figure S5.** Green Air Force buildings use less water.

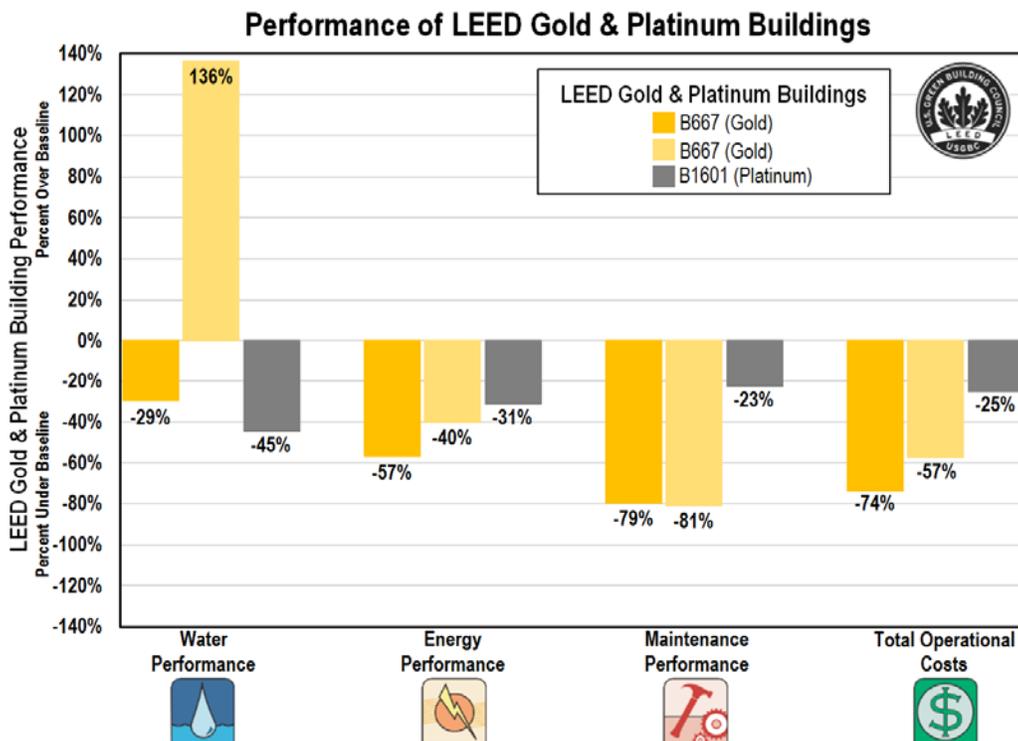
Figure S6 shows overall the two LEED Gold buildings and one LEED Platinum building in the study performed well in most of the key performance metrics with regards to baseline and their matched-pairs. Although water performance of the Main Weather Station HQ (B185) is above baseline, B185 is the building noted previously with the large number of occupants and visitors, small cafeteria and unique water-using operations.

**Figure S6.** LEED Gold buildings show exceptional performance on all of the key performance metrics.

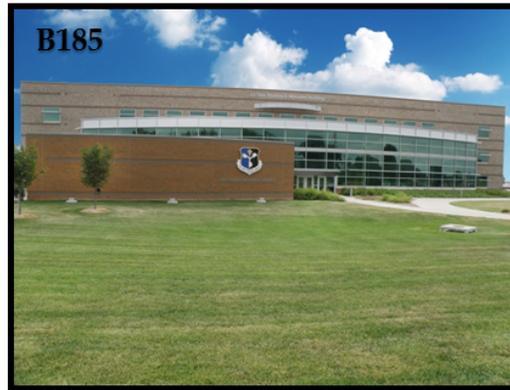
**B185**  
**Offutt AFB**  
**GSF: 202,362**  
**Year Built: 2008**  
**LEED Gold**

Identifying an ideal matched-pair for B185 (Weather Agency HQ) was difficult given the building's size, large data center, and unique operations as well as the limited Air Force buildings to select from. Although not a perfect match, B323 (Base Personnel Office) is also a large office building co-located on Offutt Air Force Base, with similar occupancy patterns and maintenance records. Given the differences (i.e., building vintages and the B185 data center) there will be comparison challenges.

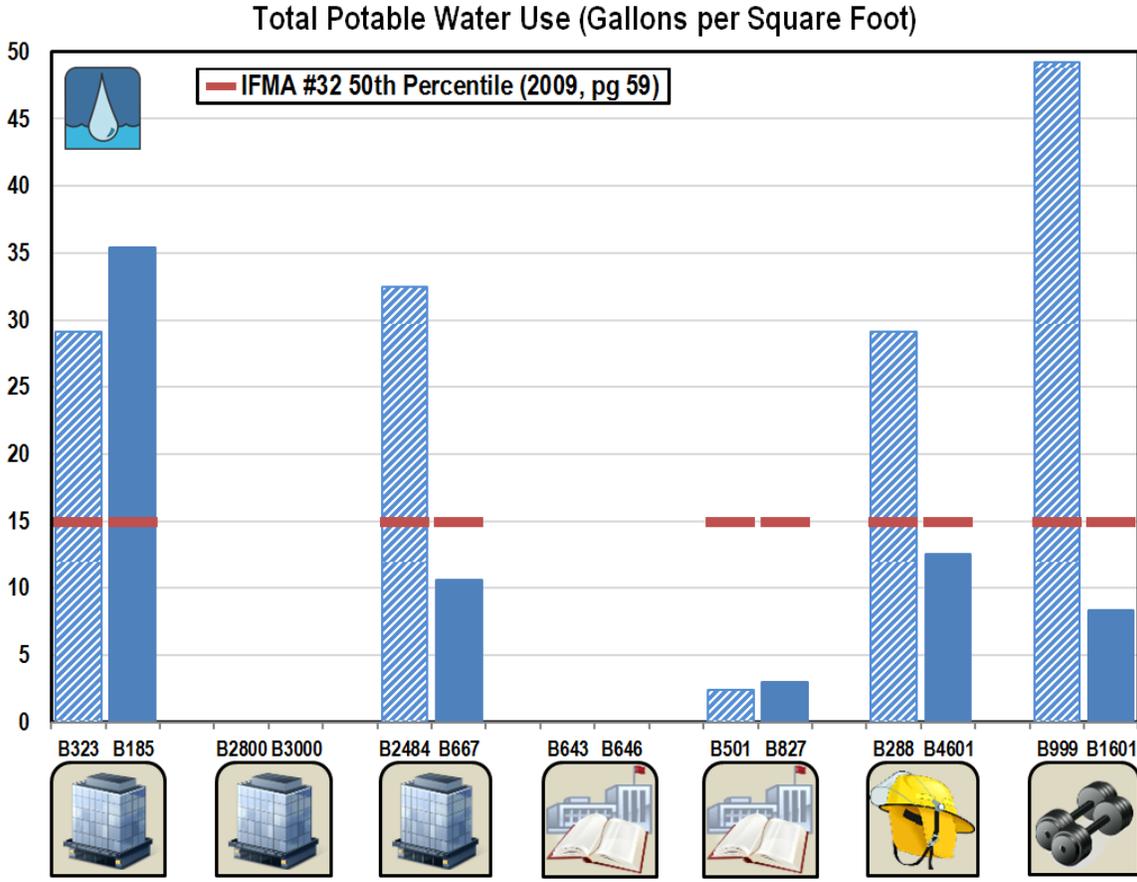
Total building water use per gross square foot includes the process water and irrigation water use. This metric shows four of the five sustainably designed buildings in this study, which have quality water data, use less water than the IFMA baseline (see Figure 2) with the average water use 7% below the industry baseline. Of the five sustainably designed buildings with water data, three of the buildings largely outperformed their matched-pairs with two of five using slightly more water per square foot. On average the sustainably designed buildings in this study use 32% less water per square foot than their matched-pairs.

Figure 2. Water use per gross square foot

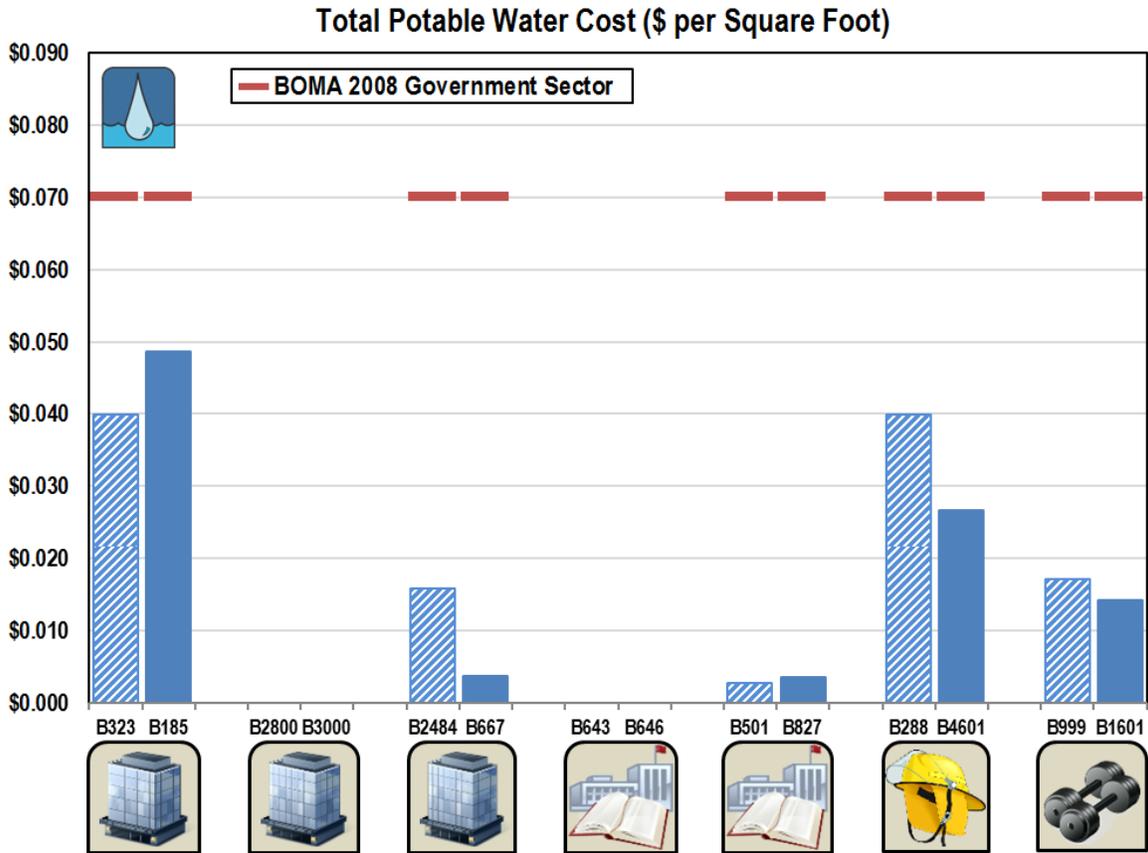
When considering the cost of water use, Figure 3 shows all of the buildings within the typical range of water cost per square foot according to the Building Owners and Managers Association baseline for the Government Sector. Water costs vary by location, which is especially noticeable when comparing the total water used per square foot with the water cost per square foot. For example, although B999 (Rambler Fitness Center, Texas) uses drastically more water per square foot than B1601 (Tyndall Fitness Center, Florida), the water utility rate at Tyndall Air Force base is almost 5 times greater than that experienced at Randolph. Low water costs decrease the likelihood of water use being a higher priority than other building operations, such as energy use and maintenance.

**Figure 3.** Water cost per square foot compared to industry baseline

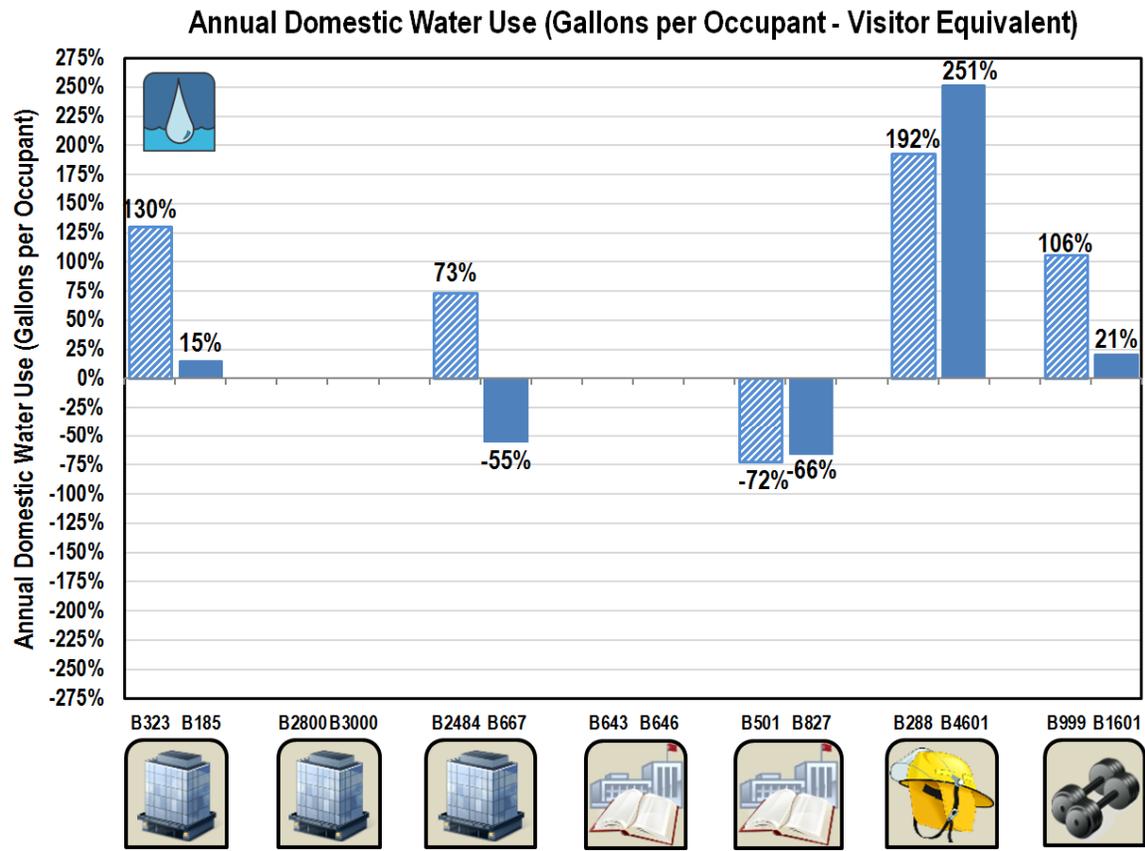
Although the water use values in Figure 4 were adjusted in an attempt to represent indoor potable water use only, it is clear that the commonly used end use distribution of water use is not representative for some of these buildings, such as B288 (Fire Crash Rescue Station), B4601 (Main Fire Station), B999 (Rambler Fitness Center), and B1601 (Tyndall Fitness Center). All of those buildings are unique building types with distinctive operations. The FEMP water use indices offer a baseline for water use per occupant. The FEMP indices do not represent water use per occupant in all building types consistently. When the Air Force buildings' water use is compared to the indices, seven of the buildings show a much greater water use per occupant than would be expected even with inefficient fixtures. It is recognized by building water use researchers that new values need to be developed.

**Figure 4.** Water use per occupant compared to the water use baseline

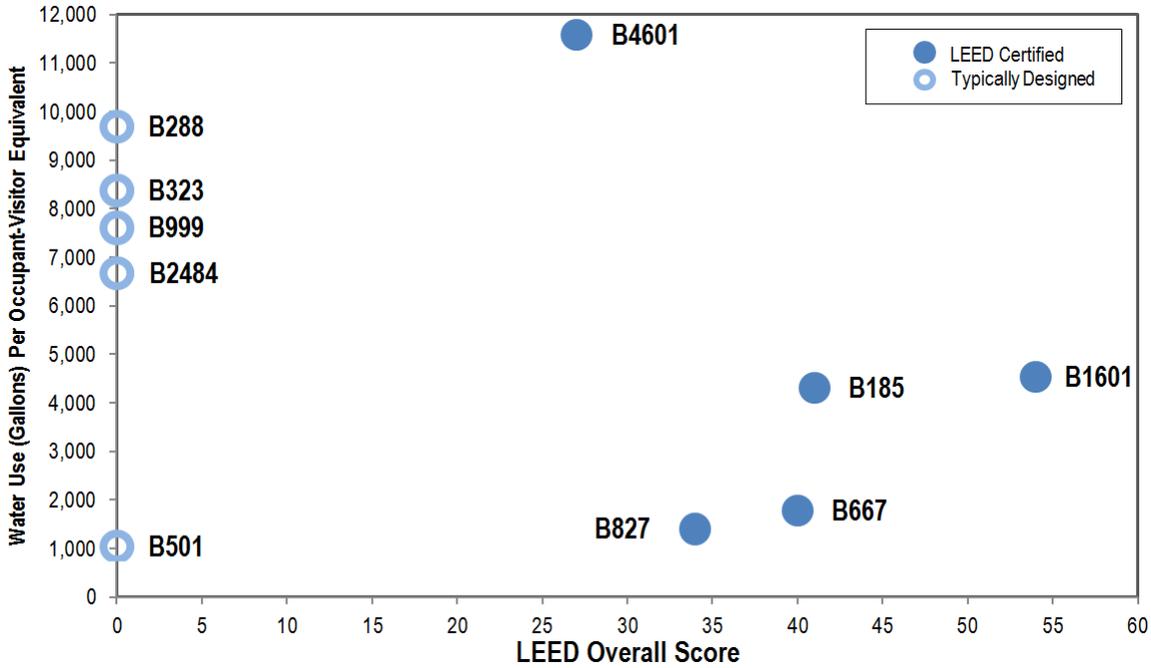
Graphically displaying the water use in comparison to the overall LEED score and total LEED WE points (Figure 5 and Figure 6) shows that water use is highly variable and there does not appear to be a strong correlation to the measured water use and the LEED credits.

Figure 5. LEED overall score and water usage

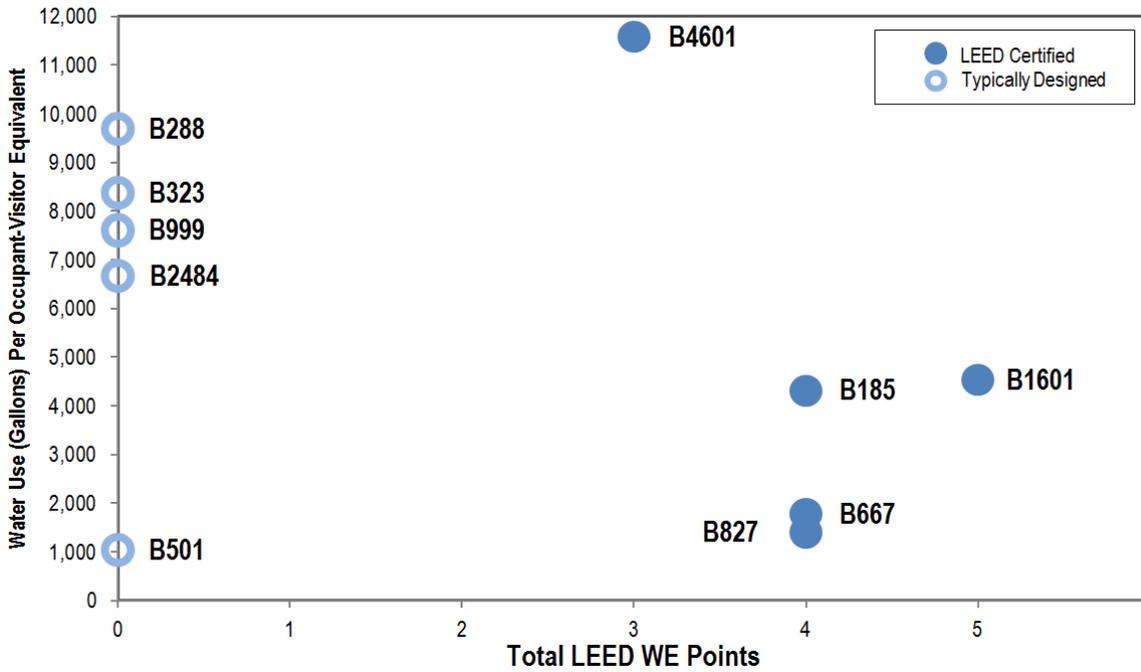
Figure 6. Total LEED WE points and water usage

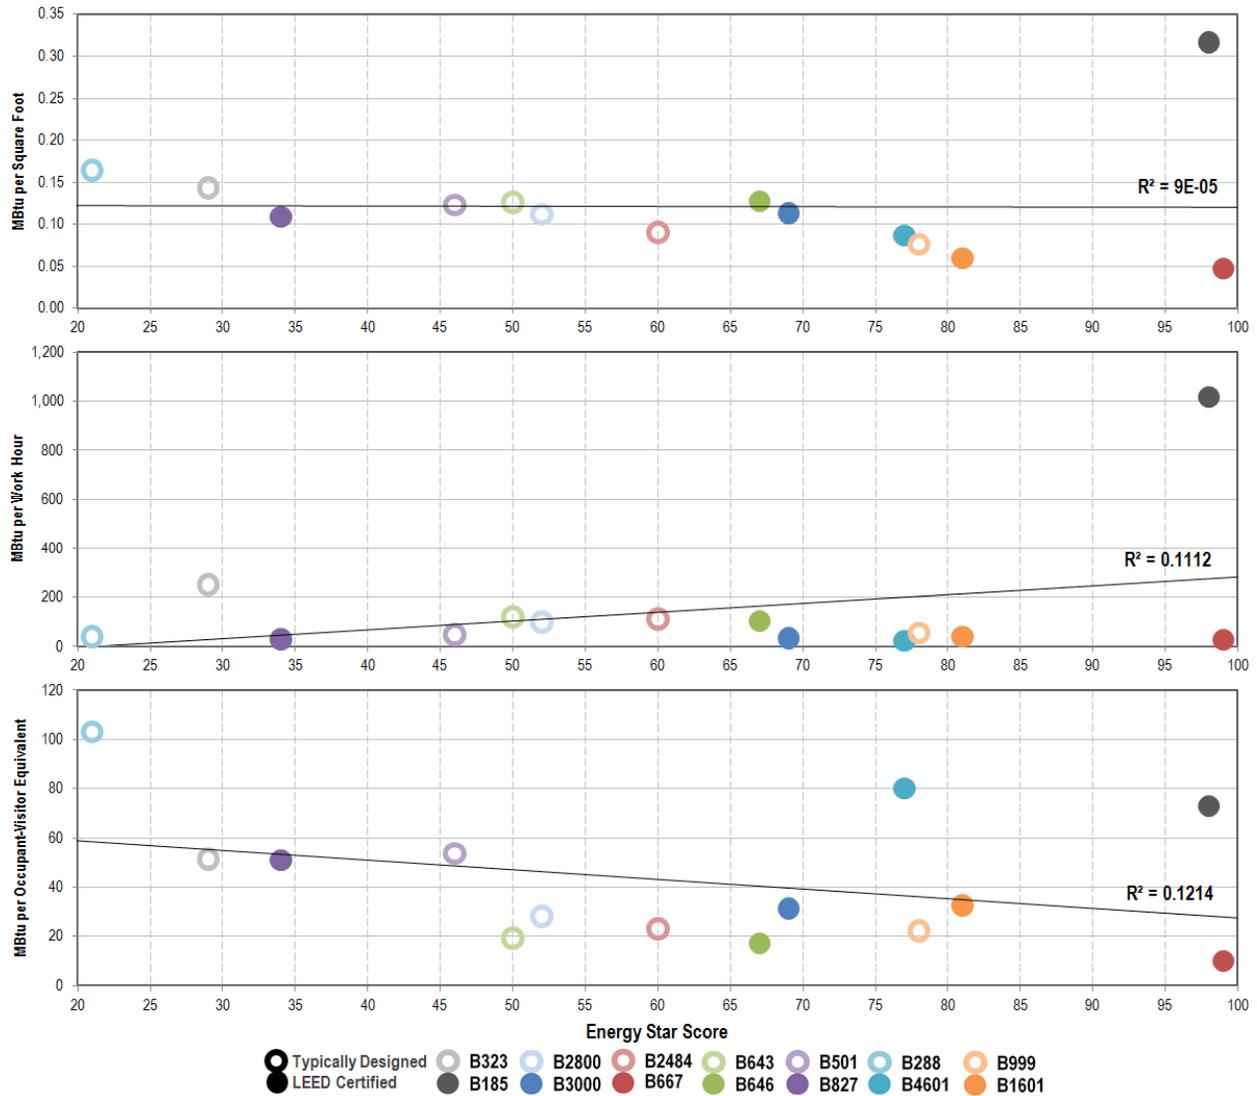
EUI is a commonly used metric calculated when the annual energy use is divided by the total building square footage. EUI does not consider the impact of the occupants with respect to how occupant density, plug load, and operating hours may impact energy use.

**Figure 7.** Energy Star score compared to energy intensity

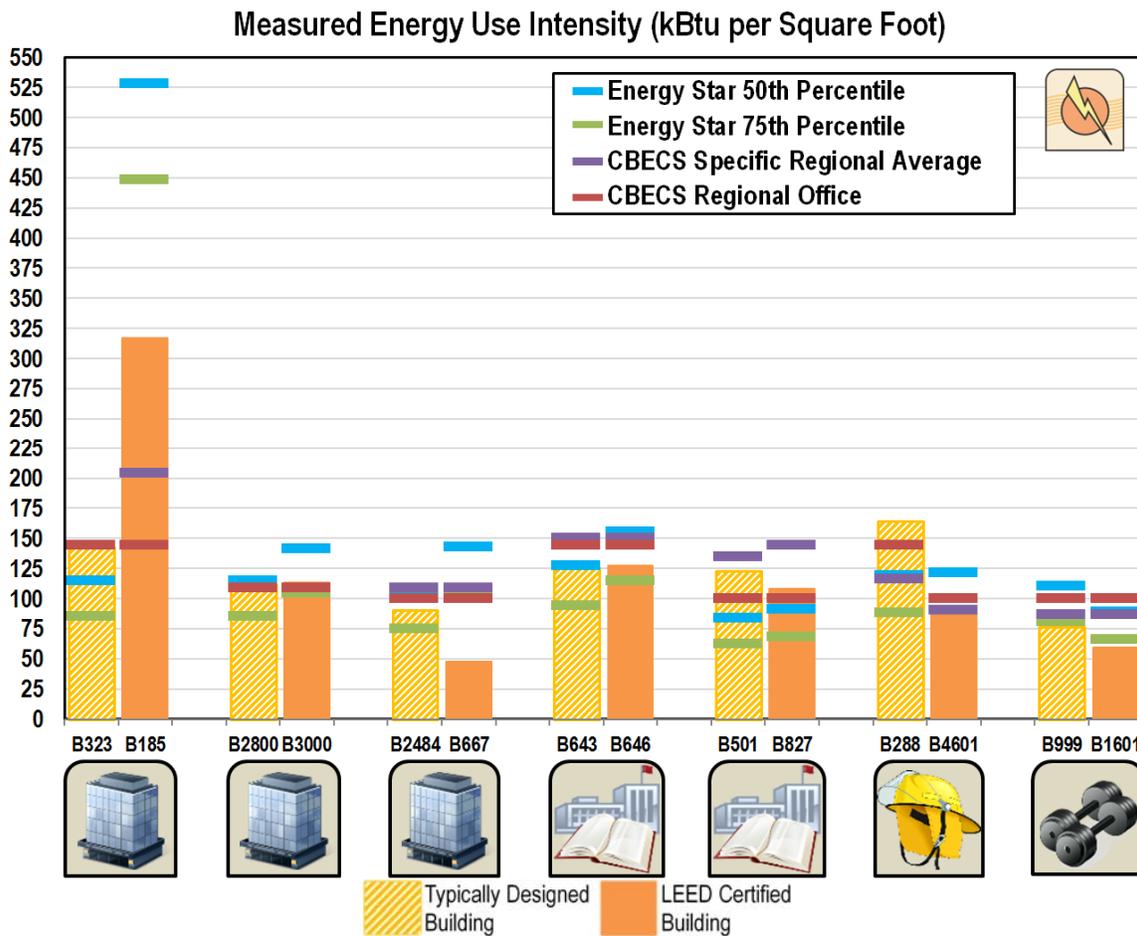
The energy performance of the seven LEED certified buildings in the study was on average 28% better than the Energy Star 50<sup>th</sup> Percentile, 3% better than the Energy Star 75<sup>th</sup> Percentile, and 10% better than the CBECS Specific Regional Averages. The energy performance of the seven typically designed buildings in the study was on average 9% worse than the Energy Star 50<sup>th</sup> Percentile, 48% worse than the Energy Star 75<sup>th</sup> Percentile, and 1% better than the CBECS Specific Regional Averages.

**Figure 8.** Study building EUIs compared to Energy Star baselines and CBECS regional EUIs

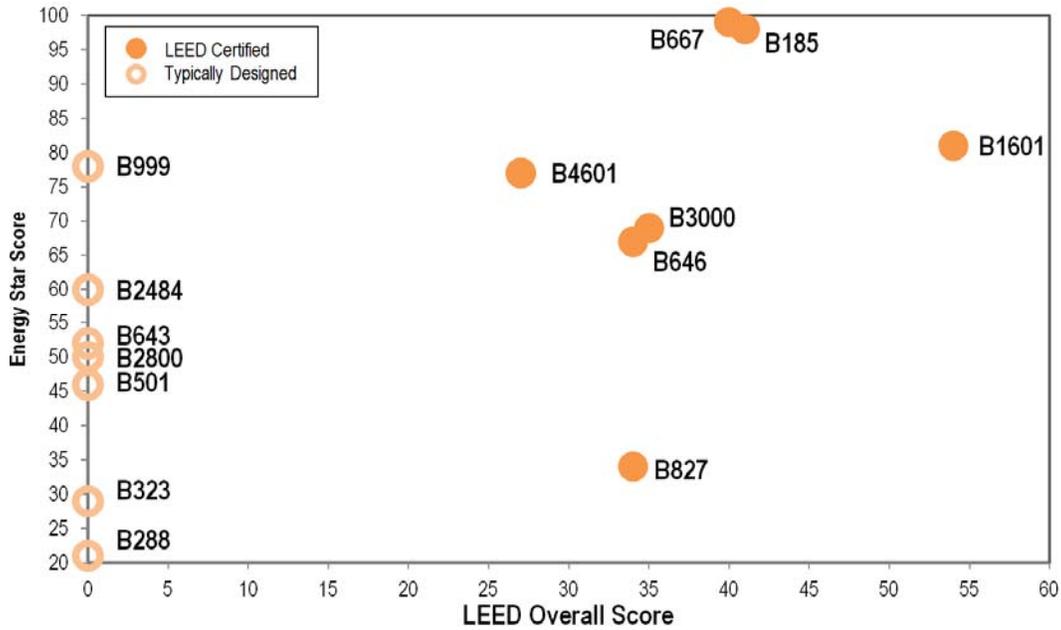
Within the next two figures (Figure 9 & Figure 10) the full orange circles represent the LEED certified buildings and the light-orange circle outlines represent the typical Air Force buildings. Comparing the Energy Star scores to the overall LEED score (Figure 9) does not appear to offer a correlation between the measured energy use and the overall LEED scores.

Figure 9. Energy Star rating and total LEED credits

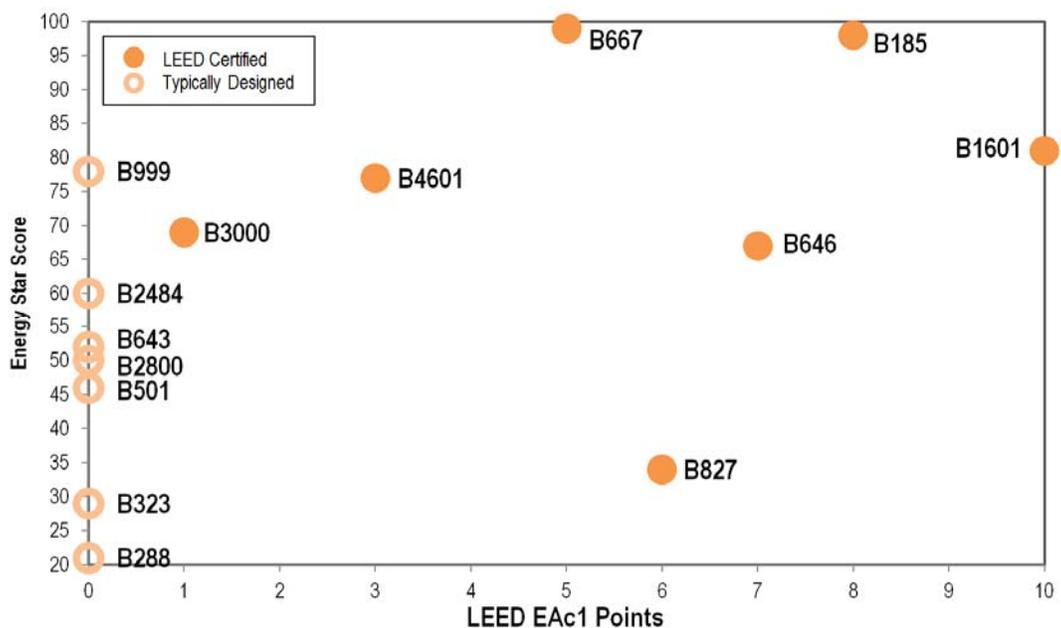
Comparing Energy Star scores with the EAc1 (Optimize Energy Performance) points (Figure 10) shows that four of the five LEED certified buildings that had five or more EAc1 points had Energy Star scores above 66, with an average Energy Star Score of 76. The remaining two LEED certified buildings with less than five EAc1 points had an average Energy Star Score of 73.

Figure 10. Energy Star rating and LEED energy credits

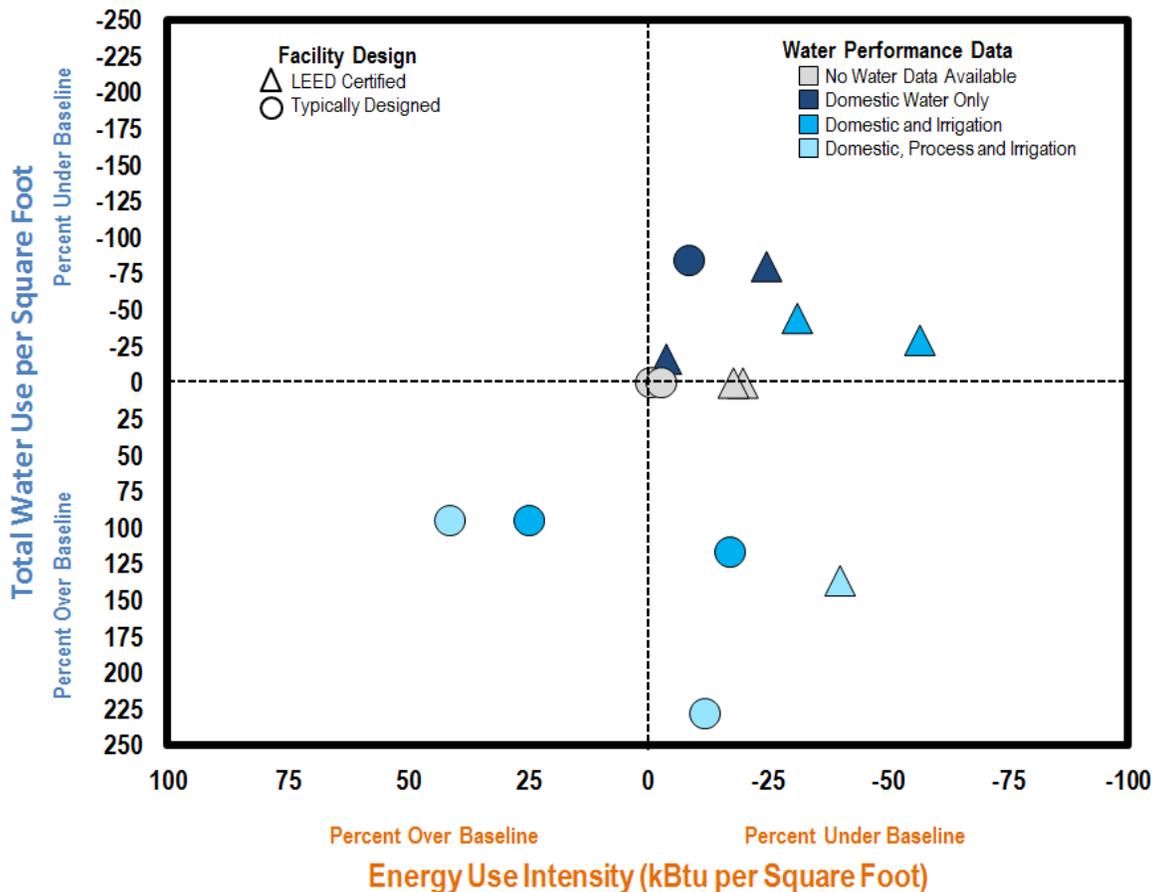
The next figure is referred to as a “quad chart.” Performance better than the baseline by the metrics on the x and y axis are placed to the right and above the baseline lines, that is, the top right quadrant. The shape of the data point indicates the facility design and the color represents the water performance data.

Figure 11. Energy (EUI) and water use per GSF performance

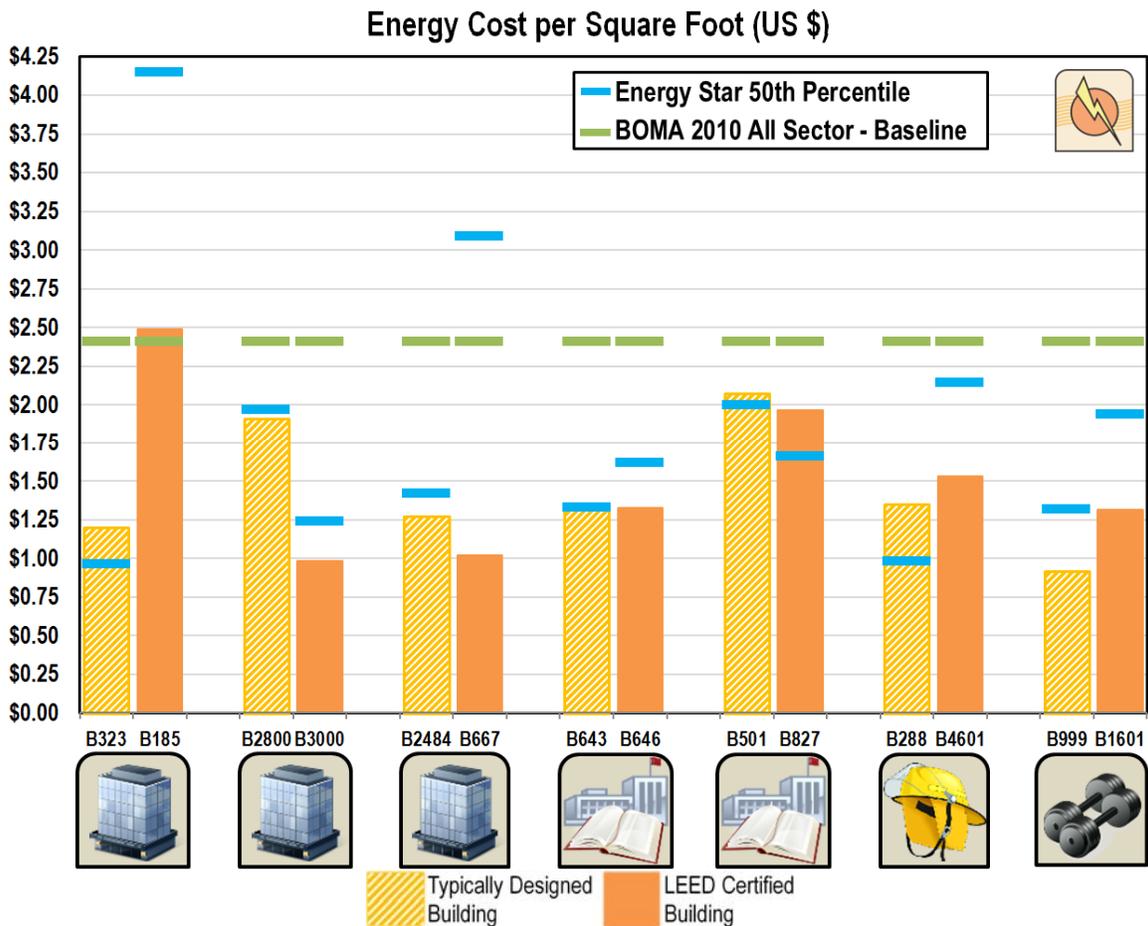
The energy-related utility costs tend to be a significant portion of a building's operating costs. Energy costs are typically expressed as cost per square foot. The baseline value for energy costs per gross square foot is based on values from EPA's ENERGY STAR Portfolio Manager 50<sup>th</sup> Percentile and BOMA.<sup>14</sup> The BOMA baselines shown in Figure 12 are national averages, thus location related differences in energy costs will not be representative. For example B4601 (Goldsboro, North Carolina) experiences a combined utility rate approximately double that of B288 (Offutt, Nebraska). The Energy Star 50<sup>th</sup> Percentile provides a baseline in which considers geographical location. Regardless of regional differences, the buildings with higher than average costs are worth investigating further in order to ensure everything possible is being done to reduce operating costs.

**Figure 12.** Energy cost per gross square foot

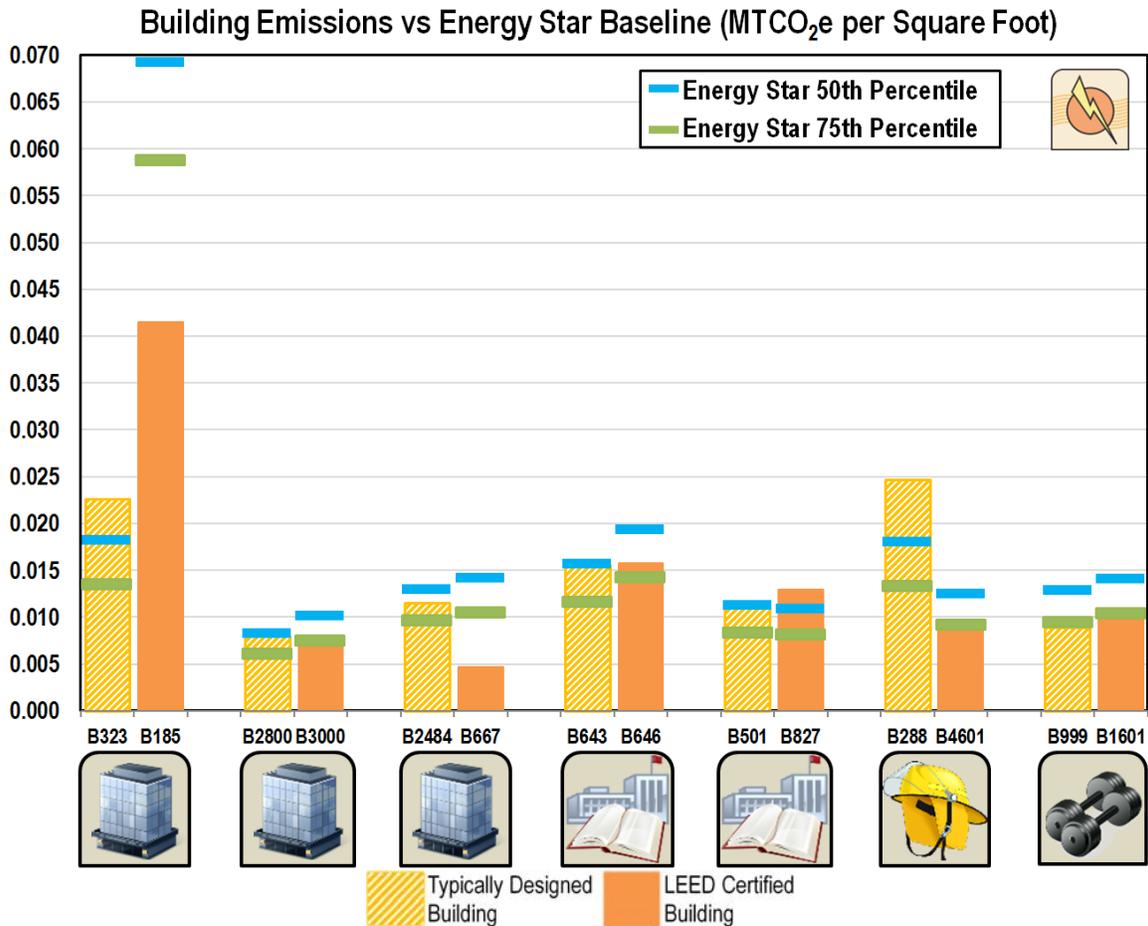
Figure 13 shows the relative baselines for each building given the energy use and utility. All but one (B827) of the seven LEED certified buildings and four of the seven typically designed buildings studied are below the industry average CO<sub>2</sub> equivalent emissions (Energy Star 50<sup>th</sup> Percentile). Three of the seven LEED certified buildings also have contracts to purchase green power (Table 13, EAc6), which would result in lower emissions (including B827). Emissions reductions from green power purchases are not represented in this graphic.

**Figure 13.** CO<sub>2</sub> equivalents compared to Energy Star baselines

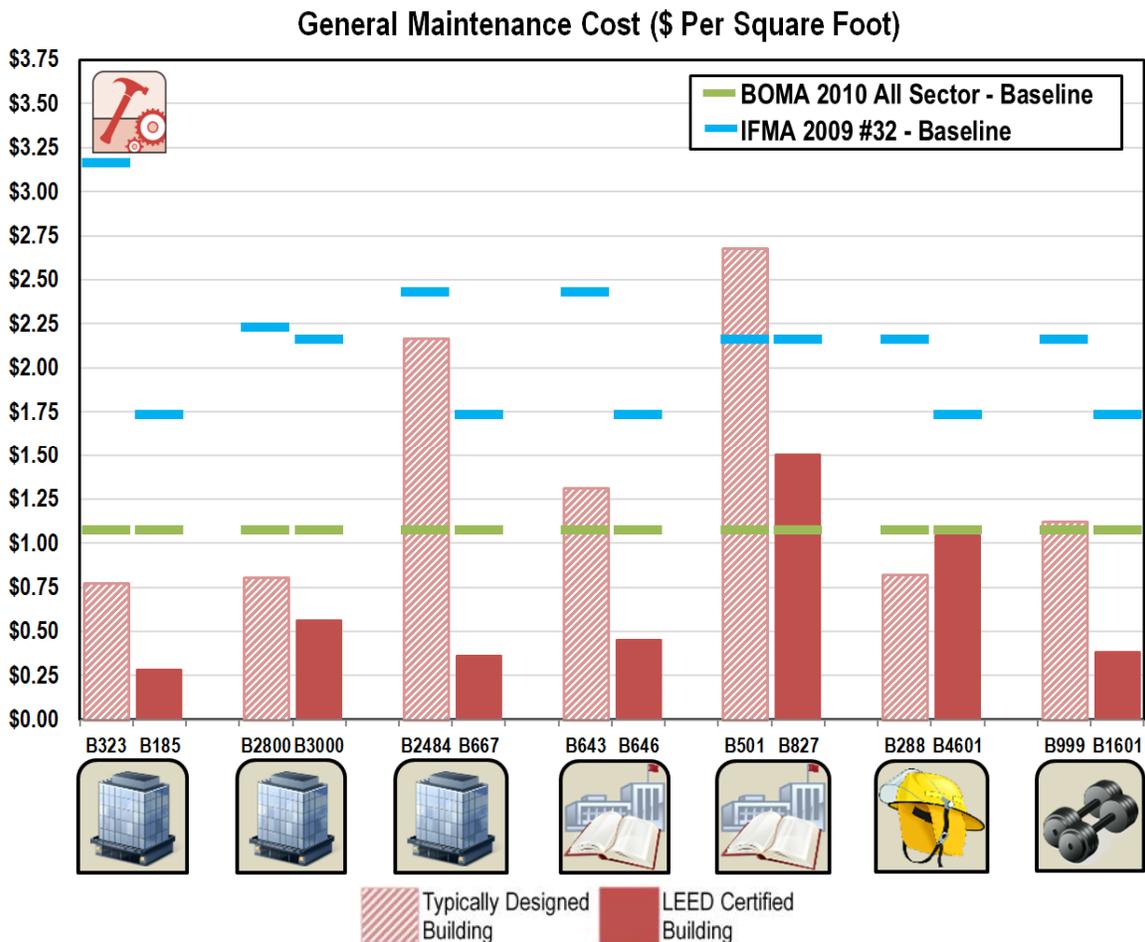
When compared to their matched-pairs, all but one (B4601, Main Fire Station) of the seven LEED certified buildings had superior performance with regards to general maintenance cost per square foot. While B4601 had general maintenance cost less than its baseline, its matched-pair (B288, Fire Crash Rescue Station) had significantly lower costs. This may be attributed to B288's backlog of service orders. At the time of the site visit, there were multiple maintenance requests pending for B288, likely affecting its energy performance. For instance B4601 out-performed B288 with regards to energy by 45%.

Figure 14. General maintenance cost per square foot

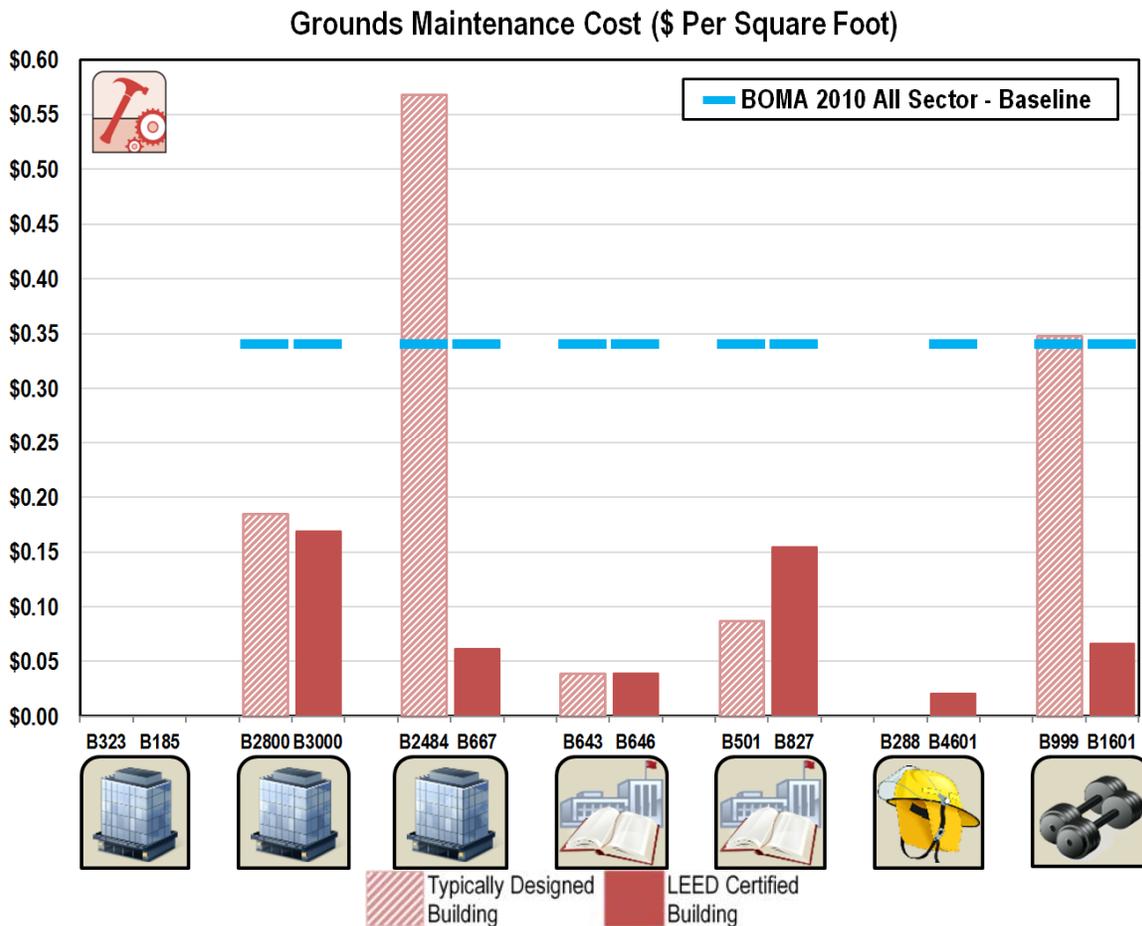
Figure 15 shows grounds maintenance costs per square foot. All but two of the fourteen buildings in the study fell within or below the baseline range. The building significantly above the baseline (B2484, Mission Support Center) is adjacent to the USAF Parade Grounds. Continuous upkeep in this area is likely contributing to the higher grounds maintenance costs. The three buildings at Offutt Air Force Base (B323, B185 and B288) did not have grounds maintenance cost available at the time of this study. Of the six LEED certified buildings with grounds maintenance data, all were under the baseline value. When compared to their matched-pairs, the LEED certified buildings performed 34% better.

**Figure 15.** Grounds maintenance cost per square foot

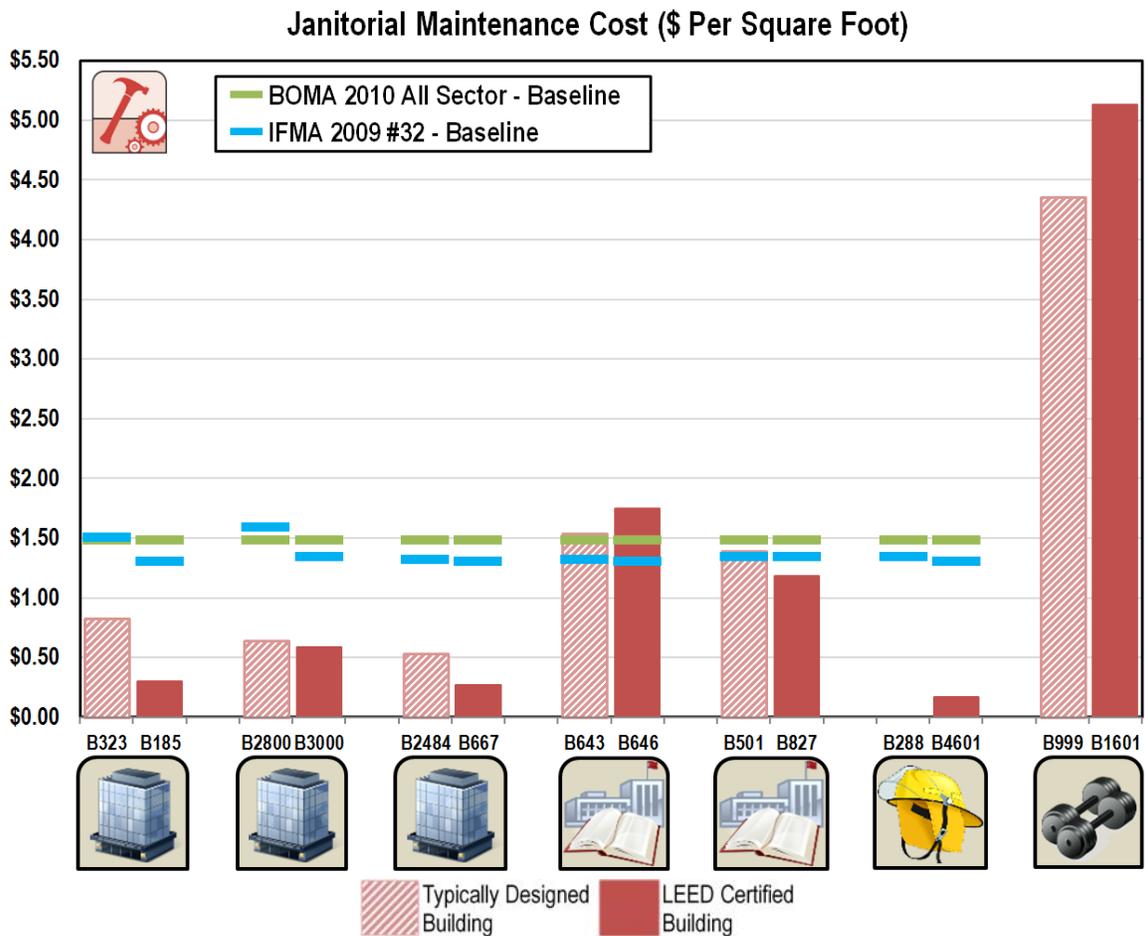
The janitorial maintenance costs for ten of the fourteen buildings were below the baseline costs (Figure 16). The BOMA 2010 baseline shown is a national average, whereas the IFMA 2009 baseline averages are based on the vintage of the buildings. The two fitness centers (B999 and B1601) were not compared to the BOMA/IFMA baselines because their building functions are distinctively different than that of the other building types. The occupants of B288 have decided to perform their janitorial duties in-house to cut facility costs. Five of the seven LEED certified buildings had janitorial maintenance costs equal to or less than the baseline, but only three were performing better than their matched-pair. On average, the seven LEED certified buildings in this study had janitorial maintenance costs similar to that of the seven typically designed buildings. As mentioned previously, the one year of costs provided in this study does not address the quality of work, potential regional cost differences, or the uniqueness of the year's janitorial needs.

Figure 16. Janitorial cost per square foot
