# ASSESSING GREEN BUILDING PERFORMANCE

A Post Occupancy Evaluation of 14 Air Force Buildings

**June 2014**

Prepared for  
the U.S. Air Force  
under Contract DE-AC05-76RL01830

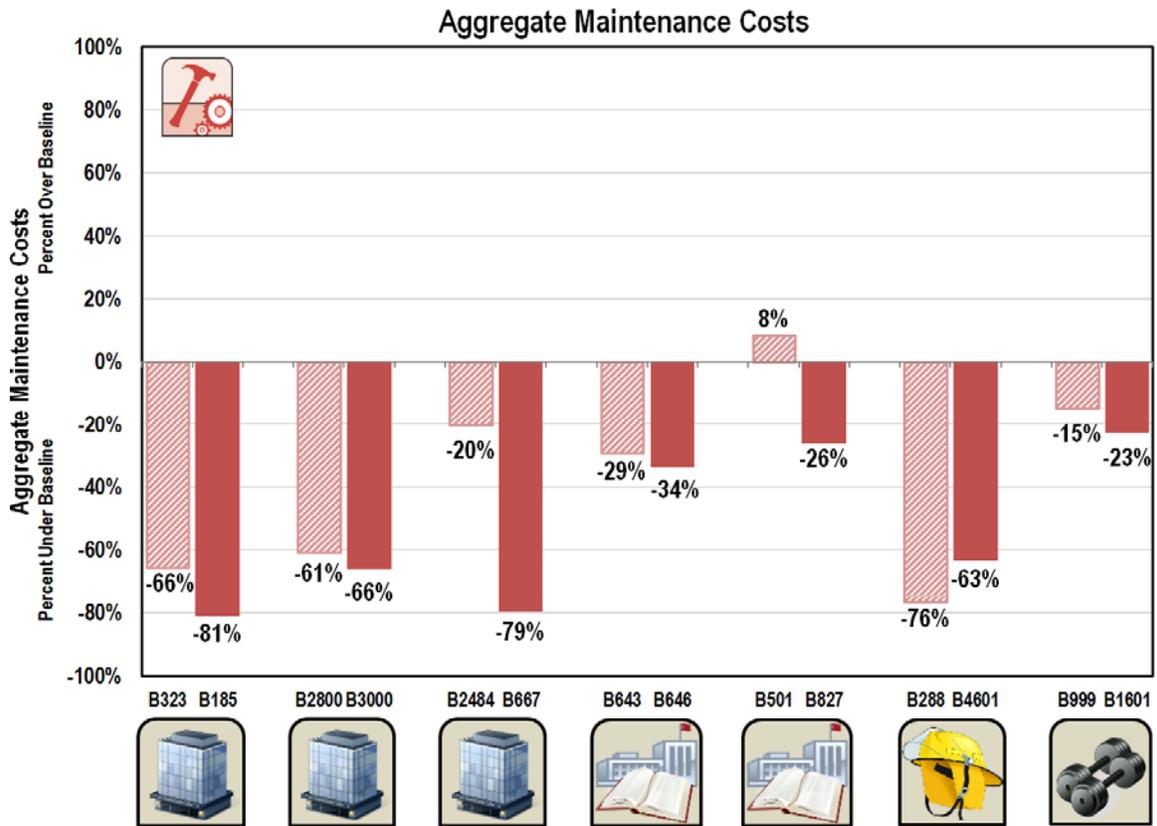
Aggregate maintenance is the summation of the general, janitorial, and grounds maintenance values. Using the aggregate general maintenance values, thirteen of the fourteen buildings had total maintenance costs less than the baselines (Figure 17). When compared to their matched-pairs, all but one (B4601, Main Fire Station) of the seven LEED certified buildings had superior performance with regards to aggregate maintenance cost per square foot.

Figure 17. Aggregate maintenance cost comparison

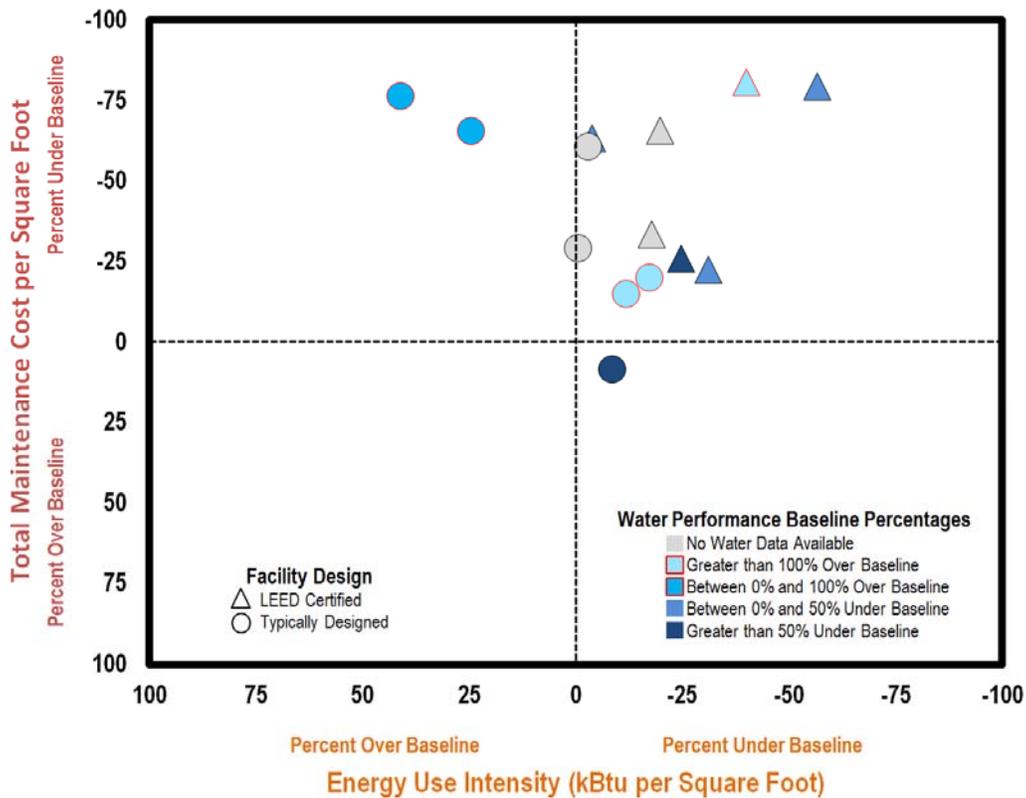
Figure 18 represents the energy, water, and aggregate maintenance for each of the fourteen buildings investigated. All of the energy use intensity values for the LEED certified Air Force buildings were better than their industry baseline and outperformed their matched-pair. The top six buildings in the energy metric and four out of the five buildings top buildings in the water metric were LEED certified. Thirteen of the fourteen buildings in this study had aggregate maintenance costs that were better than the industry baseline. The top two buildings in the maintenance cost metric were LEED-Gold certified. The buildings performing the best in all categories are located in the top-right quadrant and are dark blue colored.

Figure 18. Maintenance performance compared to energy and water performance

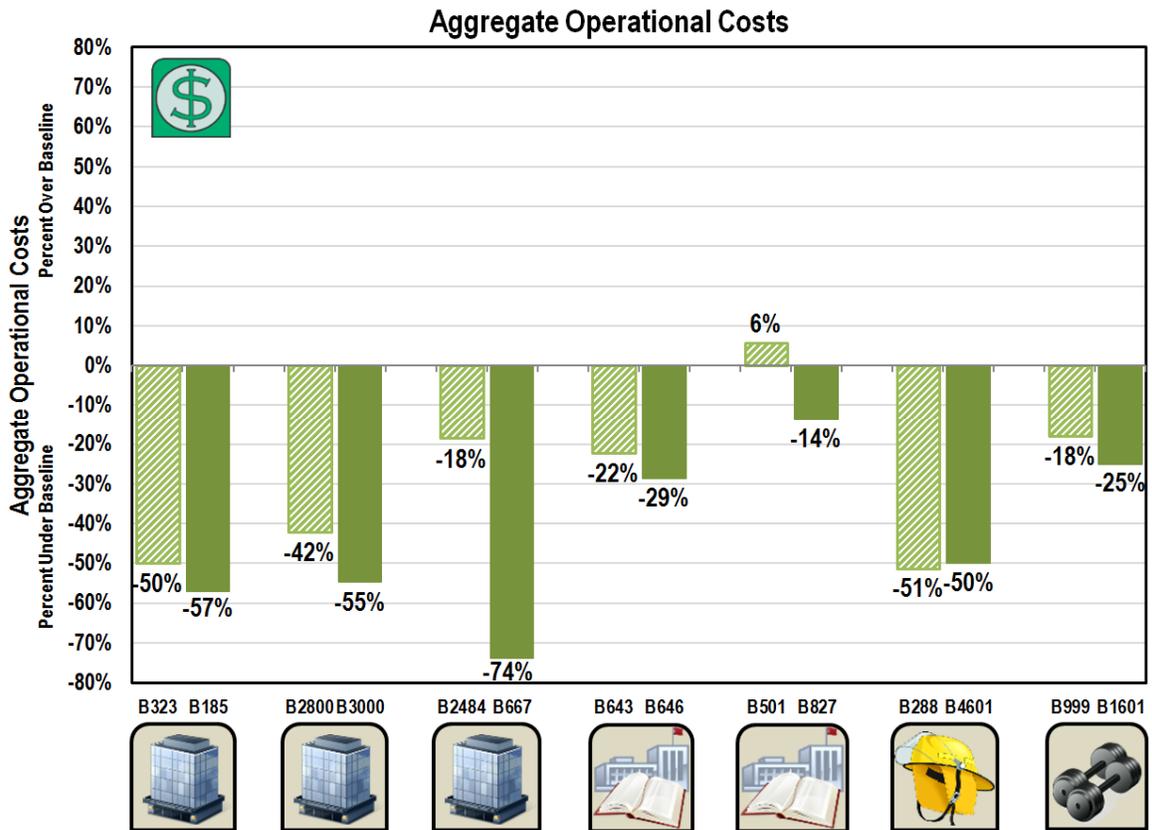
Thirteen of the fourteen buildings in this study had aggregate operational costs less than the baselines (Figure 19). When compared to their matched-pairs, all but one (B4601, Main Fire Station) of the seven LEED certified buildings had superior performance with regards to aggregate operational cost per square foot. While B4601 had aggregate operational costs less than its baseline (by 50%), its matched-pair (B288, Fire Crash Rescue Station) had slightly lower costs (around 1%). When looking at individual metrics, B4601 has superior energy (by 45%) and water (by 57%) performance and higher maintenance costs (by 13%). As stated previously, the inferior maintenance performance may be attributed to B288’s backlog of service orders. At the time of the site visit, there were multiple maintenance requests pending for B288 (effectively deflating actual maintenance costs).

Figure 19. Aggregate operational costs compared to baseline

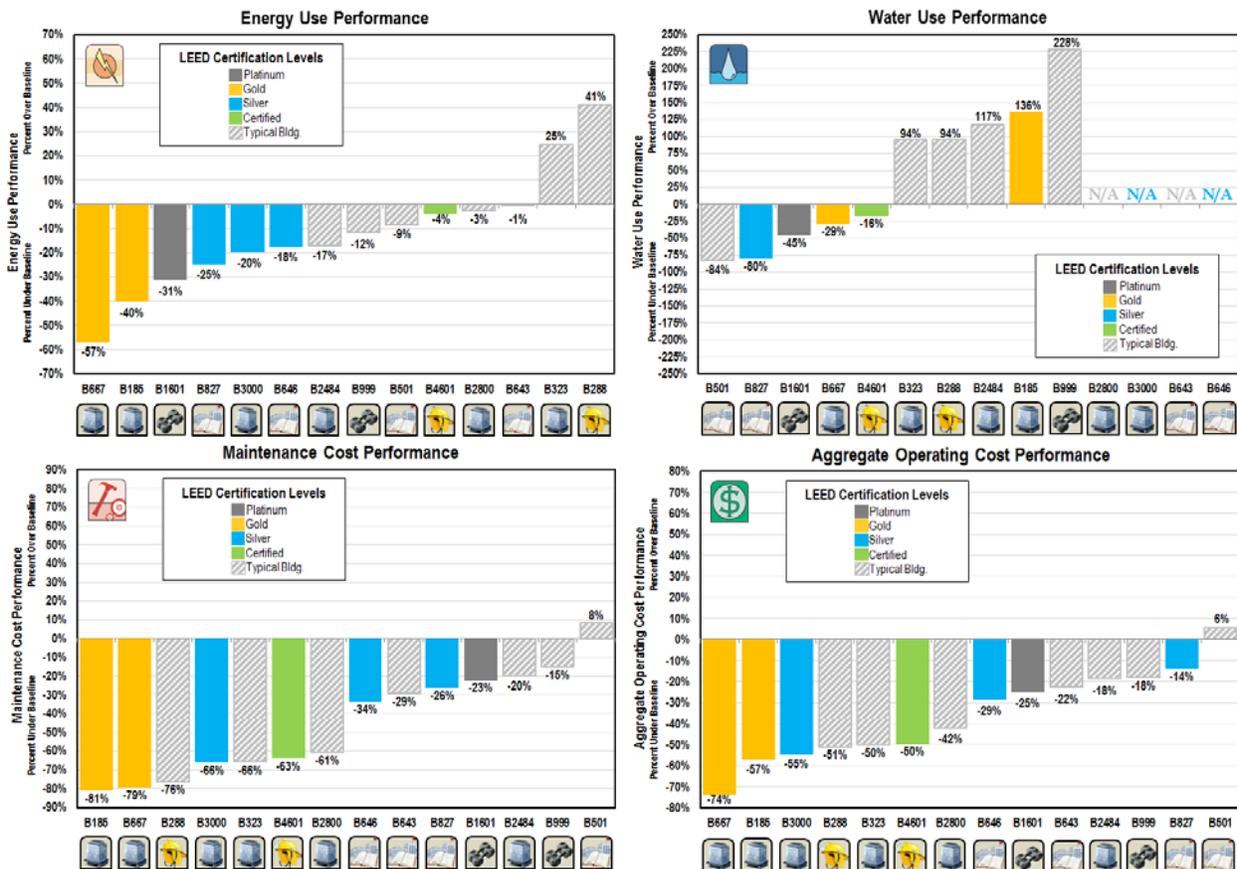
Based on the LEED credits and Energy Star scores, it was observed that when projects had incorporated sustainable design principles from the start (e.g., LEED requirements) the overall performance of the building was better than the industry standard and respective matched-pair. Additionally, the LEED Gold & Platinum buildings performed consistently well in most metrics (Figure 20) with regards to baseline and their matched-pairs. Although water performance of the Main Weather Station HQ (B185) is above baseline, B185 is the building noted previously with the large number of occupants and visitors, small cafeteria and unique water-using operations.

Figure 20. LEED Gold & Platinum buildings consistently perform well

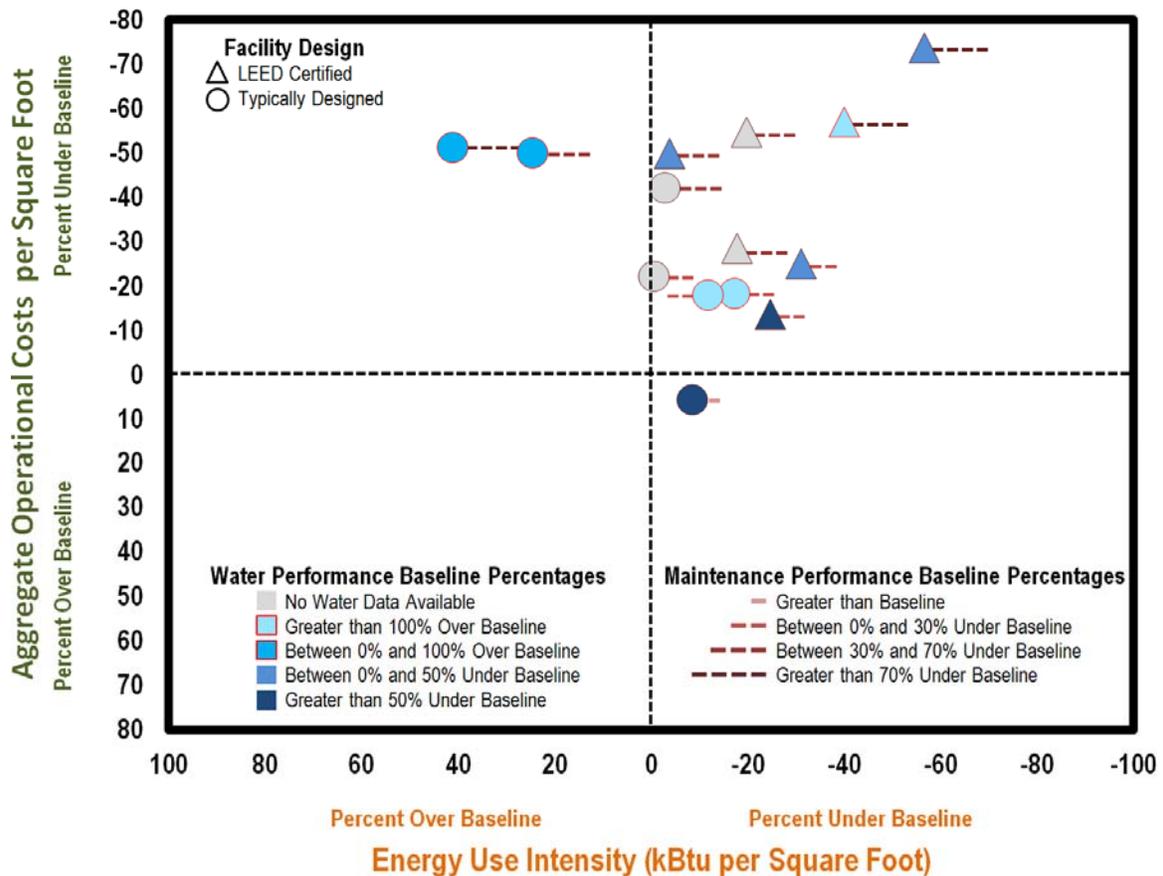
In addition to the axis metrics, the shape of the data point indicates the facility design (LEED certified or typically designed) and the color represents the water performance (the darker the blue, the better water performance) and the red tails indicate the total maintenance performance (the longer the tail, the lower maintenance costs). Note, all seven of the LEED certified buildings (triangles) are within the top right quadrant and have maintenance costs lower than baselines.

Figure 21. Aggregate operational costs compared to energy, water and maintenance performance

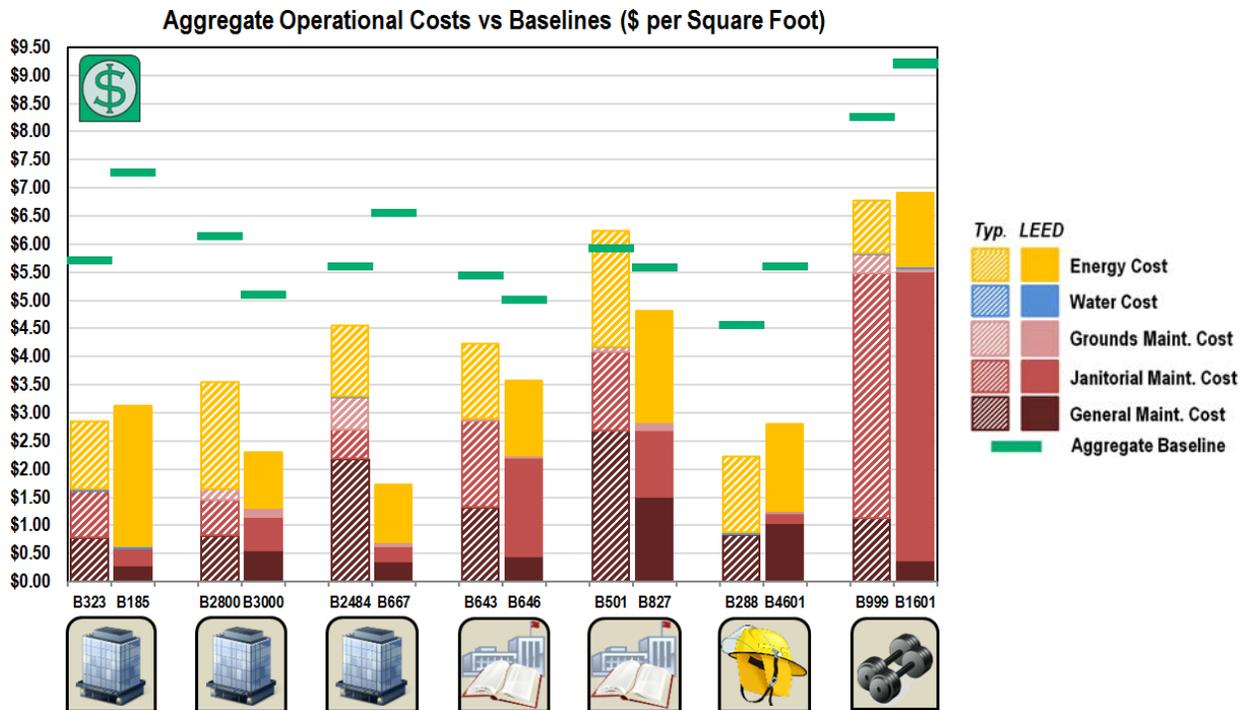
Figure 22 shows the aggregate operation costs by metric compared to the aggregate baselines. When looking at the portfolio, total maintenance costs on average are approximately 57% of the total operational costs. As a result, facilities with superior maintenance performance are likely to also perform well with regards to aggregate operational performance. Water costs comprise of less than 1% on average, and energy costs make up the remaining 43%. How a building is maintained and operated, largely affects the building energy performance, costs and occupant comfort and satisfaction.

**Figure 22.** Aggregate operational costs by metric

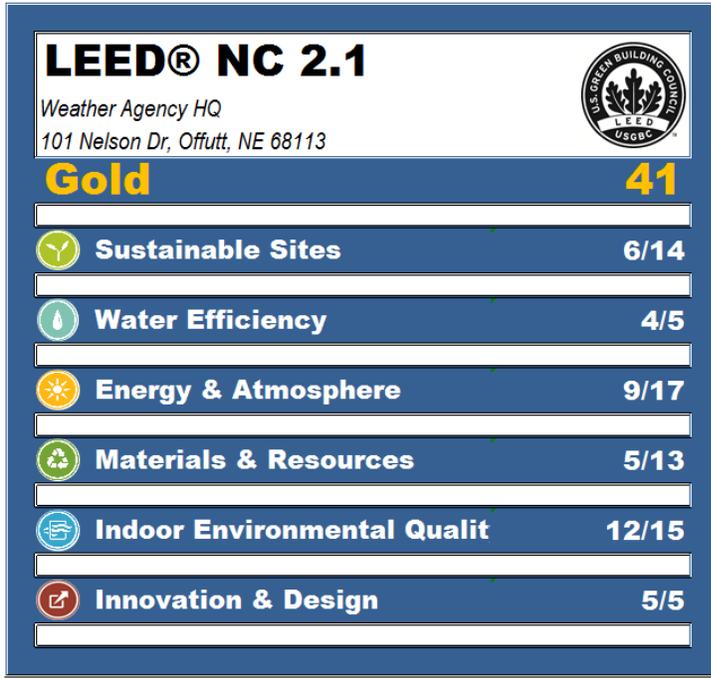
Certified: 26-32 points, Silver: 33-38 points, Gold: 39-51 points, Platinum: 52-69 points
