## Long-term Testing of LED Luminaires

**Host Site:** I-35 West Bridge, Minneapolis,  
Minnesota

# Long-term Testing Results for the 2008 Installation of LED Luminaires at the I-35 West Bridge in Minneapolis

PNNL-23702

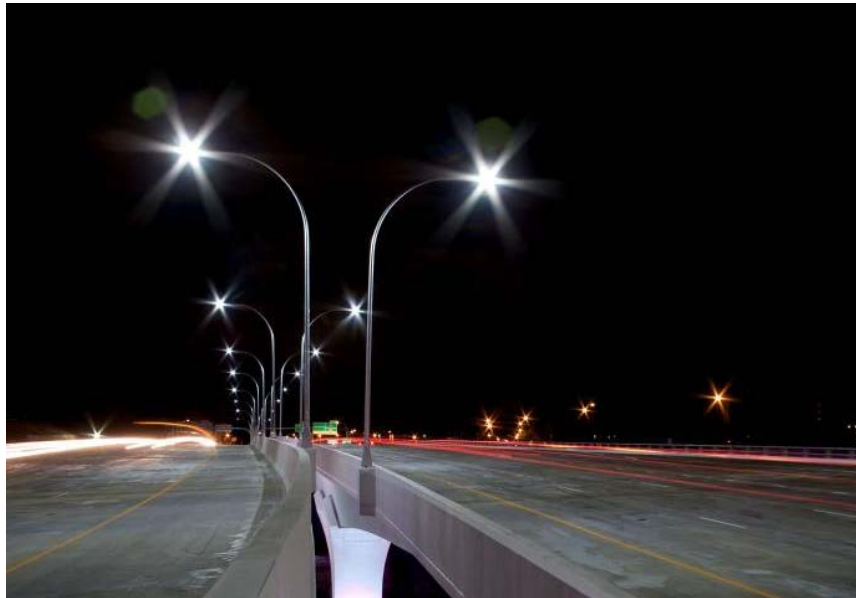
Figure 2. LED luminaires on the I-35 bridge

Two separate spans comprise the bridge, each 1215 feet long, and each containing five 12-foot-wide lanes with a 14-foot inside shoulder and 13-foot outside shoulder. Thus, the overall bridge width is 87 feet. Poles are set on 150-foot spacing down the center of the bridge (see Figure 2), with mounting heights of 40 feet.

The bridge incorporates 16 Type V distribution 200-LED luminaires (10 LED arrays with 20 LEDs each, producing nominal 16,500 lumens) across the middle span, and 4 Type III distribution 240-LED luminaires (12 LED arrays with 20 LEDs each, producing 19,000 lumens), two mounted at each end of the bridge (one on each side). Selection of this luminaire output anticipated a future lumen depreciation of 30% (i.e., to  $L_{70}$ ) while still meeting design criteria. At the prevailing average nighttime temperature in Minneapolis, the manufacturer projected that the luminaires would need to operate for several decades to reach an  $L_{70}$  level of lumen depreciation, estimating only about a 12% loss after 20 years under the given conditions.<sup>1</sup>

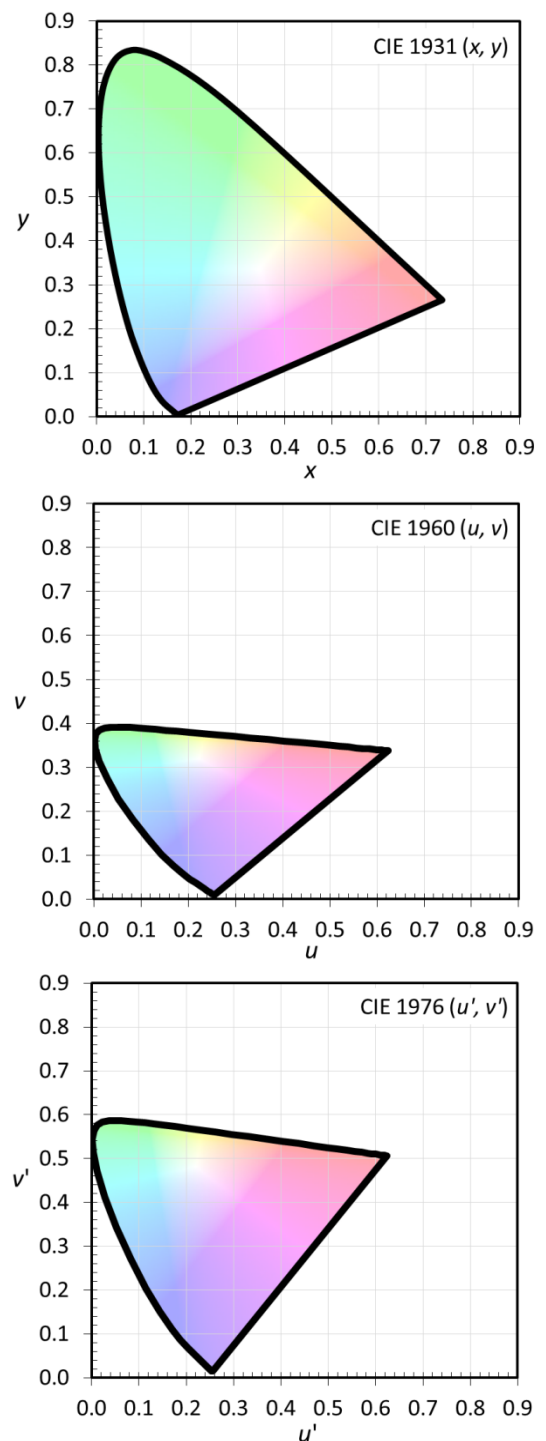
**Figure A.1. CIE 2° chromaticity diagrams.** The 1960 and 1976 versions are linear transformations of the original 1931 version. The colored backgrounds are shown for orientation only.
