LED Lighting in a Performing Arts Center

Host Site: University of Maryland,
College Park, Maryland

July 2015

University of Maryland Wall Washer Retrofit **LED Modules Replace Halogen Lamps in a Performing Arts Center**

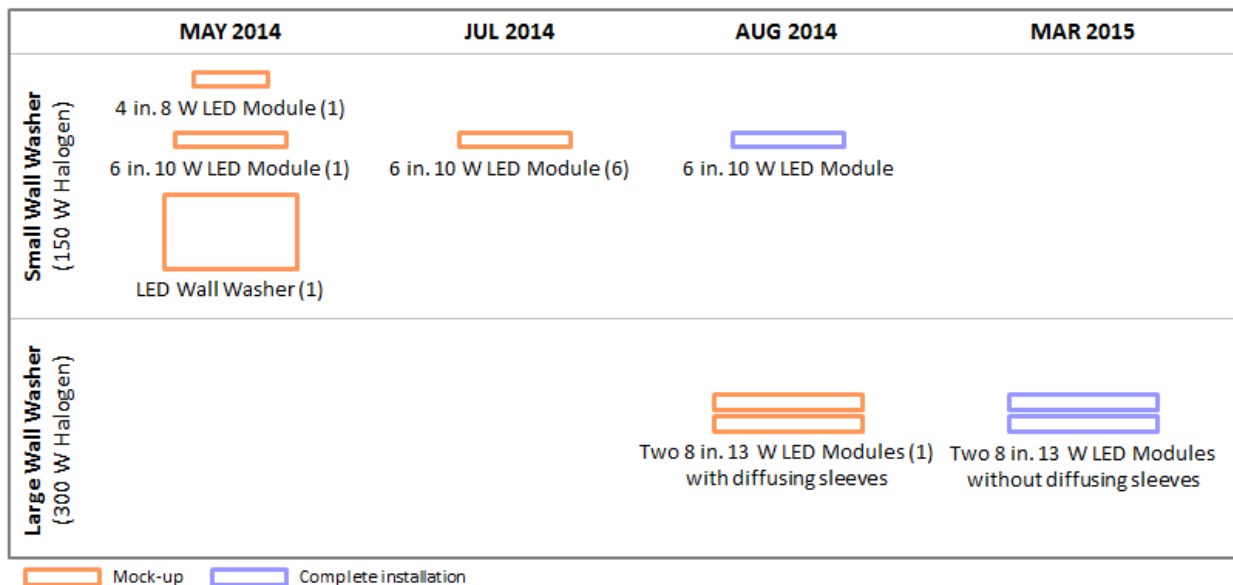
Figure 1. UMD CSPAC Wall Washer Retrofit Timeline: Mock-up and Installation. After potential alternatives to the incumbent halogen wall washers were assessed, the selected options were mocked-up in various stages, delineated above by the orange outline. The installation was completed for the small wall washers in August 2014 and for the large wall washers March 2015, shown by the purple outline. The numbers in parentheses indicate how many of a given option were installed for the mock-up.

The retrofit occurred over the course of a year in several stages (Figure 1), beginning with examining potential alternatives to the incumbent halogen wall washers, then mocking-up options, and finally retrofitting all wall washers. The options selected as a result of the mock-ups remained installed.

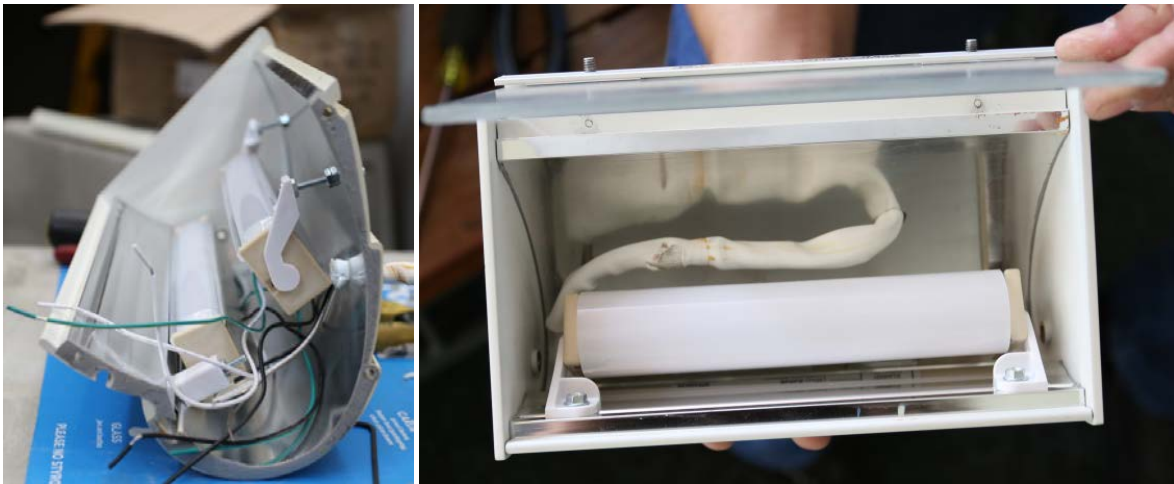
Figure 2. LED Modules in Existing Wall Washer Housings. The left image is a side view of the large wall washer housing with two LED modules and the right image is a front view of the small wall washer housing with one LED module.

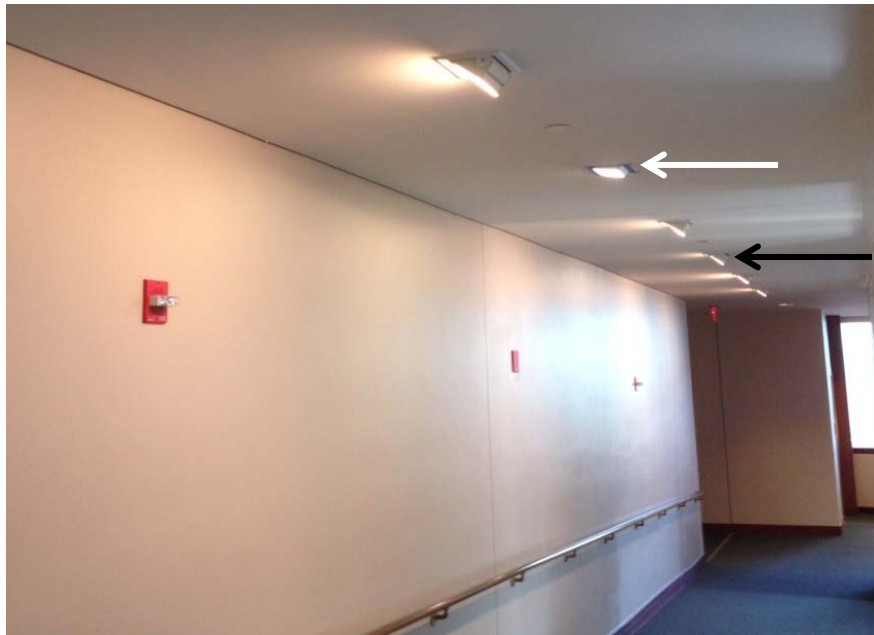
Figure 6. Initial Mock-up of the LED Wall Washer (white arrow) and the 6 in. LED Module (black arrow) with the Existing Halogen Wall Washers (no arrow). The dimming level was 30%. The LED wall washer did not provide light near the top of the wall, or distribute the light as widely on the wall, when compared to the halogen and LED module wall washers.

The mock-up compared the LED wall washer, LED module, and the existing halogen wall washer. UMD Facilities Management coordinated the mock-ups and from the beginning sought feedback from key CSPAC staff. The LED module had two financial advantages over the LED wall washer. First, the initial cost of the LED module was one-third the cost of the LED wall washer. Second, the LED wall washer was slightly smaller than the existing halogen wall washer, so patching the ceiling or fabricating custom trim plates would have been necessary—adding considerable cost and the risk of noticeable repair marks on the ceiling. In order to justify the cost difference, the LED wall washer needed to perform better than the LED module in the visual evaluation of the distribution of luminous flux, glare, and color. The side-by-side mock-up of some of the options is shown in Figure 6.

The 17 W complete LED wall washer did not provide light near the top of the wall, or as widely on the wall as the halogen lamp or LED module in the existing wall washers. The distribution of light was similar between the 150 W halogen and the 10 W 6 in. LED module. The 10 W LED module provided less light on the ceiling than the existing halogen; however, it was barely noticeable and in some cases might be preferable. The 8 W 4 in. LED module did not provide enough light on the wall, so the 10 W 6 in. LED module was selected. There was a 13 W 8 in. LED module option that would have provided more light on the wall, but it was too long for the existing small wall washer housing. Although the 10 W LED module did not provide as much light on the wall as the 150 W halogen lamp, it was considered similar enough to be acceptable by UMD Facilities Management staff as well as key CSPAC staff.

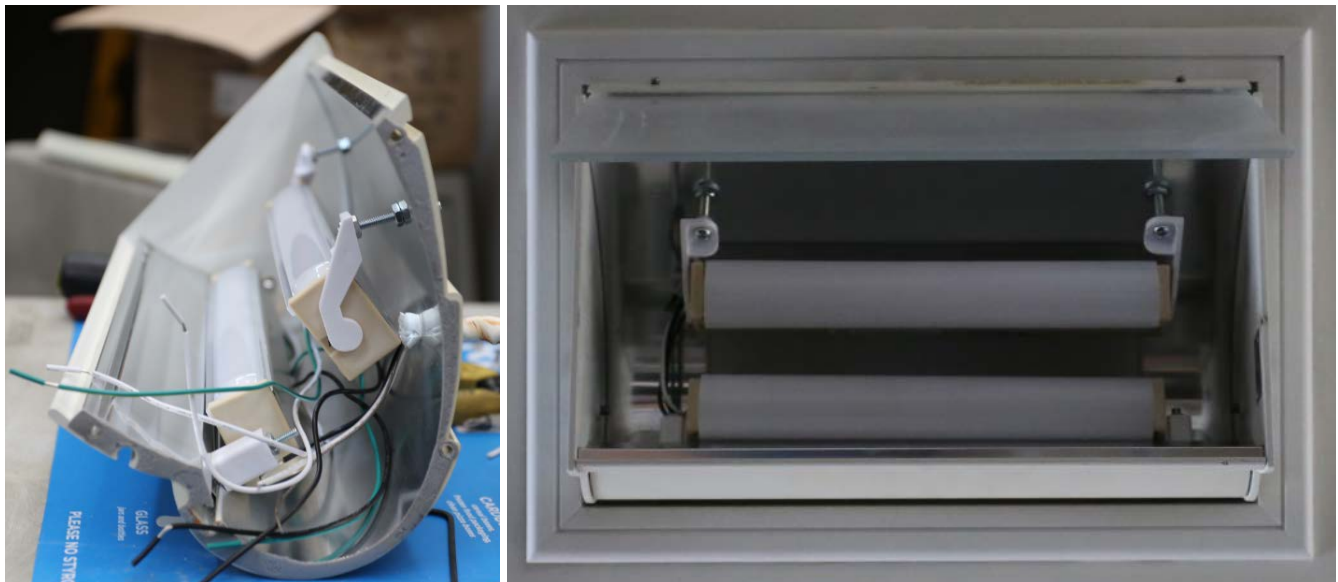
Figure 7. Large Wall Washer with Two 13 W LED Modules: Prior to Installation in Ceiling (left) and Installed in the Ceiling (right). The left photograph shows the modules without sleeves and the right photograph shows the modules with sleeves. The wall washer's glass lens was swung open and can be seen toward the top of the right photograph.

The large wall washers in the CSPAC were lamped with a single 300 W halogen lamp. For the mock-up the halogen lamp and socket were removed and replaced with two 13 W 8 in. LED modules, shown in Figure 7. The same procedure used to retrofit the small wall washers was followed. The large wall washer mock-up in August 2014 occurred at the same time as the small wall washer retrofit of the remaining 32 incumbent halogen small wall washers in the CSPAC. Since TerraLUX was selected for the small wall washers, and offered a suitable product for the large wall washers, other manufacturers were not considered. The distribution of light and color from the wall washer with two 13 W LED modules was similar to the incumbent performance of the 300 W halogen lamp, and therefore, was considered acceptable by UMD Facilities Management staff.

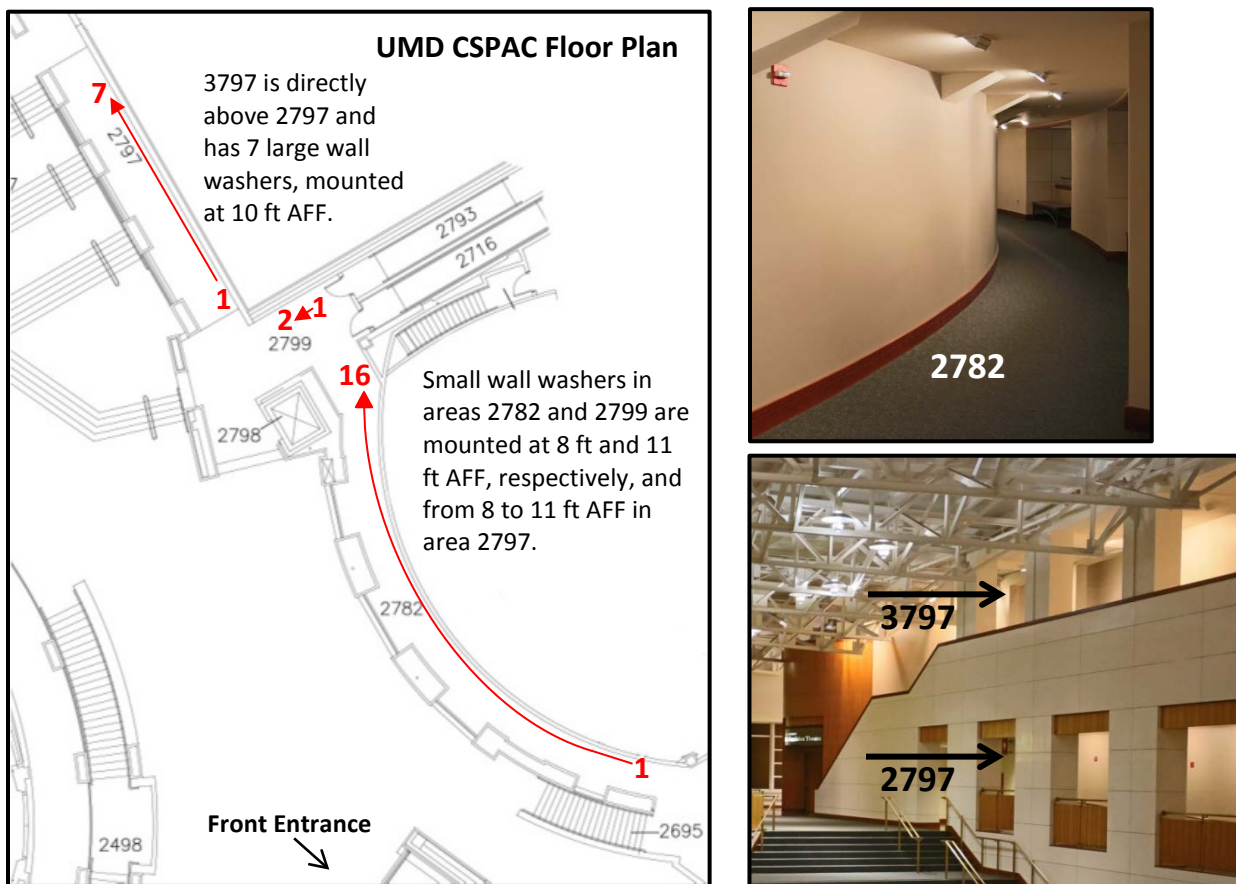
Figure 8. UMD CSPAC Interior – Partial Floor Plan of Second Floor Atrium and Adjacent Hallways (left), Photograph of Hallway 2782, and Photograph of Hallways 2797 and 3797 from Atrium. The red numbering indicates the wall washer labeling. Area 2782 has 16 small wall washers labeled 2782-1 to 2782-16, with the value following the dash representing the location of the wall washer relative to the front entrance of the building.

Measurements were recorded before and after the retrofit from halogen to LED to capture any changes in the lighting quality, as well as long-term performance of the LED technology. Illuminance and color were measured on a portion of the wall and floor in a second floor hallway that is illuminated by small wall washers and in a third floor hallway that is illuminated by large wall washers. The areas are illustrated in Figure 8 and are referenced as 2782 (second floor) and 3797 (third floor) throughout the report—keeping with the University of Maryland (UMD) nomenclature for the Clarice Smith Performing Arts Center (CSPAC) spaces. Additional color measurements were recorded for 25 small wall washers: 16 in hallway 2782, 2 in area 2799, and 7 in hallway 2797. The small wall washer mock-ups took place in hallway 2797. Each fixture is labeled according to the area, followed by the count of the fixture relative to the front of the CSPAC, e.g., 2782-1 is the wall washer in hallway 2782 closest to the front entrance.

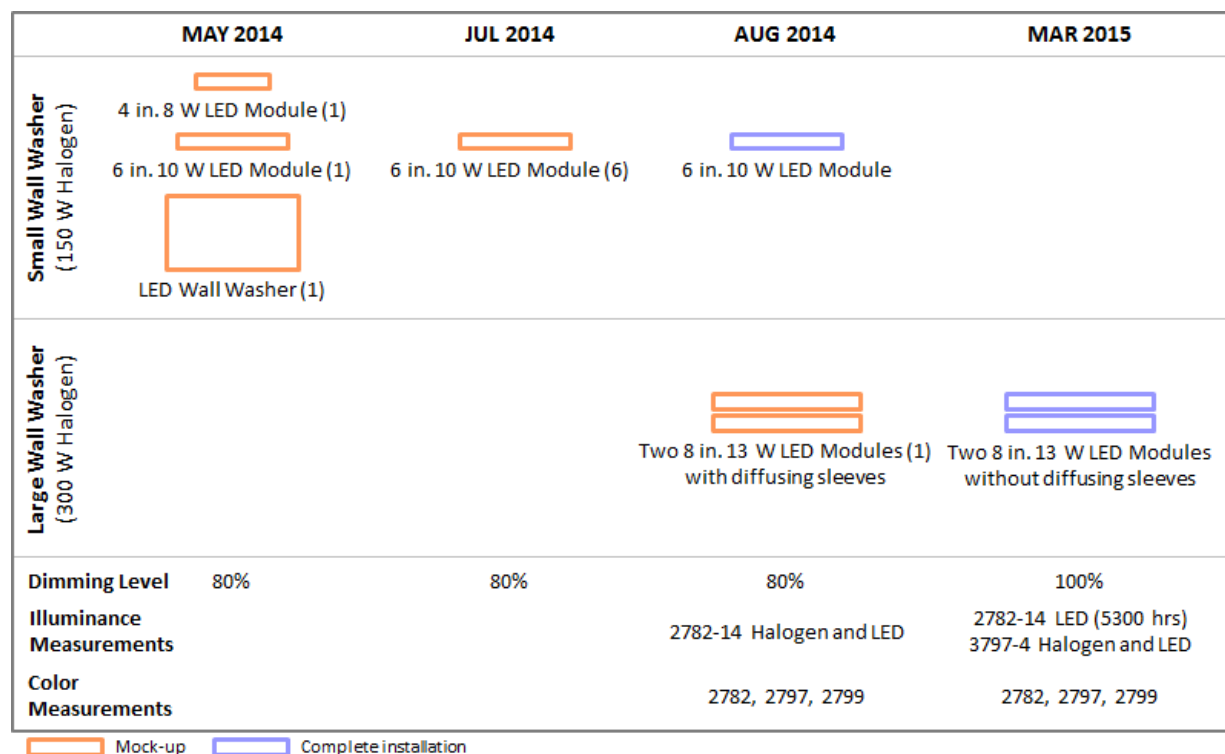
Figure 9. UMD CSPAC Wall Washer Retrofit Timeline: Mock-up, Installation, and Measurement. After potential alternatives to the incumbent halogen wall washers were assessed, the selected options were mocked-up in various stages, delineated above by the orange outline. The installation was completed for the small wall washers in August 2014 and for the large wall washers in March 2015, shown by the purple outline. The numbers in parentheses indicate how many of a given option were installed for the mock-up. The bottom third of the figure lists when and where the illuminance and color measurements were completed, and the dimming level at the time of measurement.

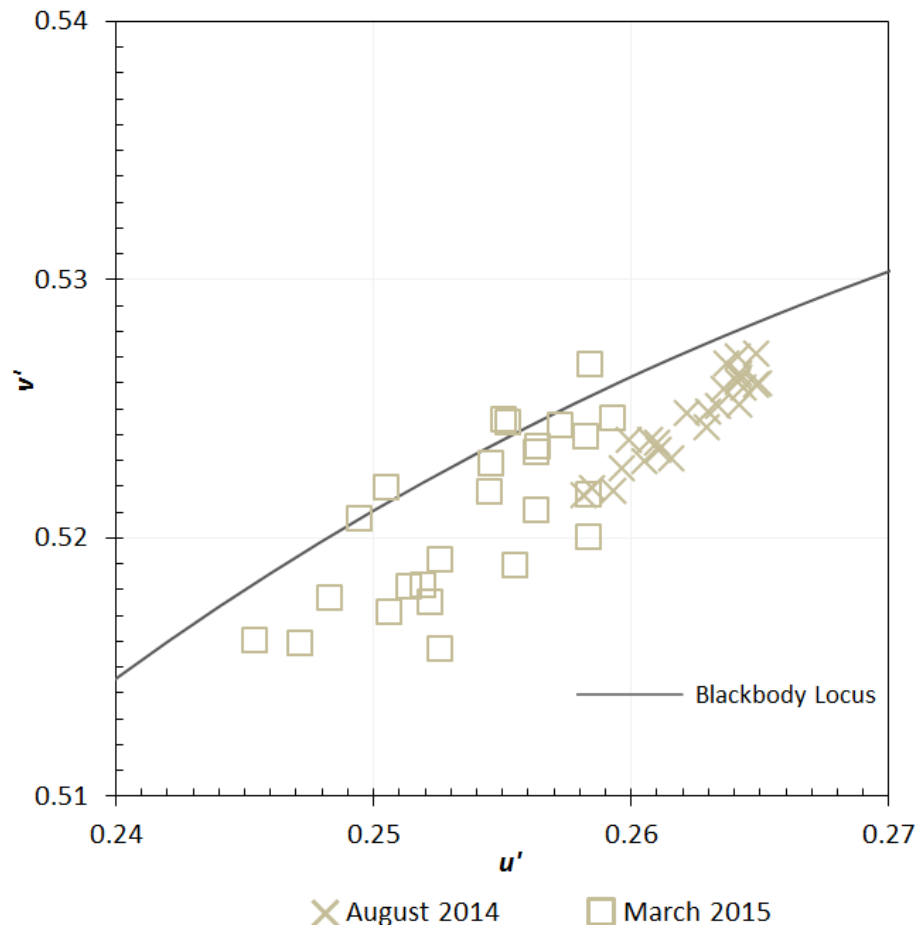
Figure 13. Small Wall Washer Chromaticity Coordinates Plotted on 1976 CIE UCS (u',v') Chromaticity Diagram. The diagram shows the chromaticity coordinates of the light exiting 25 wall washers in three different areas on the second floor, measured in both August 2014 and March 2015. In August 2014, 18 of the modules had just been installed, 6 had been operating for 700 hours, and 1 had been operating for 1600 hours—the differences due to mock-ups prior to the full retrofit of the small wall washers. In March 2015, the wall washers had been operating an additional 4600 hours since the August 2014 measurements. Three of the 50 plotted points are based only on one recorded measurement, and the remaining points are an average of two to three SPD measurements per wall washer.

coordinates in the International Commission on Illumination (CIE) 1976 uniform-chromaticity scale (UCS) chromaticity diagram (u',v'), which are plotted in Figure 13. Each plot of the (u',v') chromaticity coordinates is an average of two or three SPD measurements of a given wall washer.

In August 2014, 18 LED modules in hallway 2782 and area 2799 were installed. In hallway 2797 six LED modules had already been operating for 700 hours, and one had been operating for 1600 hours. These differences in operating hours were due to the mock-ups that occurred in May and July 2014. When the second set of SPD measurements were recorded in March 2015, the wall washers had been operating an additional 4600 hours since the August 2014 measurements.^{3,4}

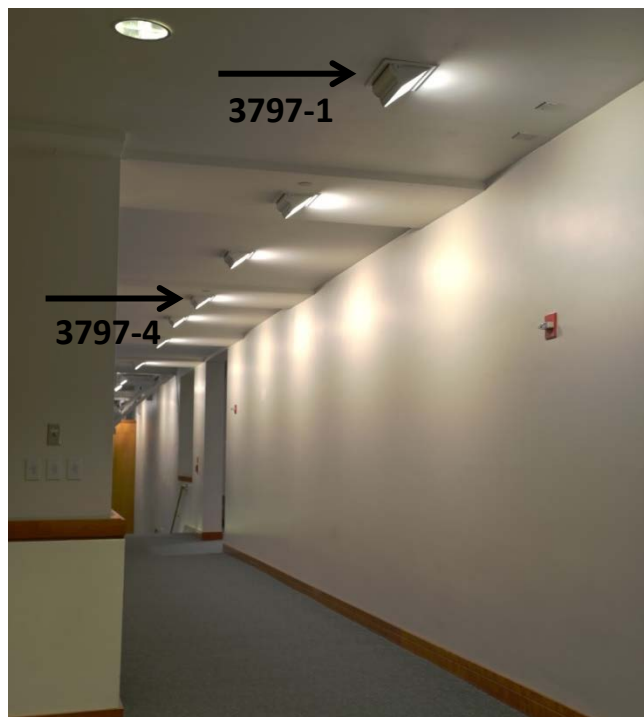
Figure 14. Hallway 3797 Photograph: LED Initial. The photograph shows the seven large wall washers in the foreground, with additional large wall washers over the stairs, illuminating the background. Wall washer 3797-1 was installed in August 2014, and the remaining wall washers in 3797 were installed in March 2015. Illuminance measurements were recorded for the wall and floor areas near 3797-4.

The day following the halogen measurements, the retrofit of the 300 W halogen lamp to two 13 W LED modules was completed for the large wall washers in area 3797, shown in Figure 14, and in the evening measurements were recorded following the same method used the prior evening. The measurements are detailed in Figure 16.

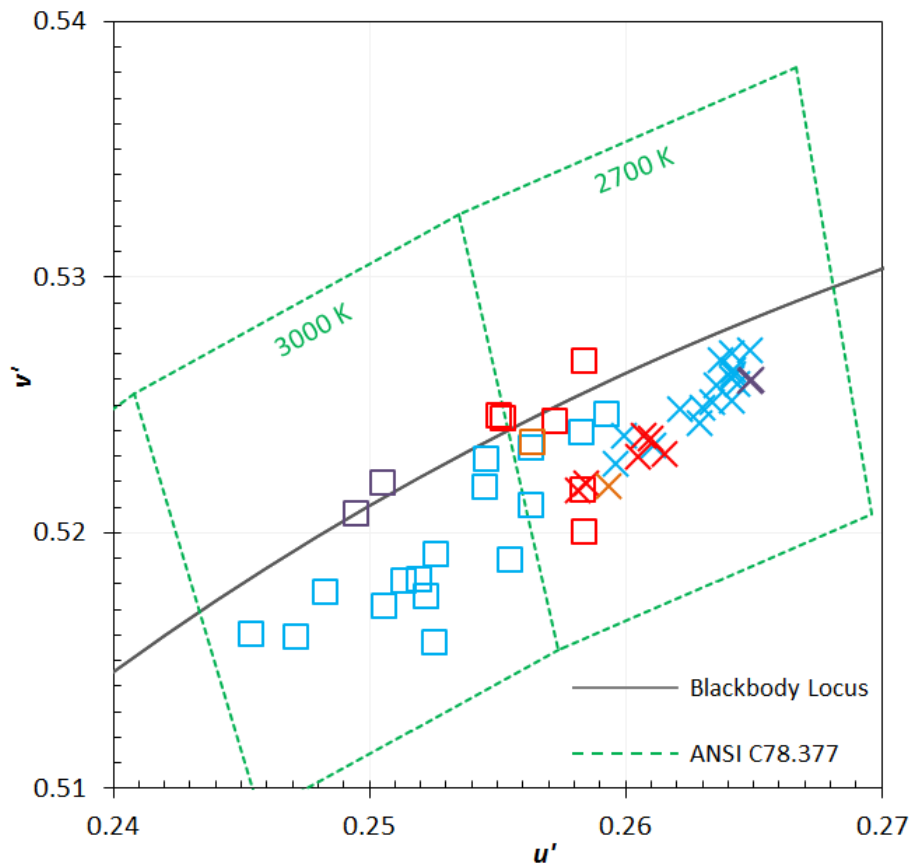
August: × 2782 (Initial) × 2799 (Initial) × 2797 (700 hr) × 2797-3 (1600 hr)

March: □ 2782 (4600 hr) □ 2799 (4600 hr) □ 2797 (5300 hr) □ 2797-3 (6200 hr)

Further analysis of the chromaticity coordinates of the light exiting the 16 wall washers reveals a trend that is dependent on the area of CSPAC, shown in Figure 19. Wall washers in areas 2782 and 2799 are generally shifting toward blue, while wall washers in area 2797 remain relatively stable. Further investigation of the installed LED modules in these areas revealed that although the 6 in. LED module labels installed in these wall washers had the same product specification, the dates on the labels were different. The LED modules installed in wall washers 2797 in May and July 2014 are dated 2013, and the modules installed in wall washers 2782 and 2799 in August 2014 are dated 2012.
