## LED System Performance in a Trial Installation—Two Years Later

**Host Site:** Yuma Border Patrol, Yuma, Arizona

April 2016

# **Yuma Border Patrol Area Lighting Retrofit LED System Performance in a Trial Installation – Two Years Later**

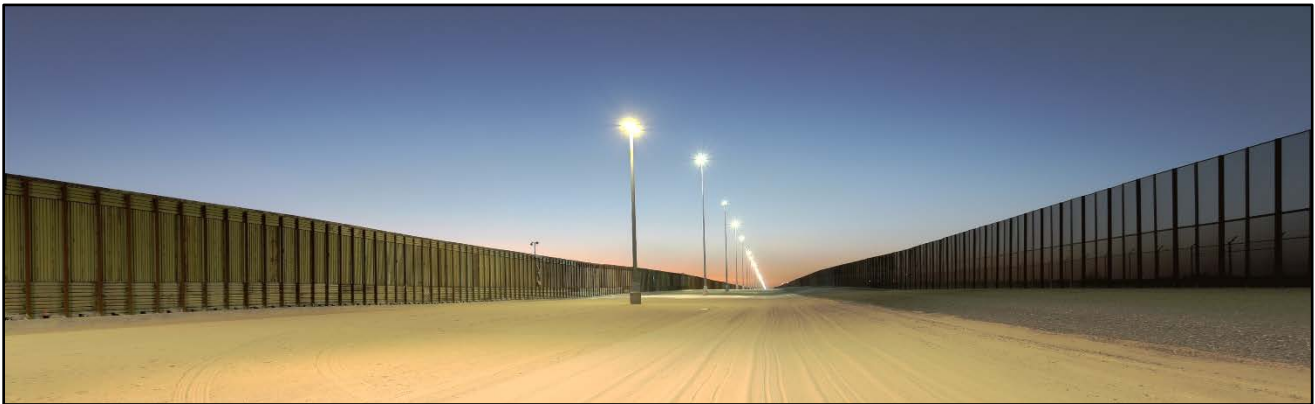
**Figure 1. Trial Demonstration Site on the U.S.-Mexico Border.** Photo taken looking west from the east end of the 7.2 mile area between poles 204 (not pictured) and 203 (pictured, front). The QMH luminaires are mounted on the poles at a height of 64 ft and the LED luminaires are mounted at 40 ft—a difference that is visible in this image. The primary fence is on the left and the secondary fence is on the right.

The 125 ft width of the border area is split by the pole line with a 45 ft distance to the primary fence and an 80 ft distance to the secondary fence, as illustrated in Figure 3. The trial LED luminaires have eight light squares,<sup>1</sup> each with Illuminating Engineering Society (IES) Type III luminous intensity distribution (as defined in Annex E of IES RP-8-14). Six light squares illuminate the area between the pole and primary fence, a distance of 45 ft, and two of the light squares are rotated 180° to illuminate the 80 ft distance between the poles and secondary fence. The primary fence and the 45 ft area between the pole and the primary fence required higher levels of illumination because these areas are the main focus of the border patrol agents at night. The 7.2 miles east of the POE require continuous surveillance by border patrol agents, and the role of the lighting is to enable the agents to perform their job equally well day or night.

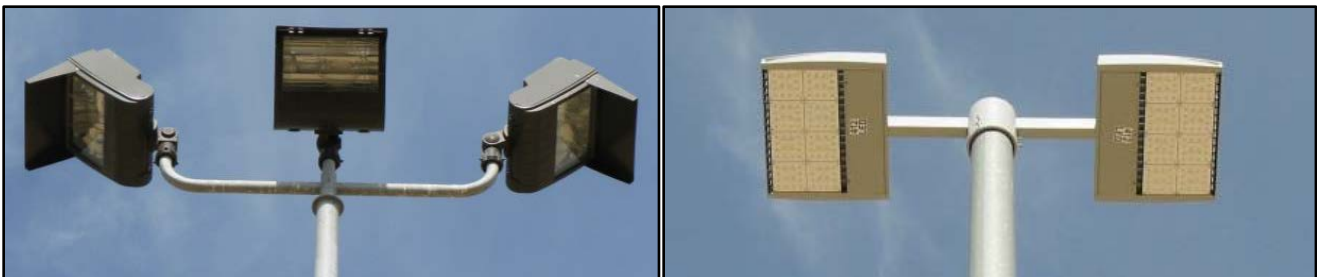
**Figure 2. Incumbent QMH Luminaires (left) and LED Luminaires (right).** A custom tenon was necessary to fit the diameter of the pole after the pole height was reduced to 40 ft, because the diameter of the tapered pole narrowed as the height increased. The QMH luminaires were originally installed with the lens tilted up from horizontal and shielded with visors to minimize stray light. In contrast, the LED luminaires were installed with luminous aperture horizontal (i.e., not tilted upward).

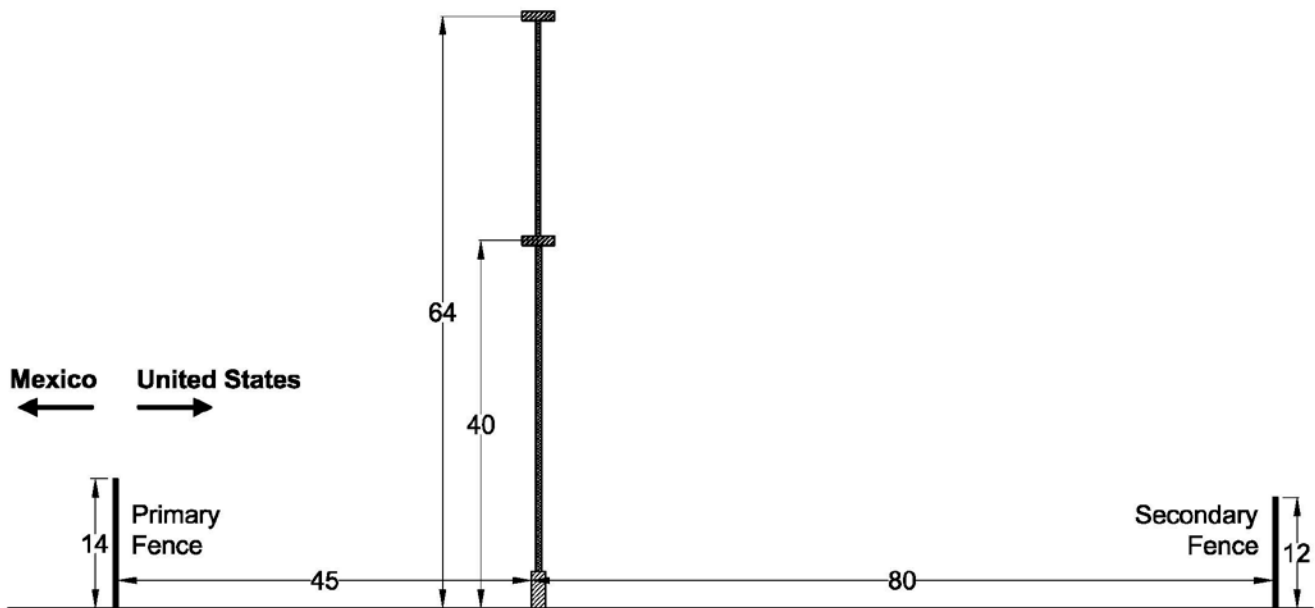
**Figure 3. Schematic Elevation of the Yuma Sector Border Patrol Area East of the San Luis Port of Entry.** The dimensions are not exact, but are representative of the 7.2 mile border area east of the POE. All dimensions are in feet. The elevation near the secondary fence was approximately 2 to 4 ft higher than the base of the concrete pole pedestal.

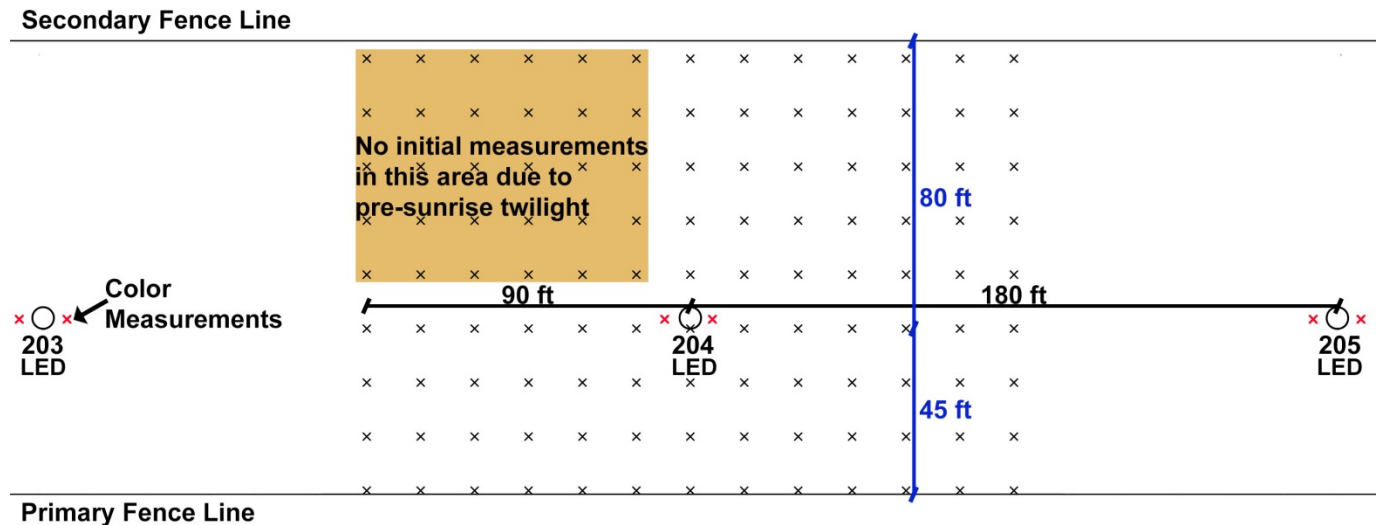
**Figure 4. Layout of Grid Measurements.** The measurements between poles 203 and 205 were recorded in a rectangular grid from the middle of the primary (south) face of the concrete pole pedestal at pole 204, with uniform 15 ft spacing in both directions. The horizontal measurements were recorded approximately 9.5 in. above the ground and the illuminance meter was leveled for each measurement with a tripod head. Vertical illuminance measurements were recorded at heights of 4 and 8 ft at each fence, along the same column as the horizontal illuminance measurements. A single color measurement was recorded under each LED luminaire, 4 ft above the ground (36 ft below the luminaire).

A total of 117 horizontal and 52 vertical measurements were recorded between poles 203 and 205, centered on pole 204. The measurements extended 90 ft east (halfway toward pole 205) and 90 ft west (halfway toward pole 203) of pole 204. Only 81 initial horizontal measurements were recorded because pre-sunrise twilight was reached before the measurements were completed.

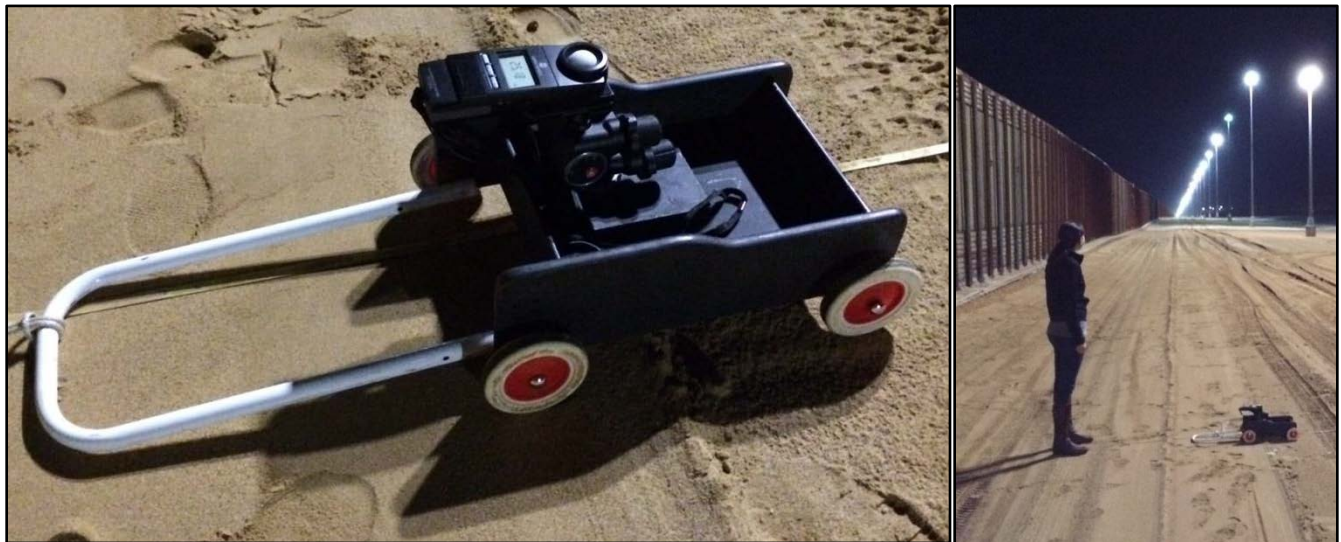
**Figure 5. Illuminance Measurement Wagon.** The illuminance meter was mounted on a tripod head, and the tripod head was attached to the base of the wagon. The knobs of the tripod head were used to adjust the front and lateral tilt of the illuminance meter to level the meter—with reference to the tripod head's leveling bubble.

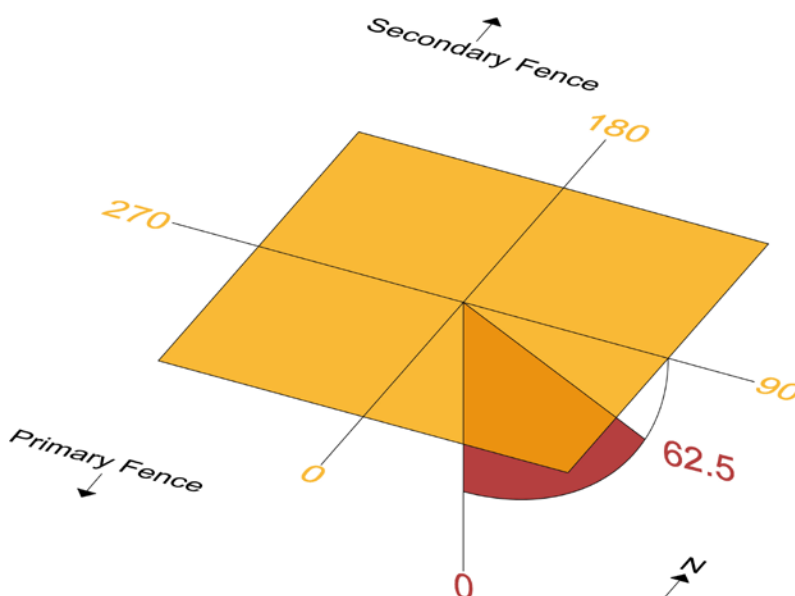
**Figure 6. Luminaire Orientation Schematic.** The horizontal angles (gold) are used to describe the photometric performance of the luminaire, and the 62.5° vertical angle (red) is illustrated in the 90° horizontal plane. View is from above.

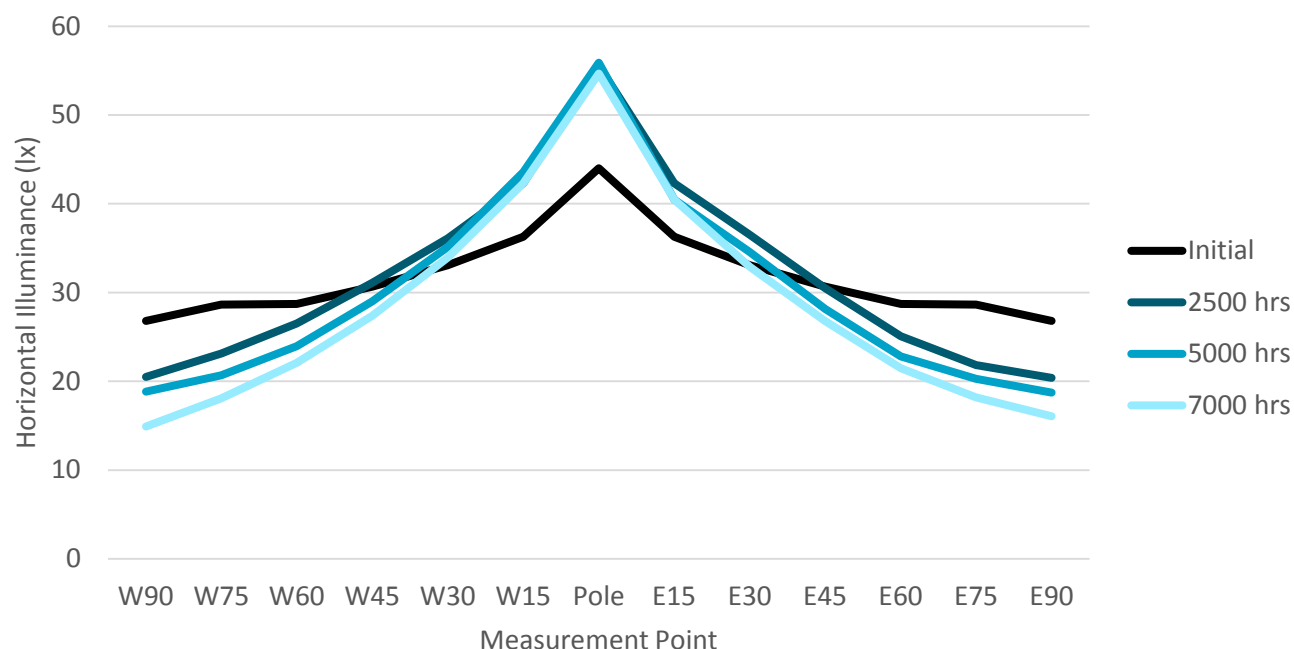
**Figure 8. Measured Illuminances along East-West Line Centered at Pole 204 at Four Different Measurement Times.** Illuminance values increased near the pole compared to the initial values, but decreased farther away from the pole. The numeric values in the labels along the horizontal axis indicate the distance from the pole in feet, and the letter indicates the direction from the pole. Illuminance values were normalized for a 25 °C (77 °F) condition.

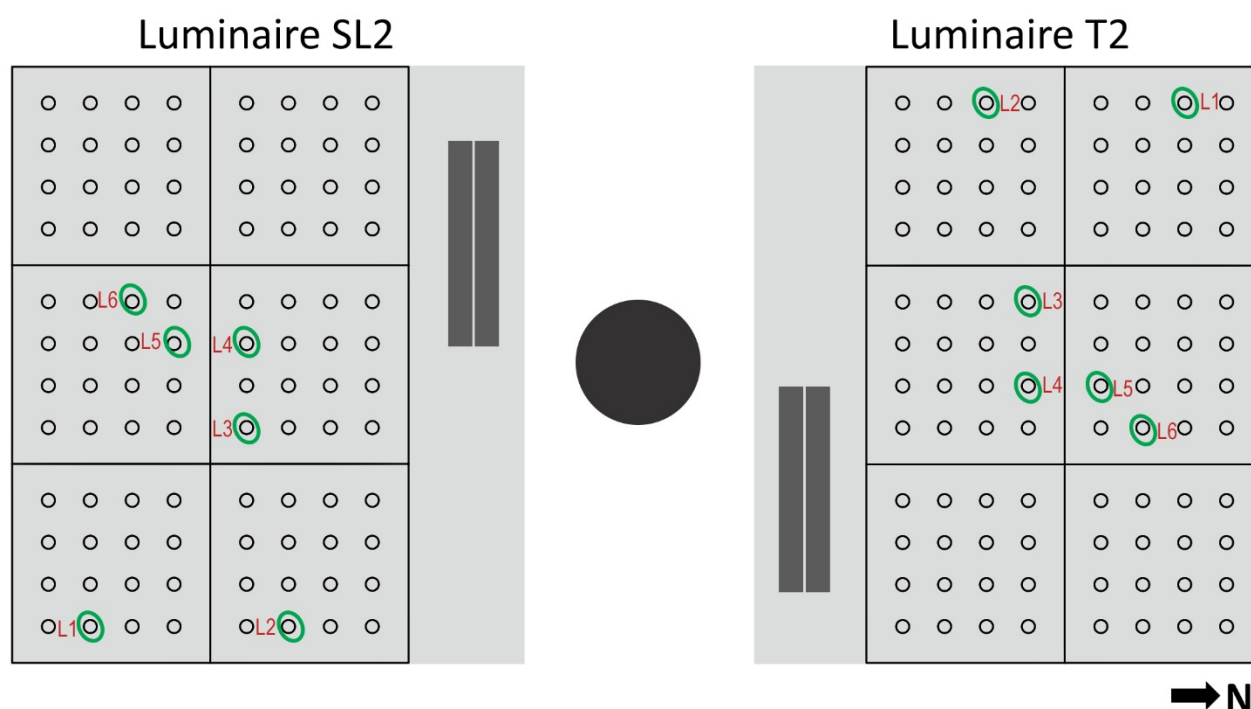
**Figure 9. LED Thermocouple Placement Schematic.** The green ovals indicate the six LED packages in each luminaire that had thermocouples installed on the TMP<sub>LED</sub>. The view of the luminaires is from below. The dark gray rectangles indicate the general location of the two drivers per luminaire, and the solid black circle represents pole 204. When the next-generation luminaires were added to the pole, they were oriented 90 degrees relative to the luminaires they replaced (luminaires A and B) for optimal performance. The next-generation luminaires have six squares and an optical design that differs from the original LED luminaires.

Each luminaire has eight internal thermocouples: one placed at the temperature measurement point (TMP<sub>LED</sub>) of each of six LED packages (locations shown in Figure 9), one attached to the interior top surface of the luminaire housing, and one attached to the temperature measurement point (TMP<sub>PS</sub>) of one of the two LED drivers per luminaire.<sup>2</sup> An additional thermocouple measures the ambient air temperature outside each luminaire, shown in Figure 10.

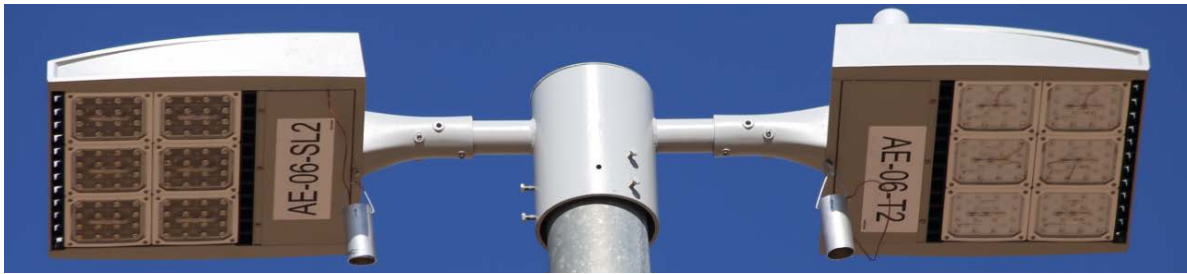
**Figure 10. Luminaires Instrumented with Thermocouples.** Eight thermocouples were placed on the internal components of each luminaire and one thermocouple measures the ambient temperature at each luminaire, shielded by the cylinder hanging from the luminaire and attached to a small block of metal that was suspended down the center of the cylinder. The two luminaires are within the same product family, but with different optical designs as indicated by T2 and SL2.

The thermocouple wires are about 60 ft long, extending from the luminaires through the tenon and pole, into the data logger enclosure at the base of the pole. This vented, weatherproof enclosure houses five Hobo Onset UX120 four-channel thermocouple loggers, shown in Figure 11. The five loggers can record measurements for up to four thermocouples each, for a total of 20 possible measurements. Eighteen thermocouples were used for the luminaires, with an additional thermocouple measuring the internal ambient temperature of the enclosure (for verification that the temperature did not exceed the rated temperature of the data loggers) and another thermocouple measuring the ambient temperature outside of the enclosure, using a solar radiation shield to block the thermocouple from direct sun (for comparison to the ambient measurements taken at the luminaire). The data loggers store the data at one-minute intervals and are periodically downloaded on-site.

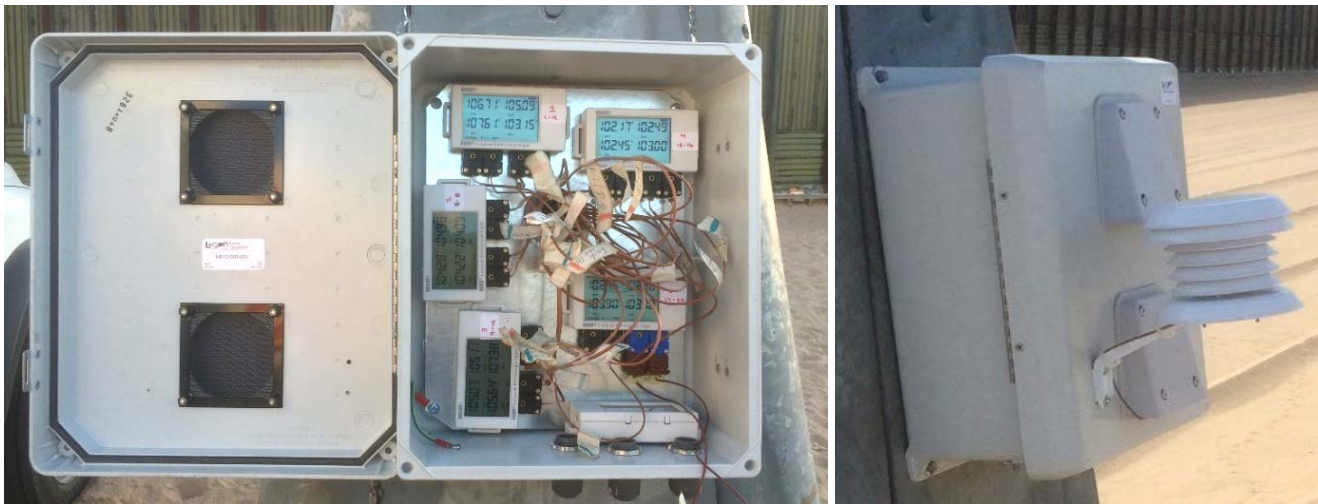
**Figure 11. Data Logger Enclosure.** The interior of the data logger enclosure (left photo) houses the five active data loggers, plus an extra substitute logger. Attached to the exterior (right photo) is the solar radiation shield.

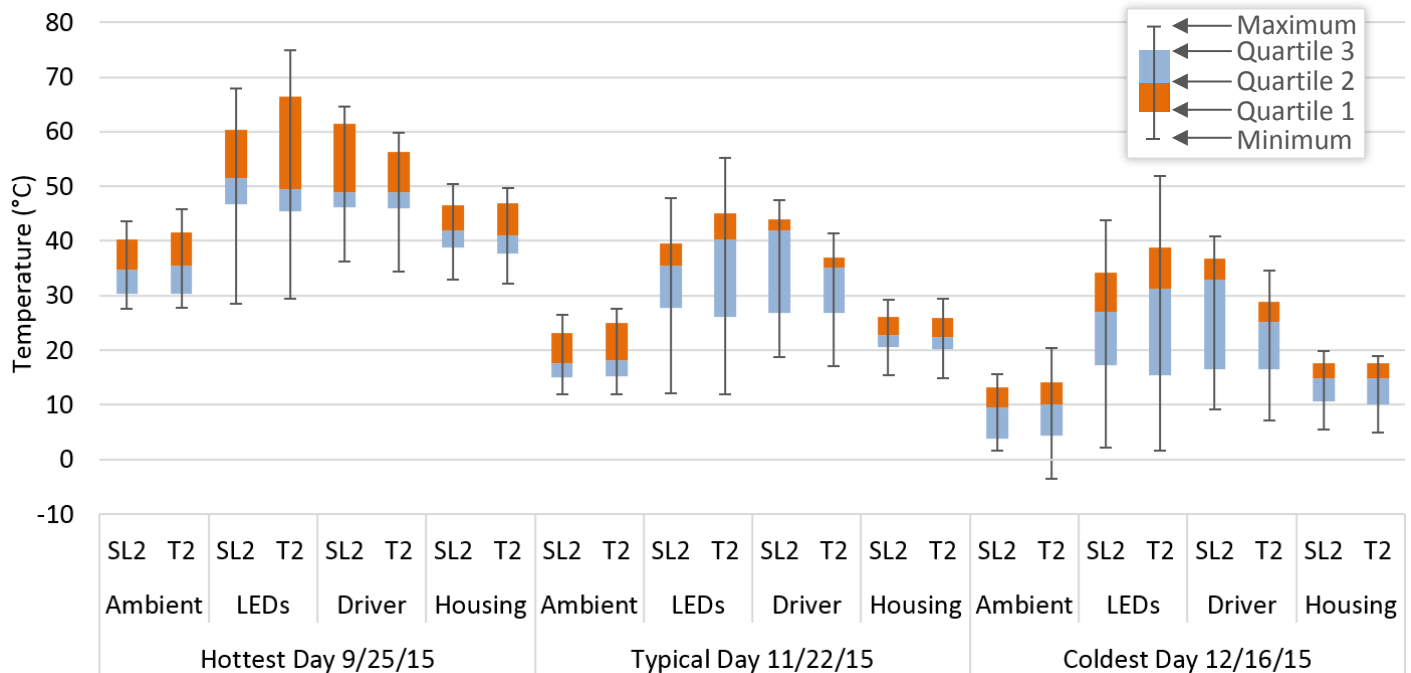
**Figure 12. Temperature Measurement Box and Whisker Plot: September 25, 2015 to February 19, 2016.** The box-plot shows the temperatures on the hottest day, a typical day, and the coldest day. The ends of the whiskers represent the maximum and minimum of all of the one-minute interval data. The typical day was defined as the day that was closest to the averages of the daily max, min, and average temperatures during this 148 day period.

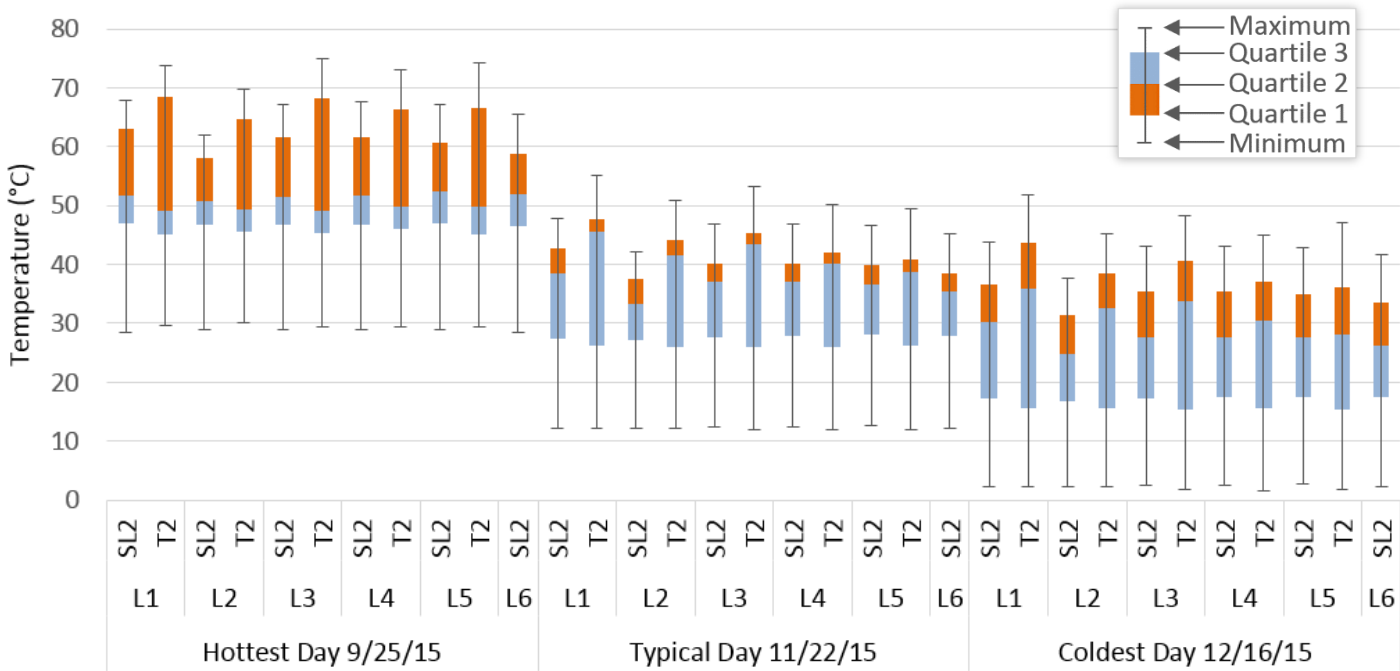
**Figure 13. LED Temperature Measurement Box and Whisker Plot: September 25, 2015 to February 19, 2016.** The box-plot shows the range of temperatures on the hottest day, a typical day, and the coldest day. The ends of the whiskers represent the maximum and minimum of the one-minute interval data. T2 L6 was not included in the analysis. The typical day was defined as the day that was closest to the averages of the daily max, min and average temperatures during this 148 day time period.

Figure 13 disaggregates the LED package data, showing the variation in temperature between the LED packages. The LED packages at the outer edge of the luminaire are L1 and L2, and the remaining LED packages measured are located in the center of the luminaire. L1 reached temperatures similar to the internal LED packages (L3, L4, L5, L6), while L2 operated at slightly lower temperatures in both luminaires. The L6 temperature measurements

are not included for luminaire T2 in this report. Data from this thermocouple were very different from the data from others, perhaps due to a faulty thermocouple or improper placement of the thermocouple.

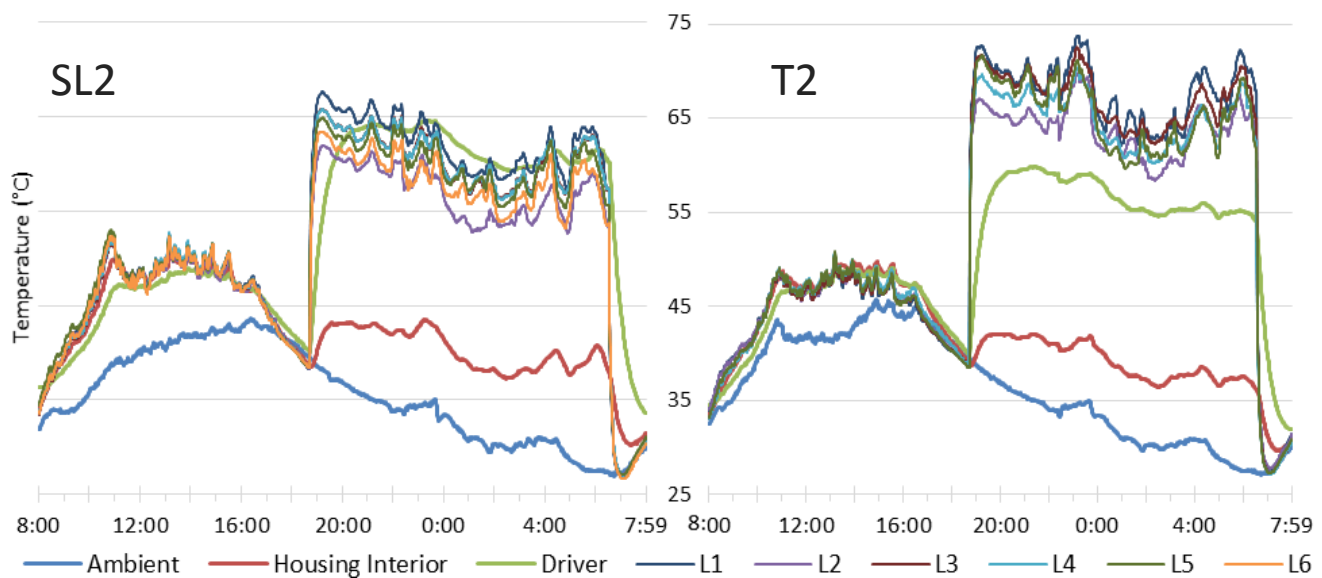
**Figure 14. Thermocouple Measurements: September 25 8:00 a.m. to September 26 7:59 a.m., 2015.** The one-minute interval thermocouple measurements for the hottest ambient temperature day recorded for luminaires SL2 and T2.

The change in temperatures over the span of the hottest day (September 25) and into the morning of the next day is plotted in Figure 14. The LED packages operated at temperatures similar to the driver for luminaire SL2, and operated above the driver temperature in T2. The LED packages tended to respond similarly to changes throughout the day, and were influenced by minor changes in ambient temperature during operation. The ambient and housing temperatures were higher during the day, when the luminaires were not operating, than at night, when the luminaires were operating. The driver and LED packages were hottest at night when the luminaires were operating. The effect of solar radiation is also evident in the plot; as the sun rose there was increasing separation between the luminaire components and the ambient temperature, and as the sun set the temperatures returned to similar values until the luminaires began operating.

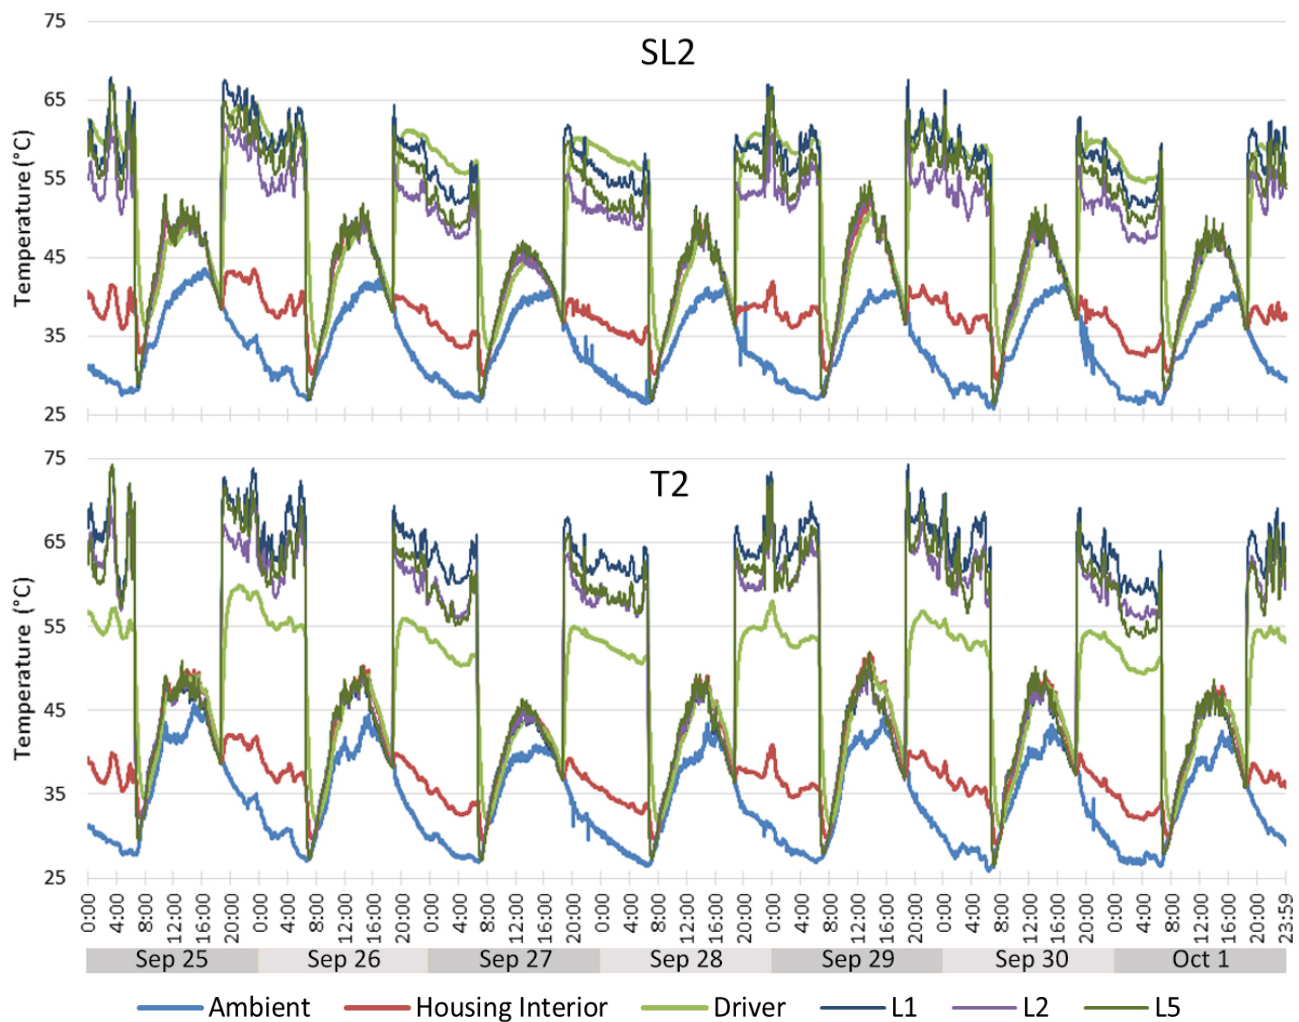
**Figure 15. Thermocouple Measurements: September 25 to October 1, 2015.** The one-minute interval thermocouple measurements for the hottest ambient temperature week recorded for luminaires SL2 and T2. Only L1, L2 and L5 are shown to aide visibility of the temperature. L1 is typically the hottest, L2 is typically the coolest and L5 varies between the temperatures of L1 and L2.

The temperatures over the span of the hottest week, September 25 to October 1, 2015, are plotted in Figure 15. The pattern remained similar throughout the week. Luminaire component temperatures increased on September 29 during the day, yet ambient temperatures remained similar. This is likely due to an increase in solar radiation, as suggested by the housing interior temperature.

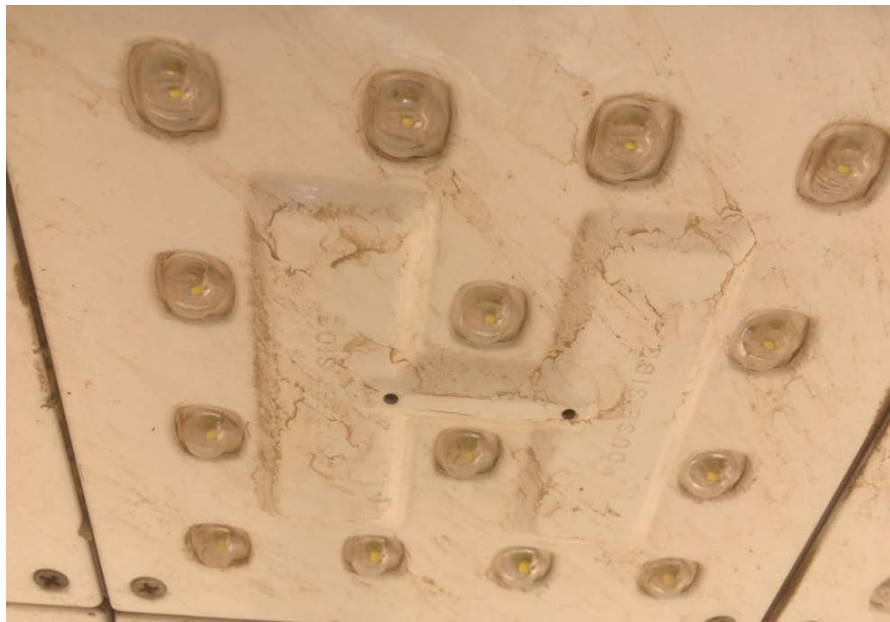
**Figure 18. Dirt Accumulation on Luminaire A.** This photograph was taken by the electrician prior to removing the luminaire.

As a final observation about the dirt accumulation on the luminaires in Yuma, it is noted that dirt does not accumulate uniformly across the entire luminaire nor even across any individual LED package's optical assembly. Figure 18 shows a close-up view of part of luminaire A from a photograph taken by the electrical contractor before removing the luminaire from the pole for testing, and additional photographs are included in Appendix C. This photo reveals that the apparent combination of wind, moisture, and dirt produce an overall effect that is not uniform across the optical elements of the luminaire, making a priori predictions of the realistic field effects very difficult.
