Light Water Reactor Sustainability Program

Evaluation of Localized Cable Test Methods for Nuclear Power Plant Cable Aging Management Programs

SW Glass, LS Fifield, TS Hartman

**M3LW-16OR0404022
PNNL-25432**

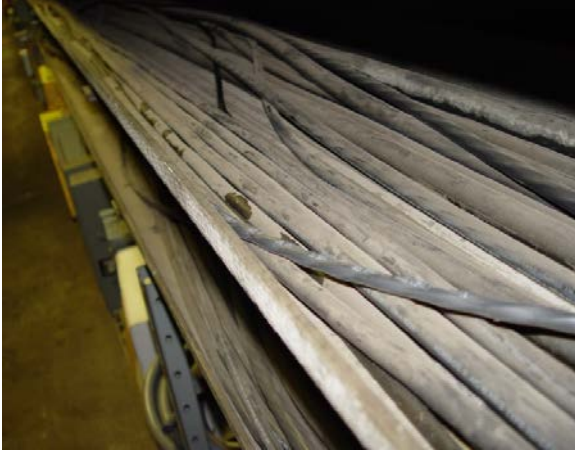
Figure 7.2. Full cable trays can make extraction of a single cable difficult and subject adjacent cables to damage. Photo courtesy of EPRI.

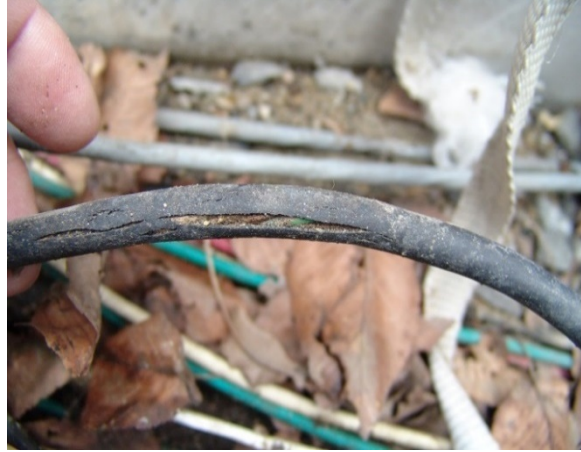
Figure 7.3. Cracked butyl jacket. Photo courtesy of EPRI.

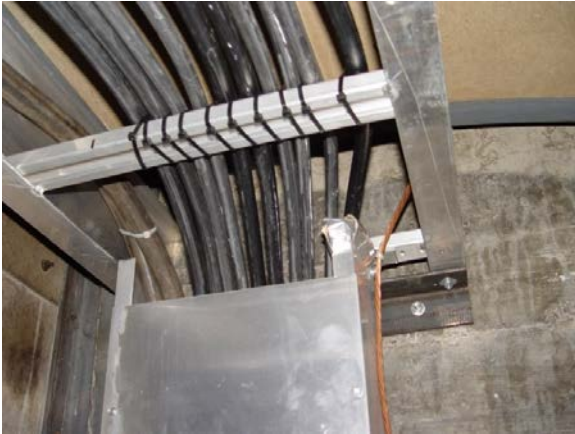
Figure 7.4. Cable contact along sharp edge. Photo courtesy of EPRI.

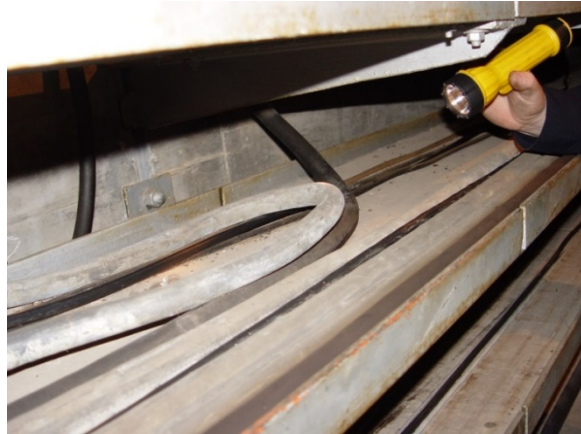
Figure 7.5. Severely bent cable. Photo courtesy of EPRI.

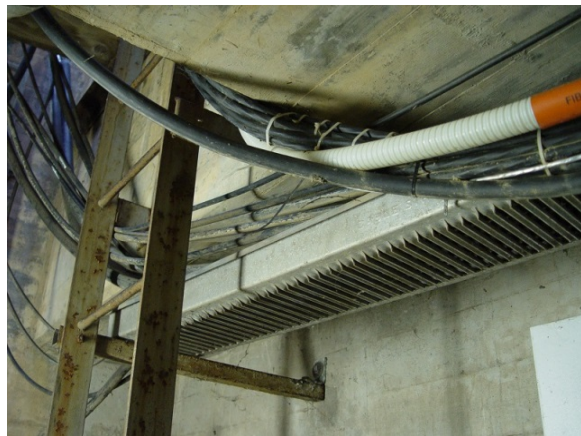
Figure 7.7. Unsupported cables outside of tray. Photo courtesy of EPRI.

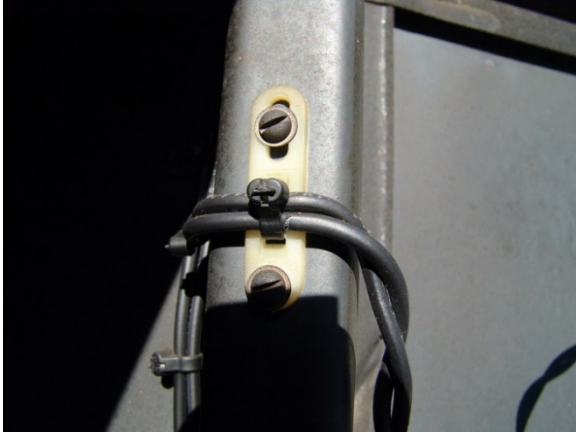
Figure 7.8. Excess cable tie tension. Photo courtesy of EPRI.

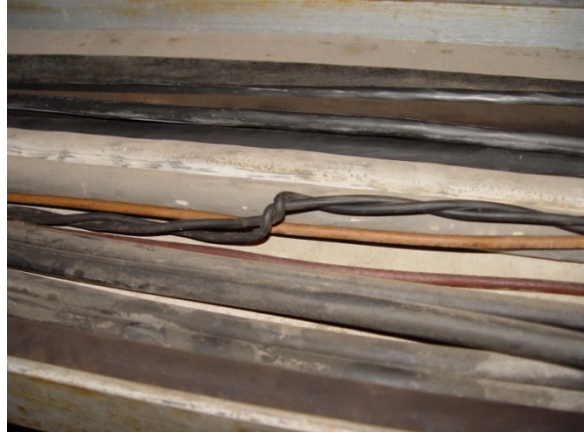
Figure 7.9. Kinked conductors. Photo courtesy of EPRI.

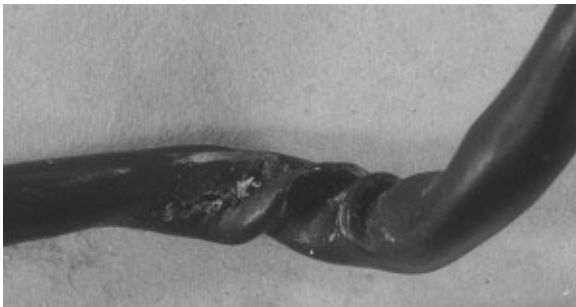
Figure 7.12. Pull-in twist. Photo courtesy of EPRI.

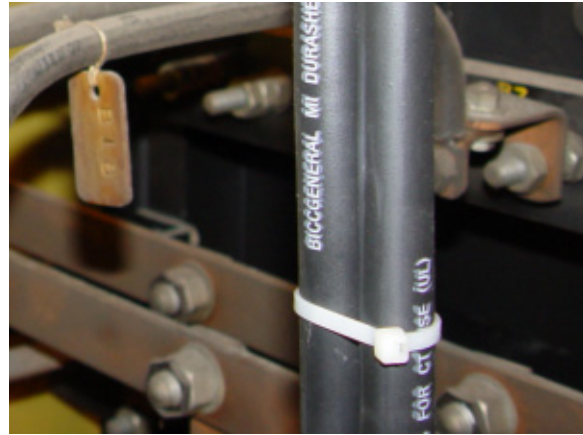
Figure 7.15. Cable ties constricting jacket and insulation. Photo courtesy of EPRI.

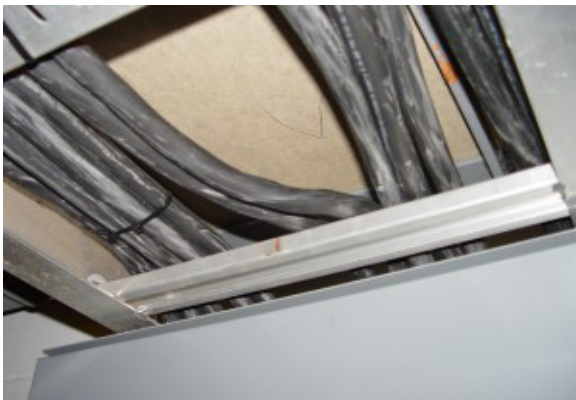
Figure 7.16. Twisted cable. Photo courtesy of EPRI.

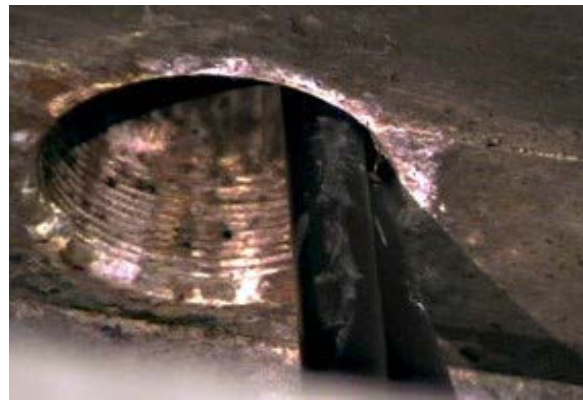
Figure 7.17. Contacting conduit edge. Photo courtesy of EPRI.

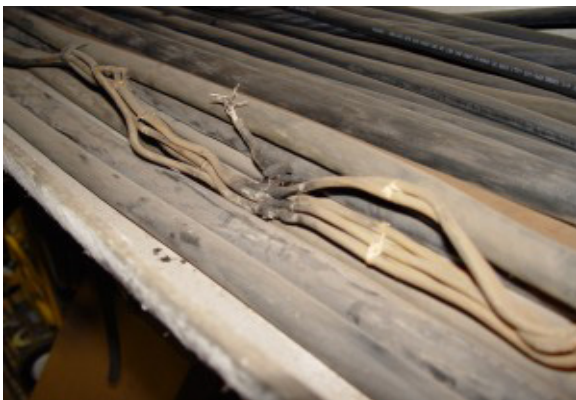
Figure 7.18. Cable short – exposed conductor. Photo courtesy of EPRI.

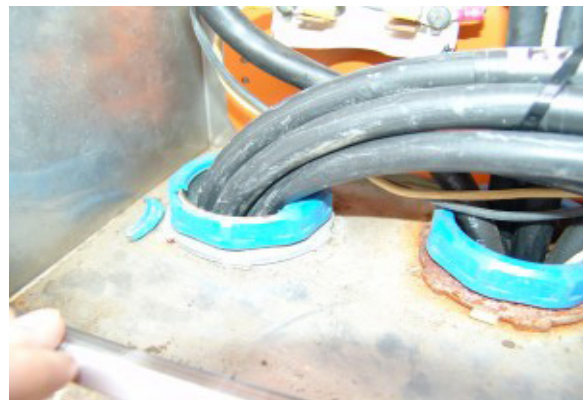
Figure 7.19. Contact with broken bushing. Photo courtesy of EPRI.

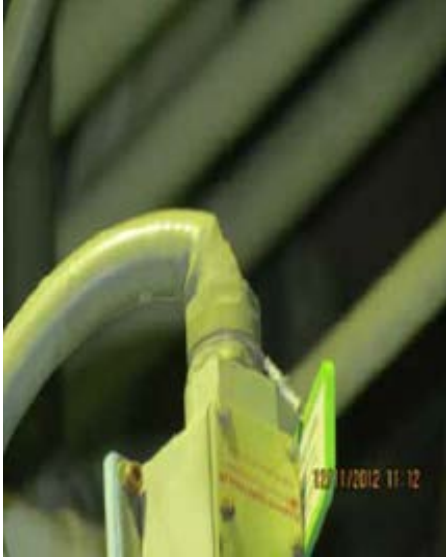
Figure 7.20. Very bent conduit entering a fitting near condensate polishing mixing bed service.

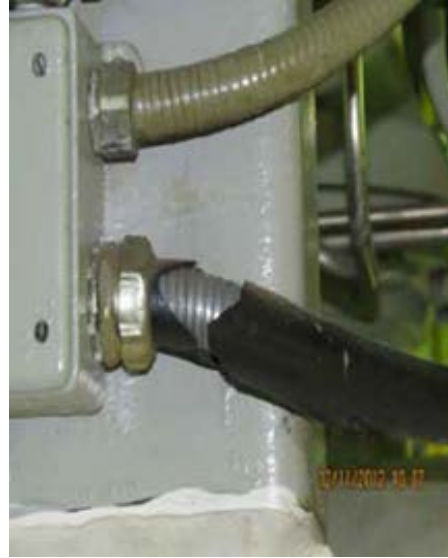
Figure 7.21. Ripped seal-tight on conduit on RCB chiller.

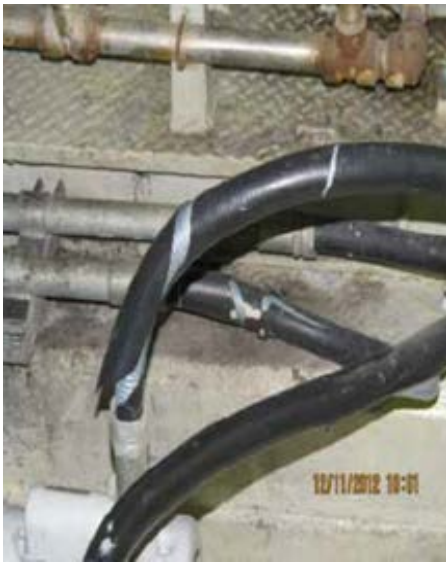
Figure 7.22. Ripped seal-tight on conduit near polyacrylic acid supply tank.

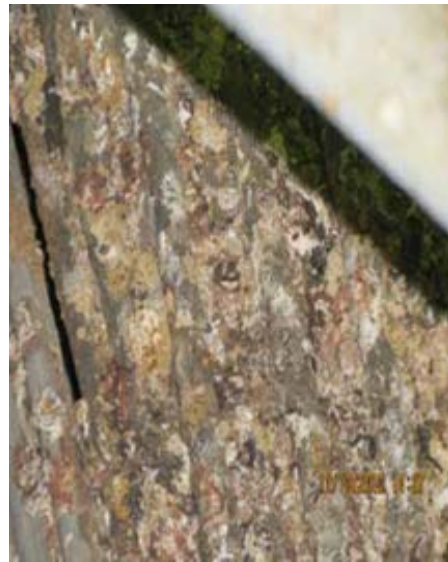
Figure 7.23. Bird feces on cables in trays.

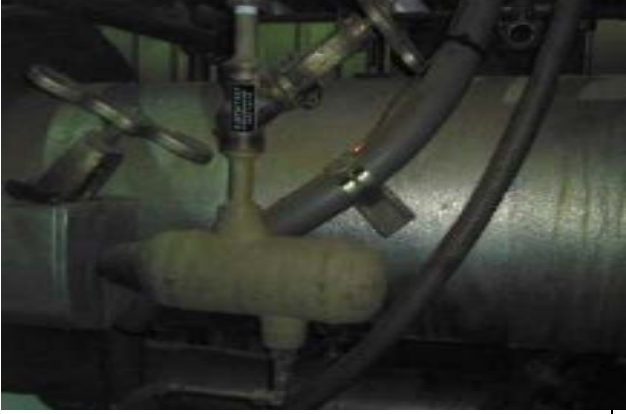
U3 TB 176 FT	Work Order ALE Walkdown	Thermographer: Dan Obrien
	Component Name (If Necessary):		
	Condensing Pot for 3JMTNFT0337**IXMITR (Iso. Vlv. 3PMTNV136 on left)

Emissivity	0.95	Date	1/26/2016
Ar1 Max. Temperature	269.8°F	Image Time	2:47:45 PM
Ar2 Max. Temperature	151.5°F	File Name	FLIR0905.jpg
Ar3 Max. Temperature	122.6°F	Image Camera Type	FLIR T450 sc
		Image Camera Lens	FOL10
		Comments: Thermal Adverse Local Environment (ALE) – Flex conduit temperatures exceed 150 Deg. F. Reference Dwg. -03-E-EDF-0005,sh.3

Figure 7.25.Example thermal IR image from plant cable walk-down noting flex conduit temperatures exceeding 150°F. Courtesy of Palo Verde Nuclear Station.

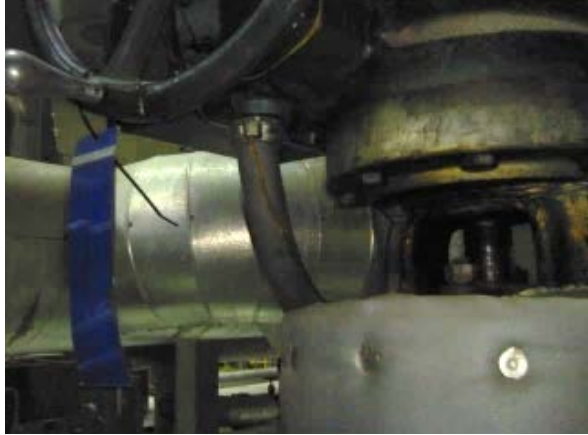
U3 TB 176 FT	Work Order ALE Walkdown	Thermographer: Dan Obrien
	Component Name (If Necessary):		
	3JMTNHV0329C**MOTORX

Emissivity	0.95	Date	1/26/2016
Ar1 Max. Temperature	275.3°F	Image Time	2:47:45 PM
Ar2 Max. Temperature	147.1°F	File Name	FLIR0905.jpg
Ar3 Max. Temperature	154.8°F	Image Camera Type	FLIR T450 sc
		Image Camera Lens	FOL10
		Comments: Thermal Adverse Local Environment (ALE) – Component housing temperatures exceed 150 Deg. F. Location Drawing - 13-E-ZTC-0026

Figure 7.26. Thermal adverse local environment (ALE) – component housing. Temperatures exceed 150°F. Courtesy of Palo Verde Nuclear Station.

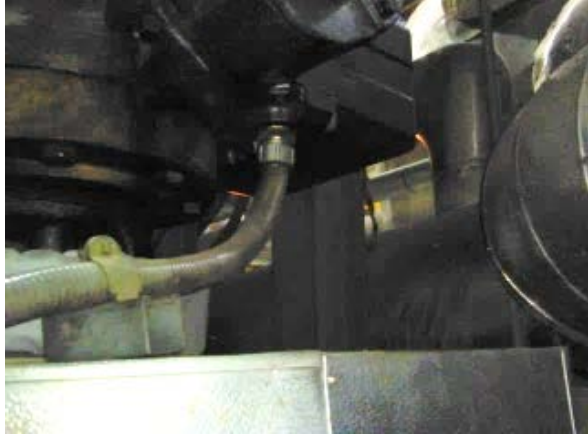
U3 TB 176 FT	Work Order ALE Walkdown	Thermographer: Dan Obrien
	Component Name (If Necessary):		
	3JMTNHV0329B**MOTORX

Emissivity	0.95	Date	7/29/2015
Ar1 Max. Temperature	156.9°F	Image Time	10:13:06 AM
Ar2 Max. Temperature	156.2°F	File Name	FLIR0673.jpg
		Image Camera Type	FLIR T450 sc
		Image Camera Lens	FOL10
		Comments: Thermal Adverse Local Environment (ALE) – Flex conduit temperatures exceed 150 Deg. F. Location Drawing - 13-E-ZTC-0025

Figure 7.27. Thermal ALE – flex conduit temperatures exceed 150°F. Courtesy of Palo Verde Nuclear Station.

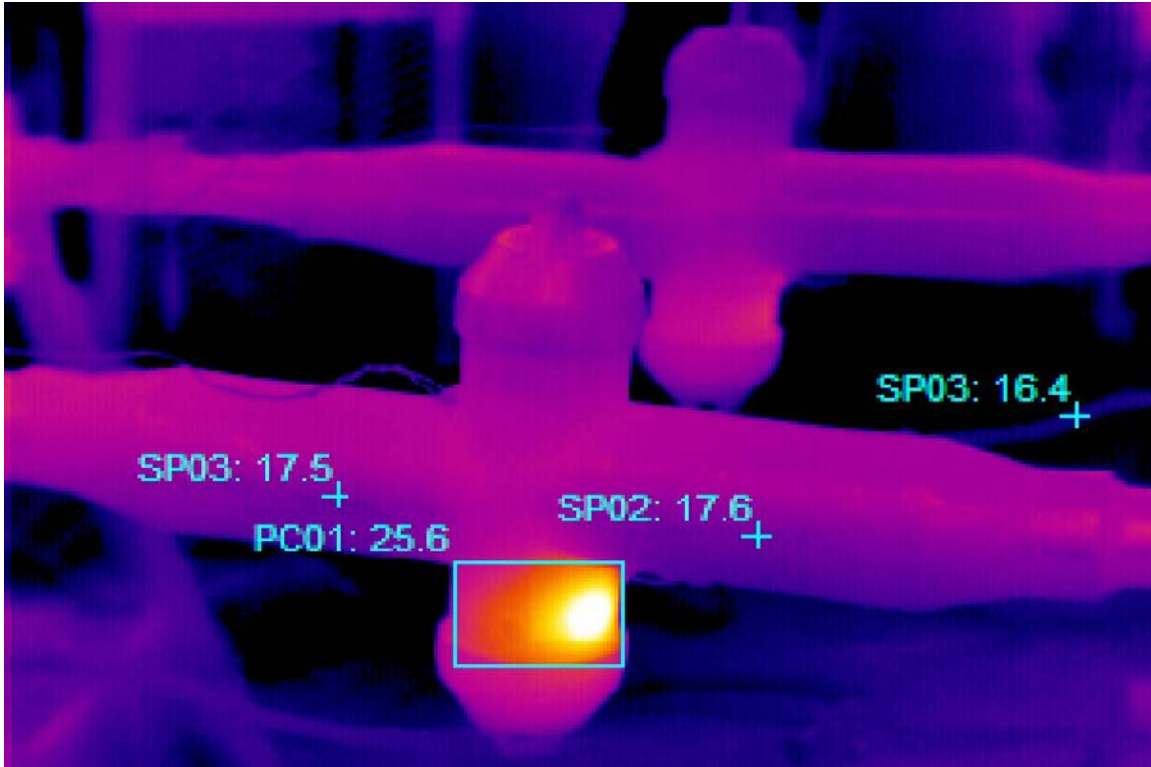
Figure 7.30. IR image – Hot spot in the bulk of insulation of a joint body (pattern 1). Image courtesy of and credited to © Hydro-Québec.

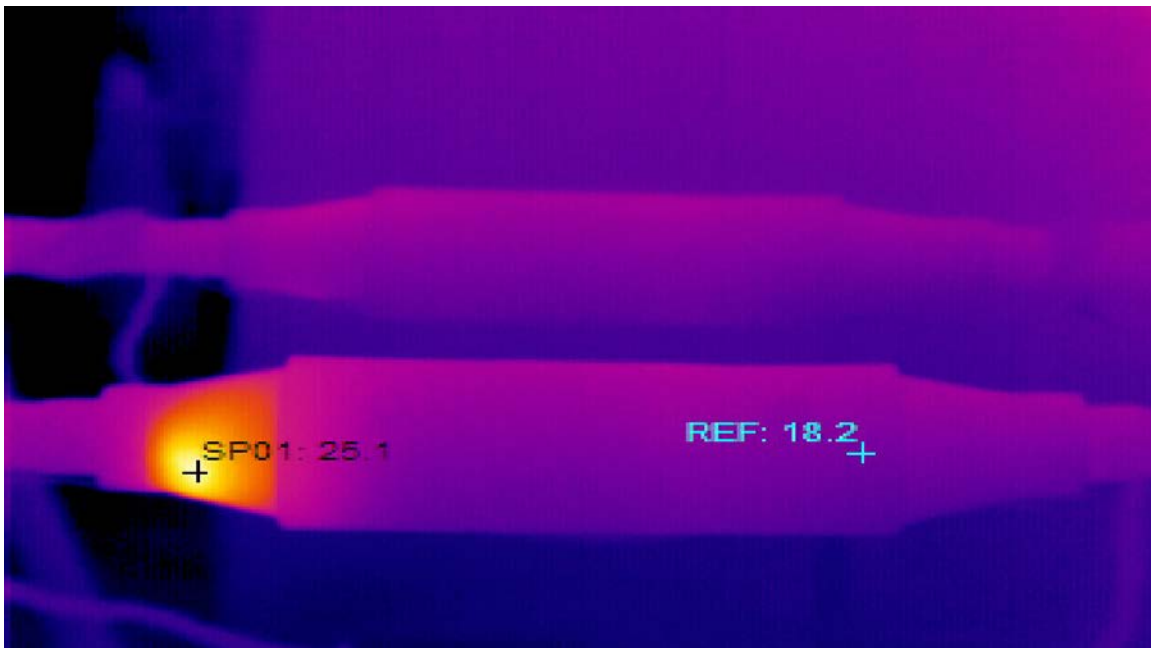
Figure 7.33. IR image – Hot spot in the bulk of insulation located on left side of cable splice. Image courtesy of and credited to © Hydro-Québec.

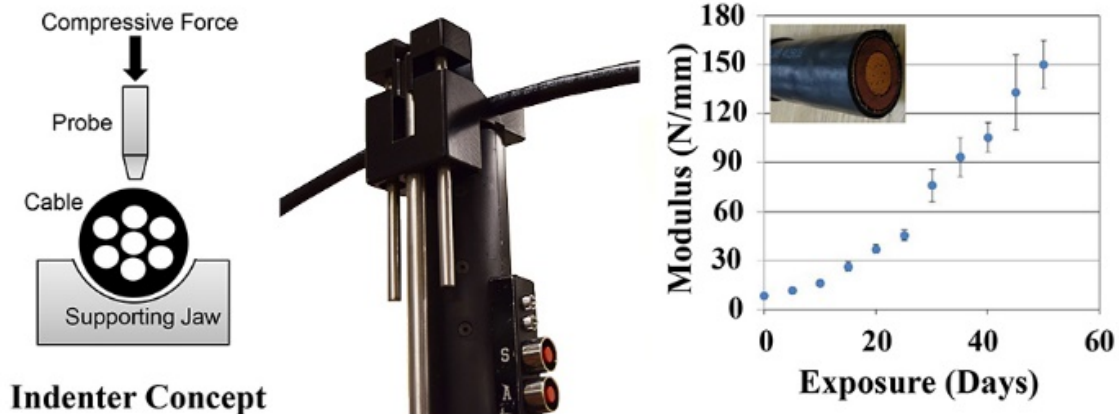
Figure 7.34. Probe, supporting jaw, and cable cross-section (*left*), instrument photo (*center*), and EPR cable modulus vs. exposure time (*right*).
