# NDE Technology Development Program for Non-Visual Volumetric Inspection Technology

## *Sensor Effectiveness Testing* Report

**August 2017**

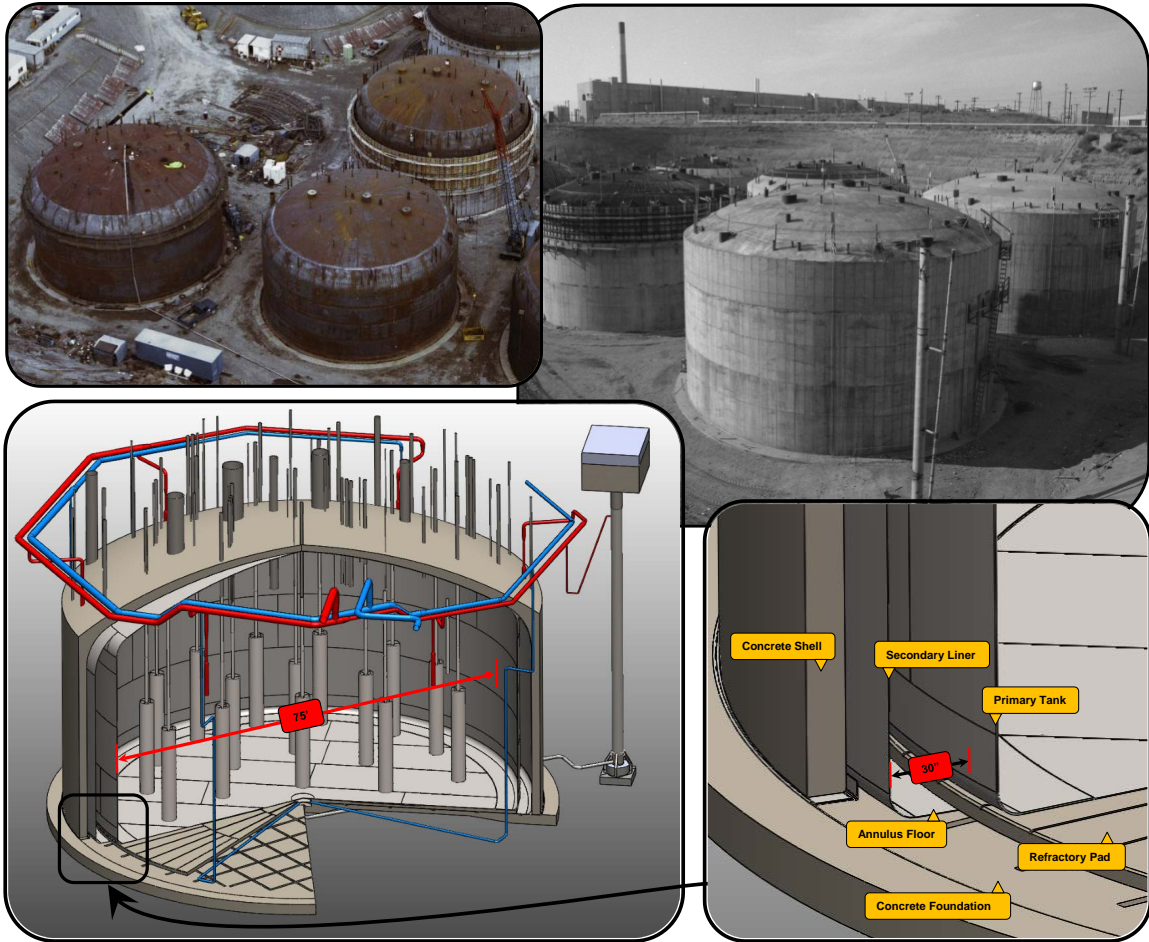
**Figure 2.1.** Hanford Double-Shell Tank Basic Design Detail

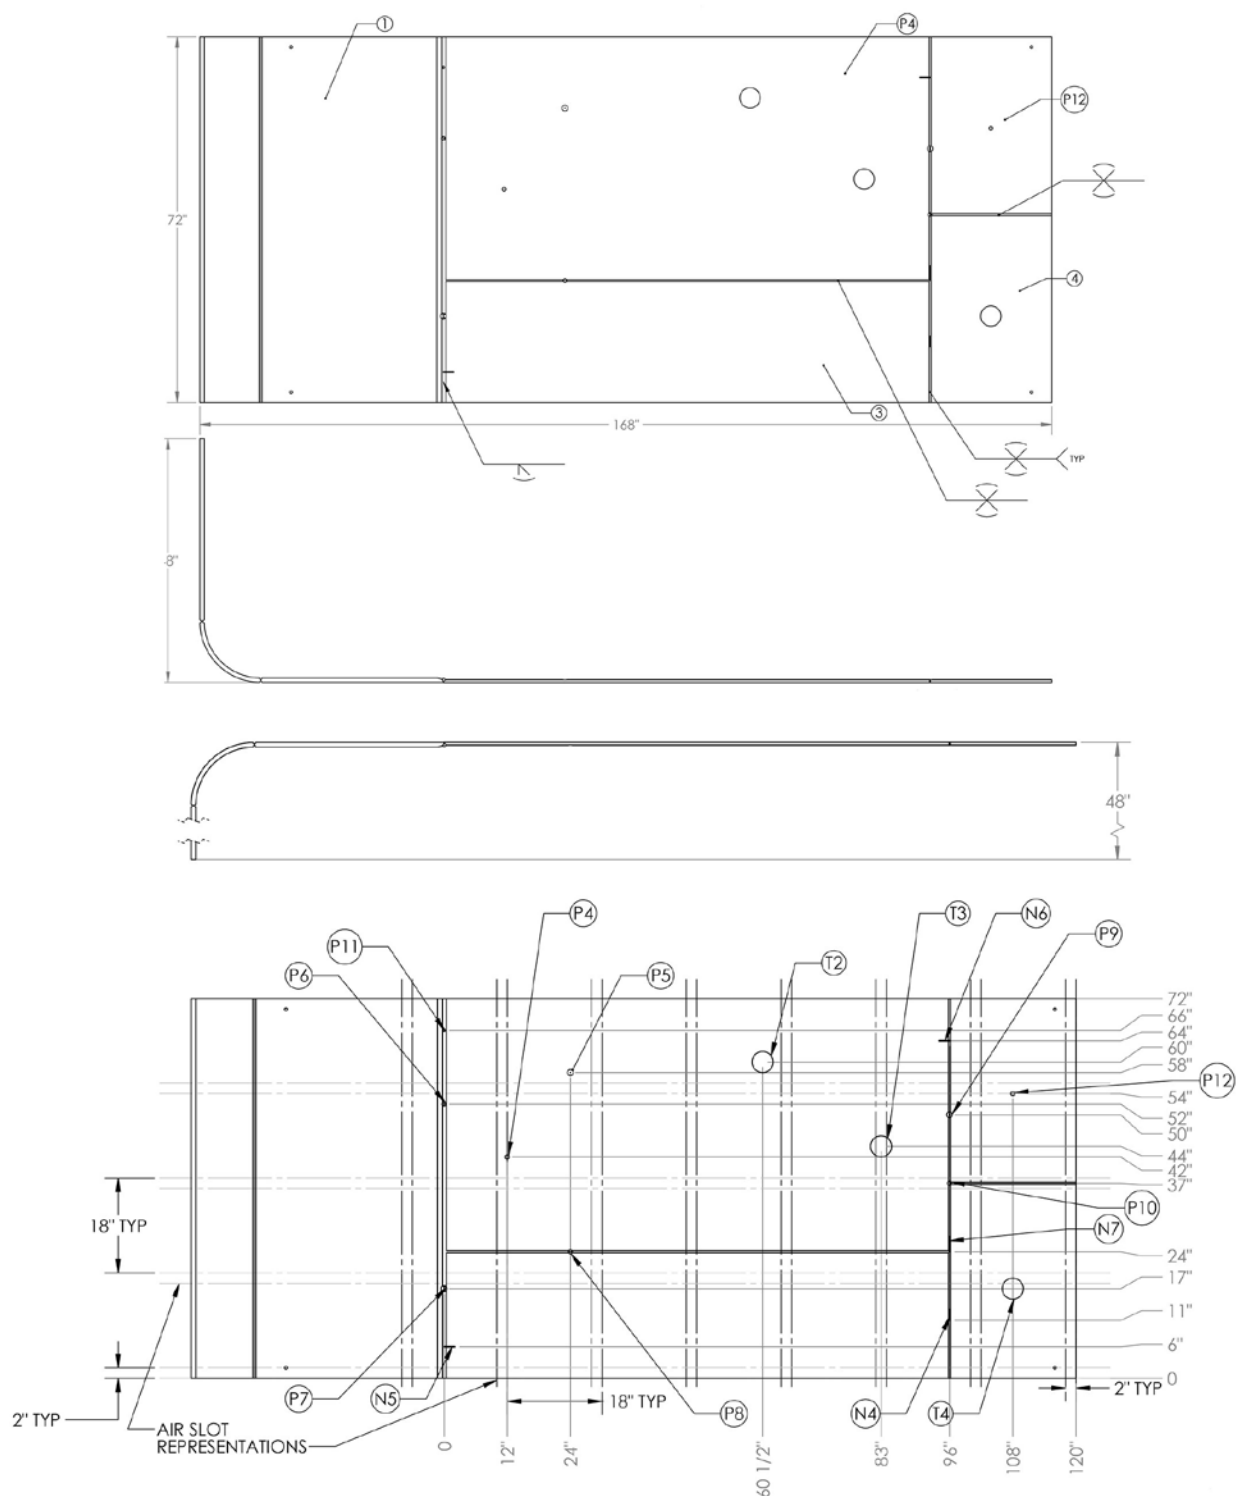
**Figure 4.2.** Top and Side View Drawings of the New *Sensor Effectiveness Testing* Mock-up in Support of *Sensor Effectiveness Testing* Including Representations of Air-Slots But Not Including the Blind Flaw Locations

Drawings of the two primary tank mock-ups that supported *Sensor Effectiveness Testing* are provided in Figures 4.1 through 4.3 (modified *Technology Screening* mock-up and *Sensor Effectiveness Testing* mock-up). The plate thicknesses of both mock-ups are representative of those found in a majority of the DSTs. The knuckle (curved plate) length and radius are also representative of those found in DST primary tanks. Using representative plate geometries for testing was necessary to host flaw sizes required for detection and to assess NDE sensitivity to the flaws the frequencies selected for the plate thicknesses.

The new *Sensor Effectiveness Testing* mock-up has a width of 6 feet and a total length of 14 feet (~80% of the distance from the outside knuckle to the first air-slot transition). Ten feet were dedicated to the 1/2-inch thick mid-floor bottom plate. The width and length of the new mock-up were selected to provide ample usable area in the mid-floor bottom plate to accommodate flaws with conservative 12-inch flaw spacing, and to accommodate a 1/2-to-1/2 inch weld pattern that may represent a high-risk area for flaw development—a 90-degree weld confluence found in the primary liner bottoms (and the secondary liner bottoms) in the AY, AZ, and SY tank farms. The mock-up was constructed A-516 Grade 70 carbon steel.

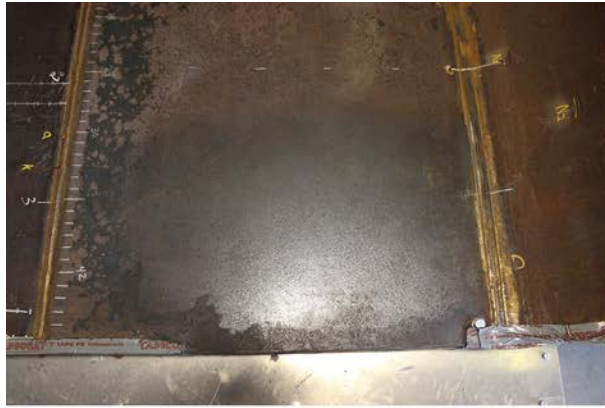
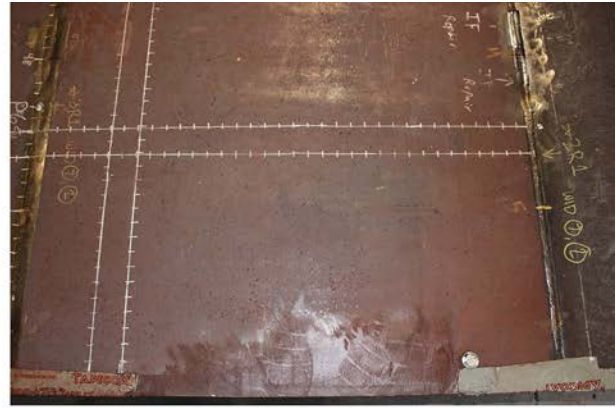
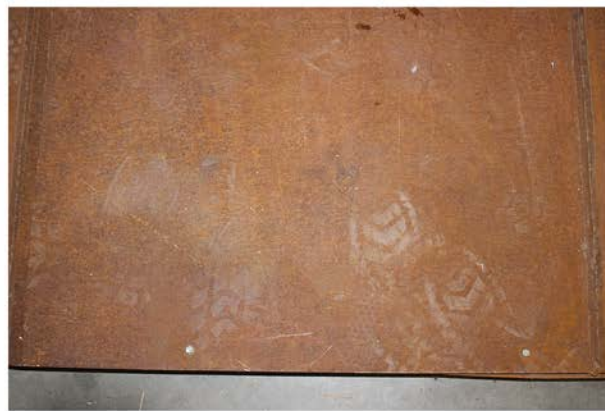
**Figure 4.4.** Rust Test using 7/8-inch Plates from Three Mock-ups with (a) Clean, (b) Mild, and (c) Field-Representative Rust/Oxide Layers

The evaluation of tolerance for rust was performed by comparing signal responses of a common reflector (edge of 7/8-inch plate) in three different mock-ups with clean, mild, and field-representative rust/oxide layers, respectively as seen in Figure 7.18 with each of the participant's technology.

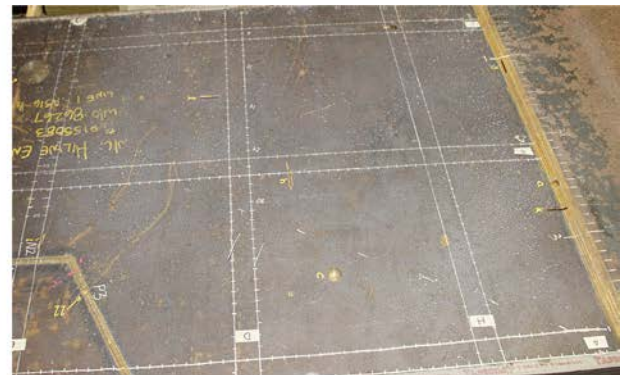
**Figure 4.5.** Dirt Test Using Pit "C" as Reflector with (a) Clean and (b) Minimal Layer of Dirt Surface Conditions

The sensor's tolerance for surface debris was determined by comparing the signal response from a surrogate flaw (Pit "C" from *Technology Screening* mock-up) with two surface conditions—clean and a minimal layer of dirt (non-metallic surface debris) between the sensors and mock-up. Figure 7.19 shows each of the participant's location with respect to Pit "C" on the surface contain a minimal layer of dirt.

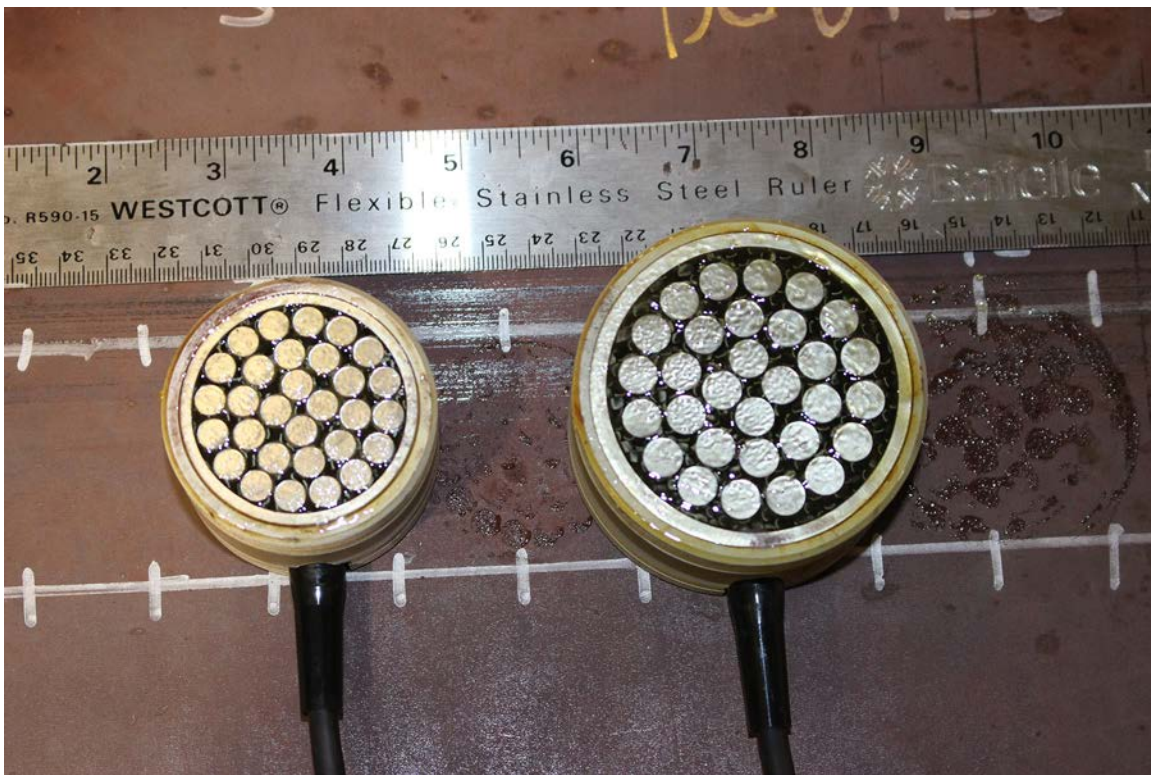
**Figure 6.1.** Guidedwave Sensor

Guidedwave selected a 165 kHz, 30-element phased-array sensor for their primary interrogation method of the mock-ups. The active element portion of this transducer array, pictured on the right of Figure 6.1, is 2 inches in diameter and 3/8 inch in height and would be small enough to fit into the air-slots of a DST. The secondary probe brought for testing is a 200 kHz, 30-element phased-array sensor with a diameter of 1.5 inches. Guidedwave can work with the manufacturer, Olympus, to redesign and build these probes to easily fit within the air-slot channels of a DST. The sensors were used to make measurements on the 1/2-

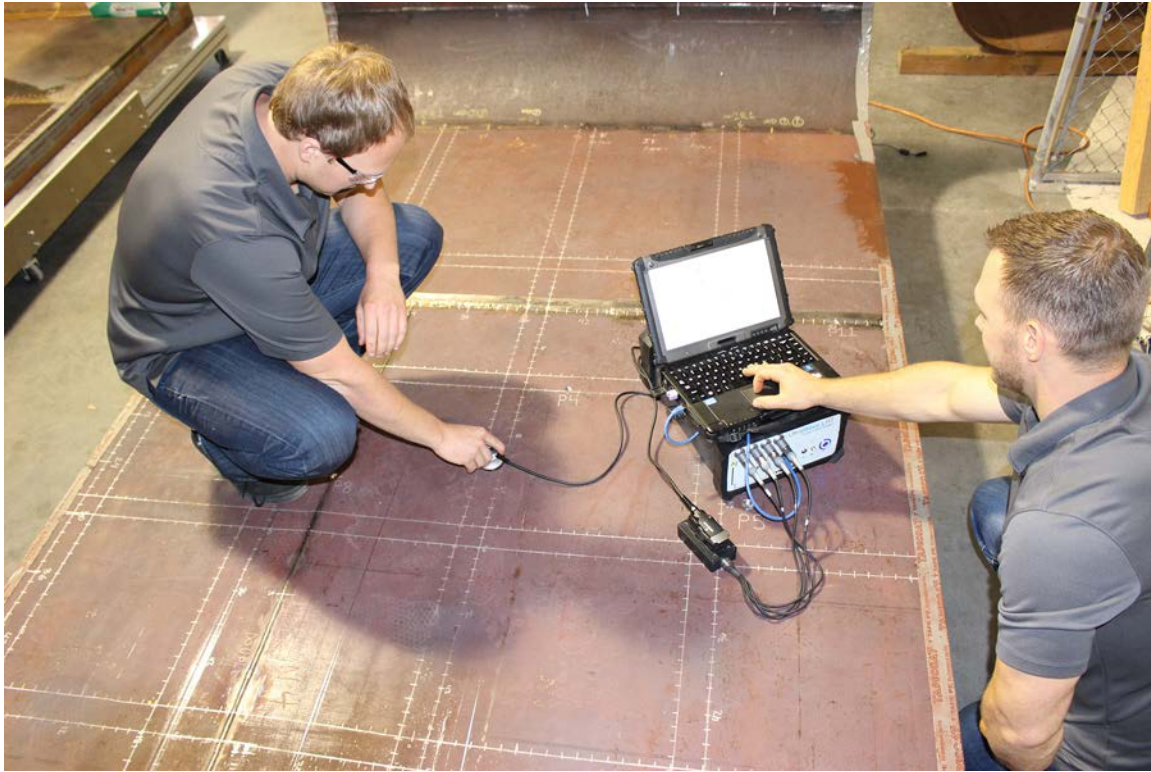
**Figure 6.2.** Inspection Locations on the 1/2-inch Bottom Plate

inch thick bottom plate of the mock-ups in a predetermined grid pattern within the simulated air-slot paths to resemble a field inspection. Multiple inspection locations on each plate allowed for post-processing of the data into a composite image. Some measurements were also made on the 7/8-inch bottom plate for the rust tests. Figure 6.2 shows the Guidedwave participants and the equipment at an inspection location on the *Sensor Effectiveness* mock-up.

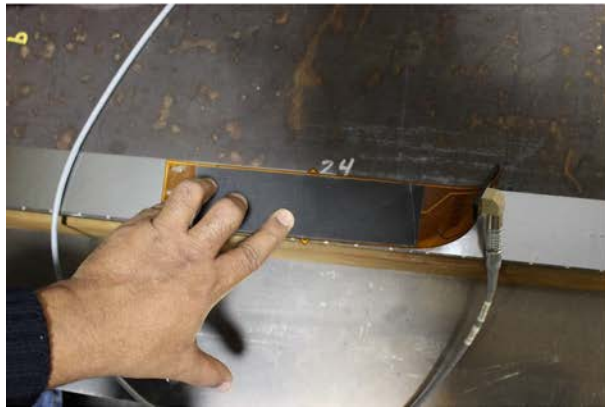
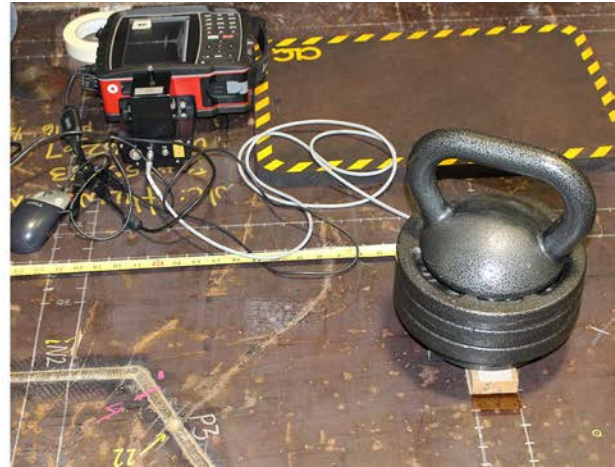
Two EMAT approaches were demonstrated by Innerspec for detecting the surrogate flaws in the DST mock-up during *Sensor Effectiveness Testing*. The first EMAT technique used a magnetostrictive strip that was attached to the probe for generating shear horizontal guided waves (Figure 6.3 right side) in the mock-up. A weight was used to apply uniform pressure on the strip for adequate coupling. This approach is a modified version of the approach that was demonstrated during *Technology Screening*, which required the magnetostrictive strip, shown in the left side of Figure 6.3, to be adhesively backed and attached to the mock-up for generating shear horizontal acoustic waves in the mock-up.

**Figure 6.3.** EMAT Technique Using Magnetostrictive Strip during *Technology Screening* (left) and *Sensor Effectiveness Testing* (right)

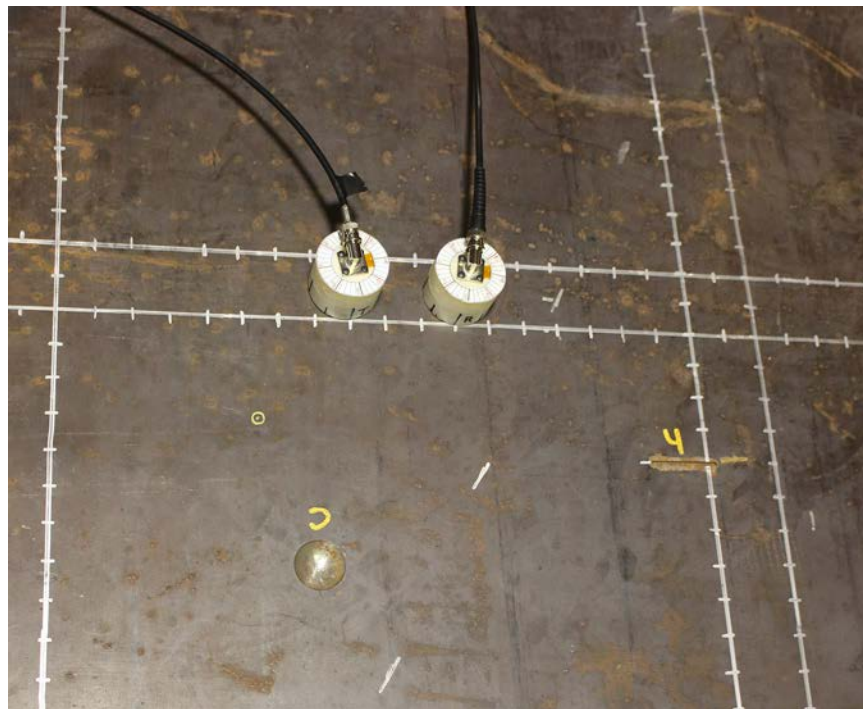
For the pulse-echo (PE) configuration, shown in Figure 6.7, the transmitter and receiver were used side-by-side with the active areas of the sensors in alignment. During *Technology Screening* this setup required an electromagnetic shield to be placed between the transmitter and the receiver; however, the shield was not used during *Sensor Effectiveness Testing* and additional separation between the sensors was required. SAFT processing was performed to reconstruct the raw data into an image. The data collected using this approach was intended to supplement and validate data collected from the PC configuration during weld inspection as appropriate.

**Figure 6.7.** Pulse-Echo Configuration

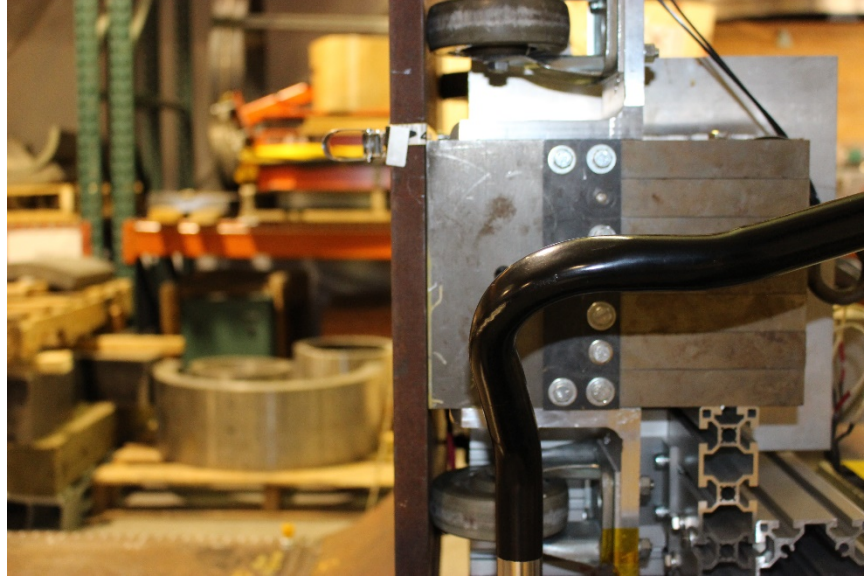
The sensor system demonstrated for the *Technology Screening* effort was specifically designed to inspect reactor containment vessels, although additional meander coil configurations, producing higher frequencies, were assembled specifically for this demonstration. The demonstrated system was rather large ( $\sim 1 \text{ ft}^3$ ) and heavy ( $> 200 \text{ lbs.}$ ) but SwRI assured that the sensor could be reduced in size and weight to accommodate deployment through a 24-inch riser into the annulus space of a DST. The system was placed on the primary wall section of the mock-ups just above the upper knuckle weld. The meander coils, electromagnets, and some circuitry were positioned at the inspection site, and this equipment was connected to the power supply and data acquisition equipment through a long umbilical cable. A side view of the sensor equipment at the examination site is shown in Figure 6.8.

**Figure 6.8.** Side View of the Sensor in Place above the Knuckle for Examining the Surrogate Flaws Remotely

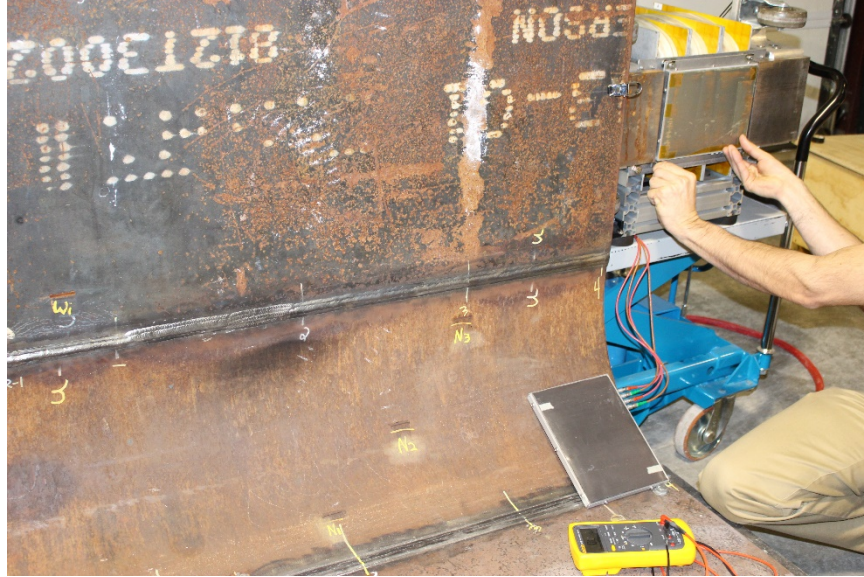
**Figure 6.10.** Meander Coil Being Replaced Between Examinations

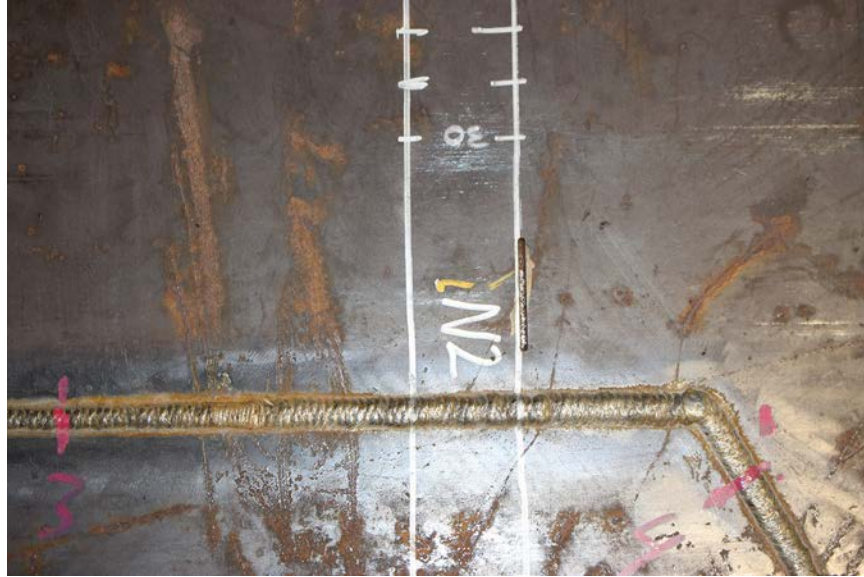
Notch “N2” was a 2-inch long, 0.125-inch wide machined notch with a depth of 50% of the plate thickness (0.25 in.). Notch “N2” was located in the base plate of the modified *Technology Screening* mock-up near the edge of the 1/2-to-1/2 inch weld and oriented perpendicular to the weld direction as seen in Figure 7.9.

**Figure 7.9.** Photograph of Notch “N2”

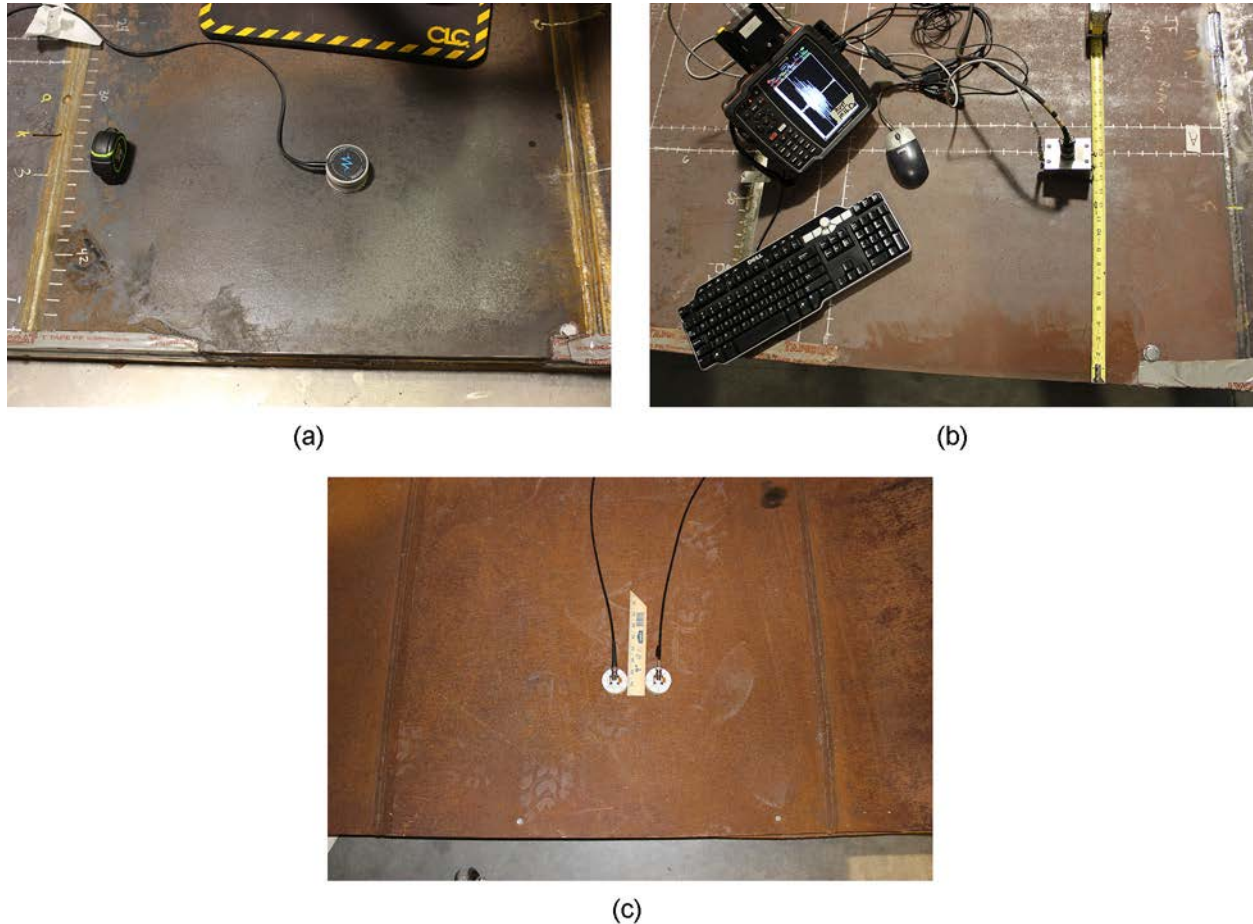
**Figure 7.18.** Rust Test Using 7/8-inch Plates from Three Mock-ups with (a) Clean with Guidedwave Sensor, (b) Mild with Innerspec Sensor, and (c) Field-Representative Rust/Oxide with Penn State Sensors

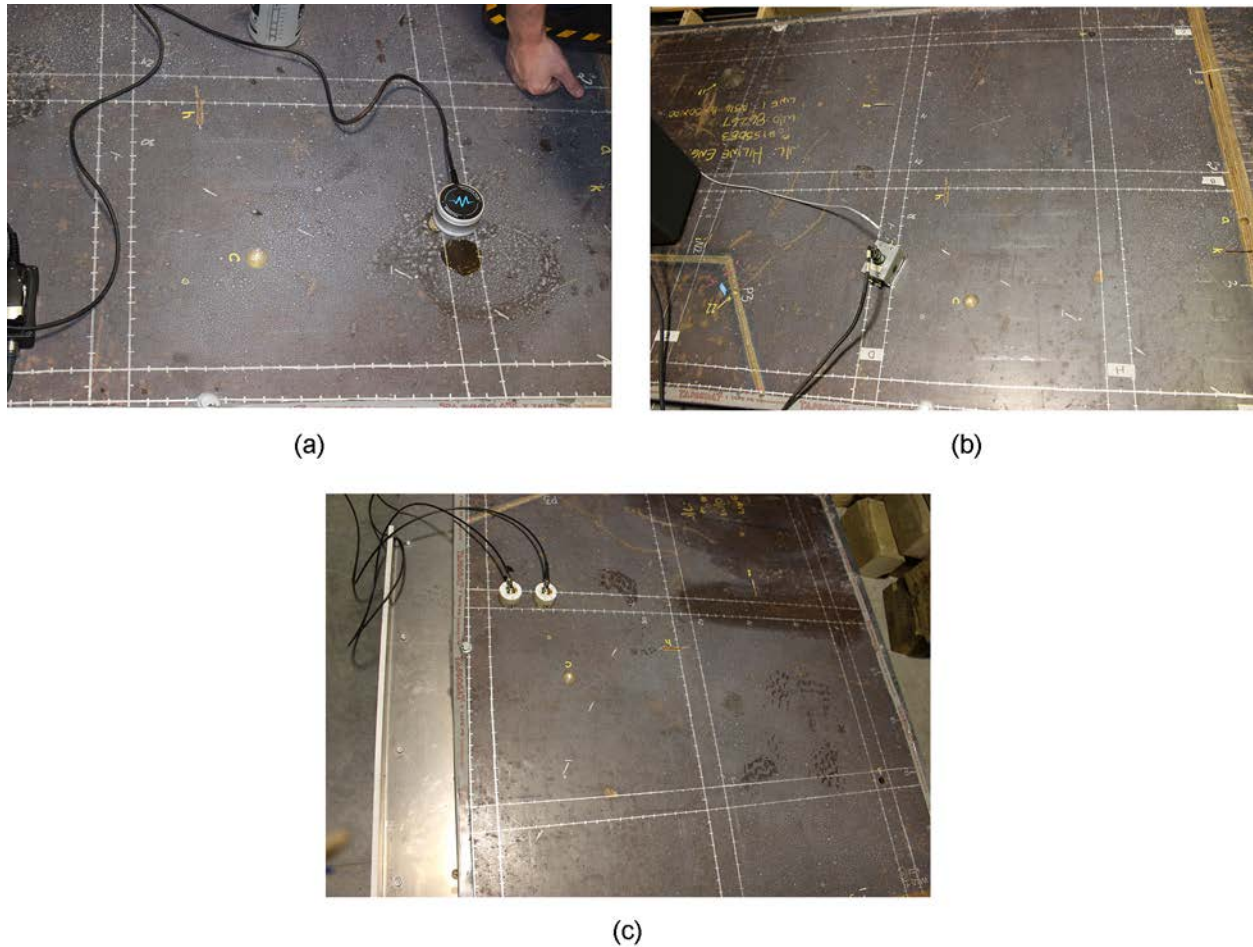
**Figure 7.19.** Dirt Test Using Pit "C" as Reflector with Minimal Layer of Dirt: c (a) Guidedwave Sensor, (b) Innerspec Sensor, and (c) Penn State Sensor Locations

Surface Condition	SNR (dB)		
	Guidedwave	Innerspec	Penn State
No debris	35.3	19	9.2
Minimal debris	34	19	6.8

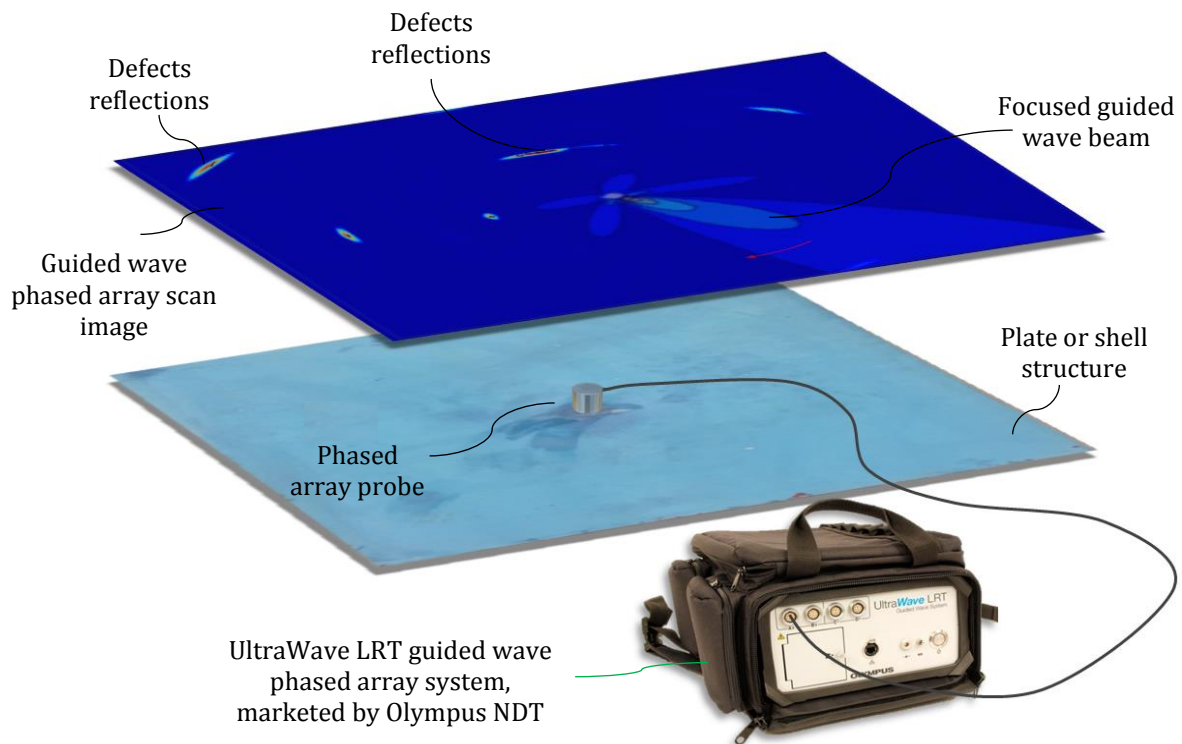
**Figure 3 Guided wave phased array technology uses a compact phased array probe to electronically steer and focus a guided wave beam around a plate-like structure; corrosion, cracks, and other anomalies can be detected. This technique resembles a radar or sonar scan and is the guided wave analogue of traditional ultrasonic bulk wave phased array, which revolutionized the UT field.**

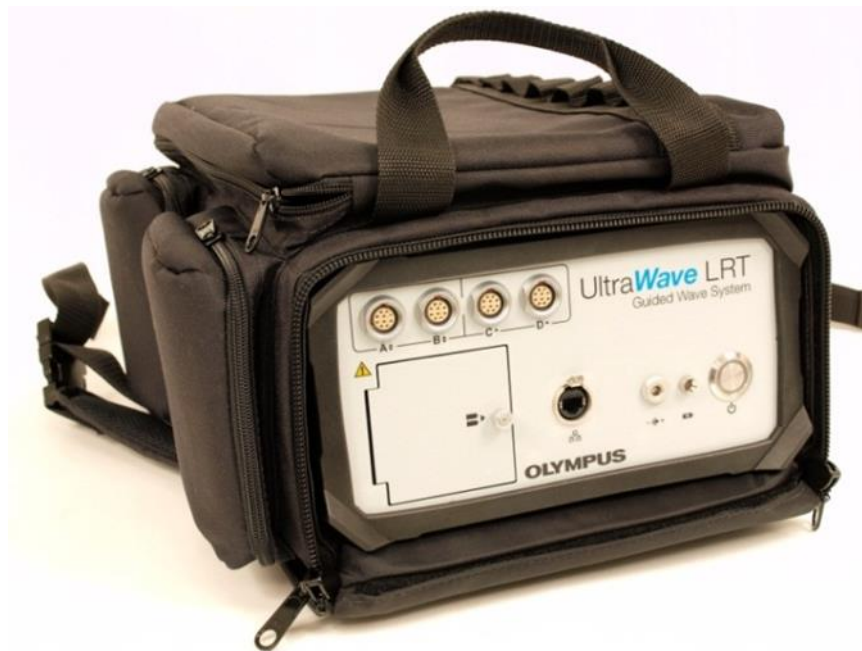
The UltraWave LRT unit, shown in Figure 4, is a multi-channel guided wave pulser-receiver platform sold and serviced through Olympus Scientific Solutions Americas (OSSA) that is currently used with the UltraWave long-range guided wave pipe inspection system, also offered by OSSA. This unit is a powerful, flexible platform for a variety of guided wave technologies, and can be utilized for GWPA applications.

**Figure 4** The UltraWave LRT guided wave pulser-receiver system sold and serviced by Olympus.

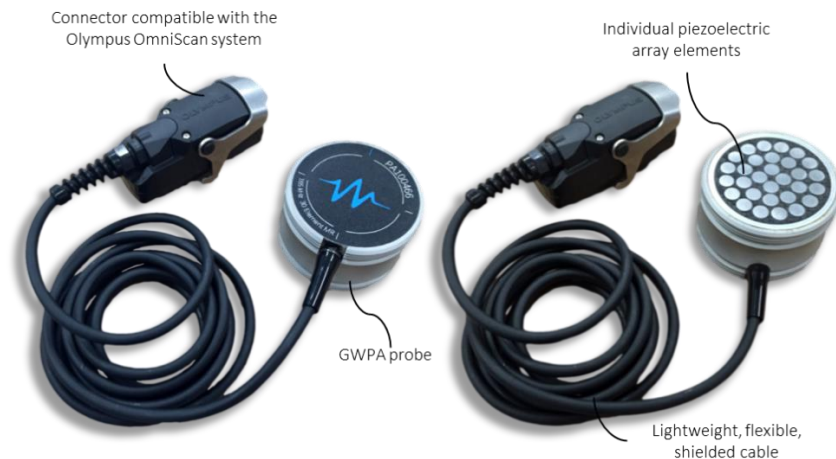
Currently, Guidedwave has designed and manufactured multiple GWPA sensors for a multitude of applications. For the primary wall mock-up, Guidedwave has selected the 165 kHz 30-element GWPA sensor PA100466 (Figure 5). This sensor offers the optimal frequency bandwidth for the given plate thickness and defect sizes expected. However, with this sensor, the resolution is slightly reduced to minimize the side lobes produced. This is necessary when there are many features in the plates or cut ends, like in a mock-up, which will produce artifacts in the final GWPA image.

**Figure 5 Photograph of a GWPA sensor that was used during the primary liner mockup inspection feasibility study**

The existing GWPA sensors have been designed to be handheld and ergonomic. The height and diameter of the 165 kHz 30-element GWPA sensor are 1.7 and 2.7 inches, respectively. However, the actual sensor array diameter is only 2 inches and the active element height is 3/8 inches. Guidedwave has fabricated sensors with diameters as small as 1.5 inches, and one of these was brought along during testing to demonstrate. Guidedwave is also in the process of building a probe with elements half the size of the smallest yet developed, which could possibly reduce the dimensions even further, if necessary. Therefore, a smaller diameter GWPA probe is absolutely possible for this application. We work with Olympus NDT to produce the GWPA probes, based on our specifications, so it is quite reasonable to redesign the probe for the limited-access channel geometry.

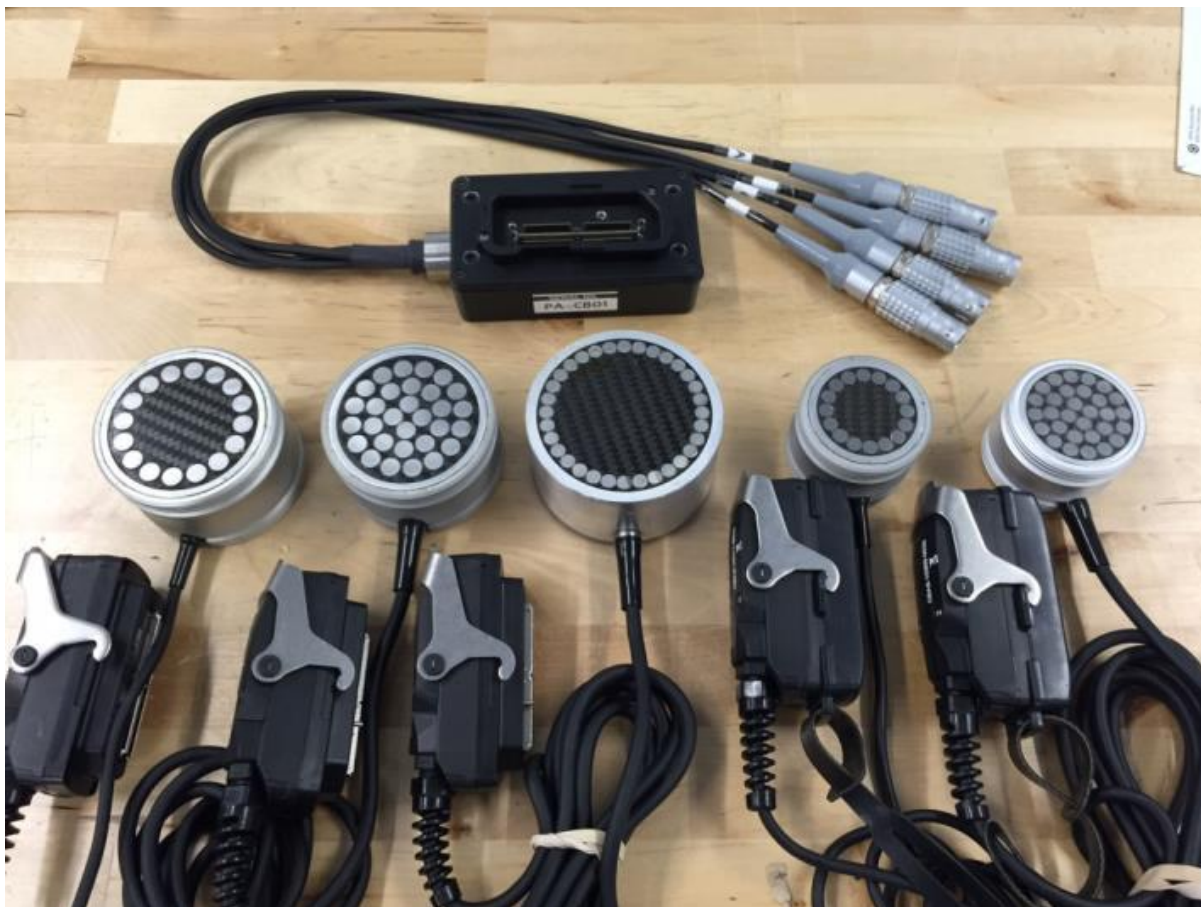
**Figure 6 Photograph of several GWPA probes produced to date, including the C16-10-40 probe (second from left) utilized for the Technology Screening and almost all of the Sensor Effectiveness Testing and the smaller C16-10-4S probe (far right) that demonstrates the possibility of reducing the probe size.**

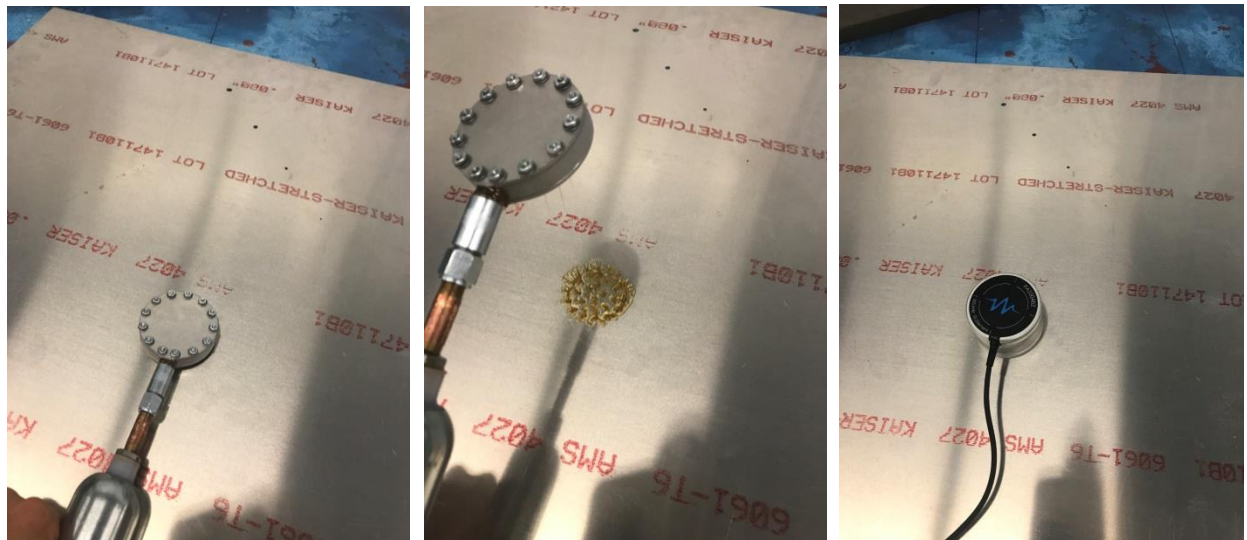
**Figure 8 Photographs showing the process of applying the couplant with the dispenser, removing it, and placing the probe over the couplant prior to scanning. This process can be adapted for robotic implementation. The couplant dispensing mechanism could also possibly be incorporated into the probe.**

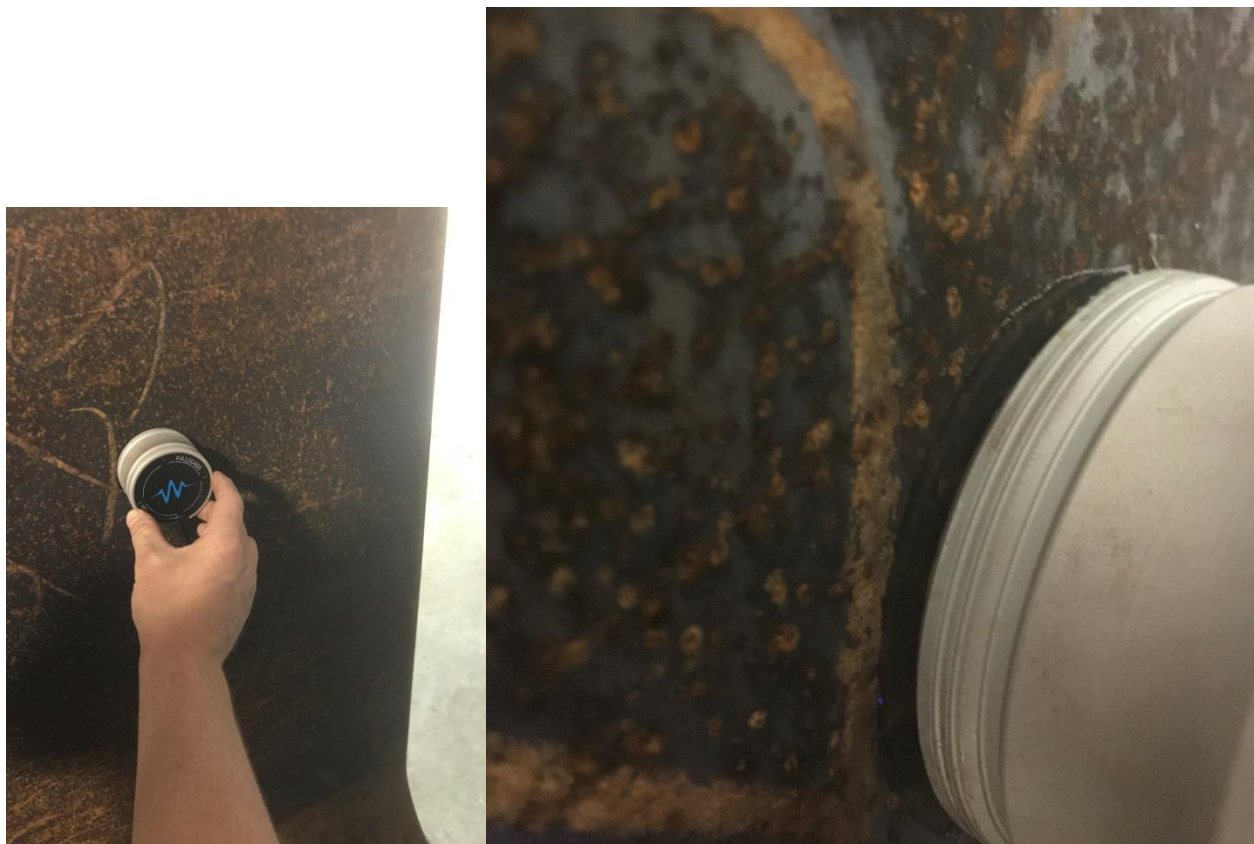
**Figure 18** Photographs of the probe (left) and close-up of the surface condition on the vertical plate of the Level 3 rust mockup, which has even more surface roughness than the Level 3 rust plate; this surface also had no effect on the SNR of the GWPA data.

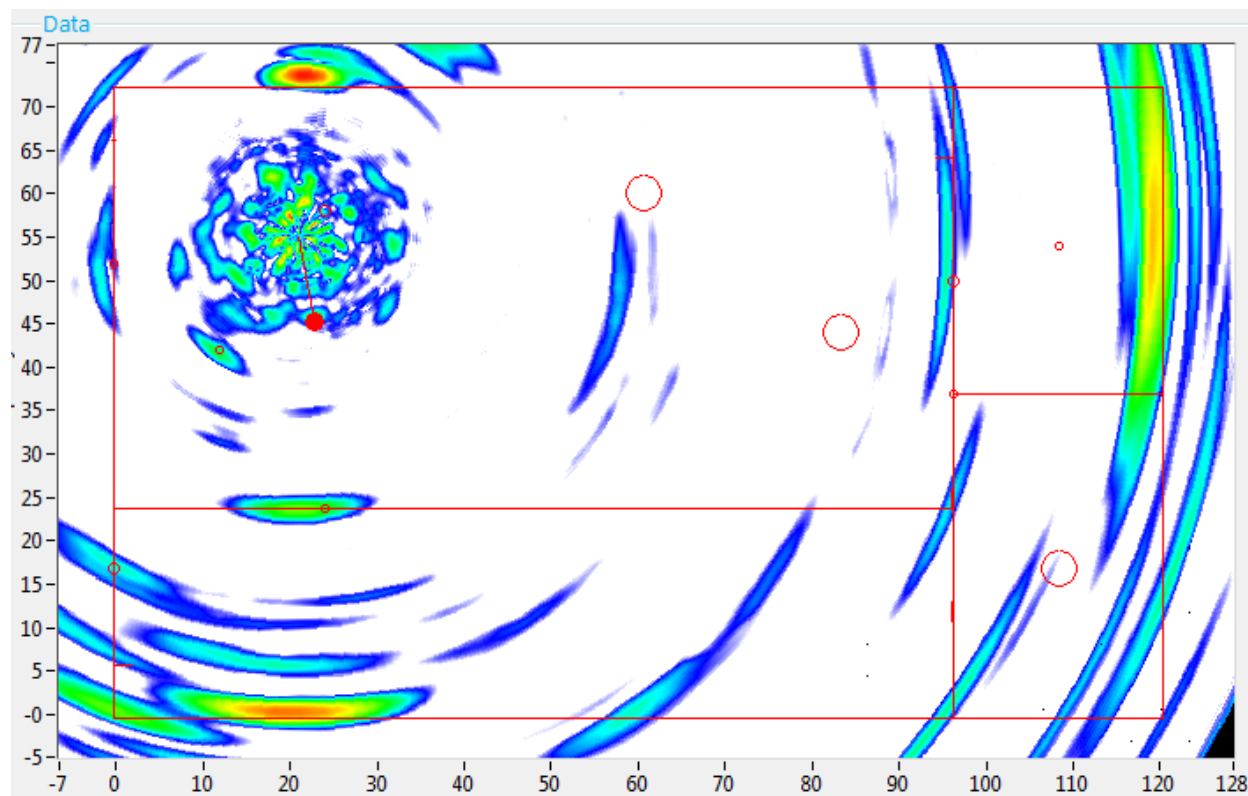
**Figure 20** One example of the “noise level” for Location A.

Signal-to-noise ratio (SNR) was calculated from the C-filtered GWPA scans, and not from individual A-scans. This is the most accurate method of SNR analysis, since this is the form of the data that would most likely be analyzed by a user. Note that a separate SNR analysis was performed for each defect based on the composite image(s). The precise “noise” level is difficult to characterize in a GWPA scan because of the presence of artifacts from side lobes. Typically, the C-filter removes most sidelobe artifacts quite effectively, so these are not of concern. However, due to the presence of free edges on the mockup (even with the T-tape), there are some sidelobe artifacts that remain; in real-world inspections, these would not be present. Isolated sidelobe artifacts were generally ignored in the SNR analysis, unless they were present to such a degree that they effectively raise the “noise level” in the scan, such as in some shots near free edges or on the very small edge plates, in which reverberation also contributed to the noise floor. Therefore, the noise floor was generally considered to be the peak of the noise level at a medium distance in the data set. This SNR analysis was applied to all the data in the same manner. Figure 20 illustrates one example of the “noise level” in the GWPA data for Location A at 160 kHz, which was approximated to be at 59.4 dB. In this figure, the colormap threshold is set to 59.4dB such that the peaks of the noise are just barely visible in light blue. The remaining indications are weld or edge reflections, defect indications, dead zone noise, sidelobe artifacts from the free edges, or reverberations from the free edges.

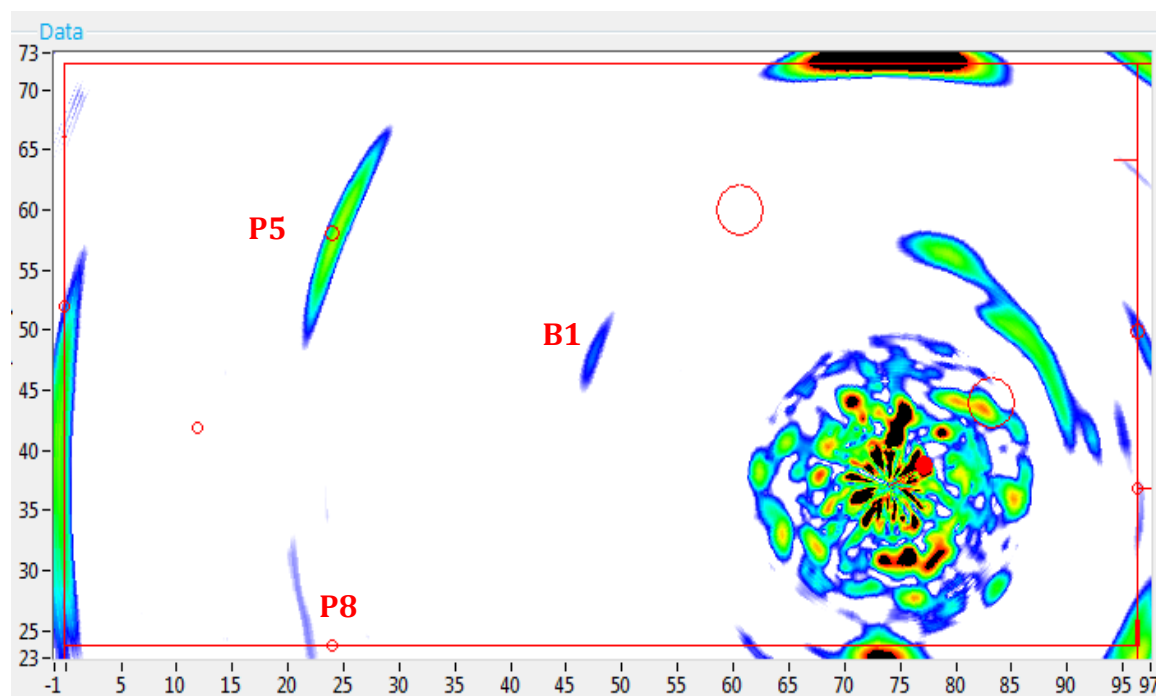
**Figure 21** GWPA scan from Location H showing typical pit indications at P5 (ID), P8 (ID), and B1 (OD).

The following images provide typical examples of pit, notch, and wall thinning defect indications from various locations on the Sensor Effectiveness Testing mockup.

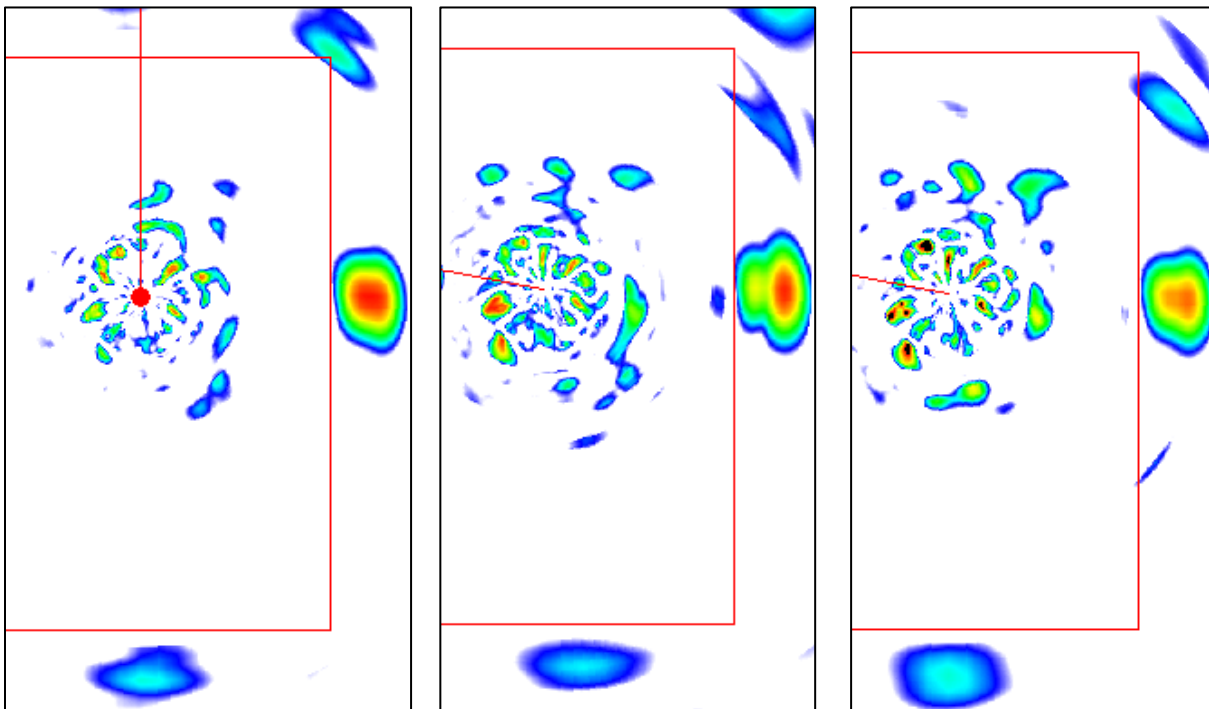
**Figure 25 Comparison of images from shot 2 of the Rust Test for surface rust level 1 (left), surface rust level 2 (center), and surface rust level 3 (right).**

The following images are examples of these used to analyze the effect of surface rust on the GWPA scan data SNR. The free edge reflection of the mockup is highlighted with the cursor.

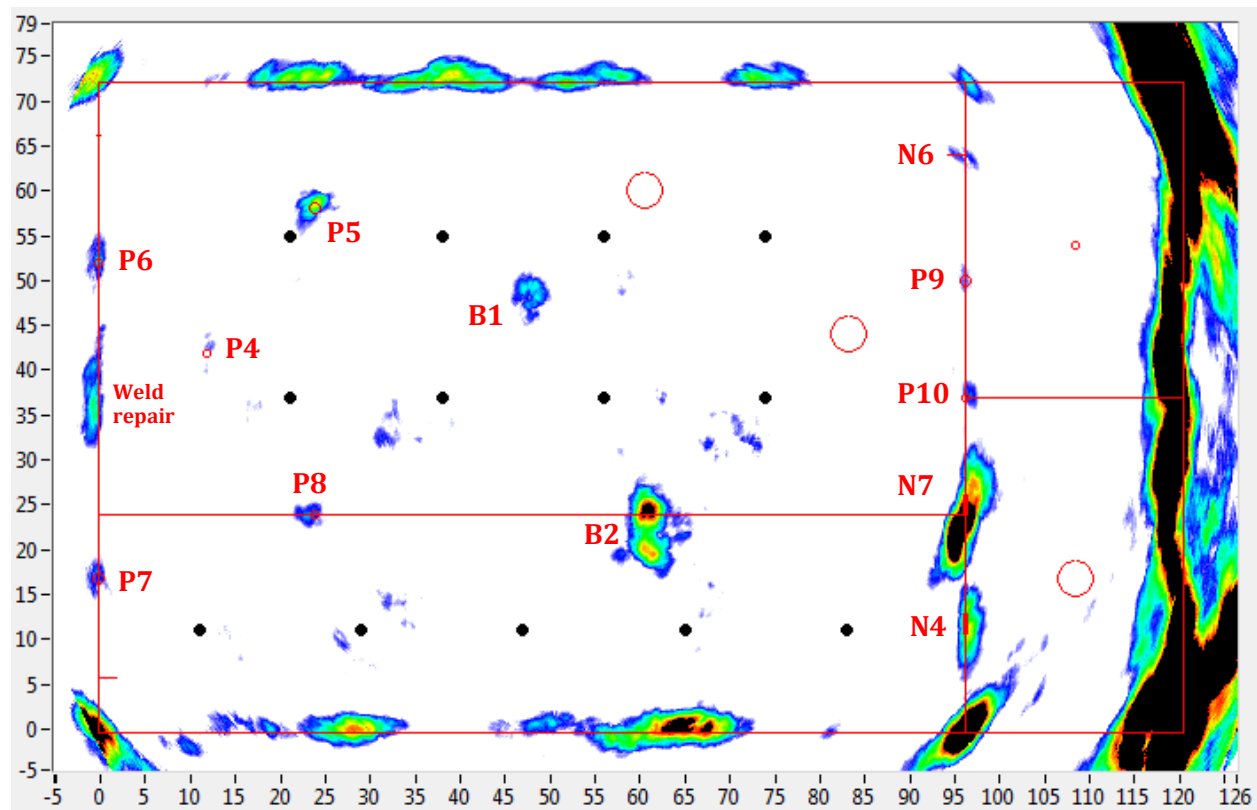
**Figure 26 Composite image from Sensor Effectiveness Testing mockup showing detection of defects P4, P5, P6, P7, P8, P9, P10, N4, N6, N7, blind flaw B1, and blind flaw B2. Also note the area of heavy weld repair along the transition weld was also visible in the composite image.**

The composite images provided excellent results, showing clear indications of the vast majority of defects in a single image; see Figure 26. This easy-to-interpret image would provide a very straightforward means of inspection for an operator with limited training. The black dots in the composite image correspond to the scan locations used to construct it. Note that in the composite image in Figure 26, one area of heavy weld repair is also visible along the transition weld; this is not noise.
