# NDE Technology Development Program for Non-Visual Volumetric Inspection Technology

## *Sensor Effectiveness Testing* Report

**August 2017**

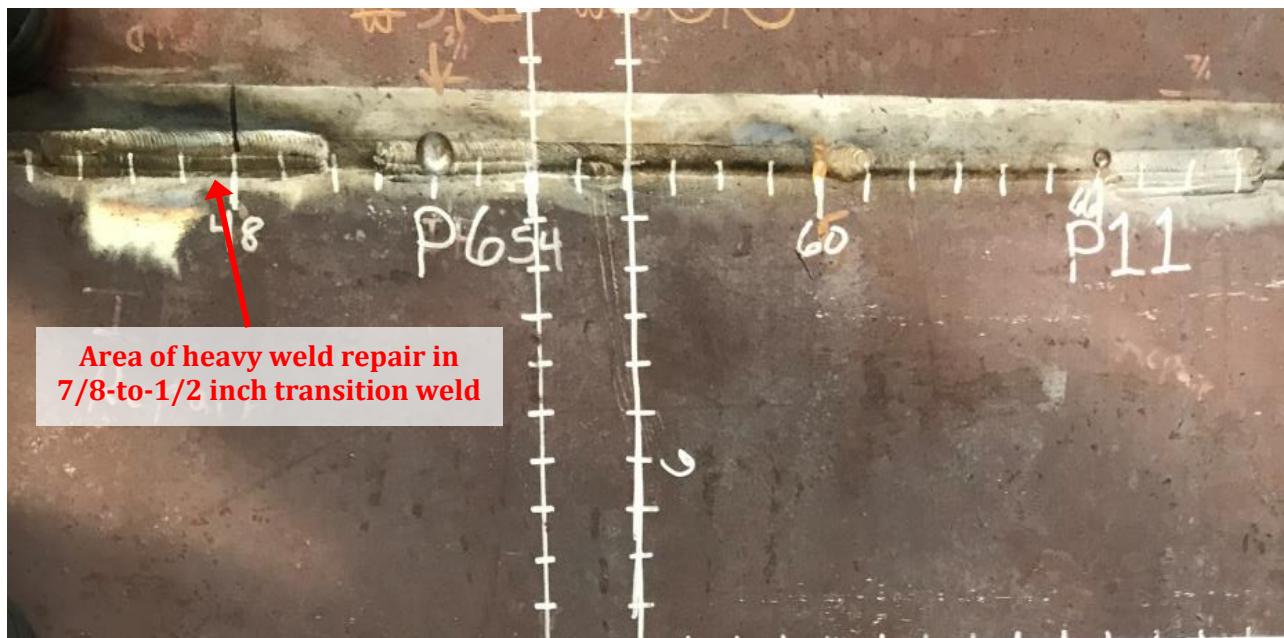
**Figure 28 Photograph of the 7/8-to-1/2 inch transition weld including the area of heavy weld repair that was detected in the composite images above.**

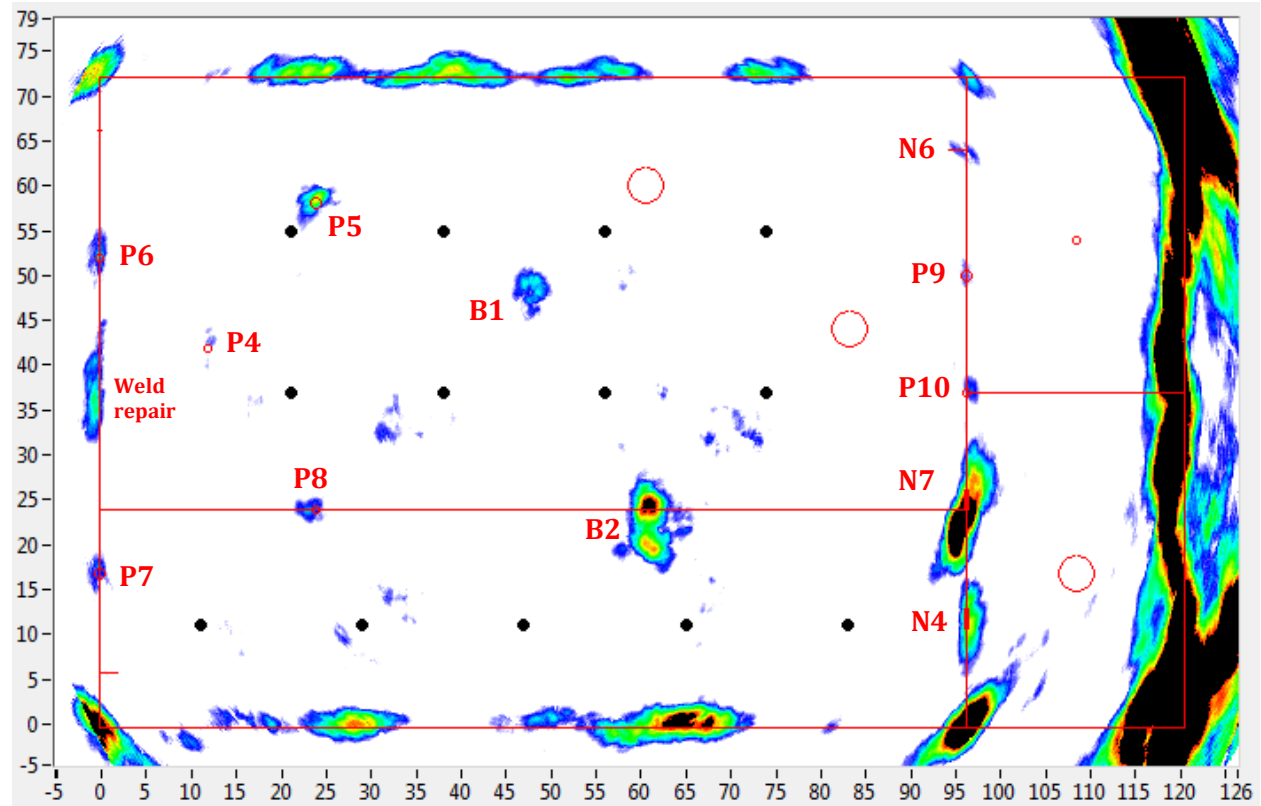
**Figure 35 Composite image from Sensor Effectiveness Testing mockup showing detection of defects P4, P5, P6, P7, P8, P9, P10, N4, N6, N7, blind flaw B1, and blind flaw B2.**

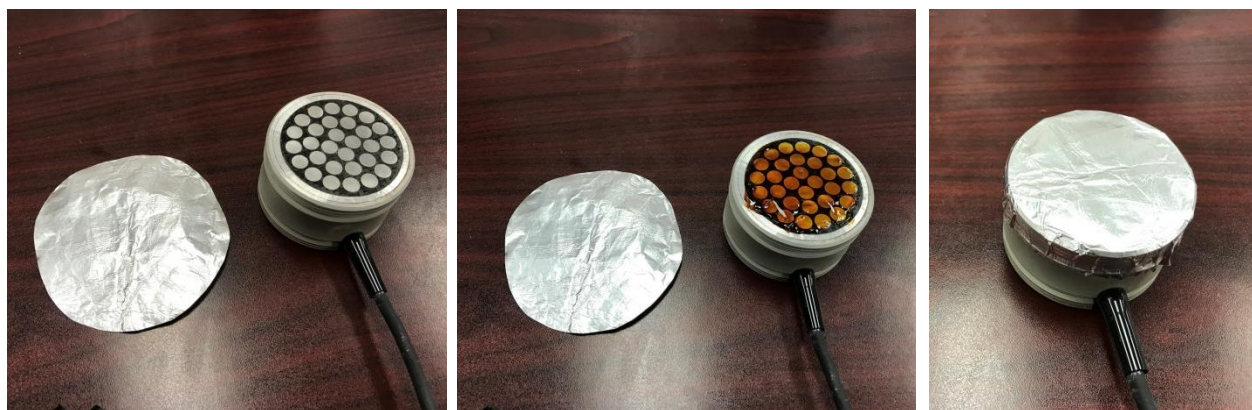
The method for dry-coupling the GWPA probe involves applying a layer of shear couplant to the probe face and then covering it with a sheet of thin aluminum foil (between 0.0005" and 0.0050" thick), as shown in Figure 1. The aluminum foil acts as a barrier between the couplant and the test surface, but still provides excellent coupling efficiency on rough or smooth surfaces when applied with a reasonable application force. Note that Guidedwave already utilizes aluminum foil couplant in a similar configuration (with the shear gel couplant layer) for normal- and high-temperature torsional wave magnetostrictive pipe inspection applications, with great success.

**Figure 1 Process for preparing the "dry-coupled" GWPA probe; (left) a small sheet of aluminum foil is prepared; (center) a thin layer of shear couplant is applied to the probe face; and (right) the aluminum foil is placed over the shear couplant.**

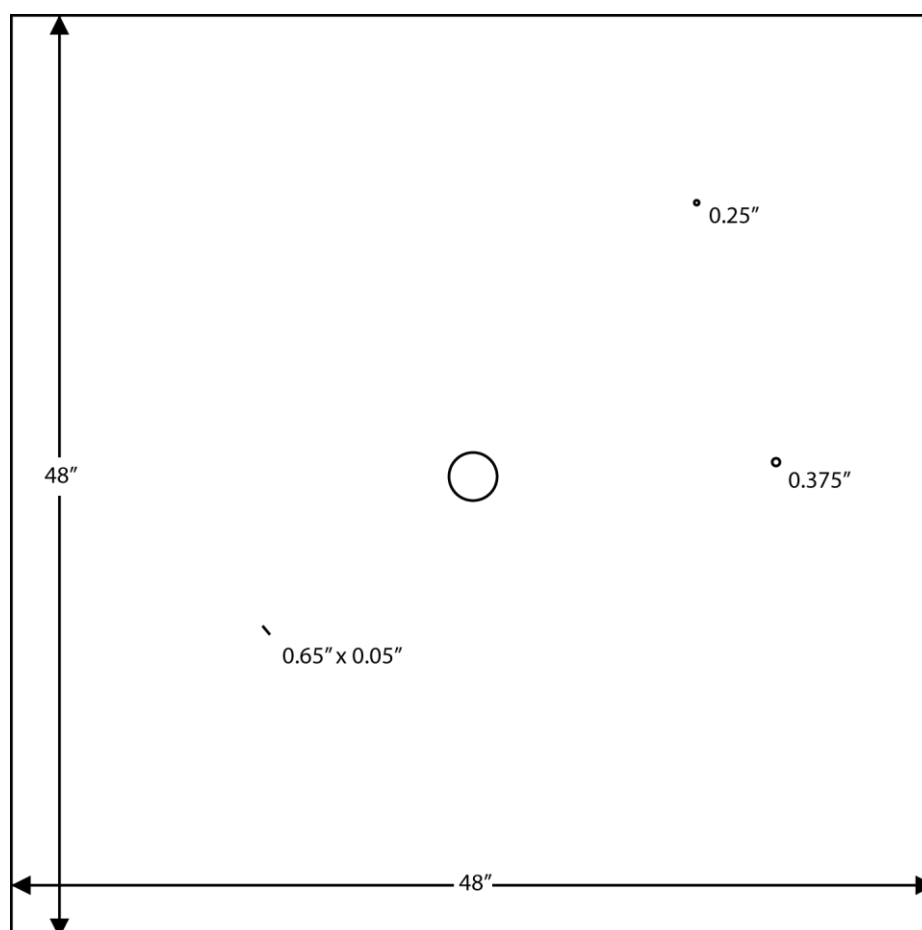
**Figure 2 Drawing of the test panel used for couplant method comparison testing; the panel includes three manufactured flaws: two holes and one notch.**

To characterize the performance of the new coupling methods, comparison tests were conducted on the new dry-coupled configuration and the conventional shear gel-coupled configuration that was used during testing at PNNL. The test specimen was a 48" x 48" x 0.080" aluminum panel with three manufactured flaws, as shown in Figure 3. The flaws included a 0.65" x 0.05" notch, a 0.25"-diameter through hole, and a 0.375"-diameter through hole. Data was collected with the probe in the center of the plate and 25 dB of receiver gain; this is approximately 20 dB less than was used during testing at PNNL, due to the smaller size of the test structure.

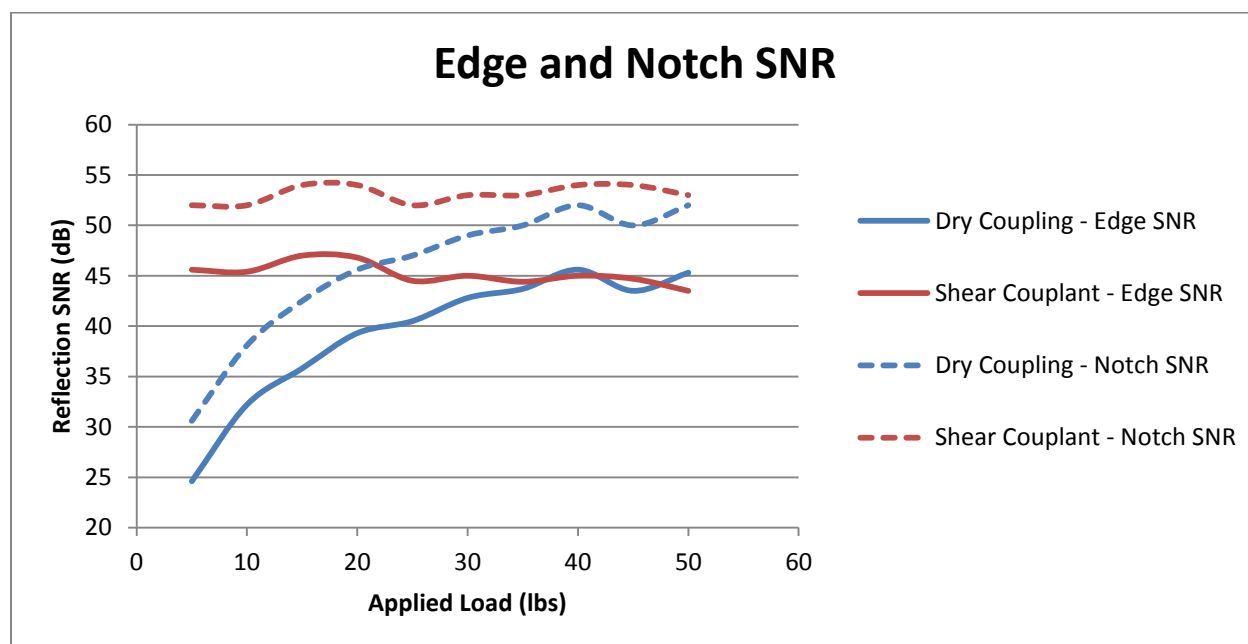
Figure 5 Edge and notch SNR values (in dB) for both coupling mechanisms versus load.

Tests were conducted with the dry-coupling mechanism using varying static loads applied to the back of the probe. Loads of from 5 to 50 lbs were applied 5 lb increments, and the signal attributes were compared to each other and those of a probe coupled directly with shear gel couplant. Figure 5 compares the plate edge and notch defect SNR for the two coupling mechanisms versus load. For this measurement, a higher value is better. The shear gel-coupled probe SNR was generally independent of applied load, while the dry-coupled probe SNR increased with load, but leveled off near the values for the gel-coupled probe near 40 lbs.

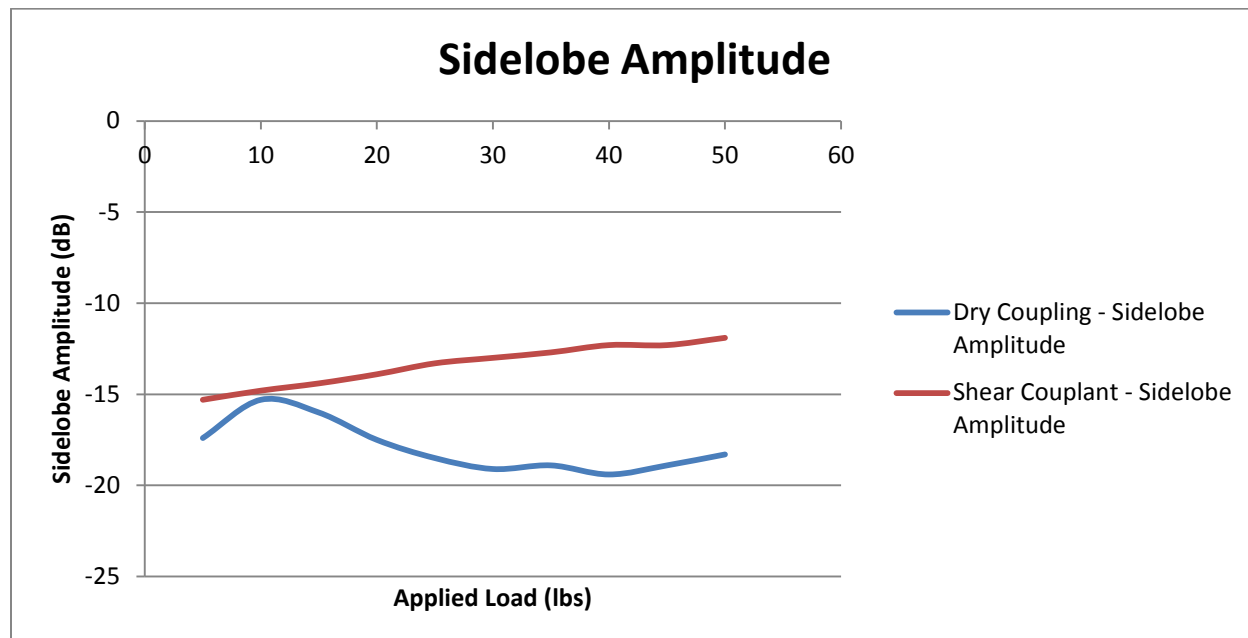
**Figure 7 Sidelobe amplitude for both coupling conditions versus load.**

Figure 7 compares the sidelobe amplitude from the notch reflection for the two coupling mechanisms versus load. For this measurement, a lower value is better. The shear gel-coupled probe sidelobes were stronger and got worse with load, while the dry-coupled probe sidelobes were weaker and generally improved with load.

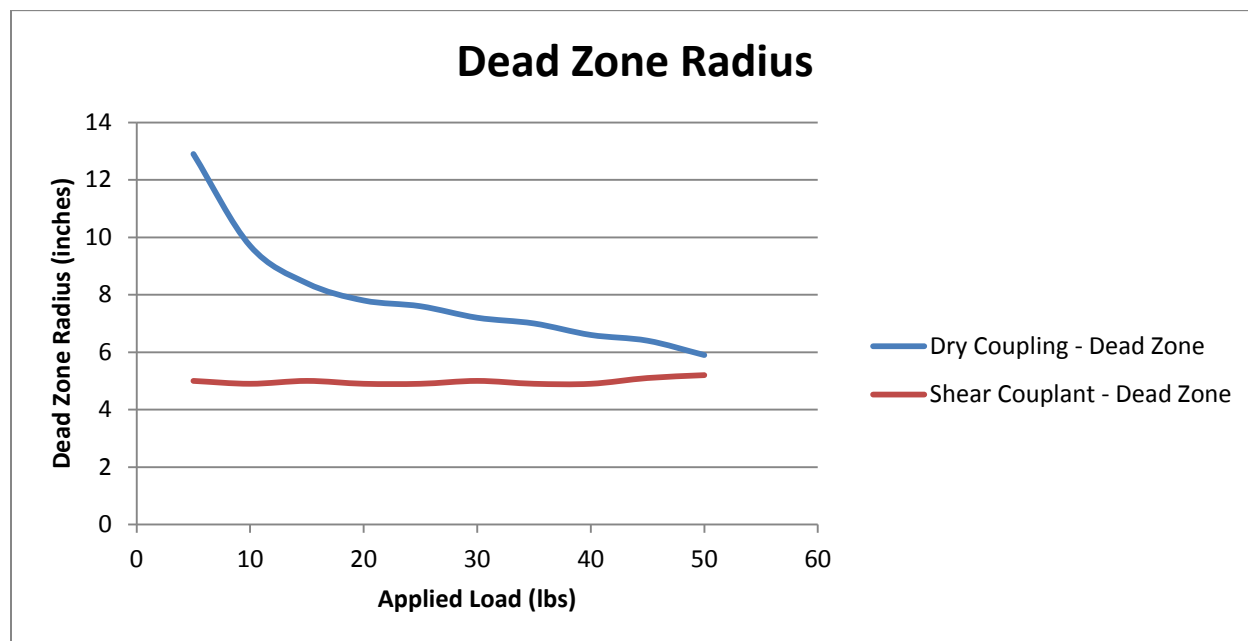
**Figure 8 Dead zone radius for both coupling mechanisms versus load.**

Figure 8 compares the dead zone radius for the two coupling mechanisms versus load. For this measurement, a lower value is better. The shear gel-coupled probe dead zone was small and constant with load, while the dry-coupled probe dead zone was larger and rapidly decreased with load, approaching the value for the gel-coupled probe around 50 lbs.

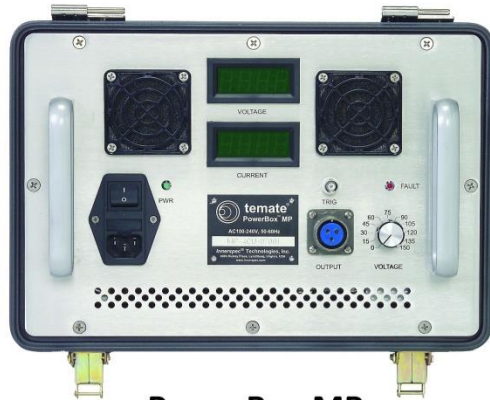
**PowerBox MP**

The equipment used in this testing was our standard off the shelf portable system which included an EMAT UT Tester branded as “PowerBox® H” and a pulsed-dc electromagnet also known as “PowerBox® MP”.

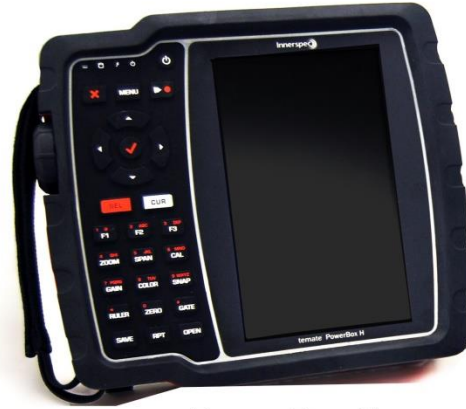
**PowerBox H**

The PowerBox® H equipment has limited capabilities due to its smaller size and being battery operated portable EMAT UT tester. For automated inspections we normally use our rack mounted systems capable of performing inspections at high speeds and high repetition rates with abilities to automatically save all data for post processing. The sensor attached with this portable equipment cannot be extended beyond 6 feet. However, the rack mounted industrial system can allow us to extend sensors to several hundred feet. The sensors used for this test included an Electromagnet mounted with an EMAT meander coil to generate SV waves at 2.25MHz and a second EMAT sensor including a meander coil glued with a tape to the magnetostriction strip along with weights applied through a wooden block for even pressure. The sensors used in these tests are shown in the following figure.

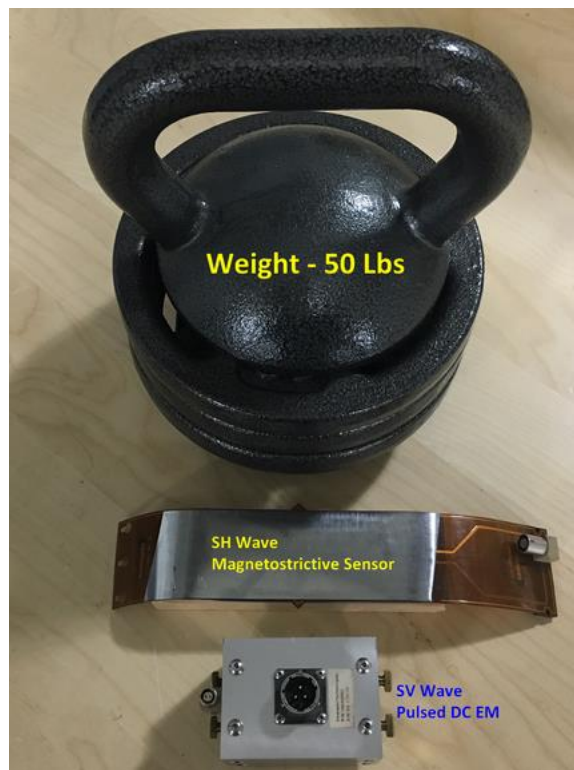
**Figure 6: SH Wave Magnetostrictive Sensor with Weights and SV Wave Sensor with Electromagnet**

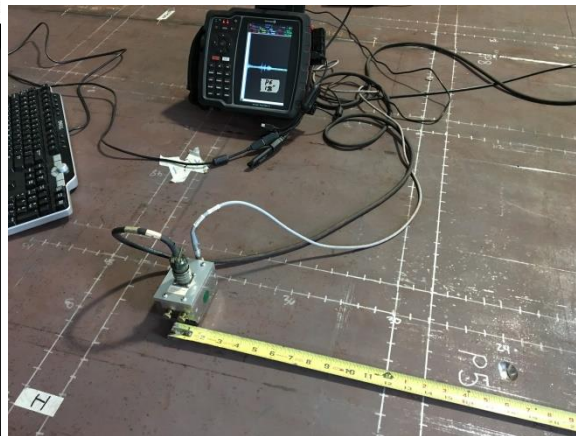
Response on MockUp-2 from Pit-P5 at a range of 18 inches

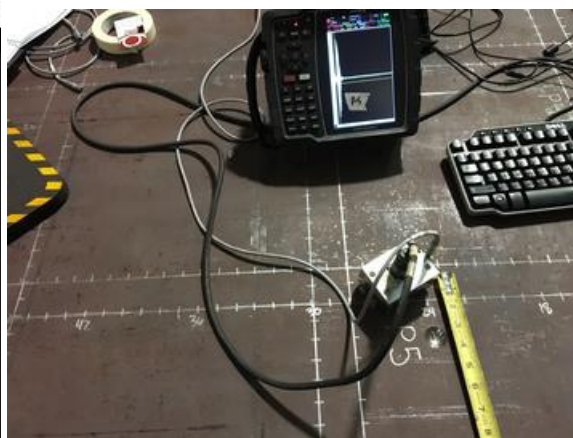
Data and Snapshot of Defect Pit-P5

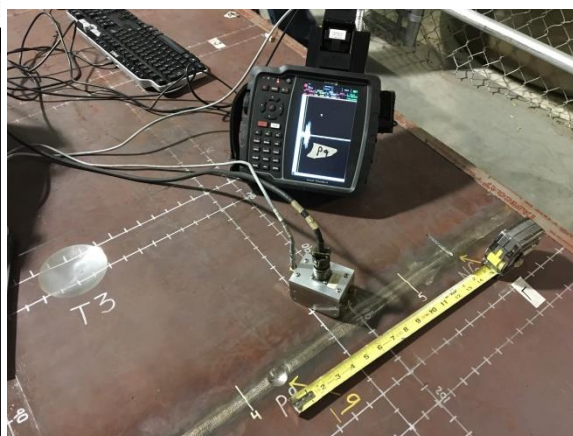
Data and Snapshot of Defect Pit-P9

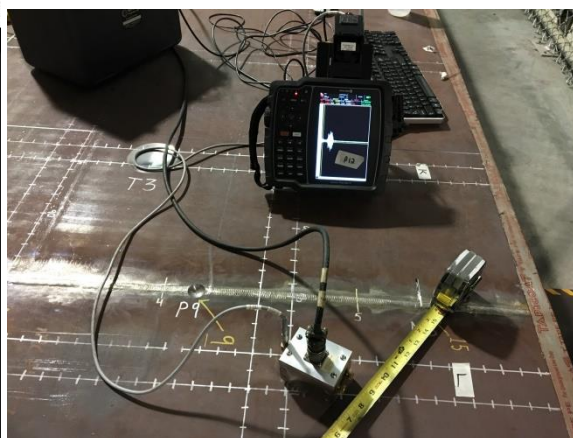
Data and Snapshot of Defect Pit-P12

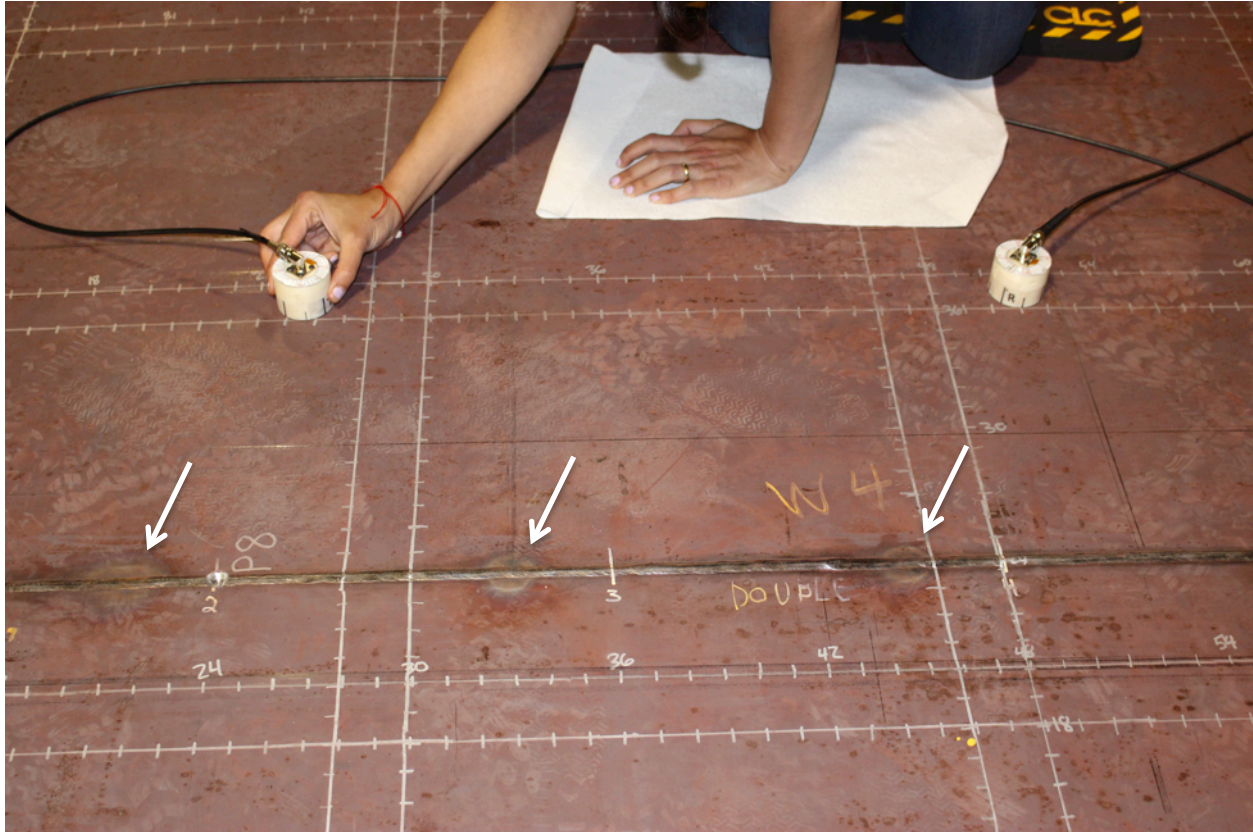
Photo showing what we called a ‘weld repair’ along the weld line  $x=24$ ” on new mockup. These anomalies are periodic and indicated in the previous SAFT image. Note that this is not the same region as shown in the SAFT image.
