Behavior, Distribution, and Passage Metrics of Juvenile Chinook Salmon Above and Below Lookout Point Dam, Fall 2016 and Spring 2017

Final Report

April 2018

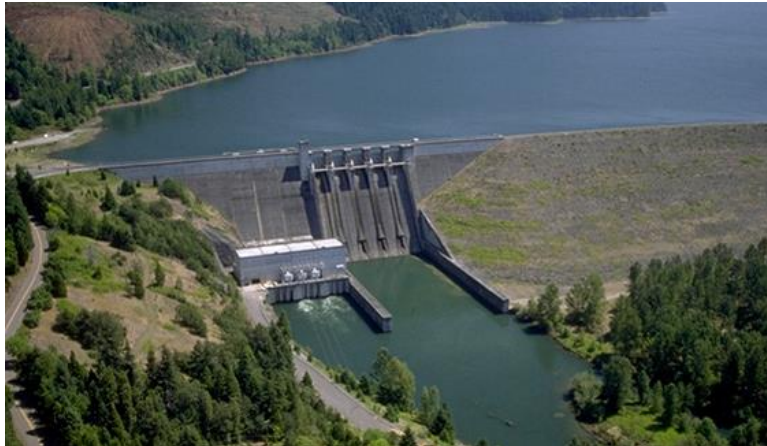
Figure 1.2. Aerial Photograph of Lookout Point Dam (courtesy of the USACE [<http://www.nwd-wc.usace.army.mil/dd/common/projects/www/pics/lop.jpg>])

the river. The dam has a powerhouse with three Francis turbine units each with one penstock, a total generating capacity of 120 MW, and a total hydraulic capacity of 9,300 cfs. The dam has a spillway with five spill bays and four regulating outlets (Figure 1.2). Operation of the spill bays (spillway crest 887.5 ft) and regulating outlets depends on forebay pool elevation, turbine operations, runoff conditions, season, and other factors. The maximum forebay pool elevation is rated at 929 ft (relative to mean sea level [msl]) and the minimum conservation pool is 825 ft (<http://www.nwd-wc.usace.army.mil/report/lop.htm>).

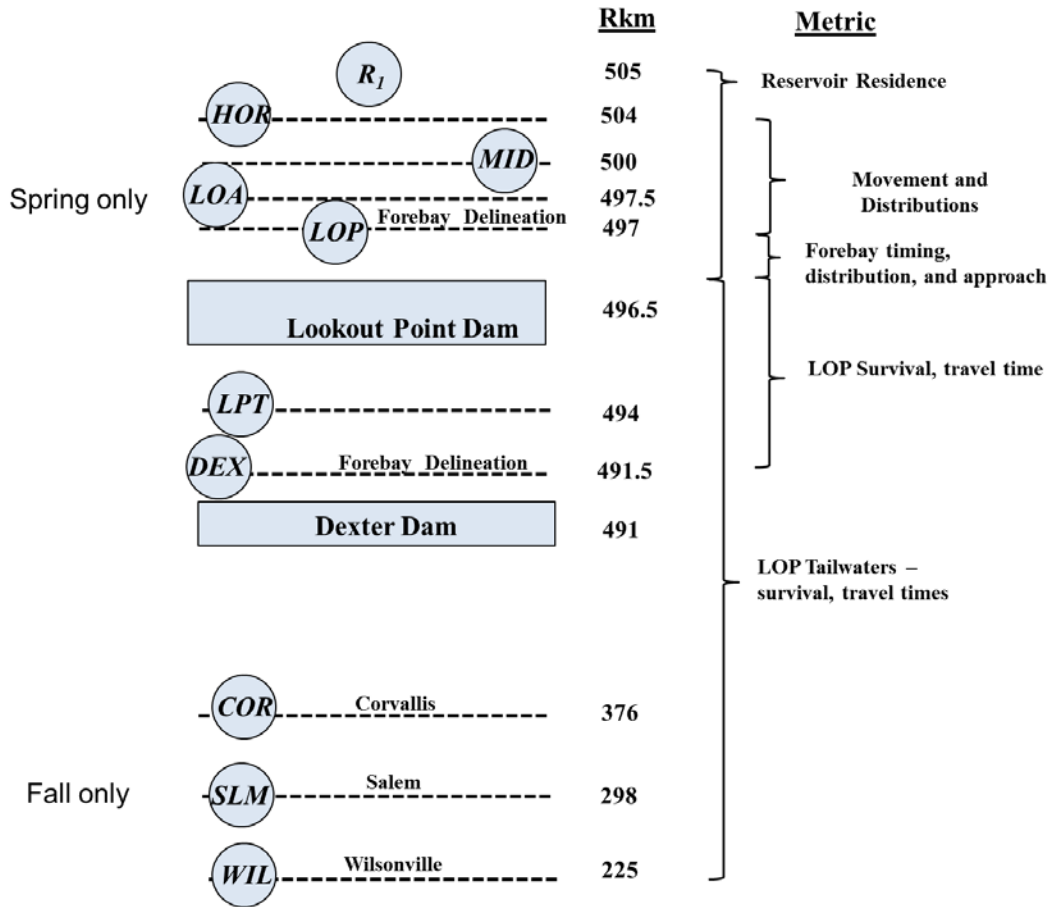
Figure 2.1. Schematic of the Study Design Used to Estimate Project Metrics at Lookout Point. The release (R_1) was tracked at three locations in the Lookout Point reservoir to assess movement and behavior (HOR, MID, LOA [Spring], and LOP) and the LOP array served as the final detection array above Lookout Point. Downstream detection arrays in the Lookout Point reservoir were used to estimate tailrace egress (LPT) and reservoir travel times. Detection arrays in Corvallis (COR), Salem (SLM [Fall]), and Wilsonville (WIL) were used to account for fish moving through the Middle Fork and mainstem Willamette River.

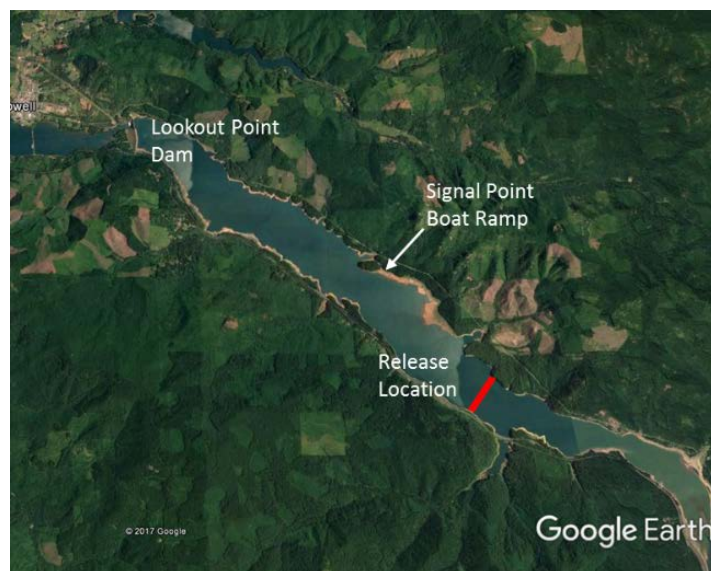
Figure 2.3. Release Location at Lookout Point Reservoir, 9.5 km from the Dam

Upon arriving at the reservoir, fish buckets were transferred to a boat for transport to in-river release locations at each release cross section. Fish were released at one transect upstream of the Signal Point Boat Ramp in the Lookout Point reservoir (Figure 2.3). The transect consisted of three equidistant points. At each release point, all buckets to be released were set apart and the lids were scanned using a Biomark HPR Plus PIT-tag reader, which recorded the global positioning system coordinates and time of release. Just before fish were released in the river, the buckets were opened to check for dead or moribund fish. If dead or moribund fish were observed, they were removed and their PIT codes were noted on the release sheet. All remaining fish were then lowered in the bucket over the side of the boat into the water and allowed to swim out of the bucket into the reservoir.

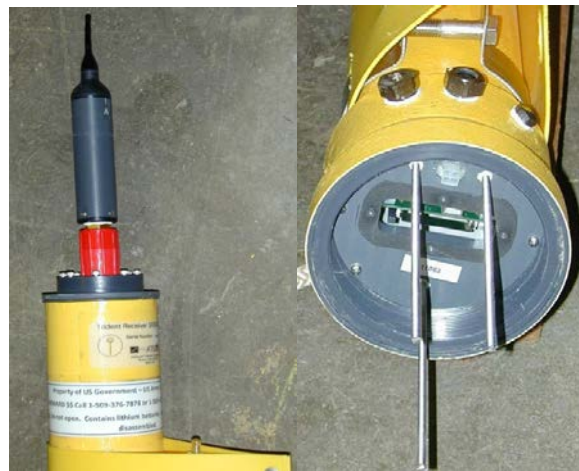
Figure 2.4. Outer (left) and Internal (right) Views of an Autonomous Node

The autonomous receivers used for this study (referred to as an “autonomous node” or “node”), were designed by ATS for detection of acoustic tags in a riverine environment. Each node—an independent, self-contained data-acquisition instrument that may be anchored in the river where necessary—consists of a top section that houses a hydrophone (Sonic Concepts, Inc.), a data processing circuit board, a compact flash card for data storage, an internal battery housing and battery, and USB cable connectors (Figure 2.4). An external beacon (an acoustic tag with a larger battery in a cylindrical housing) and stabilizing fin were attached to the outside of the housing to stabilize the node, shed turbulence, and to maintain positioning of the hydrophone tip toward the water surface. All hydrophones and receivers were calibrated and tested for acceptable detection performance in a specialized anechoic testing tank prior to deployment.

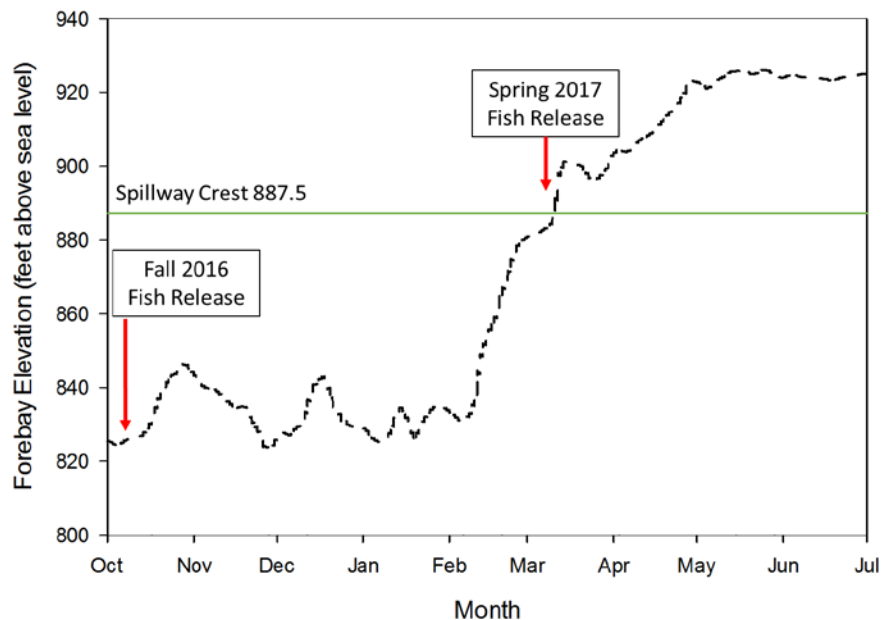
Figure 3.1. Forebay Elevation (msl) during the Study Period (October 2016 through June 2017)

The Lookout Point forebay elevation follows a rule curve managed by the USACE Reservoir Control Center. The rule curve dictates lowering the forebay pool elevation in fall to prepare for storage and flood damage reduction during winter months. Generally, the fall drawdown begins on or after September 1 and refill begins on or around February 1. Any deviations in the timing of refill and drawdown periods are coordinated through the Reservoir Control and local stakeholders.

During spring 2016, warm, dry conditions persisted over much of the Willamette Valley; these conditions did not allow most of the reservoirs in the Willamette Valley to fill to normal summer pool elevations. When the fall drawdown started in September 2016, water levels were already very low. By the time the fish releases occurred in October the Lookout Point reservoir had reached the winter pool elevation of 825 ft (Figure 3.1). The Lookout Point reservoir remained low until the beginning of February, when water levels started to rise. When fish releases occurred in early March the reservoir was filling rapidly. Several large rain and late seasonal snow events in early spring caused the reservoir to fill quicker than anticipated, and efforts to maintain water levels close to the rule curve required several days of additional spill. The Lookout Point reservoir reached summer full pool (926 ft) in early May and was maintained throughout the remainder of the spring study.

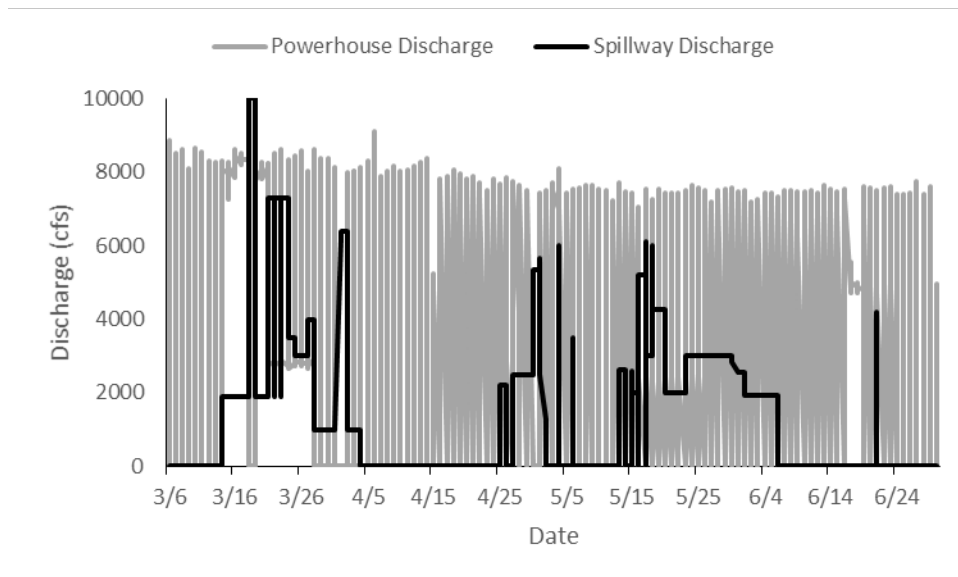
Figure 3.4. Average Hourly Powerhouse Discharge and Average Hourly Spillway Discharge for Each Day of the Spring Study Period (March 7 through June 30, 2017)

Turbine operations at Lookout Point Dam generally vary throughout the year depending on power demand, maintenance schedules, and forebay fluctuations. Turbine operations also vary greatly during a given 24 h period; it is common for power generation to fluctuate on and off daily. During the fall study period, turbine hourly discharge ranged from 0 cfs to a peak of 9,510 cfs in December 2016 (Figure 3.3). During the spring study period several large rain and snow events occurred, which caused the Lookout Point reservoir to fill rapidly and, at times, exceed the rule curve. During these times, powerhouse generation fluctuated with discharge between 0 cfs and a peak in April of 9,100 cfs and at times excess water was also released through the spillway in an effort to maintain approved water levels (Figure 3.4)

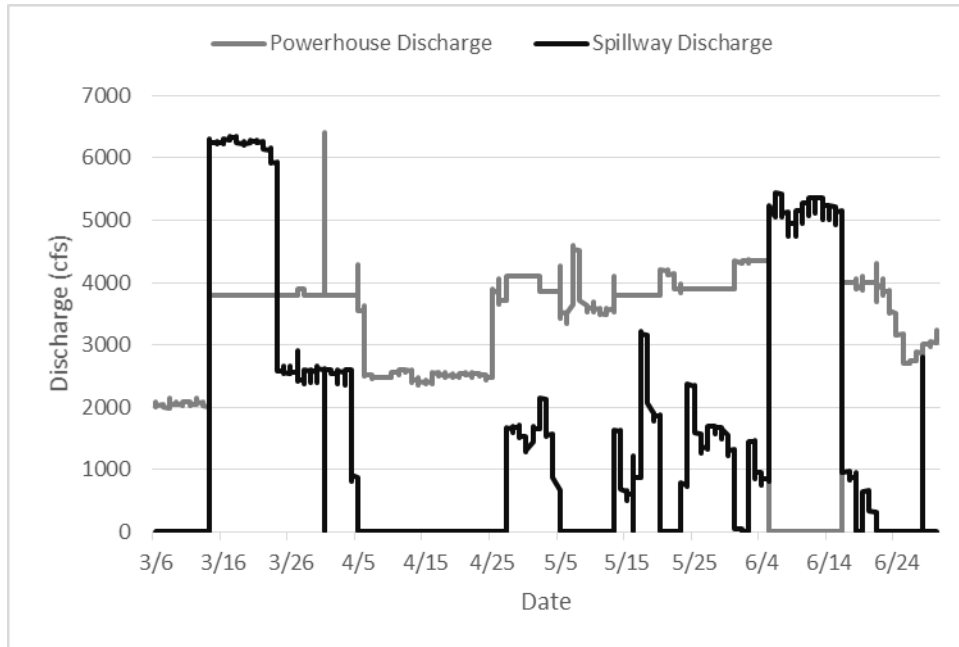
Figure 3.6. Range of Hourly Powerhouse and Spillway Discharge for Each Day of the Spring Study Period (March 7 through June 30, 2017)

Operations at Dexter Dam also varied throughout the year depending on power demand, water availability and maintenance schedules. Unlike Lookout Point Dam, turbine operations at Dexter Dam are more uniform during a given 24 h period. The spillway at Dexter was also used at sporadic times to pass excess water downstream. During the fall study period, turbine hourly discharge ranged from 0 cfs to a peak of 4,400 cfs in December 2016 with spillway discharge ranging from 0 cfs to a peak of 5,970 in December 2016 (Figure 3-5). During the spring study period, as noted above, several large rain and snow events occurred, which caused excess water to be passed through both Lookout Point and Dexter Dams. During these times at Dexter Dam, powerhouse generation fluctuated with discharge between 0 cfs and a peak in April of 6,400 cfs and at times excess water was also released through the spillway in an effort to maintain appropriate forebay elevation (Figure 3.6).

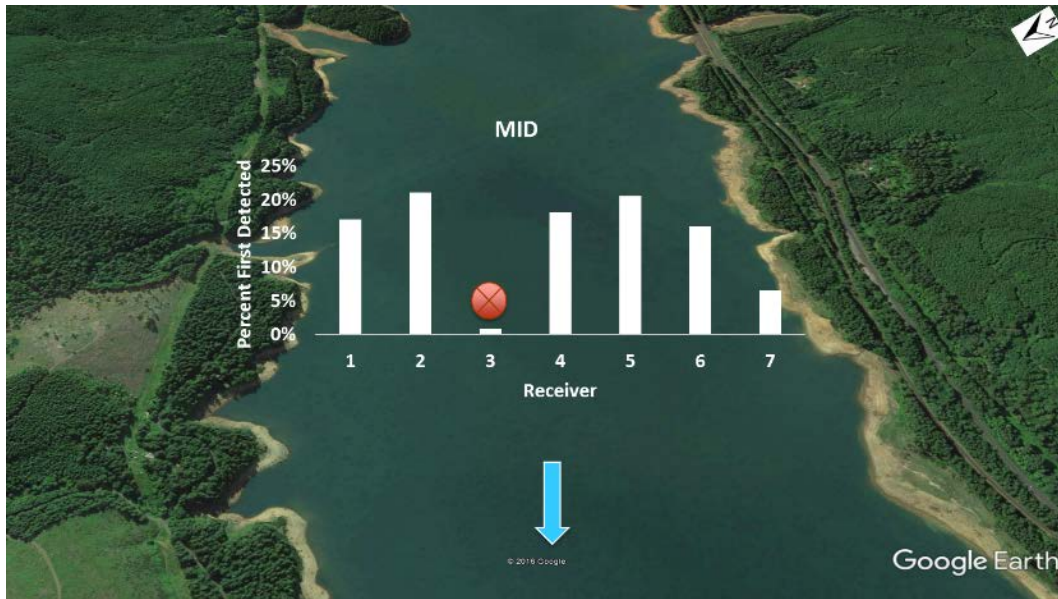
Figure 4.4. MID Horizontal Distribution by Receiver Using the First Detection of CH0 Passing by Array (blue arrow represents river flow direction, red dot indicates malfunctioning receiver)

At the MID array, fish were evenly distributed across most of the array and receivers 1, 2, 4, 5, and 6 each had between 15% and 20% of the fish detected (Figure 4.4). Receiver 7, located on the southern bank, had the lowest percentage of first detections (8%) and receiver 3 malfunctioned during the early part of the study and did not collect data.

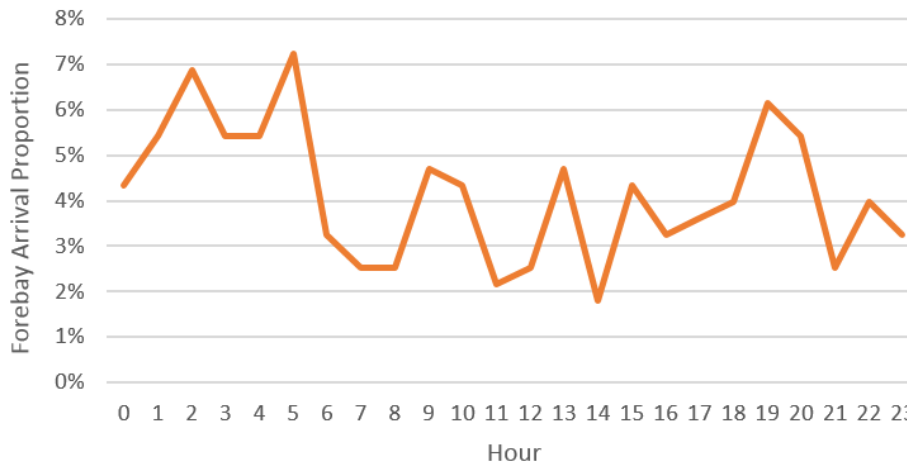
Figure 4.6. Diel Arrival Distributions of First Detection of CH0 at the LOP Forebay Array in Fall 2016

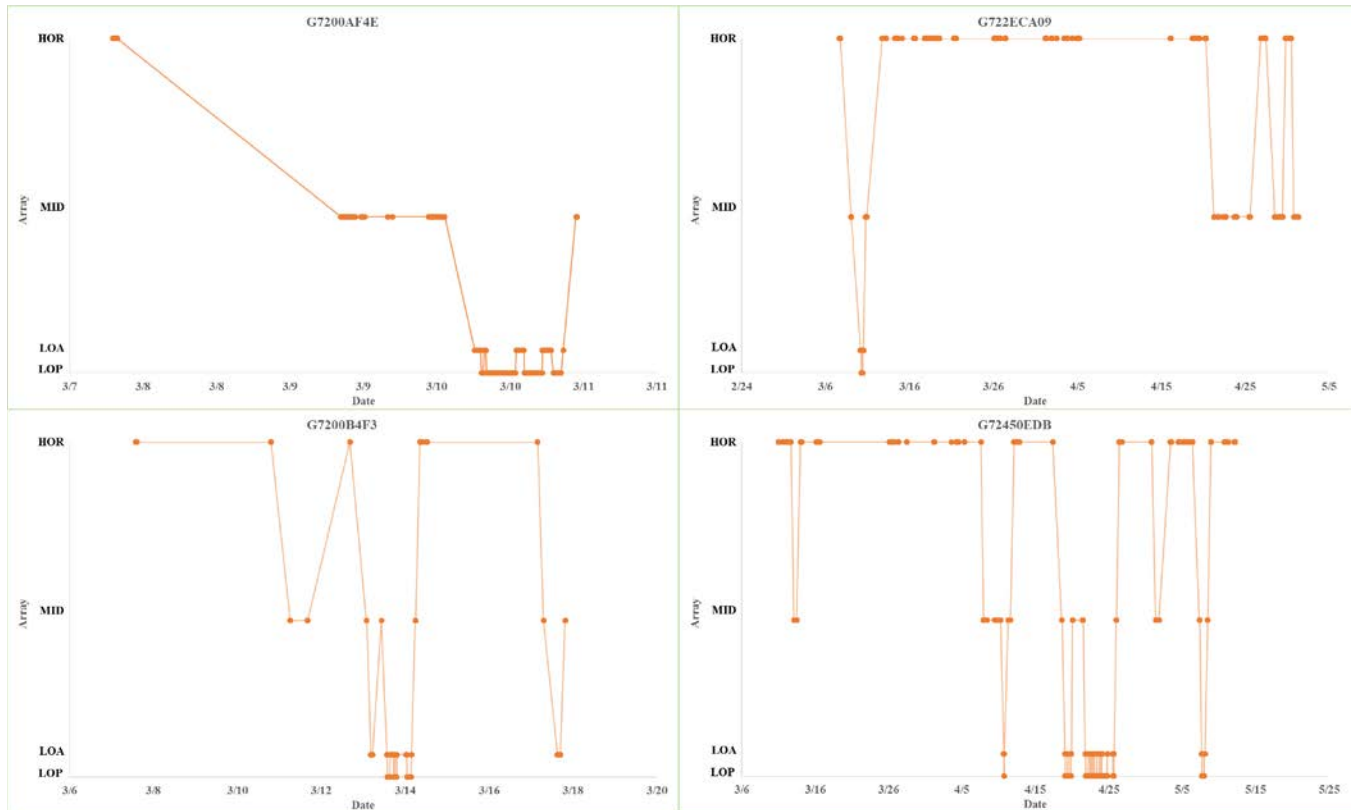
Figure 5.2. Movement of Randomly Selected Study Fish Within the Lookout Point Reservoir during Spring 2017
