PNNL-27419

April 2018

Evaluation of Crystal Accumulation in High-Level Waste Glasses with Research-Scale Melter

Pacific Northwest National Laboratory
Richland, Washington 99352

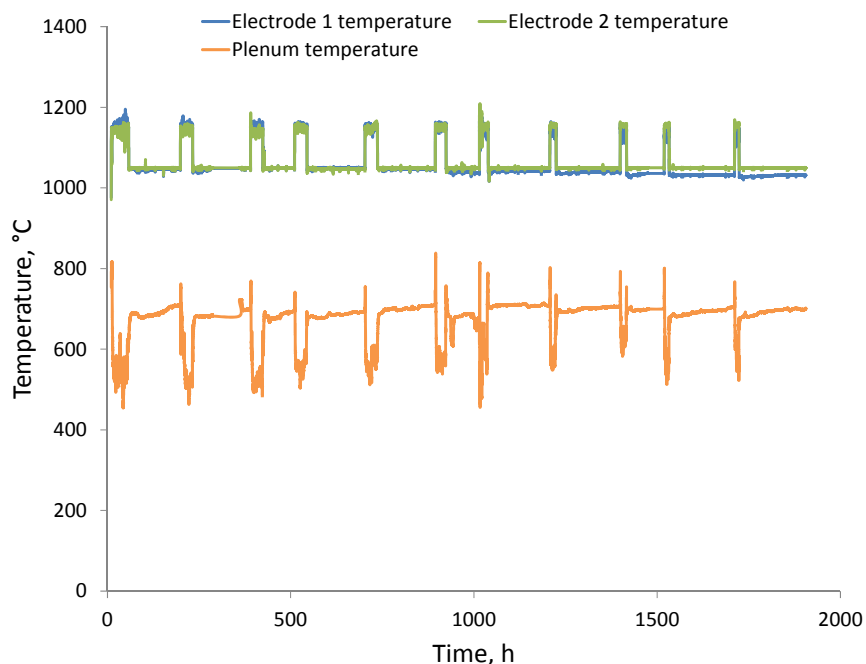
The temperatures of the glass pool were relatively stable, with a standard deviation of less than 10.3 °C from the target of 1150 °C over the course of feeding/pouring. The temperature of the thermocouple adjacent to the bubbler was generally lower. This difference was attributed to the cooling effect of air bubbles. The plenum temperature ranged from 515 to 622 °C during steady-state operation, which was within the targeted temperature range of 500 to 700 °C. The maximum steady-state feed rate was 2.6 kg/h and occurred during the 10th feeding/pouring cycle. The average feed rate was 1.76 kg/h. The feed rate was regularly adjusted to maintain cold-cap coverage of 85 to 95%. The temperatures of the melt at each electrode and plenum temperatures were recorded throughout the duration of the test and are shown in Figure 5.1. Higher plenum temperatures occurred during idling periods due to the absence of feed charging into the melter. The temperature spike of 1210 °C observed during 7th feeding/pouring period

was the result of two overfeeding incidents (discussed in Section 5.2) when the thermocouples were no longer immersed in molten glass and the DAC system was trying to maintain the temperature of the glass pool at 1150 °C.

Figure 5.1. Temperature History for the Bulk of the Melter (Electrodes 1 and 2) and Plenum Space

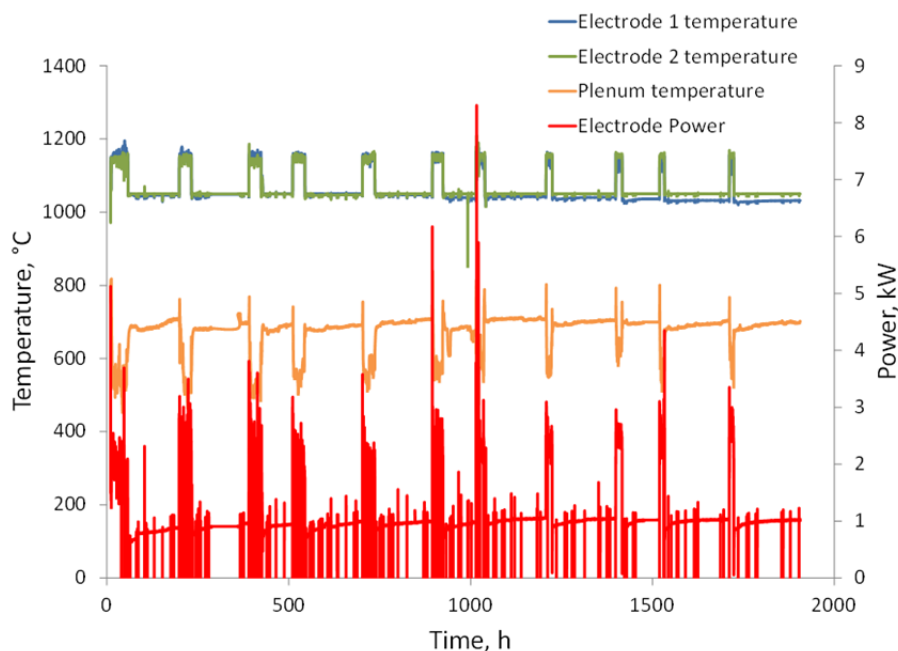
Figure 5.4. RSM Power Profile and Temperature History for the Bulk of the Melter (Electrodes 1 and 2) and Plenum Space

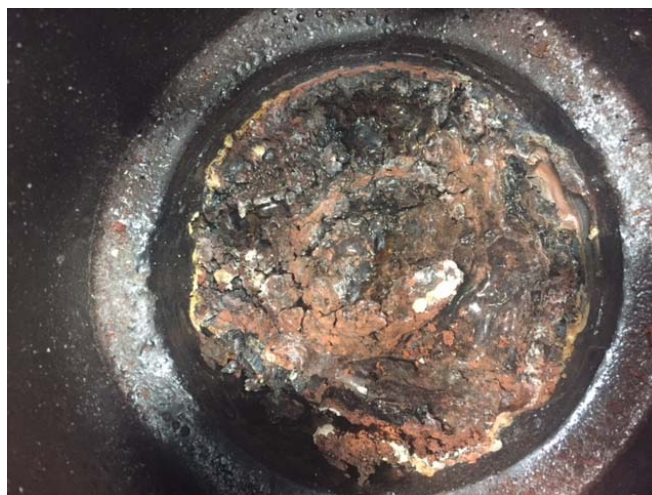
Figure 5.9 and Figure 5.10 show melter electrodes after the test. The electrodes were discolored but did not show signs of heavy corrosion. However, there was some oxidation and evidence of small pits on the surface. The Inconel 690 bubbler (replaced at the end of the fifth feeding/pouring cycle) showed no sign of corrosion or structural damage. Figure 5.11 and Figure 5.12 show the top and bottom of the lid of the RSM, respectively. Figure 5.12 also shows the location of each melter component within the lid area for reference. Inspection of the lid revealed a significant amount of material adhered to its underside. The deposits appeared to be sintered feed and glass from back-splash during feeding. Also included were deposits that originate from volatilization of components such as Na and B during idling periods. Figure 5.13 shows the top of the melt after quenching.

Figure 5.13. Top View of Melt Pool after Quenching (After Completion of the Test)

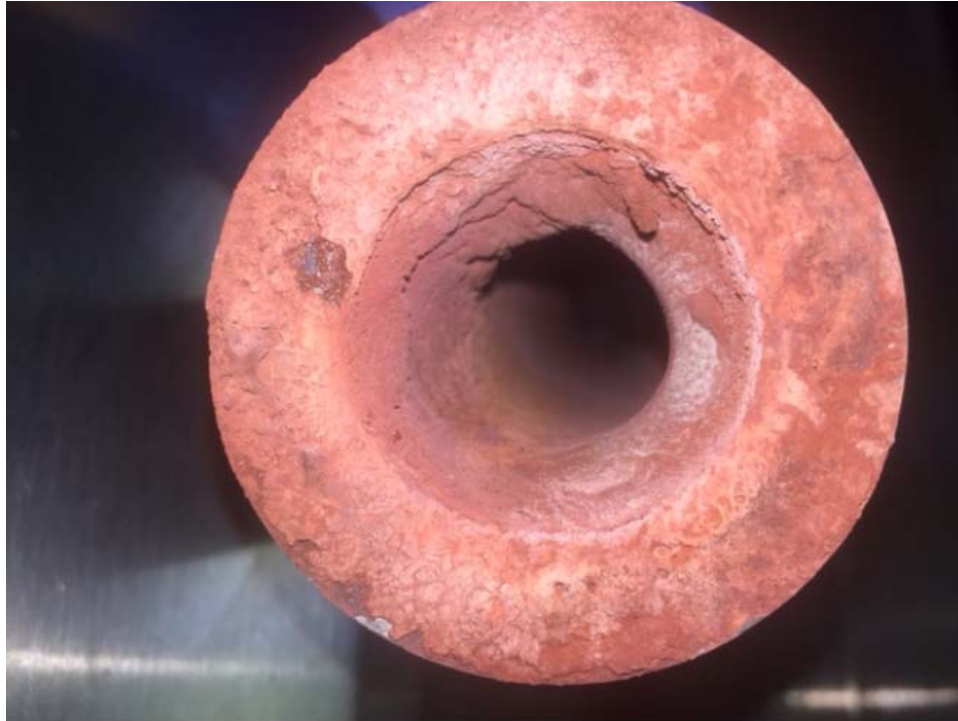
Figure 5.15. Off-Gas Deposits in the Film Cooler

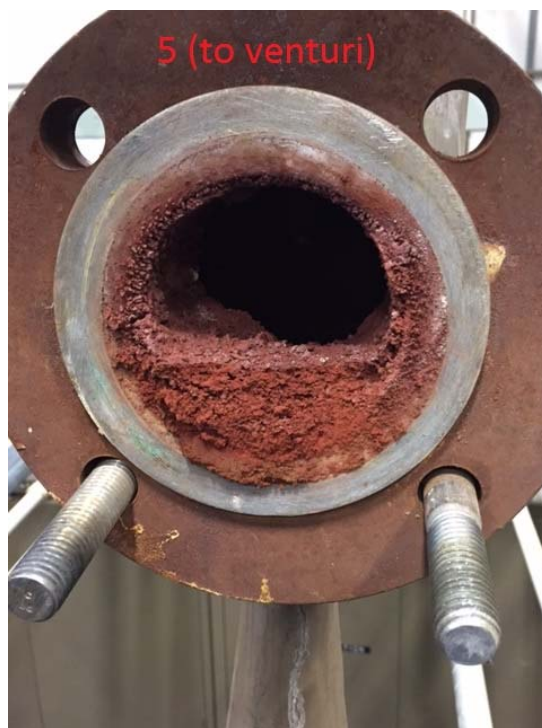
Figure 5.17. Off-Gas Deposits at the Entrance to the Ejector Venturi Scrubber (EVS) System

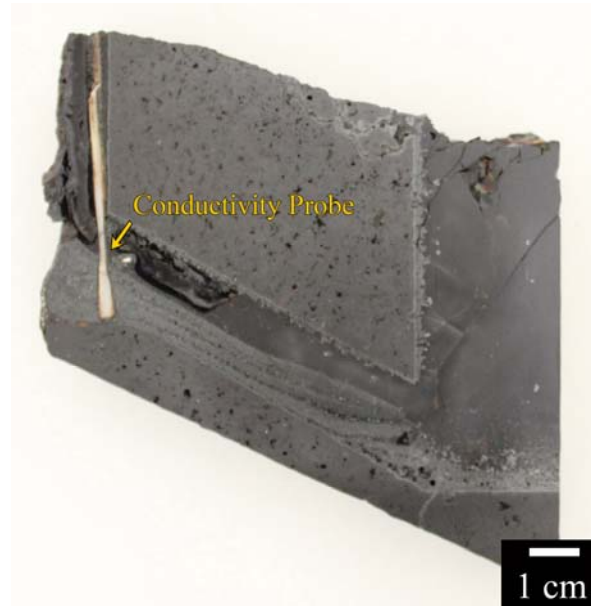
Figure 5.21 shows the location of the conductivity probe along with the accumulated layer of spinel crystals. Both electrodes of the probe were buried in the accumulated spinel layer. Blockage of the riser was not achieved by the end of this test. However, two large pour events likely removed most, if not all, deposits accumulated over the period of seven idlings. Therefore, it is important to acknowledge that more than half of the riser opening was blocked by the accumulated layer of spinel crystals and that a thick layer formed in the bulk of the melter after just four idlings.

Figure 5.21. Polished Cross Section of the Other Half of the RSM Glass-Discharge Riser Section
