Research Technology Laboratory (RTL) Disposition Program Final Status Survey Report

S740277-RPT-05

April 2019

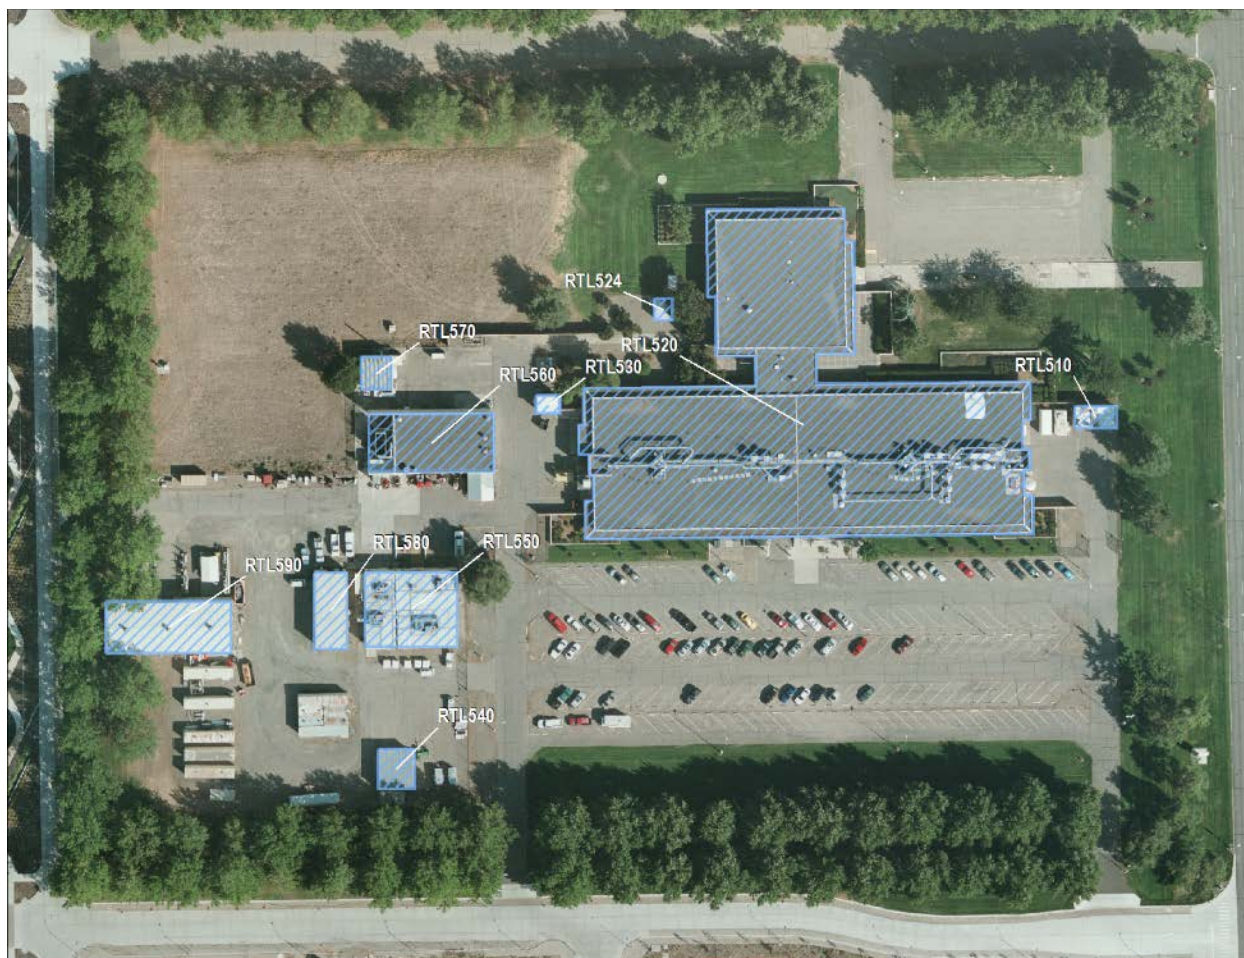
Figure 3. Layout of the RTL Complex prior to demolition

The BMI-owned RTL Complex property and the facility's spatial relationship to the rest of the PNNL campus are outlined in pink in Figure 2. Prior to demolition, the RTL Complex was composed of 10 buildings (510, 520, 524, 530, 540, 550, 560, 570, 580, and 590) on the 15.2-acre property. In addition to buildings, there was a tank vault (along the northwest wing of RTL 520), underground piping (asbestos pipe, hot/chilled water pipeline chase way, and sewer line), parking lots, and open areas. Figure 3 shows the locations of the buildings in the RTL complex prior to demolition.

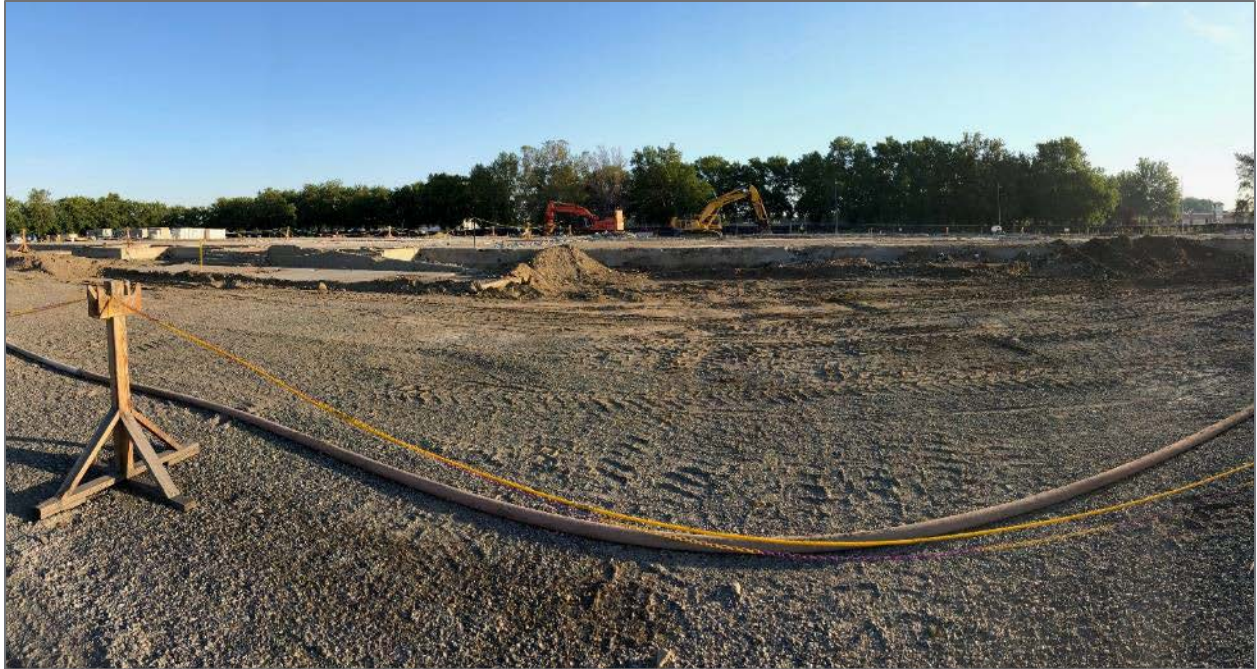
Figure 4. Above-grade demolition of RTL Complex structures was completed in July 2018

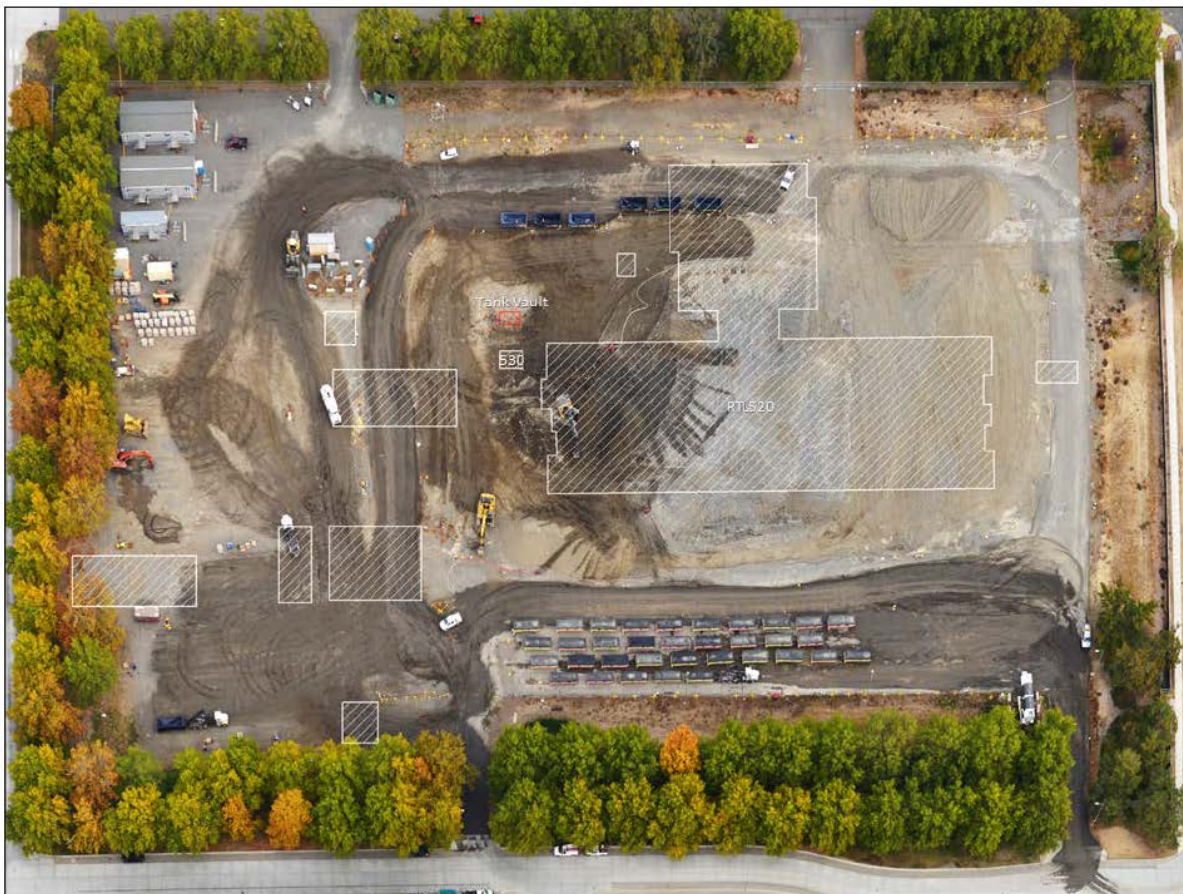
Figure 5. Subsurface remediation was completed in October 2018

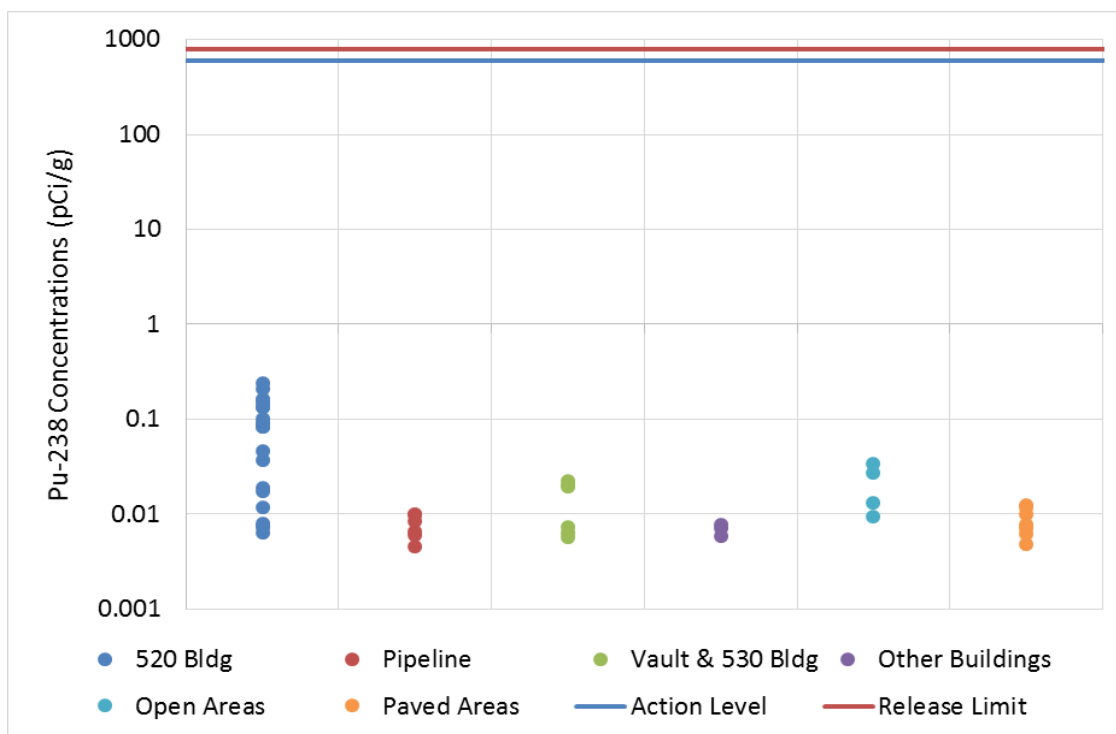
Figure 9. Lognormal plot of plutonium-238 concentrations by survey unit shown in relation to the action level (600 pCi/g) and release limit (800 pCi/g)

Results for each radiological COPC from both random and specific judgmental locations were plotted by survey unit to illustrate the range of concentrations observed relative to the release limits and action levels. A lognormal axis was used to show the range of concentrations that were orders of magnitude (10 to 1000 times) lower than the release limits and action levels. Due to the use of the lognormal scale, only the positive non-zero values are presented in Figure 9 through Figure 15. These figures indicate that the reported concentrations are orders of magnitude below the release limits and similar concentrations are observed across each of the survey units.

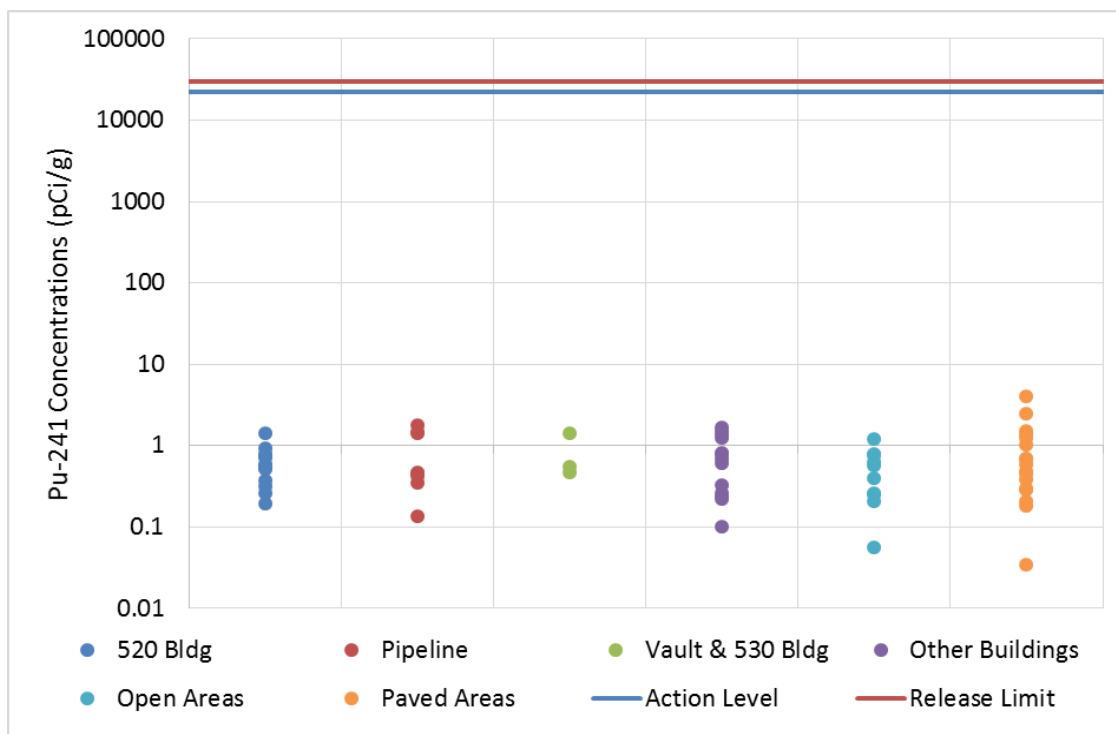
Figure 11. Lognormal plot of plutonium-241 concentrations by survey unit shown in relation to the action level (22,500 pCi/g) and release limit (30,000 pCi/g)

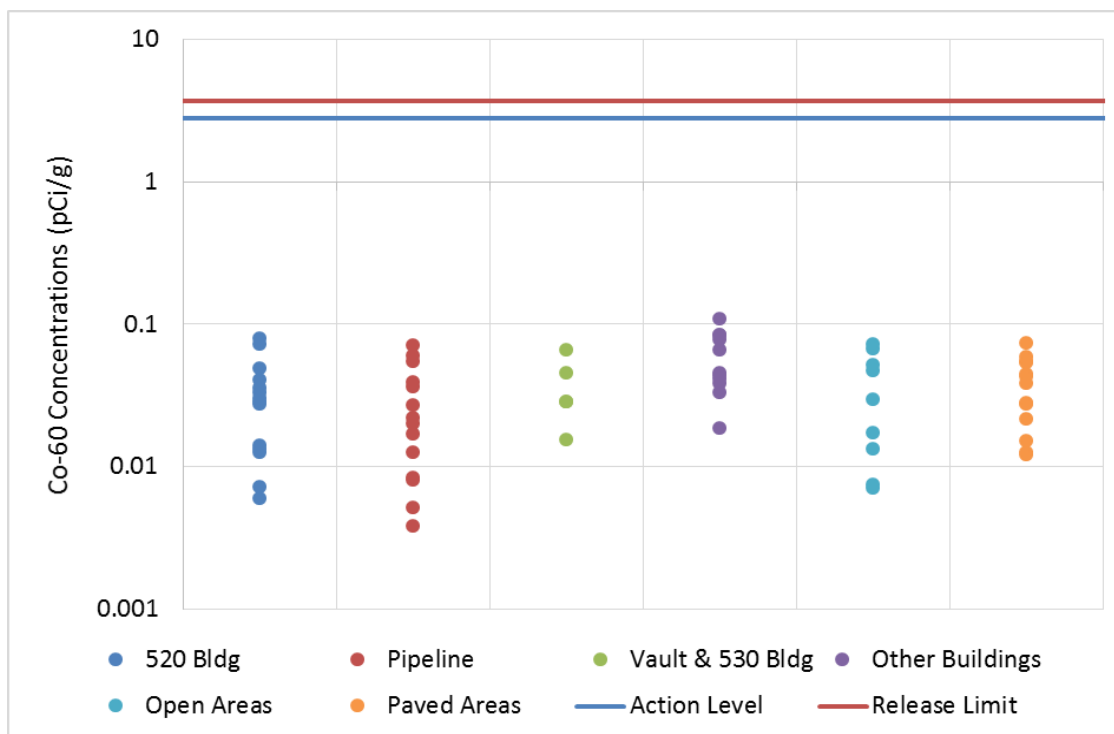
Figure 15. Lognormal plot of cobalt-60 concentrations by survey unit shown in relation to the action level (2.8 pCi/g) and release limit (3.7 pCi/g)

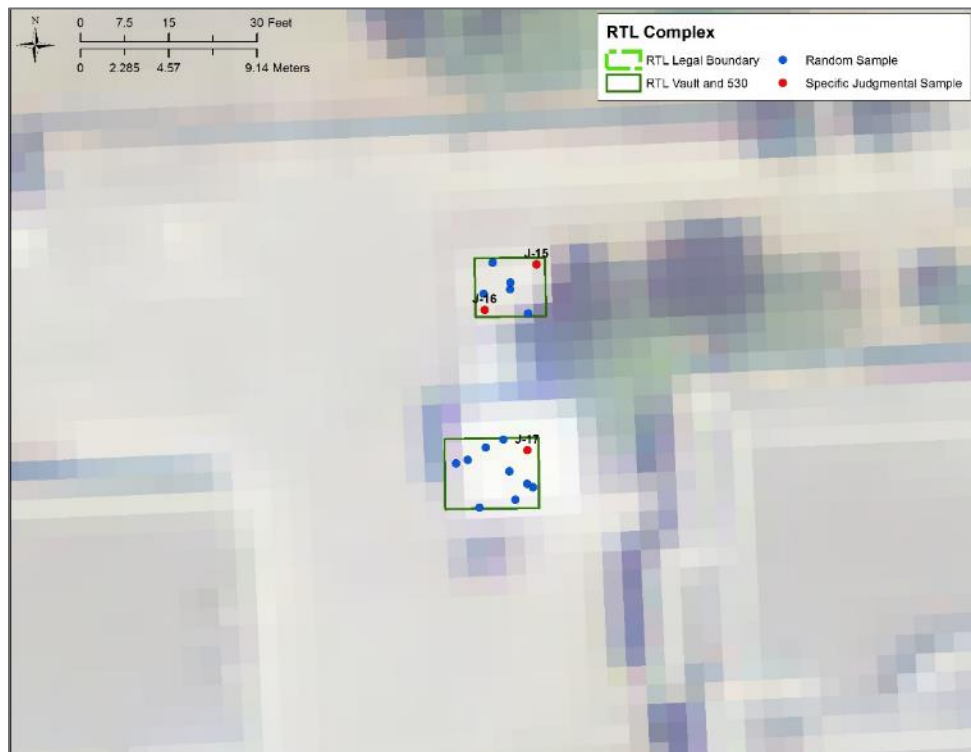
Figure A.5. RTL tank vault and 530 footprint with random and specific judgmental sample locations
