PNNL-29113

Baseline Evaluation of Eddy Current Testing for PWSCC Susceptible Materials

Technical Letter Report

September 2019

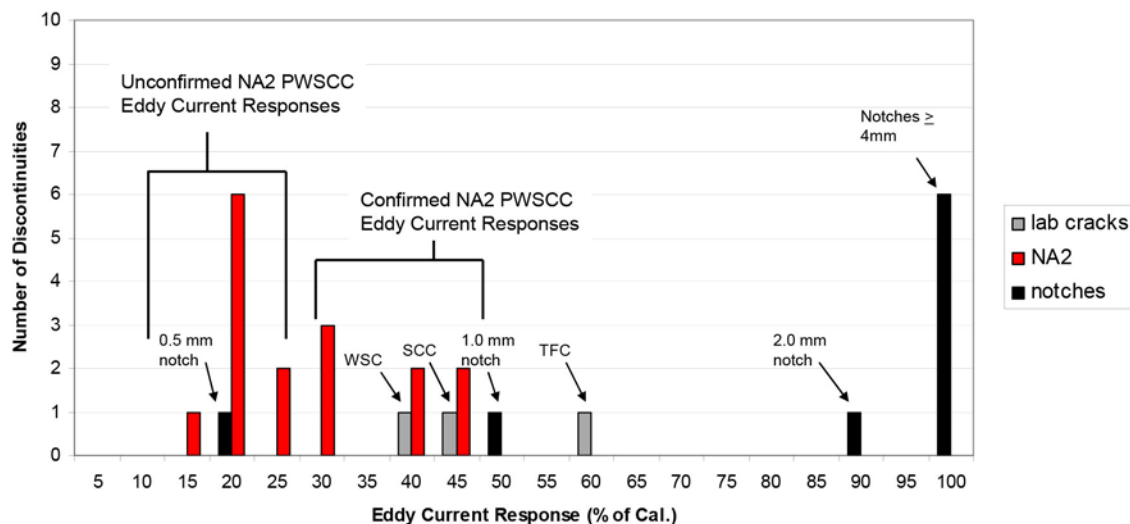
Figure 2.1. Number and Amplitude of Non-relevant Indications (unconfirmed by DT), Actual PWSCC, and Laboratory-Produced Cracks as Compared to Various Notch Sizes. All the confirmed PWSCC responses exceed the response from the ASME Code-specified calibration notch depth (0.5 mm; 0.020 in).

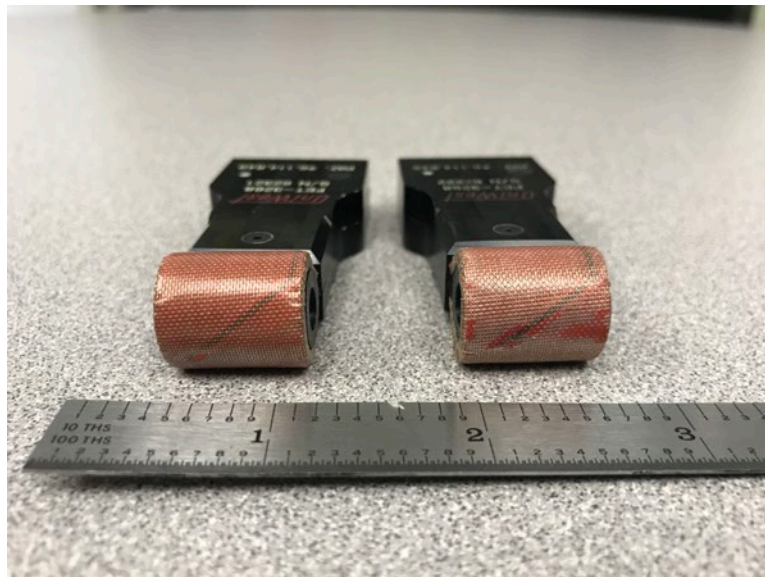
Figure 4.1. Flex Probes with Coils Wound in Helical Direction

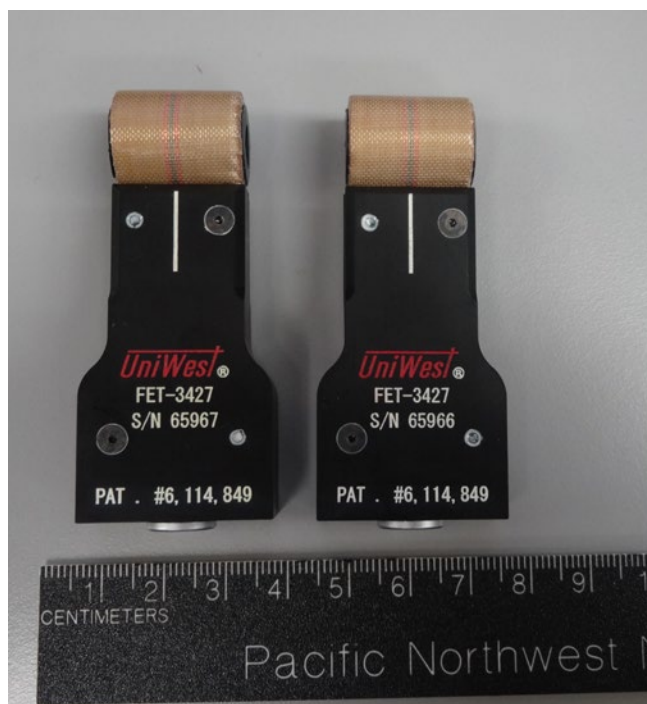
Figure 4.2. Flex Probe with Coils Wound in the Circumferential Direction

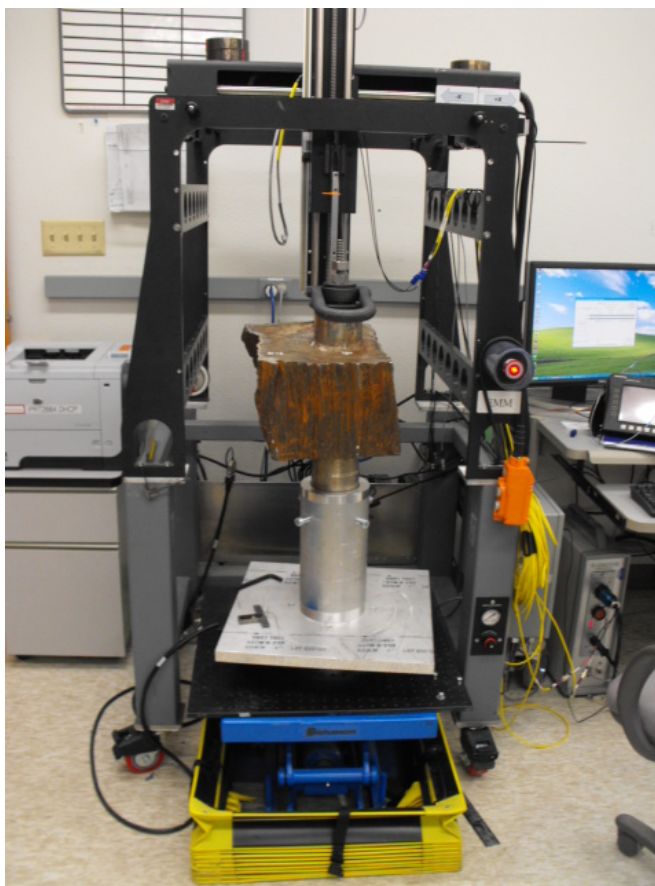
Figure 4.4. Translation Stage Capable of Motion in Four Axes (X, Y, Z, rotation) Used for Examining Specimens in this Study

A four-axis scanner was used to acquire data throughout this study. The scanner is capable of encoded motion in X, Y, Z, and θ directions. Motion in the X, Y, and Z directions is achieved with three linear rails, and motion in the θ axis is achieved by a rotation table mounted to a hydraulic scissor lift at the bottom of the scanner structure. This configuration was used primarily for examination of the CRDM specimens as shown in Figure 4.4 where the CRDM nozzle is mounted to the rotation table and rotated to provide indexing for fillet weld examinations.

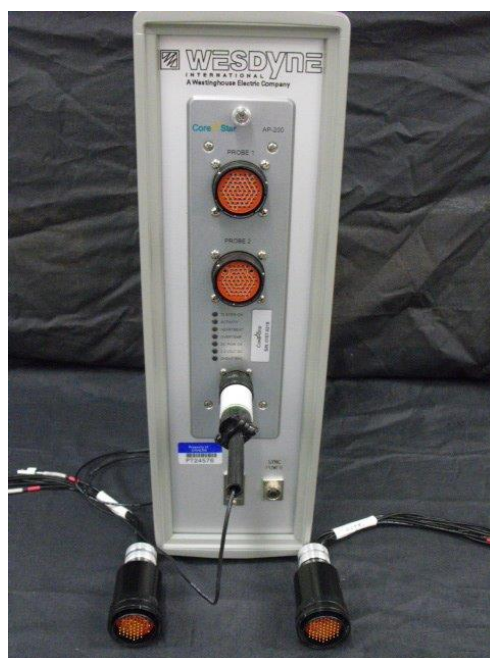
Figure 4.6. WesDyne IntraSpect Eddy Current Examination System

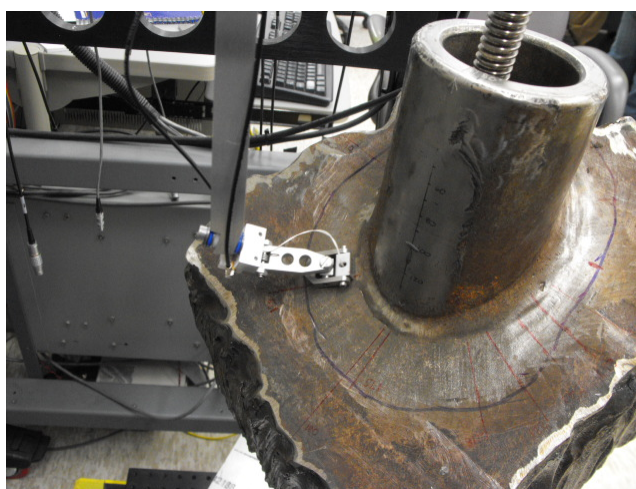
Figure 4.7. Photo Showing CRDM Nozzle Examination Region from the Edge of Cladding, Indicated by Black Line, up to the J-groove Weld

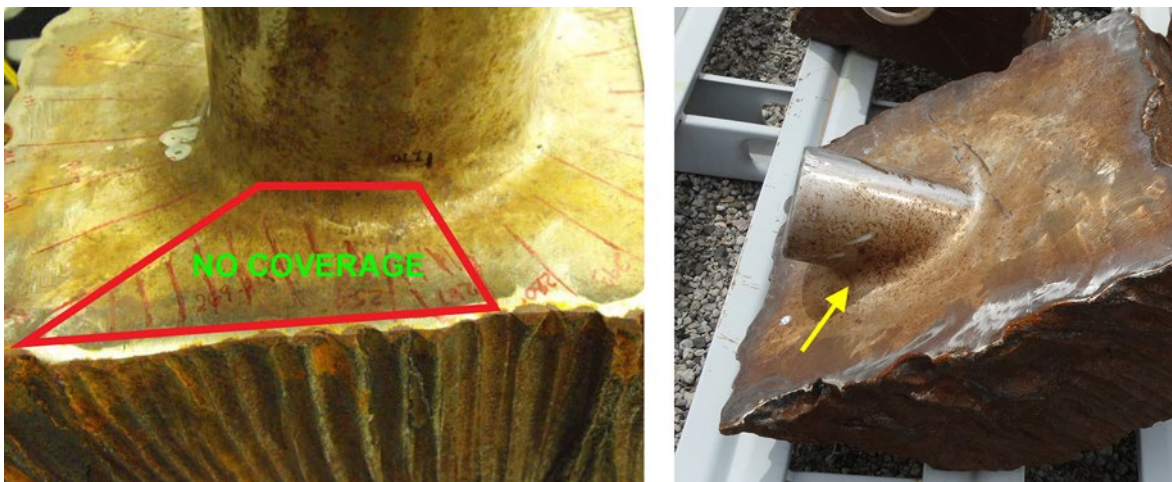
Figure 4.9. Example of Regions with Limited or No Examination Access Due to the Curvature of the Inside Surface of the RPV Head that Occurs Downhill from the Top-Center of the RPV Head

Because of the use of a scanner with primary motion in Cartesian axes and the large tilt of the RPV head material relative to the CRDM nozzles, select portions of the J-groove weld and RPV material were precluded from examinations. An example of a region where no coverage was achieved is provided in Figure 4.9. Examination of these regions requires either manual hand scanning or a specialized scanning apparatus capable of accounting for the tilt of the RPV head and maintaining proper probe compliance with the examination surface.

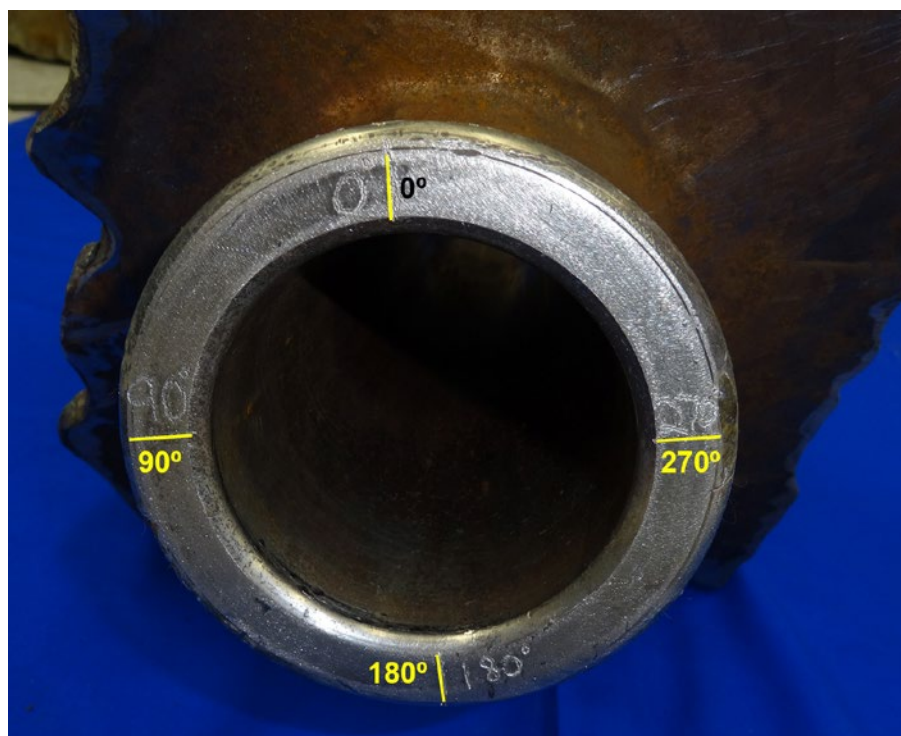
Figure 4.11. View of Azimuthal Coordinate System of Inside Surface of the RPV Head (“wetted” side) for a CRDM Penetration-Nozzle Assembly Mockup

For consistent measurements and testing, a coordinate system was generated and physically marked (etched) on each CRDM penetration-nozzle assembly mockup. This consists of a 0° mark at the lowest absolute angle on the wetted side of the mockup. In other words, the 0° mark is at the $\angle a$ of the CRDM mockup on the “downhill” side. From the zero point, the coordinate system increases in angle in the counter-clockwise direction, with marks at 90° , 180° (at the $\angle b$ location), and 270° . Figure 4.11 illustrates the azimuthal coordinate system on these mockups.

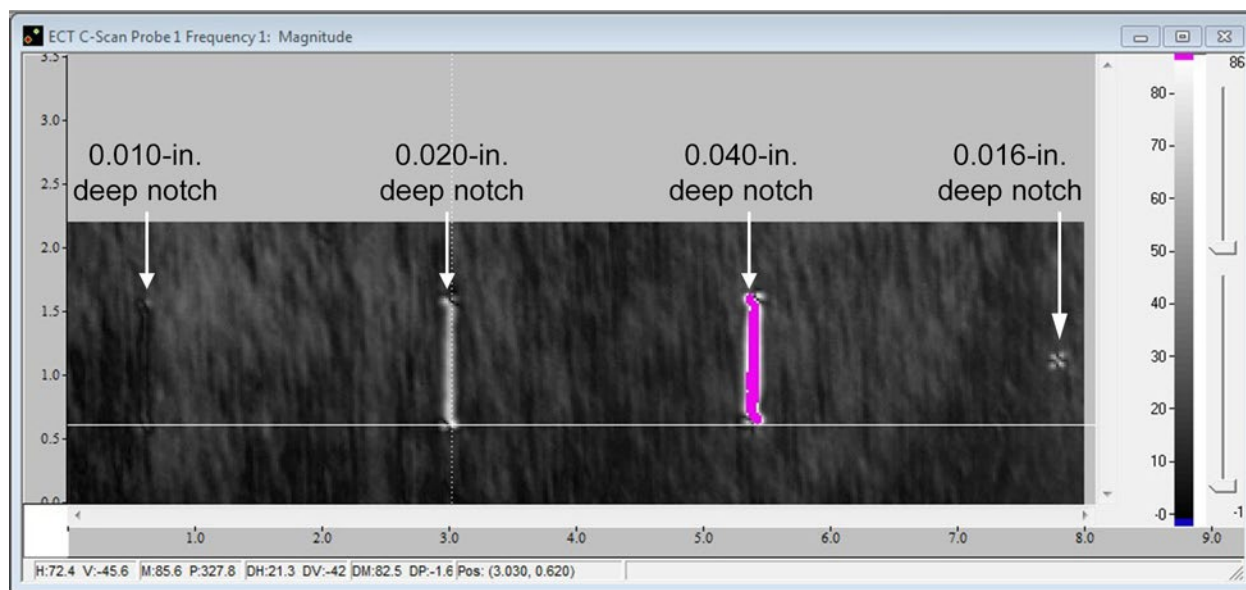
Figure 5.1. Magnitude ET Response of the Inconel 600 Calibration Plate Collected at 400 kHz

The calibration scan of the Inconel 600 plate with the Grooveman probe ensured that the system had adequate sensitivity. A magnitude plot of the calibration plate response at 400 kHz is provided in Figure 5.1. The magnitude plot is in the same orientation as the design drawing provided earlier in Figure 4.12 where the notches from left to right have depths of 0.25 mm (0.010 in.), 0.5 mm (0.020 in.), 1.02 mm (0.040 in.), and 0.41 mm (0.016 in.). In this figure, the cursors are placed on the peak response of the 0.5 mm (0.020 in.) deep notch, the amplitude window is set to match the maximum response of the 0.5 mm (0.020 in.) notch, and responses greater than the threshold are colored pink. The 0.5 mm (0.020 in.) deep notch had a maximum response of 86 eddy current units (ECU). Eddy current units are used in the WesDyne analysis software in reference to signal amplitudes. A signal response in ECU is, by itself, a relative quantity, and is only useful when compared to a known response such as a notch or in reference to background noise. A representative sampling of the background noise was measured to have a mean response of 28 ECU, ensuring the signal-to-noise ratio of the acquired data met ASME requirements.

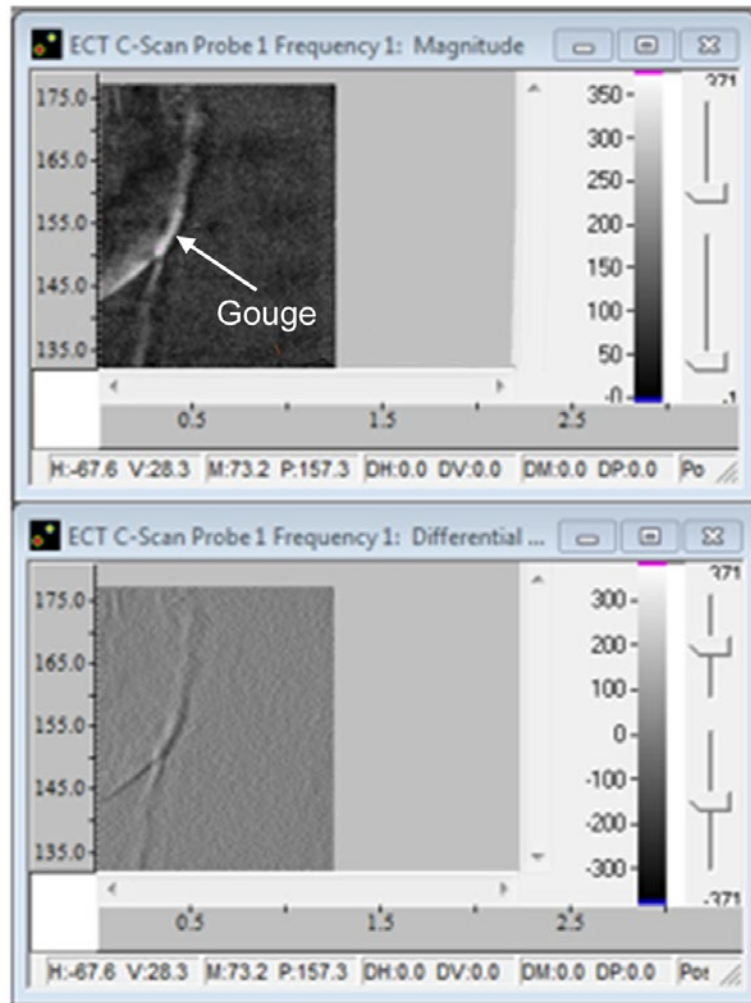
Figure 5.6. Example of Surface Gouge Response from Examination of Sample #6 Between 132° and 177°

Sample #6 examination between 132° and 177°. An example of a weld slag response acquired on Sample #9 between 199° and 220° is provided in Figure 5.7.

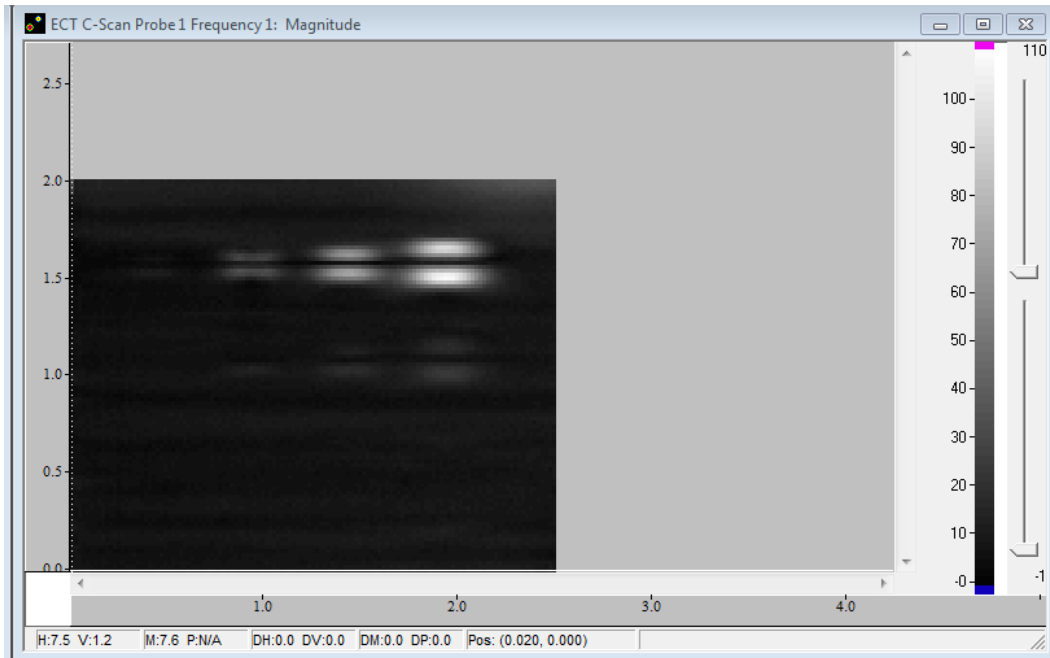
Figure 5.10. C-scan Magnitude Image of the Bottom-Drilled Hole Plate Acquired at 400 kHz Using the Optimized Flex Probe Design

Preliminary data on the bottom-drilled hole standard plate was acquired with the optimized flex probe (FET-3427). A magnitude C-scan image acquired at 400 kHz using the updated flex probe is shown in Figure 5.10. An analysis of detection capability was performed that compared two of the flex probes featuring the optimized design. A summary of these examinations is provided in Table 5.3. The results are presented by row as the depth ranges here from row A to D, and the results show the non-detection of row D. The design drawing of the plate is provided in Figure 4.15 for reference. As expected, the performance of each probe was very similar and only small differences in absolute amplitude were noted. The optimized flex probe performed on par with the Grooveman probe and struggled with the same challenges as the Grooveman probe where the targets in the plate lacked linear features making them more difficult to detect.

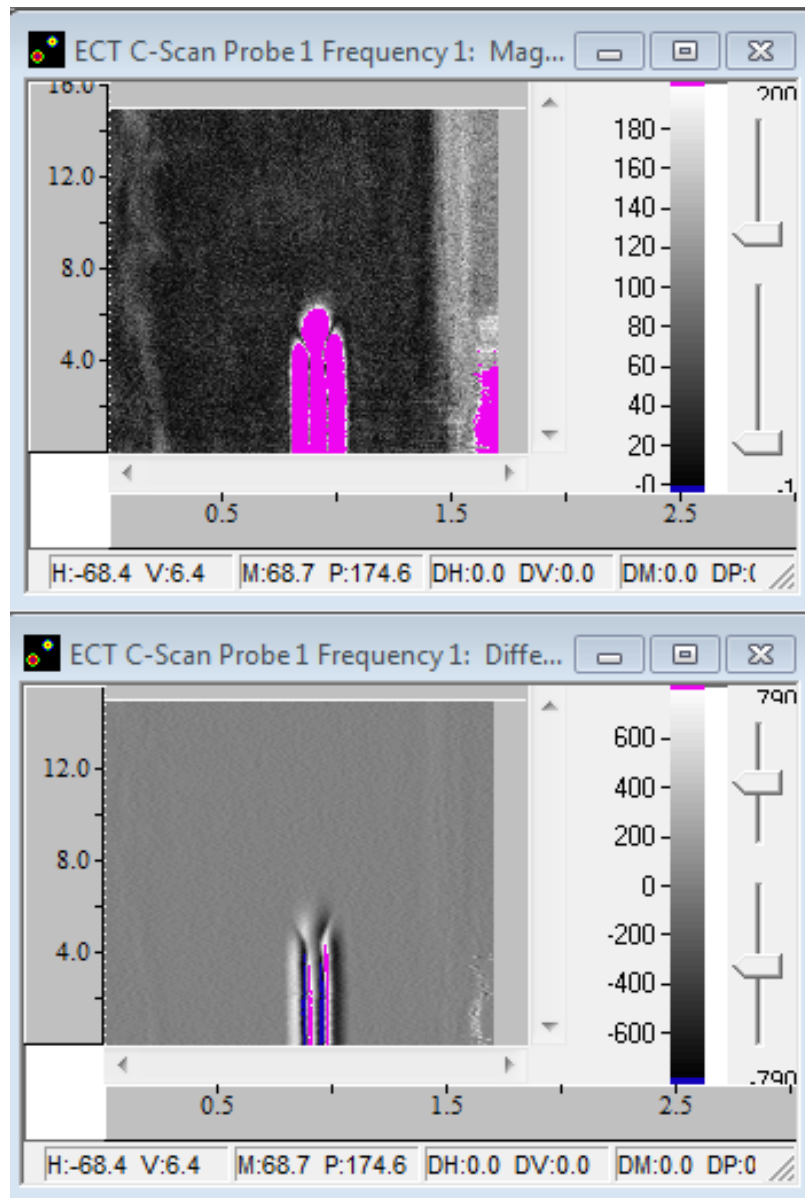
Figure 5.14. CRDM Sample #12 Examination Between 345°–360° where Copper Strip was Applied to the Surface Parallel to the Weld to Represent a Notch Response

The final portion of the copper-strip work conducted to date involved placing a copper strip parallel to the J-groove weld such that it was partially in the examination region for the 345°–360° scan. The response from this copper strip is clearly evident in the data as shown in Figure 5.14. The copper-strip response was much larger than the notch response from the Inconel notch plate indicating that further refinement of the notch geometry is necessary to better approximate the notch response. The effort to simulate notch responses using copper strips is inconclusive at this point because this portion of the effort was not completed. The flex probe designs have shown very promising results, and further investigation is required to conclusively determine the detection capabilities of the optimized flex probe near the challenging geometry of the J-groove weld.
