Spent Crystalline Silicotitanate Storage Study—Post AP-105DF Processing

January 2021

SK Fiskum
AM Westesen
RA Peterson

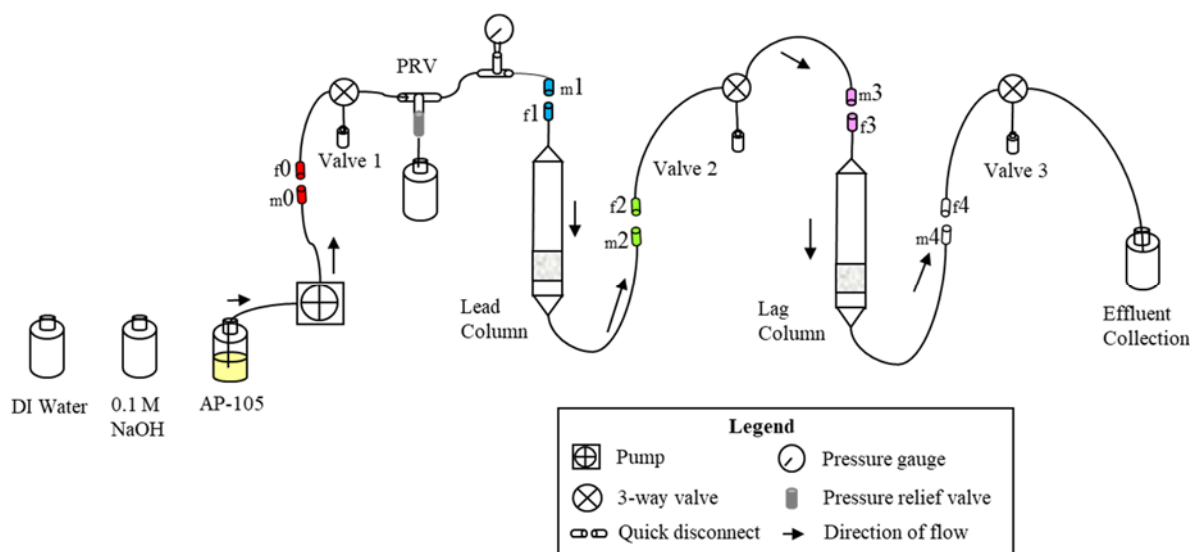
Figure 3.1. Ion Exchange System Schematic

Two duplicate ion exchange systems were constructed and were designated System A and System B. Figure 3.1 provides a schematic of the ion exchange process systems; the two systems were set up similarly to those used for simulant testing (Fiskum and Peterson 2020). Flow through each system was controlled with a Fluid Metering Inc. positive displacement pump. Fluid was pumped past an Ashcroft pressure gage and a Swagelok pressure relief valve with a 10-psi trigger point. The 1/8-inch outside diameter, 1/16-inch inside diameter, polyethylene tubing was purchased from Polyconn (Plymouth, MN). The 1/8-inch outside diameter, 1/16-inch inside diameter, stainless steel tubing was hard plumbed to the manifold structure. Valved quick disconnects were purchased from Cole Parmer (Vernon Hills, IL). Use of the quick disconnects enabled easy column and solution flow realignment. The quick disconnects were color-coded to ease correct alignment.

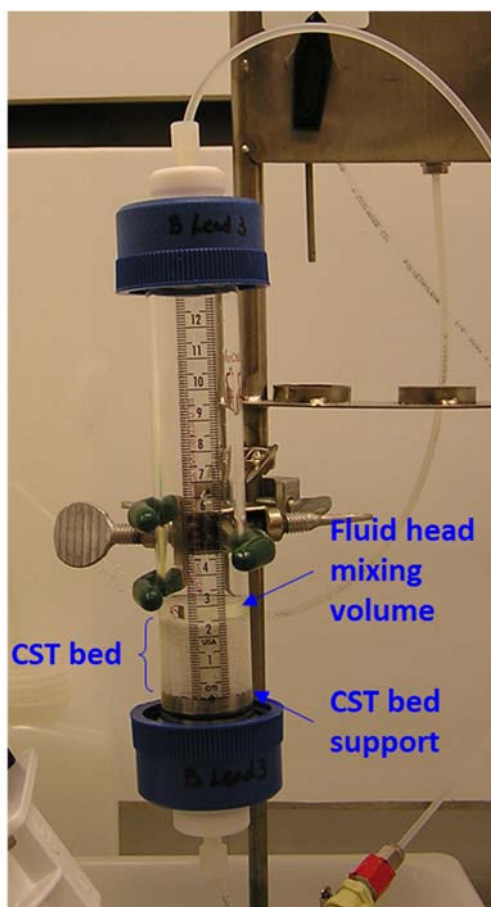
Figure 3.2. Closeup of Loaded System B Column 3

The system was filled with water and then slightly pressurized to confirm system leak tightness. The pressure relief valve was confirmed to trigger at the manufacturer set point (10 psig). Water was removed from the columns and replaced with 0.1 M NaOH. Four 12-mL aliquots of CST were measured using a 25-mL graduated cylinder and quantitatively transferred to each of four columns. The CST was allowed to settle through the 0.1 M NaOH solution, thus mitigating gas bubble entrainment. The columns were tapped with a rubber bung until the CST height no longer changed. Figure 3.2 provides a closeup image of the System B lead column just after processing was completed; it shows the CST bed, the fluid headspace, and the CST bed support.

The CST BV corresponded to the settled CST media volume as measured in the graduated cylinder prior to transferring the media into the ion exchange column. The reference CST BV was 12.0 mL. The settled CST bed heights in the columns were 2.5 cm. With a column inner diameter of 2.54 cm, this corresponded to a length/diameter ratio of 0.98.

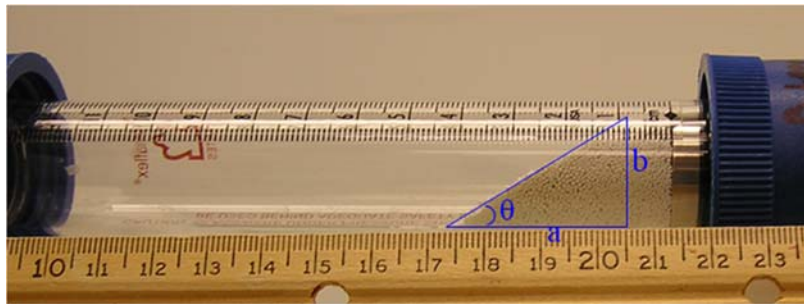
Figure 3.3. Column 3 Angle of Repose Measure

The angle of repose for CST was measured for each column after rotating the columns 90° onto their sides and allowing the CST beads to spread naturally. Images were collected such that the angle of repose could be calculated as shown in Figure 3.3. In this case, a right triangle was superimposed over the image to match the shape of the slumped CST. The length (a) and height (b) of the right triangle were measured and the angle, θ , was calculated according to standard geometric functions. The furthest longitudinal distance a CST particle traveled was also noted. After testing, the columns were gently turned upright.

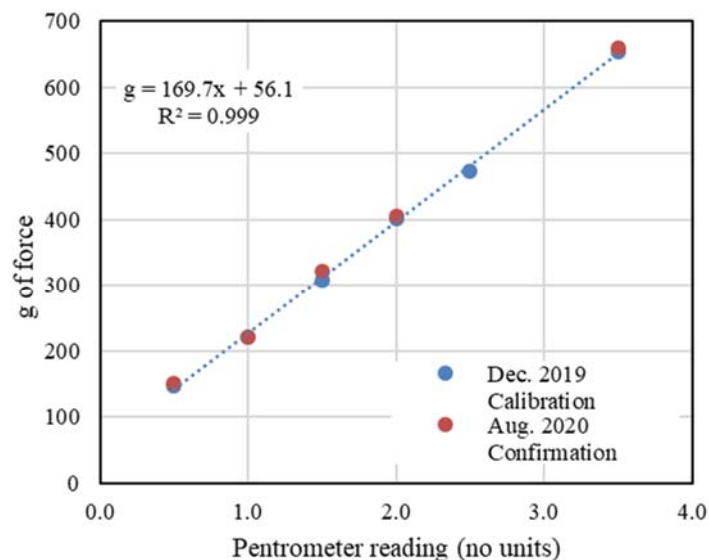
Figure 3.4. Penetrometer Calibration Curve, g of Force vs. Penetrometer Reading

A 3/16-inch (0.476-cm) diameter rod was mated to the foot of an AMS pocket penetrometer (AMS Inc. American Falls, ID) using a union prepared in-house. The penetrometer was calibrated using a balance to measure compressive force per penetrometer increment (Figure 3.4). Because of the nearly 6-month interval between the non-radiological and radiological tests, the December 2019 calibration was confirmed in August 2020.

The penetration test consisted of pushing the rod extension of the penetrometer into each CST bed by hand and measuring the penetrometer compressive force required to reach the bottom of the bed. Using the calibration curve, the g of force was determined.

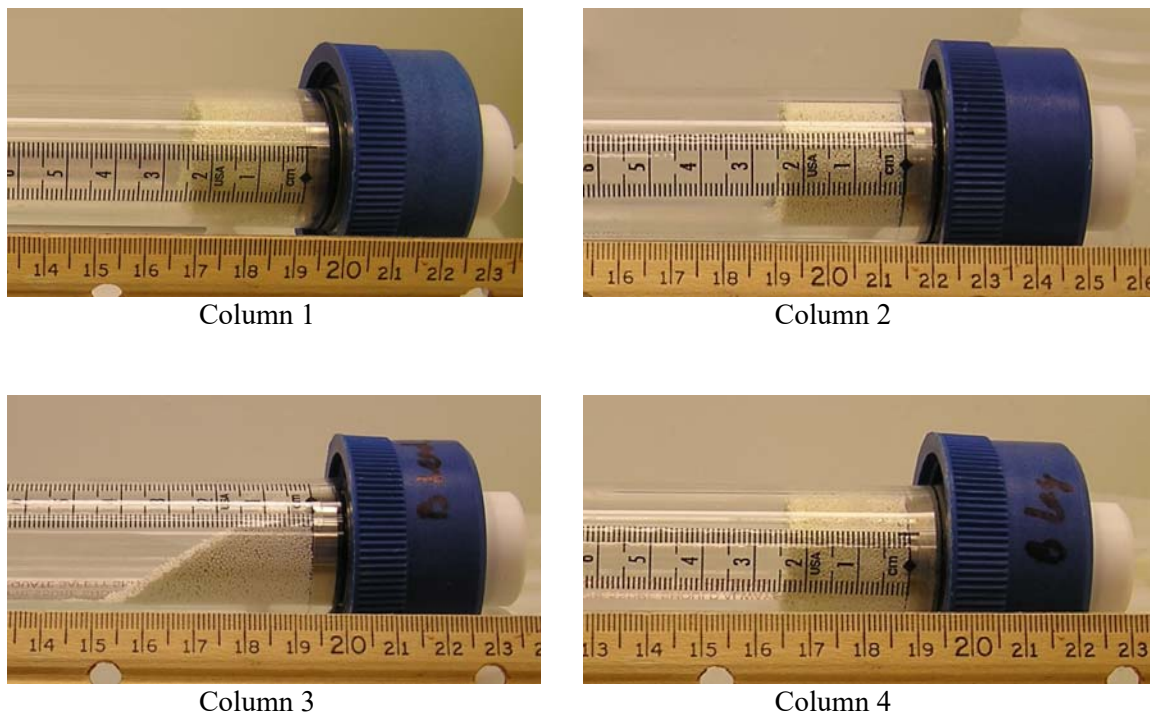
Figure 4.1. Angle of Repose, All Tests

The dried CST beds associated with disruptions at various process steps during TSCR operations were evaluated. Only one CST bed (Column 3) flowed readily with no evidence of agglomeration and the bed could be penetrated to the support screen with no measurable force. All other CST beds were “cemented” in place with the dried salts (see Figure 4.1). A 400 – 560 g, compressive force applied to Columns 1, 2, and 4 resulted in no bed penetration.

The behaviors of the two pairs of CST beds processed with simulant AP-105 (Columns 5 and 6, Fiskum and Peterson 2020) and actual AP-105 tank waste (Columns 1 and 3) under similar conditions were compared. Column 1 and Column 5 were dried with feed in place. Both CST beds were immovable and impenetrable with up to ~600 g force. Column 3 and 6 were rinsed with 1.4 AVs 0.1 M NaOH. The angles of repose for Column 3, 31°, agreed with that of Column 6 angle. Like Column 6, Column 3 could be easily penetrated to the support screen with no resistance measured by the penetrometer.

These results again indicated that the residual salts from actual tank waste in the CST bed, following processing of 1.4 AVs of FD solution, may not lead to a catastrophic CST bed recovery and that the simulant accurately emulated the angle of repose and bed penetration properties.

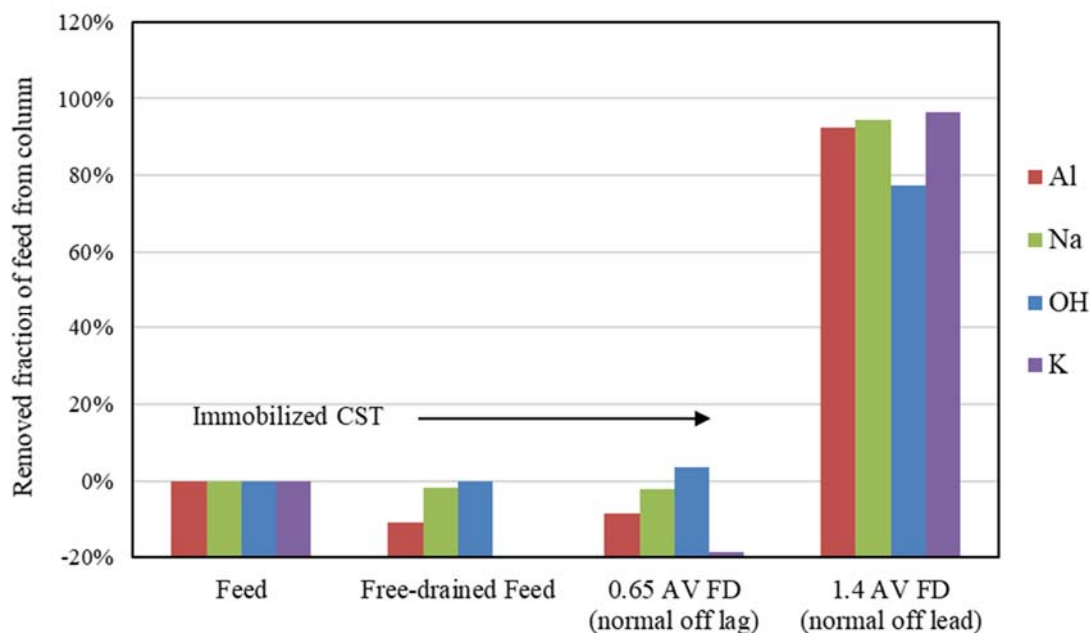
Figure 4.2. Fraction of Feed Removed from Column System during Key Process Steps

Very little feed removal was realized at the lag column following the FD step (Column 4, 0.65 AV), whereas significant feed reduction was observed for the lead column (Column 3, 1.4 AVs). The data set was reevaluated for fraction of analyte remaining in the CST bed and is summarized in Figure 4.2. The ~90% reduction of the interstitial AP-105 feed content following the 1.4 AVs of FD (Column 3) allowed easy movement of CST post-drying. Note that the 1.4 AVs FD rinse following the AP-105 simulant test showed a lower (60%) removed fraction; in that test the sample was collected at the valve, which incorporated another ~5 mL downstream from the bed and therefore likely contained more tank waste simulant associated with the larger holdup volume. Processing 0.65 AV of FD was insufficient to measurably decrease the solution in contact with the CST below the nominal feed composition. The free-drained CST apparently contained enough interstitial tank waste to create salt bridging between CST particles upon drying.
