Alternate Methods for Cleaning Zirconium Plate

April 2022

PACIFIC NORTHWEST NATIONAL LABORATORY
operated by
BATTELLE
for the
UNITED STATES DEPARTMENT OF ENERGY
under Contract DE-AC05-76RL01830

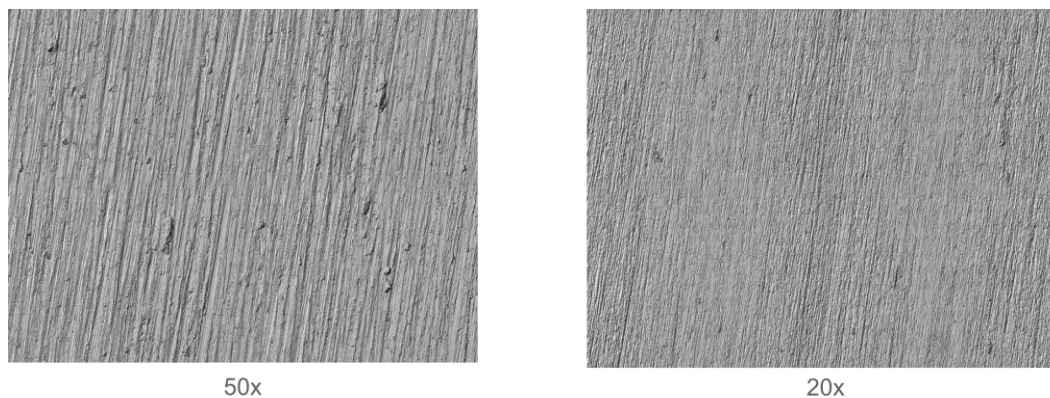
Figure 1. The 50x and 20x magnification images of As-Received 702 Zirconium Sheet.

Sheets of 702 Zirconium (Zr) were acquired to test different cleaning methods utilized before and after hot rolling of zirconium to uranium. The plates were nominally 12 inches by 24 inches in size with thickness either 0.020 inch or 0.040 inch and received with an initial polish with measured surface roughness ranging between 0.2-1.0 μm (8-40 μin) Ra, measured by LCM. The 50x and 20x magnification C-DIC images are shown in Figure 1. XRD and surface analysis with SEM was also performed on the as-received material. XRD found carbon compounds on the surface that were identified as carbides (Figure 2). However, surface scans by SEM (Figure 3) did not find carbide inclusions on the surface so the carbon recognized by XRD is likely part of the microstructure of the purchased material and not a surface defect.

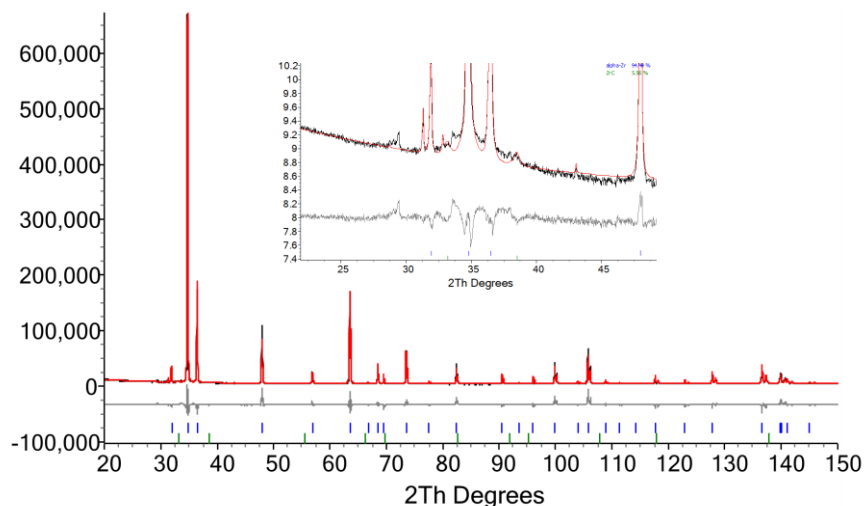
Figure 2. XRD Scan of As-Received 702 Zirconium Sheet.

Note: The blue markers identify peaks associated with Zr metal while the green markers identify peaks associated with zirconium carbide.

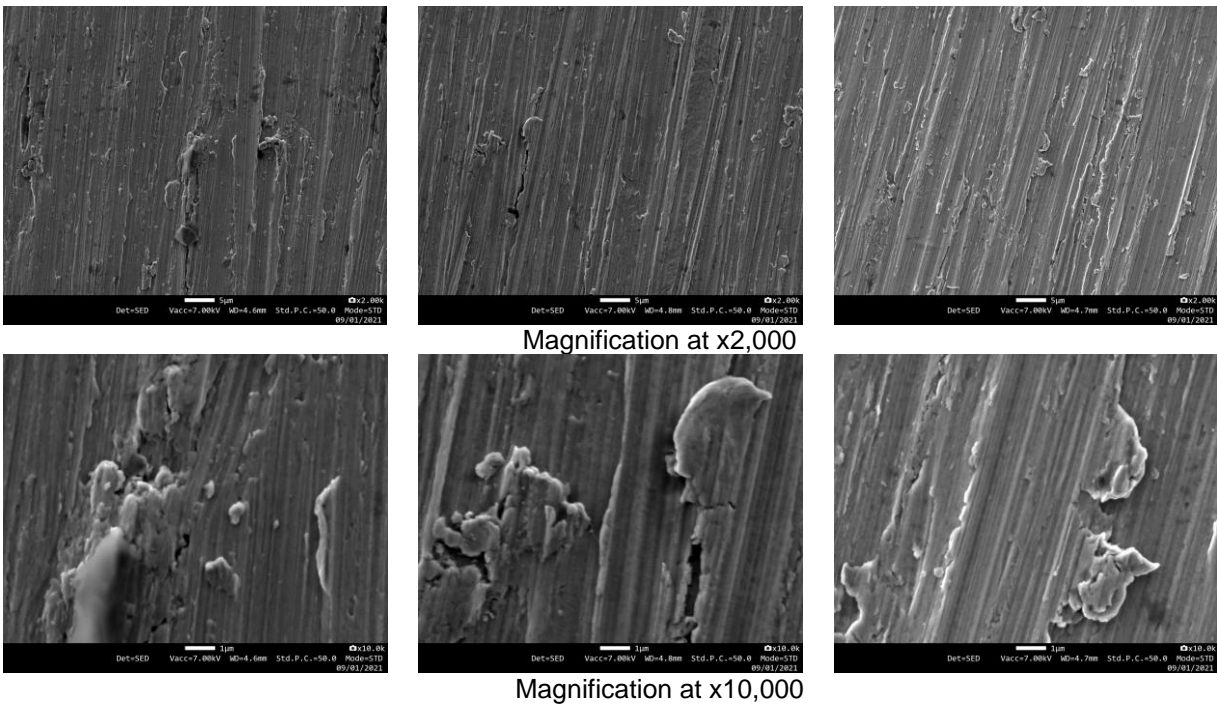
Figure 3. SEM Surface Scan Images of As-Received 702 Zirconium Sheet at x2k and x10k Magnification

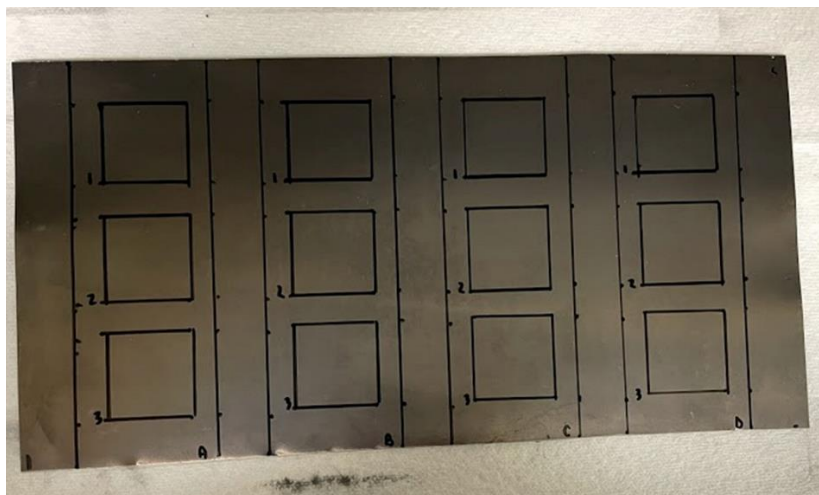
Figure 5. Divisions of each sheet evaluated before and after cleaning.

The plates were removed from the furnace and cleaned with ethanol and Wypall® wipes until no more Neolube was removed. Each sheet was divided into four 2-inch strips and three, 1.25 x 1.25-inch squares were marked in each strip for further analysis.

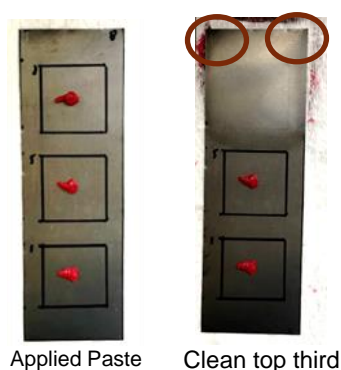
Figure 6. Application of the diamond paste to zirconium sheet and results of hand polishing top third of sheet

The diamond paste was applied to each section of a sheet as shown in Figure 6 and then hand polished over the surface of the metal. While the center of the sheet could be polished within a few minutes, a great deal of time was spent hand polishing the edges of the sheet to remove the polish. Figure 6 shows the initial results of polishing the top third of a sheet where the edges still show indications of the paste after 5 minutes, indicating that this process requires a great deal of effort and experience to perform well.

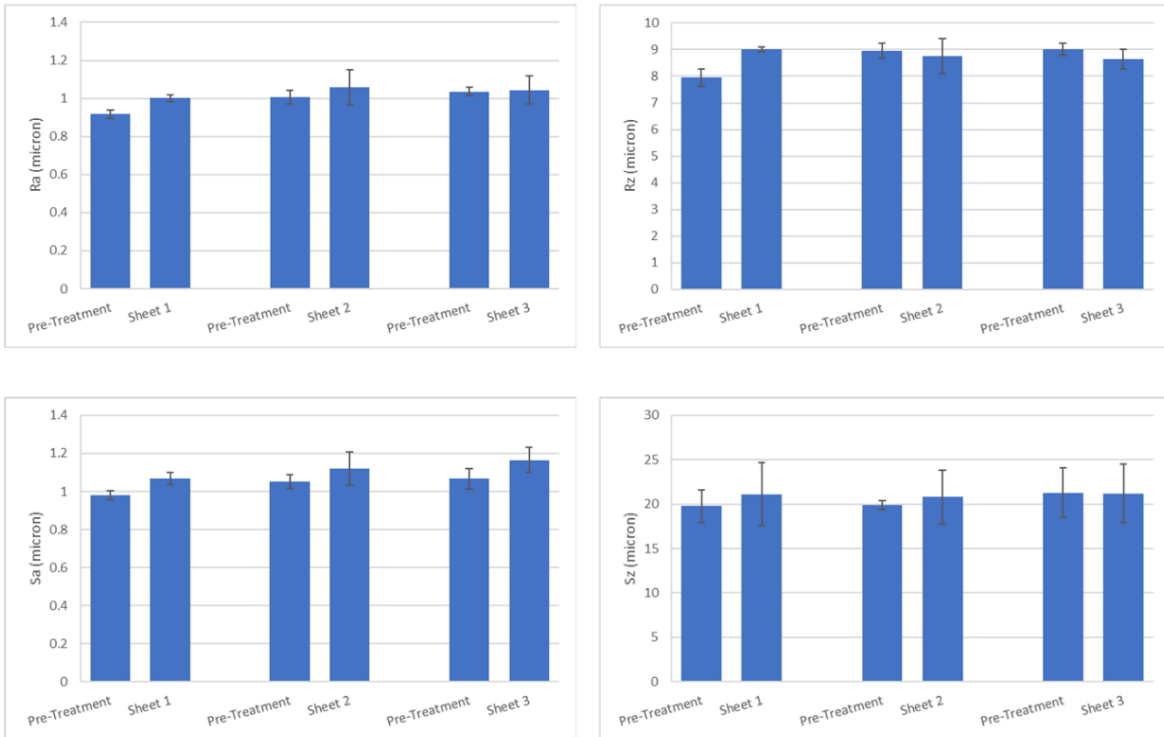
Figure 7. Comparison of the Ra, Rz, Sa, and Sz before and after polishing with diamond paste for each sheet.

An LCM data comparison is shown in Figure 7. The 10x magnification C-DIC images are shown in Figure 8. The LCM data indicates that the surface roughness was not improved by polishing with the red diamond grit paste as compared to the as-received sample.

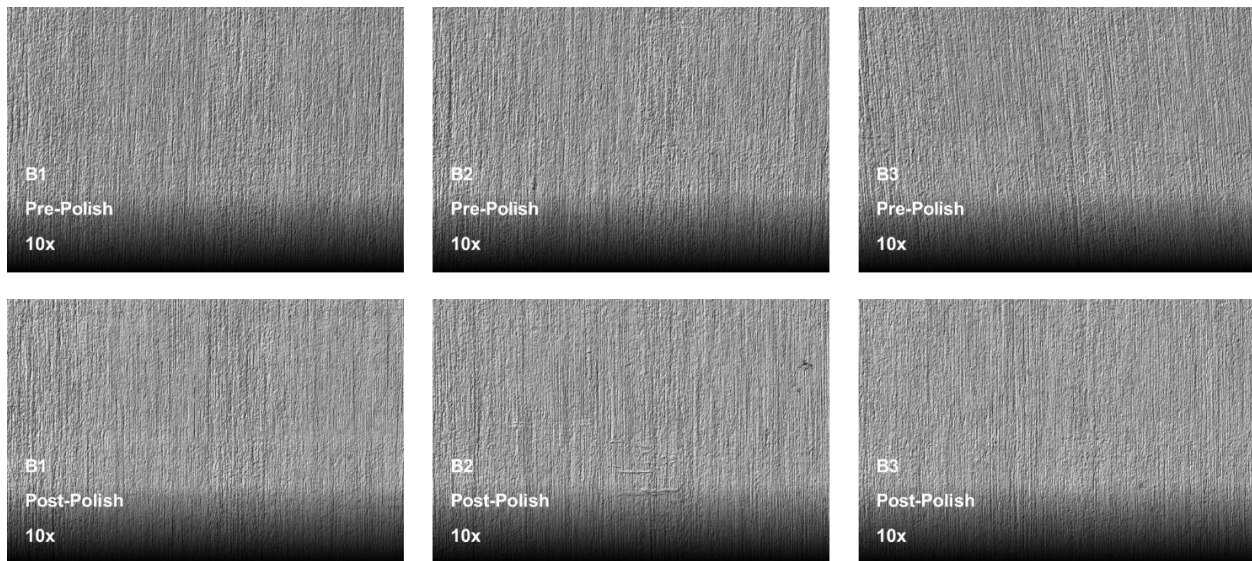
Figure 8. The 10x magnification C-DIC images from Sheet 1 before and after polishing with the diamond grit buff compound.

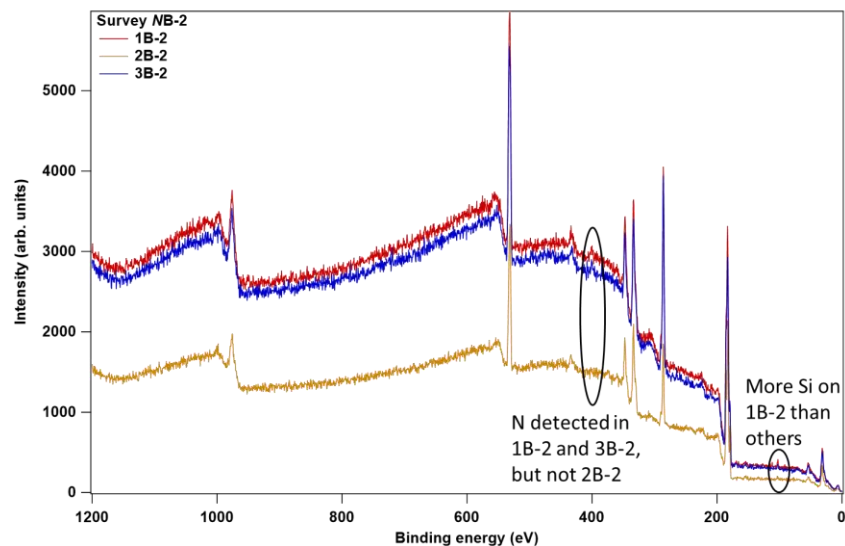
Figure 9. XPS Scan of Zirconium Plate after Diamond Paste Polish

The XPS data (Figure 9) indicated the presence of oxygen and zirconium at a valence state (Zr^{+4}) indicating an oxide layer is still present even after polishing. Silicon and nitrogen were also detected which are present in the diamond grit paste. XRD indicated the presence of carbon at levels similar to the as-received sheet.

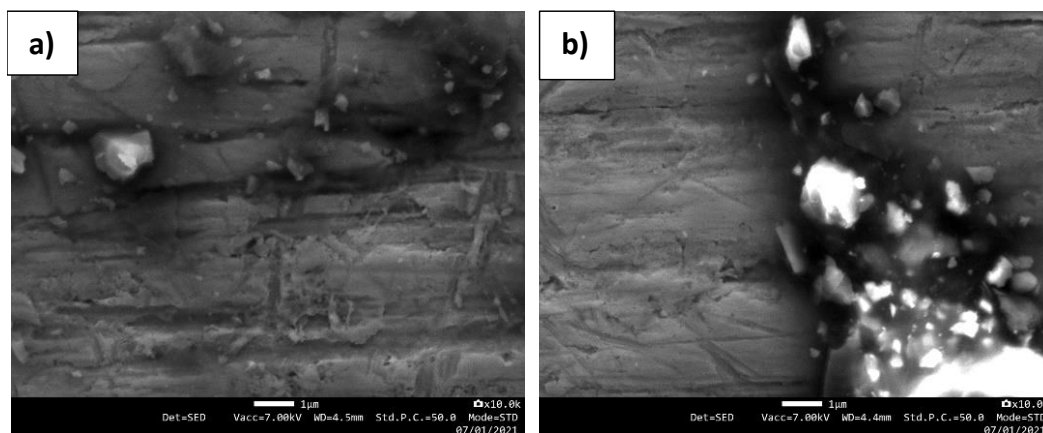
Figure 10. SEM images for the samples polished by hand. Images a) and b) represent two regions analyzed at 10,000x magnification. The inclusions are remnants of the diamond grit paste.

Figure 10 shows SEM images of the polished surface with remnants of the diamond grit buff compound on or embedded zirconium surface, which correlates with the results from the XPS. Figure 11 shows the results of cross-sectional images of the polished sheet. As indicated from XPS, oxide layers were found present on the surface, with a measured thickness between 3 to 6 μm . While XRD indicated the presence of carbon, no carbide inclusions were seen on the surface by SEM.

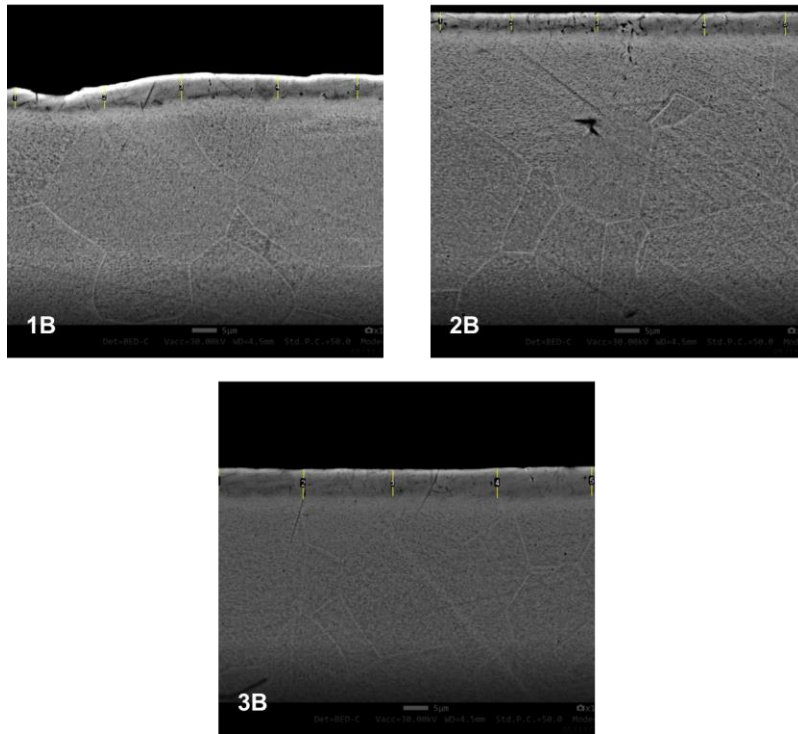
Figure 11. SEM cross section images showing the oxide layers for the hand-polished sheets.

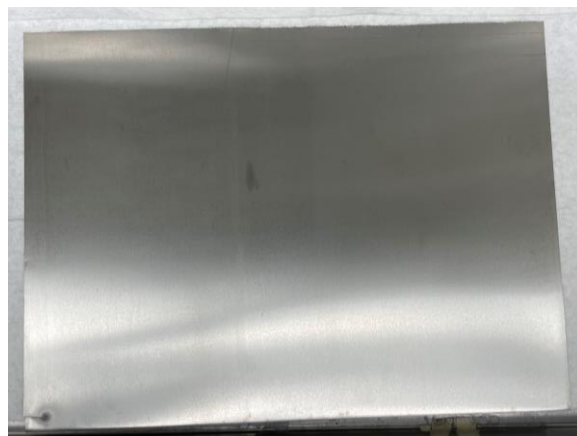
Figure 12. The Zr sheet following wet polishing at 3M.

The Zr sheet following wet polishing at 3M is shown in Figure 12. Staining was found present on the surface from the water-soluble coolant not being completely cleaned off the surface upon exiting the wet polisher. Zirconium can easily stain after machining and either requires hand cleaning with a solvent (acetone/alcohol) that quickly dries or allowed to passivation in water to allow the oxide layer to grow to a level where irregular growth does not occur. While the impact is cosmetic, it indicates possible contaminants from the coolant may be present.

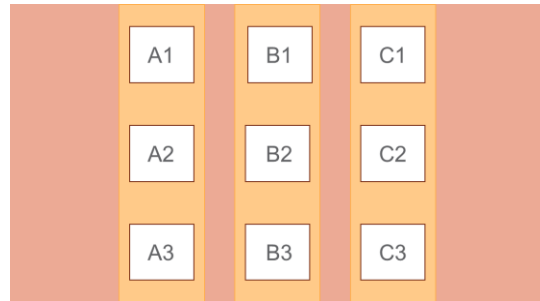
Figure 13. The locations of LCM data collection for the wet-polished Zr sheets.

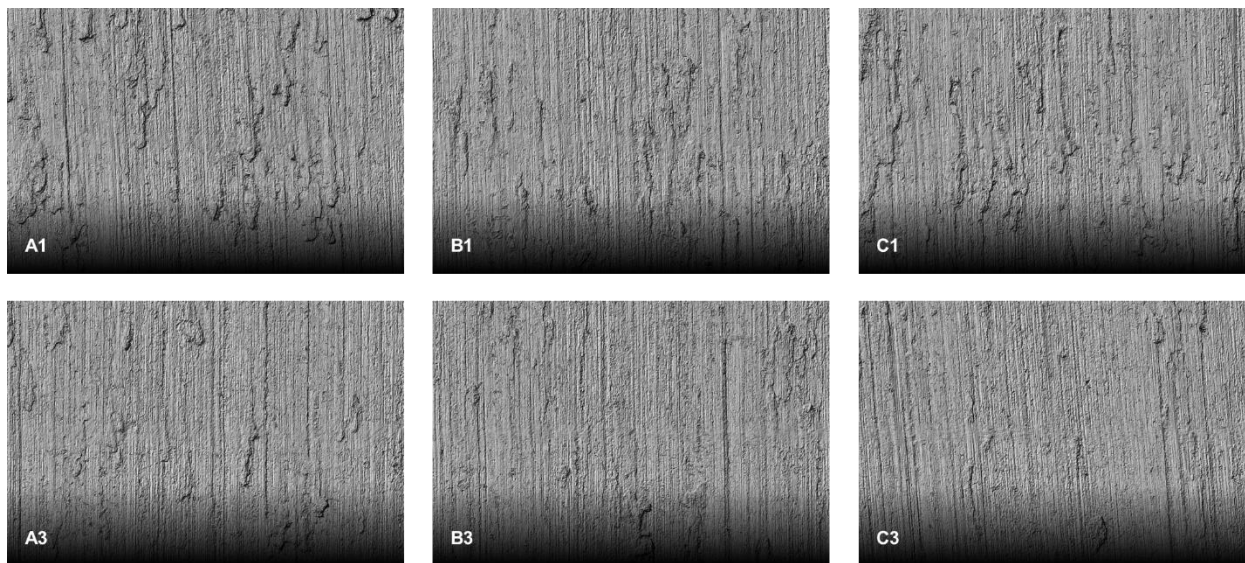
Figure 14. C-DIC images for rows 1 and 3 at 20x magnification.

plate is slightly better than the as-received ($R_a = 0.9\text{-}1.0\ \mu\text{m}$) and diamond polished plate ($R_a \sim 1.0\ \mu\text{m}$). The C-laser differential interference contrast (C-DIC) images for each location are shown in Figure 14 for the 20x magnification and are within a surface roughness range expected from the Trizact™ belt sequence used for this testing.

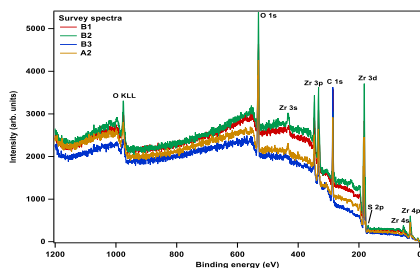
Figure 15. XPS results for wet polished surface

XPS analysis indicated the presence of Zr, O, and trace amounts of sulfur as shown in Figure 15. The carbon and sulfur present were likely from the water-soluble coolant used for the polishing, and the zirconium again was seen at a valence state indicating the presence of an oxide layer, like the as-received sample. XRD analysis also found similar levels of carbon present as found in the as-received material.

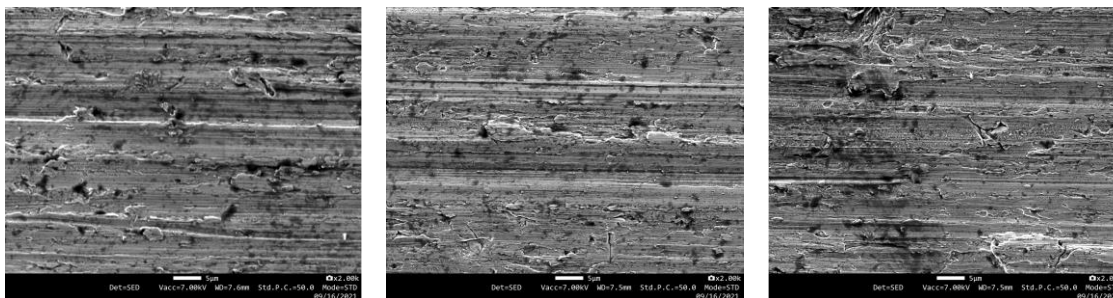
Figure 16. SEM images at three different locations on sample C2

SEM images are shown in Figure 16, showing no abrasive or carbide inclusion were detected on the surface.

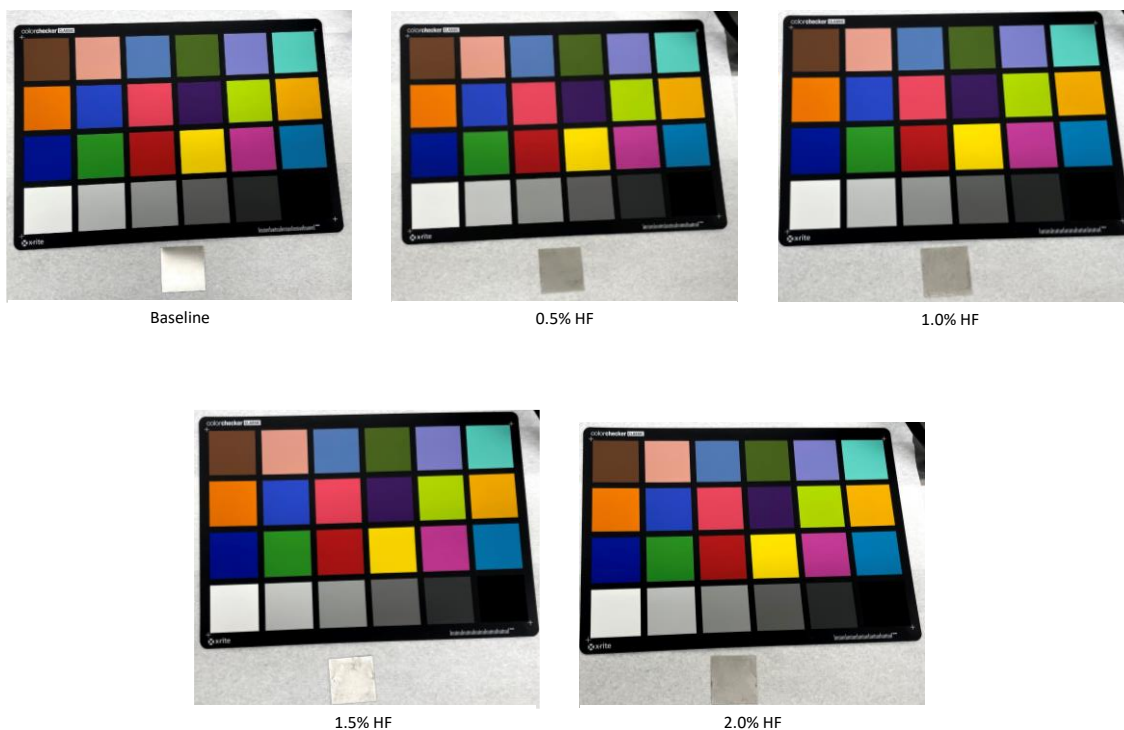
Figure 17. Flash etching Set 1 samples compared to a color chart. Each etched sample had brown staining and more of a matte finish than the shinier, silver baseline sample.

Samples were etched for 20 seconds in etchant solutions with 30 wt% nitric acid and varying concentration of hydrofluoric acid (0.5 wt% to 2.0 wt%). The pre-etched baseline and etched samples visual appearances are compared to a color chart in Figure 17. Each etch had brown staining on the surface and an increase in surface roughness. As the concentration of HF was increased, the etch was faster, correlating to an increase in staining. LCM surface roughness measurements of baseline and etched sample were taken and summarized in Figure 18. The plates were consistently rougher after etching with nitric acid/HF as compared to the baseline diamond polished material. The 20x magnification C-DIC images are shown and Figure 19.

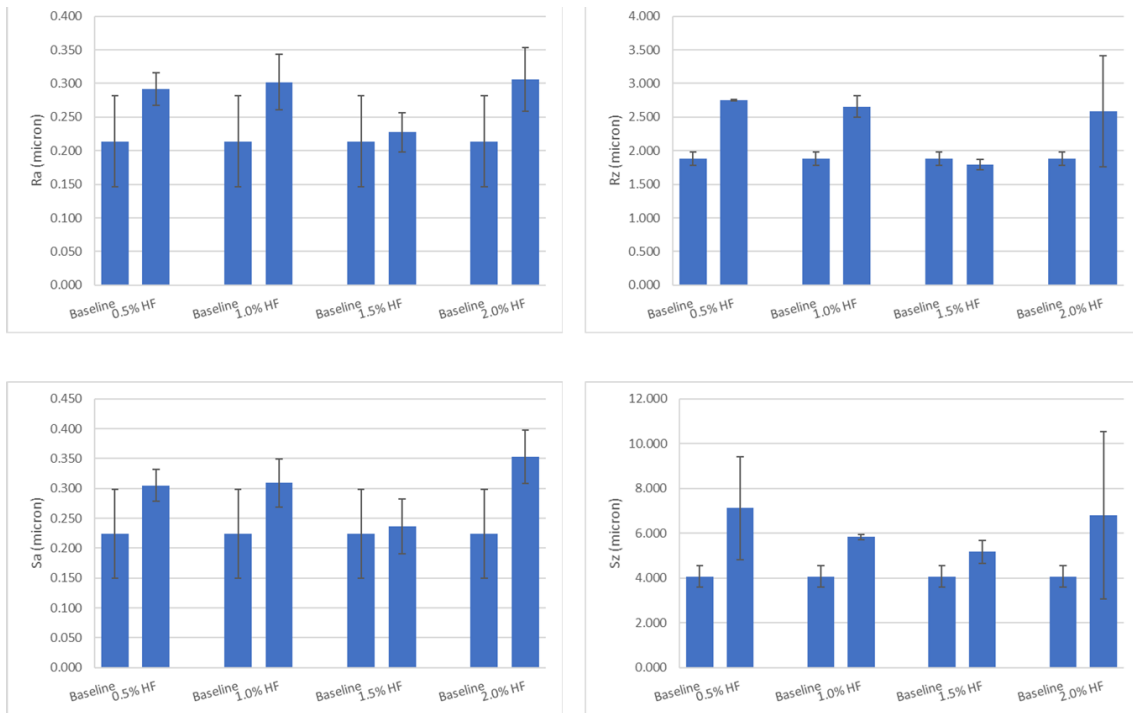
Figure 18. Comparison of the Ra, Rz, Sa, and Sz values before and after etching for Set 1 samples etched in 30% HNO₃ and varying concentrations of HF.

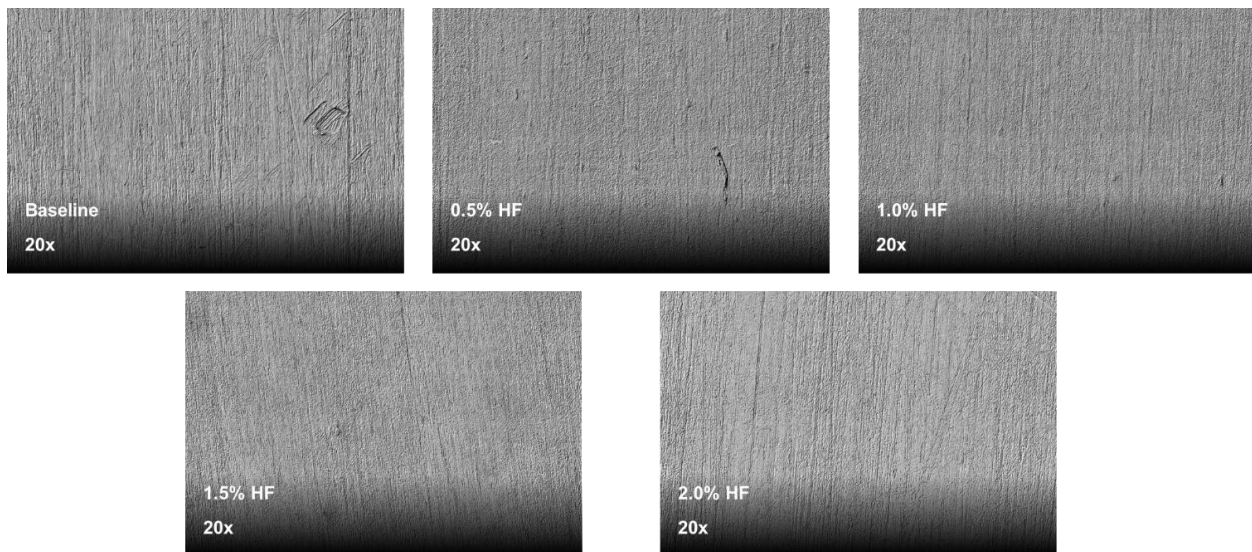
Figure 19. C-DIC images at 20x magnification for Set 1 etched samples in 30% HNO₃ and varying concentrations of HF.

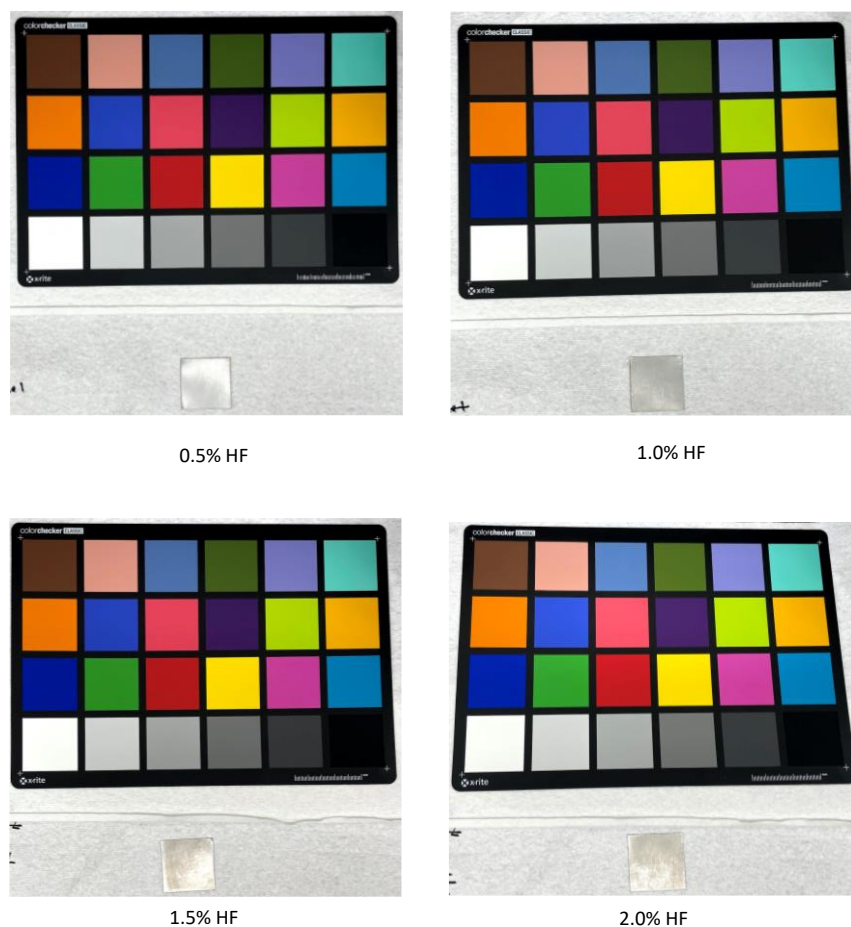
Figure 20. Etch Set 2 samples compared to a color chart from the duplicate flash etch testing at 30 wt% nitric and varying hydrofluoric concentrations. Etch time was 20 seconds.

The initial set of flash etching testing (Set 1) at 30 wt% nitric acid and varying hydrofluoric acid conditions for 20 seconds was repeated (Set 2) to collect mass loss data. Images of each sample etched for 20 seconds is shown in Figure 20. The comparison data for each square and the baseline sample analyzed via LCM is shown in Figure 21. The 20x magnification C-DIC images are shown in Figure 22. Results were comparable to the first etch test with increases in surface roughness measured afterwards and increased staining with increasing hydrofluoric acid concentration.

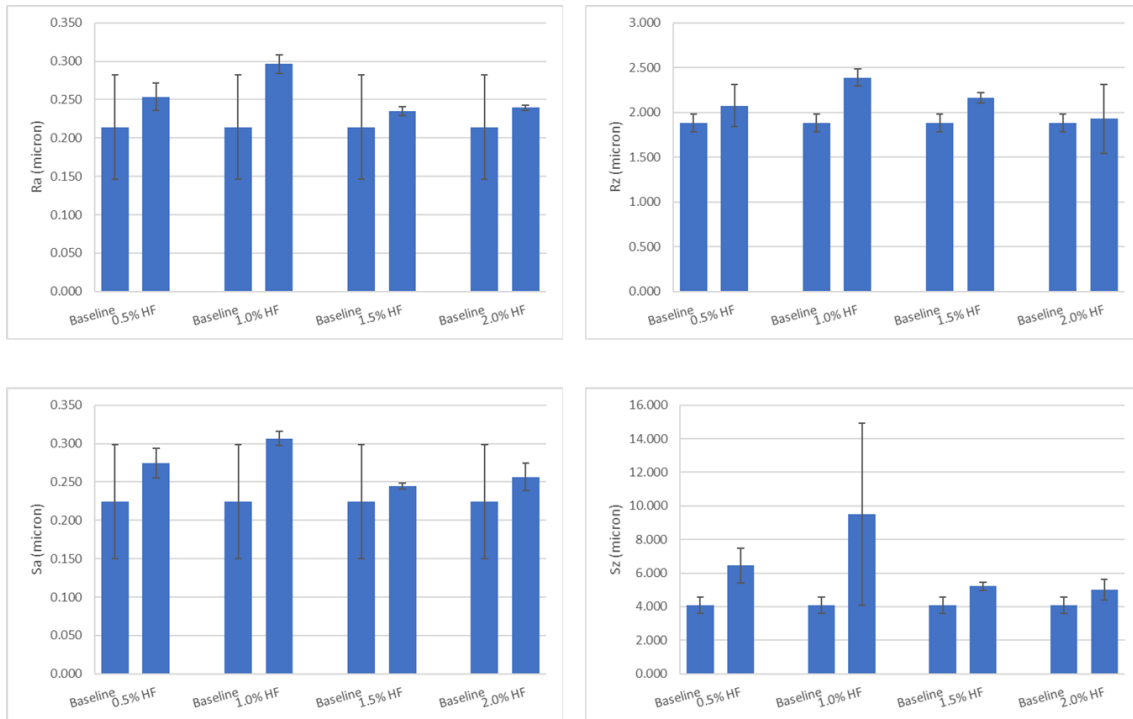
Figure 21. Comparison of the Ra, Rz, Sa, and Sz values before and after etching for Etch Set 2 samples etched for the duplicate in 30% HNO₃ and varying concentrations of HF. Each etch lasted for 20 seconds.

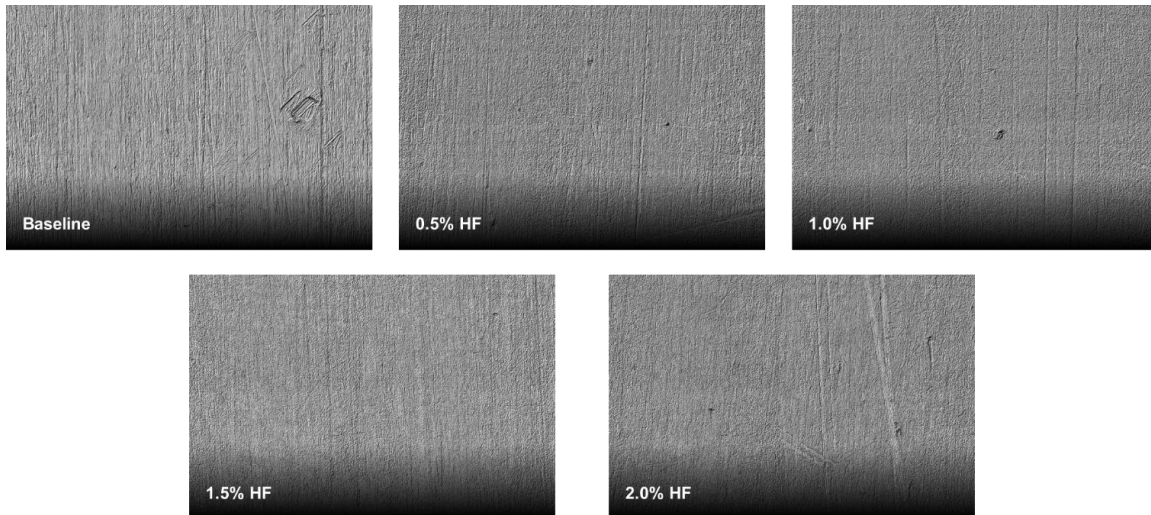
Figure 22. C-DIC images at 20x magnification from etched Set 2 samples from the duplicate testing at 30% HNO₃ and varying concentrations of HF. Each etch lasted for 20 seconds.

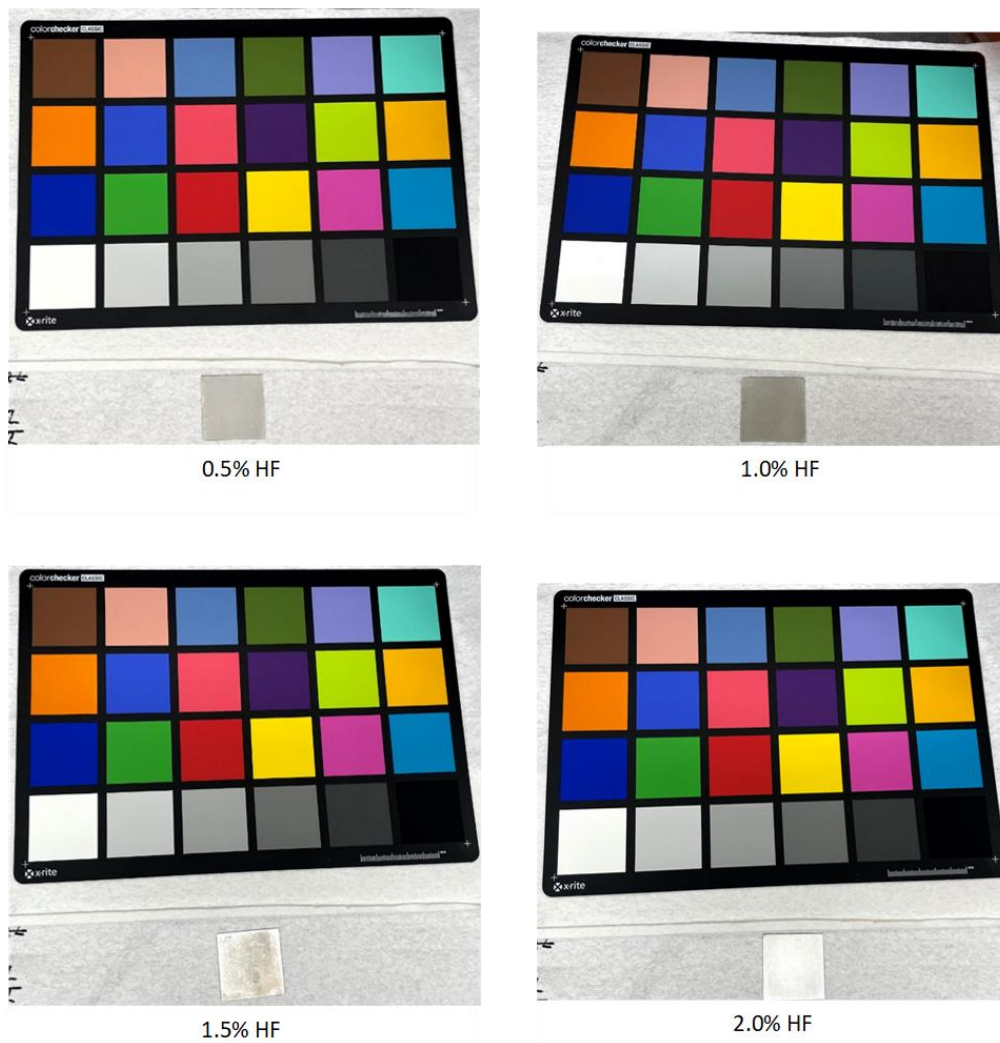
Figure 23. Set 3 samples etched at 30 wt% nitric and varying hydrofluoric concentrations compared to a color chart. Etch time was for 40 seconds.

For the third flash etching test (Set 3), the concentrations of the solutions remained the same, but the etch time was increased to 40 seconds. Images of the Zr metal squares following the 40 second etch are shown in Figure 23. The data comparison for each sample and the baseline for the 40 second etch are shown in Figure 24. The 20x magnification C-DIC images are shown in Figure 25. The surface roughness changes at 2 wt% HF were not as significant as they were at the lower concentrations with the increased time and the surface appears brighter. Staining was still present on all samples.

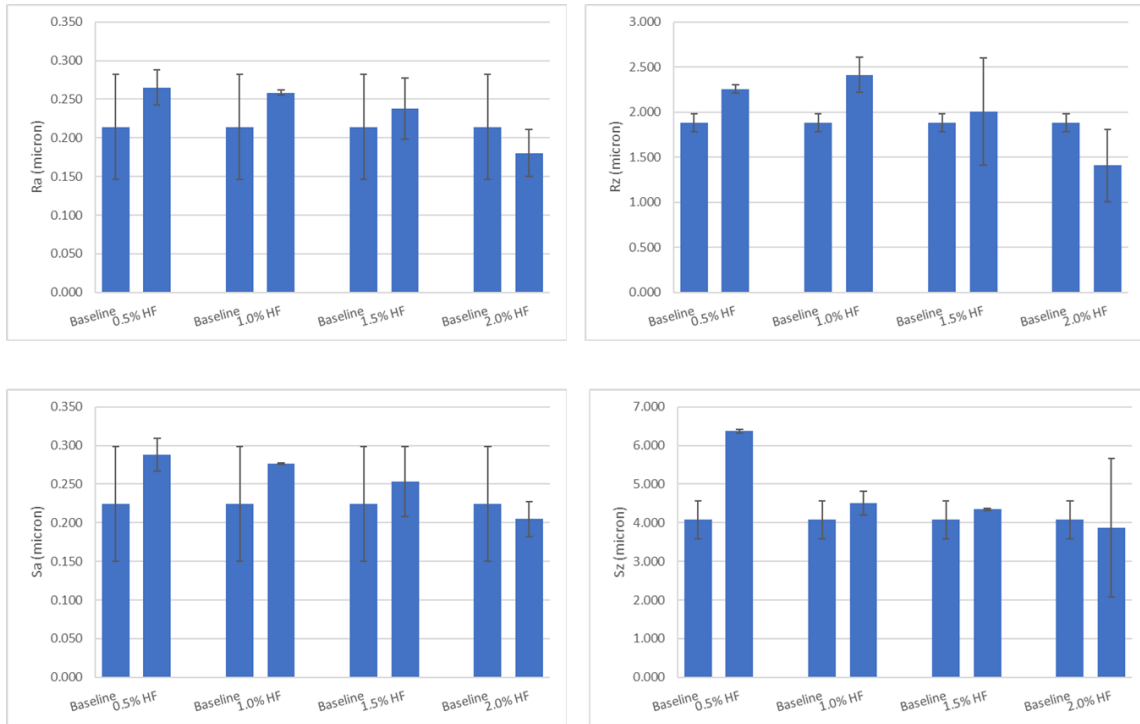
Figure 24. Comparison of the Ra, Rz, Sa, and Sz values before and after etching for Set 3 samples etched in 30% HNO₃ and varying concentrations of HF. Each etch lasted for 40 seconds.

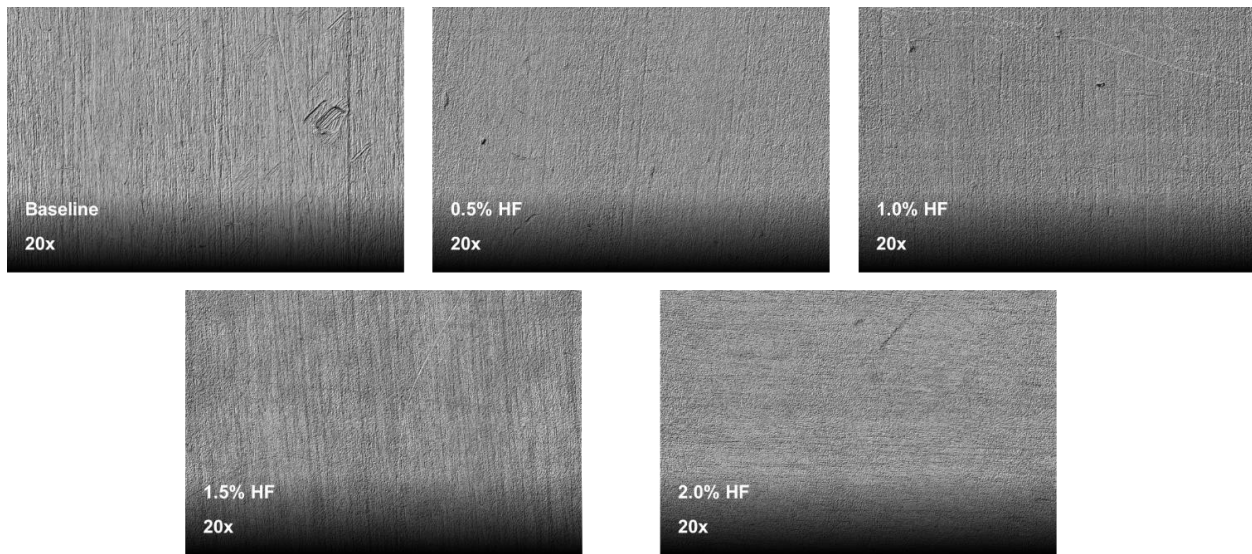
Figure 25. C-DIC images at 20x magnification for Set 3 samples etched in 30% HNO₃ and varying concentrations of HF. Each etch lasted for 40 seconds.

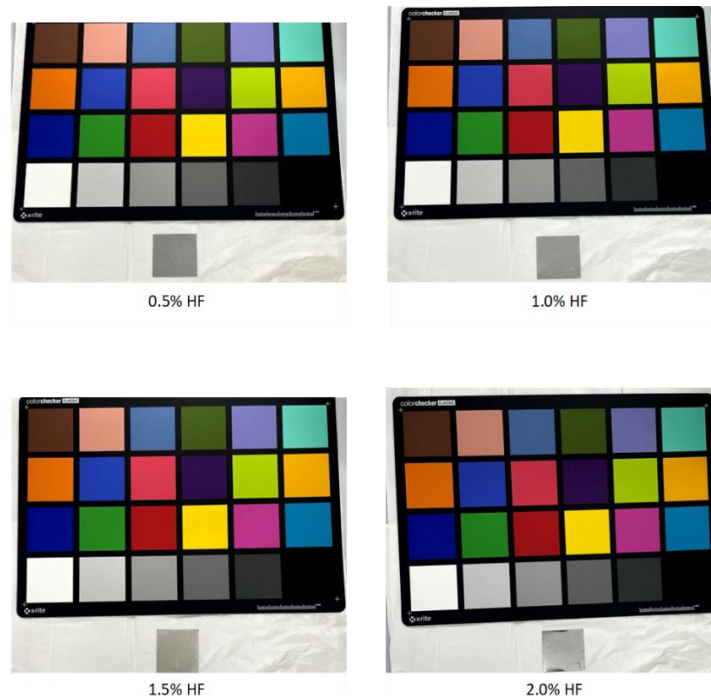
Figure 26. Comparison of the Set 4 post-etch samples and a color chart etched in 40wt% HNO₃ at varying HF concentrations. The etch time was 20 seconds.

Flash etching test for Sets 2 and 3 were repeated, but the concentration of nitric acid was increased to 40 wt%. Images of the Set 4 post-etch samples, etched at 40 wt% nitric and varying hydrofluoric acid concentrations for 20 seconds is shown in Figure 26. The LCM data for this data set are shown in Figure 27. The 20x magnification C-DIC images are shown in Figure 28, respectively. Surface roughness changes were more significant at lower hydrofluoric concentration while staining is more prominent with increasing hydrofluoric concentration when compared to against the as-manufacture material and baseline hand abrasive polish.

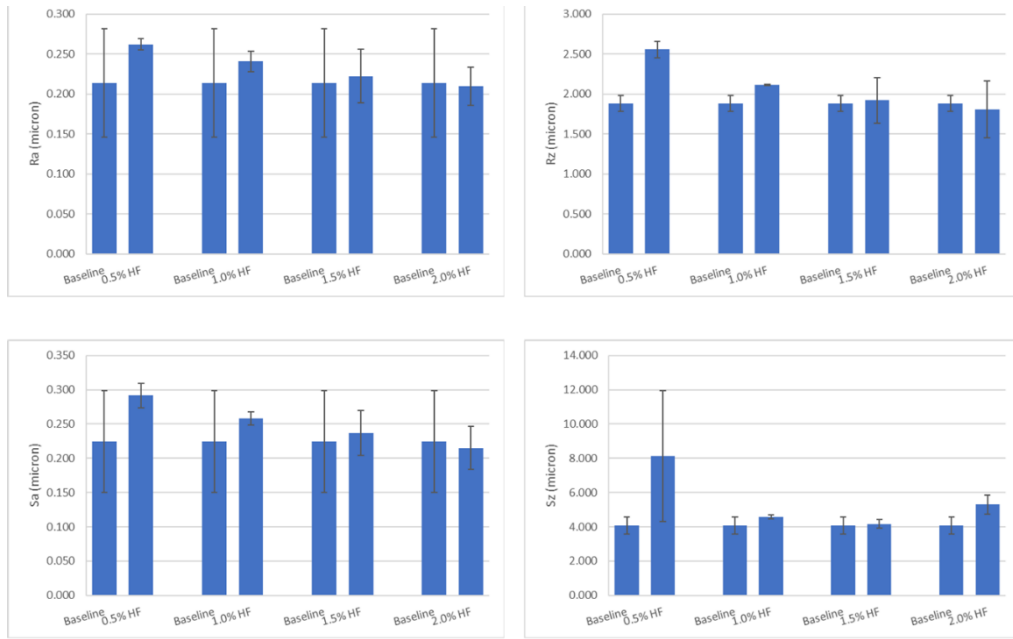
Figure 27. Comparison of the Ra, Rz, Sa, and Sz values before and after etching Set 4 samples etched in 40wt% HNO₃ and varying concentrations of HF. Each etch lasted 20 seconds.

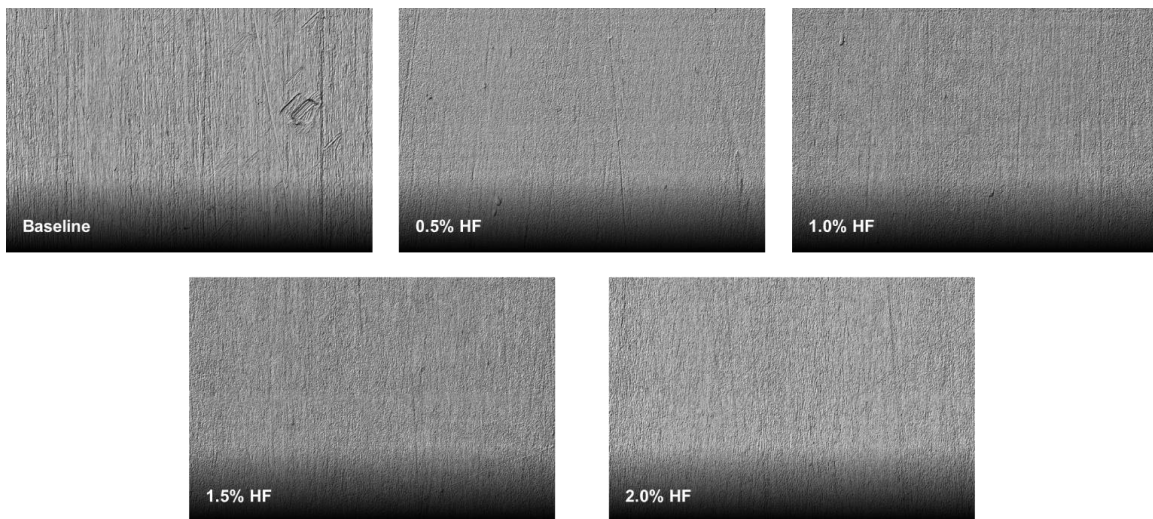
Figure 28. C-DIC images at 20x magnification for Set 4 samples etched in 40% HNO₃ and varying concentrations of HF. Each etch lasted for 20 seconds.

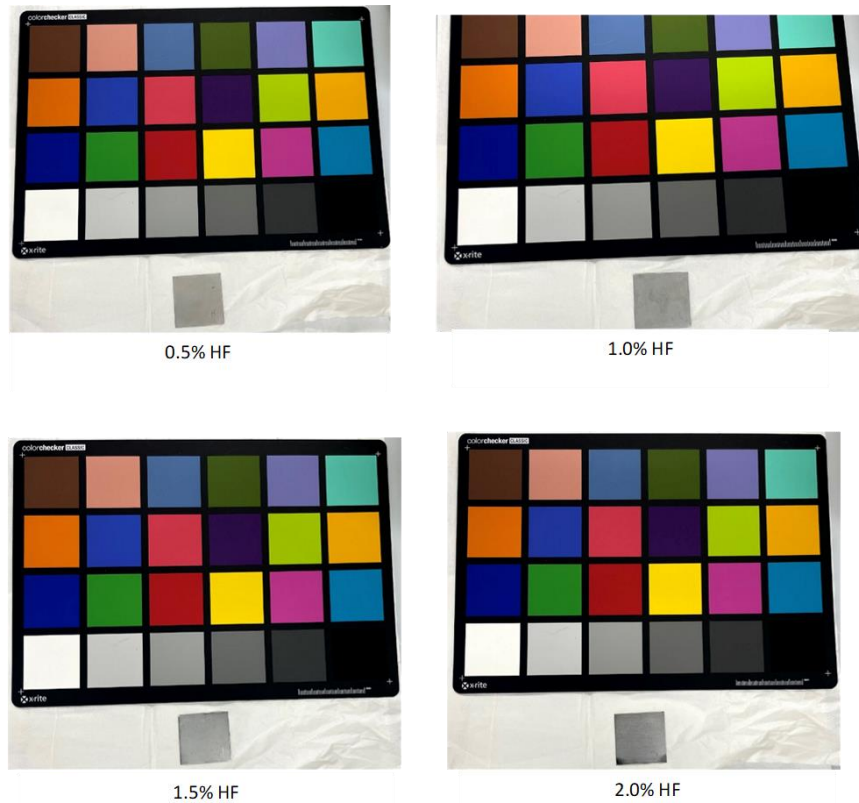
Figure 29. Comparison of the Set 5 post-etch samples and a color chart etched in 40wt% HNO₃ at varying HF concentrations. Etch time was 40 seconds.

Set 5 zirconium samples etched in 40wt% HNO₃ and varying HF concentrations, but the etch time was increased to 40 seconds. The comparison between each etched square and a color chart is shown in Figure 29. The LCM data for this data set are shown in Figure 30 with the C-DIC images at 20x magnification for each sample are shown in Figure 31. The results are very similar to all the previous test results with staining on the surface that increased with increasing HF concentration.

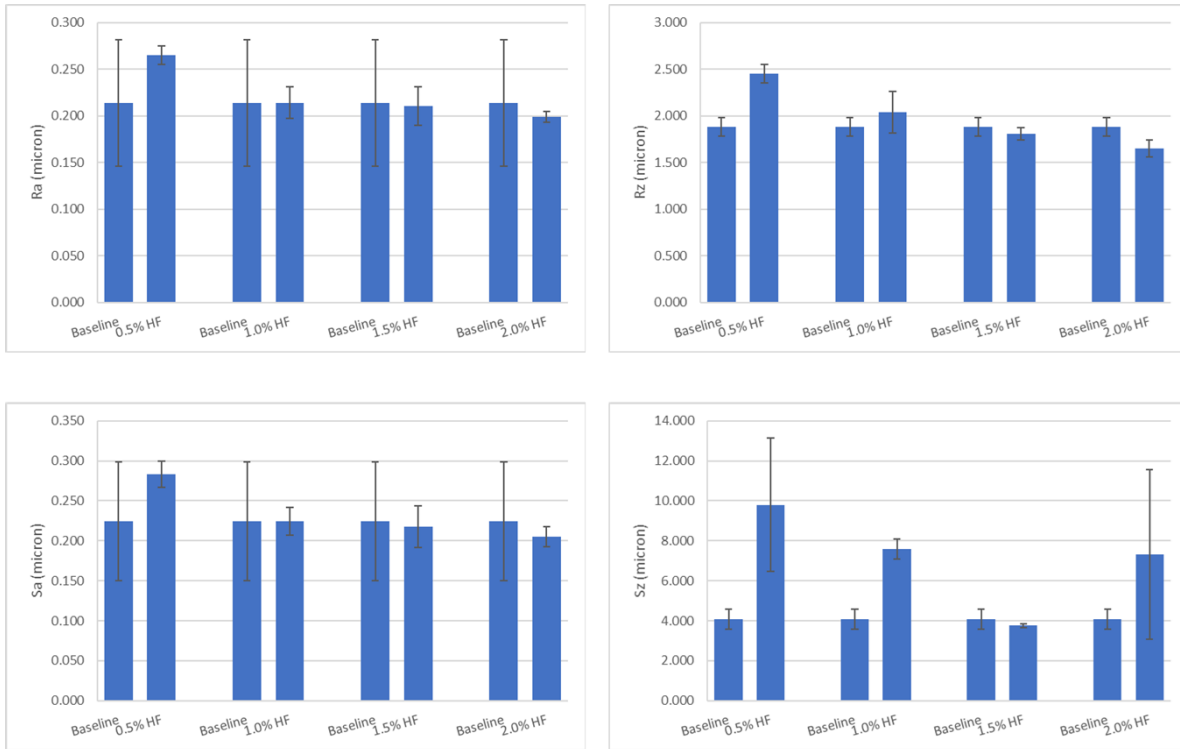
Figure 30. Comparison of the Ra, Rz, Sa, and Sz values before and after the Set 5 were etched in 40wt % HNO₃ and varying concentrations of HF. Each etch lasted for 40 seconds.

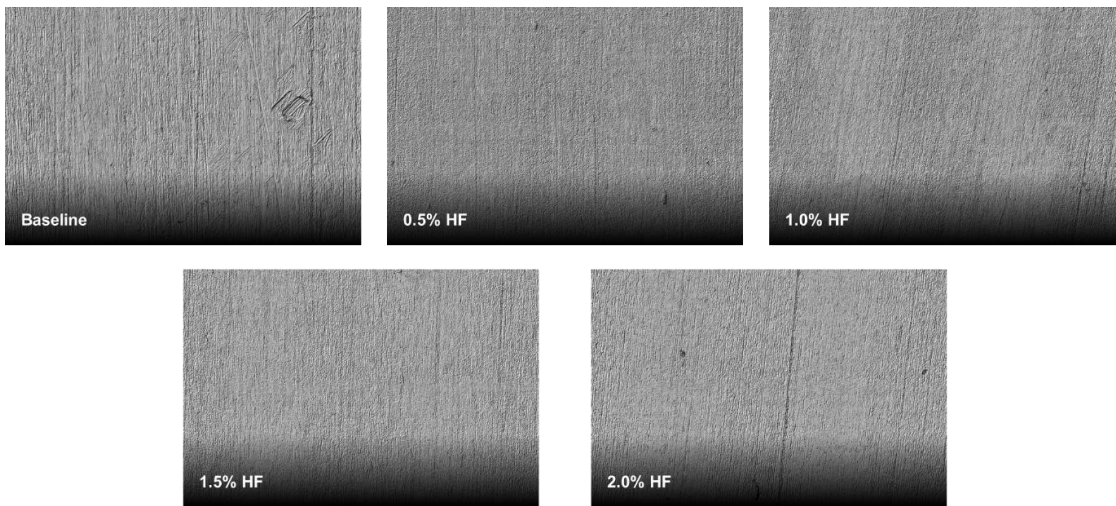
Figure 31. C-DIC images at 20x magnification for the Set 5 samples etched in 40% HNO₃ and varying concentrations of HF. Each etch lasted for 40 seconds.

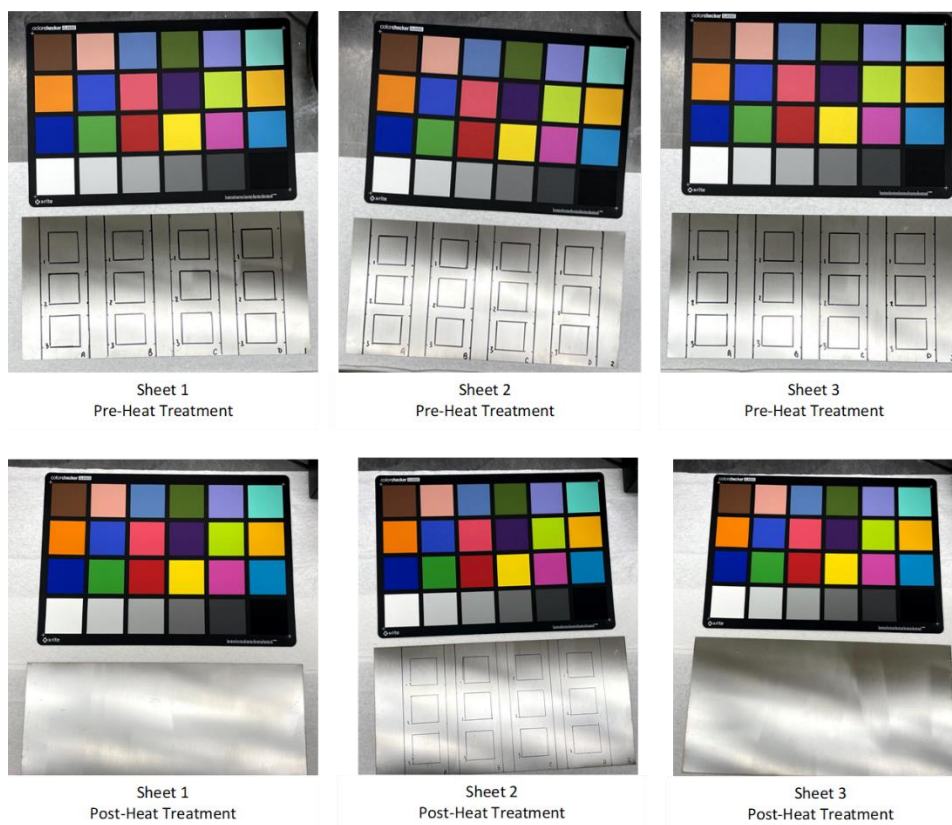
Figure 32. Sheets 1–3 before and after heat treatment between two Neolube-coated, stainless-steel sheets.

Three Zr sheets were heat treated in close contact with Neolube-coated steel plate as described in Section 2.3.1. The three Zr sheets prior to heat-treatment are compared to those heat-treated as shown in Figure 32. No visual difference in the surface appearance was found.

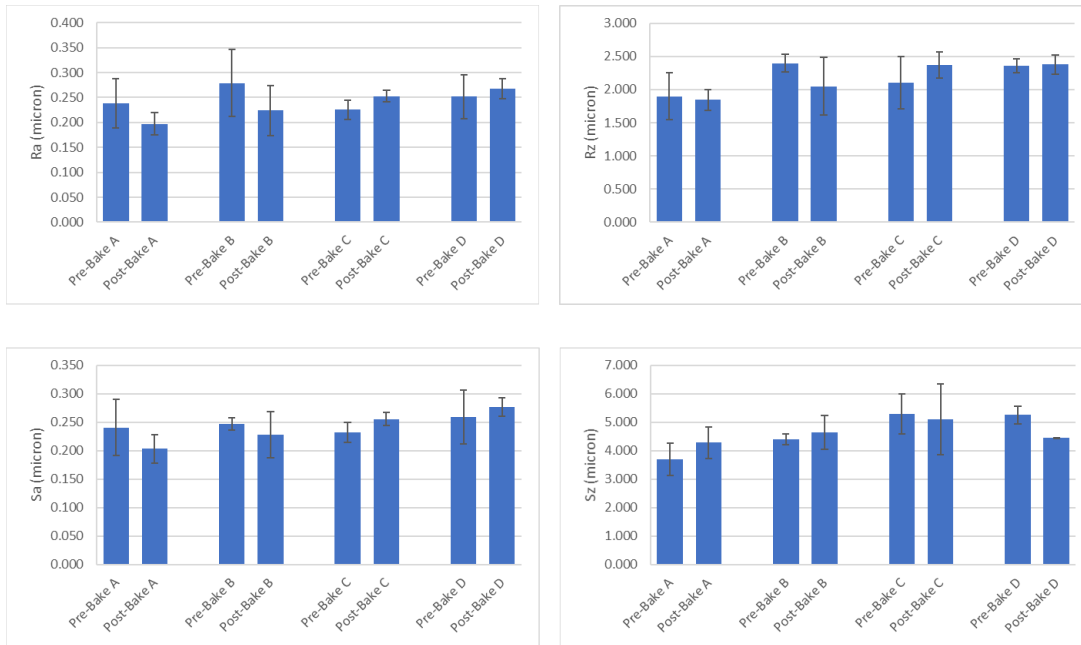
Figure 33. Ra, Rz, Sa, and Sz values for Sheet 2 before and after alcohol cleaning after heat treatment in contact with Neolube.

Sheet 2 was further analyzed via LCM before and after heat treatment to evaluate possible changes in the surface condition. A data comparison before and after heat-treatment/cleaning on this plate is shown in Figure 33 and C-DIC image comparisons are shown in Figure 34. No significant change to the surface was observed by LCM.
