Alternate Methods for Cleaning Zirconium Plate

April 2022

PACIFIC NORTHWEST NATIONAL LABORATORY
operated by
BATTELLE
for the
UNITED STATES DEPARTMENT OF ENERGY
under Contract DE-AC05-76RL01830

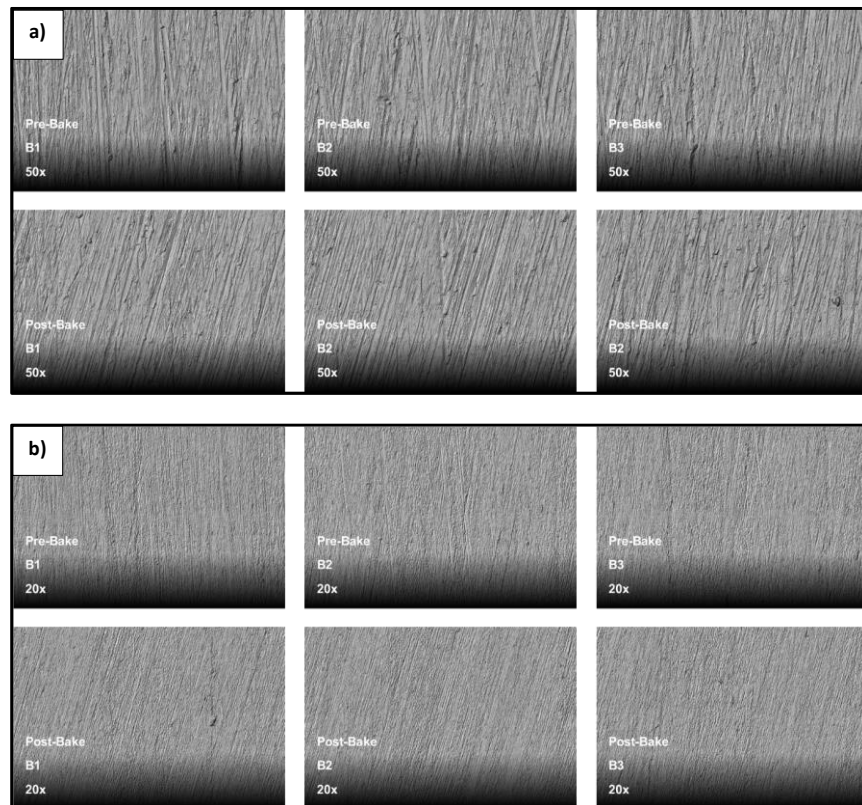
Figure 34. C-DIC images at (a) 50x and (b) 20x magnification of Sheet 2 before and after alcohol cleaning after heat treatment in contact with Neolube.

Sheet 2 was further analyzed via LCM before and after heat treatment to evaluate possible changes in the surface condition. A data comparison before and after heat-treatment/cleaning on this plate is shown in Figure 33 and C-DIC image comparisons are shown in Figure 34. No significant change to the surface was observed by LCM.

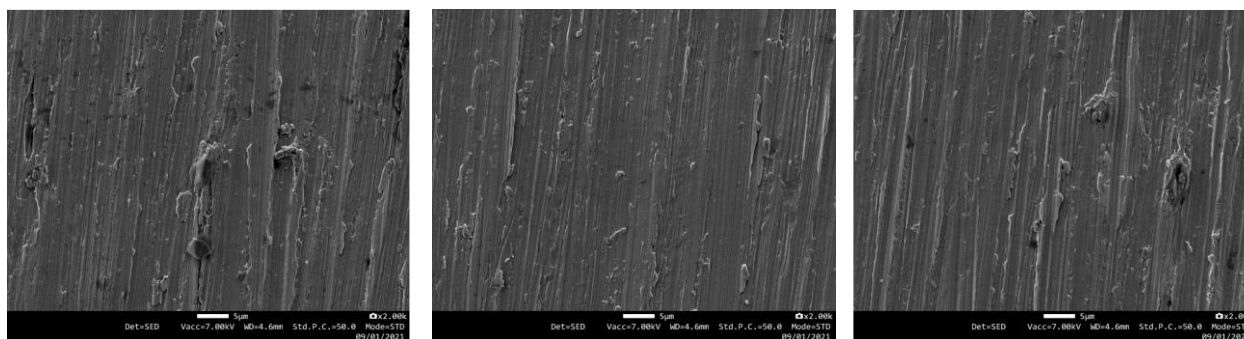
Figure 35. SEM surface images from Plate 2 after alcohol cleaning after heat treatment in contact with Neolube

Sheet 1 was analyzed via XRD, XPS, and SEM to determine if contaminants or inclusions were present on the surface. XRD and XPS indicated the presence of oxygen and carbon on the surface, consistent with the as-received material. SEM images from each location are shown in Figure 35. No inclusions were found on the surface of the heat-treated samples during SEM analysis.

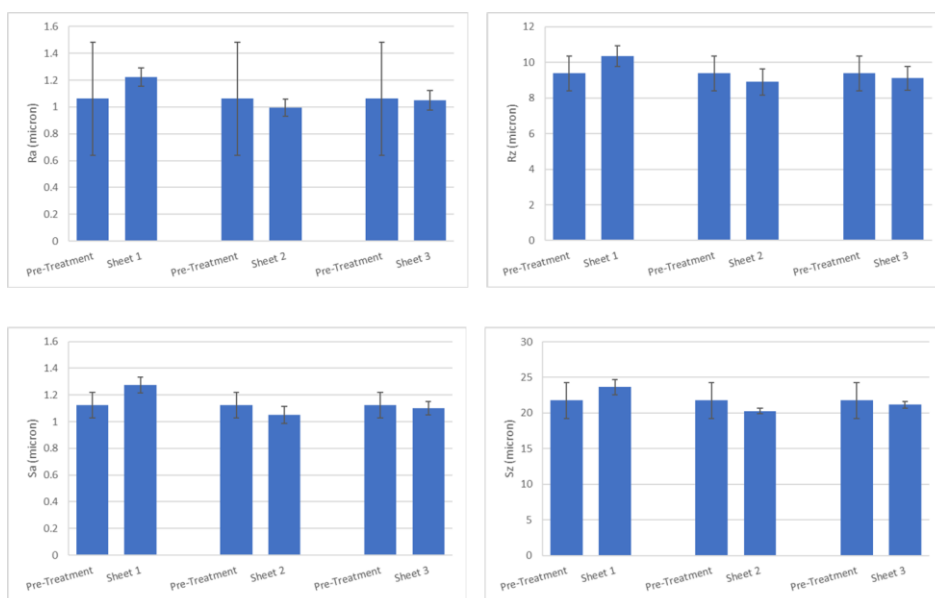
Figure 36. Ra, Rz, Sa, and Sz values for Section A cleaned with ethanol before and after heat treatment and Neolube removal. There was little difference in surface roughness values.

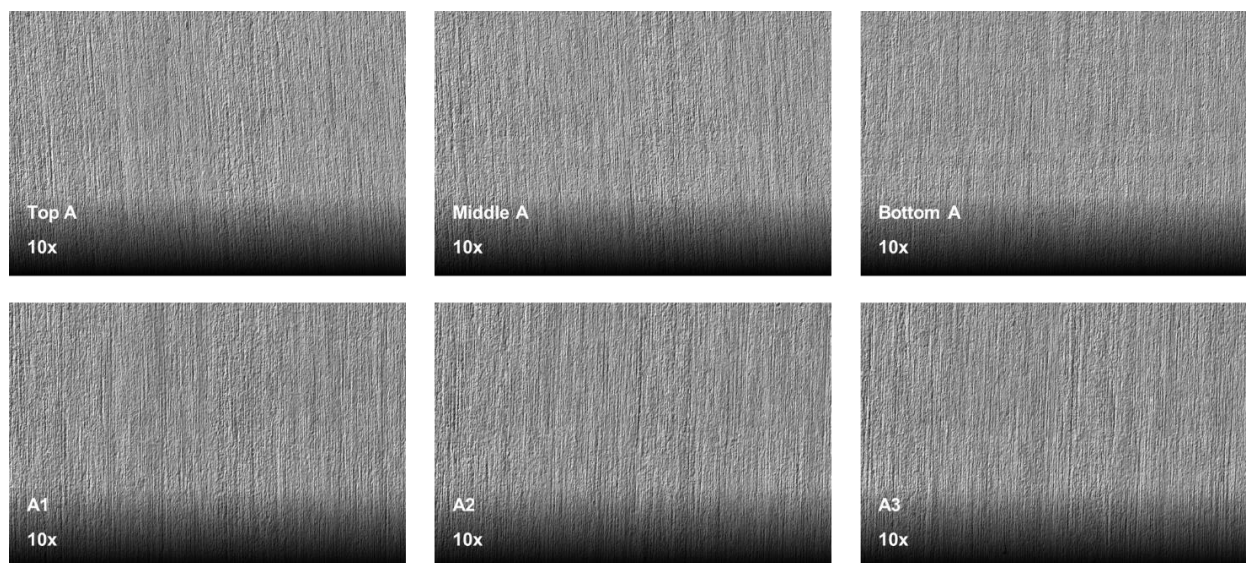
Figure 37. The 10x magnification C-DIC images before and after heat treatment and Neolube removal with ethanol.

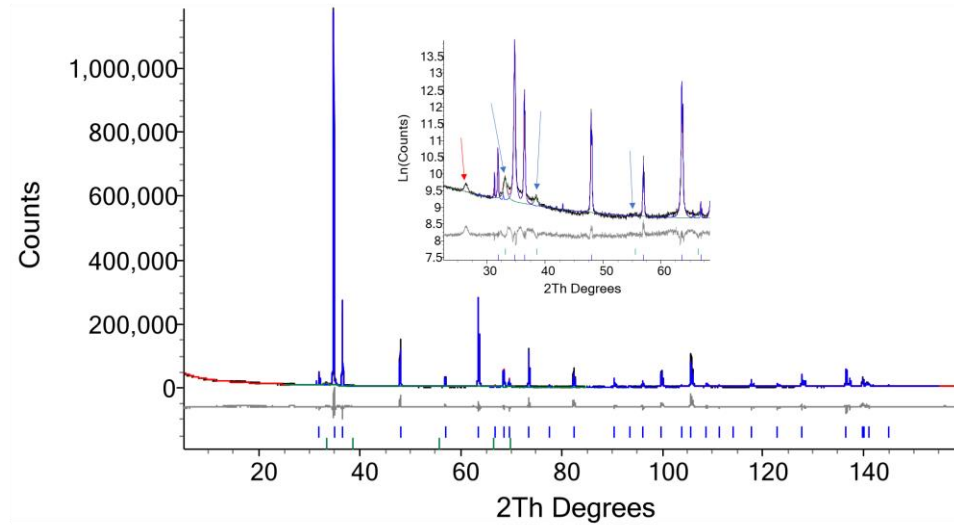
Figure 38. XRD scan of alcohol clean plate heat treated with Neolube on surface. Similar pattern found on as-received material.

The XRD scan data of the surface of the ethanol cleaned samples are shown in Figure 38. The scans indicate carbon compounds present on the surface. XPS analysis indicates the presence of Zr, O, and C, which confirms the information obtained by XRD analysis. However, similar scans by XRD indicate similar patterns on the as-received material as well. SEM analysis the surface found no sign of carbide inclusions on the surface (Figure 39). SEM imaging of the cross sections indicated an oxide layer with a thickness of between μm 2-4 shown in Figure 40. This is a similar thickness as seen on the as-received Zr samples indicating no significant impact of Neolube presence after the alcohol wipe.

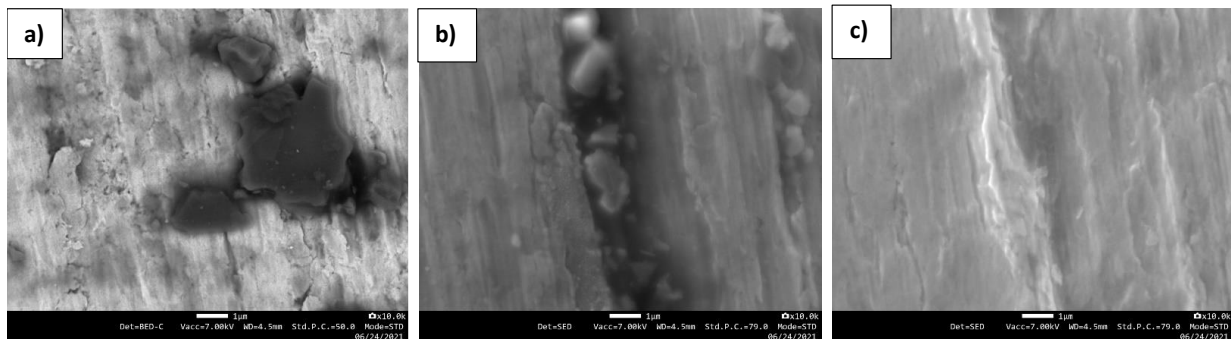
Figure 39. SEM images for the samples cleaned with ethanol. Images a), b), and c) represent three different regions analyzed at 10,000x magnification. These images show no carbide inclusions.

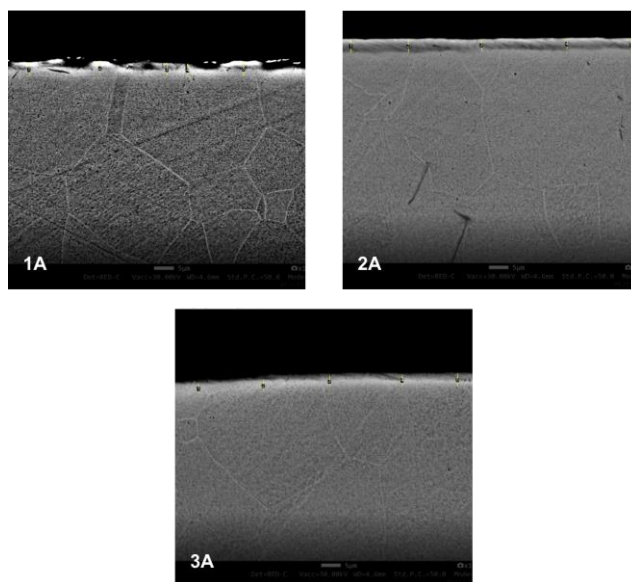
Figure 40. Oxide layers found on the ethanol cleaned sheets

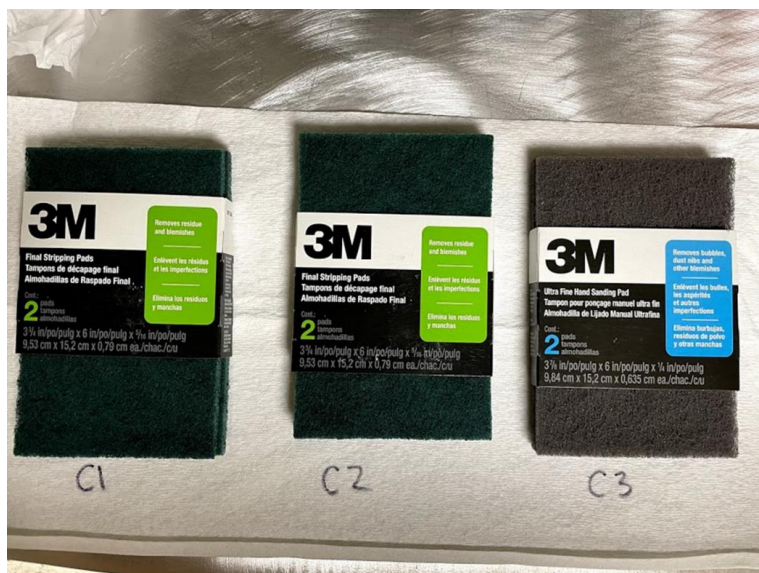
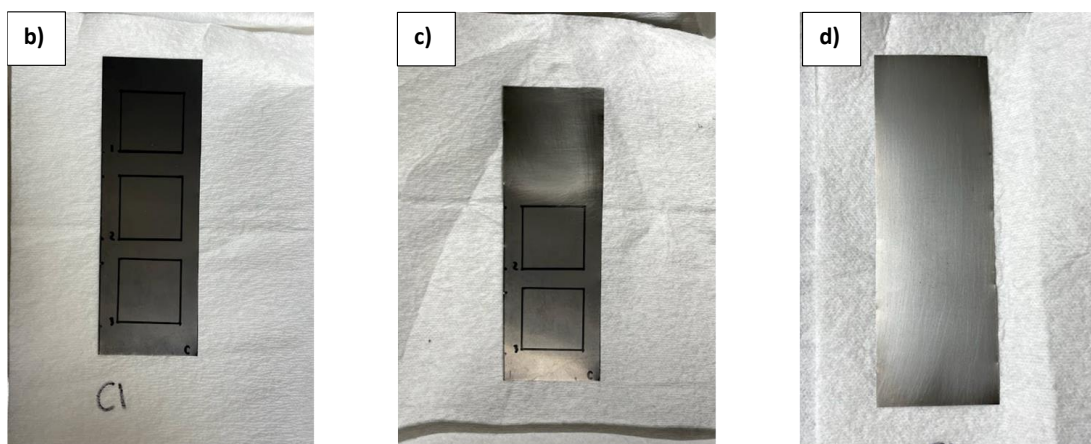
Figure 41. Scotch-Brite Pads (a) used for cleaning. Strip C1 before (b), during (c), and after cleaning (d).

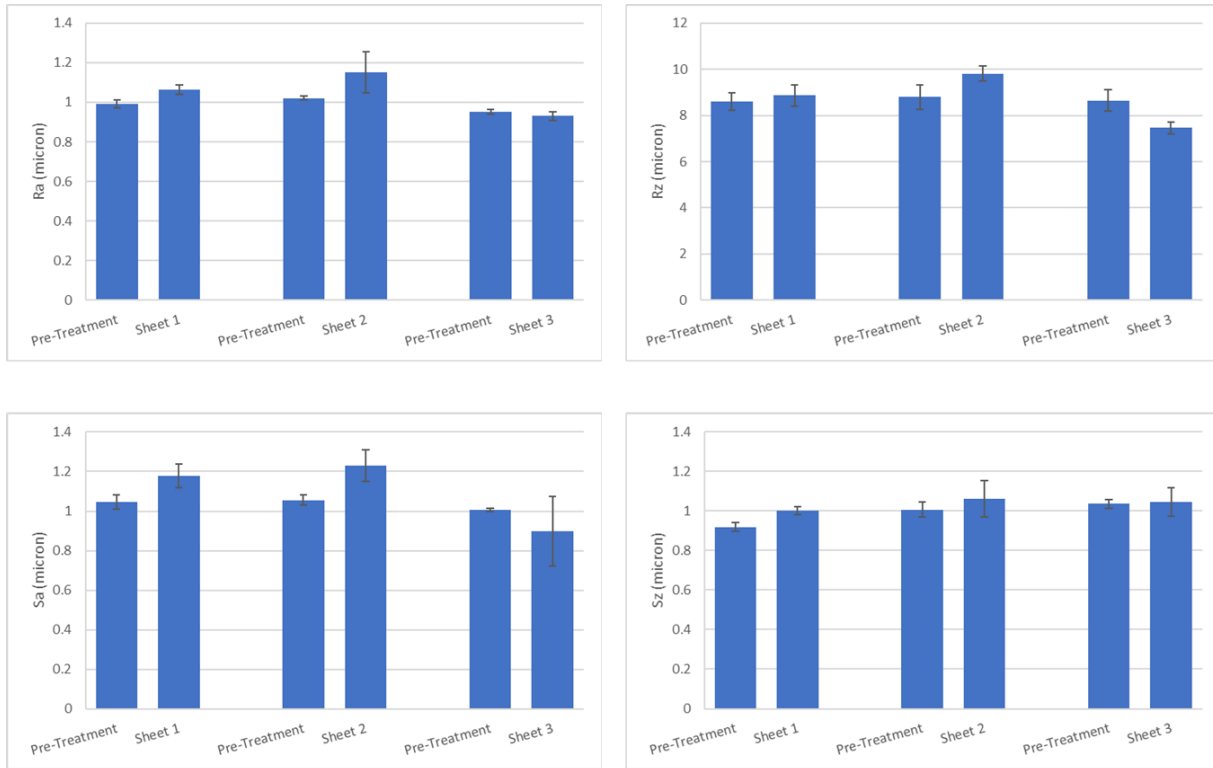
Figure 42. Comparison of the Ra, Rz, Sa, and Sz values before and after polishing with Scotch-Brite™ to remove residual Neolube on surface of heat-treated zirconium.

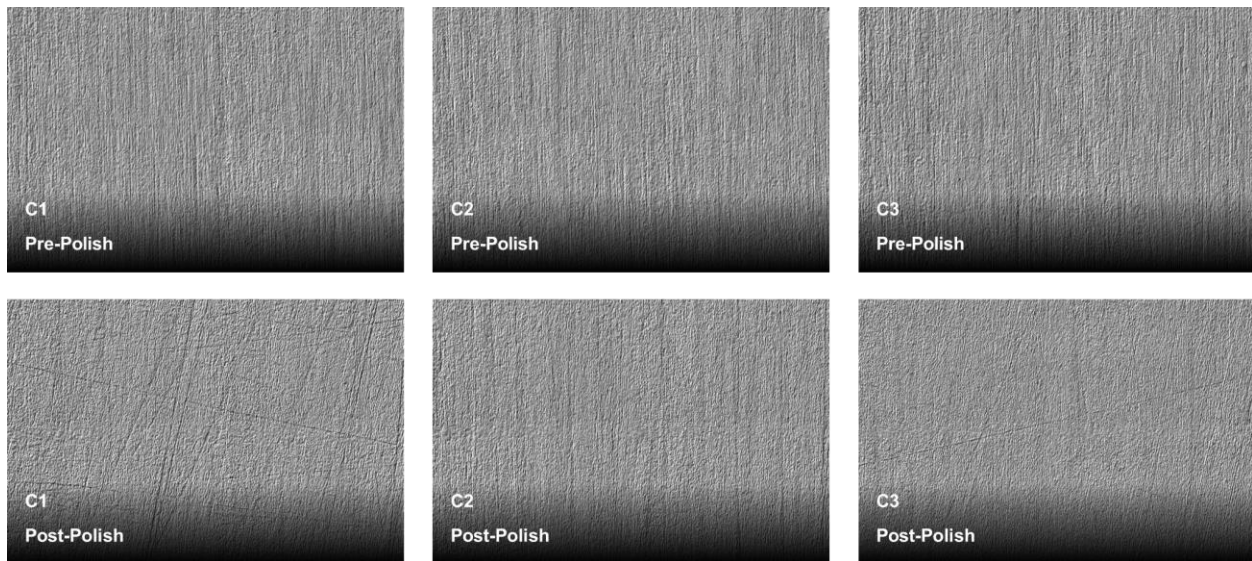
Figure 43. The 10x magnification C-DIC images for Section C from Sheet 1 before and after polishing with the Green Fine Grade Scotch-Brite pads to remove residual Neolube on surface of heat-treated zirconium.

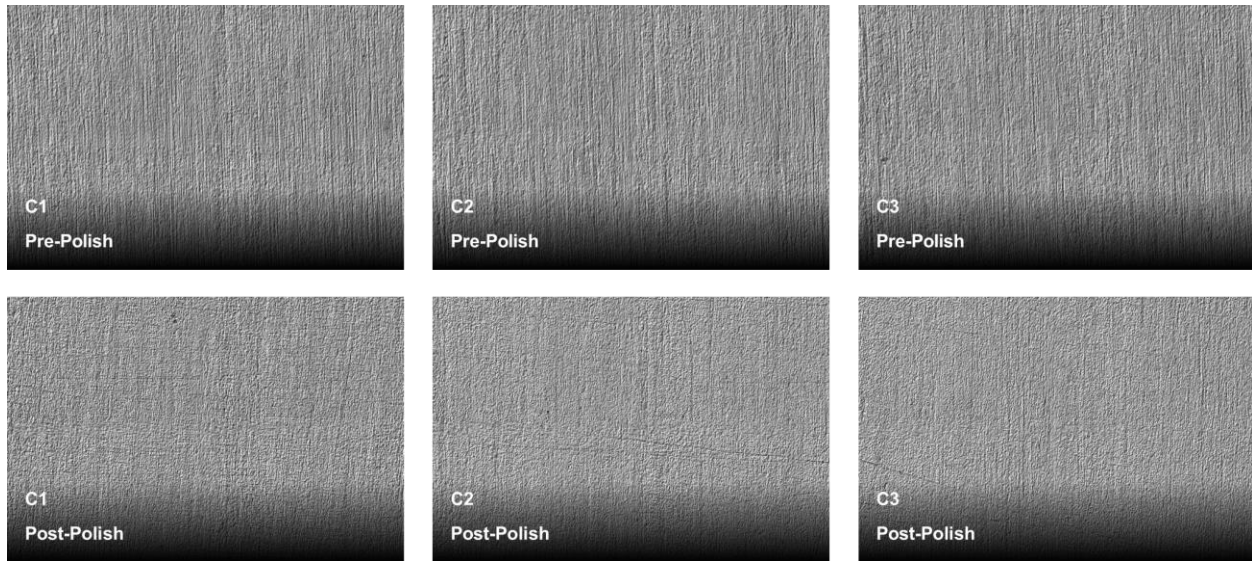
Figure 44. The 10x magnification C-DIC images from Section C of Sheet 3 before and after hand polishing with the Ultra Fine Scotch-Brite™ pad to remove residual Neolube on surface of heat-treated zirconium.

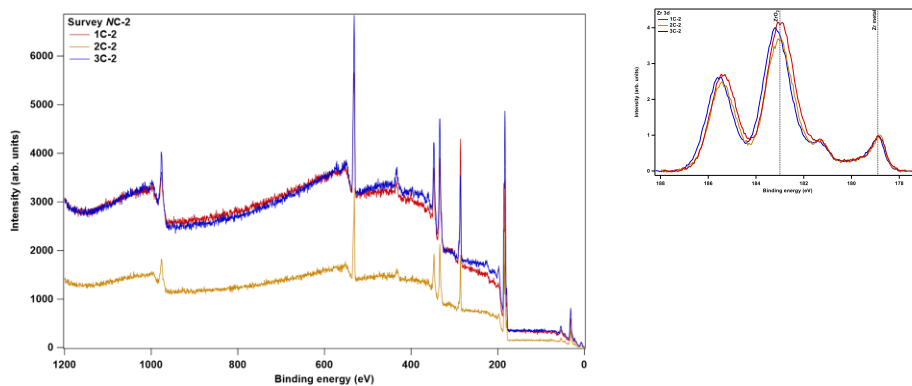
Figure 45. XPS scans of hand polished surface using Scotch-Brite™ pad to remove residual Neolube on surface of heat-treated zirconium.

XRD analysis data found of carbon compounds on the surface like that found on the received plate. The XPS analysis (Figure 45) found carbon present as well along with an oxide layer on the polished plate. XPS also found indications of trace amounts of nitrogen on some of the plates, which is present in the nylon backing of the pads.

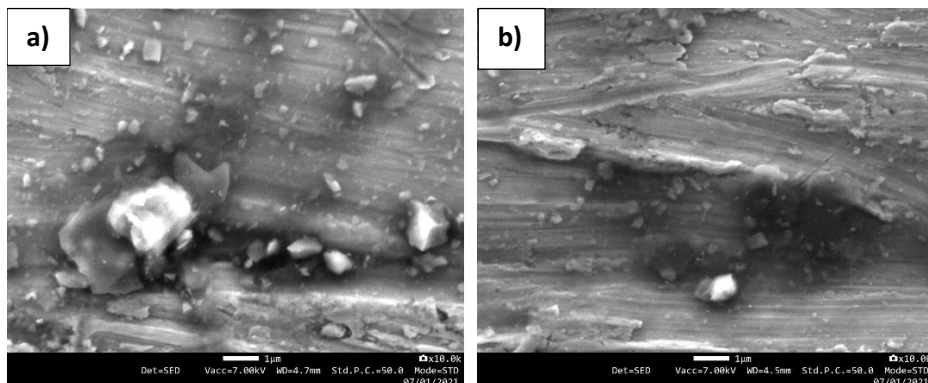
Figure 46. SEM images for samples polished using Scotch-Brite™ pads. Images a) and b) represent locations analyzed at 10,000x magnification.

The SEM surface scans and found no carbide inclusions present. However, imbedded grit particles on the surface are shown in Figure 46, which is a concern when implementing a dry polishing method. Oxide layers were found on the surface of by SEM inspection of the plate cross sections as shown in Figure 47. Thickness measurements were between 2 to 5µm, similar to the other measurements performed.

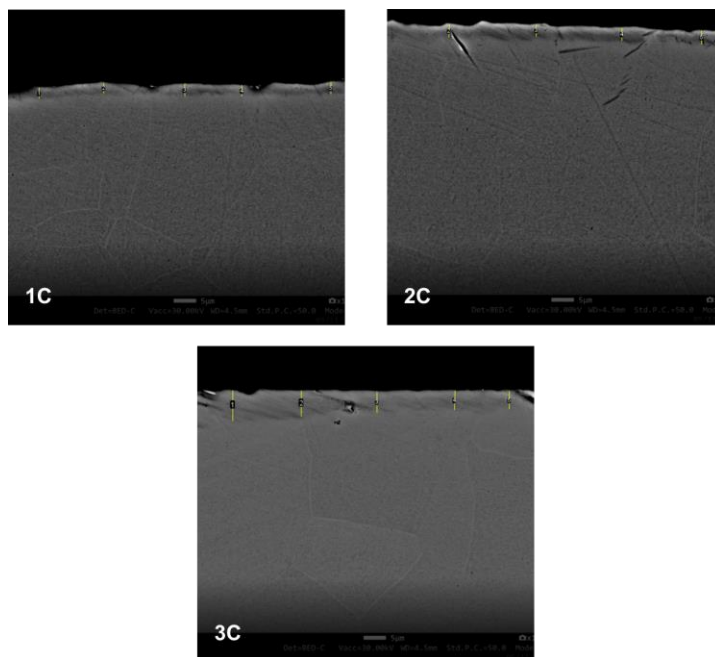
Figure 47. SEM images for the Scotch-Brite™ polished sheets. An oxide layer is visible on each sheet.

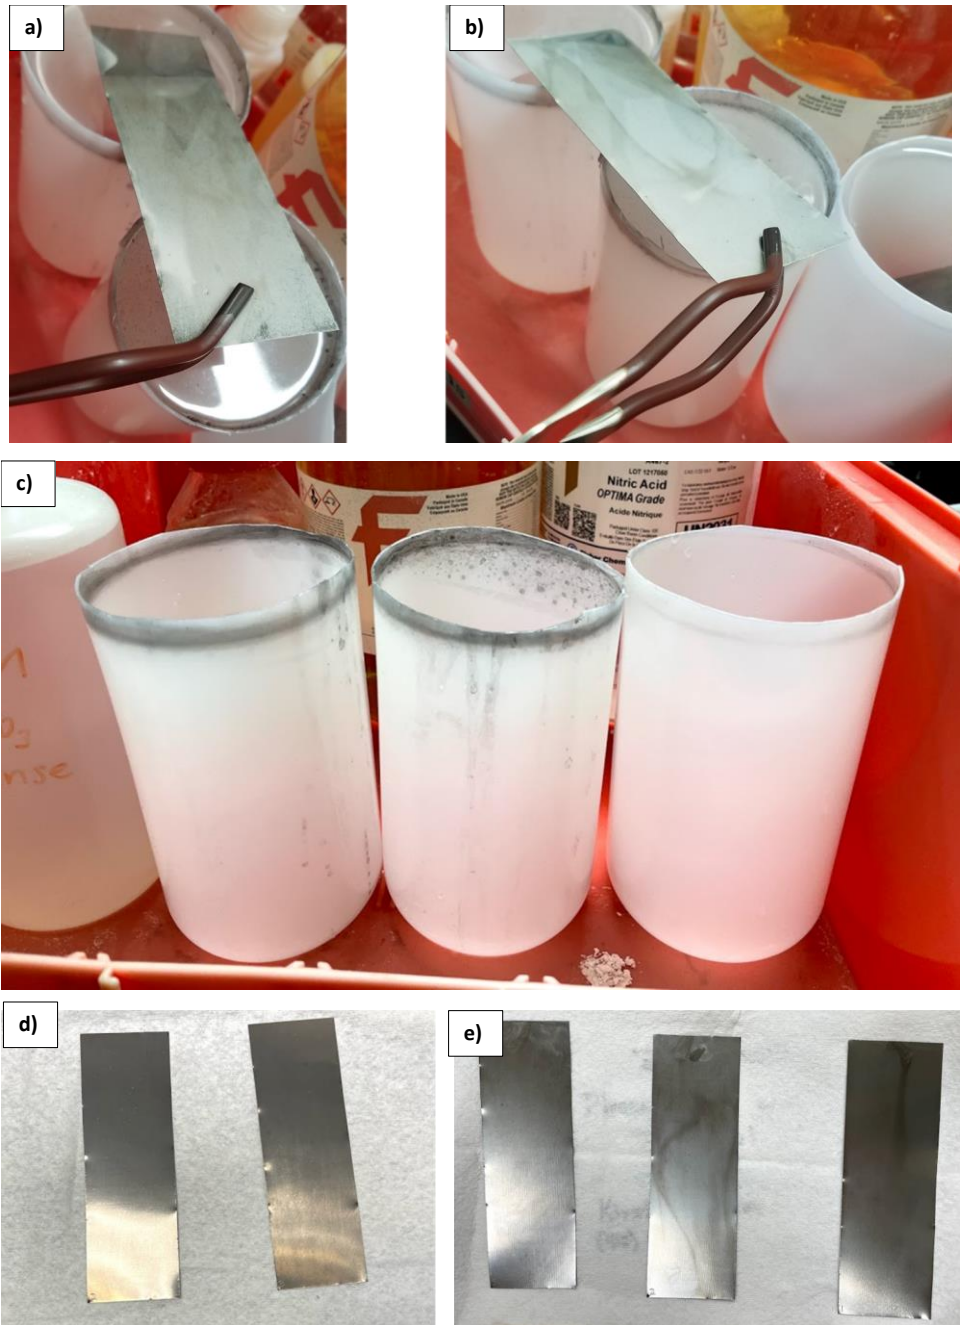
Figure 48. The flash etching process for removing residual Neolube from heat-treated zirconium.

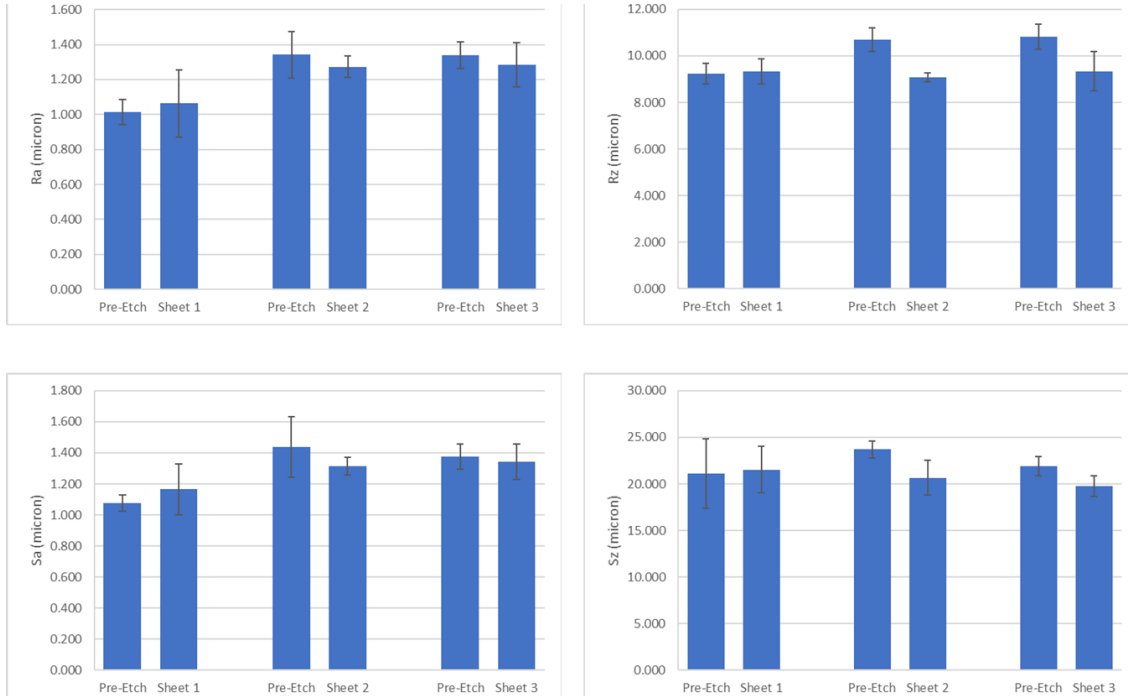
Figure 49. Comparisons of the Ra, Rz, Sa, and Sz values before and after flash etching with HF/nitric acid mixture to remove residual Neolube on surface of heat-treated zirconium.

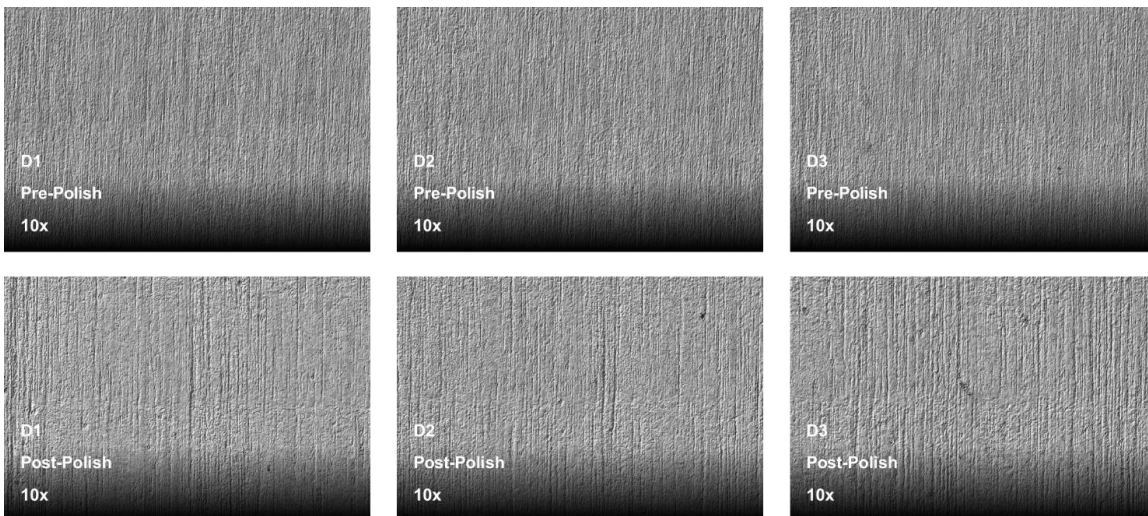
Figure 50. The 10x magnification C-DIC images before and after flash etching with HF/nitric acid mixture to remove residual Neolube on surface off heat-treated zirconium. Note: The top row represents the sheet prior to etching and the bottom row represents the sheet after etching.

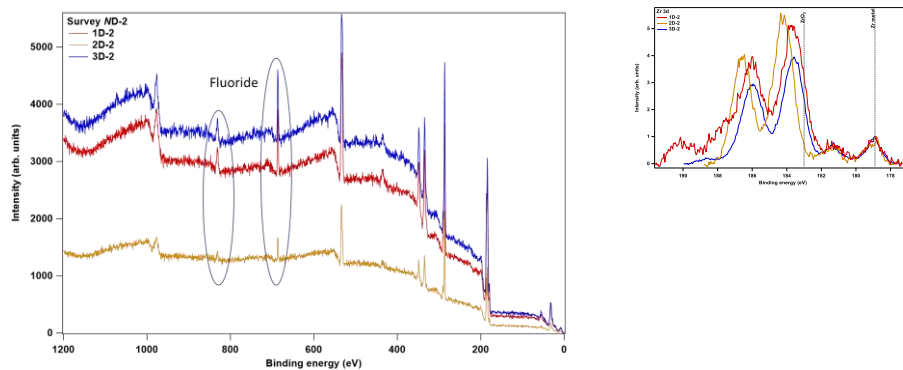
Figure 51. XPS scans of flash etched heat-treated zirconium using HF/nitric acid mixture to remove residual Neolube from surface.

The XRD data and XPS analysis did not find any traces of carbon on the surface, unlike the other testing performed. However, XPS analysis (Figure 51) found strong indications of fluoride present, likely from the use of hydrofluoric acid in the etchant. XPS also found strong indications of a zirconium oxide layer present with a noticeable shift in the binding energy when compared to the other oxide layers detected (Figure 51). The shift is believed to be caused by the presence of fluoride in the oxide layer.

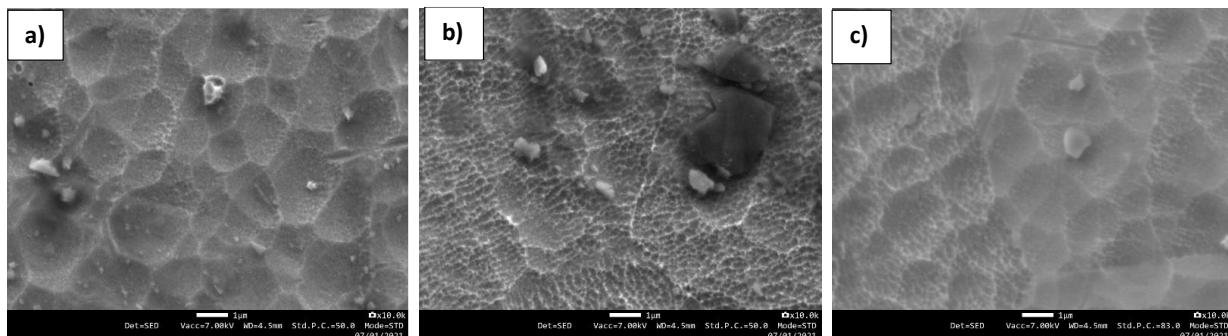
Figure 52. SEM images for etched samples. Images a), b), and c) represent the three locations imaged at 10,000x magnification. No inclusions were found on the surface.

SEM images of the surface (Figure 52) found the surface free of any carbide inclusions. Comparison with the polished surfaces show differences from the etch, with a “cratered” appearance that comes from the generation of gas on the surface from the etchant, versus the “scratched” surface seen from abrasive media. SEM examination of the cross-sections of the surface (Figure 53) indicate an oxide layer was present like other cleaning methods, supporting the XPS findings.

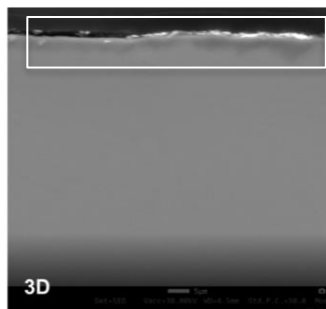
Figure 53. The SEM images for the cross sections of the flash etched sample with indication of oxide layer present.
