PNNL-32984

Final Report: Improved Understanding of Zircaloy Hydrogen Pickup Mechanisms in BWRs

NSUF Report

June 2022

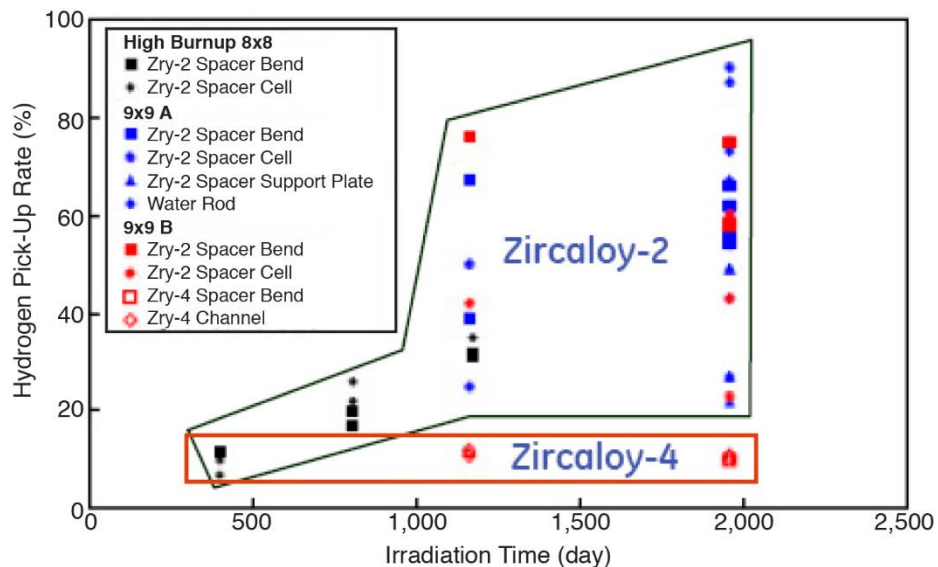
Figure 1: Hydrogen Pickup Rate vs. Irradiation Time for Non-Heat Transfer Fuel Components¹.

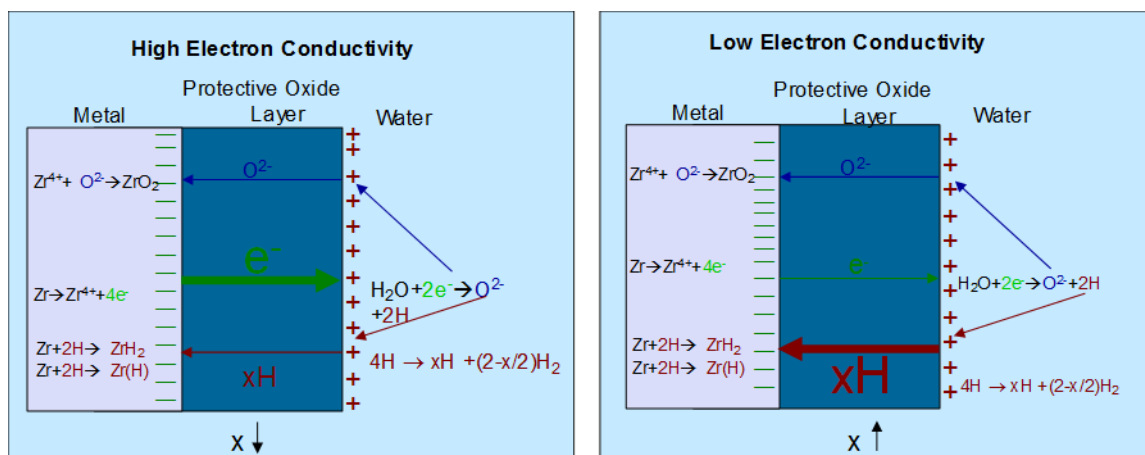
Figure 3: Schematics of hypothesis on oxide electron conductivity and hydrogen pickup relationship. Derived from recent work by Couet ⁷⁻⁸.

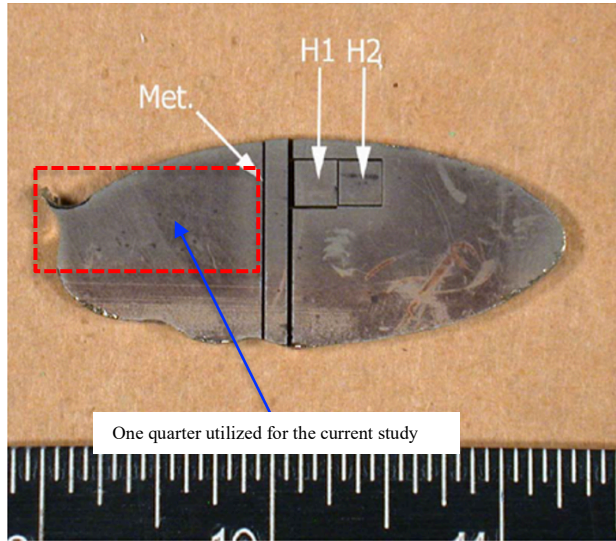
Figure 5: One-quarter of each irradiated fuel channel coupon utilized for the current study; H1, H2 and Met specimens utilized for previous study

One-fourth of each of the irradiated fuel channel was utilized for the current study (performing electrochemical testing), as shown in Figure 5. The dose rates of each sample (one quarter) ranged from 50-80 mrem/hour @ contact and less than 5 mrem/hour @ 30 cm. The photographs of fuel channel samples (22A, 22C, 12A and 12C; Material #16-1, #16, #12-1 and #12) are shown in Figure 6-Figure 9.

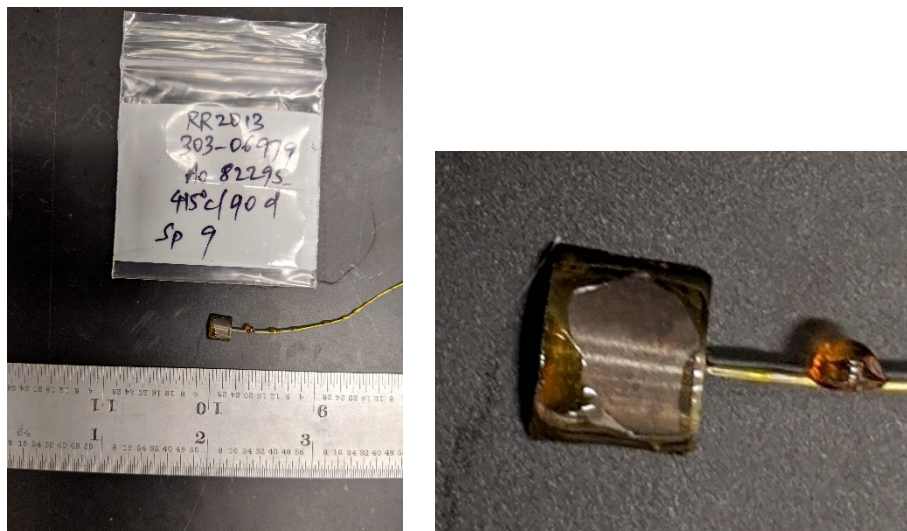
Figure 35: Polyimide coated unirradiated oxidized Zr-2 specimen (oxide side)

layer to be studied (top side) is supposed to remain uncoated (polyimide), a smaller amount of insulating coating was applied in areas that appeared weak (oxide layer potentially damaged) as shown in Figure 35. The photographs do not clearly show the application of coating on the specimen due to light reflection. Physical observation showed that the specimen was protected by the coating in the intended regions. Certain regions on the specimen showed the presence of a thicker layer (bubble-like appearance) of coating that accumulated after drying. The exposed area was determined using an optical micrograph and comparing with the known dimensions.

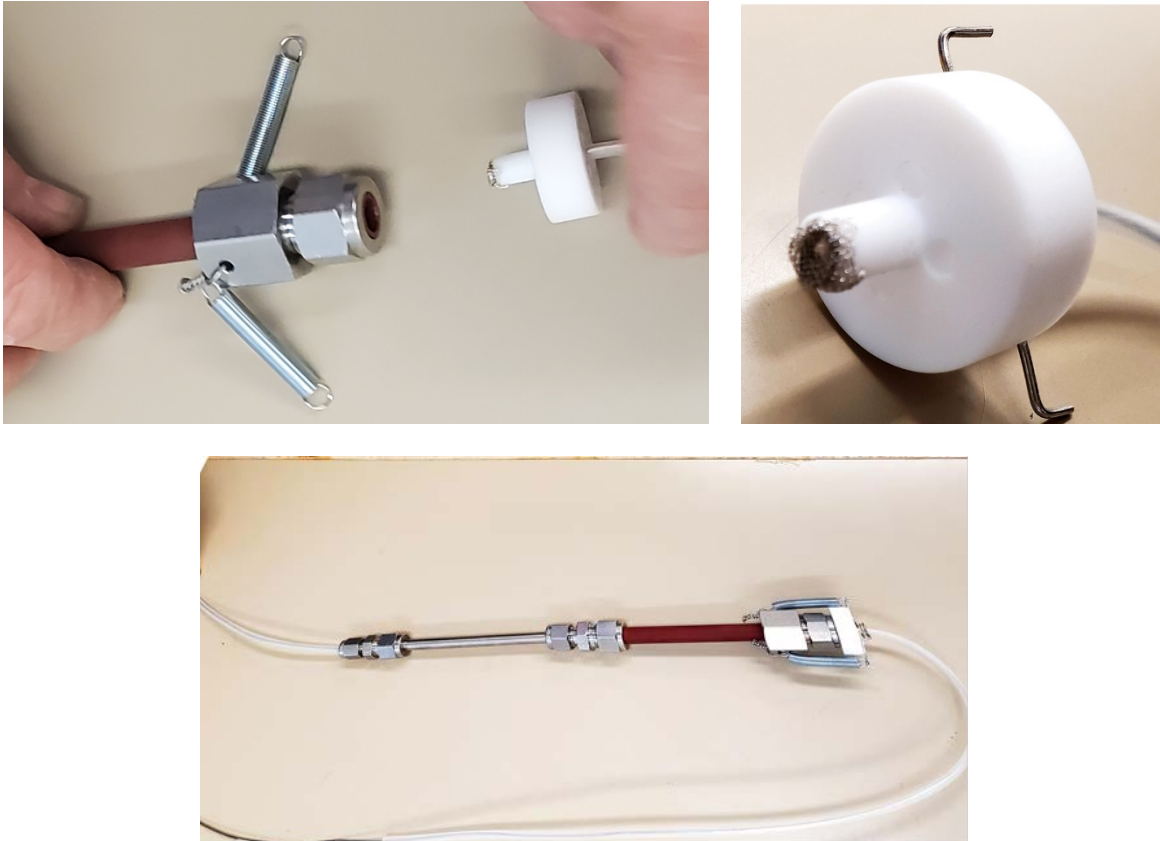
Figure 47: Photograph of EIS test fixture and design #3

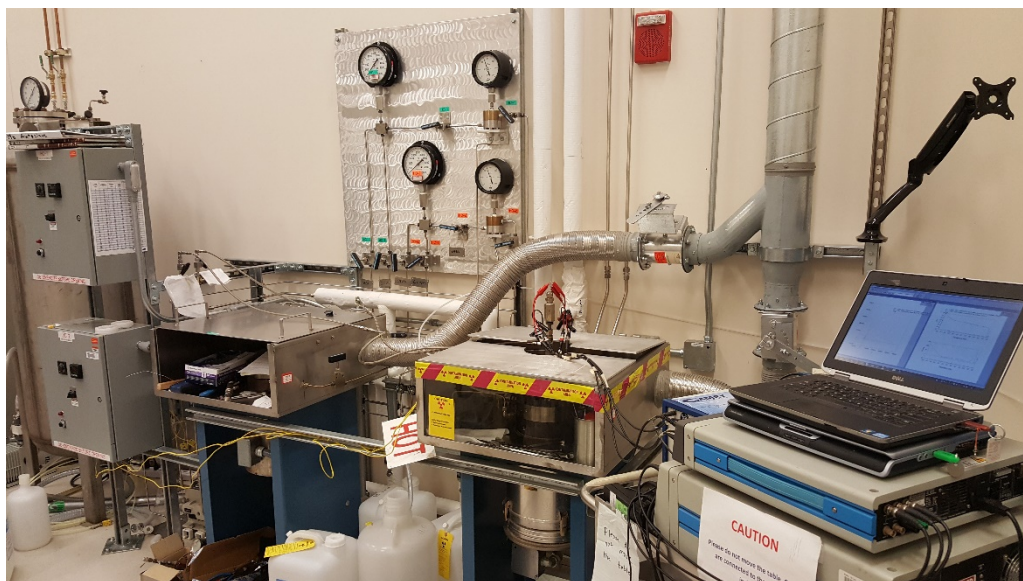
Figure 52: Electrochemical test setup with an autoclave

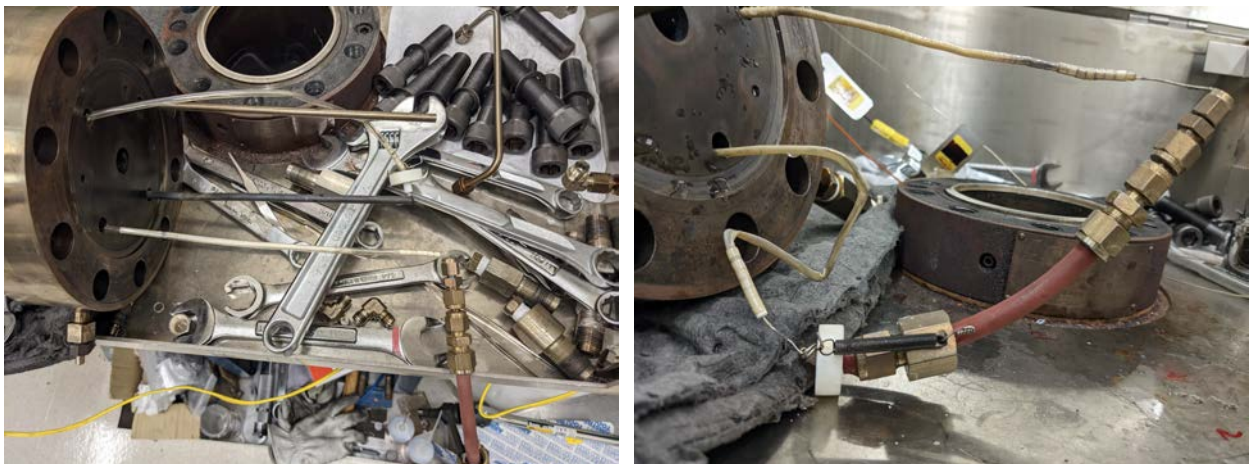
Figure 75: PNNL Fixture Design #3 (before and after 288°C testing inside an autoclave with PWR water)

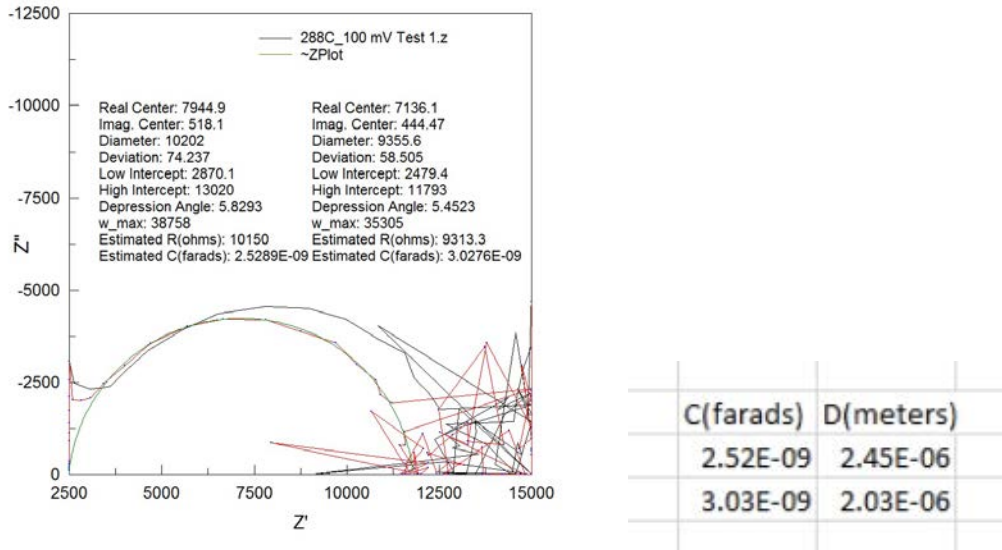
Figure 76: Estimated oxide thickness (D) from EIS test data (100 mV AC amplitude) - unirradiated Zr water rod sample with a 6-micron oxide layer tested in PWR water at 288°C.
