# Biofouling Analysis for Wave Energy Piston Design

## Post-Access Test Report

Awardee: Triton Systems, Inc.

Facility: Pacific Northwest National Laboratory – Marine and  
Coastal Research Laboratory

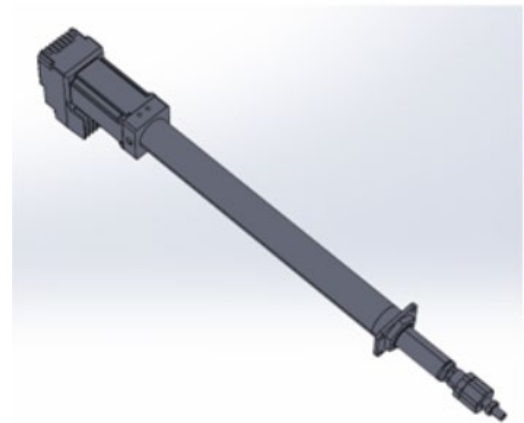
Table 1: Actuator Details

Item	Detail	Description
Manufacturer	Tolomatic	
Model	ERD15	Rod-style actuator
Stroke length	310 mm	
Motor	ASCI DC integrated servo	NEMA 23 frame size
Excitation	24 VDC	External power supply
Coupler	ALC	Alignment Coupler
Pitch	BNM05	5mm Ball Screw

Tolomatic's Actuator Sizing tool was used to select an actuator for this application. A 100lb loading scenario was used with an average speed of 0.5in/s. The tool recommended an ERD15 actuator and selections were refined and confirmed by a local representative. The official part number is ERD15 BNM05 SM310.000 LMI ST1 AMI2C1A1 FFG ALC ARI CR58.

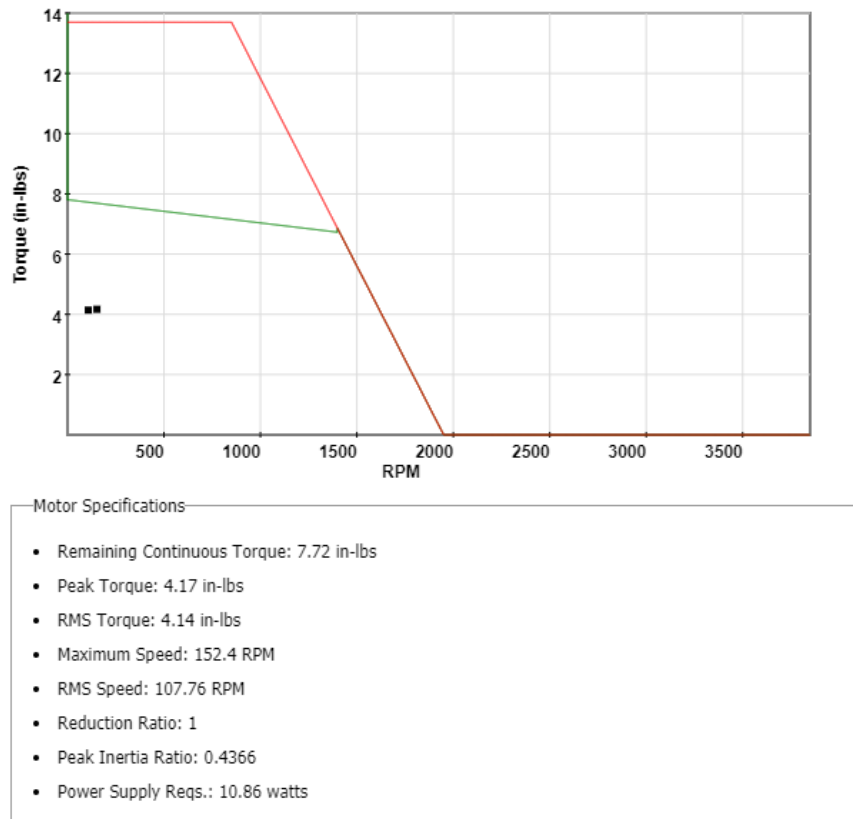
Figure 8: Motor Specifications for Tolomatic ERD Actuator

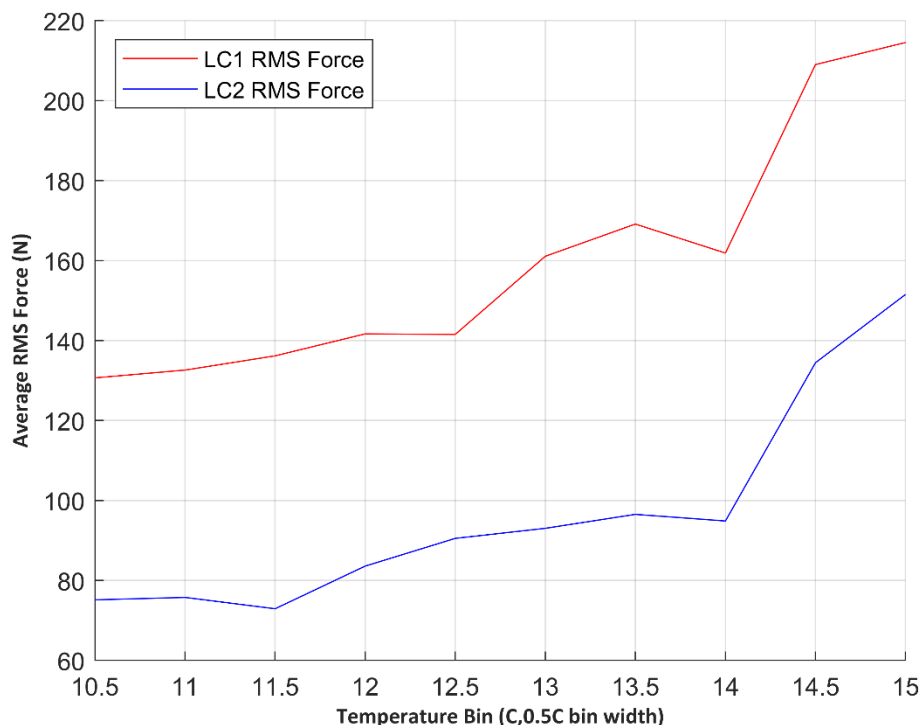
Figure 17: Average RMS force by temperature bin for assembly 1 (LC1) and assembly 2 (LC2)

Load cell force was binned based on corresponding temperature readings, and the results are plotted in Figure 18. The general trend demonstrates increasing forces for both assemblies with increasing

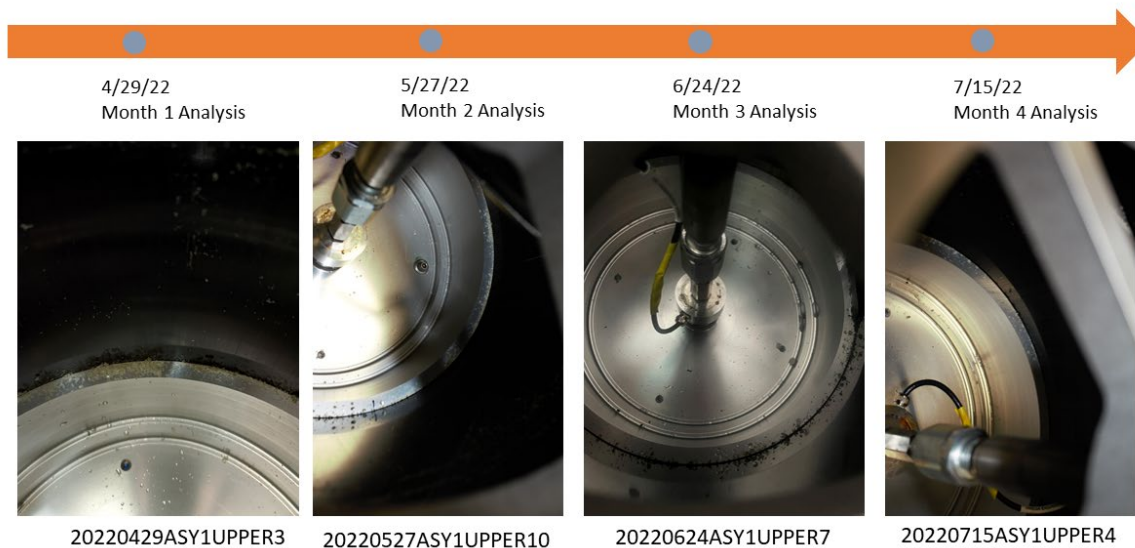
Figure 22: Top of piston 1 before removal of assembly from tank, photographed at 1 month intervals over 4 months of testing

Continuation of the described trends was observed until the assemblies were pulled from the tank for the final time in month 4. Barnacles were more numerous and larger than previously observed, with some measuring as large as 10 mm in diameter. The biofilms interior to the tube and above the piston head continued to grow, as did the white/clear nodules forming in void spaces.
