Light Water Reactor Sustainability Program

Extended Bandwidth Spread Spectrum Time Domain Reflectometry Cable Test for Thermal Aging, Low Resistance Fault, and Water Detection

September 2023

**S.W. Glass, J. Tedeschi, M.P. Spencer, J. Son, D. Li, M. Elen, L.S. Fifield
Pacific Northwest National Laboratory**

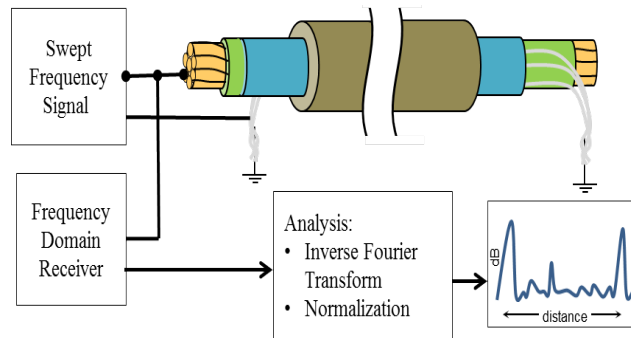
Figure 1. FDR cable test introduces a swept frequency chirp onto a conductor then listens for any reflection from any impedance change along the cable length. Listening is captured in the frequency domain then transformed to time domain using an IFT (Glass et al. 2017).

FDR is being used in NPPs particularly to locate areas of concern (AMS 2019). The FDR instrument—typically a VNA—is connected to two cable conductors, with one considered the primary conductor under test and the other considered as the system ground, as shown in (Figure 1), or to a parallel conductor within the cable bundle (Glass et al. 2017). The instrument directs a swept frequency chirp along the conductor and then listens for any reflection caused by an impedance change along the cable length. By listening and detecting reflections in the frequency domain then transforming to the time domain with an inverse Fourier transform (IFT), significant noise immunity and sensitivity to subtle impedance changes can be achieved. BW for FDR is software adjustable up to 1.3 GHz, but experience has shown that the best responses occur from 100 MHz to 500 MHz for cable anomaly detection. Higher BW FDRs produce sharper peaks capable of spatially resolving more closely spaced impedance changes, but higher frequencies do not propagate as far along the cable length. FDR instruments are restricted to relatively low voltages and currently cannot tolerate testing on energized cable systems.

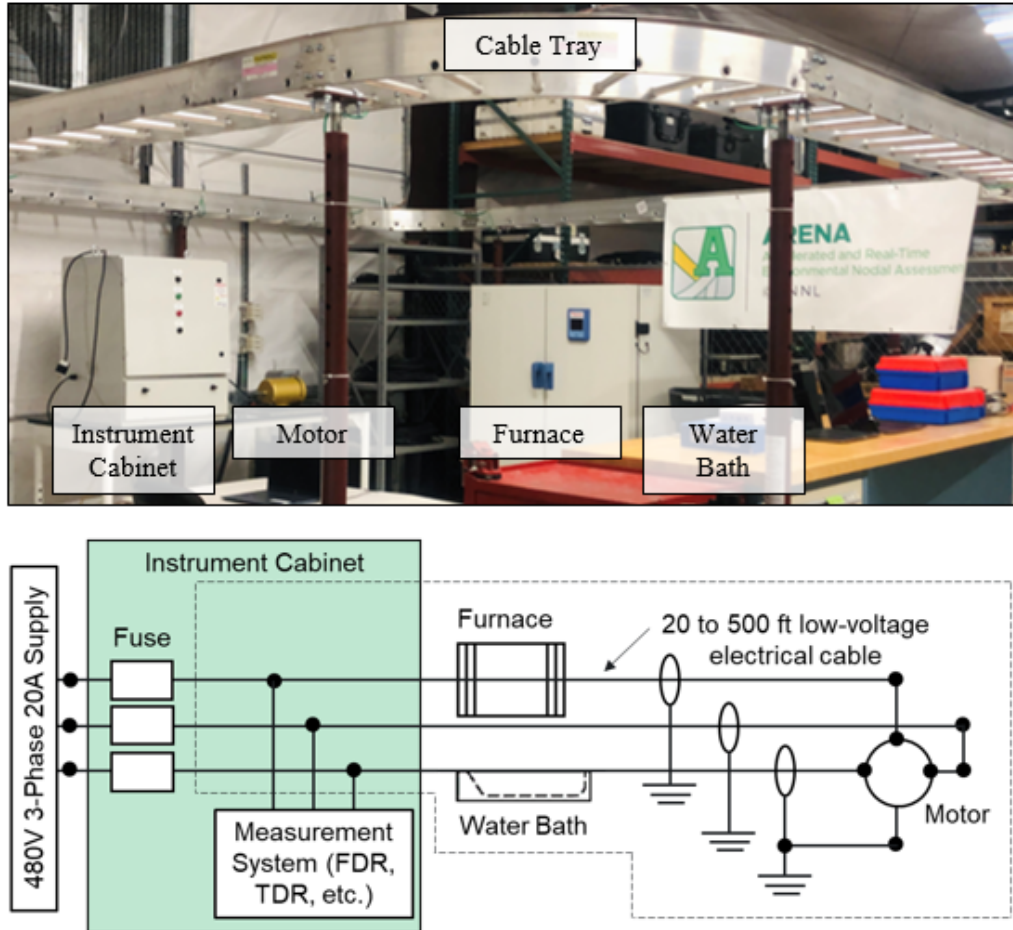
Figure 5. The ARENA test bed (top) digital image and (bottom) schematic (Glass et al. 2023).

To evaluate the degradation of electrical cables, particularly the interaction of electrical cable test technologies with various damage mechanisms, PNNL developed the ARENA test bed (Glass et al. 2023); see Figure 5. The vision behind creating this facility was to establish a modular test facility that allows for implementation of a broad range of test methods to detect faults and anomalies in a variety of cables and systems in a controlled environment. The test setup was similar for the 2022 work, and as much as possible, the test arrangement was repeated for this round of FDR and SSTDR cable tests.

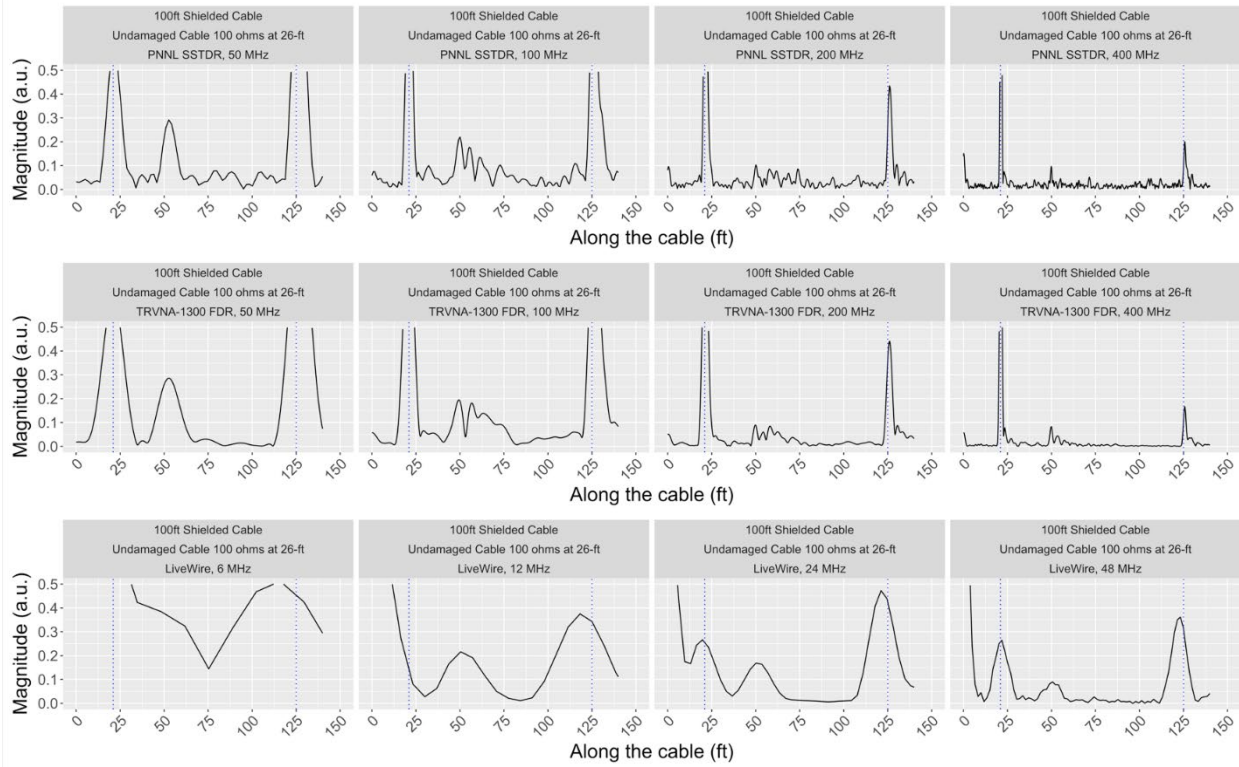
Figure 7. Magnitude response for 100 ft shielded and undamaged cable with 100 ohms at 26 ft (shown as approximately 50 ft on plot due to test lead).

Phase-to-phase faults were detected to varying degrees depending on the instrument and BW. Responses to 100, 312, and 2k ohms at 26 ft are shown in Figure 7, Figure 14, and Figure 15. Generally, the higher frequency PNNL SSTDR and FDR plots showed responses most clearly. The 100 ohm fault was seen by FDR, PNNL SSTDR, and LiveWire, but LiveWire did not detect the 312 ohm or 2k ohm faults. This seemed to be a case where the higher PNNL SSTDR BW improved detection.

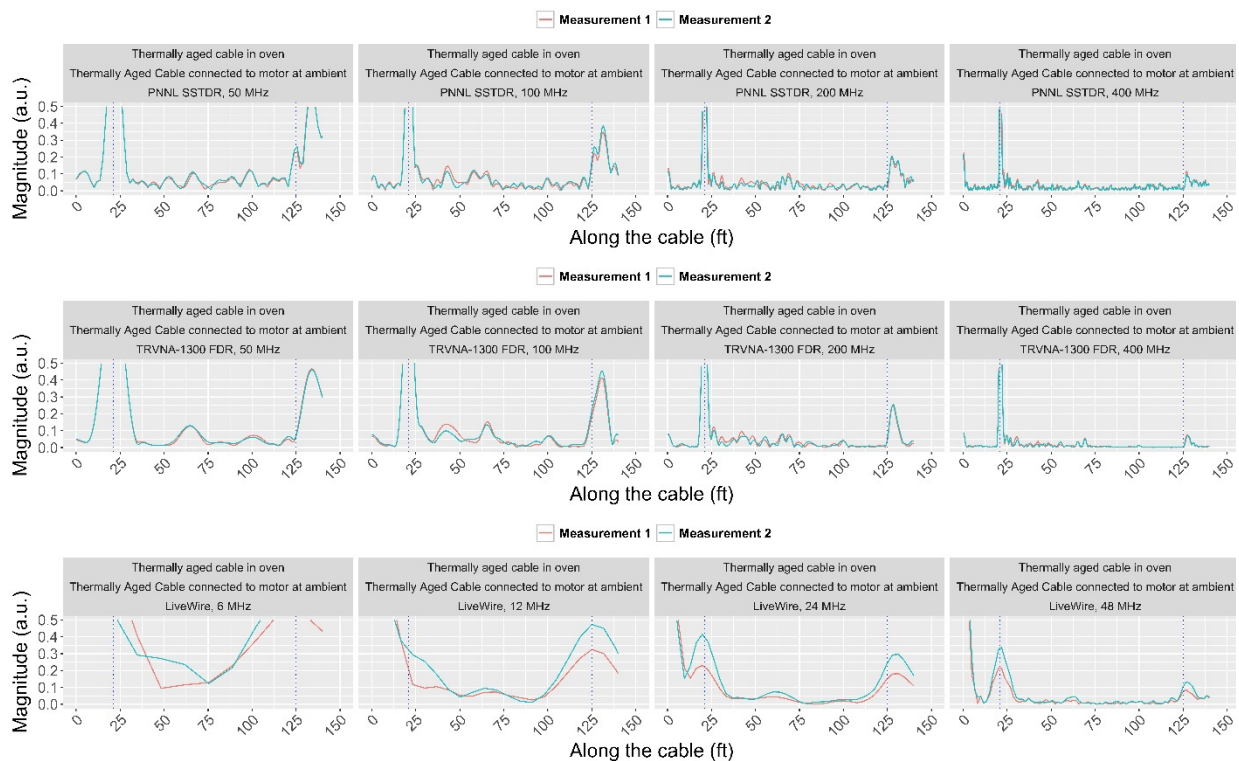
Figure 10. Measurement repeatability tests separated by one month; thermally aged cable in oven connected to motor at ambient temperature.

There was some concern that the indications from the 60 day thermally aged cable were not as obvious as had been previously observed. There was also an interest to repeat earlier measurements to check for measurement repeatability after a period of time. The thermally aged cable was still in place from tests performed a month earlier, so the tests were repeated. Responses are shown in Figure 10 and Figure 11. The two test conditions (measurement 1 and measurement 2) were essentially the same except that they were separated by more than one month. The largest differences were noted in the LiveWire SSTDR response, but overall, the measurements were remarkably similar. Much of the plots are separated by a line width or less.

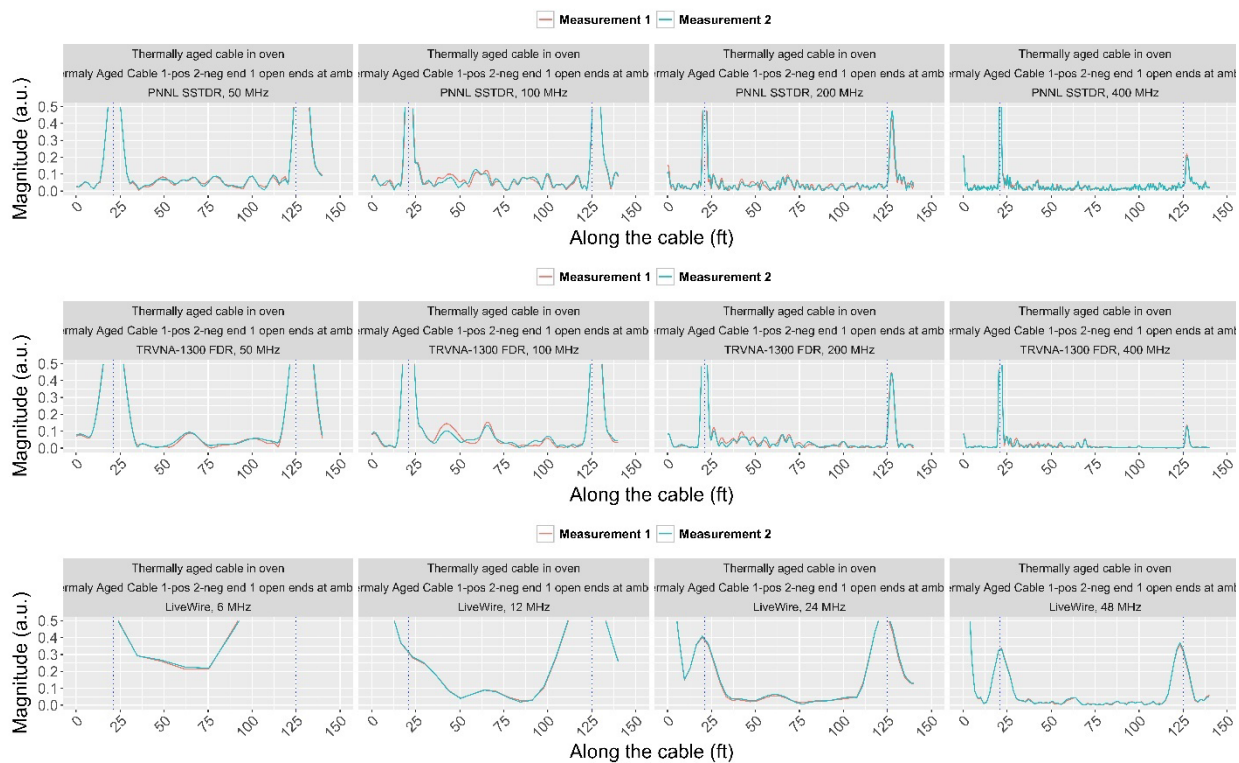
Figure 11. Measurement repeatability tests separated by one month; thermally aged cable in oven open ends at ambient temperature.

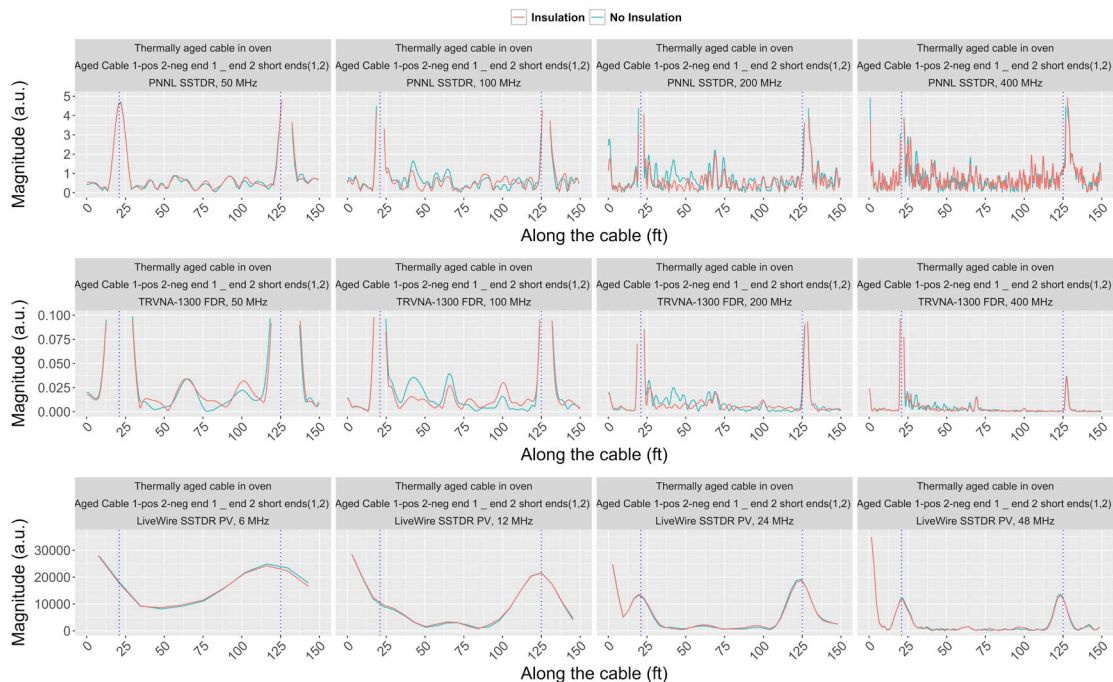
Figure 13. Overlaid reflectometry plot with and without foam insulation between cable and cable rack. Note reduced peak amplitude at 40 ft, particularly for 100 and 200 MHz BW plots with foam insulation. Entry and exit from the oven at 60 and 100 ft are observed clearly on the FDR plots at 50 and 100 MHz and to a lesser degree only on FDR 200 and 400 MHz and perhaps (mostly for oven entry) for PNNL SSTDR @ 50 and 100 MHz.

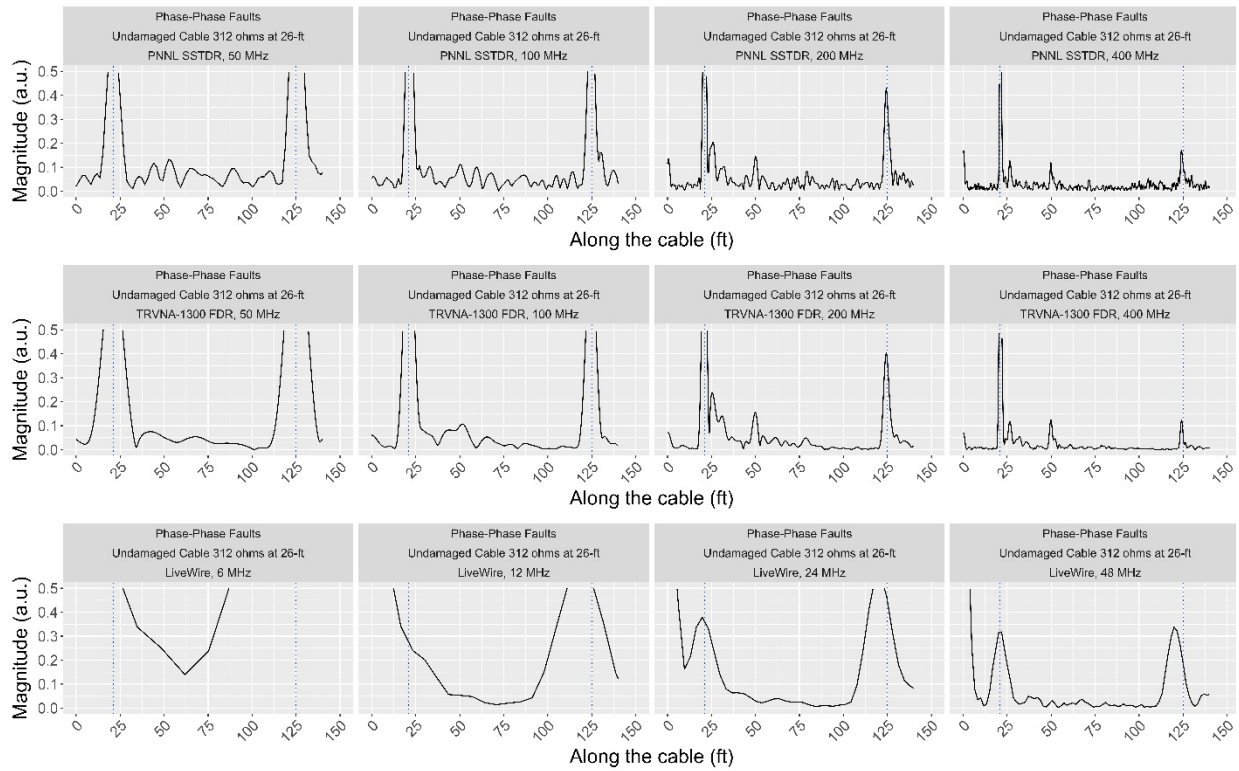
Figure 14. Magnitude response for 100 ft cable with 312 ohm fault at 26 ft (26 ft on cable, 50 ft on plot due to test lead).

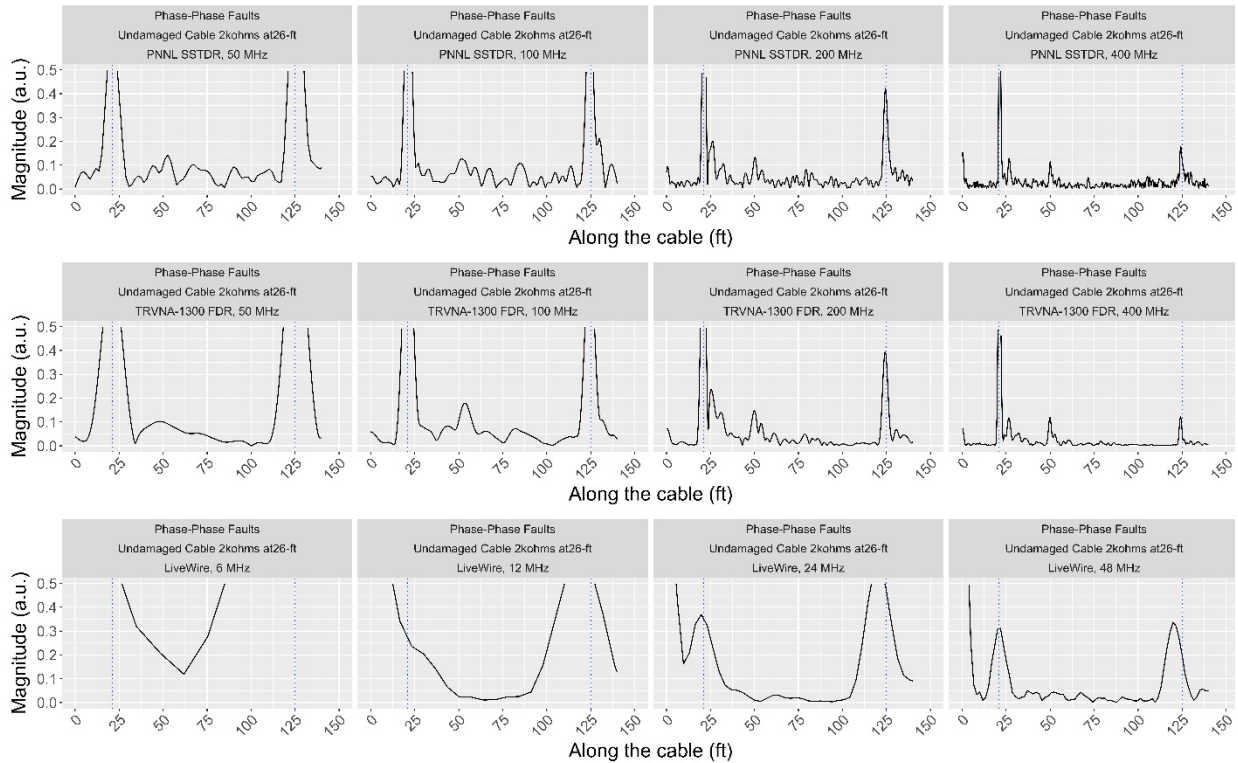
Figure 15. Magnitude response for 100 ft cable with 2k ohm fault at 26 ft (26 ft on cable, 50 ft on plot due to test lead).

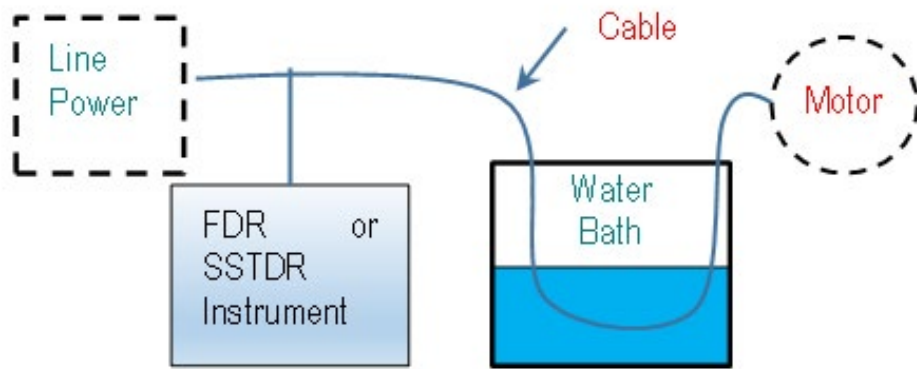
Figure 16. Water bath test configuration shown connected to live power (above) and photographed in cable in the water bath (below). Tests shown in this report did not have the cable energized but this has been shown in earlier reports.

The submerged section of the unshielded cable in the ARENA water bath at 60 ft along the cable (Figure 16) can be seen in Figure 17 as a single peak in the 50 and 100 MHz FDR and the 48/50 MHz SSTDR responses. The PNNL SSTDR 100, 200, and 400 MHz BW have peaks that seem to correlate with the cable entry and exit from the water bath, but the surrounding noise makes this hard to confirm with certainty. As expected, there were no peaks observed in the shielded cable passing through the water bath.

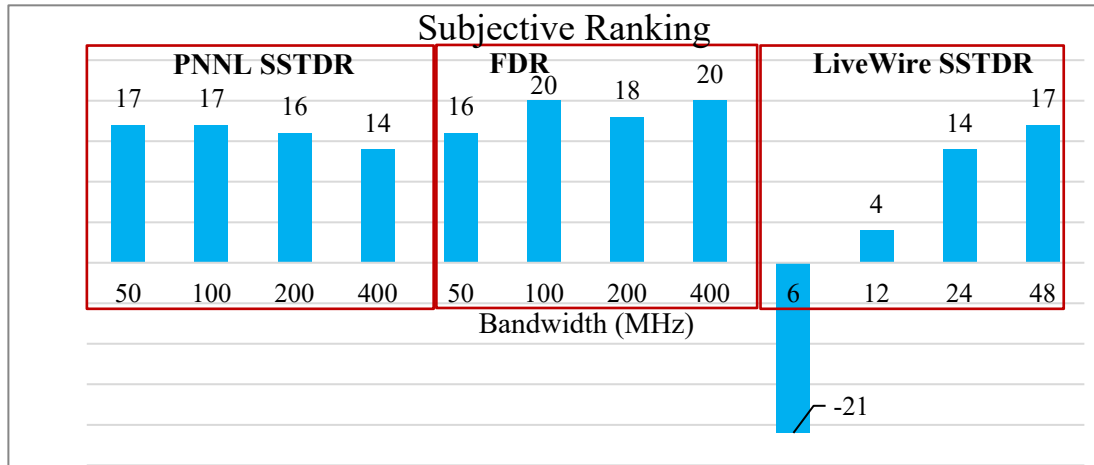
Figure 18. Subjective ranking of instruments and BWs to detect damaged and undamaged reflectometry results.

The subjective ranking of the three techniques and their respective BWs are shown in the bottom row of the table summing the columns for each frequency BW. This is recognized only as a figure of merit but does serve to capture and compare all instruments and their available BW data. These totals are shown visually in Figure 18. As expected, scores were highest for FDR and were similar for the PNNL 50 MHz and LiveWire 48 MHz BWs. Scores for the lower frequency LiveWire SSTDR (6 and 12 MHz) and the higher frequency PNNL SSTDR (400 MHz) were lower.
