# PIE-Enabled Study of Aqueous Corrosion & Zr Hydriding in Cr-Coated Cladding

M3GV-23PN0101132

May 2026

<sup>1</sup> Pacific Northwest National Laboratory

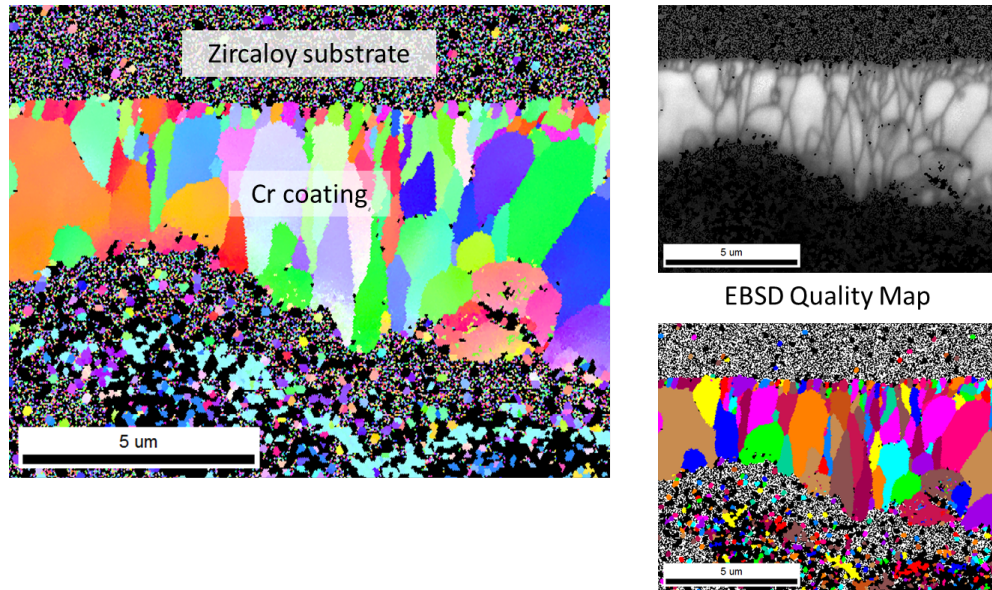
Figure 3.9. EBSD mapping collected at lower magnification of the PVD Cr-coated non-radiological cladding.

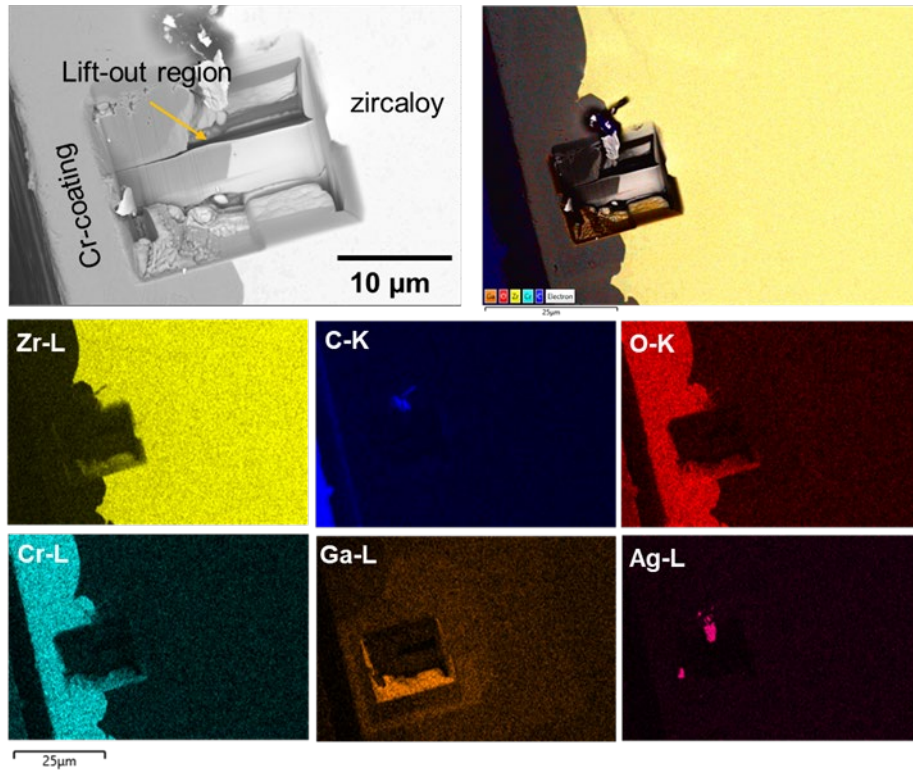
Figure 3.24. SEM analysis of the region from the TEM lift-outs, showing the Cr-Zr interface area. Ga and Ag were contaminants from the ion gun and the conductive coating, respectively.

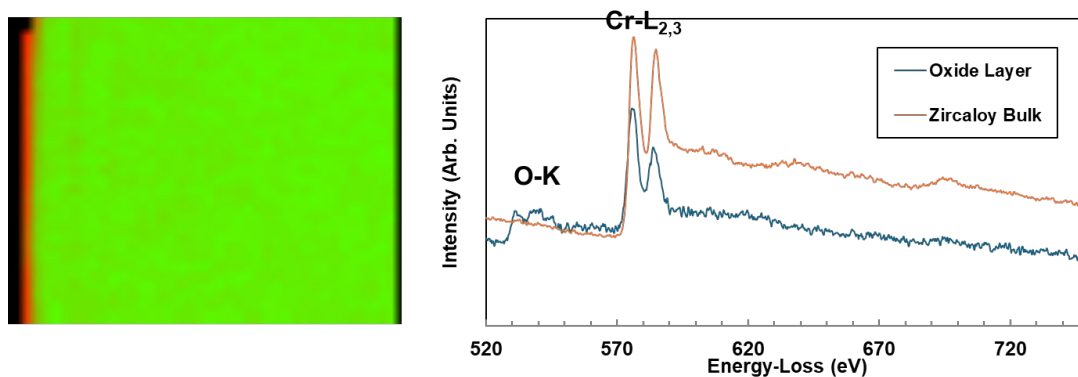
Figure 3.30. There was evidence of an oxide layer in MO-Z-C1-1 on one side of the lift-out in the bulk chromium region from the TEM lift-out with EELS.

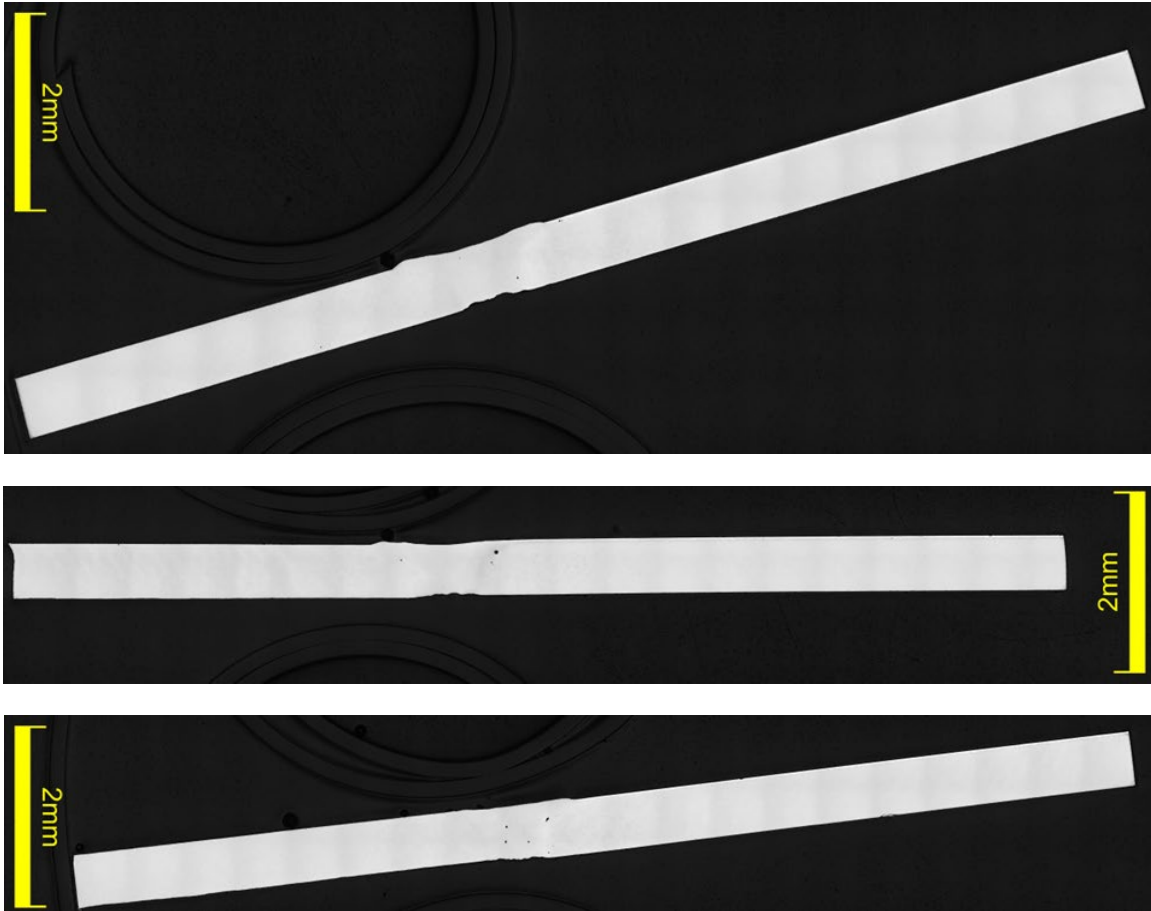
The second laser sample, which captured the second weld on the parent sample, was also prepared in the same longitudinal manner, and potted in epoxy and polished for OM observation. Figure 3.48 shows the longitudinal images from the OM, with the samples showing high variability in straightness in the welded zone nearing the center of the specimen. In agreement with the L1-1 sample, the L1-3 laser welded sample exhibited no hydrides in the material.

Figure 3.48. Polished longitudinal edges of MI-Z-L1-3, samples 1, 2, and 3.

Images of the welded zone show high variability and deformity in the general welded area. It is unclear what the black speckles observed in the welded area are, but given they are concentrated in the heat affected weld area, this could be a consequence of the welding process as opposed to debris remaining from potting and polishing process. The variability in the weld area and black speckling was further pronounced in Figure 3.49.

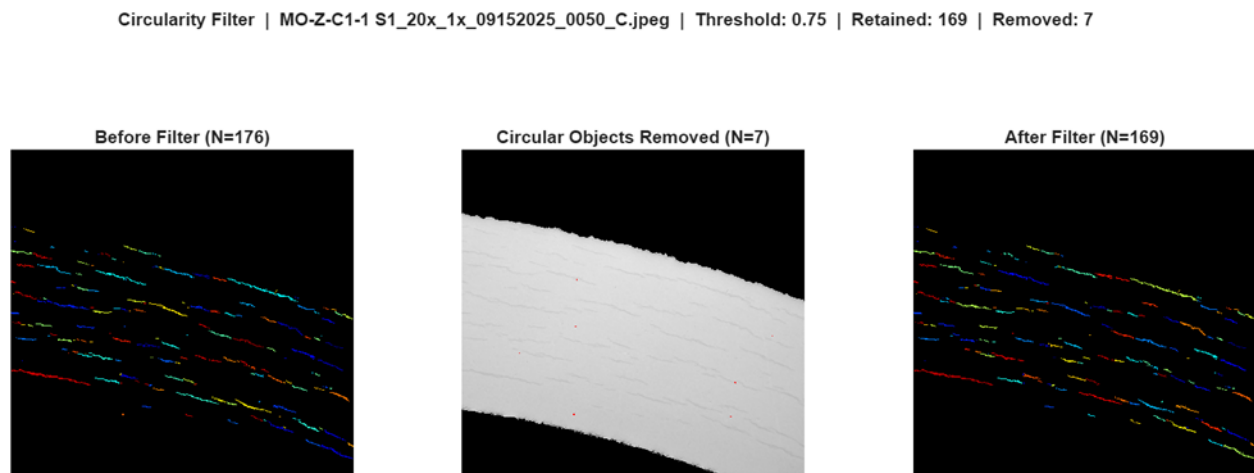
Additionally, a circularity filter was applied to the binary to remove any objects that exceeded the minimum hydride size but are clearly not hydrides. In observation, hydrides form long, narrow, objects, so filtering based on circularity works well to remove artifacts like dust particles or pits (Figure 3.70).

Figure 3.70. Circularity filter visualization for sample MO-Z-C1-1 S1.

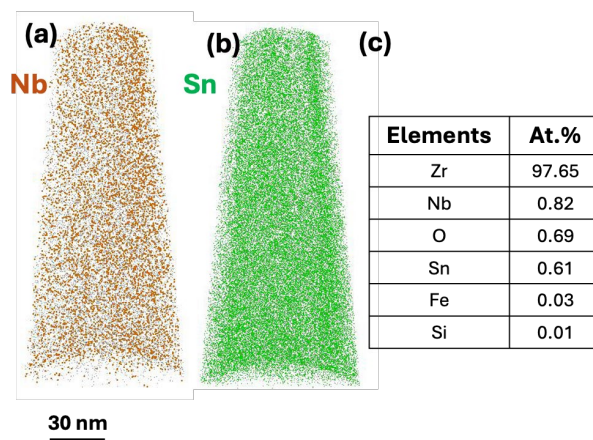
Figure 4.14. APT analysis of the Zr alloy region in as-fabricated cold spray sample R-Z-C1 (specimen prepared  $\sim 1 \mu\text{m}$  from the Cr/Zr interface): three-dimensional atom maps showing a uniform distribution of (a) Nb and (b) Sn; (c) measured bulk composition table confirming the absence of detectable Cr or Fe, consistent with no interdiffusion in the as-fabricated state.
