BEDA Accelerator

UBID Matching Washington, DC

Kevin Keene, Nora Wang, Mark Borkum
Pacific Northwest National Laboratory

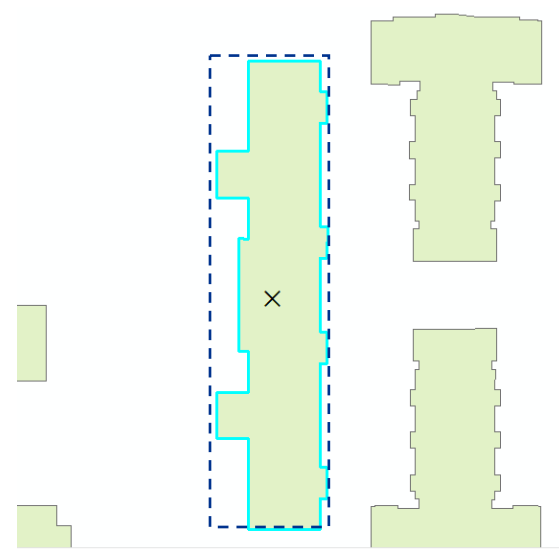
Benchmarking Point

PID: PM05823132

87C4VXJM+452-0-0-0-0

Footprint (Bounding Box)

87C4VXJM+456-29-5-29-6

UBID₀ is used for intermediate matching step between points and polygons

MATCH

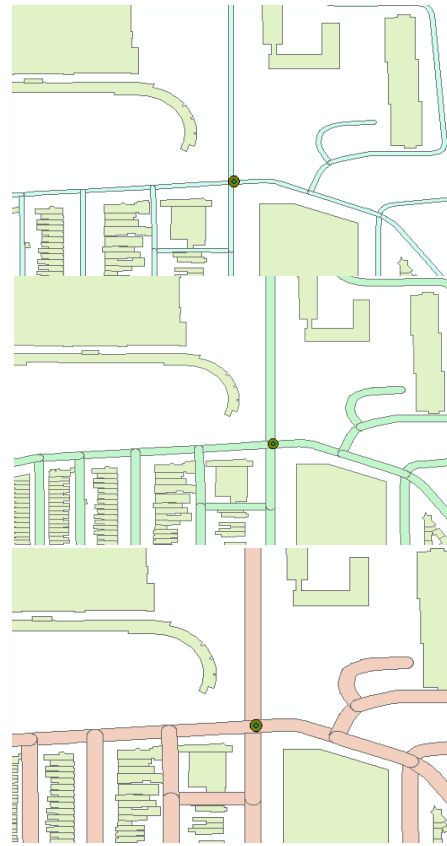
Unmatched: UBID₀ in Street

- 5ft buffer: 32 UBID₀
- 10 ft buffer: 66 UBID₀
- 15ft buffer: 71 UBID₀

Note: streets are specified as alley, avenue, etc – can make different buffers size for each (buffer sizes above just a proof of concept)

- Detect using street shapefile and buffer zone

Recommended Solution: Use address matching to match majority of cases, manual matching for what remains of the ~70 cases

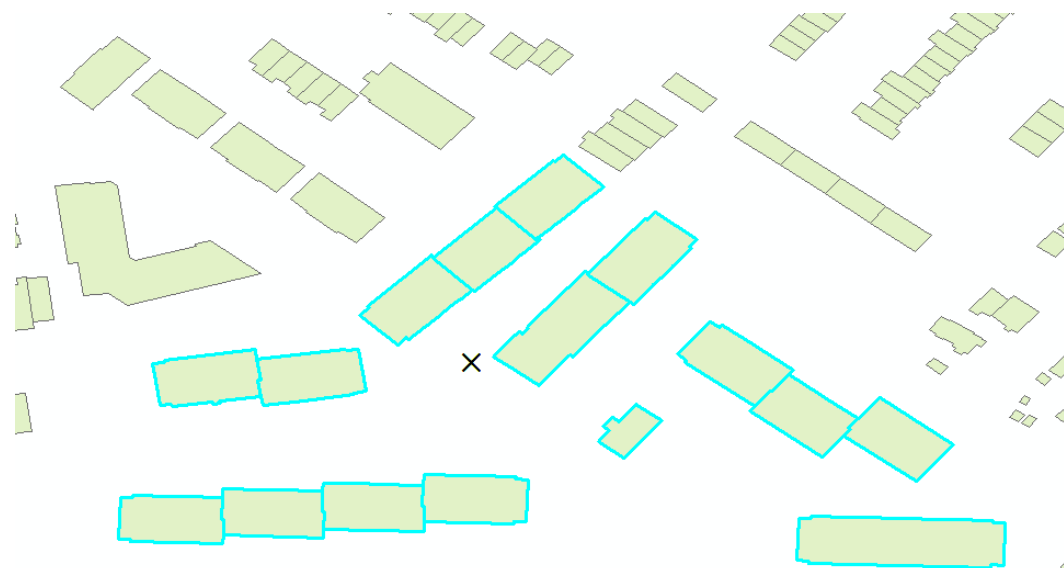
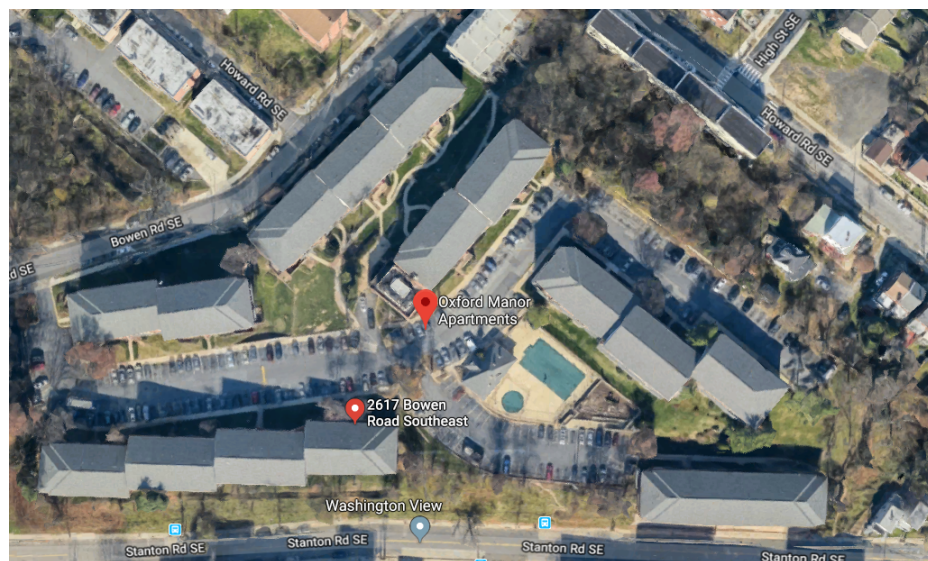
Unmatched: One UBID₀ represents multiple buildings

- Detection: all unmatched cases that aren't in street (and have multiple buildings on property)

Example:

- Estimated area (with area map tool): 77k * 4 floors = ~308k sqft
- Reported area = 280k sqft
- Conclusion: Benchmarking data represents all buildings in this multi-family housing unit but didn't match because fell outside bounding box of all footprints

Recommended Solution: If parcel footprints are available, match to corresponding parcel footprint UBID (parent-child)

If parcel footprint isn't available, can use lot ID from address data to detect all footprints with matching lot ID (more data processing involved)C

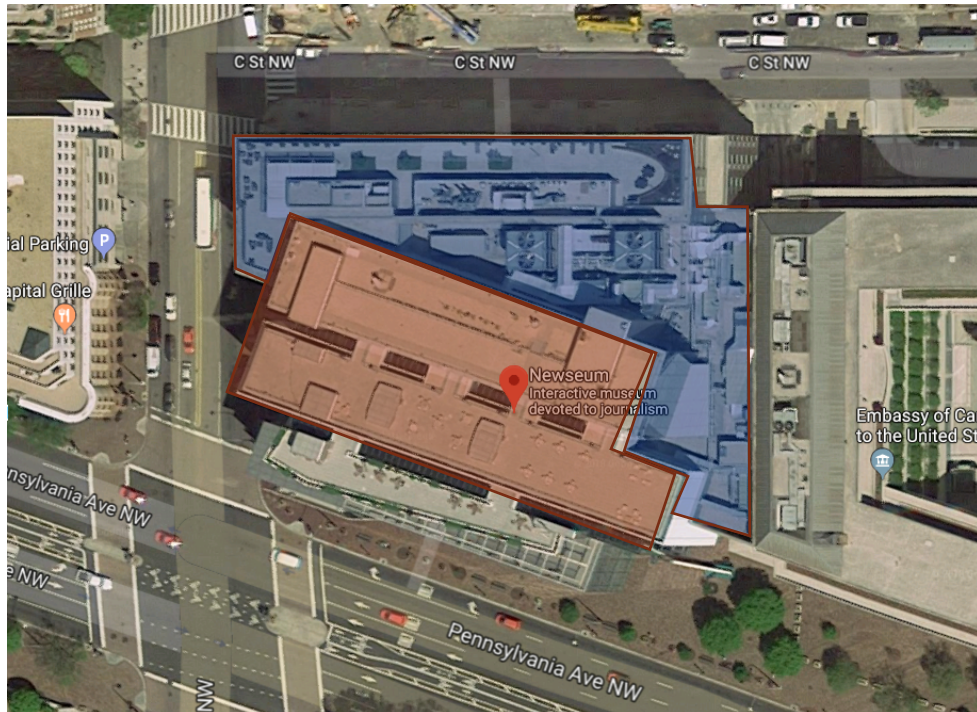
UBID₀ represents one space in a building footprint

Recommended Solution: No way to determine which buildings or spaces correspond to benchmark, even manually
Match to the corresponding footprint or property and flag as not totally representative (if able to detect)

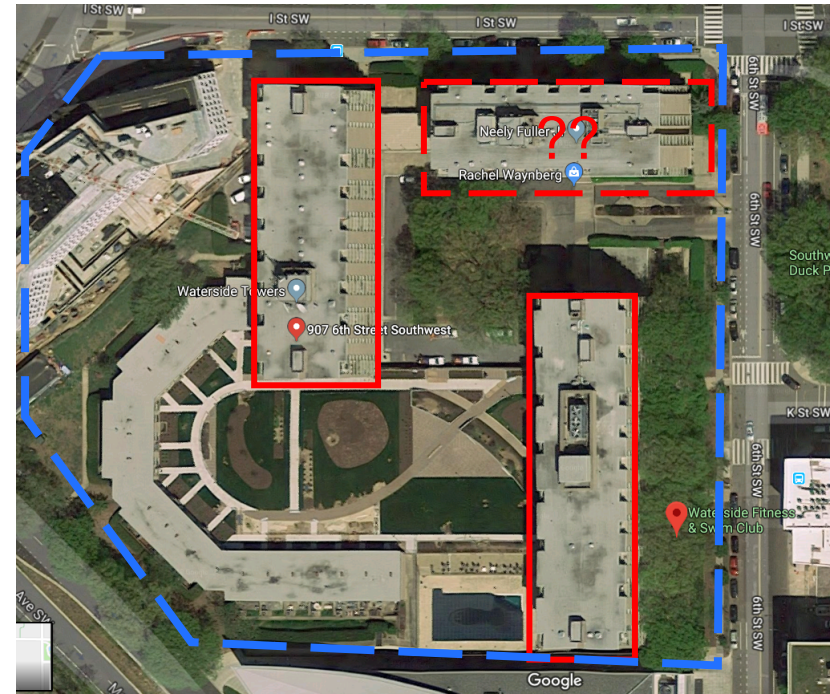
UBID₀ represents multiple buildings, but not all buildings, on a property

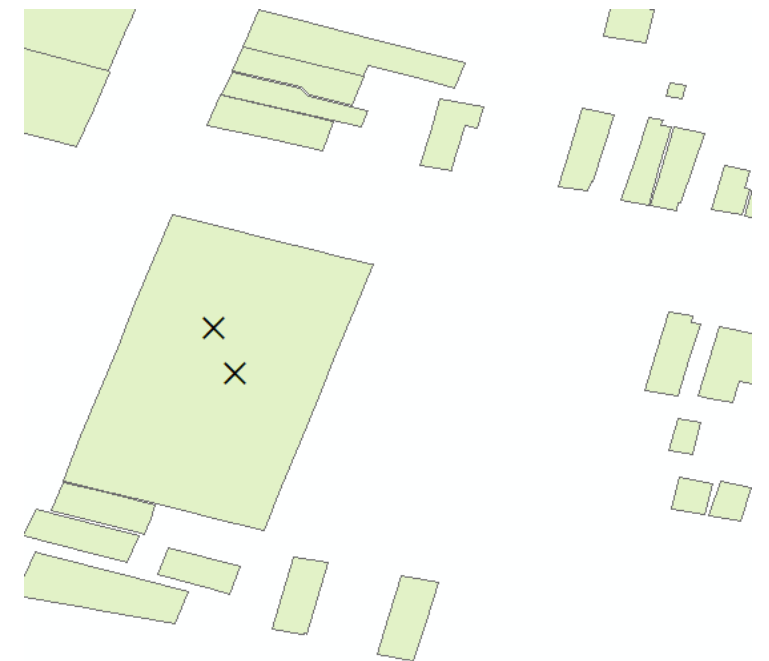
Multiple UBID₀ represents various spaces in a building footprint

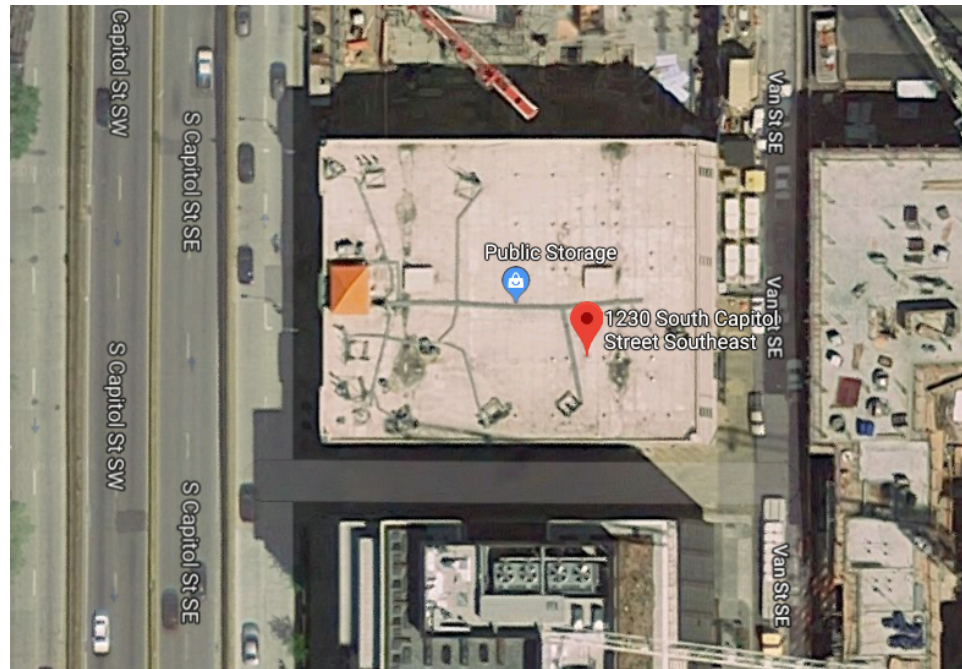
Unverified Incorrect: Incorrect Location

- Example:
 - Listed address: 1263-1265A A 1st St SE
 - Address corresponding to location: 1230 S Capitol SE (a few blocks away)
- Conclusion: Incorrect coordinates entered for second address
- This was caught by chance, unclear how many instances exist

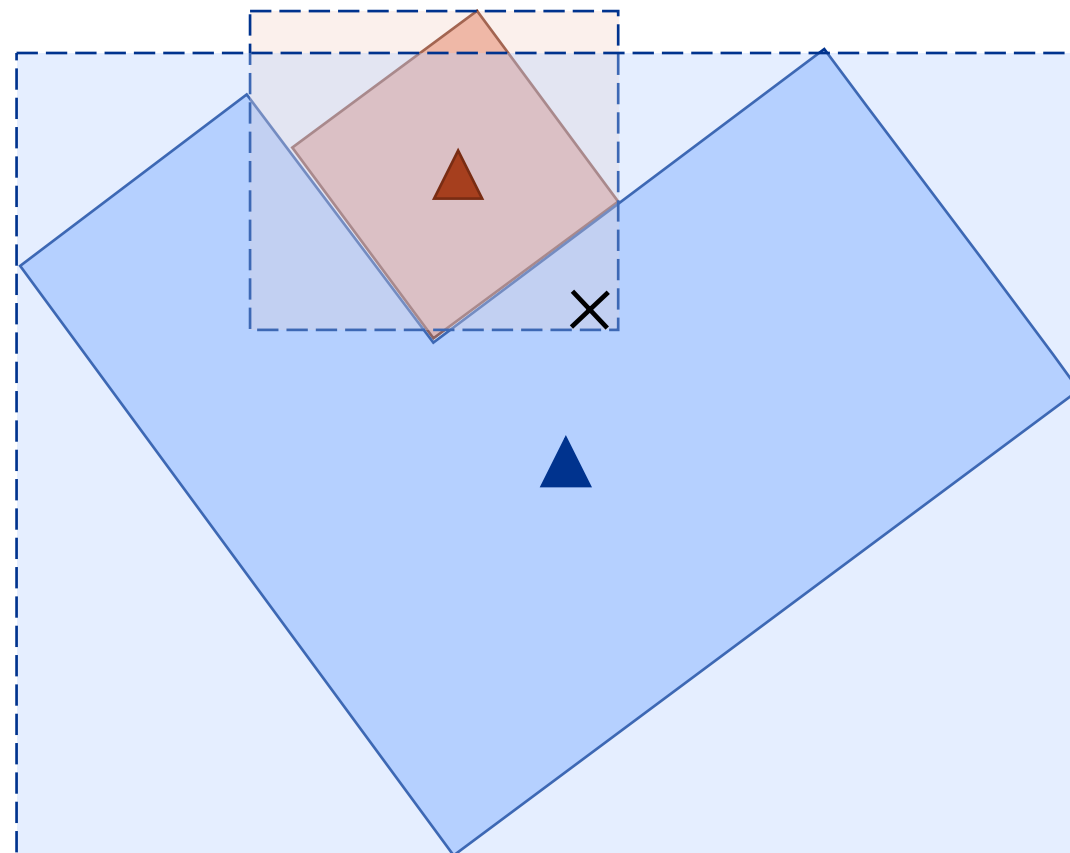
Unverified Incorrect: Incorrectly Matched

- If benchmarking geolocation isn't well aligned with center of the bounding box of the footprint, there is a chance it could be falsely matched to neighboring footprints

- × Benchmarking Location
- Footprint
- Footprint Bounding Box
- ▲ Footprint Bounding Box Centroid

Currently not detected, but further UBID analysis could help detect this:

- Compare 1st and 2nd centroid distance
- Large bounding box to footprint ratio
- Large distance between UBID₀ and centroid

Manually inspect results and fix
