REMPLEX 2025

# A trial of geoelectrical methods for leak detection and monitoring during waste retrievals from the Magnox Swarf Storage Silo, Sellafield, UK

<sup>1</sup>Oliver Kuras, <sup>1</sup>Paul Wilkinson, <sup>1</sup>**James Boyd**, <sup>1</sup>Yin Jeh Ngui, <sup>1</sup>Harry Harrison, <sup>1</sup>Philip Meldrum, <sup>2</sup>James Mair, <sup>2</sup>Stephen Gregory, <sup>2</sup>Nick Barnes, <sup>2</sup>John Heneghan

*1. British Geological Survey, Keyworth, Nottingham, UK*

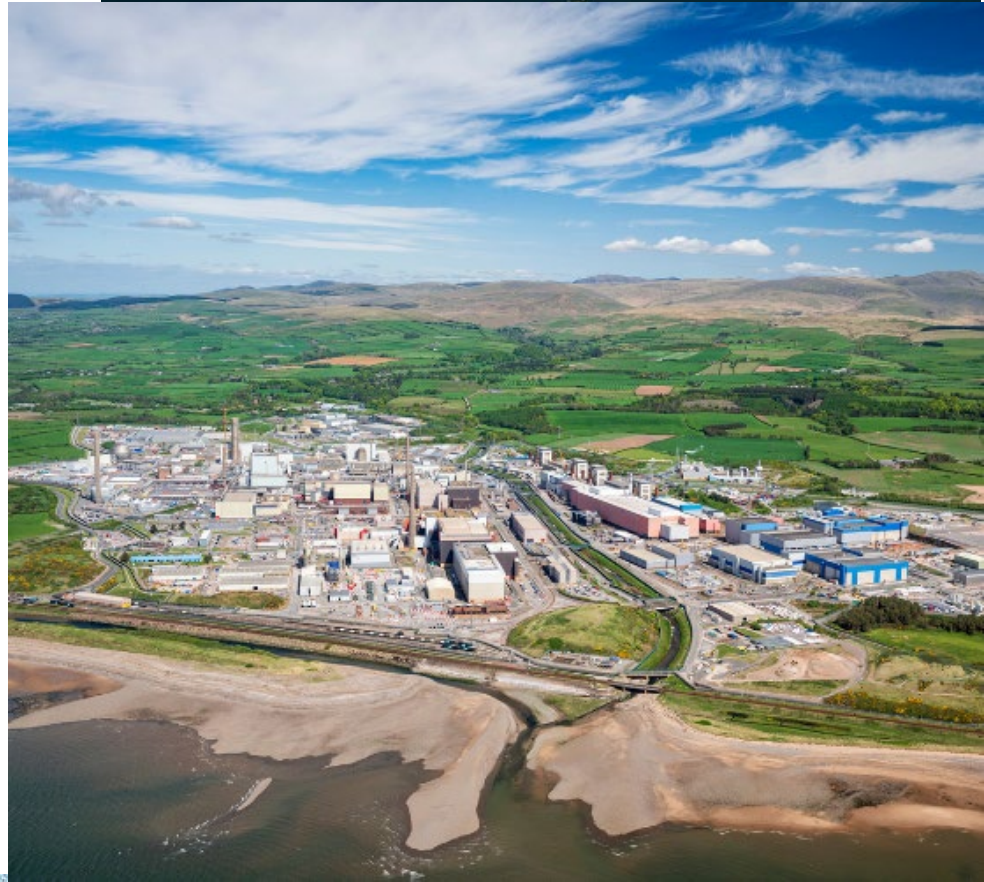
- Located at the Sellafield site, Cumbria, England.
- Originally constructed in the 1960s, to store nuclear waste.
- The building was extended 3 times throughout the 1970s and 1980s as it filled up.
- The building has been leaking radioactive liquor into the ground below MSSS.
- Efforts are ongoing to remediate and decommission the site.

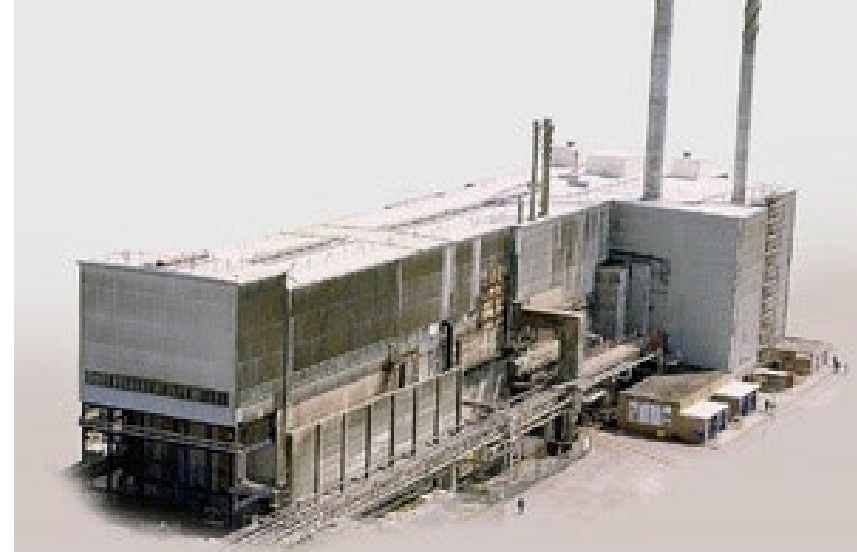
- Contains concrete storage silos which contain water-covered **corroded magnesium alloy** swarf among **other** nuclear waste products
- A leak was first identified in the 1970s, however the leak apparently self sealed, but since 2019 the MSSS has been leaking again.
- Several metallic perforated and blind tubes installed around MSSS to monitor radioactivity.
- No way to fix the leak until all the **waste is removed** (expected to take **several decades**).

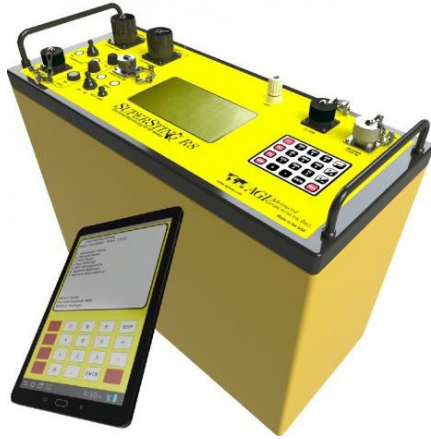
## Advanced Geosciences Inc. (AGI) SuperSting R8.

- Measures on up to 8 channels simultaneously.
- Outputs currents of 1- 2000 mA, up to 400 V.
- The output of the Sting was deemed a risk for energising the silos as it may ignite flammable gases contained within. Hence the **electrode connections** were routed through **guard resistors**.
- MALM measurements only made in reciprocal configuration.

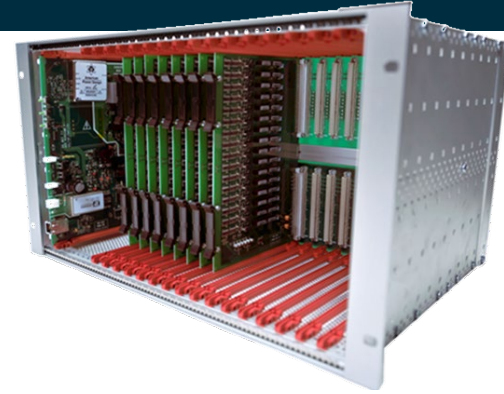
## British Geological Survey (BGS). PRoactive Infrastructure Monitoring and Evaluation (PRIME) instrument.

- Measures on up to 7 channels simultaneously.
- Originally designed to be power efficient for autonomous monitoring and hence outputs comparatively small currents (1- 100 mA).
- Customised to limit the output voltage to 48 V, which was deemed safe to excite the silos.
- MALM measurements made in forward and reciprocal configurations.

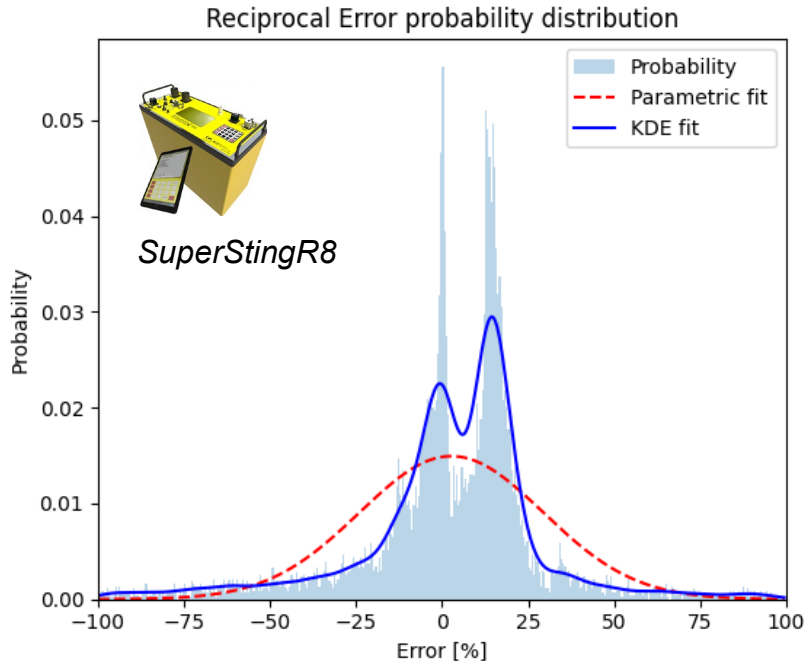
*Large reciprocal errors and bimodal distribution, not good - shows measurements are inconsistent. Sting measurements are therefore disregarded from 2025.*

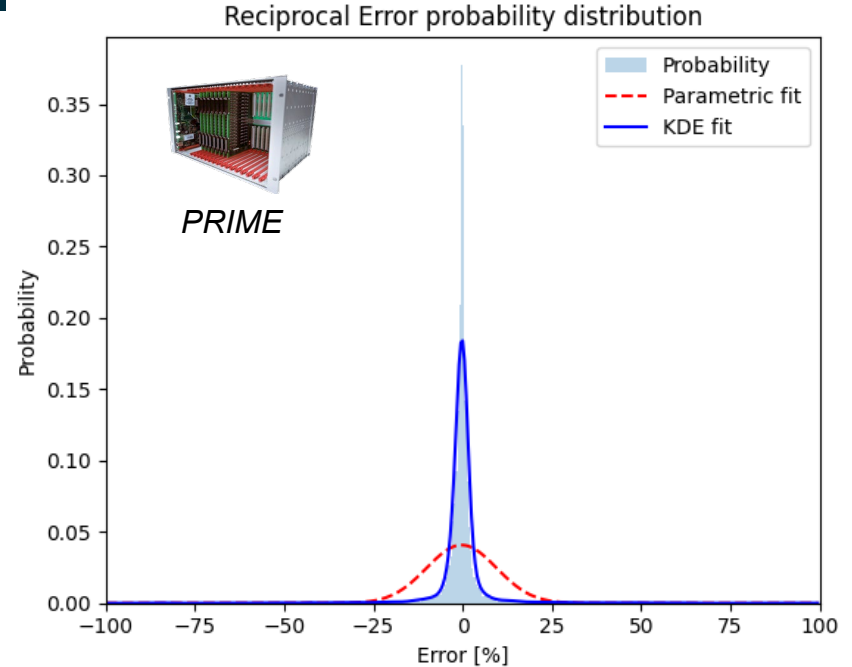
*Tight gaussian distribution, demonstrates PRIME has made consistent measurements in the forward and reverse configurations.*

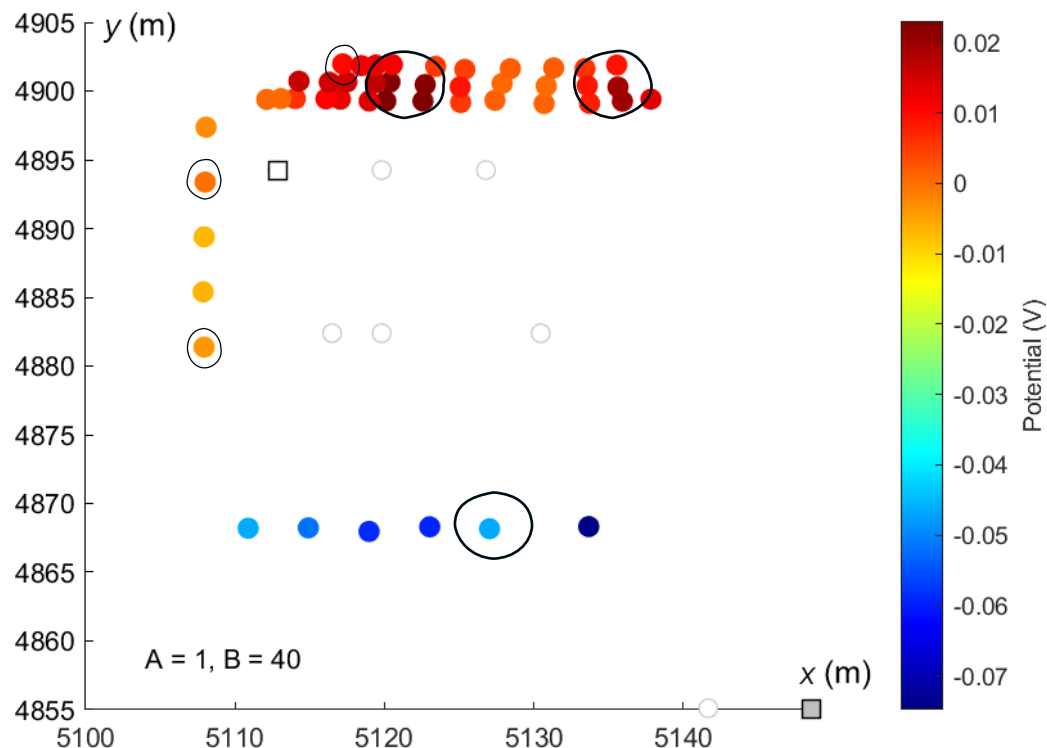
# Peaks in the data

- Local maxima may indicate peaks.
- Clearer picture to be had when interpolating the points and displaying as a 3D surface.

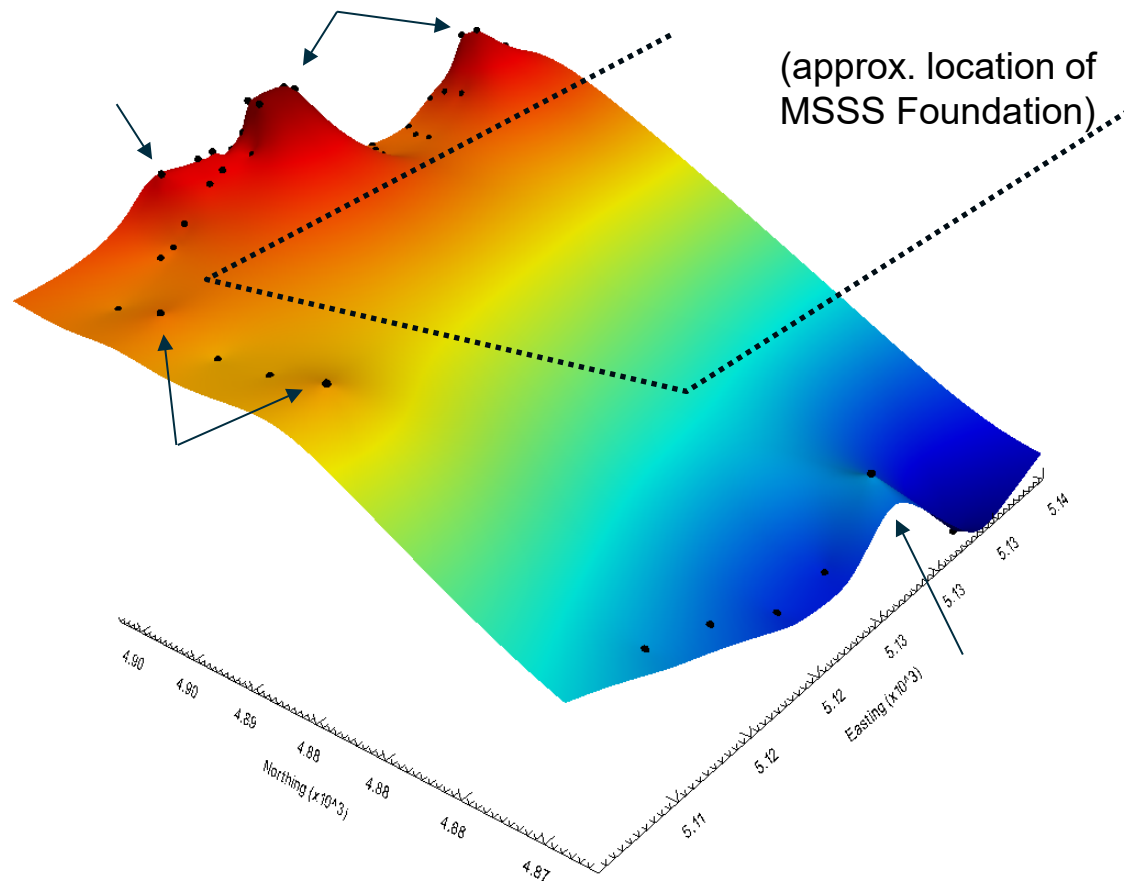
# MALM PRIME results - leaks

- Silo electrode positive – current escaping from building → local potential maximum
- Two strong isolated peaks on north side, but evidence for electrical shorting into silos
- Weaker peak on north, no apparent shorting but proximity obscures interpretation
- Two weak peaks on west, possible leaks
- Strong peak on south, indicative of a preferential conductive pathway.

- PRIME MALM measurements were made in standard and reciprocal configurations.
- Proves that current can pass from silo to exterior.
- Evidence of some blind tubes on north side being electrically shorted together and into the silos.
- Peaks occur on the west and south side of MSSS, indicative of leaks.
- Silos are in excellent electrical contact with each other (so electrodes could be moved between silos as retrievals progress)

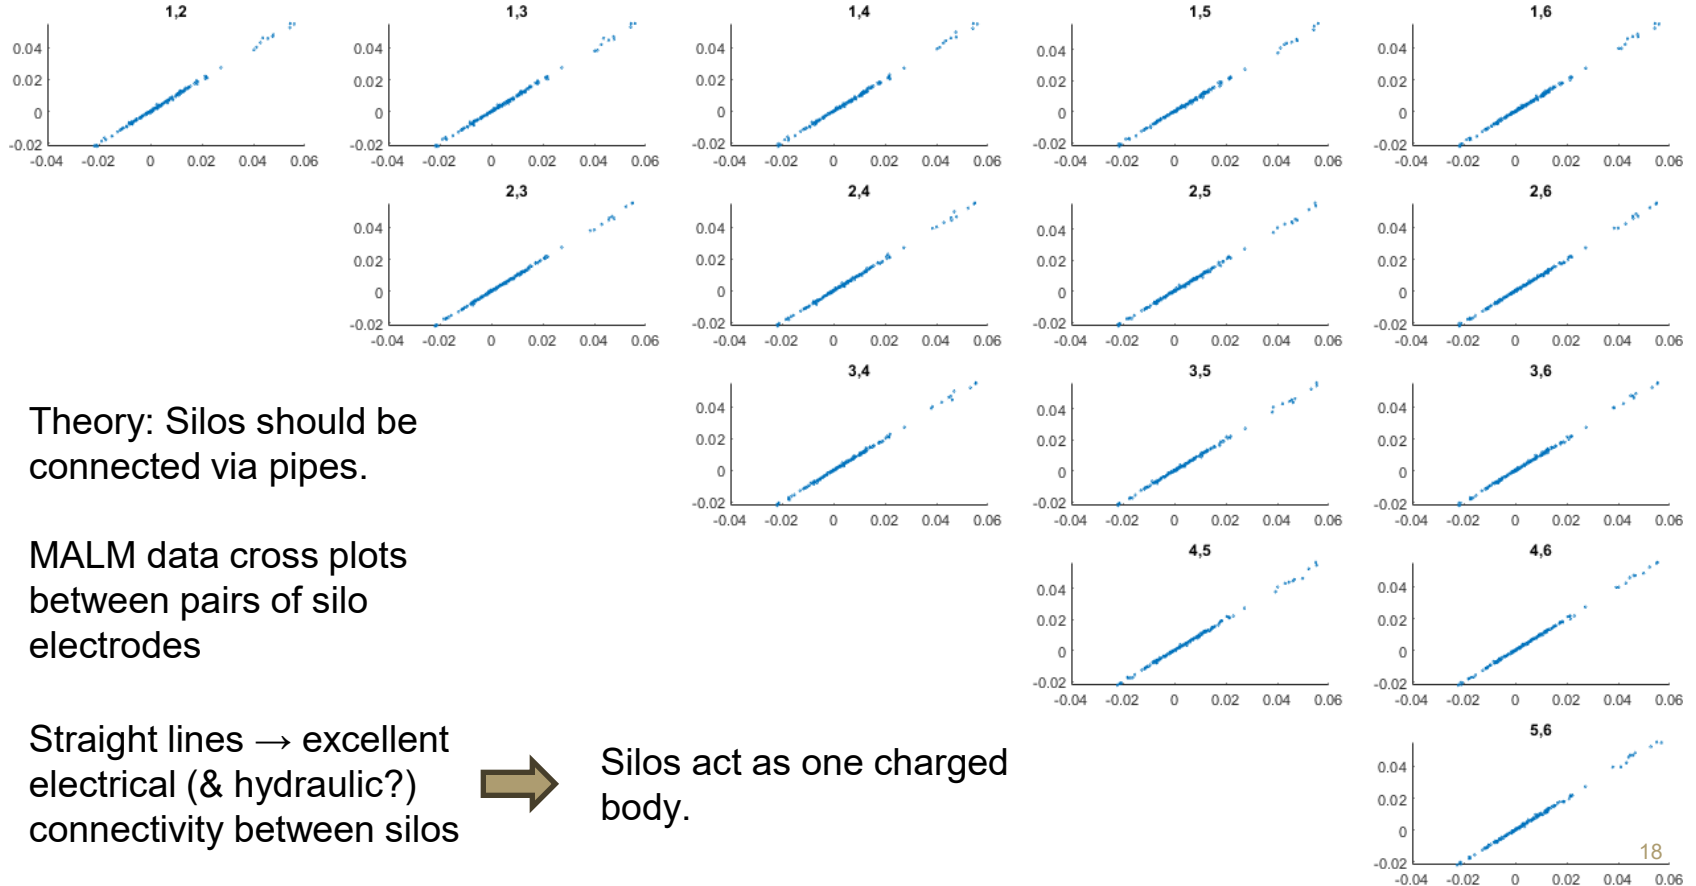
# Silo connectivity

Theory: Silos should be connected via pipes.

MALM data cross plots between pairs of silo electrodes

Straight lines → excellent electrical (& hydraulic?) connectivity between silos

Silos act as one charged body.

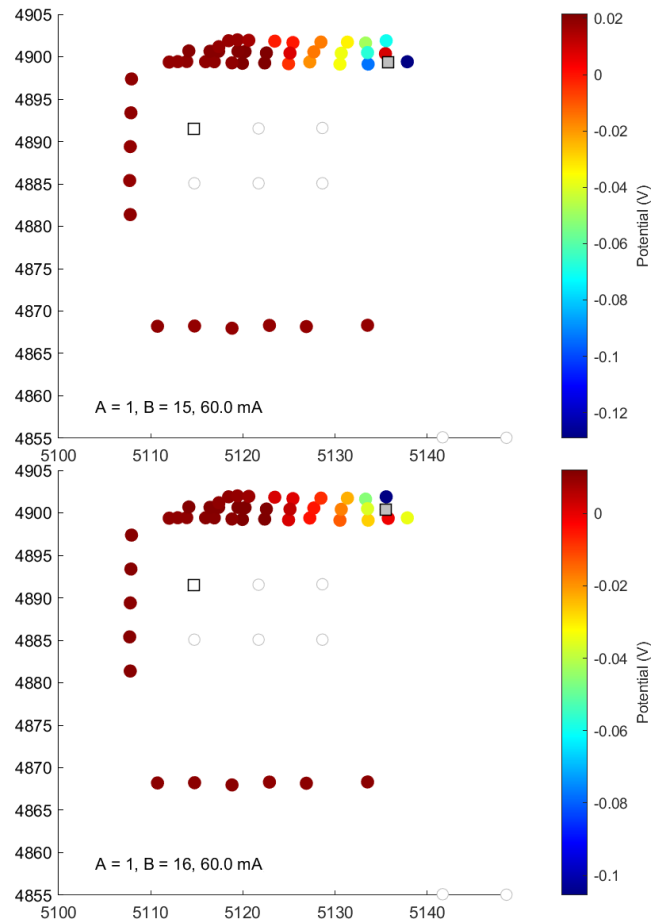
15 and 16 appear to have a low resistivity connection but possibly through the building / silo rather than being in direct contact
