Attic Air Sealing Upgrade

Photo Report

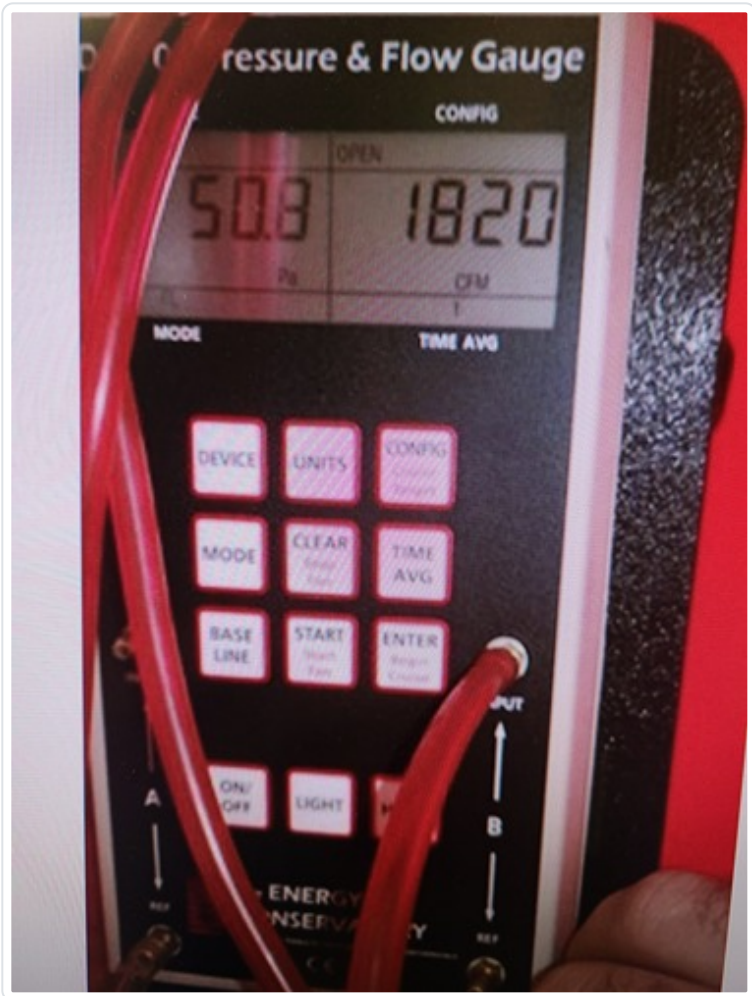
Timestamp: August 10, 2023 at 12:14 PM PDT

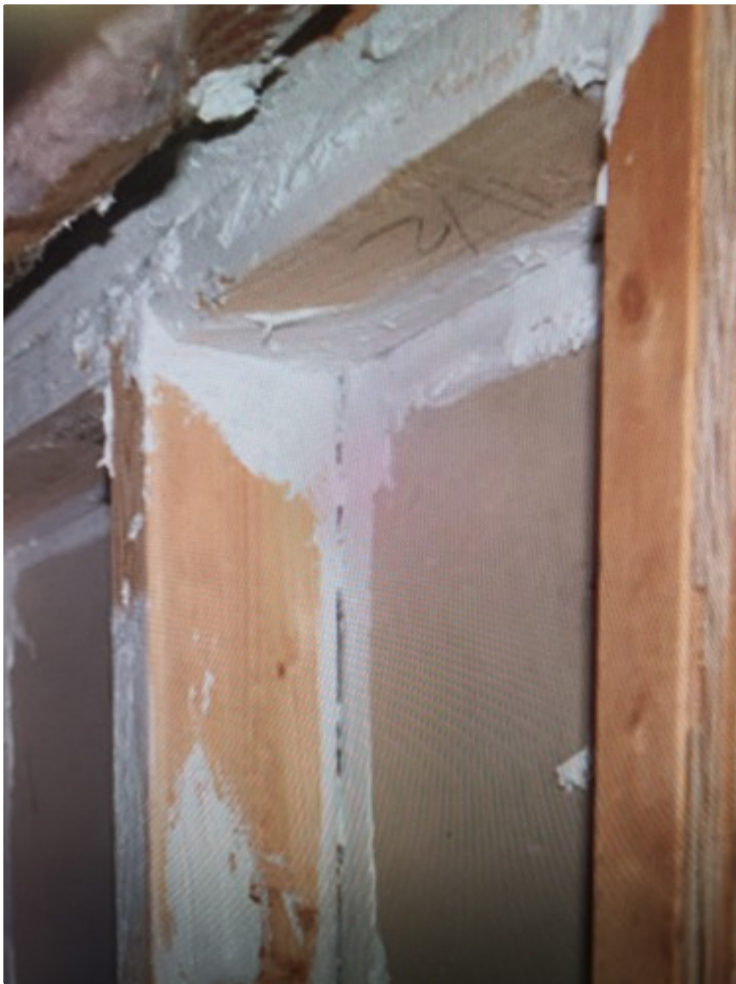
Timestamp: August 10, 2023 at 12:20 PM PDT
