# **Lessons Learned at the Magnox Swarf Storage Silo Facility (Sellafield Nuclear Site, UK) on Planning and Optimization of intervention and Clean Up Approaches**

# Understanding the impact to ground and groundwater

John Heneghan – Sellafield Ltd., UK

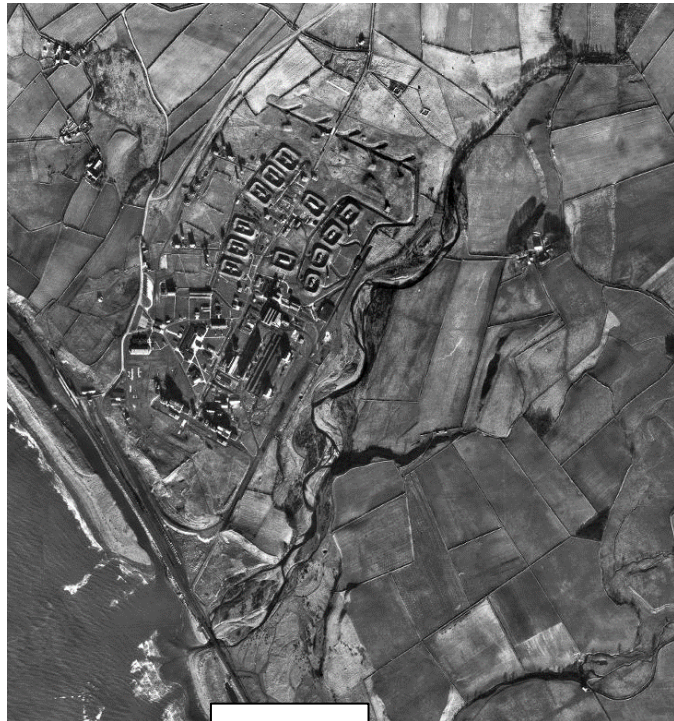
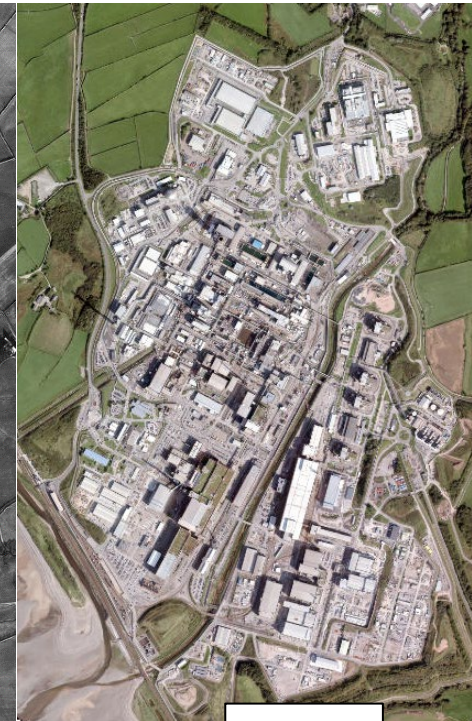
- Coastal plain setting
- Cumbrian mountains rise from approx. 5km inland
- 80 years of development have significantly modified the site topography and ground cover

1940's

2010's

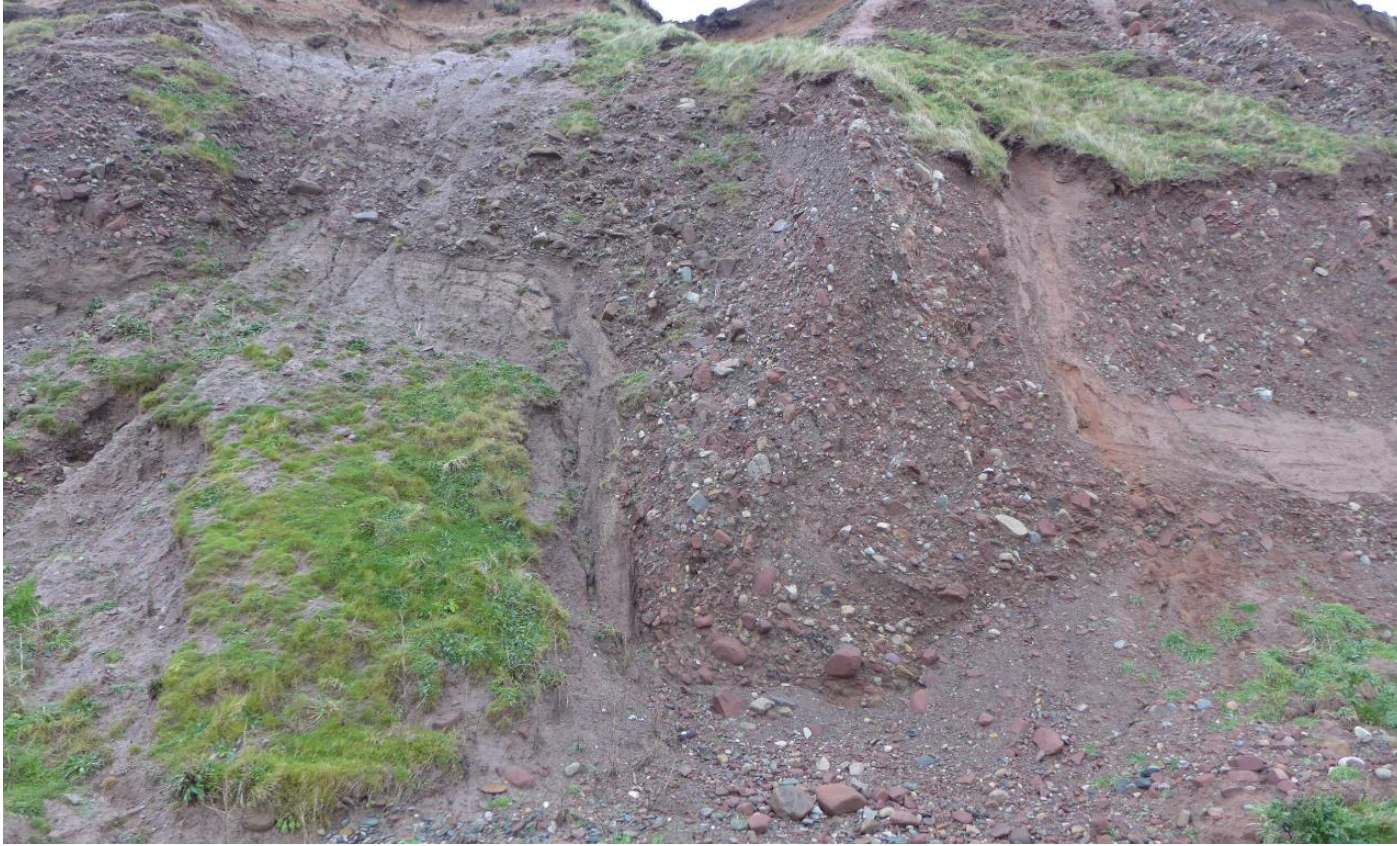
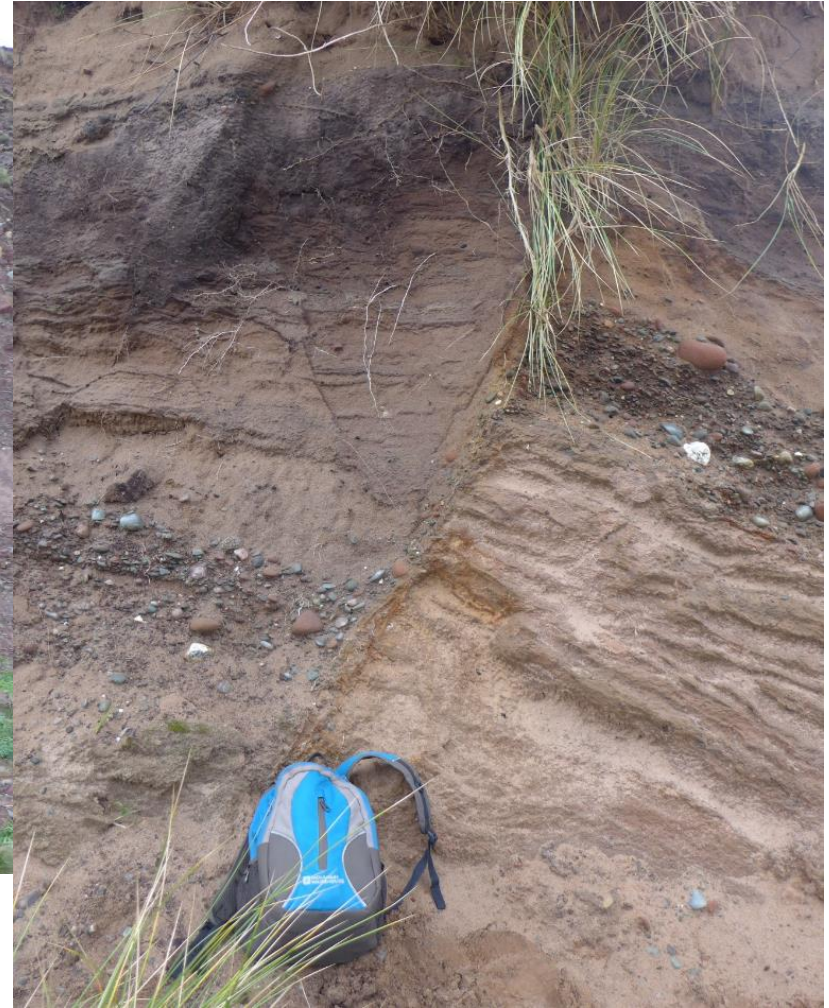
Nearby Drigg site

# Heterogeneity in superficial deposits

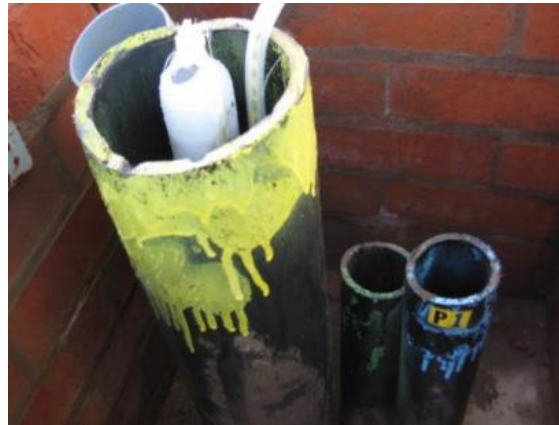
- Groundwater and blind tube (gross gamma) monitoring commenced in the 1970's (700 series wells)
- Quickly realised that Cs-137 (bulk of activity) has limited mobility in ground
  - 95% of total activity remains within a few meters of the leak point
- Sr-90 more mobile than Cs-137, but travel time to biosphere estimated at 50 years (worst case)
- Monitoring infrastructure focused in the area of MSSS
- Downgradient monitoring network relatively sparse (laterally and vertically)
  - Limited monitoring in bedrock
  - Long well screens
  - Nested piezometers

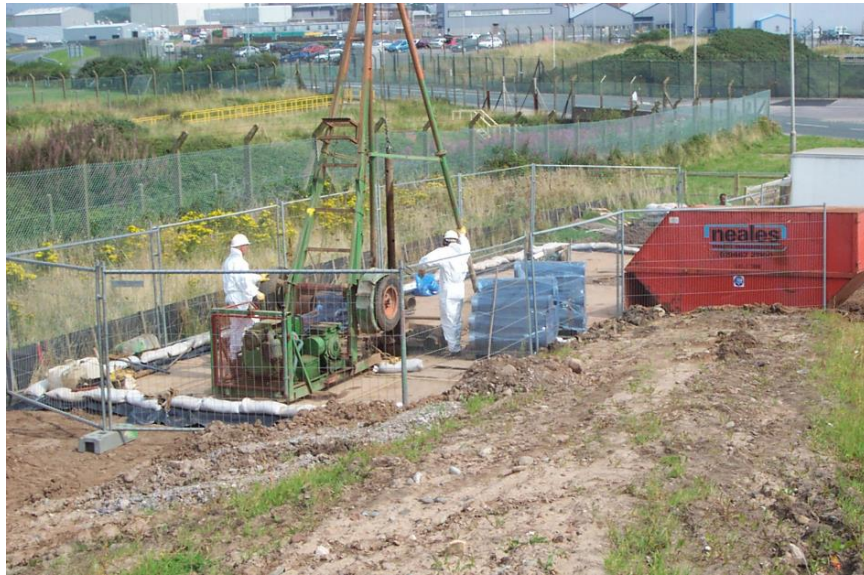
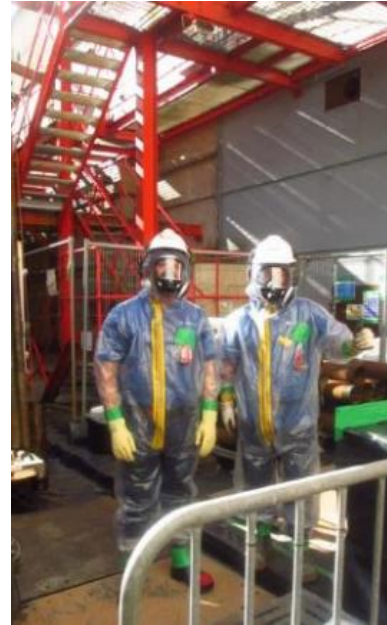
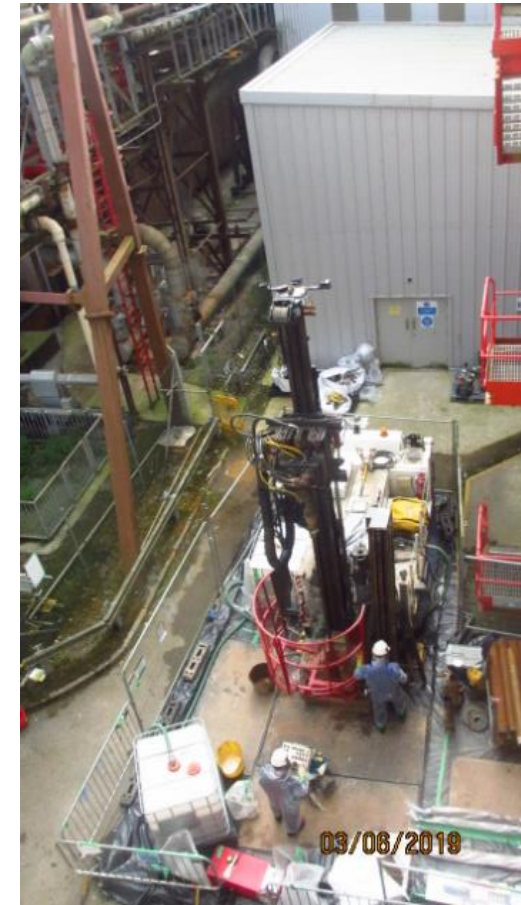
- Up to SCL&GMP most wells were drilled by shell & auger in superficial deposits (cable percussion techniques)
- Move to rota-sonic technique during SCL&GMP

- Rota-sonic drilling typically provides much higher fidelity data
  - Log extracts are from two adjacent wells – shell & auger and sonic
  - Much greater detail to comparable depth in sonic log

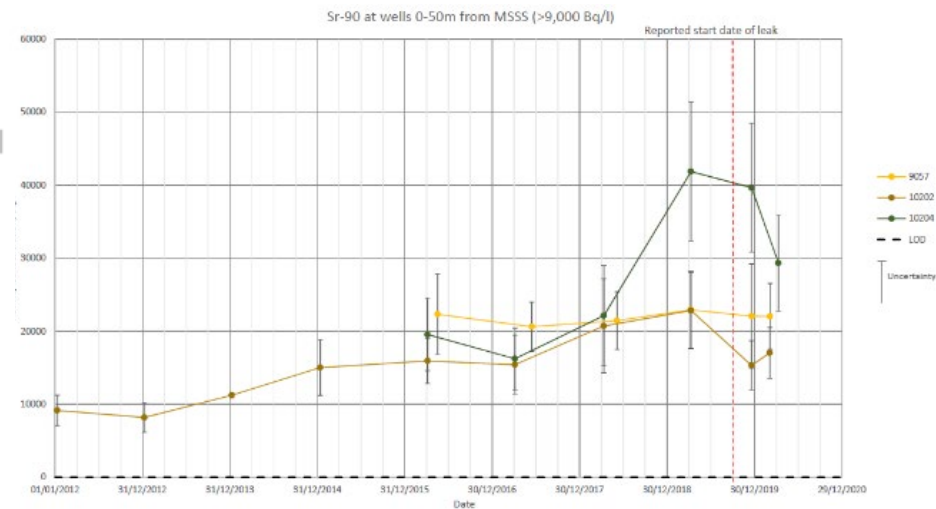
- Historic data provides good insights into contaminant trends and behaviour near silo
  - Limited information on relatively mobile radionuclides (e.g. Tc-99, C-14, Cl-36) – majority had advected away from the area prior to monitoring of these starting
- Good Cs-137 and Sr-90 data

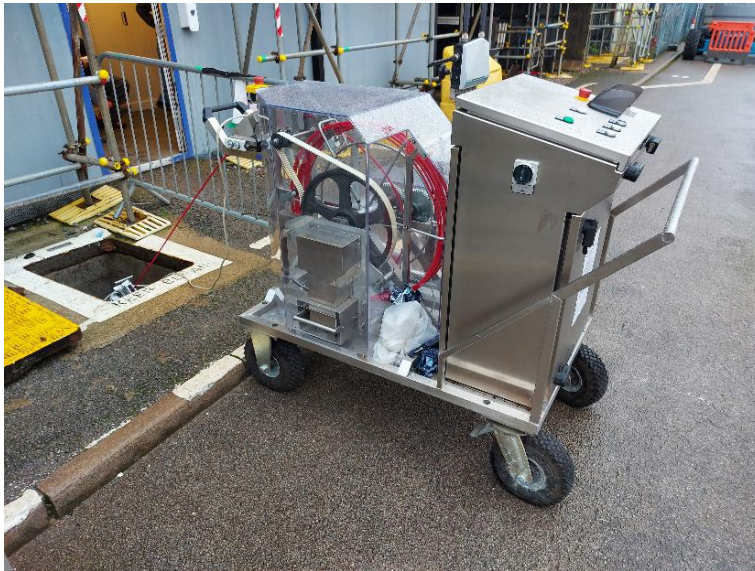
- Routine monitoring allows monitoring of trends – principally Cs-137
- Migration of Sr-90 possibly evident with trends thought to be associated with bremsstrahlung radiation

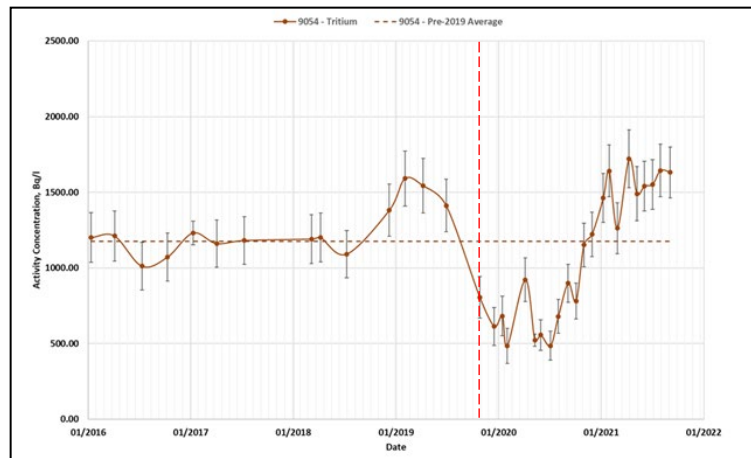
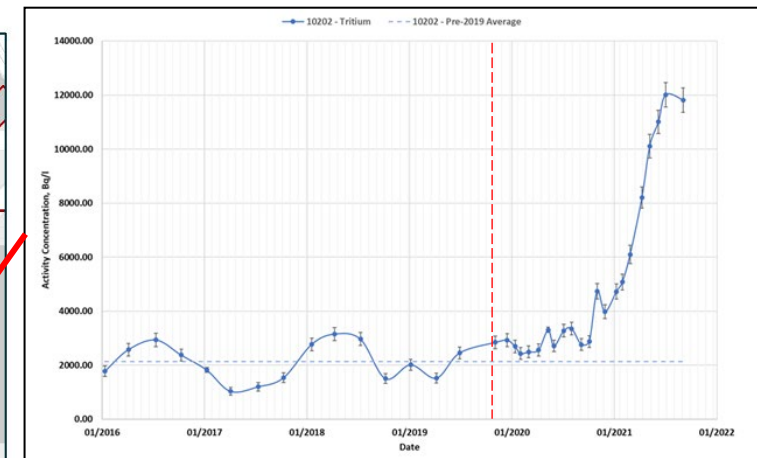
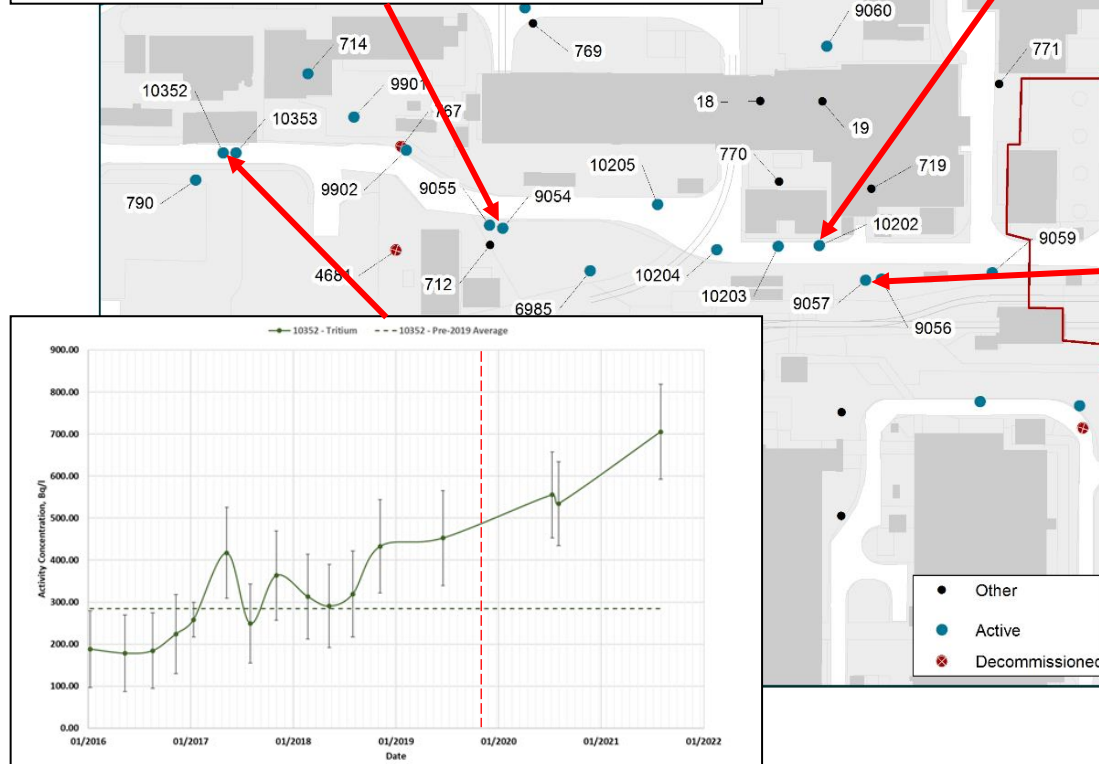
- The current leak is starting to show in groundwater
  - H-3 showing upward trend (care in interpretation – multiple H-3 sources)
  - Cl-36 – first definitive marker of silo liquor from current leak in groundwater
  - C-14 starting to show upward trends
- Monitoring frequency and range of analysis increased
  - Approach is in line with Leak to Ground Risk Management Plan – latest version dated 2019
  - Continuing vigilance – monitoring intensity based on observations with changes based on recorded trends

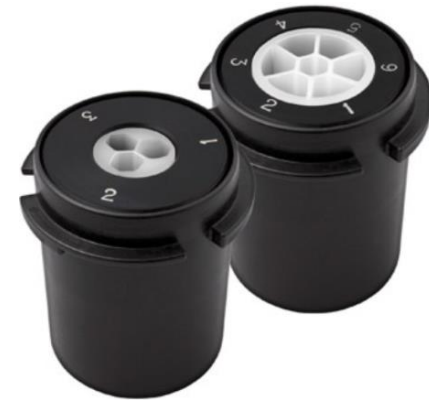
- DQO study undertaken to cover groundwater monitoring – current arrangements considered to be good, but some gaps identified
  - Filling gaps limited by infrastructure constraints
  - Design needs to consider 3D aspects – lateral & vertical spacing
  - Work underway to design new wells
- Characterisation support to mitigation options development
- Extensive groundwater level logger deployment
- Groundwater monitoring technology review
  - Recommendations on instrumentation
  - Consideration of multi-level sampling systems
    - Solinst 403 CMT recommended
