**Pacific Northwest
National Laboratory**

**Ultrasonic Examination of Double-Shell
Tank 241-AW-103 Examination
Completed September 2006**

April 2007

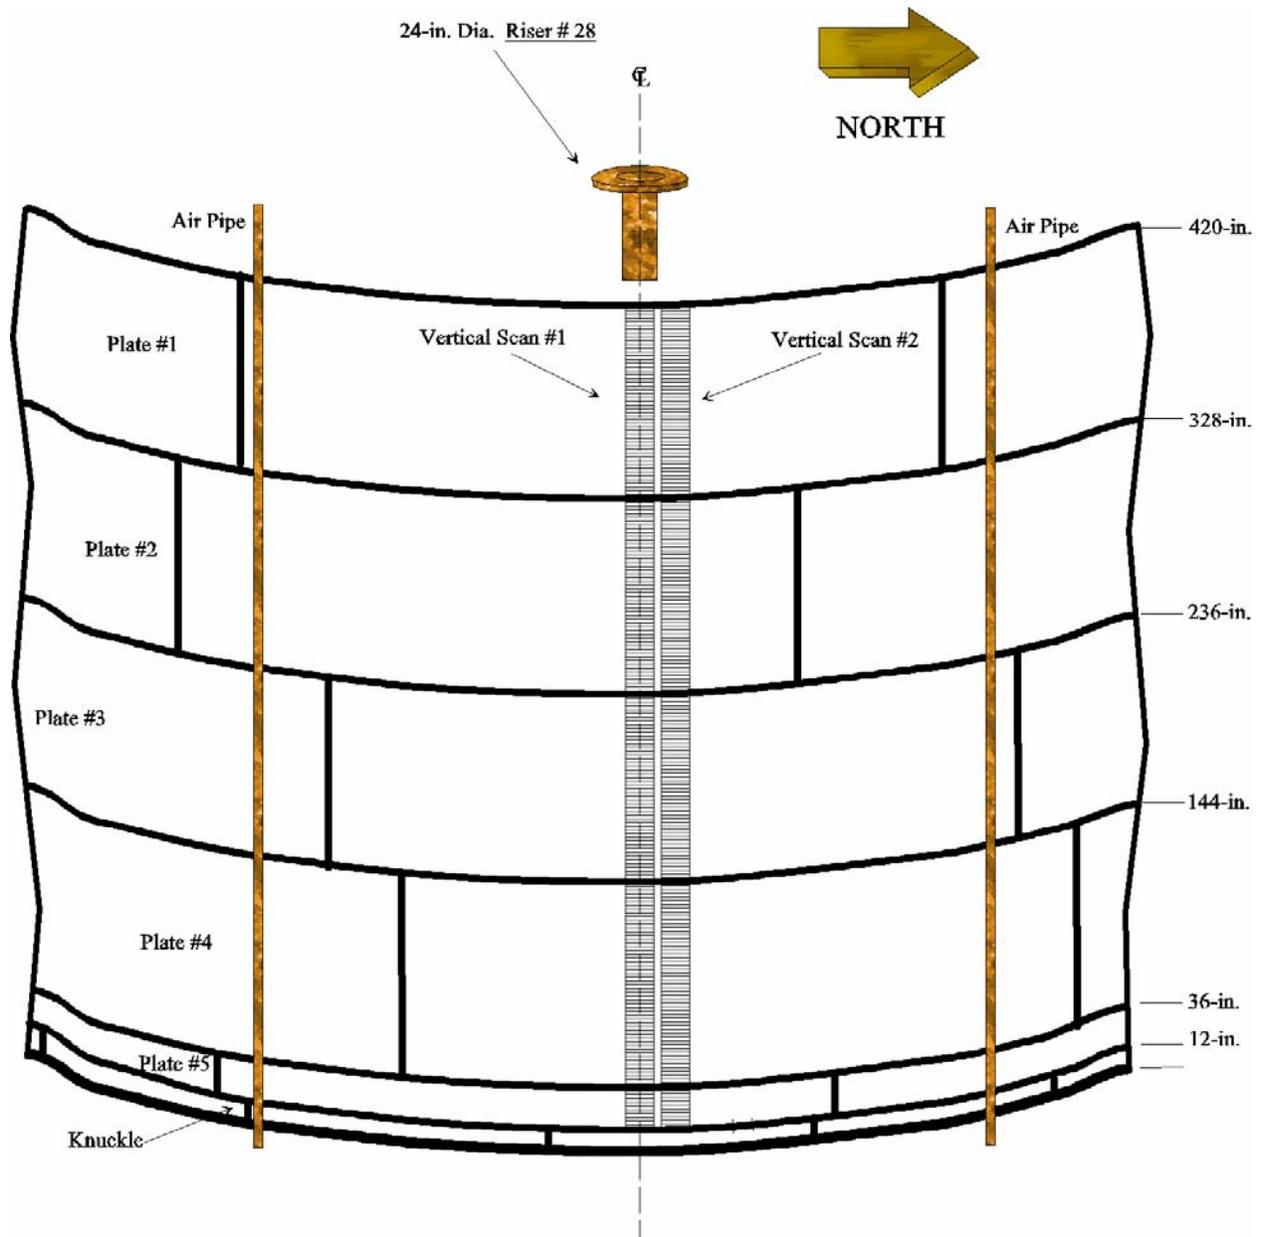
Figure 4.2. Sketch of Scan Paths on 241-AW-103 Primary Tank from Riser 28

Two 15-in.-wide vertical scan paths were performed on Plates #1, #2, #3, #4, and #5 from Riser 28. The plates were examined for wall thinning, pitting, and cracks oriented vertically on the primary tank wall. There were no areas of wall thinning that exceeded the reportable level of 10% of the nominal thickness. No pitting or vertical crack-like indications were detected in Plates #1, #2, #3, #4, or #5.

Figure 4.2 describes the areas on the primary wall of Tank 241-AW-103 that were ultrasonically examined from Riser 28 located on the east side of the tank. Two 15-in.-wide vertical scan paths were performed on Plates #1, #2, #3, #4, and #5 below the entrance to Riser 28.

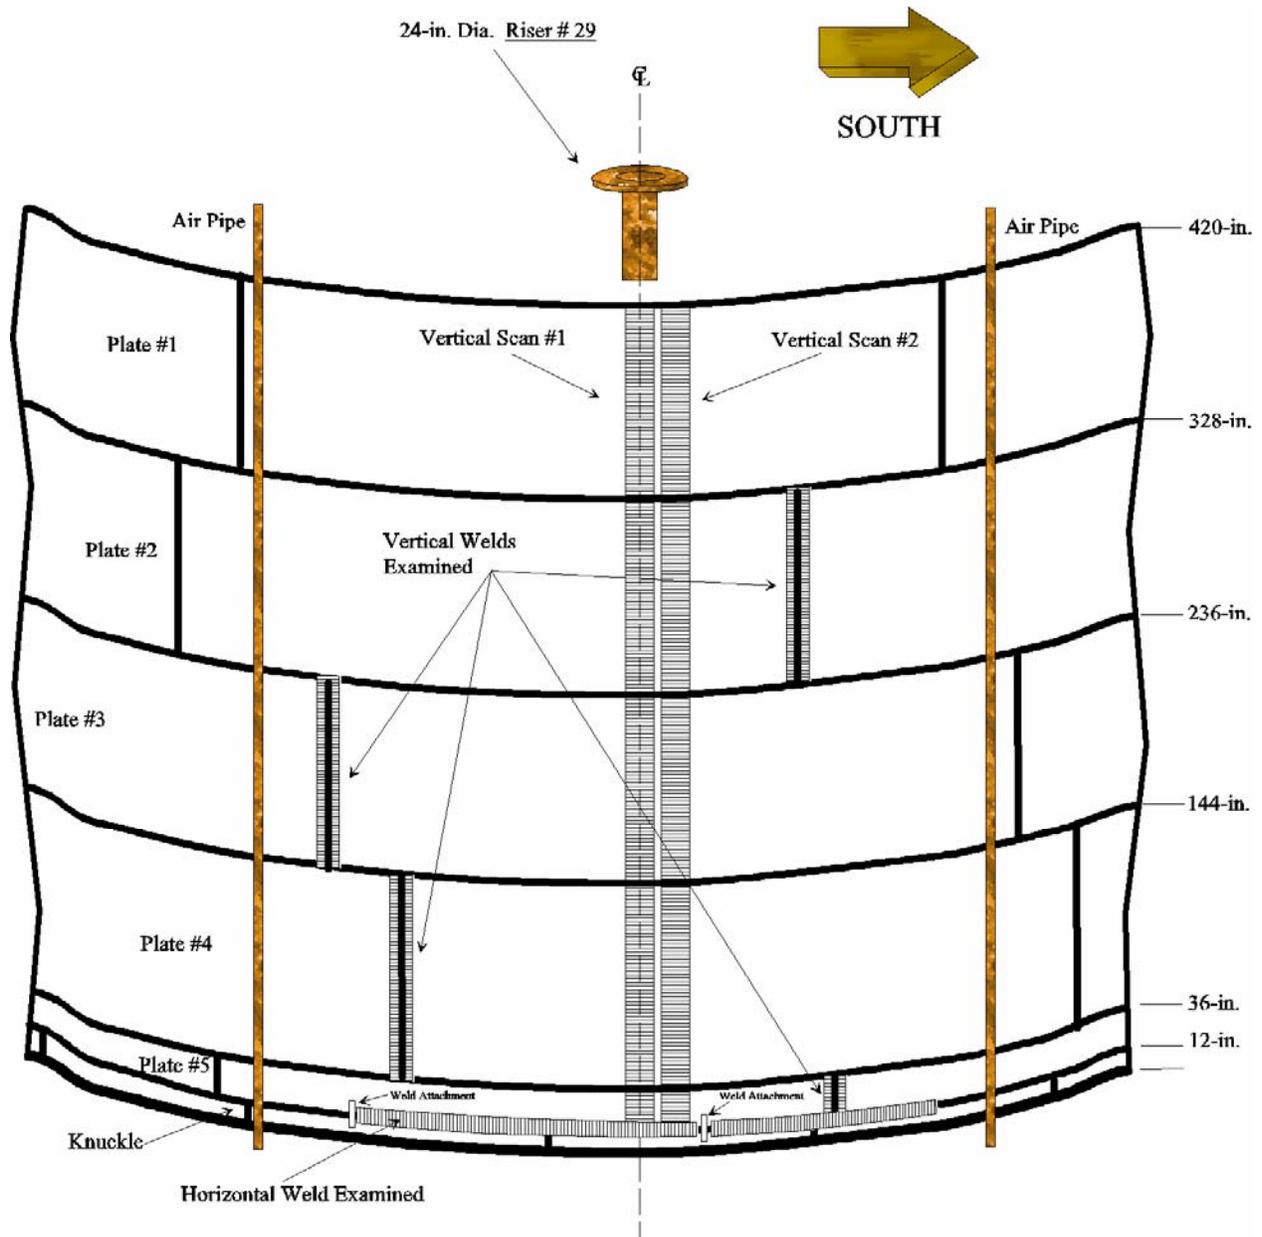
Figure 4.3. Sketch of Scan Paths on Tank 241-AW-103 Primary Tank from Riser 29

Two 15-in.-wide vertical scan paths were performed on Plates #1, #2, #3, #4, and #5 from Riser 29. The plates were examined for wall thinning, pitting, and cracks oriented vertically on the primary tank wall. There were no areas of wall thinning that exceeded the reportable level of 10% of the nominal thickness. No pitting or vertical crack-like indications were detected in Plates #1, #2, #3, #4, or #5.

The HAZ of vertical welds in Plates #2, #3, #4, and #5 from Riser 29 were examined for wall thinning, pitting, and cracks oriented either perpendicular or parallel to the weld. There were no areas of

wall thinning that exceeded the reportable level of 10% of the nominal thickness. No pitting or crack-like indications were detected in the weld HAZ areas in Plates #2, #3, #4, and #5.

The HAZ of the horizontal weld between Plate #5 and the tank knuckle from Riser 29 was examined for wall thinning, pitting and cracks oriented either perpendicular or parallel to the weld. There were no areas of wall thinning that exceeded the reportable level of 10% of the nominal thickness. No pitting or crack-like indications were detected in the weld HAZ areas on Plate #5 side or on the knuckle side of the horizontal weld.

Figure 4.3 describes the areas on the primary wall of Tank 241-AW-103 that were ultrasonically examined from Riser 29 located on the west side of the tank. Two 15-in.-wide vertical scan paths were performed on Plates #1, #2, #3, #4, and #5 below the entrance to Riser 29. Vertical weld HAZ examinations were done on Plates #2, #3, #4, and #5, and the horizontal weld HAZ examination was done on the transition Plate #5 to knuckle weld.

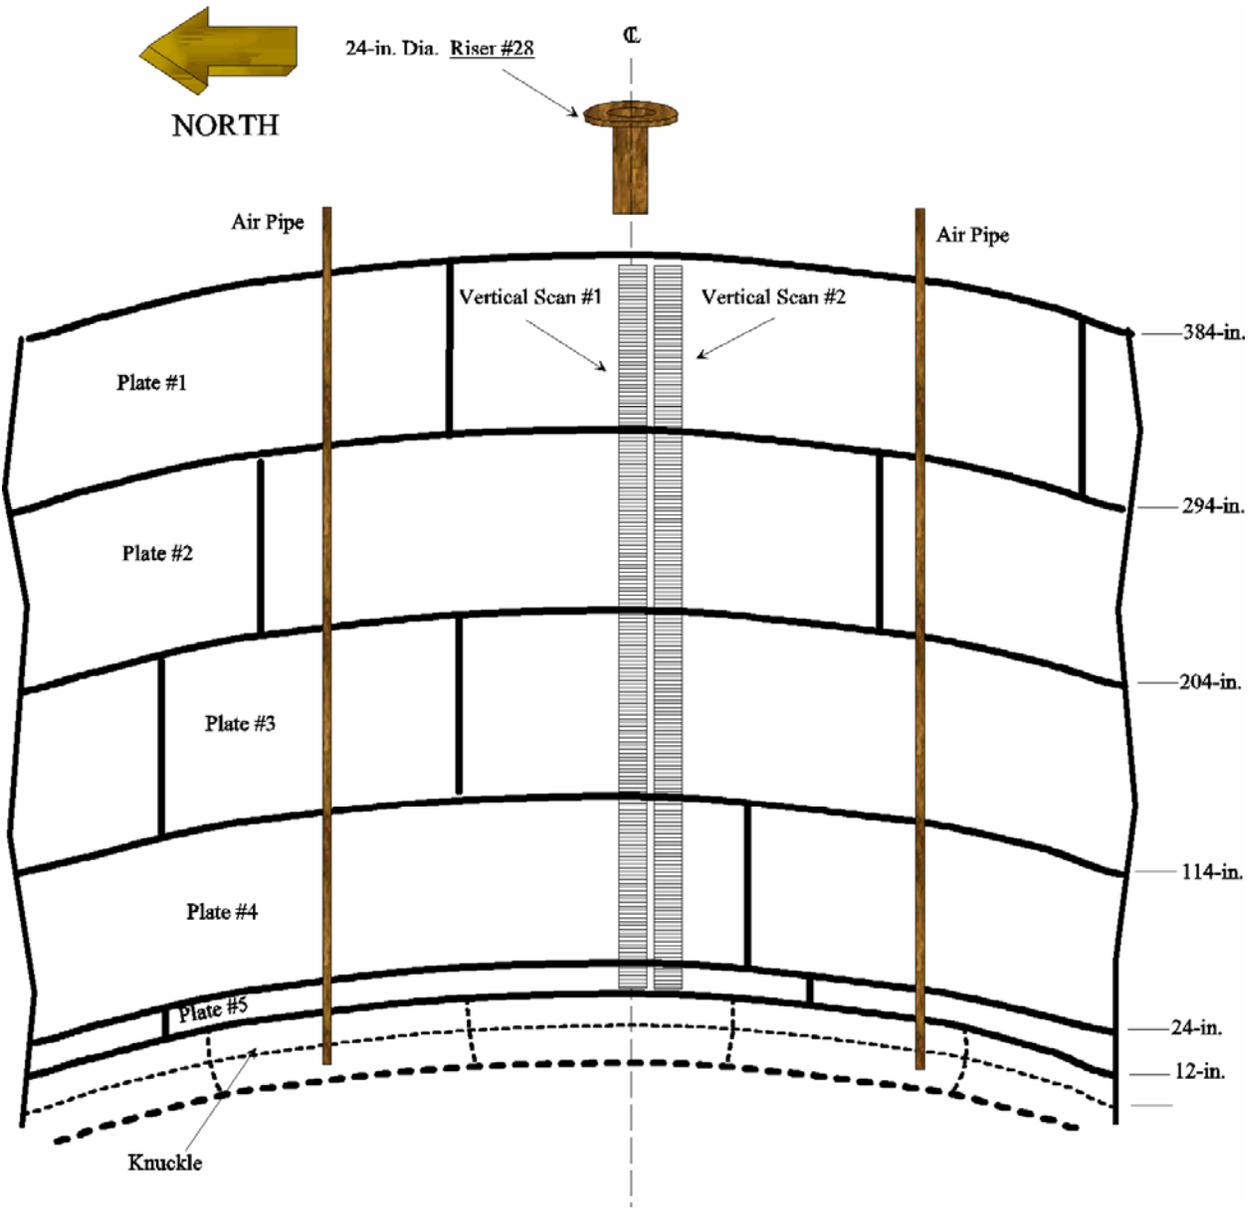
Figure 4.4. Sketch of Scan Paths on Tank 241-AW-103 Secondary Tank from Riser 28

Two 15-in.-wide vertical scan paths were performed on the secondary tank wall on Plates #1, #2, #3, #4, and #5 from Riser 28. The plates were examined for wall thinning, pitting, and cracks oriented vertically on the secondary tank wall. There were no areas of wall thinning that exceeded the reportable level of 10% of the nominal thickness. No pitting or vertical crack-like indications were detected in Plates #1, #2, #3, #4, or #5.

Figure 4.4 describes the areas on the secondary wall of Tank 241-AW-103 that were ultrasonically examined from Riser 28 located on the east side of the tank. Two 15-in.-wide vertical scan paths were performed on Plates #1, #2, #3, #4, and #5 below the entrance to Riser 28.
