PNNL-22553

Final Assessment of Manual Ultrasonic Examinations Applied to Detect Flaws in Primary System Dissimilar Metal Welds at North Anna Power Station

March 2014

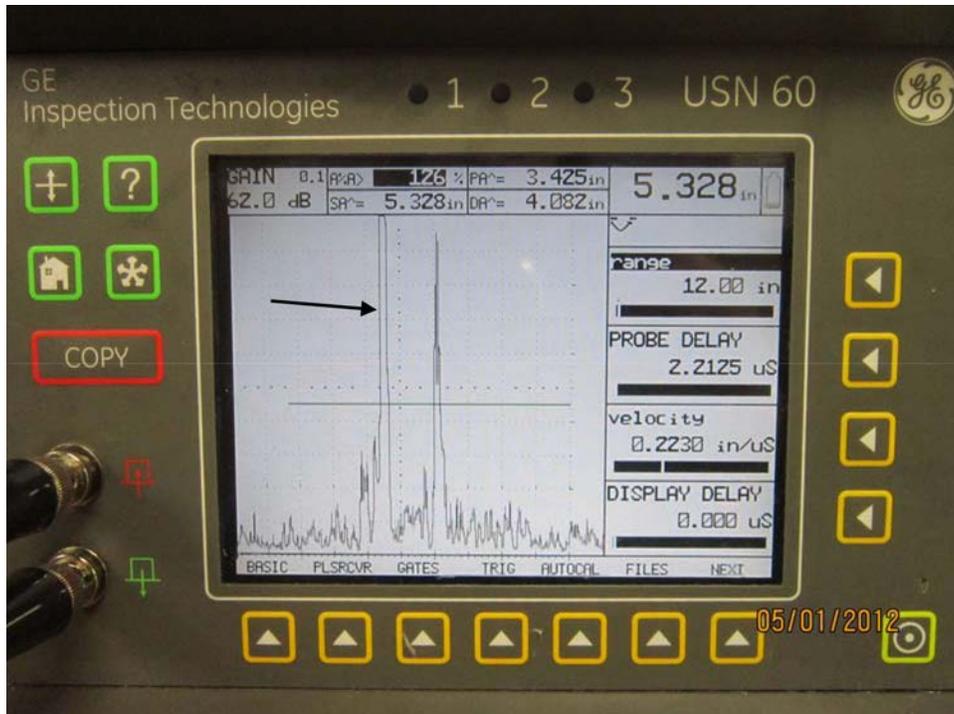
Figure 4.5. DM-05 End-of-Block through Safe End

The end-of-block response from the mock-up, which represents a 100% through-wall smooth reflecting surface, was very easy to detect when scanning from the wrought safe end, but exhibited a significantly lower response when scanning through the weld material. In addition, the UT response from the end-of-block appeared to be slightly shifted out in time, indicating that the weld microstructure may be re-directing the primary sound beam “upward” or at a higher inspection angle. There was a noticeable difference in sensitivity between the LR and RR tandem probes—this was on the order of 4 to 6 dB—and each set of probes exhibited a high-pitched “whining” sound. It should be noted that this repetitive “whining” noise occurred while exciting the probes with the USN60 in the “High” square-wave mode setting (while at North Anna and during assessments at PNNL). The USN60 contains two square wave mode pulser voltage settings – high and low. The USN60 low voltage setting was not applied, as this evaluation was aimed at assessing the field operation at NAPS-1. However, when lower voltage settings were subsequently applied to the tandem probes using instrumentation at PNNL, no audible “whine” was observed.

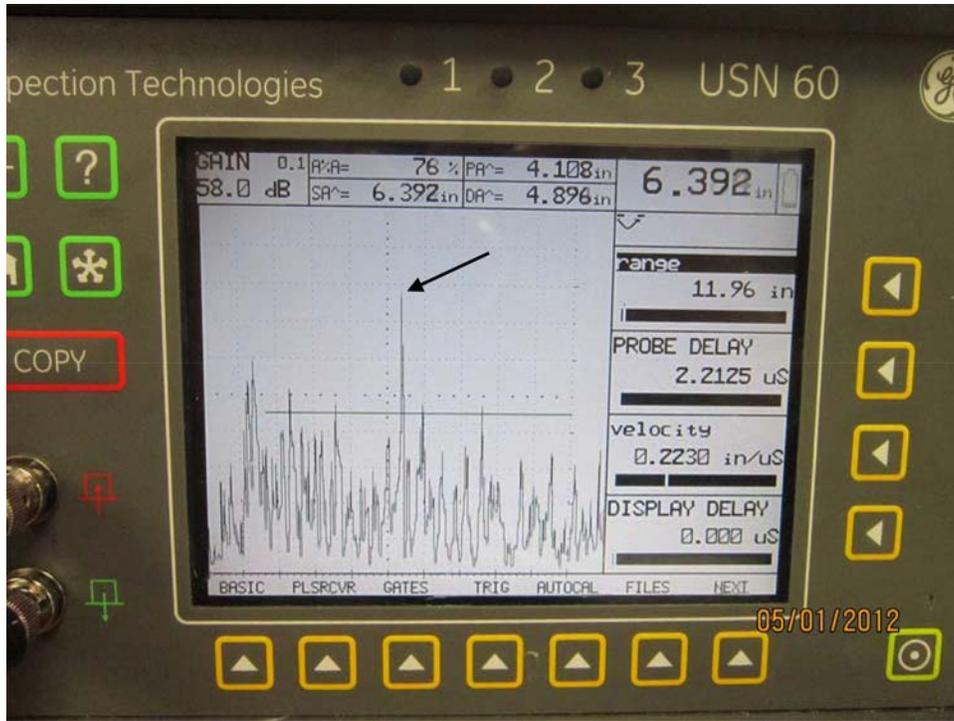
Two axial flaws were detectable with the LR probe (less so with RR), and the SNRs were poor. Each pair of tandem probes required careful manipulation (skewing) to approach a SNR of 2:1. Many larger fabrication/ implantation artifact responses were observed in DM-10 in contrast to those observed in DM-05; these were also found in the near vicinity of the axial flaw locations. The end-of-block response appeared somewhat higher in amplitude through the weld, which could indicate that the weld microstructure varies between DM-05 and DM-10. Figures 4.7 through 4.9 provide additional pictorial support of the discussion in this section.

Figure 4.8. Assumed DM-10 17% Through-Wall Axial Flaw with LR Probe

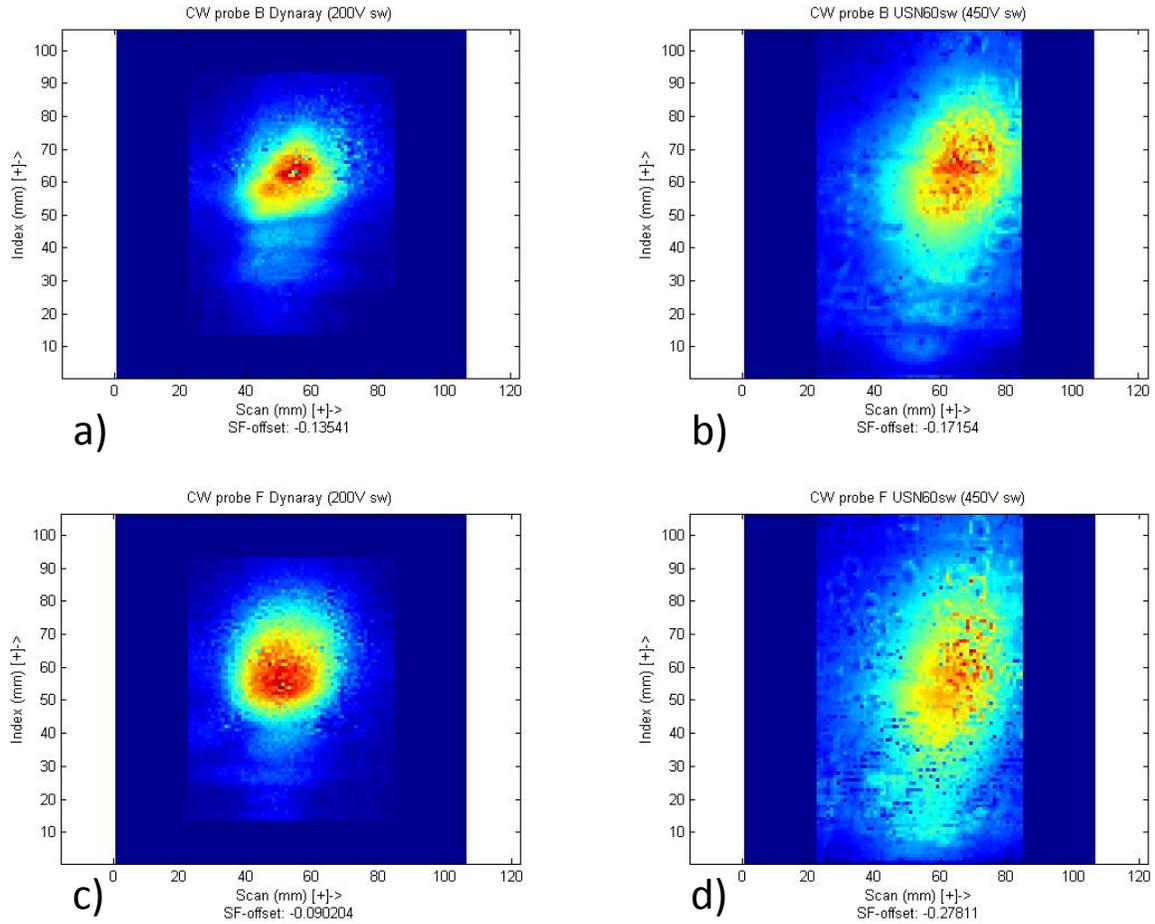
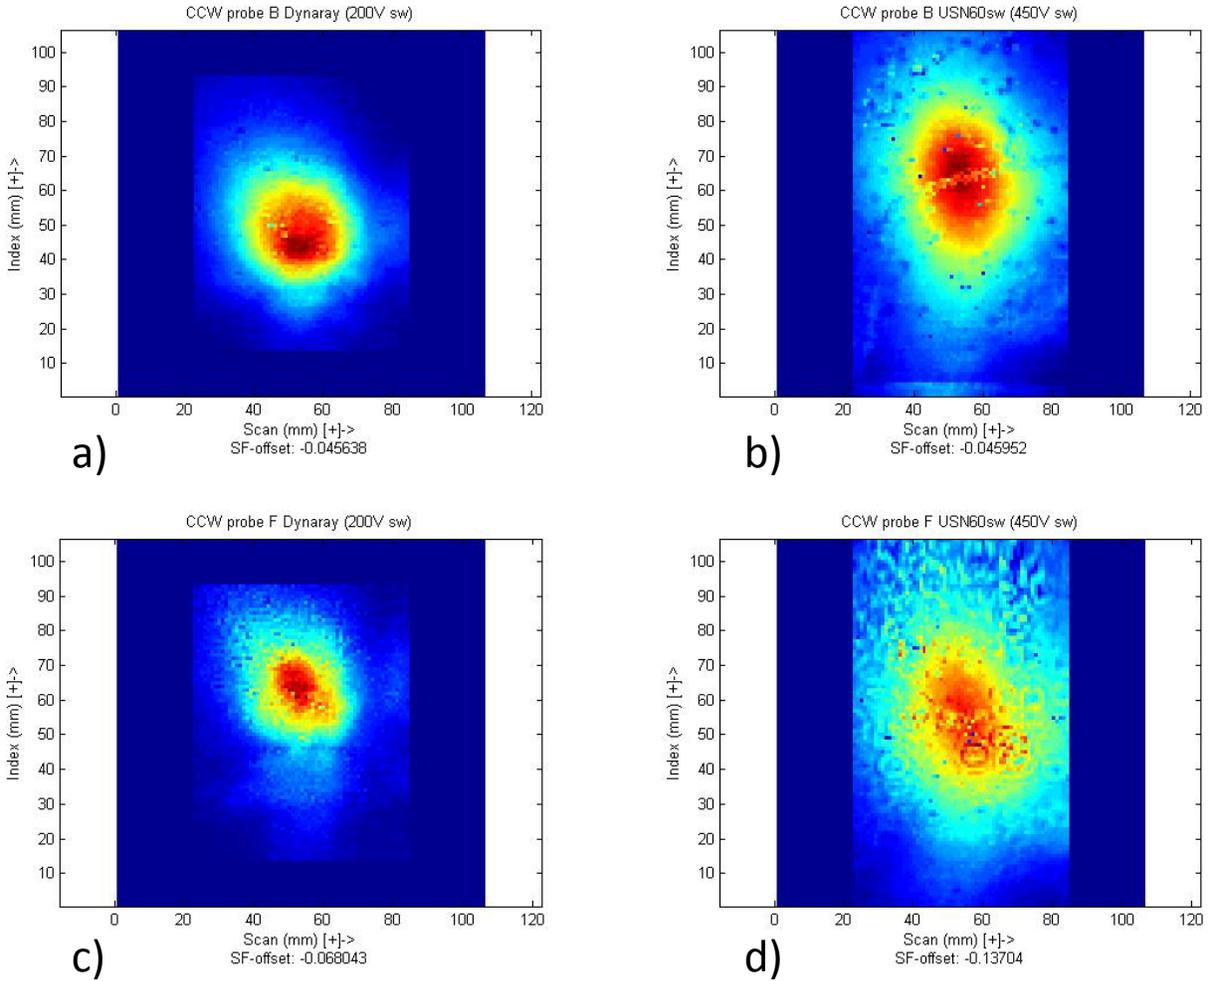
Figure 5.8. Sound Field (MatLab) Images from the CW Tandem Probe: a) back element DYNARAY square wave pulser at 200V; b) back element USN60SW square wave pulse at 450V; c) front element DYNARAY square wave pulser at 200V; d) front element USN60SW square wave pulse at 450V

Figure 5.9. Sound Field (MatLab) Images from the CCW Tandem Probe: a) back element DYNARAY square wave pulser at 200V; b) back element USN60SW square wave pulse at 450V; c) front element DYNARAY square wave pulse at 200V; d) front element USN60SW square wave pulse at 450V

To assess the images in a quantitative sense, the beam sizes at the -6 dB level were measured using the sound field data in Figures 5.8 and 5.9. The DYNARAY and the USN60SW square waves were tuned to the same pulse duration so that the voltages of 200 and 450 could be compared. The results are listed in Table 5.2. Also listed are the ratios of the beam sizes in the scan (image horizontal) direction relative to the beam in the index (image vertical) direction. The DYNARAY pulser produces a more focused and symmetric beam in all scenarios. Symmetry variations in the DYNARAY system are as much as 17% from an ideal (ratio of 1); whereas, the USN60SW shows a deviation of up to 38%. The USN60SW beam size is approximately 20% to 2 times larger in the scan direction (horizontal) and 2 to 2.5 times greater in the index direction (vertical) than the DYNARAY beam. A metric to measure scatter is discussed in the following paragraph.

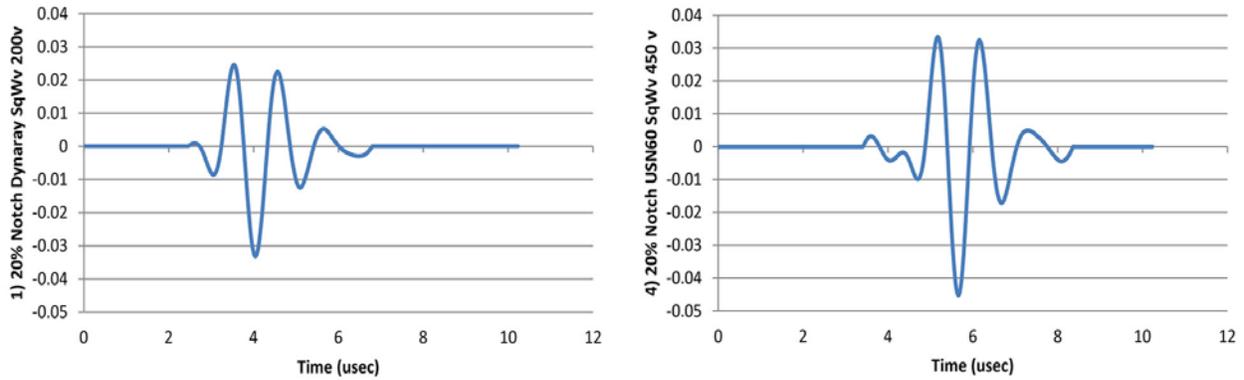
All of the notch responses were received and recorded with the DYNARAY system. The A-scan waveforms from the notch are displayed in Figure 5.10 with the response from the DYNARAY on the left and USN60SW on the right. The peak responses were measured as 0.033 and 0.045 volts for the DYNARAY and USN60SW pulsers, respectively (an increase of 36%).

Figure 5.10. Ultrasonic Responses from a 20% Through-wall Deep Notch: DYNARAY square wave pulser at 200V on the left; USN60SW square wave pulser at 450V on the right

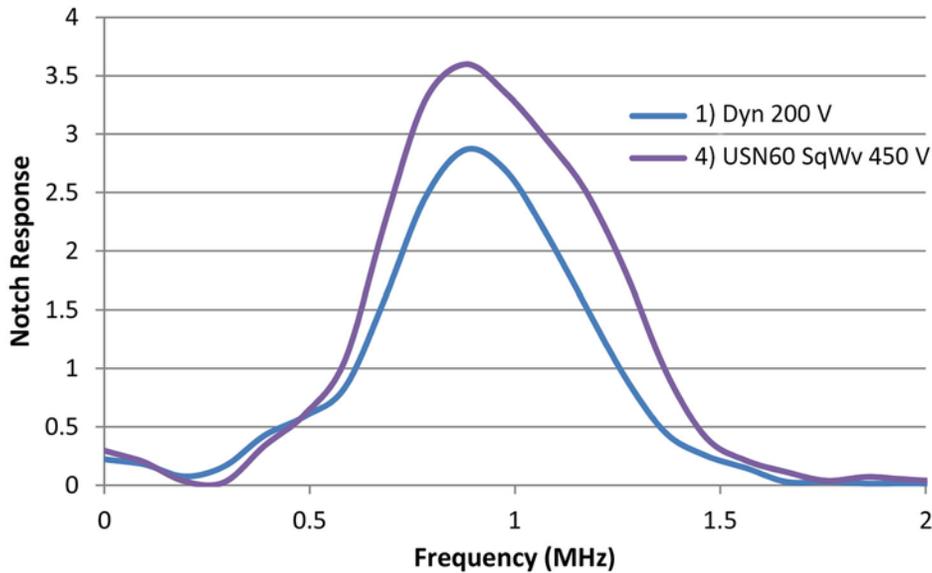
The frequency content of these waveforms was obtained through spectral analyses, with the results shown in Figure 5.11. As expected, the 200-volt DYNARAY response has less energy than the 450-volt USN60SW pulse. Center frequencies are similar for either pulser at 0.92 MHz for the DYNARAY system and 0.96 MHz for the USN60SW system. The bandwidth of the USN60SW pulse response was slightly greater (by 14%) at 65% as compared to the 57% bandwidth of the DYNARAY pulse response. Finally, the SNRs from the reflected notch waveforms were calculated at 22.4 and 24.2 dB for the DYNARAY and USN60SW pulsers, showing minimal to no variation. These SNRs were calculated from the A-scans and represent a peak signal to mean noise value. Peak signal to peak noise values were 8.7 and 9.6 dB for the DYNARAY and USN60SW pulsers.

Figure 5.11. Frequency Content of the Notch Response Waveforms Obtained with Two Pulse Excitation Scenarios

In summary, the square wave pulse excitation function from the DYNARAY at 200 volts and USN60SW at 450 volts were each evaluated on the response from a 20% through-wall deep reference notch in stainless steel. This evaluation used the DYNARAY system as receiver for both pulsers, so this was not a completely independent evaluation of the pulsers, as was done with the sound field mapping exercise. The amplitude response from the USN60SW was approximately 35% greater than the DYNARAY response, but SNRs as measured by both peak response-to-peak noise in the A-scan and peak response-to-mean noise in the A-scan were similar. Frequency responses showed similar center frequencies in the reflected echoes and approximately 15% greater bandwidth in the USN60SW response. It appears that both pulsers produce strong responses from the notch in this stainless steel material. The notch signal from either pulser has a good SNR and both show similar frequency responses; that is, the frequency content of the notch response waveforms obtained with the two pulse excitation scenarios are similar.

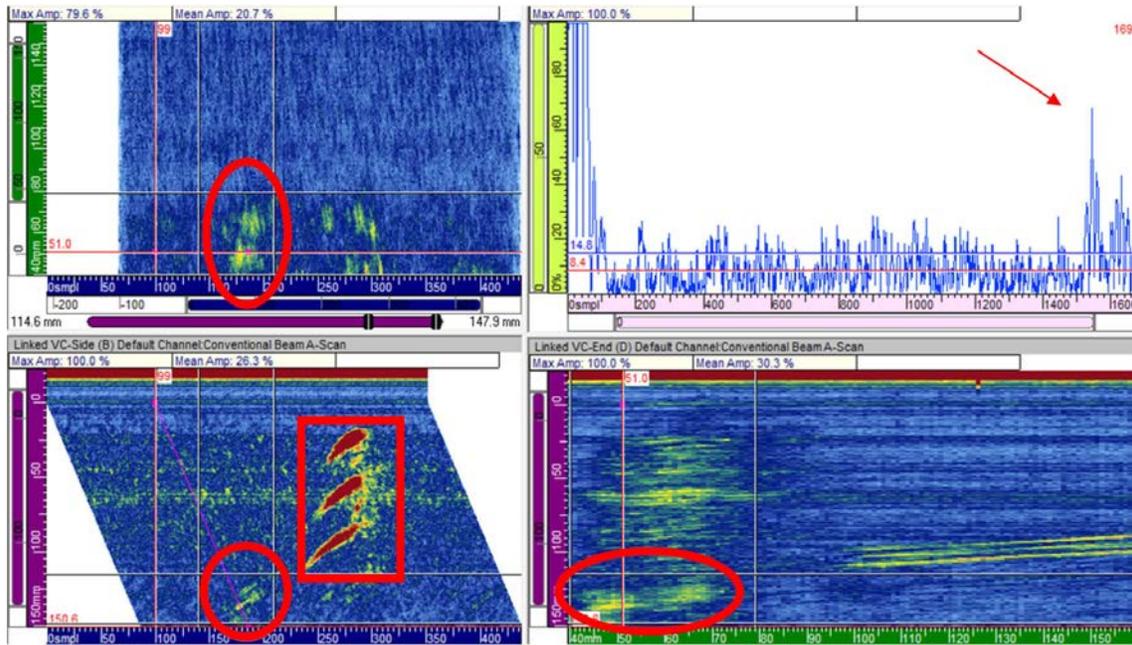
Site-specific mock-ups DM-05 and DM-10 were evaluated with both CW and CCW Sigma tandem probes. Data were acquired with the DYNARAY system using a 200V square wave pulse. Figure 5.12 displays the data acquired from axial flaw 1 and the end-drilled holes in DM-05 with the axial flaw indications circled in red. (A brief overview of the ultrasonic data view(s) used in this report is presented as Appendix A.) The C-scan top view is shown in the upper left, the rectified A-scan in the top right, the B-scan side view in the bottom left and the D-scan end view in the bottom right. The A-scan was acquired along the slanted red measurement line displayed in the B-scan side view. At this position the peak flaw response is well above the noise. During image analyses, SNR is normally calculated as a measure of the peak flaw response relative to the mean noise in the image at the same part path or through-wall depth. The imaged SNR for flaw 1 from Figure 5.12 was calculated as 9.9 dB. This same technique does not apply to an A-scan analysis. For example, Figure 5.13 shows the A-scan from the flaw with the average noise level represented by the red line. The dashed red lines represent +1 and +2 standard deviations (σ). A peak signal response and mean noise level SNR from the A-scan results in a SNR of 15.5 dB. If, however, peak signal response and peak noise level are used, the SNR is 7.4 dB. For

comparison, the peak response compared to the noise as defined by the mean+2 σ , for a 95% confidence interval, results in a SNR of 10.2 dB.

Figure 5.12. DM-05 CW Tandem Probe, Axial Flaw 1 (circled in red and noted by arrow in A-scan) and End-Drilled Hole Responses (boxed in red)

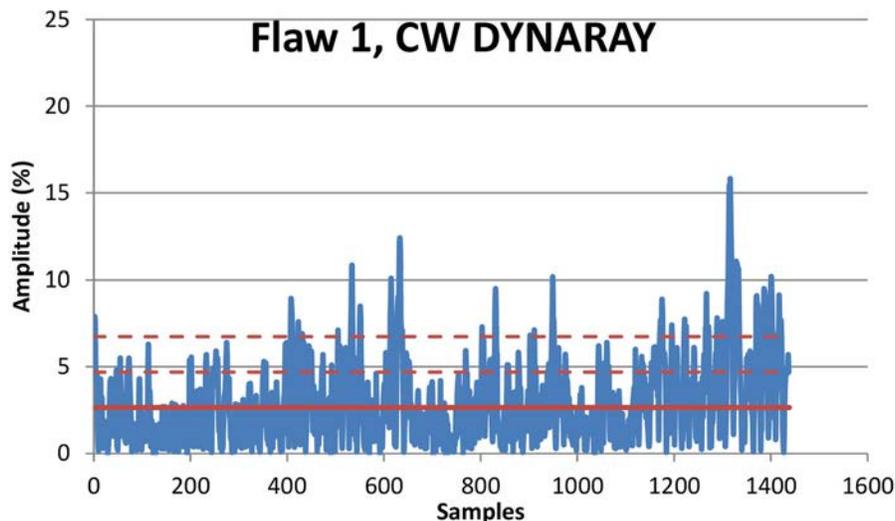
In a manual non-encoded examination, the operator observes the UT instrument screen and, in real time, assesses transient reflections while assuring the transducer is being properly manipulated; thus, a peaked reflector response may not be observed during successive manual scan paths. There can also be significant changes in the A-scans over small changes in probe position. For example, Figure 5.14 shows the data from flaw 1 at a scan position that was incremented by two samples [or 2 mm (0.08 in.)]. This response has a peak-to-mean SNR of 15.5 dB and a peak-to-peak SNR of only 2.1 dB. This response was more typical of the manual data presented in Section 4.0 where SNRs were reported to be at best 2:1 or 6 dB. Figure 5.15 shows the A-scan data with added horizontal lines for the mean, mean +1 σ and +2 σ . The SNR at the mean +2 σ level was 3.3 dB.

Figure 5.15. DM-05 Axial Flaw 1 Response with the Tandem CW Probe at a Scan Position 2 mm (0.08 in.) from the Image Peak Response. The average noise level is noted by the solid red line and the average +1 σ and average +2 σ noise levels are noted by the dashed lines.

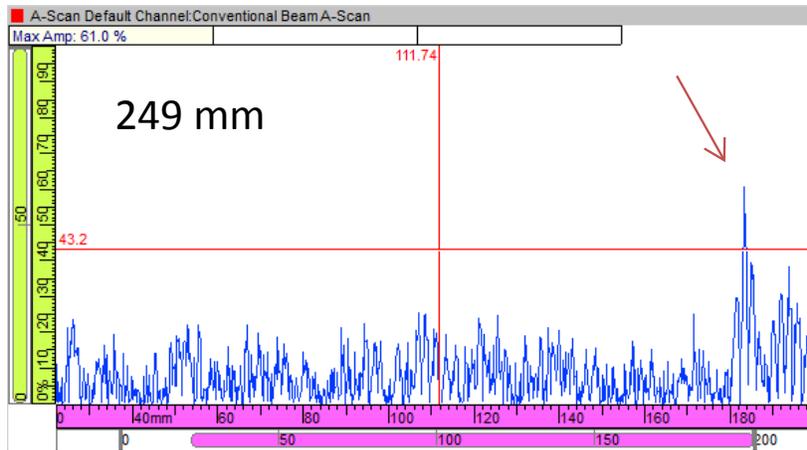
Another important issue was discovered when assessing axial flaw responses using encoded tandem probe data. A fundamental variable when applying manual ultrasonic evaluations is flaw persistence, or the amount of time an examiner has to observe a transient flaw response that is visible above ambient background noise. This persistence is affected by not only the overall signal-to-noise response, but also by scan speed and examiner skill. In order to determine the maximum persistence of a typical axial flaw in the mock-up when using the tandem probe configuration, PNNL employed encoded data. The peak flaw response from Axial Flaw 1, as detected with the CW tandem probe, occurred at an index position of 51 mm (2.0 in.) and a scan position of 249 mm (9.80 in.). The response was noted to peak at 61.0% full screen height (FSH) with 29 dB of total gain (20.0 dB of hardware gain and 9.0 dB of soft gain) being applied. The system gain level was based on an end-of-block edge response. This edge was set at a high enough gain to stay just below saturation.

Figure 5.16. Peak Response from Axial Flaw 1

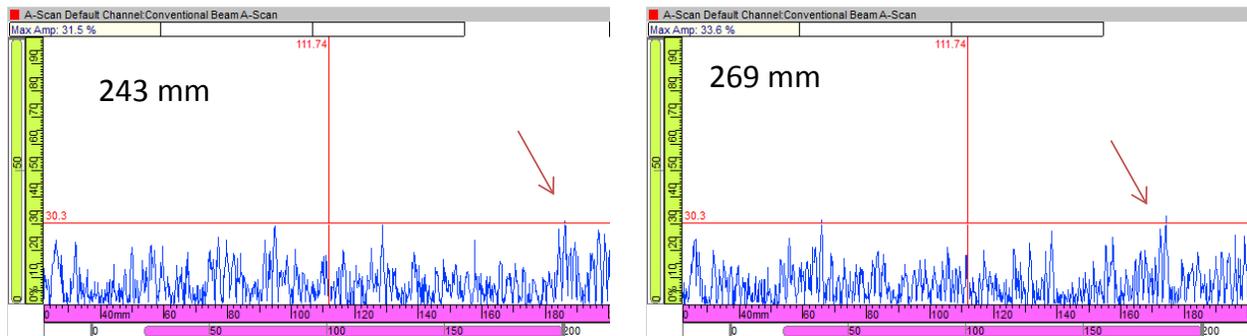
In order to measure persistence, the scan position was moved forward (toward the flaw) until the signal dropped to a 50% amplitude level (−6 dB, or about 30% FSH) and then backward (away from the flaw) to a 50% amplitude level. This full scan distance between −6 dB points was measured to be approximately 26.0 mm (1.02 in.), which represents the flaw persistence while scanning. The A-scan data are displayed in Figure 5.16 for the peak response at the 249-mm scan position. Figure 5.17 shows the two positions where the signal drops to the 50% level at 243 and 269 mm in the scan axis. The flaw signals at this 50% (−6 dB) level are comparable to ambient peak noise responses in the A-scan; thus, at these points, the flaw is essentially undetectable.

Figure 5.17. Responses at 50% Amplitude Level (-6 dB)

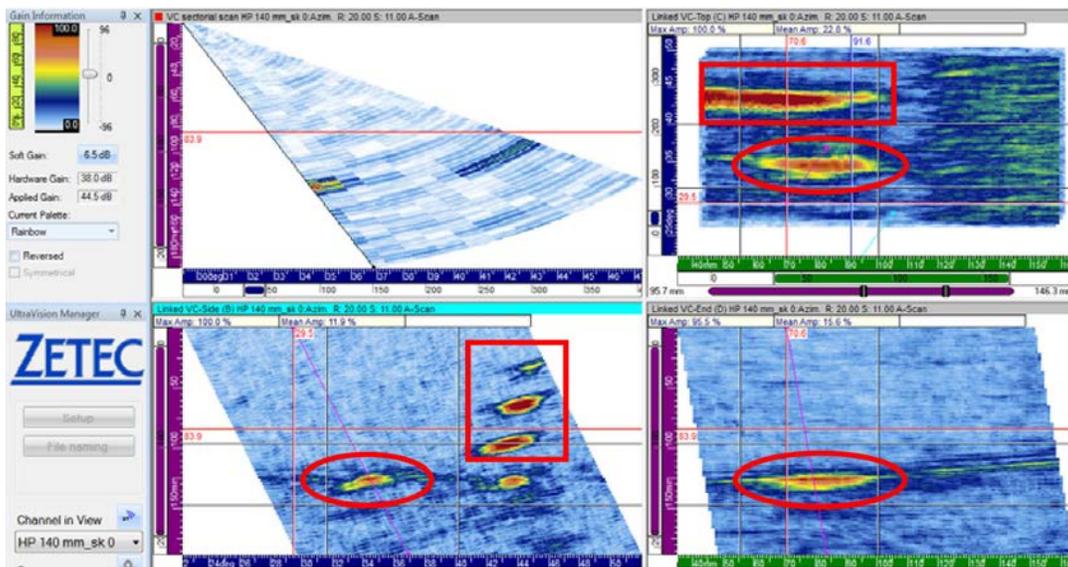
After initial reviews of a portion of the data, the half-path focusing was found to produce images with similar or slightly better (1 dB) SNRs. Figures 6.8 and 6.9 show the true-depth and half-path images from axial flaw 1 and three SDHs in DM-05. This presentation of data will be the standard format for the 0.5-MHz PA data in this report. The sector scan is displayed in the upper left, the C-scan top view in the upper right, the B-scan side view in the lower left, and the D-scan end view in the lower right. Electronic gating is accomplished with the black horizontal and vertical lines. Because the half-path focusing produced similar or marginally better SNRs, only the half-path data were analyzed to expedite the data review.

Figure 6.8. Mock-up DM-05 Axial Flaw 1 (circled) and Three SDHs (boxed) with a True-Depth Focus at 125 mm (4.92 in.). The scan is in the CW direction with a 0-degree skew.

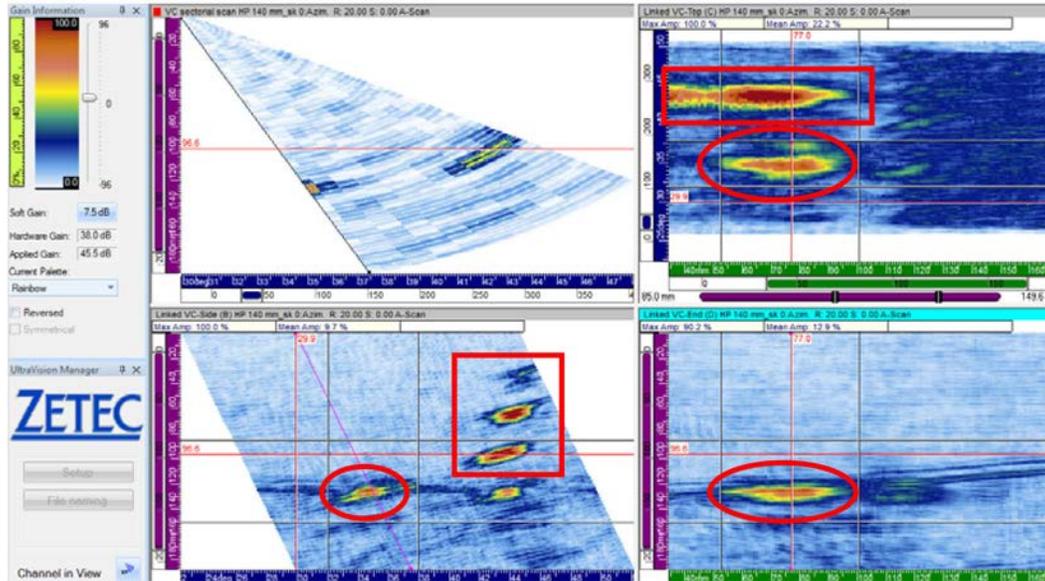
Figure 6.9. Mock-up DM-05 Axial Flaw 1 (circled) and Three SDHs (boxed) with a Half-path Focus at 140 mm (5.51 in.). The scan is in the CW direction with a 0-degree skew.

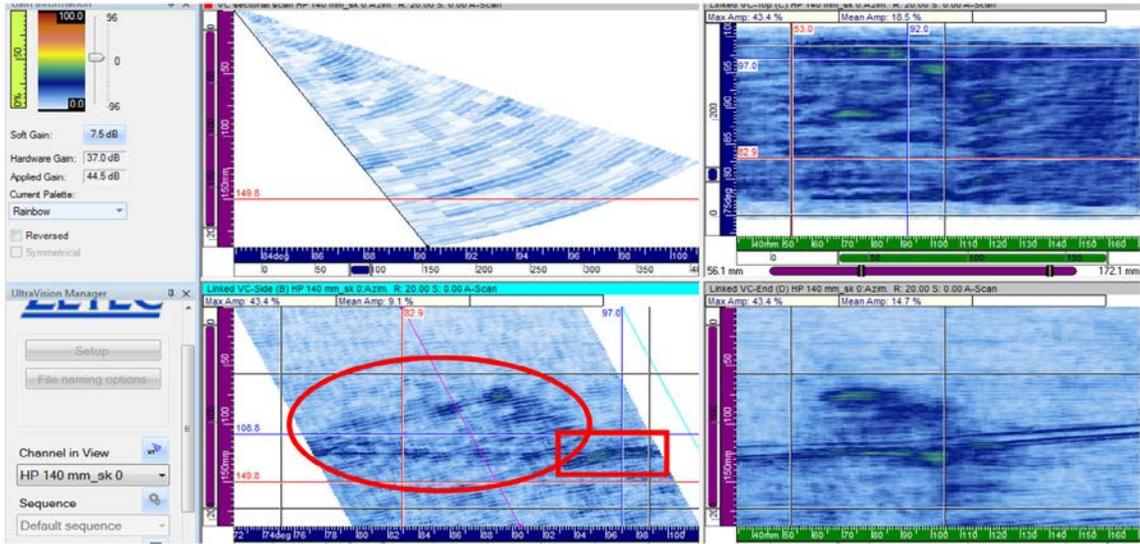
Implantation artifacts are evident in the region of circumferential flaw 2 as shown in Figure 6.14, also circled in red. This flaw is reported at the circumferential region between 83 and 97 degrees. While a strong ID corner response is not visible, except possibly to the right at 94 to 98 degrees (in the red boxed region) with a peak response of 28.7%, there is a noticeable upper flaw signal response. This upper signal

has a peak response of 29.0%, well over the mid-wall peak and average baseline noise levels determined earlier. The flaw depth is measured at 50.5 mm (2.00 in.) while the true depth is reported at 62.0 mm (2.44 in.). This nearly 50% through-wall deep circumferential flaw is thus detected by a mid-wall response outlining the upper part of the flaw and by possible stronger ID signal responses at the extremities of the flaw.

Figure 6.14. DM-05 B-scan Side View (bottom left) Depicts an Implantation Artifact from Circumferential Flaw 2 (circled) and ID Corner Response (boxed)

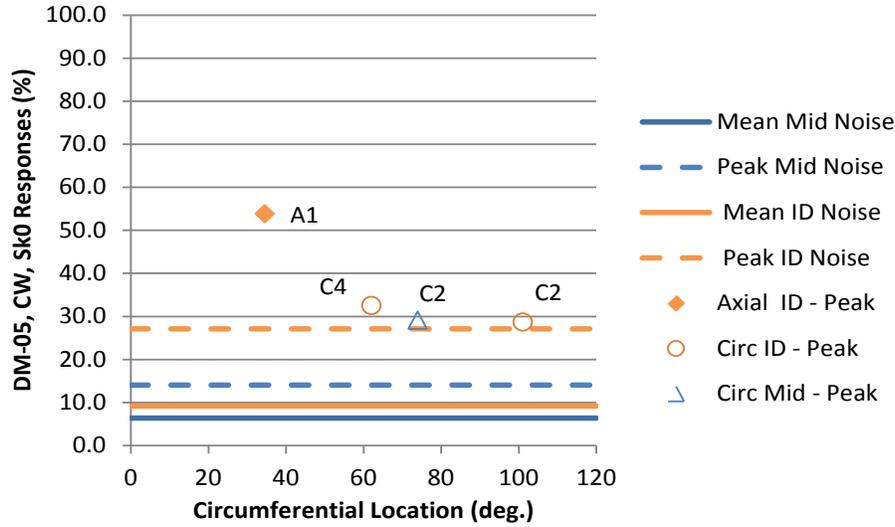
A summary plot of the CW data responses obtained with a skew angle of 0 degrees is shown in Figure 6.15. The mean and peak ID noise values are represented by the solid and dashed orange horizontal lines, respectively. The noise from the mid-wall region as measured by the mean and peak values is represented by the blue solid and dashed lines, respectively. In general the color orange denotes ID signals and blue denotes mid-wall signals. Further, the axial flaw response (A1) is plotted as a filled diamond symbol. These signals, noise and axial flaw responses, establish a baseline to which all unknown signals may be compared. Based on the comparison, it is believed that all of the artifact responses can be attributed to circumferential flaw implantation and are plotted with hollow markers (except for circumferential flaw 2 in the DM-05 mock-up which shows an artifact at 10 degrees, which is not a documented flaw implantation site). The horizontal axis represents the circumferential position of the peak response. Indication length and proximity of indications will be presented later. The peak ID artifact or circumferential flaw 4 (C4) signal observed at 62 degrees is plotted as well as the circumferential flaw 2 (C2) artifact peak responses from the ID and mid-wall regions. Clearly the peak mid-wall response from circumferential flaw 2 is much greater than the peak noise value in the mid-wall region of the mock-up as was seen in the data image. The ID response of circumferential flaw 2 is not noticeably larger than the peak ID response in the mock-up but is well above the mean ID noise. This flaw might not be detected based solely on its ID response amplitude, but the ID signal was wider (in time or depth) than the baseline noise and the large mid-wall indications clearly show the presence of an implantation artifact in this location.

Figure 6.15. Summary of Noise and Signal Responses for DM-05 Scanning CW with a Skew Angle of 0 Degrees. The normalized gain setting is 41 dB.

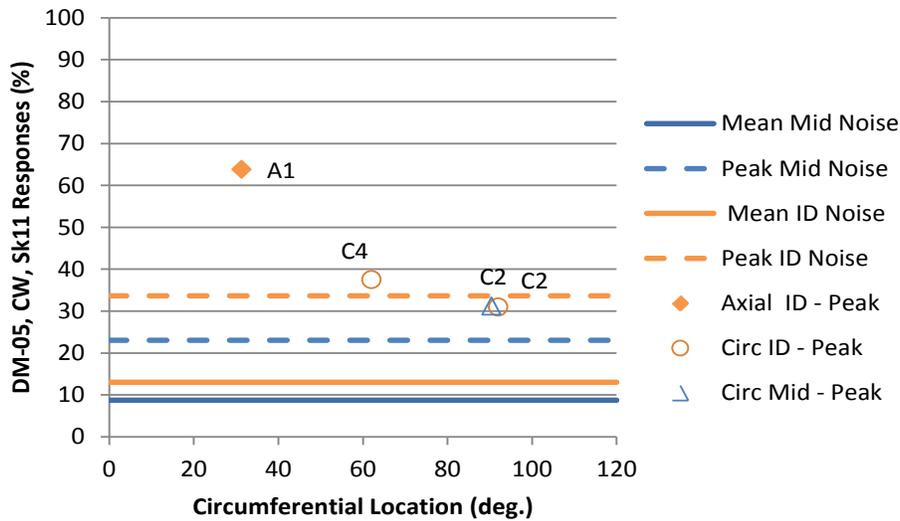
The DM-05, CW data with a skew angle of 11 degrees were similarly analyzed for noise, known signals, and artifact responses. A summary of these results is plotted in Figure 6.16 and is comparable to the skew 0-degree data in Figure 6.15. Within measurement error, the true state location is the same as what is plotted. The axial flaw response is well above the noise levels and the mid-wall signal from the circumferential flaw 2 stands out along with the artifact or circumferential flaw 4 signal observed at the ID (at 62 degrees). Artifacts from circumferential flaw 3 implantation were not detected in either of the CW data sets.

Figure 6.16. Summary of Noise and Signal Responses for DM-05 Scanning CW with a Skew Angle of 11 Degrees. The normalized gain setting is 41 dB.

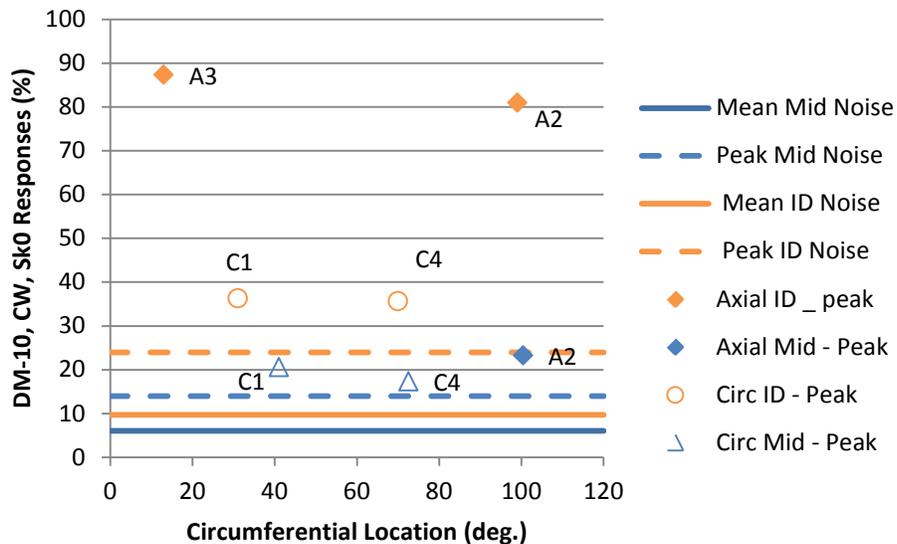
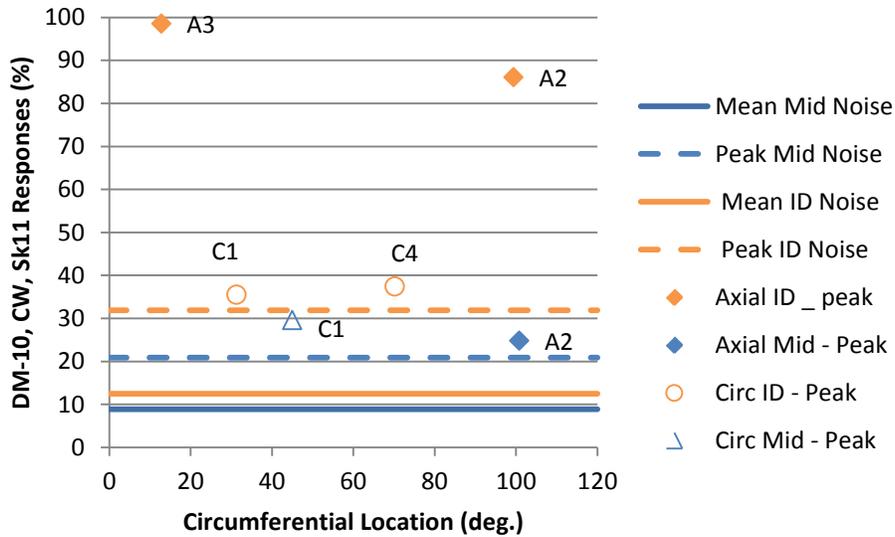
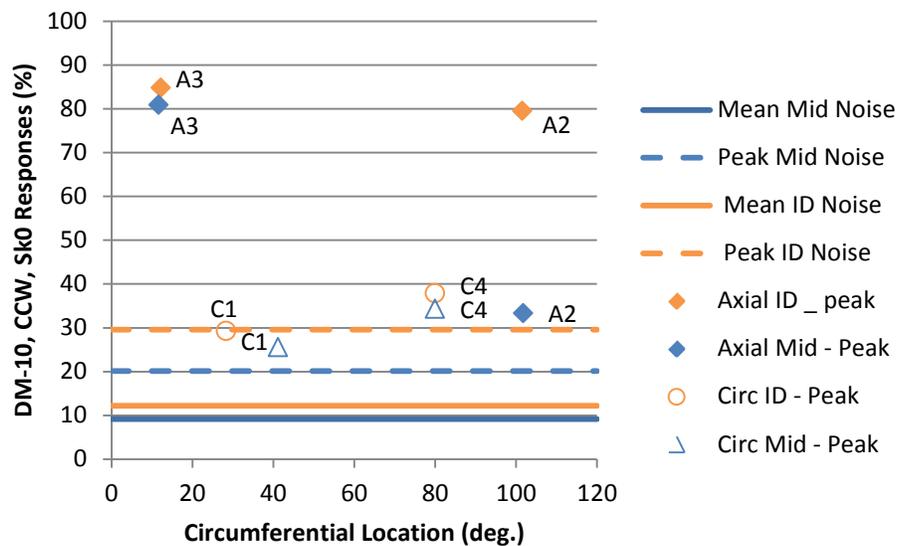
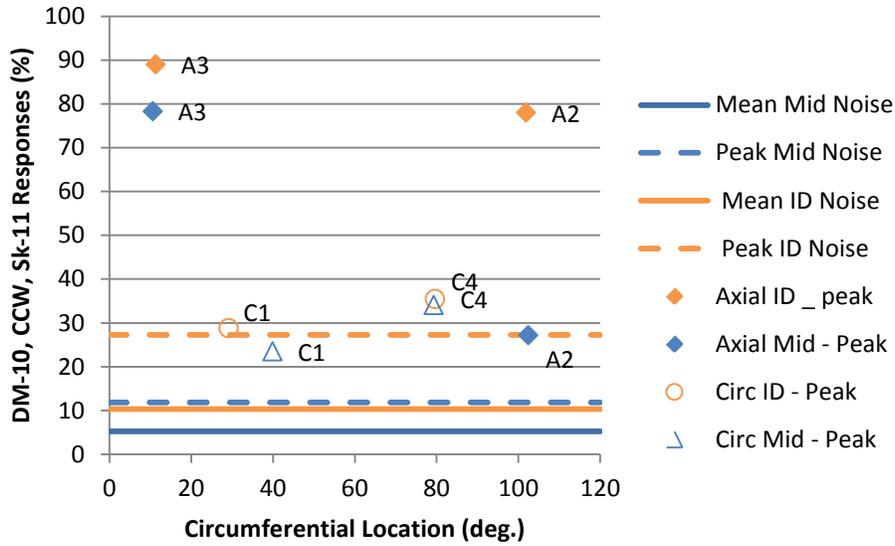
The data summaries in graphical form for the DM-10 mock-up are displayed in Figures 6.20 through 6.23. Figures 6.20 and 6.21 capture the CW scan data with skew angles of 0 and 11 degrees, respectively, while Figure 6.22 and 6.23 capture the CCW scan data with skew angles of 0 and -11 degrees, respectively. The two axial flow responses (orange diamonds A2 and A3) from the ID are well above the noise levels. A smaller mid-wall response is evident in axial flow 2 (blue diamond A2) in all data sets; however, a large mid-wall response is seen from axial flow 3 (blue diamond A3) when scanning in the CCW direction. This response is nearly as bright as the ID corner response and is indicative of a specular reflection from the flaw as opposed to a tip signal. It could also be an effect of the implantation and not a direct flaw response. Implantation artifacts are evident from circumferential flaws 1 and 4 in all data sets with the 42% through-wall deep circumferential flaw 1 more noticeable than the 23% through-wall deep flaw 4. The PA data images are presented in Appendix C.

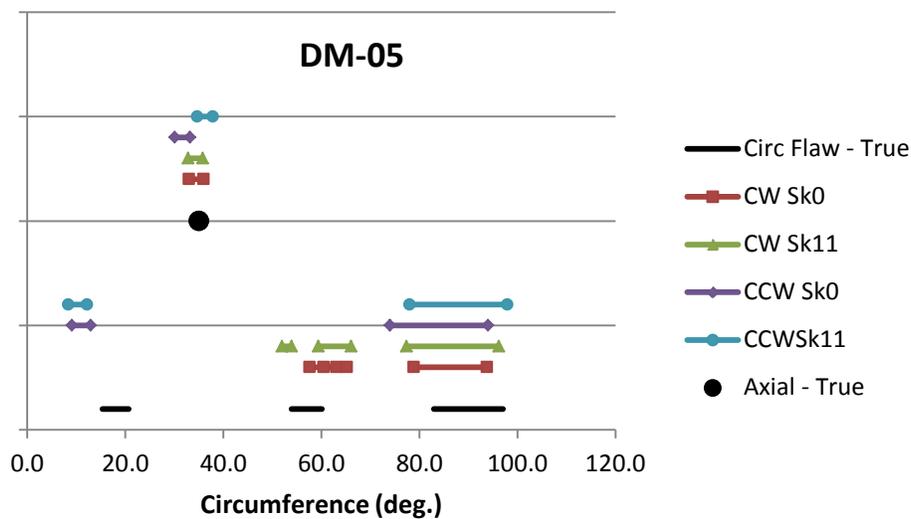
The responses from circumferential scans to detect axial flaws were mapped to circumferential locations with the results summarized in Figures 6.24 and 6.25. These figures show the reported or true axial flaw locations as black dots and the circumferential flaw locations as black lines. The beginning and ending positions of the flaw response in the circumferential extent as measured at the approximately -6 dB level are plotted along the horizontal axis. The vertical axis has no units and is merely a means of displaying the responses from the CW scan direction at skew 0 and 11 degrees and CCW scan direction at skew 0 and -11 degrees all on the same plot. From Figure 6.24, the axial flaw was detected at all four probe scanning combinations as were implantation artifacts from circumferential flaw 2 at 90 degrees. Circumferential flaw 3 artifacts at 18 degrees were only detected using the CCW data and circumferential flaw 4 at 57 degrees was only detected in the CW data. The two axial and two circumferential flaws in DM-10, Figure 6.25, were detected in all four scan configurations. Based on using the PNNL 0.5-MHz PA probes and the ability to use imaging analyses from encoded data, adequate separation between the targeted axial flaws and circumferential flaw implantation artifacts is observed; thus, the artifacts do not negatively influence axial flaw sizing. However, axial flaw detection and/or sizing using a manual non-encoded method would not be expected to resolve the responses this easily.

Figure 6.24. Circumferential Location of Flaws and Responses in Mock-up DM-05

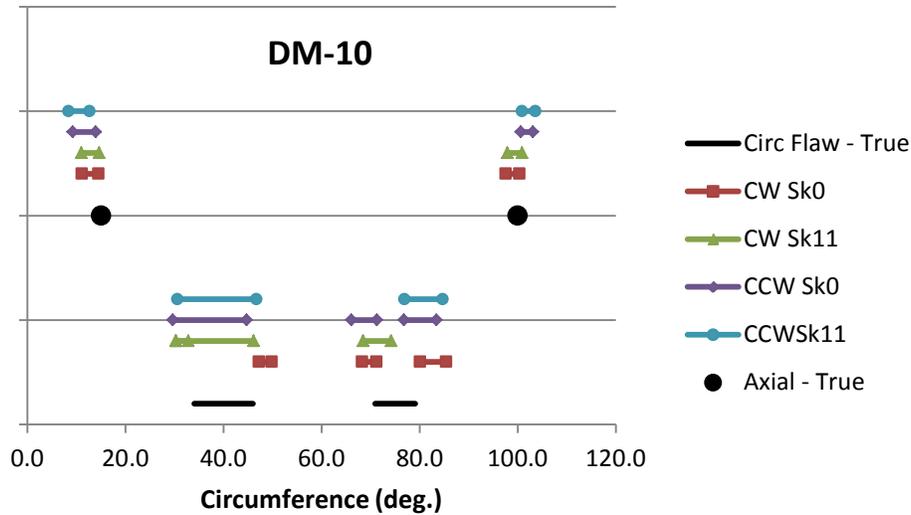
Figure 6.25. Circumferential Location of Flaws and Responses in Mock-up DM-10

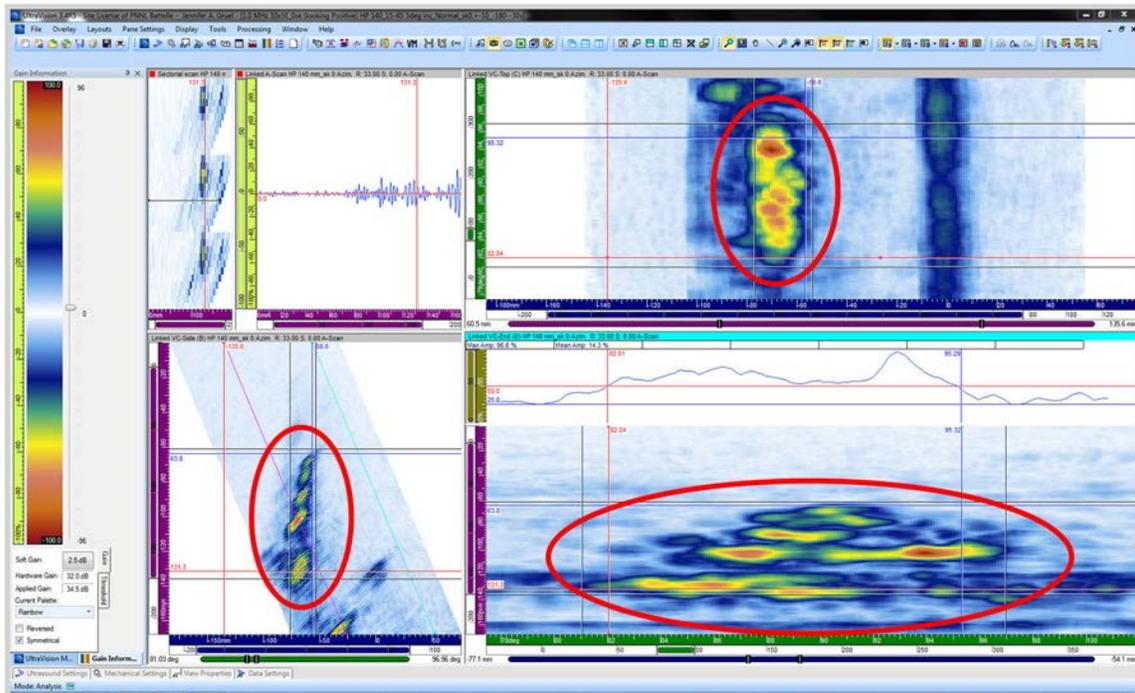
The mock-ups were scanned in the axial direction to assess and validate detection of the five implanted circumferential flaws. All of the circumferential flaws were detected. Results of the data analyses are listed in Table 6.6 and include the measured flaw length, depth, and SNR. Figure 6.33 shows circumferential flaw 2 from DM-05 examined at the refracted angle of 33 degrees. The flaw response is circled in the figure. This flaw has strong specular reflections from multiple locations along its through-wall extent that facilitate characterization. Occasionally it was difficult to separate flaw ID corner responses from weld geometrical signals; however, the upper portion of a flaw could be isolated in most

Figure 6.33. 1.0-MHz Axial Scan, Circumferential Flaw 2 in DM-05 Circled in Red

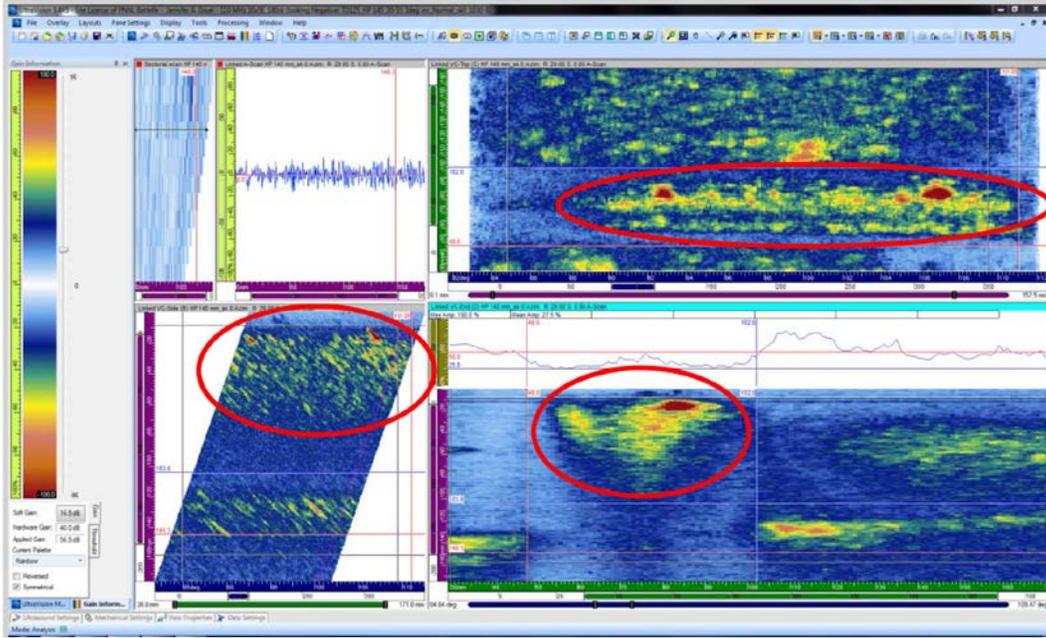
Analysis of 2.0-MHz circumferential scan data included an assessment of artifacts previously seen that were neither intentional flaws nor geometric responses. As with the 1.0-MHz data, the 2.0-MHz data scans only covered regions containing the implanted flaws and not the full 120-degree circumference of the mock-ups. Unlike the 0.5 MHz and 1.0-MHz data that displayed several ID response artifacts in regions of, or adjacent to, the intentional flaws, the 2.0-MHz data exhibit a lack of signal response at the ID flaw/weld region, but the presence of a significant number of weld fabrication flaws that begin in mid-wall and extend to the OD were observed. Figure 6.35 shows a cluster of weld fabrication flaws circled in red in the C-scan, B-scan, and D-scan views from the CCW data in the flaw 2 region of DM-10. The fabrication flaws are located directly in the weld region of the component with volumetric-like responses indicative of slag or porosity as a result of the welding process.

Figure 6.35. DM-10 CCW Skew 0 View of Axial Flow 2 Region (flaw not detected) with Weld Fabrication Flaws Circled in Red

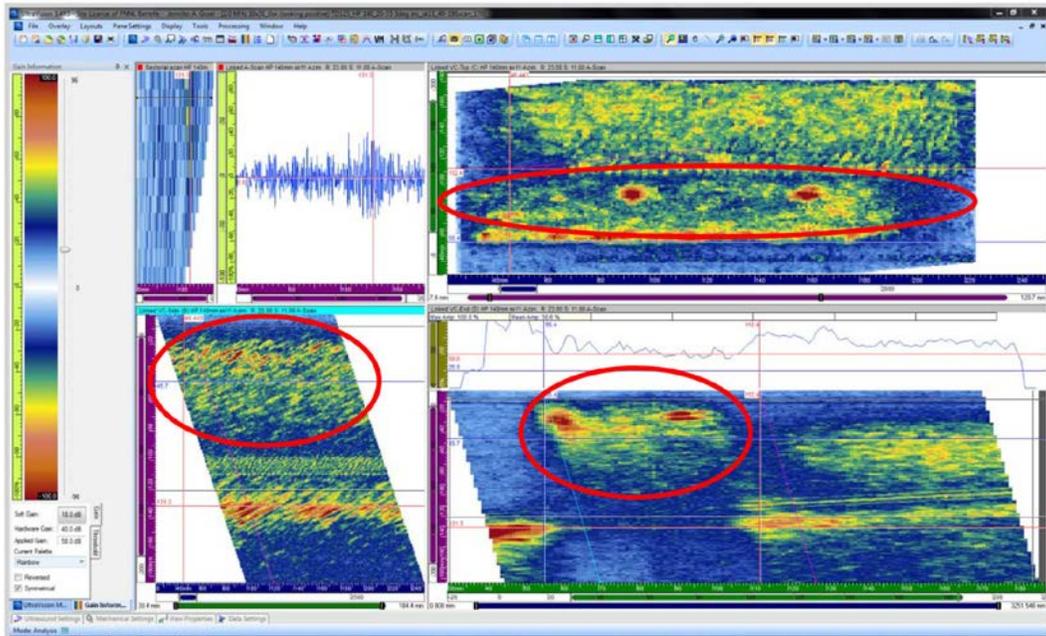
Data from the axial flow 3 region of DM-10 also has a significant population of fabrication flaws in the weld region as circled in red on Figure 6.36. The responses again appear volumetric.

Figure 6.36. DM-10 CW Skew 10 View of Axial Flow 3 Region (flaw not detected) with Weld Fabrication Flaws Circled in Red

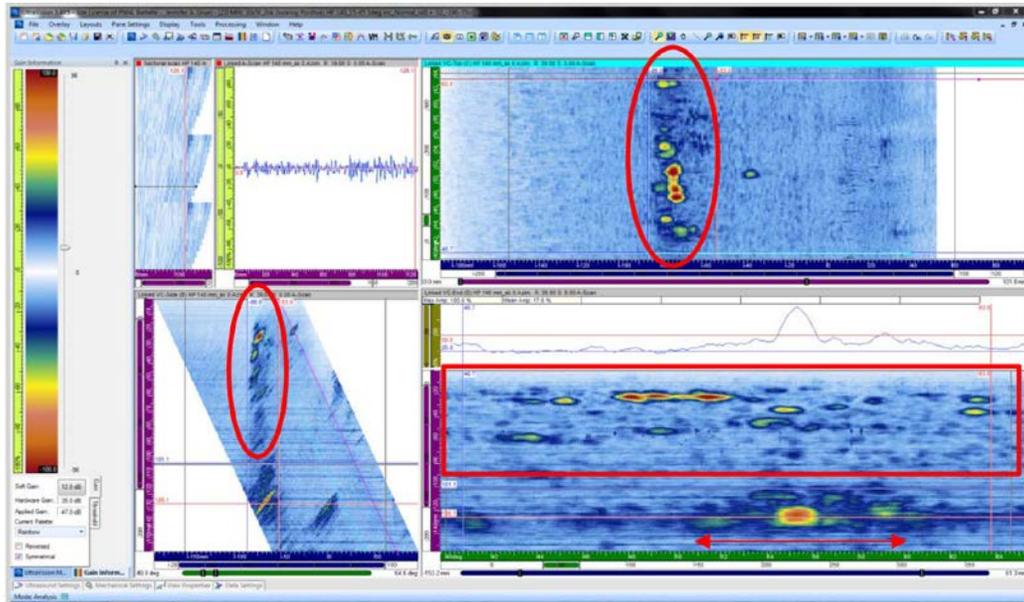
Figure 6.37 shows the CW view of the circumferential flaw 3 region in DM-05. The data gates have been applied to isolate the region above the ID region. The C-scan view shows the many indications in the weld region (circled in red) that are likely a result of the welding process. The B-scan view shows the depth variation of the indications. Similarly, Figure 6.38 shows the CW view of circumferential flaw 4 with similar strings of indications found mid-wall.

Figure 6.38. Looking Positive Skew 0 View of Circumferential Flaw 4 (indicated by red arrow) DM-05 with Weld Fabrication Flaws Circled and Boxed in Red

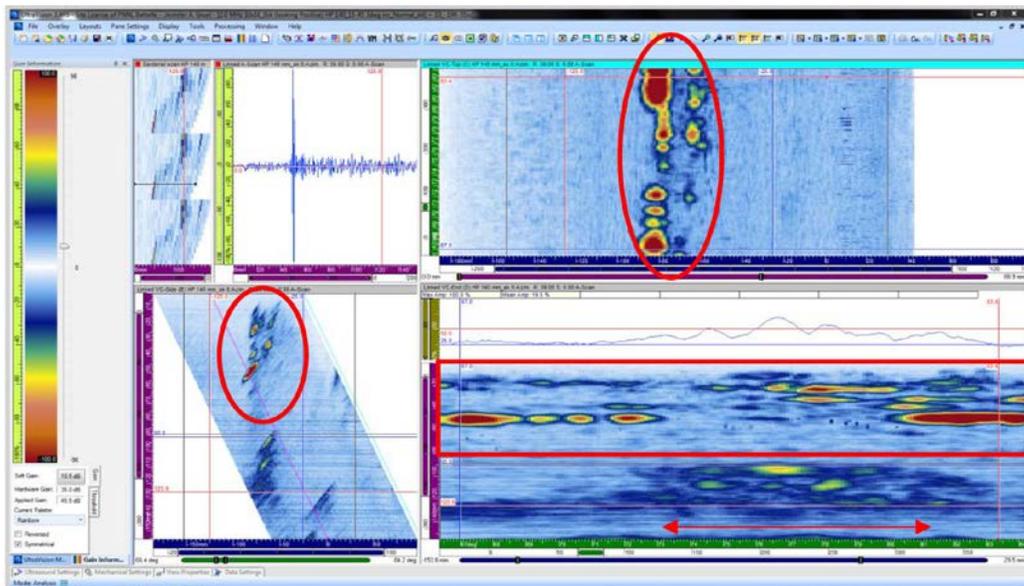
Specimen DM-10 also presented a range of fabrication flaws present in the weld region of the specimen. The circumferential flaw 4 region depicted in Figure 6.39 highlights some of the stronger, more detectable strings of fabrication indications present. Here, the fabrication flaws (circled and boxed) are actually stronger than the intentional flaw of the region, marked by the red arrow.

Figure 6.39. Looking Positive Skew 0 View of Circumferential Flaw 4 (indicated by red arrow) DM-10 with Weld Fabrication Flaws Circled and Boxed in Red
