PNNL-22553

Final Assessment of Manual Ultrasonic Examinations Applied to Detect Flaws in Primary System Dissimilar Metal Welds at North Anna Power Station

March 2014

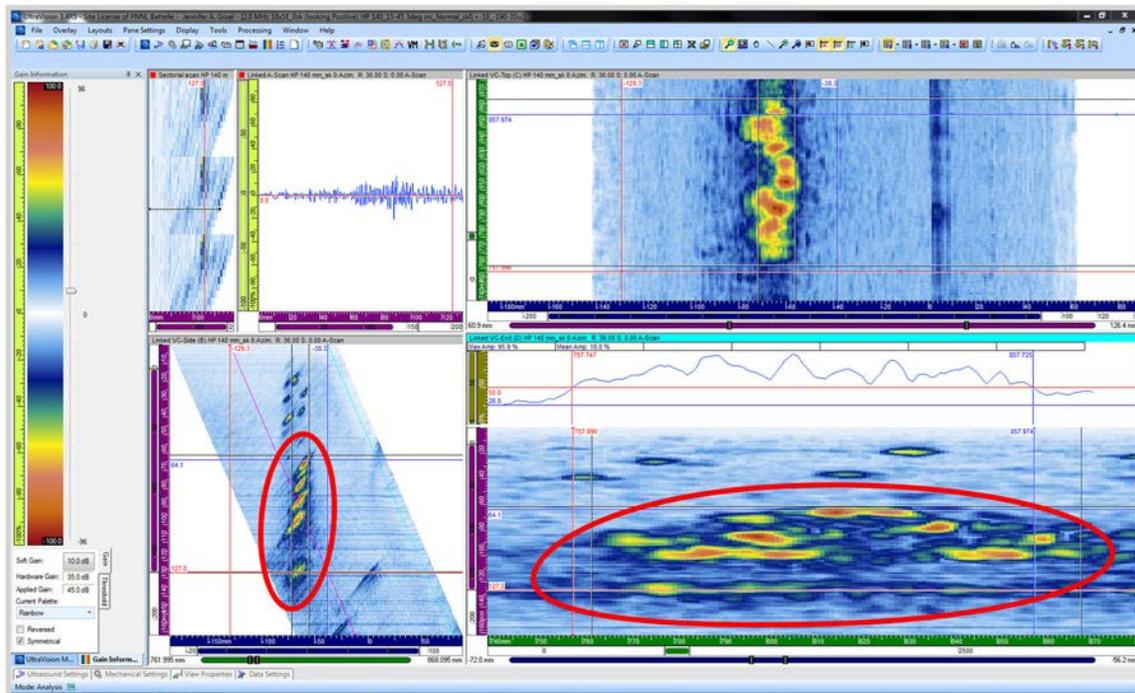
The mock-ups were scanned in the axial direction for the detection of the five implanted circumferential flaws. Results of the data analyses are listed in Table 6.7 and include the measured flaw length, depth, and SNR. Figure 6.40 shows circumferential flaw 1 (circled) from DM-10 examined at the refracted angle of 36 degrees. This flaw also has strong specular reflections from multiple locations along its through-wall extent that facilitate characterization. All of the circumferential flaws were detected; however, occasionally it was difficult to separate flaw ID corner responses from weld geometrical signals. The SNRs as measured at the ID were between 13.6 and 18.6 dB. The full set of data images are presented in Appendix E.

Figure 6.40. 2.0-MHz Axial Scan, Circumferential Flaw 1 (circled in red) in DM-10

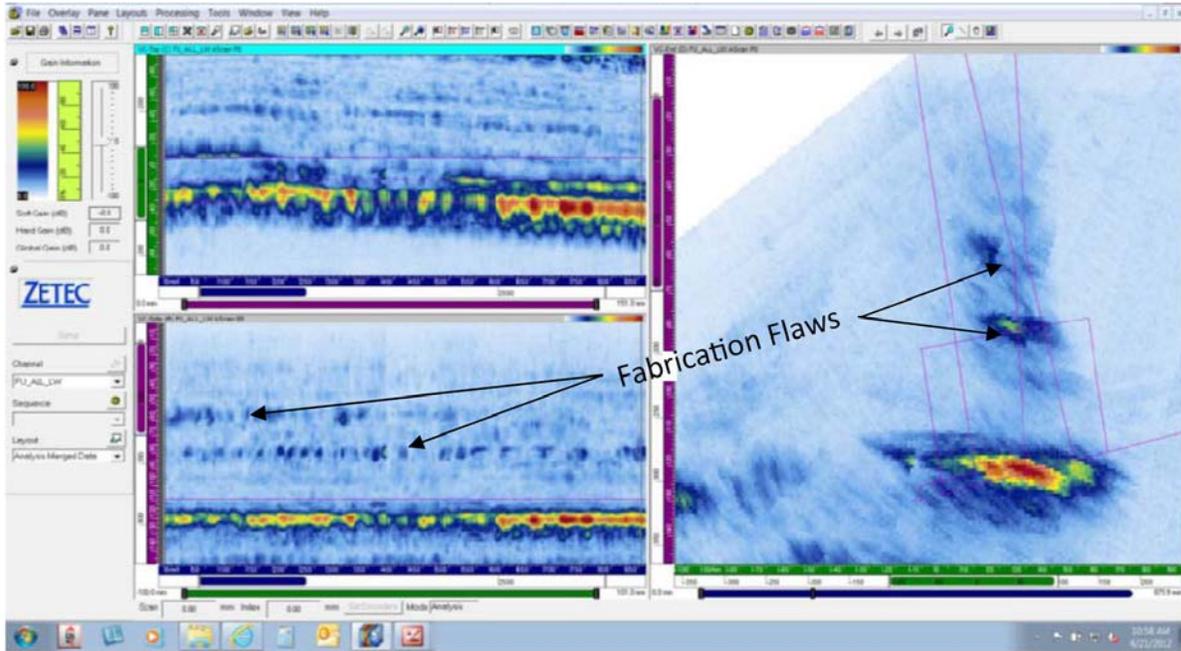
One cold leg weld was fully evaluated while individual quadrants of the remaining two cold leg welds were selected to assess trends seen in the primary weld that was initially examined. In addition, data from hot leg welds were provided by Dominion and a review and screen capture exercise was conducted on those components as well. Figures 6.42 and 6.43 show example data containing fabrication flaws and general weld 'noise' from the field welds.

Figure 6.42. Axial Scan Data from a Field Weld

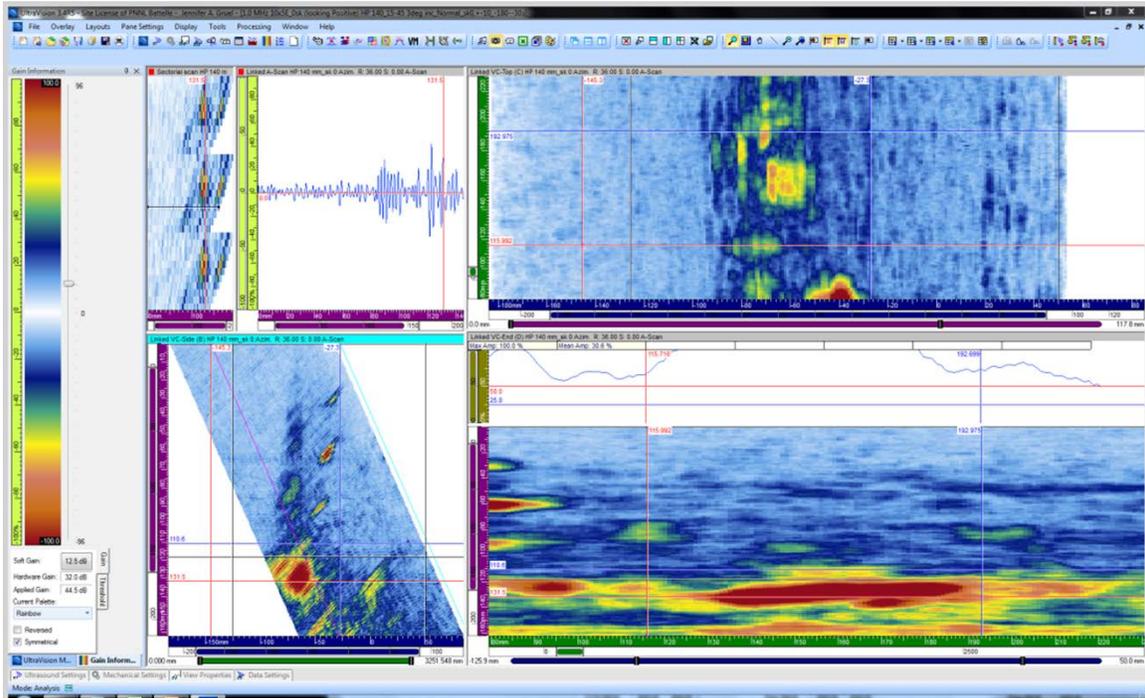
Figure A.5. CW Probe, DM-10 Axial Flaw 2 Circled in Red

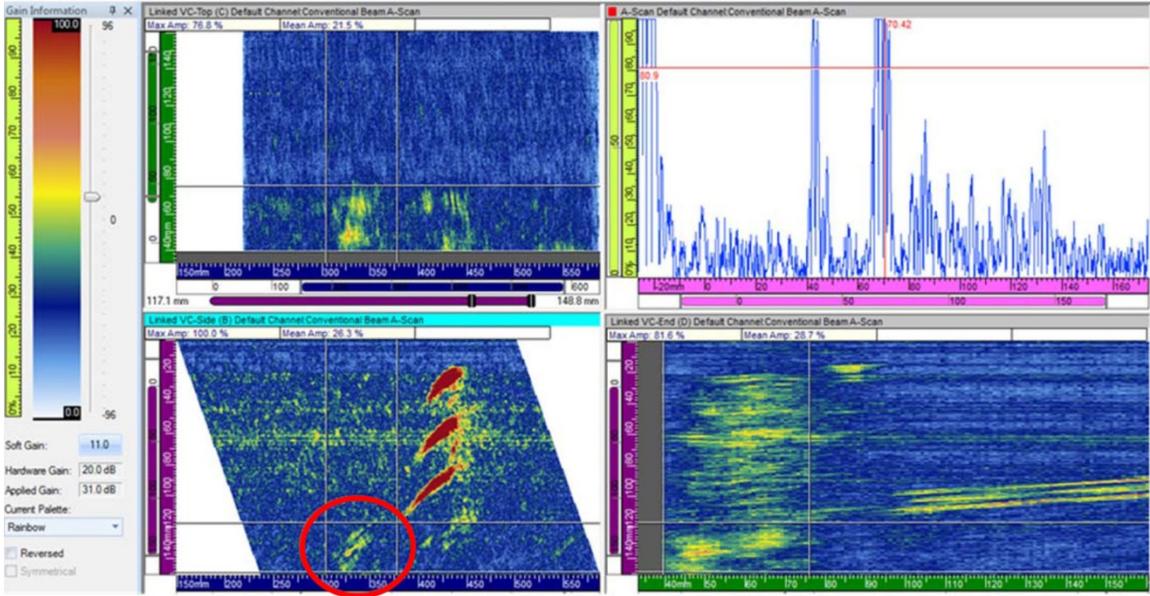
Figure B.3. CW Probe, DM-05 Axial Flaw 1 Circled in Red

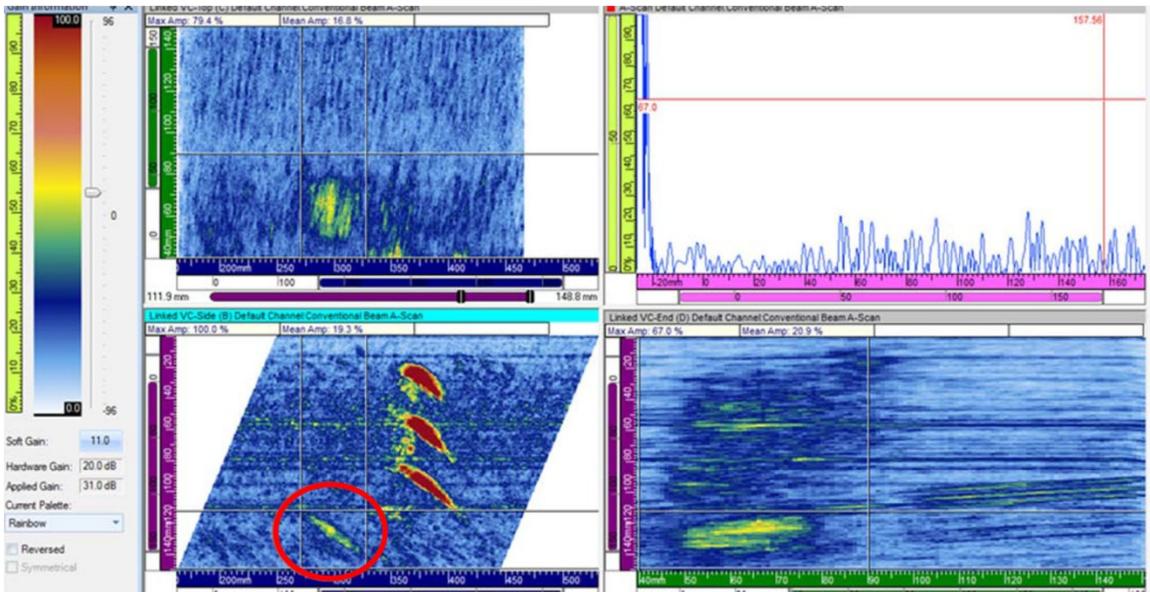
Figure B.4. CCW Probe, DM-05 Axial Flaw 1 Circled in Red

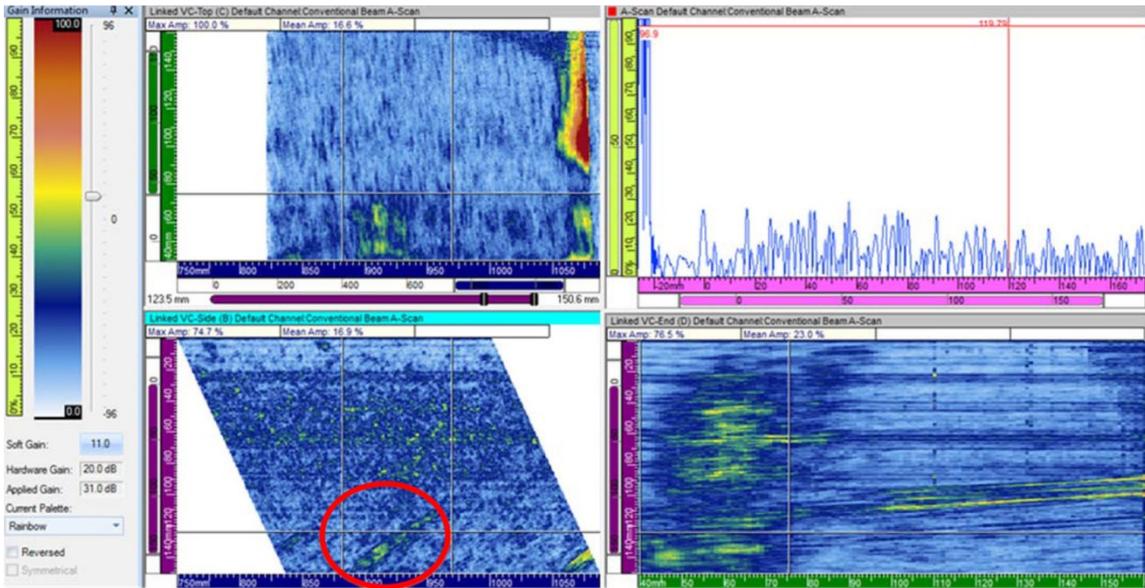
Figure B.5. CW Probe, DM-10 Axial Flaw 2 Circled in Red

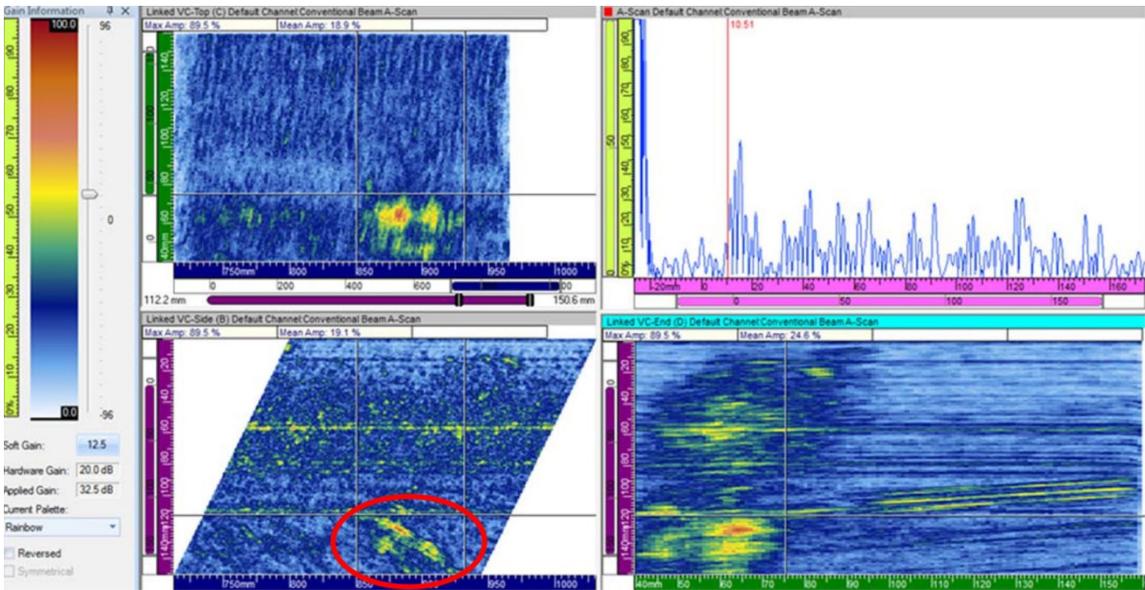
Figure B.6. CCW Probe, DM-10 Axial Flaw 2 Circled in Red

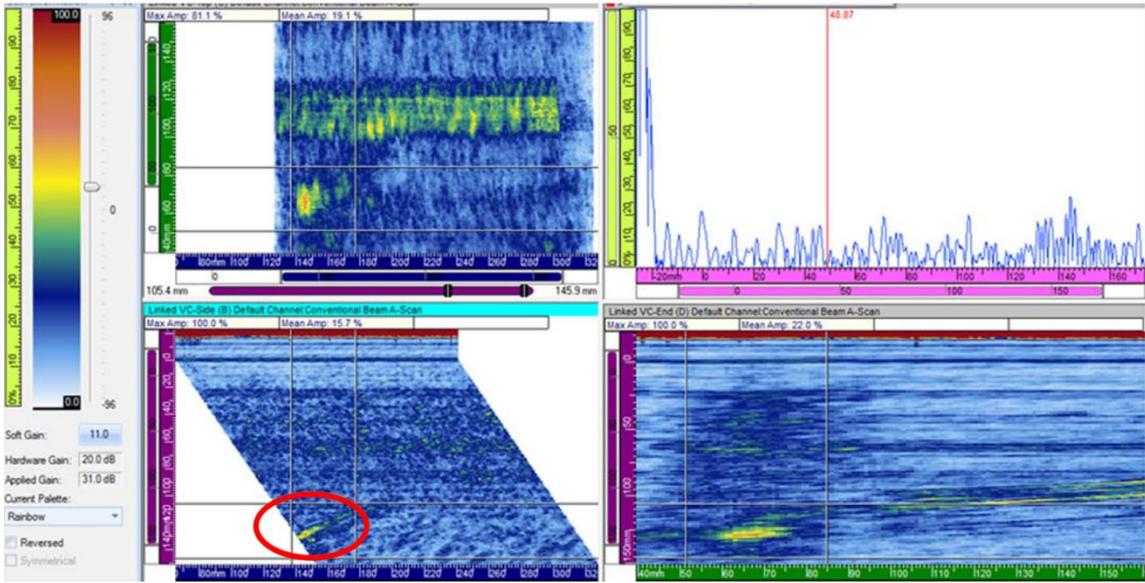
Figure B.7. CW Probe, DM-10 Axial Flaw 3 Circled in Red

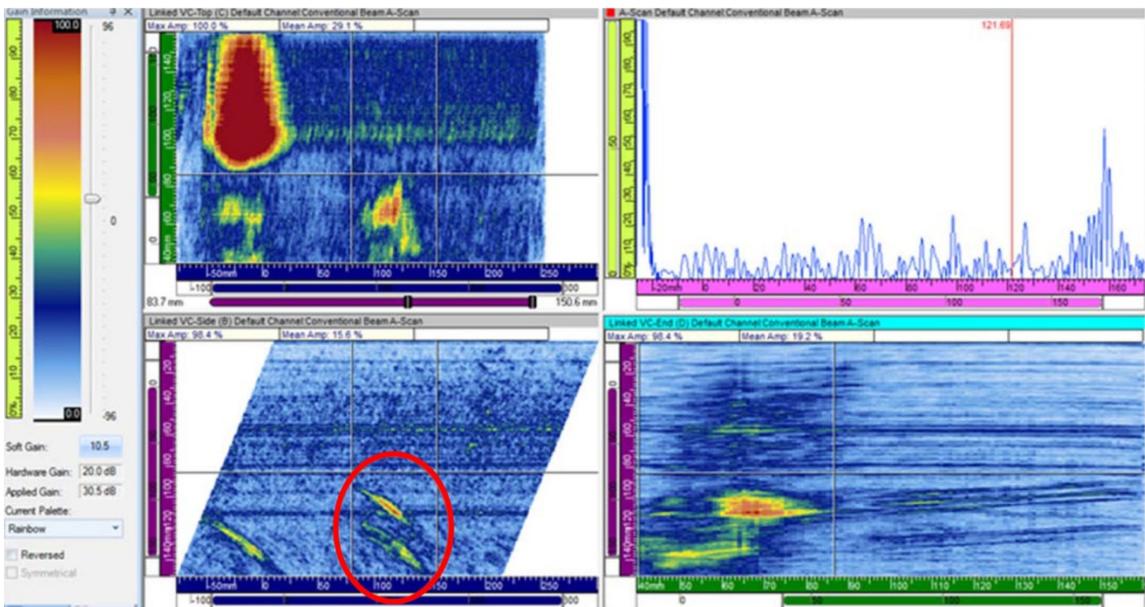
Figure B.8. CCW Probe, DM-10 Axial Flaw 3 Circled in Red

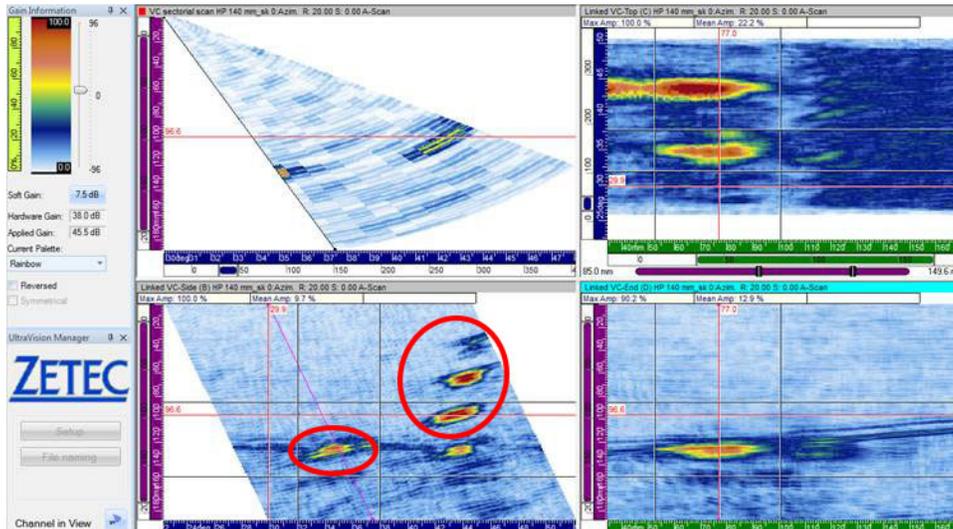
Figure C.2. CW, Skew 0, File 240 to 440 (mm). Axial flaw 1 (left) and three side-drilled holes (right) are circled in red.

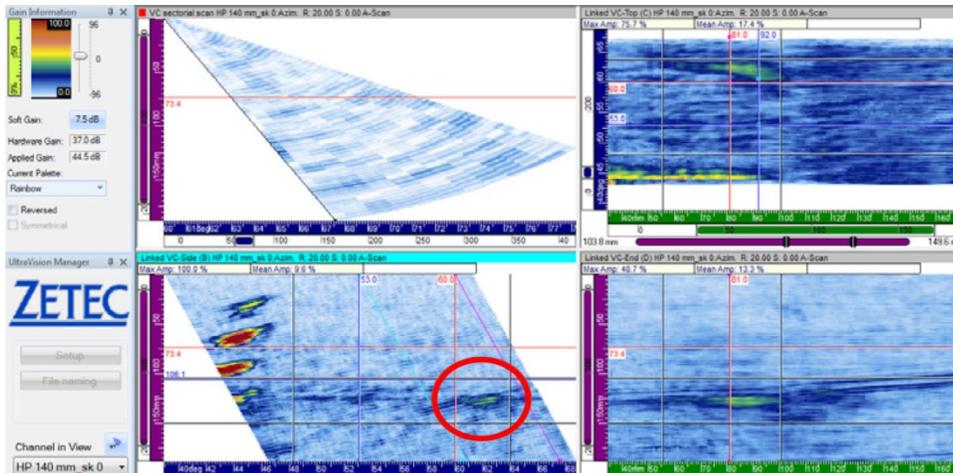
Figure C.3. CW, Skew 0, File 390 to 590 (mm). Artifact is visible at 62 degrees (circumferential flaw 4) and circled in red.

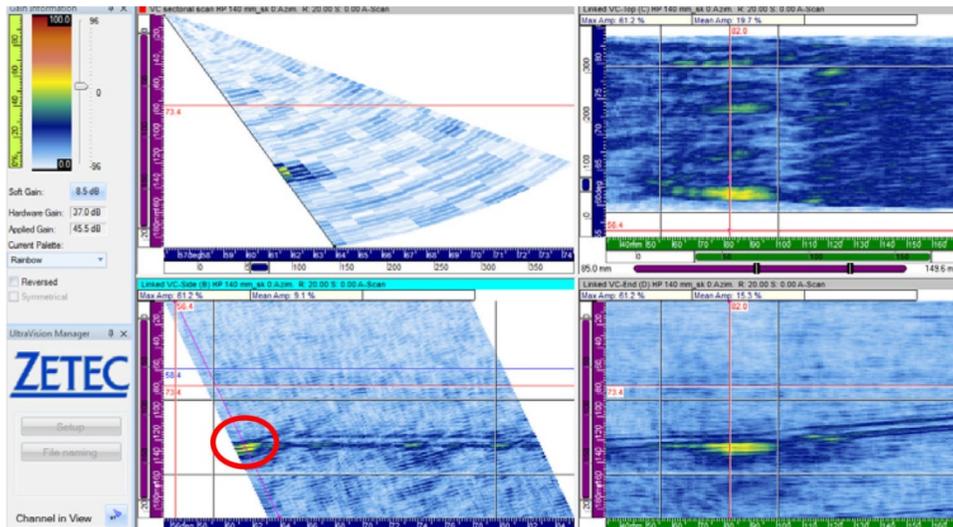
Figure C.4. CW, Skew 0, File 540 to 740 (mm). Artifact is visible at 62 degrees (circumferential flaw 4) and circled in red.

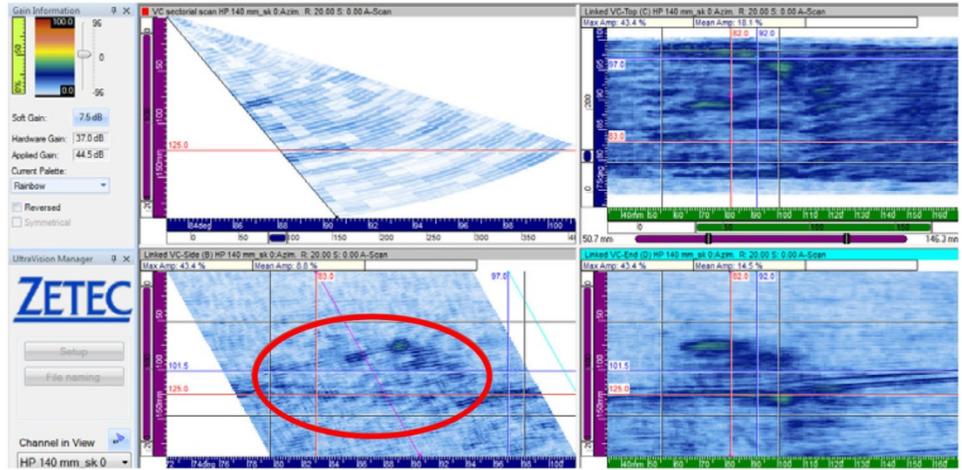
Figure C.5. CW, Skew 0, File 690 to 890 (mm). Circumferential flaw 2 implantation artifact is visible and circled in red.

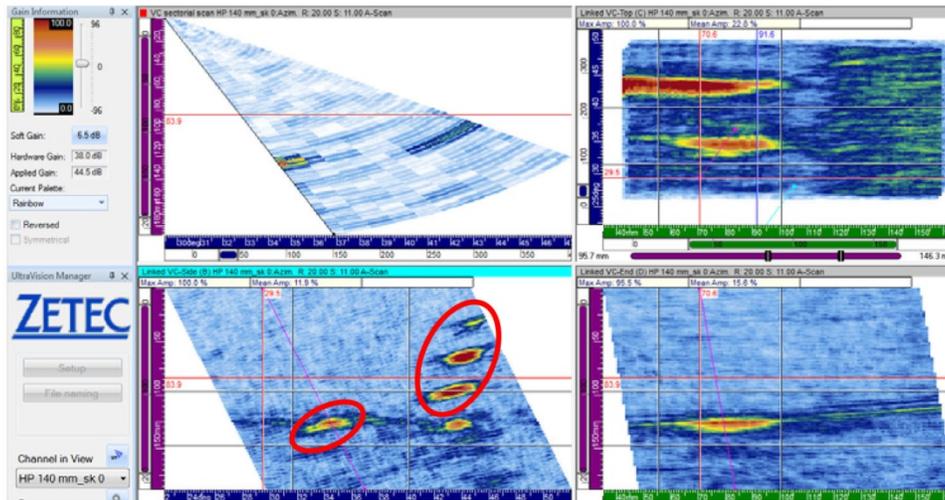
Figure C.8. CW, Skew 11, File 240 to 440 (mm). Axial flaw 1 (left) and the three side-drilled holes (right) are visible and circled in red.

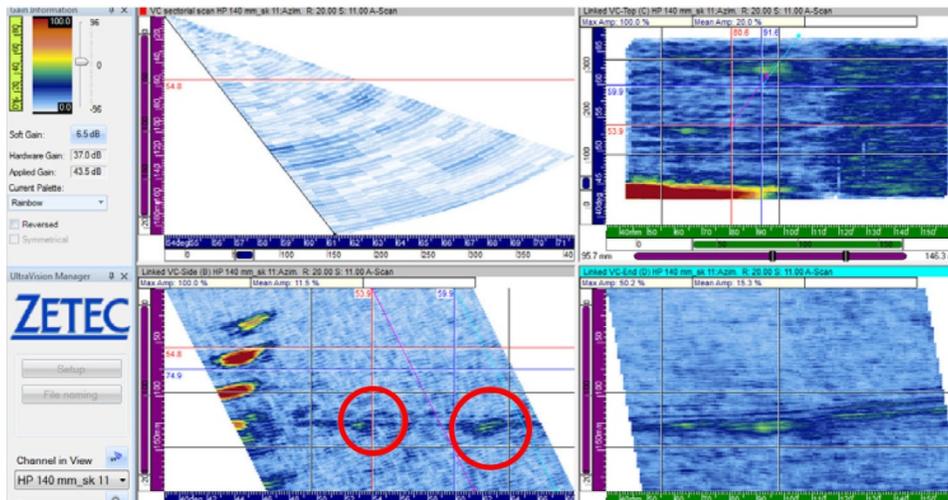
Figure C.9. CW, Skew 11, File 390 to 590 (mm). Possible implantation artifacts at 53 and 62 degrees are visible from circumferential flaw 4 and circled in red.

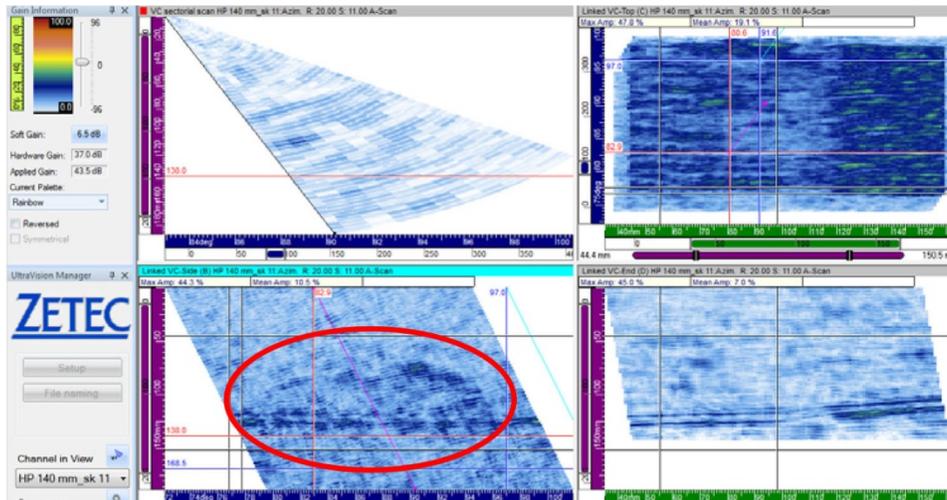
Figure C.11. CW, Skew 11, File 690 to 890 (mm). Possible implantation artifact from circumferential flaw 2 is visible and circled in red.

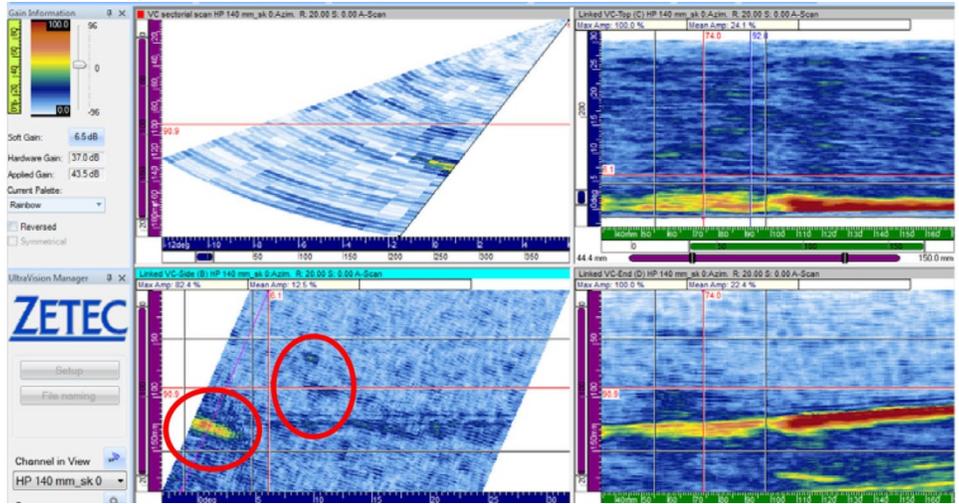
Figure C.13. CCW, Skew 0, File 250 to -3 (mm). The end of the specimen (left) is visible as well as mid-wall circumferential flow 3 artifacts (right) and circled in red.

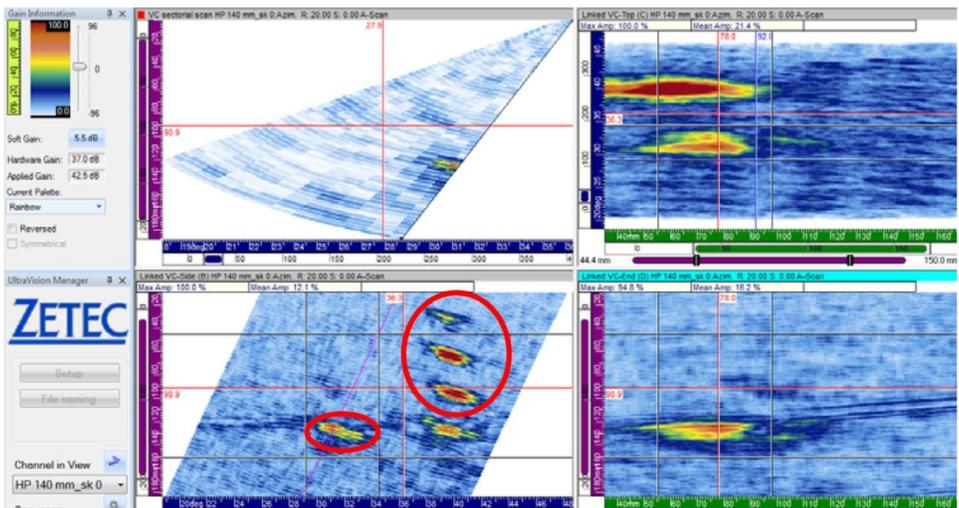
Figure C.14. CCW, Skew 0, File 400 to 200 (mm). Axial flaw 1 (left) and the three side-drilled holes (right) are visible and circled in red.

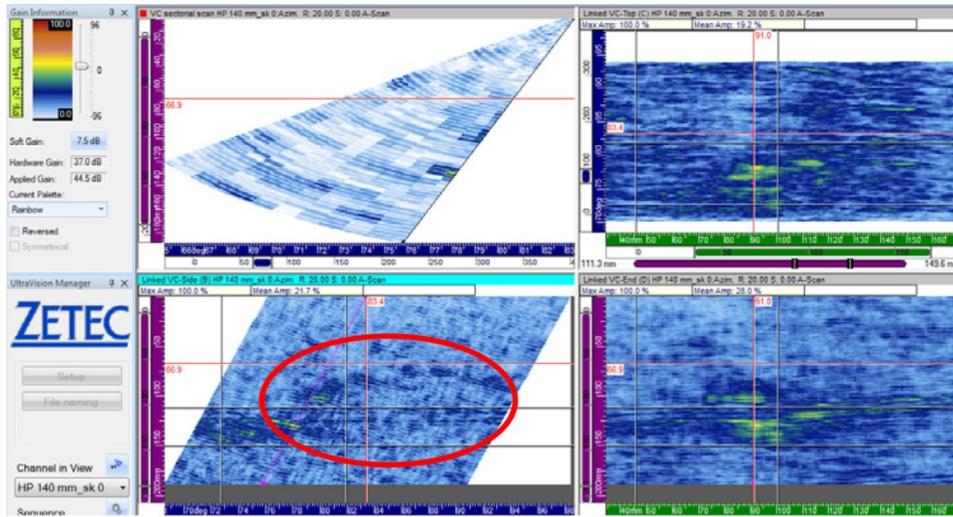
Figure C.17. CCW, Skew 0, File 850 to 650 (mm). Possible artifact from circumferential flaw 2 is visible and circled in red.

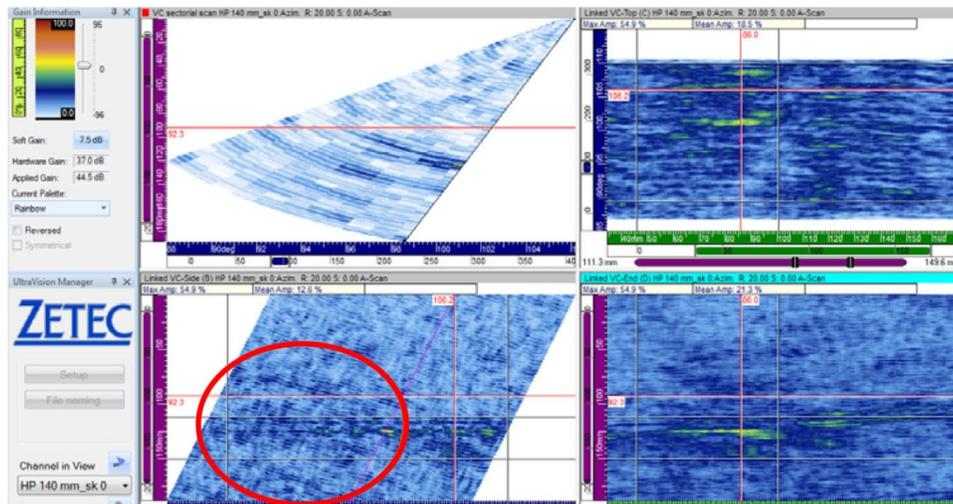
Figure C.18. CCW, Skew 0, File 1000 to 800 (mm). Possible artifact from circumferential flaw 2 is visible and circled in red.

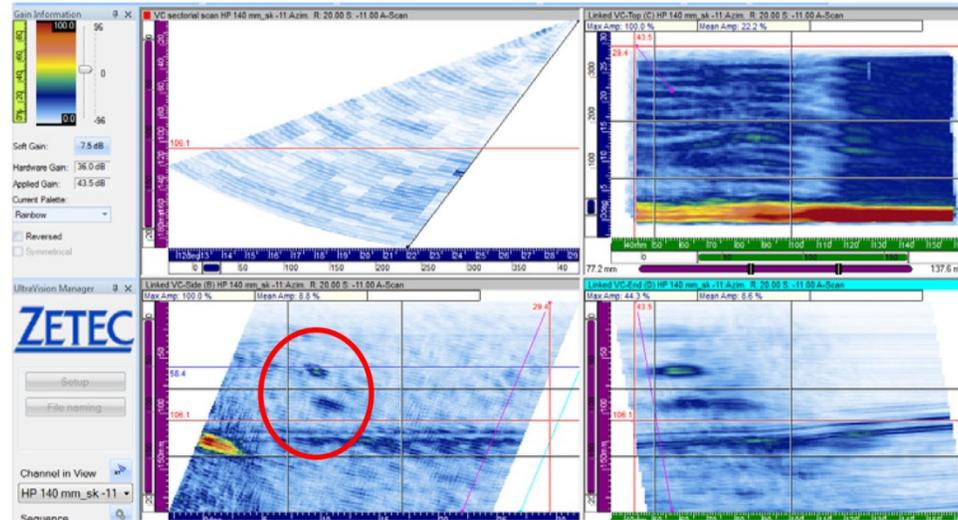
Figure C.19. CCW, Skew 11, File 250 to -3 (mm). Possible circumferential flaw 3 artifact at 10 degrees is visible and circled in red.

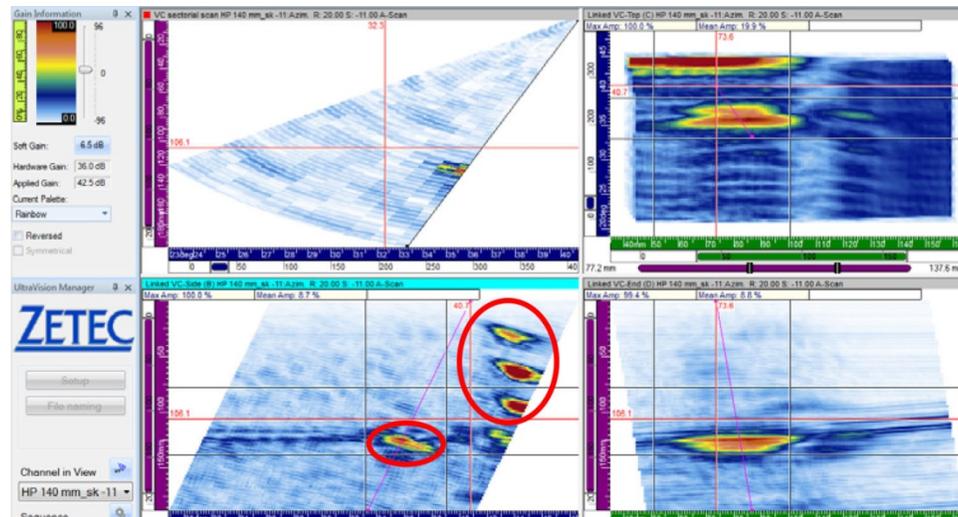
Figure C.20. CCW, Skew 11, File 400 to 200 (mm). Axial flaw 1 (left) and three side-drilled holes (right) are visible and circled in red.

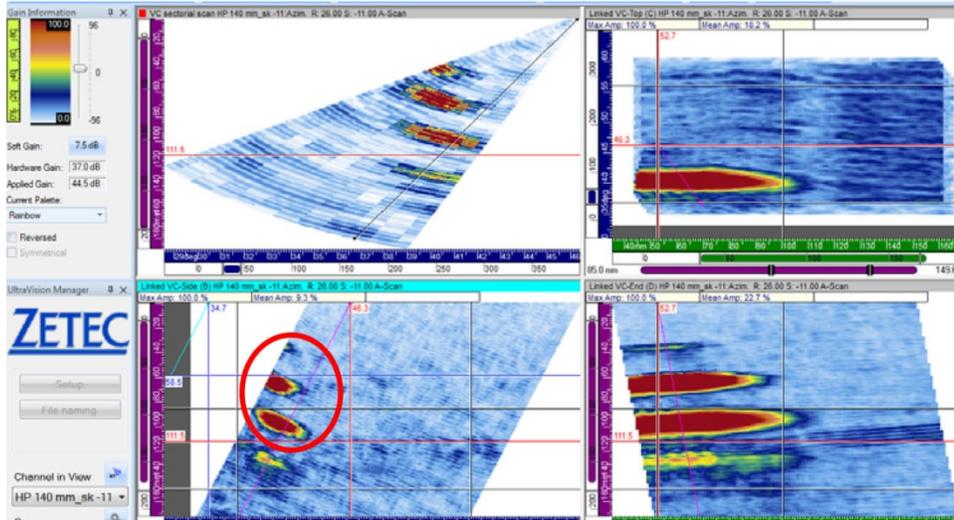
Figure C.21. CCW, Skew 11, File 550 to 350 (mm). The three side-drilled holes are visible and circled in red.

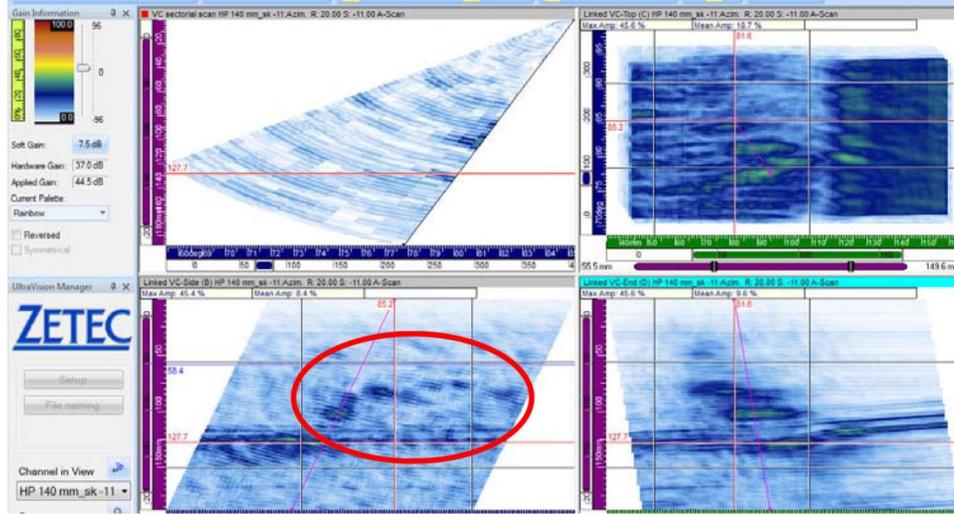
Figure C.23. CCW, Skew 11, File 850 to 650 (mm). Possible implantation artifact from circumferential flaw 2 is visible and circled in red.

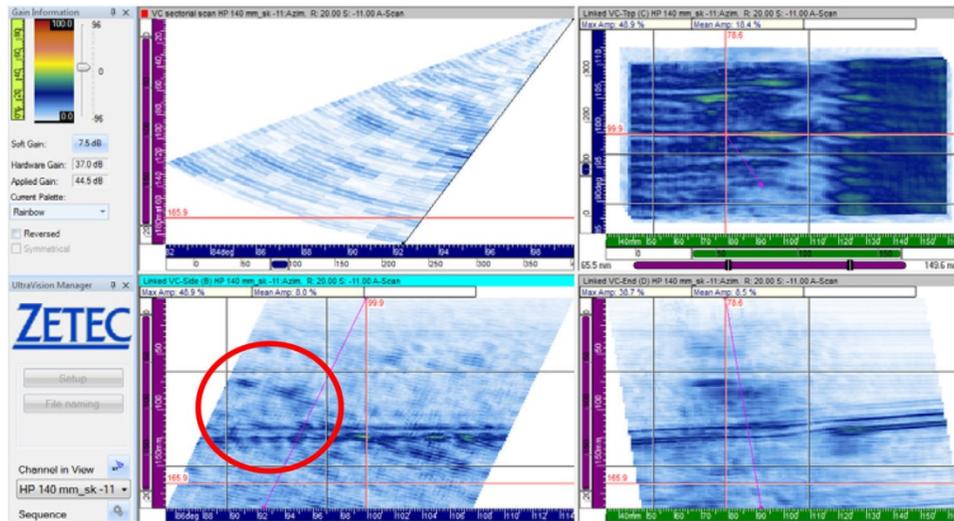
Figure C.24. CCW, Skew 11, File 1000 to 800 (mm). Possible implantation artifact from circumferential flaw 2 is visible and circled in red.

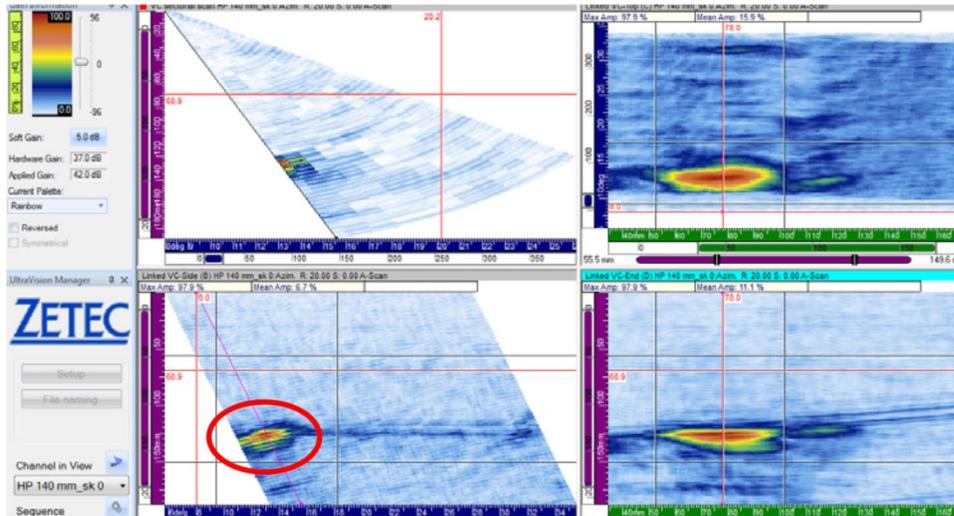
Figure C.25. CW, Skew 0, File 90 to 290 (mm). Axial flow 3 is visible and circled in red.

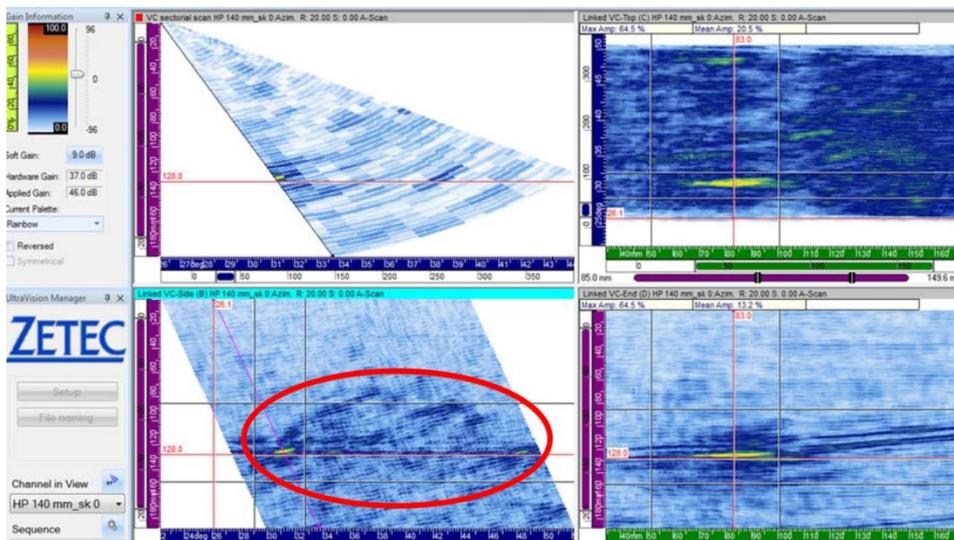
Figure C.26. CW, Skew 0, File 240 to 440 (mm). Possible implantation artifact from circumferential flaw 1 is visible and circled in red.

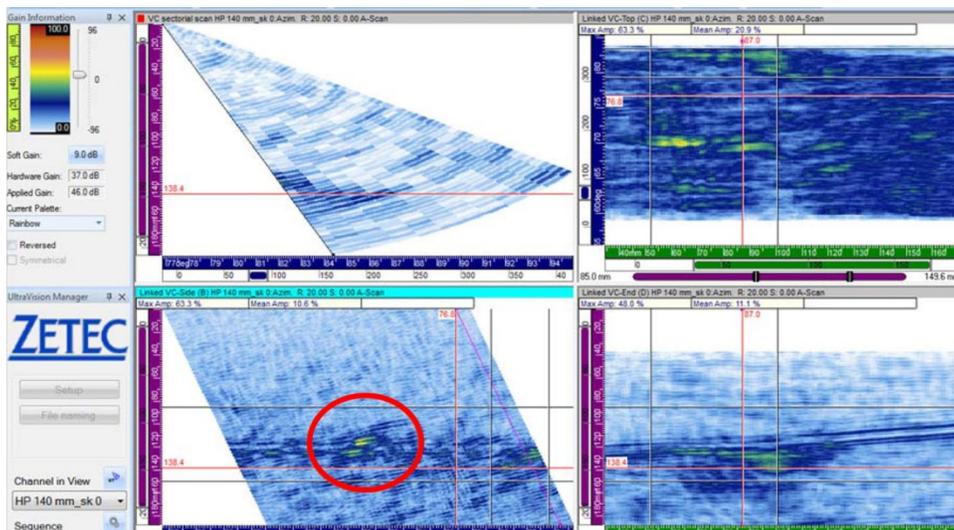
Figure C.28. CW, Skew 0, File 540 to 740 (mm). Possible flaw implantation artifact from circumferential flaw 4 is visible and circled in red.

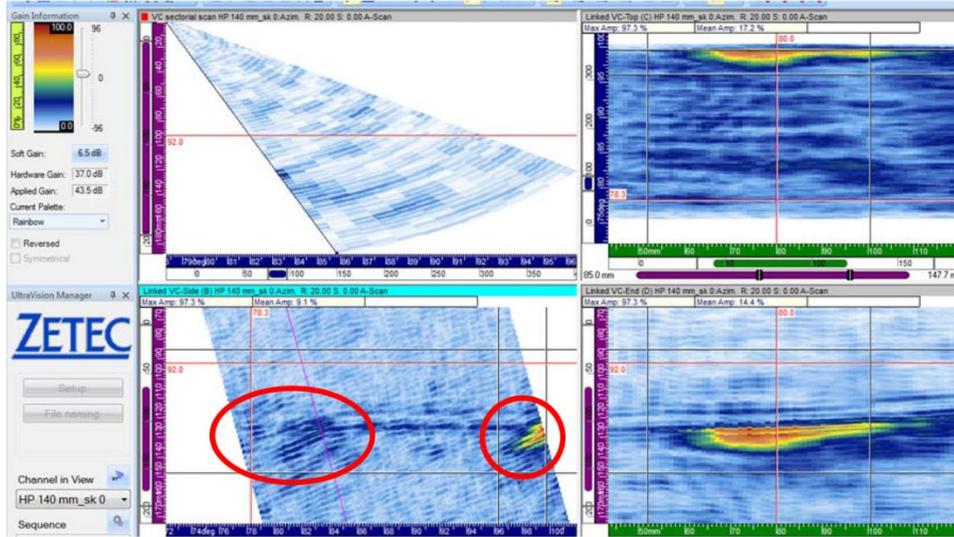
Figure C.29. CW, Skew 0, File 690 to 890 (mm). Circumferential flow 4 implantation artifact (left) and axial flow 2 (right) are visible and circled in red.

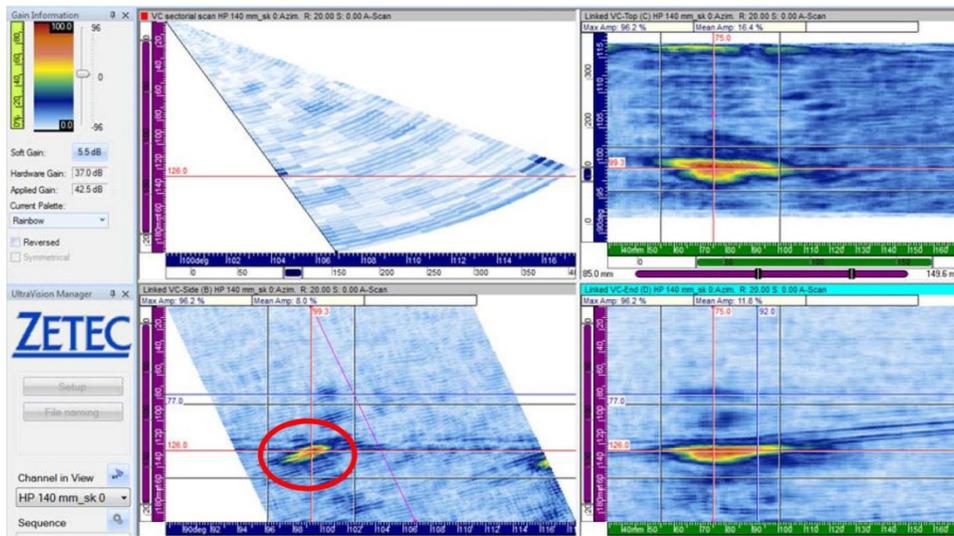
Figure C.30. CW, Skew 0, File 840 to 1040 (mm). Axial flow 2 is visible and circled in red.

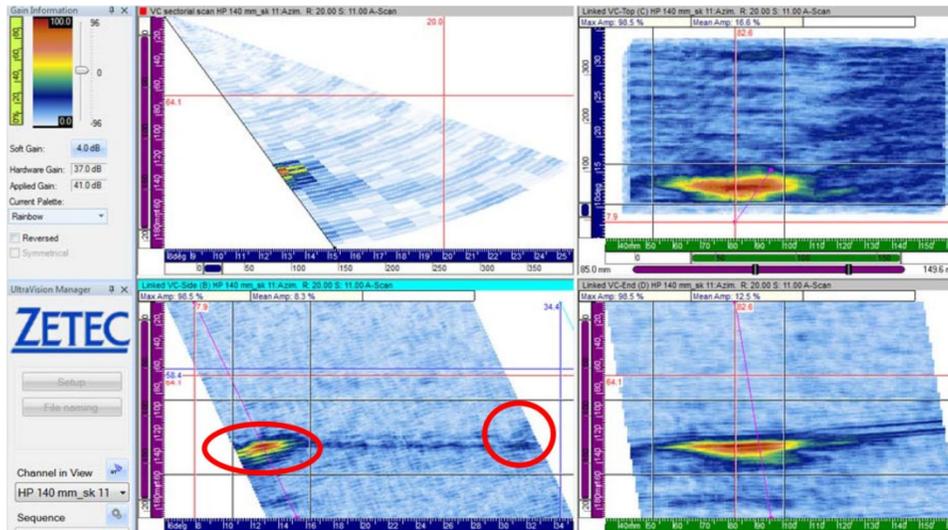
Figure C.31. CW, Skew 11, File 90 to 290 (mm). Axial flaw 3 (left) and possible implantation artifact from circumferential flaw 1 (right) are visible and circled in red.

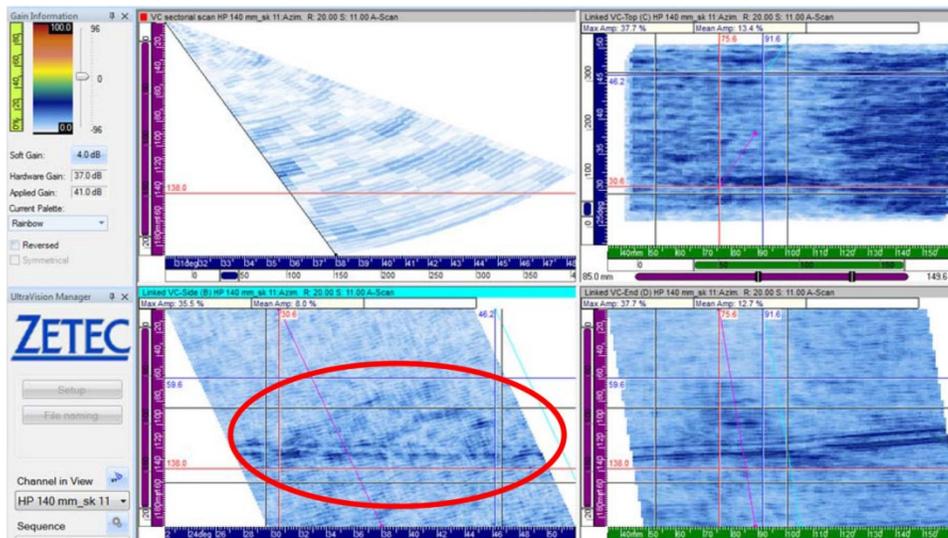
Figure C.32. CW, Skew 11, File 240 to 440 (mm). Possible implantation artifact from circumferential flaw 1 is visible and circled in red.

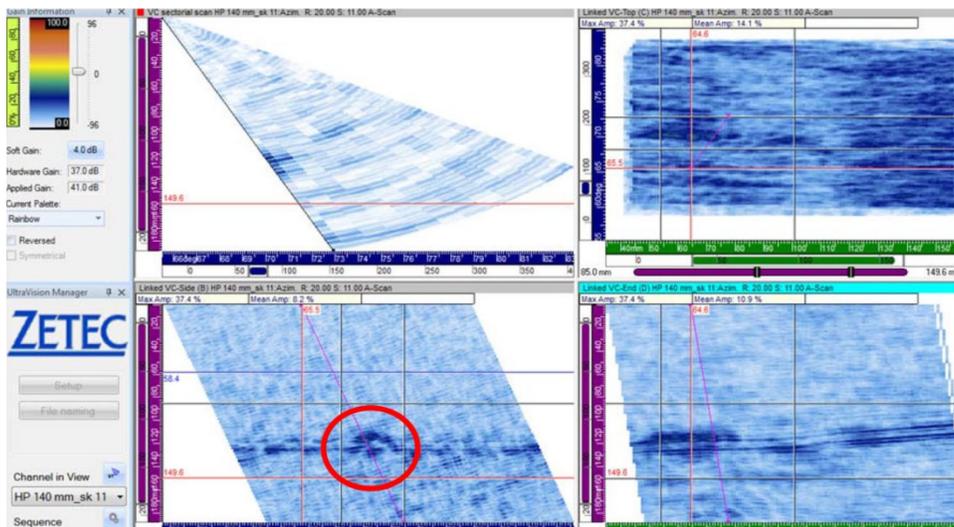
Figure C.34. CW, Skew 11, File 540 to 740 (mm). Possible implantation artifact from circumferential flaw 4 is visible and circled in red.

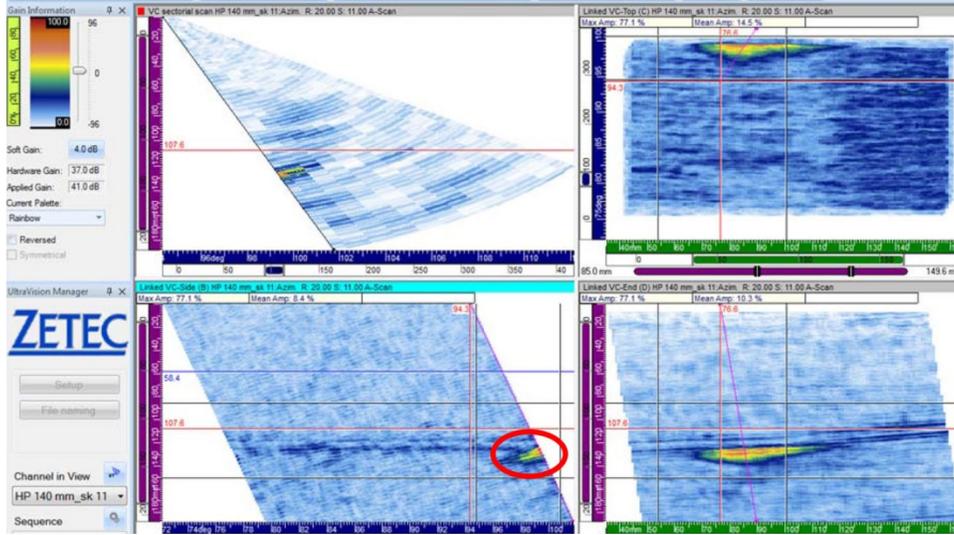
Figure C.35. CW, Skew 11, File 690 to 890 (mm). Axial flaw 2 is on the edge of the scanned aperture and circled in red.

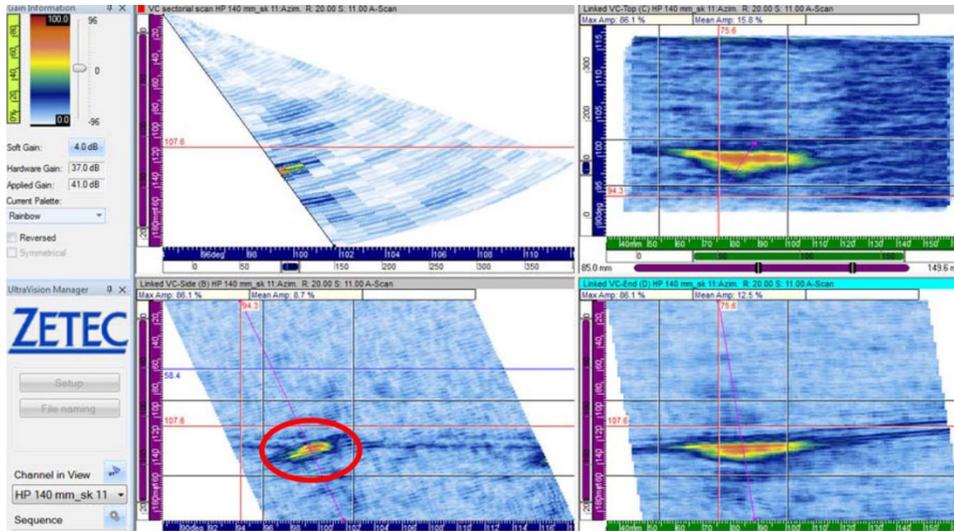
Figure C.36. CW, Skew 11, File 840 to 1040 (mm). Axial flaw 2 is visible and circled in red.

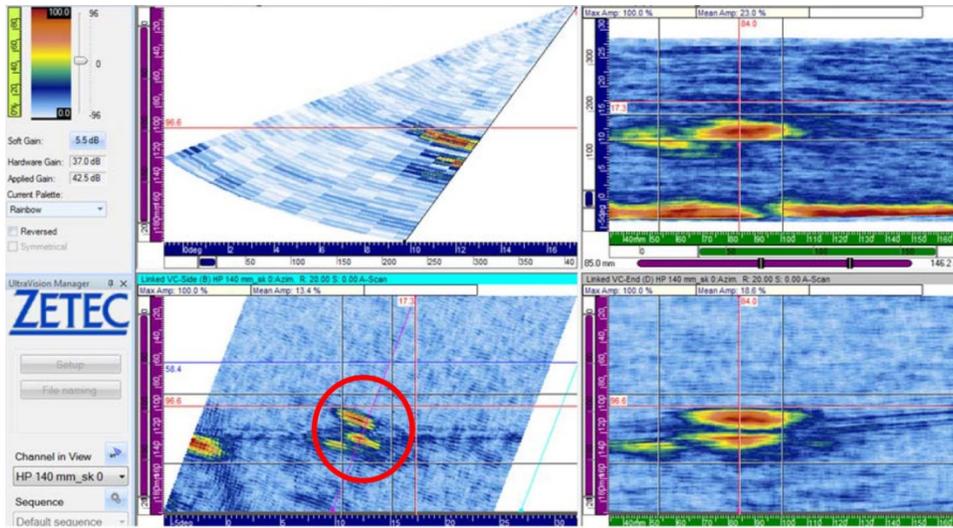
Figure C.37. CCW, Skew 0, File 250 to -20 (mm). Axial flaw 3 is visible and circled in red.

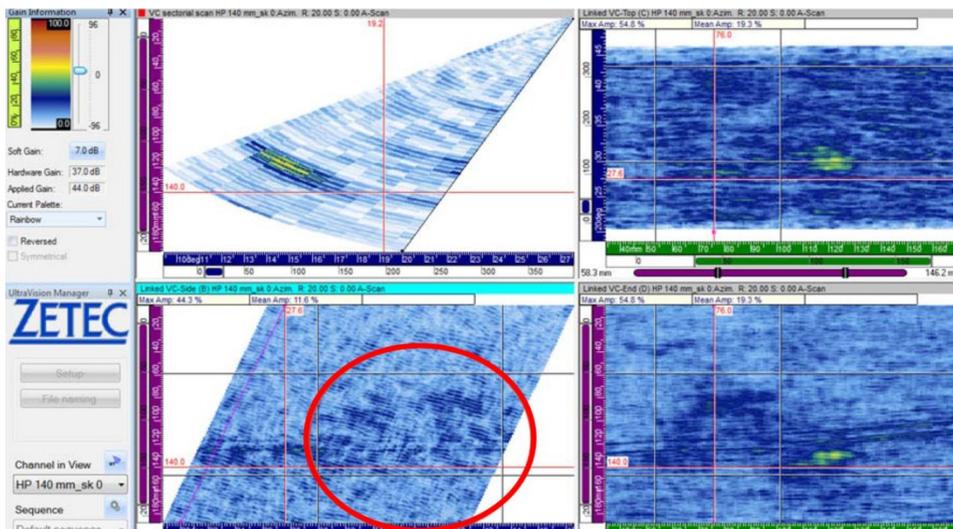
Figure C.38. CCW, Skew 0, File 400 to 200 (mm). Possible implantation artifacts from circumferential flaw 1 are visible and circled in red.

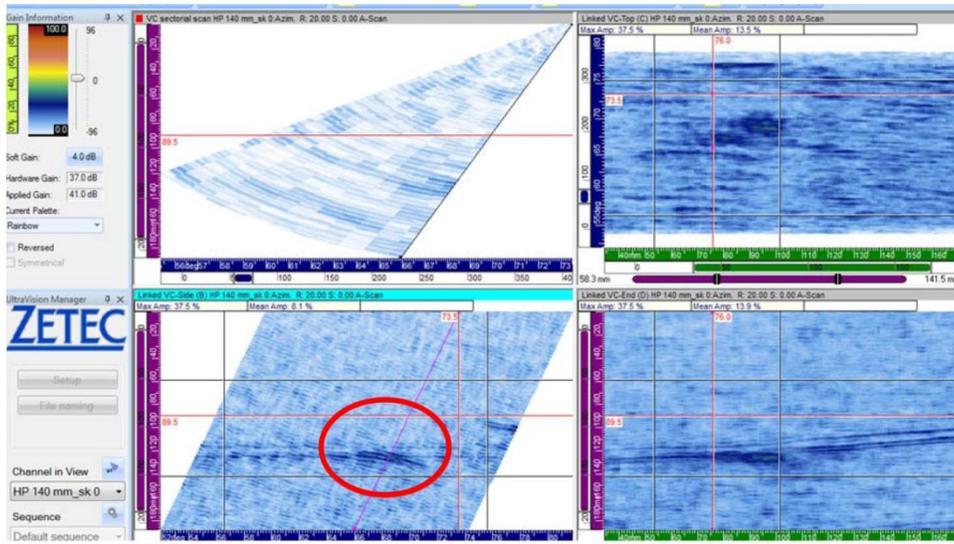
Figure C.40. CCW, Skew 0, File 700 to 500 (mm). A possible implantation artifact from circumferential flaw 4 is visible and circled in red.

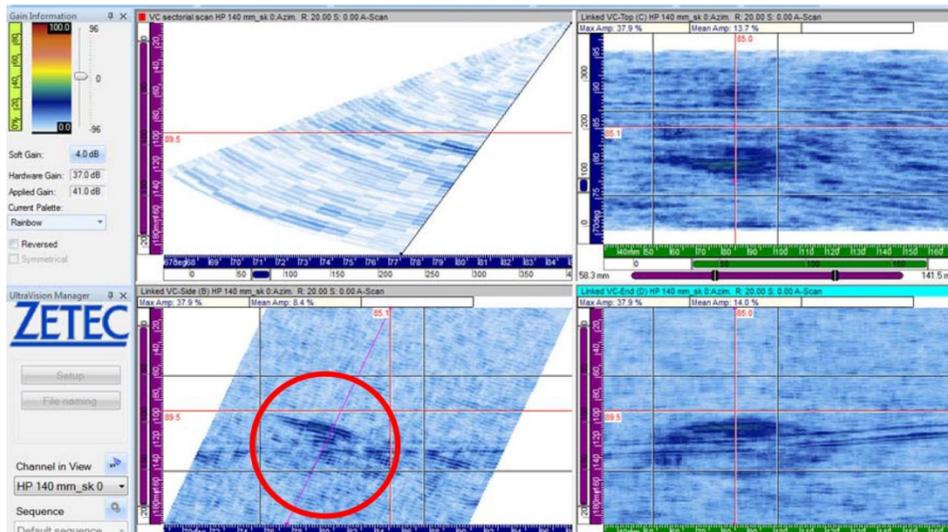
Figure C.41. CCW, Skew 0, File 850 to 650 (mm). Possible artifact from circumferential flow 4 is visible and circled in red.
