PNNL-22553

Final Assessment of Manual Ultrasonic Examinations Applied to Detect Flaws in Primary System Dissimilar Metal Welds at North Anna Power Station

March 2014

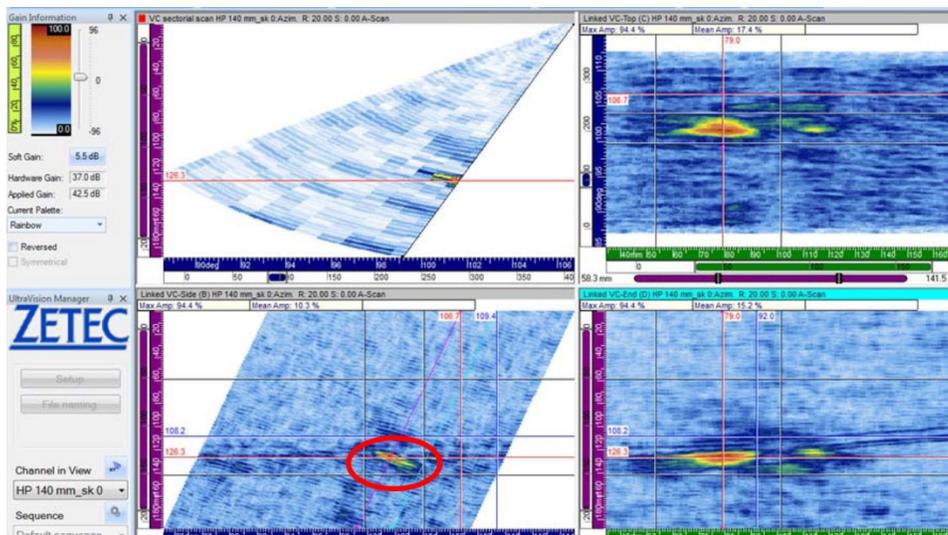
Figure C.42. CCW, Skew 0, File 1000 to 800 (mm). Axial flow 2 is visible and circled in red.

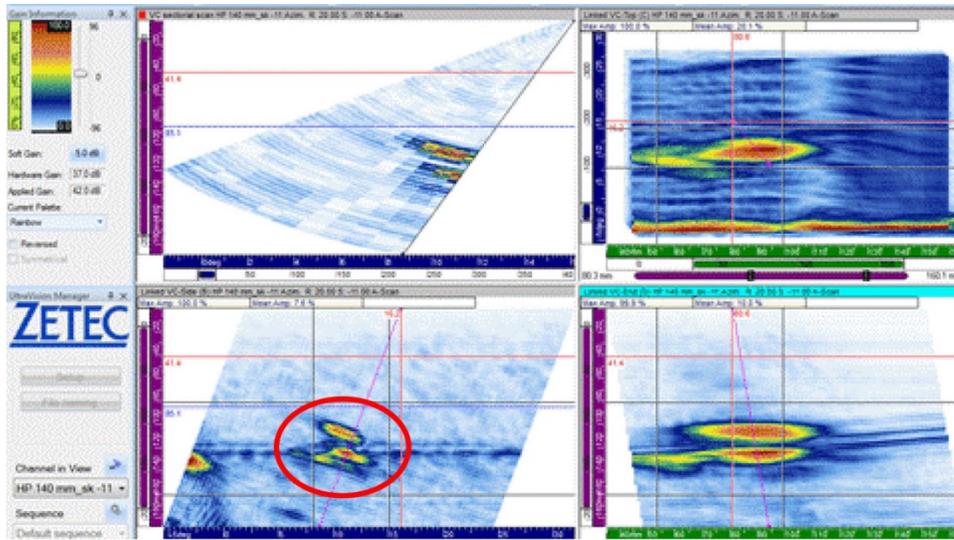
Figure C.43. CCW, Skew 11, File 250 to -20 (mm). Axial flow 3 is visible and circled in red.

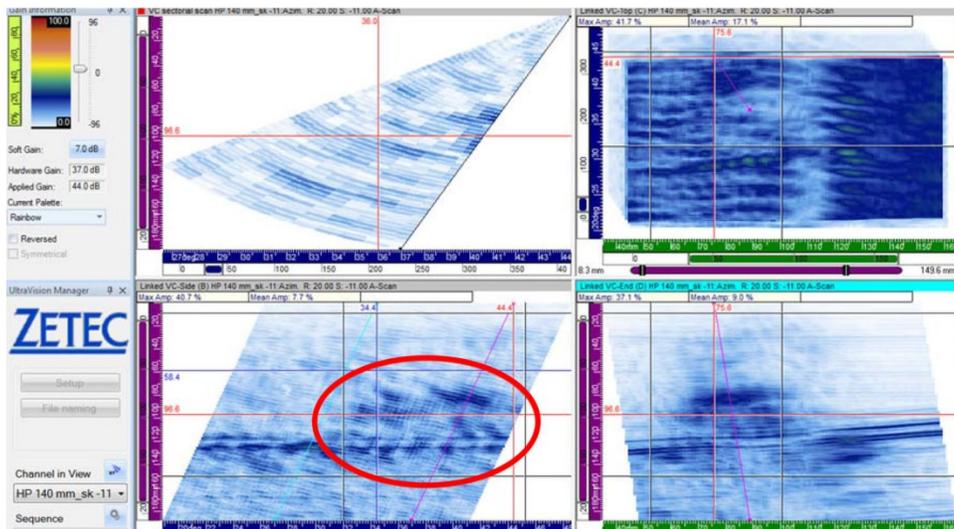
Figure C.44. CCW, Skew 11, File 400 to 200 (mm). Possible implantation artifacts from circumferential flaw 1 are visible and circled in red.

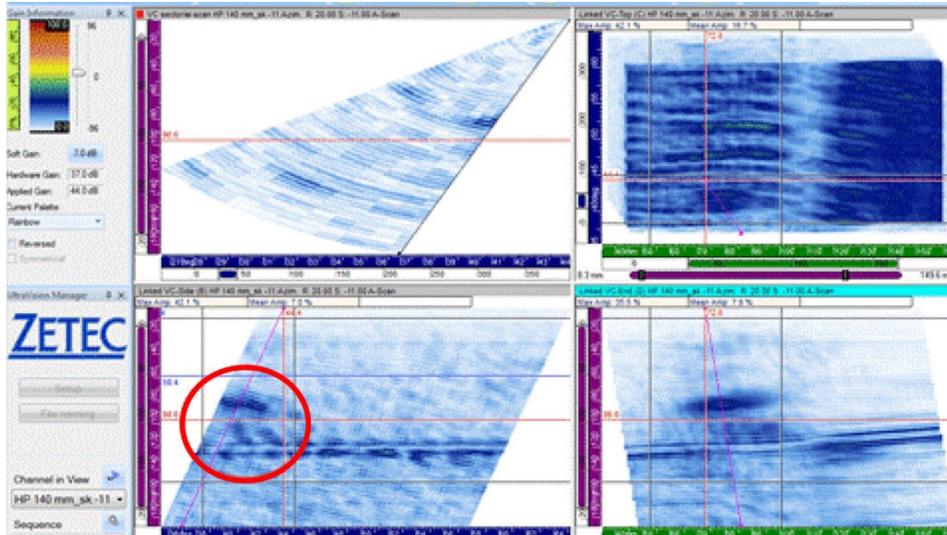
Figure C.45. CCW, Skew 11, File 550 to 350 (mm). Possible implantation artifacts from circumferential flaw 1 are visible and circled in red.

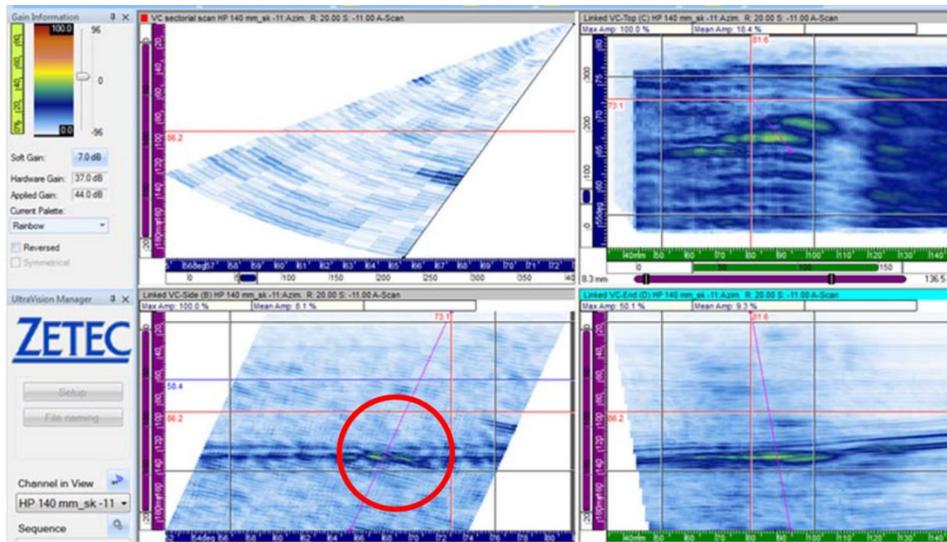
Figure C.46. CCW, Skew 11, File 700 to 500 (mm). A possible implantation artifact from circumferential flaw 4 is visible and circled in red.

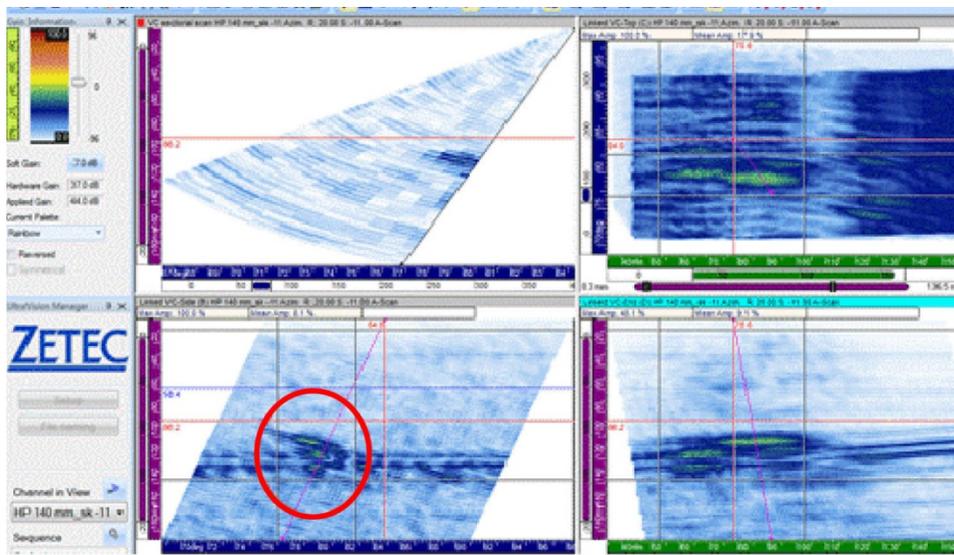
Figure C.47. CCW, Skew 11, File 850 to 650 (mm). Possible implantation artifact from circumferential flaw 4 is visible and circled in red.

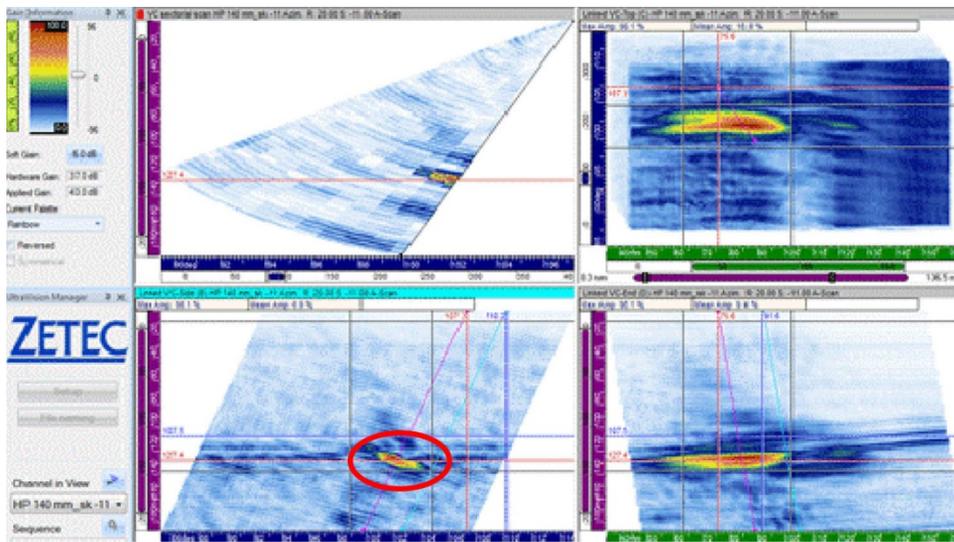
Figure C.48. CCW, Skew 11, File 1000 to 800 (mm). Axial flaw 2 is visible and circled in red.

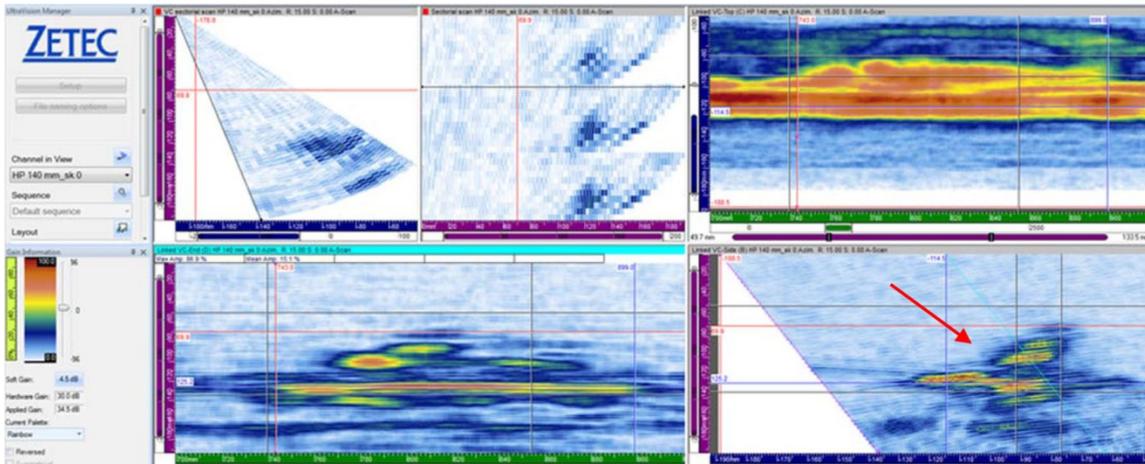
Figure C.49. DM-05 Flaw 2, Noted by Red Arrow

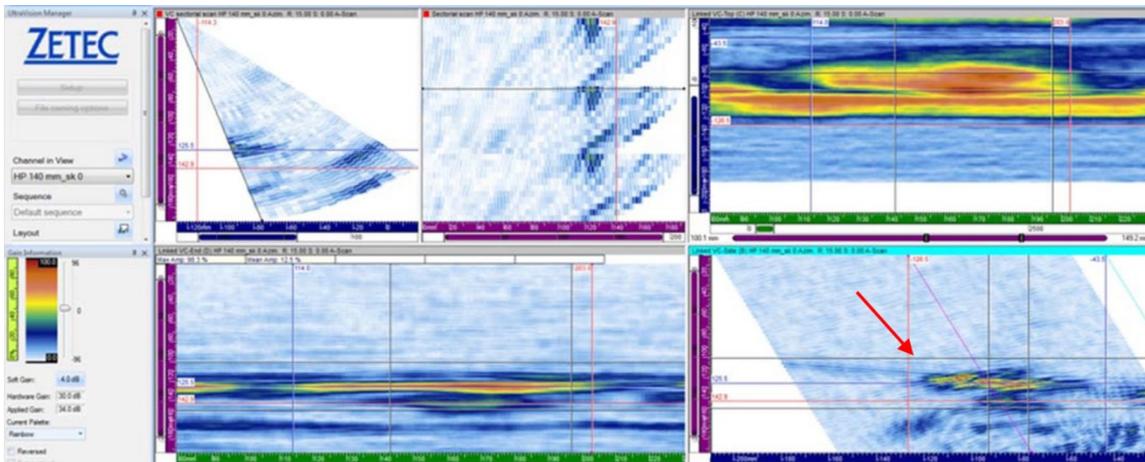
Figure C.50. DM-05 Flaw 3, Noted by Red Arrow

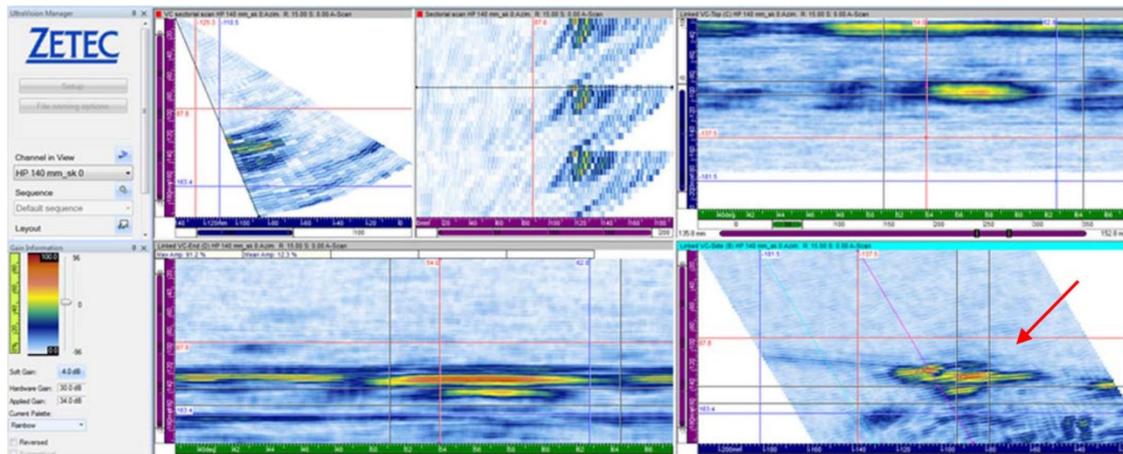
Figure C.51. DM-05 Flaw 4, Noted by Red Arrow

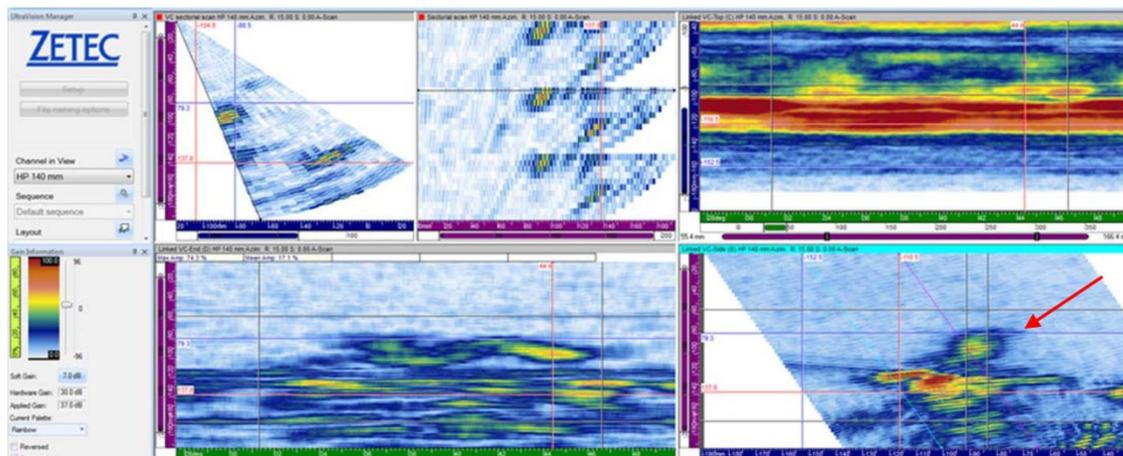
Figure C.52. DM-10 Flaw 1, Noted by Red Arrow

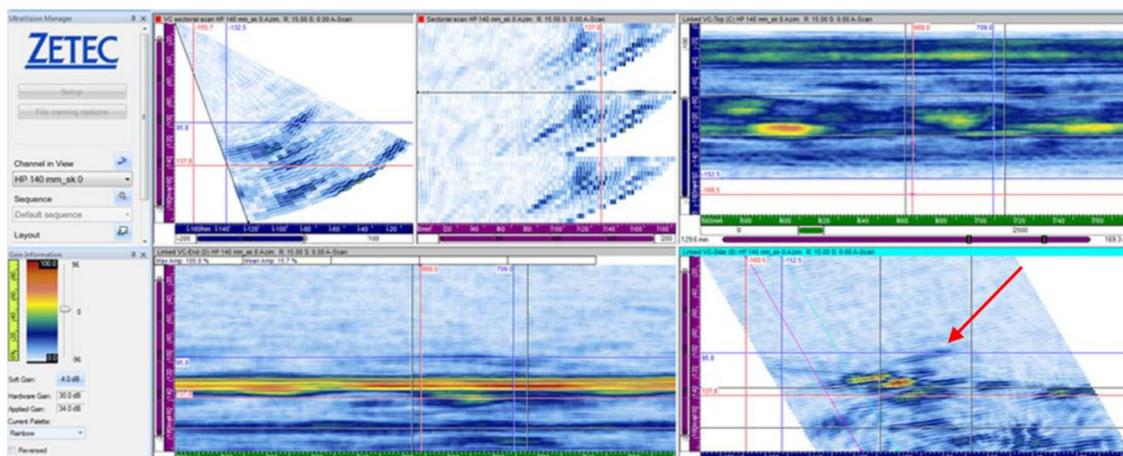
Figure C.53. DM-10 Flaw 4, Noted by Red Arrow

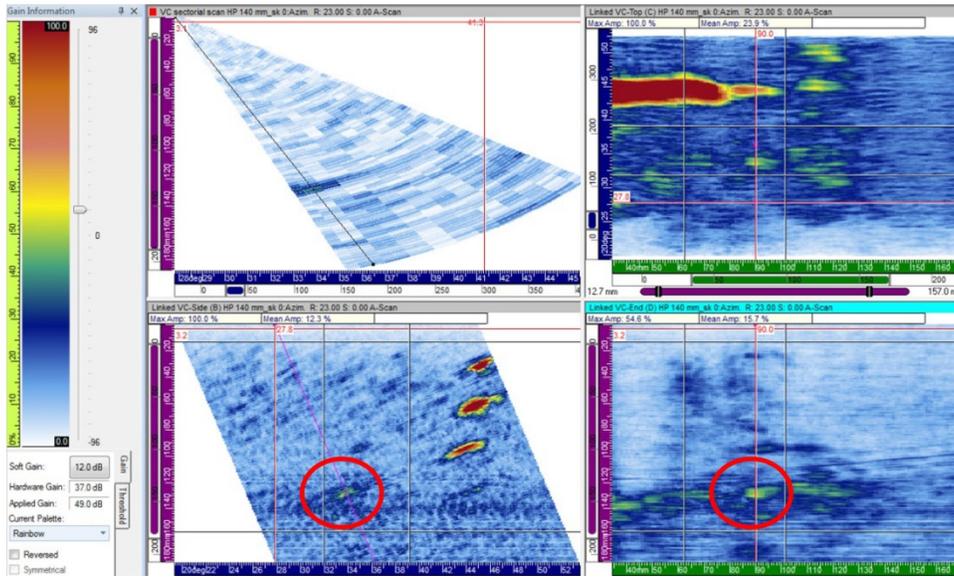
Figure D.1. CW, Skew 0, Axial Flaw 1, Circled in Red

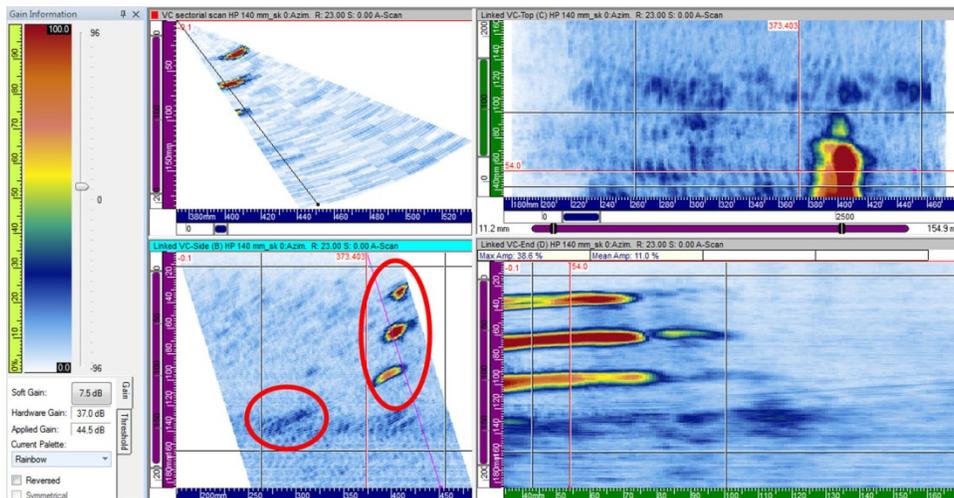
Figure D.2. CW, Skew 0 (reduced gain). Axial flaw 1 (left) and three side-drilled holes (right) are visible and circled in red.

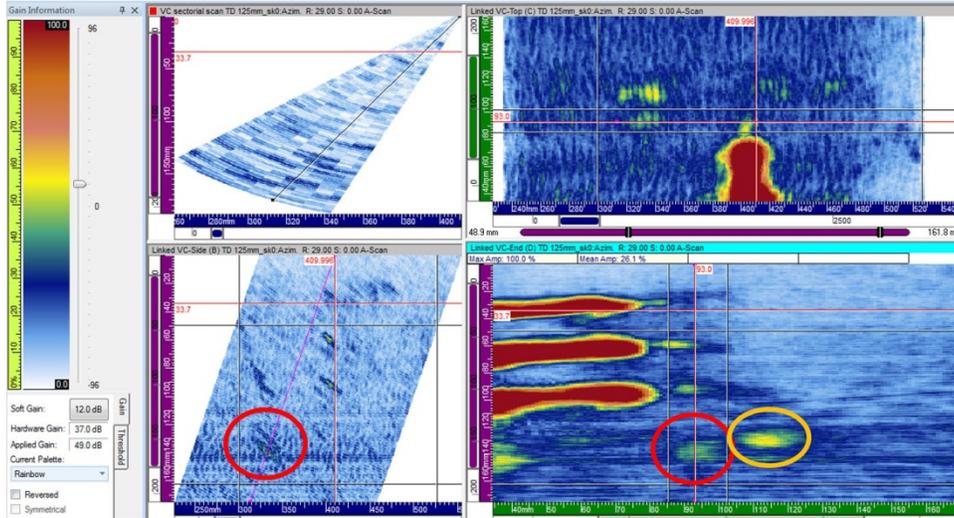
Figure D.3. CCW, Skew 0, Axial Flaw 1, Circled in Red. An artifact extending into the safe end is circled in orange.

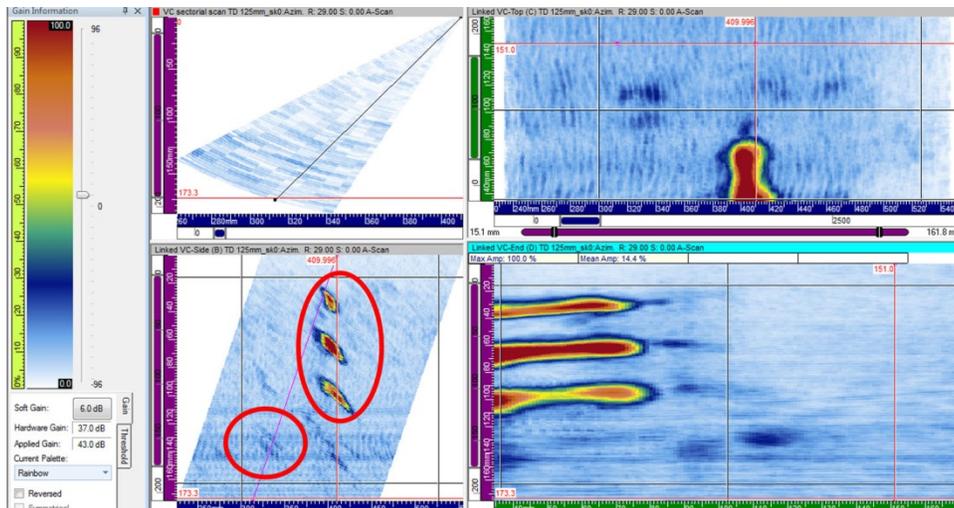
Figure D.4. CCW, Skew 0, Reduced Gain. Axial flaw 1 (left) and three side-drilled holes (right) are visible and circled in red.

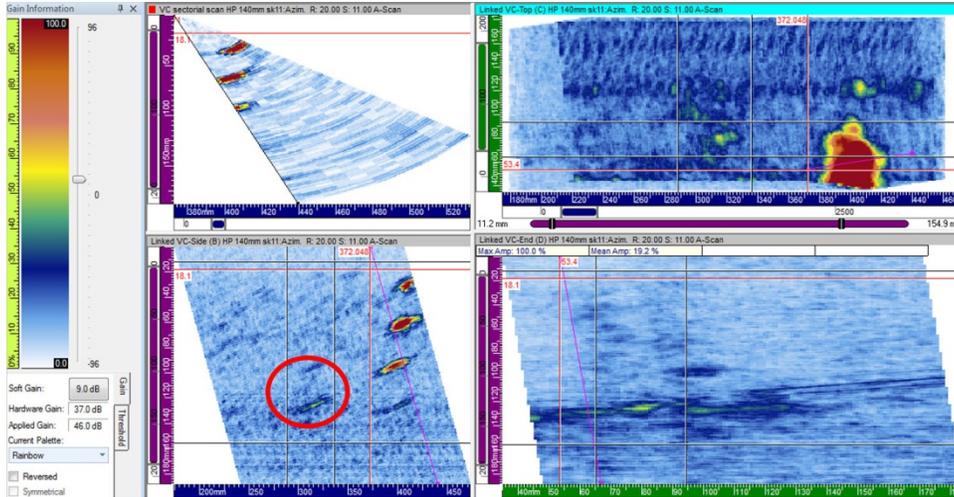
Figure D.5. CW, Skew 11, Axial Flaw 1, Circled in Red

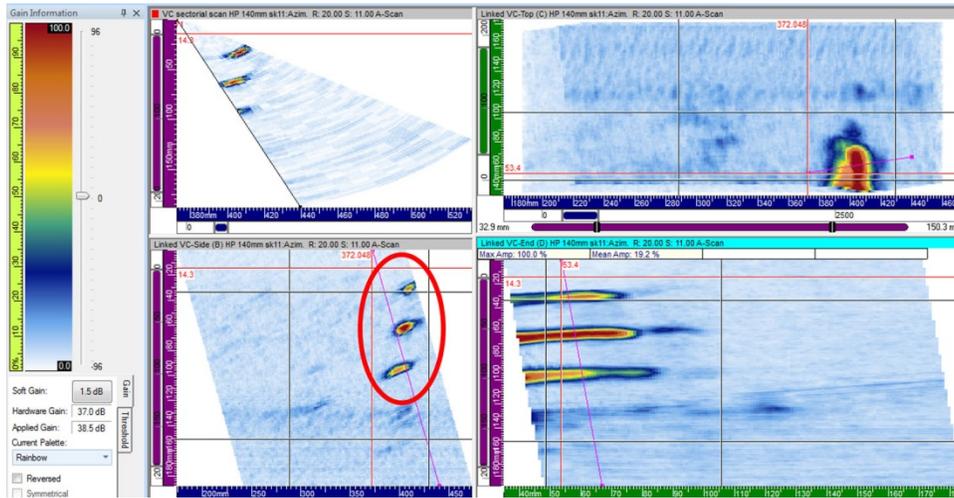
Figure D.6. CW, Skew 11, Reduced Gain. Three side-drilled holes are visible and circled in red.

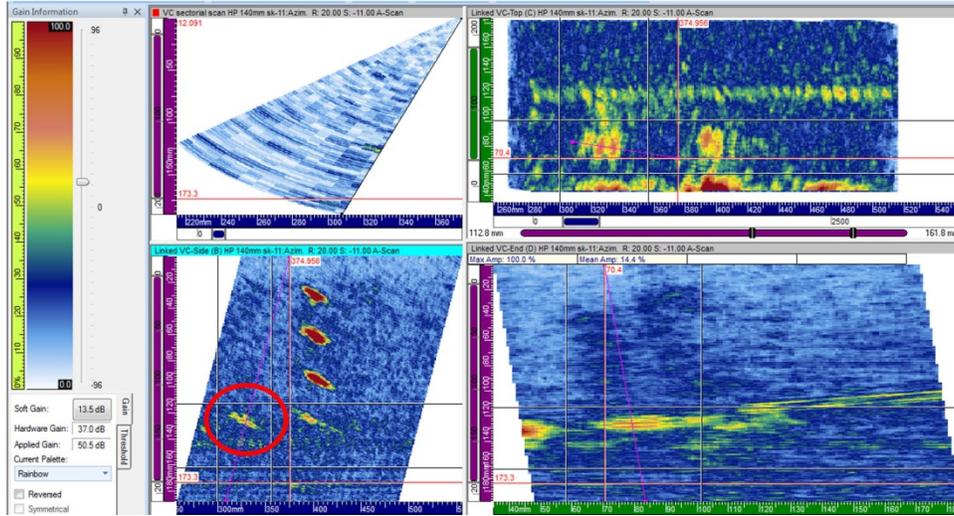
Figure D.7. CCW, Skew 11, Axial Flaw 1, Circled in Red

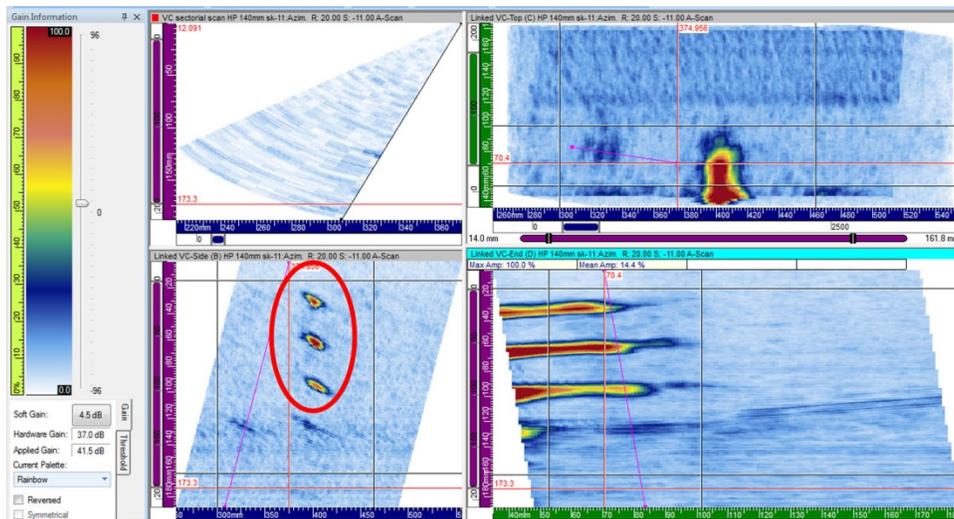
Figure D.8. CCW, Skew 11, Reduced Gain. Three side-drilled holes are visible and circled in red.

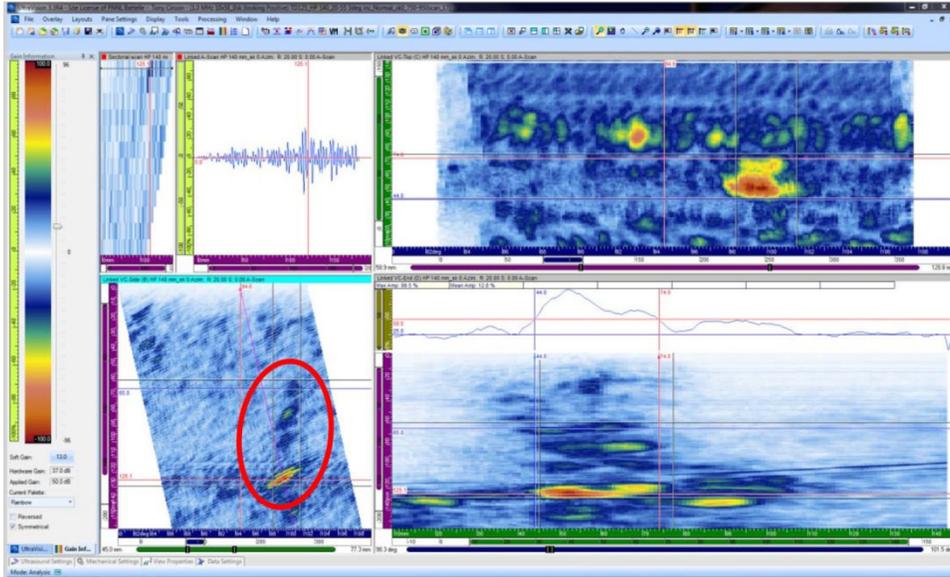
Figure D.9. CW, Skew 0, Axial Flaw 2, Circled in Red

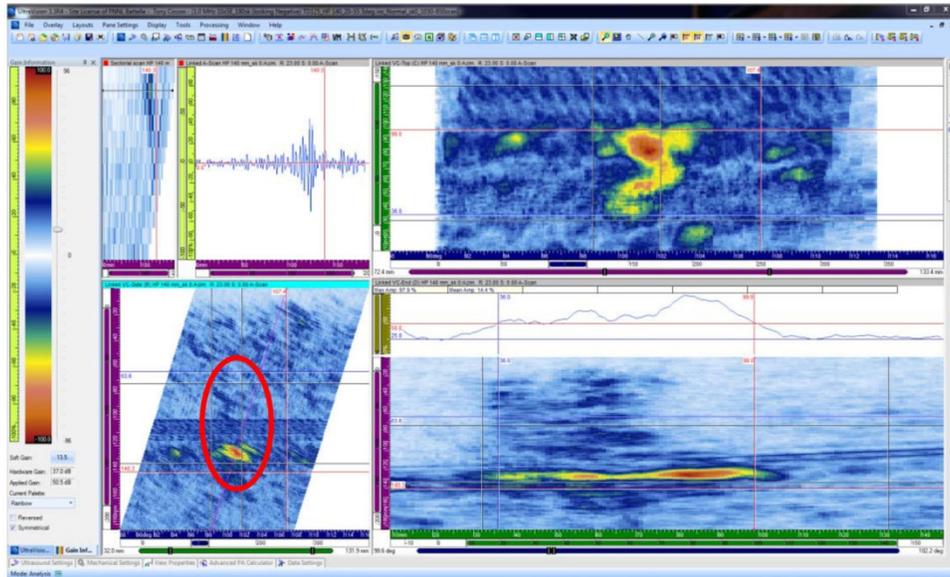
Figure D.10. CCW, Skew 0, Axial Flaw 2, Circled in Red

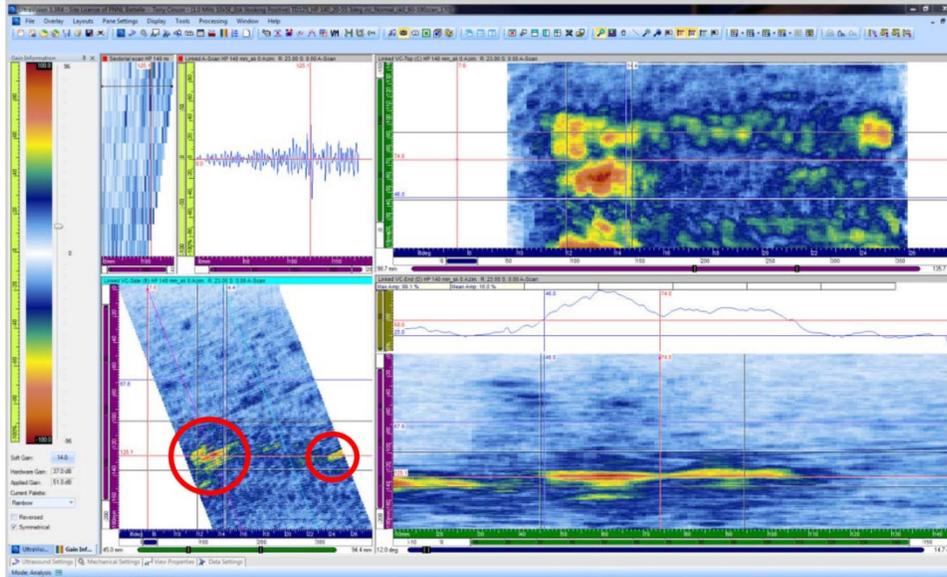
Figure D.11. CW, Skew 0. Axial Flaw 3 (left) and artifact (right) are visible and circled in red.

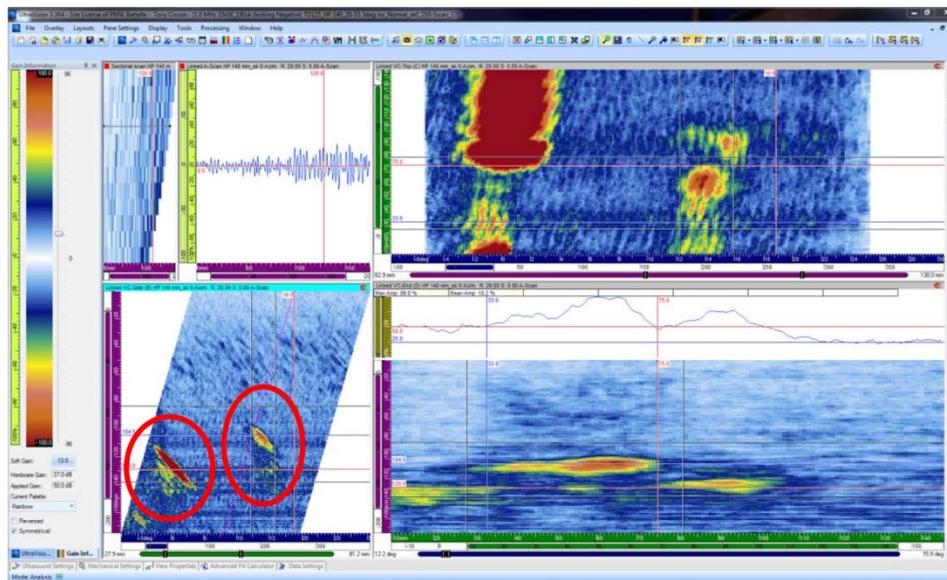
Figure D.12. CCW, Skew 0. Axial Flaw 3 and artifact (right), and end-of-specimen (left) are visible and circled in red.

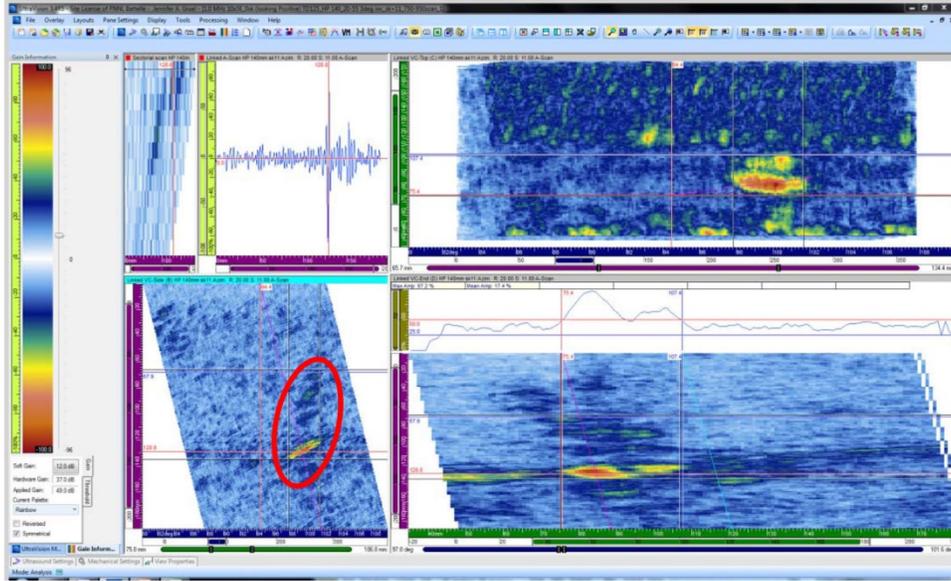
Figure D.13. CW, Skew 11, Axial Flaw 2, Circled in Red

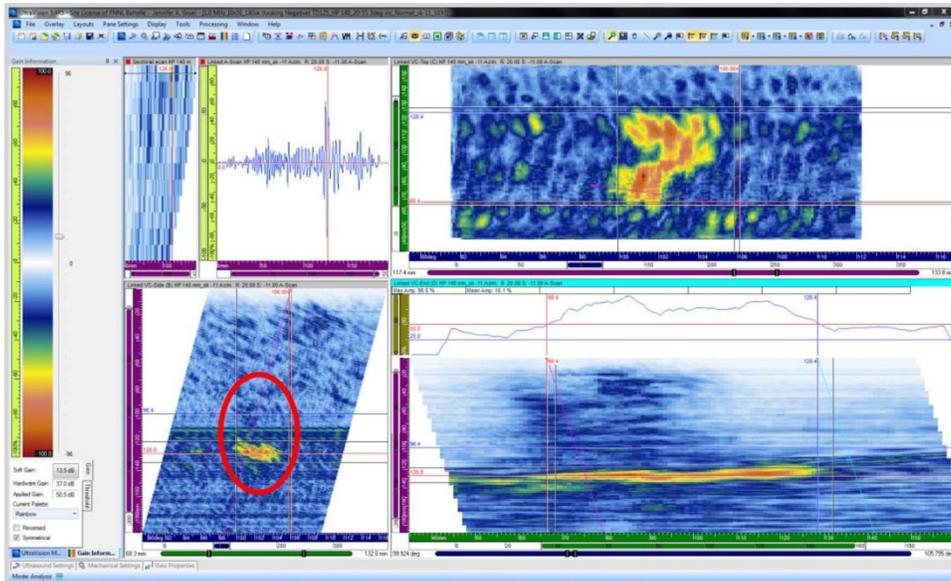
Figure D.14. CCW, Skew 11, Axial Flaw 2, Circled in Red

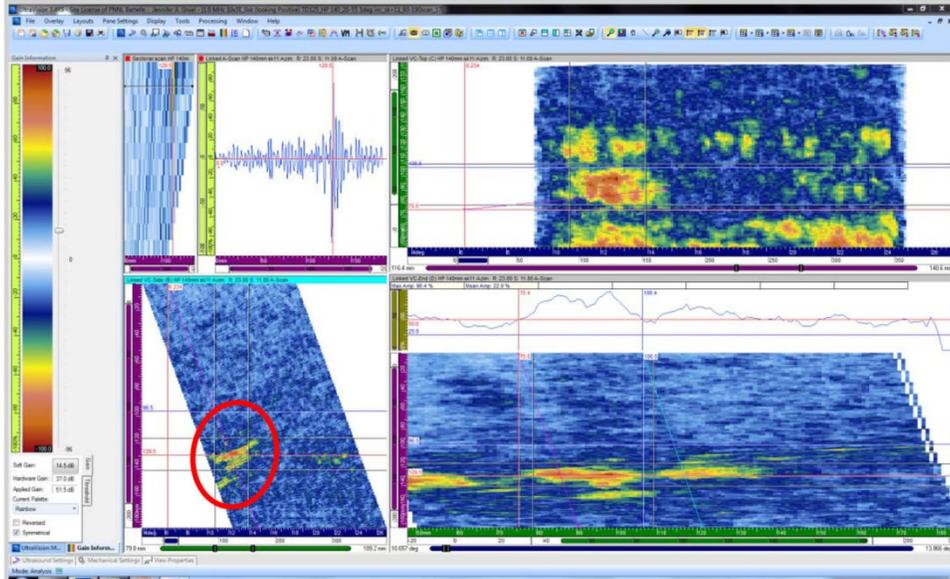
Figure D.15. CW, Skew 11, Axial Flaw 3, Circled in Red

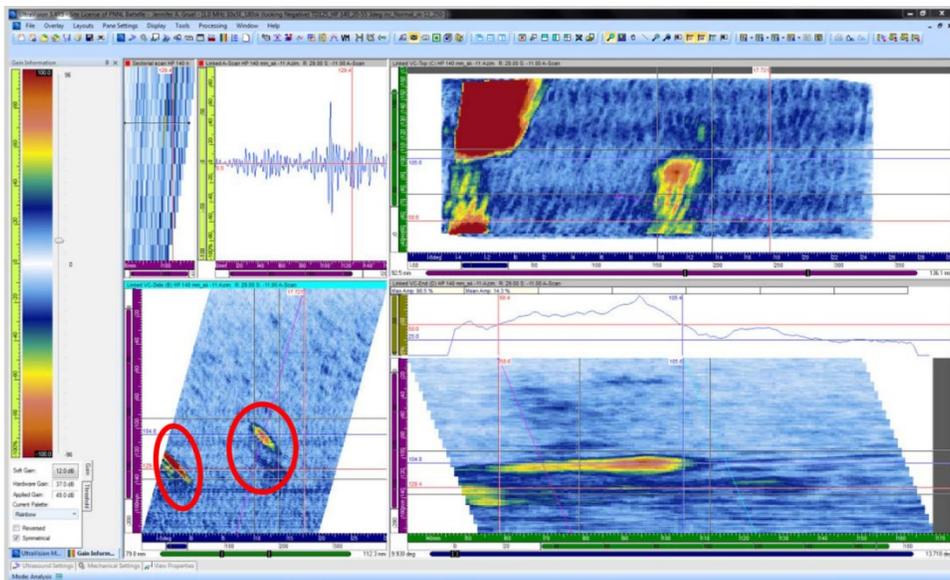
Figure D.16. CCW, Skew 11. Axial flaw 3 (right) and end-of-specimen (left) are visible and circled in red.

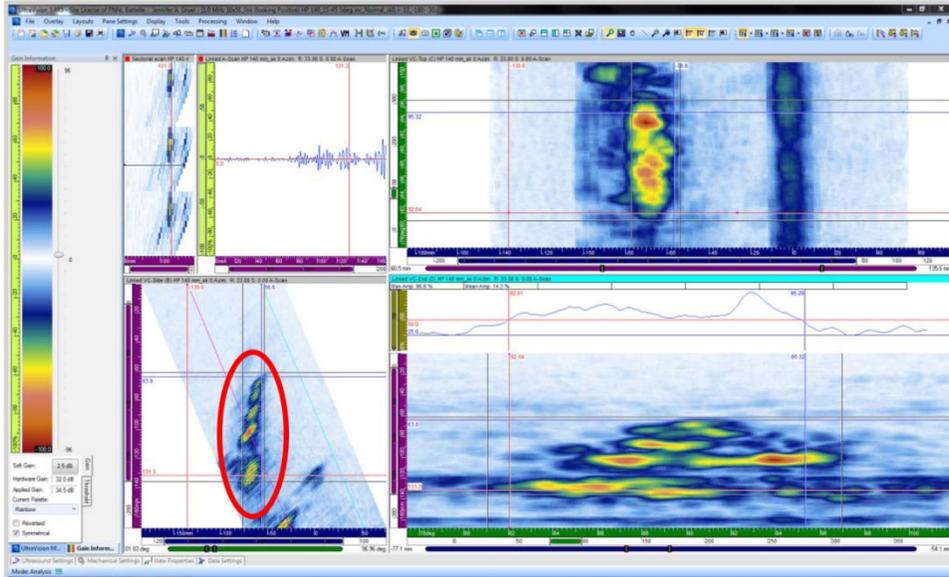
Figure D.17. DM-05 Flaw 2 Circled in Red

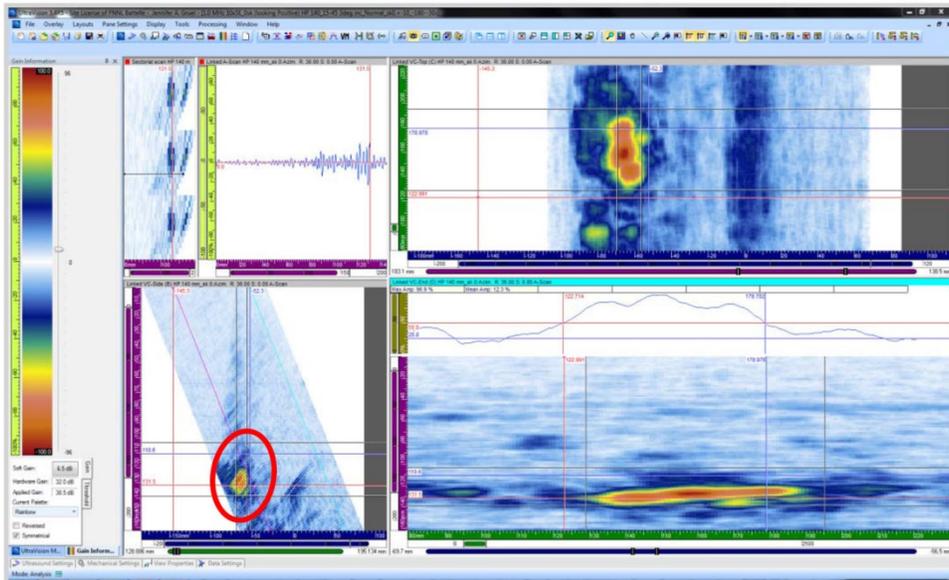
Figure D.18. DM-05 Flaw 3 Circled in Red

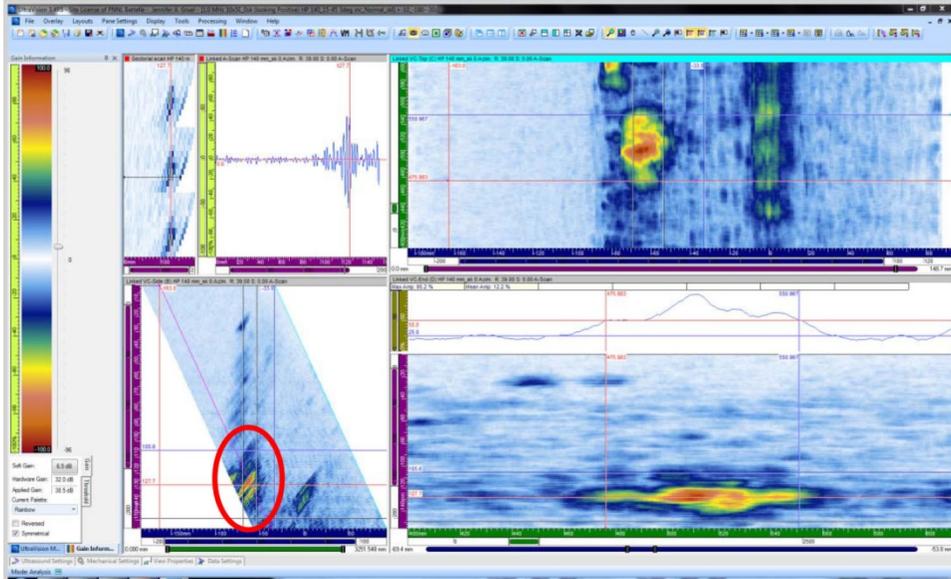
Figure D.19. DM-05 Flaw 4 Circled in Red

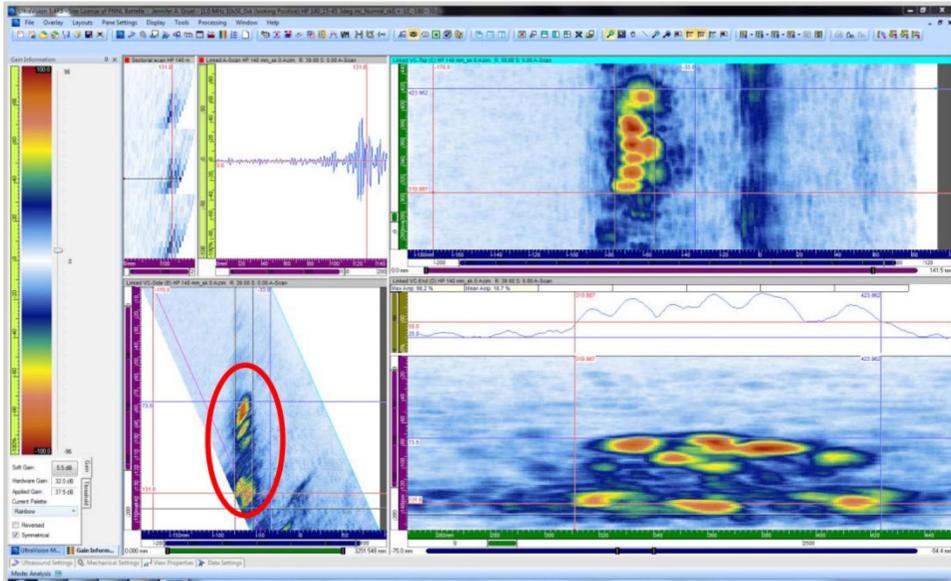
Figure D.20. DM-10 Flaw 1 Circled in Red

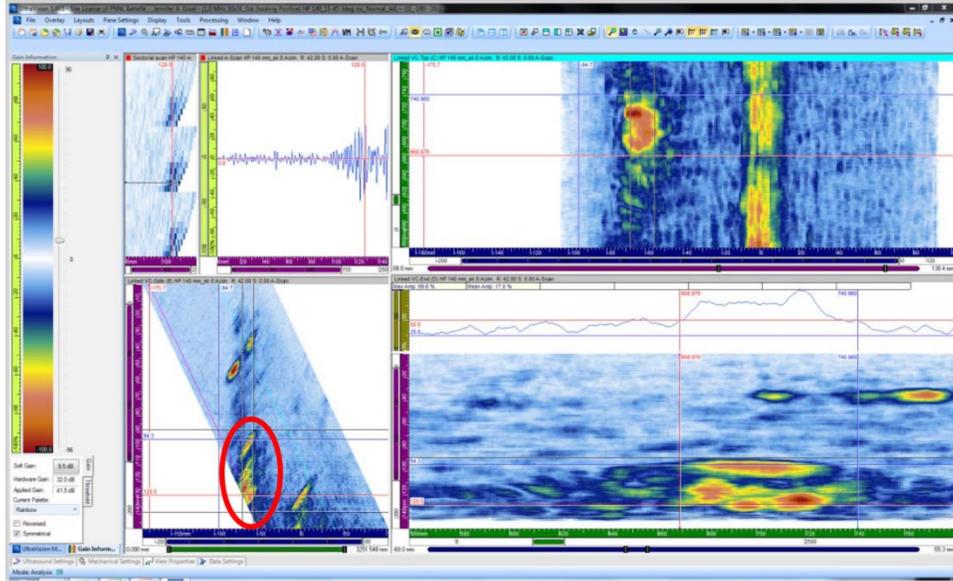
Figure D.21. DM-10 Flaw 4 Circled in Red

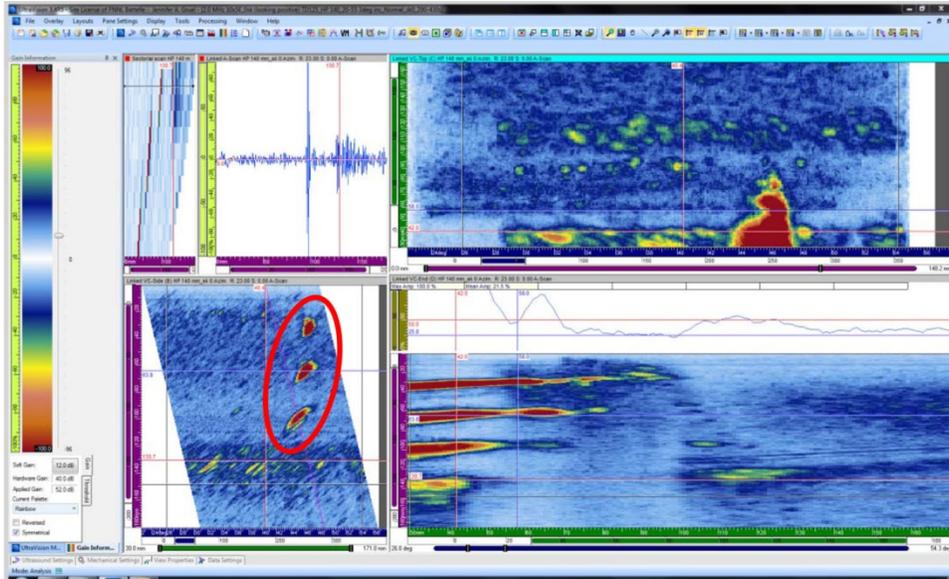
Figure E.1. CW, Skew 0, Axial Flaw 1 Region. Flaw not detected. Three side-drilled holes are visible and circled in red.

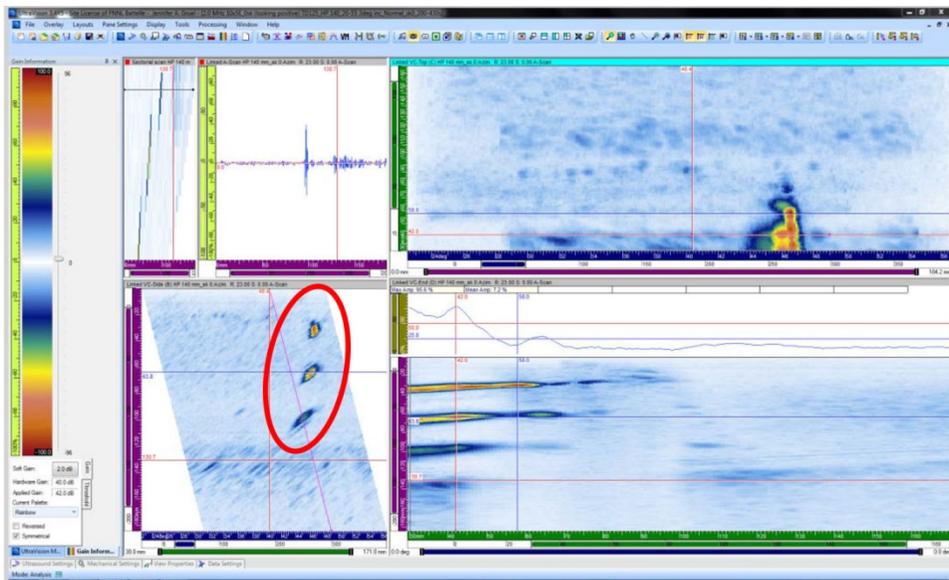
Figure E.2. CW, Skew 0, Reduced Gain. Three side-drilled holes are visible and circled in red.

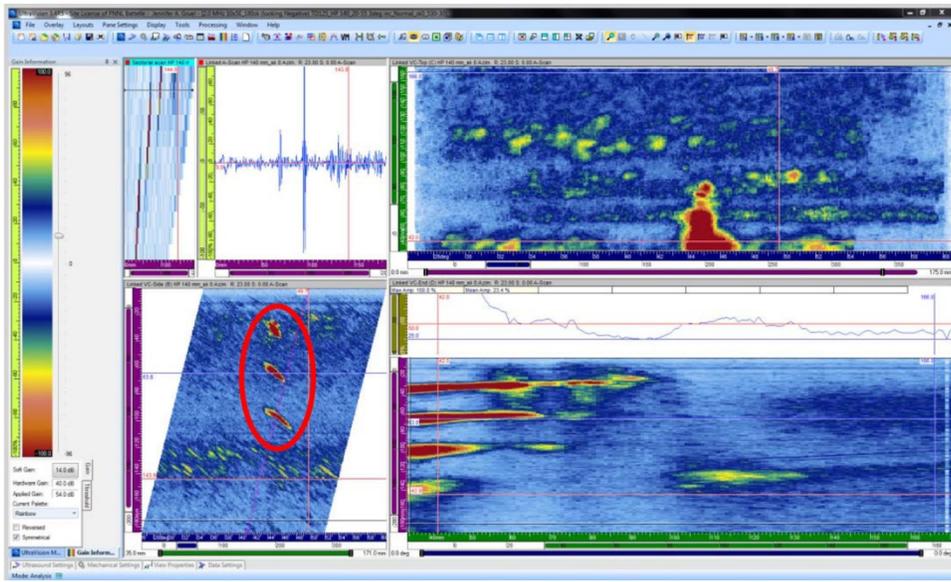
Figure E.3. CCW, Skew 0, Axial Flaw 1 Region. Flaw not detected. Three side-drilled holes are visible and circled in red.

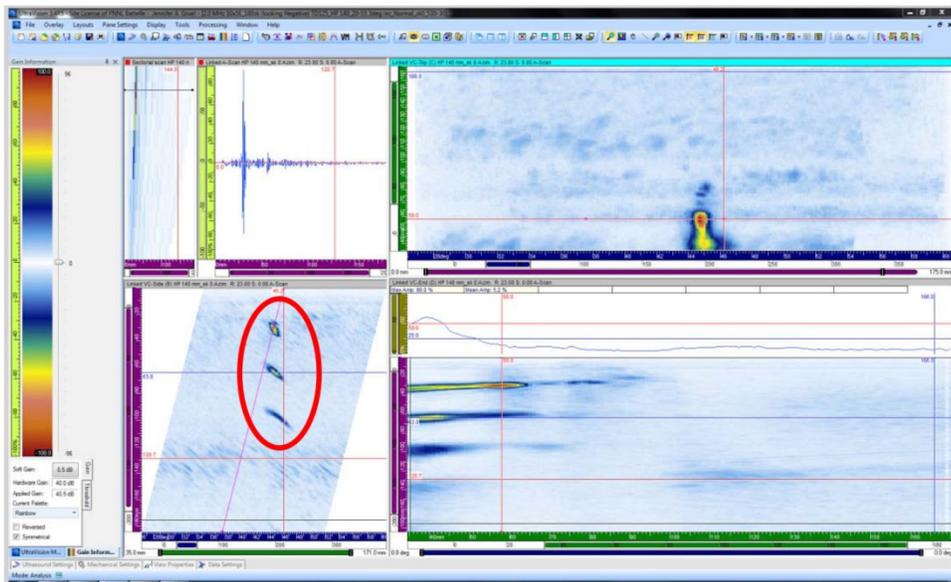
Figure E.4. CCW, Skew 0, Reduced Gain. Three side-drilled holes are visible and circled in red.

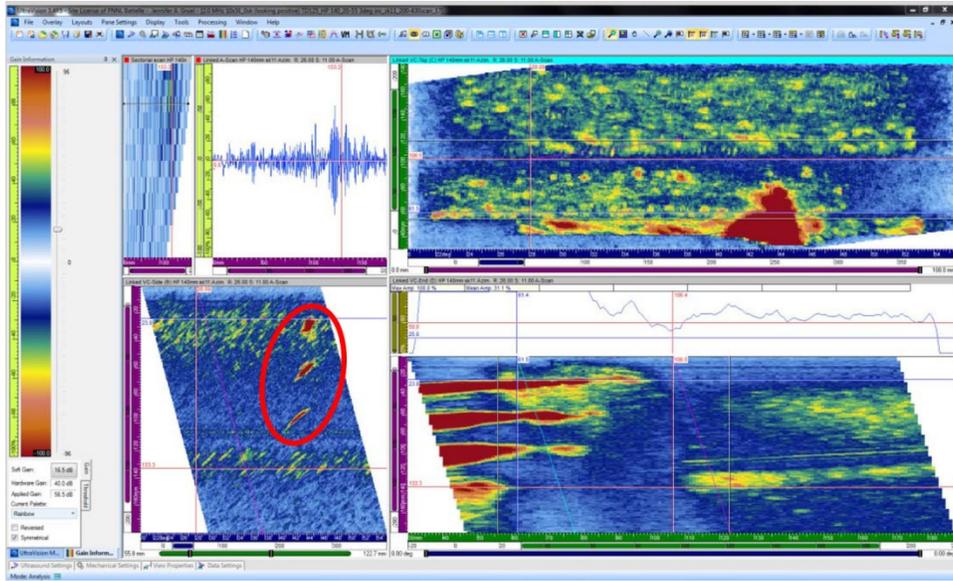
Figure E.5. CW, Skew 11, Axial Flaw 1 Region. Flaw not detected. Three side-drilled holes are visible and circled in red.

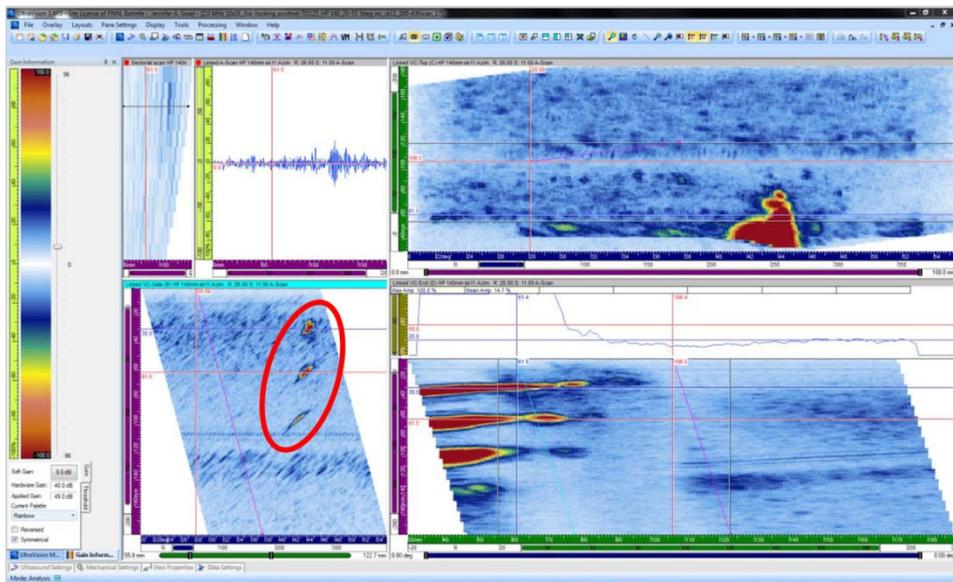
Figure E.6. CW, Skew 11, Reduced Gain. Three side-drilled holes are visible and circled in red.

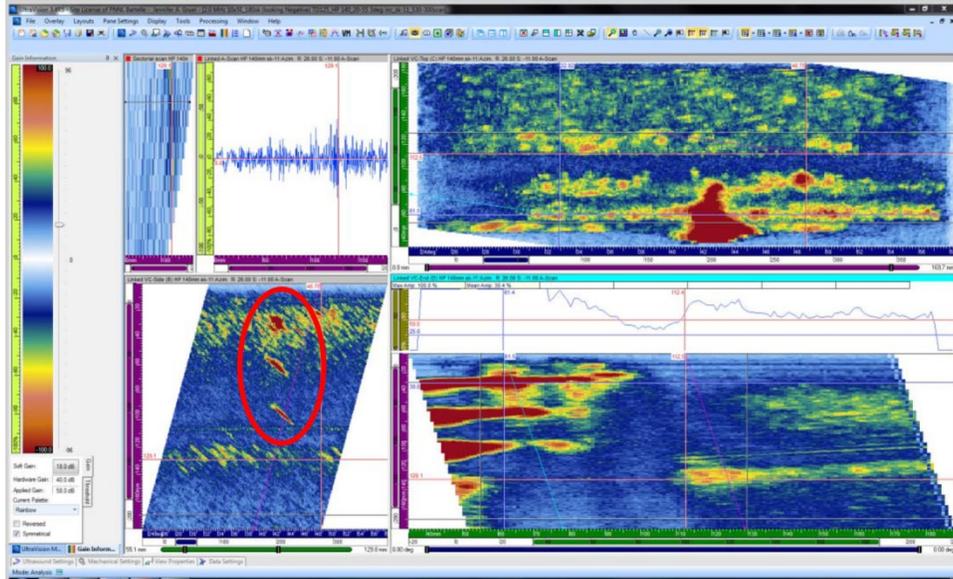
Figure E.7. CCW, Skew 11, Axial Flaw 1 Region. Flaw not detected. Three side-drilled holes are visible and circled in red.

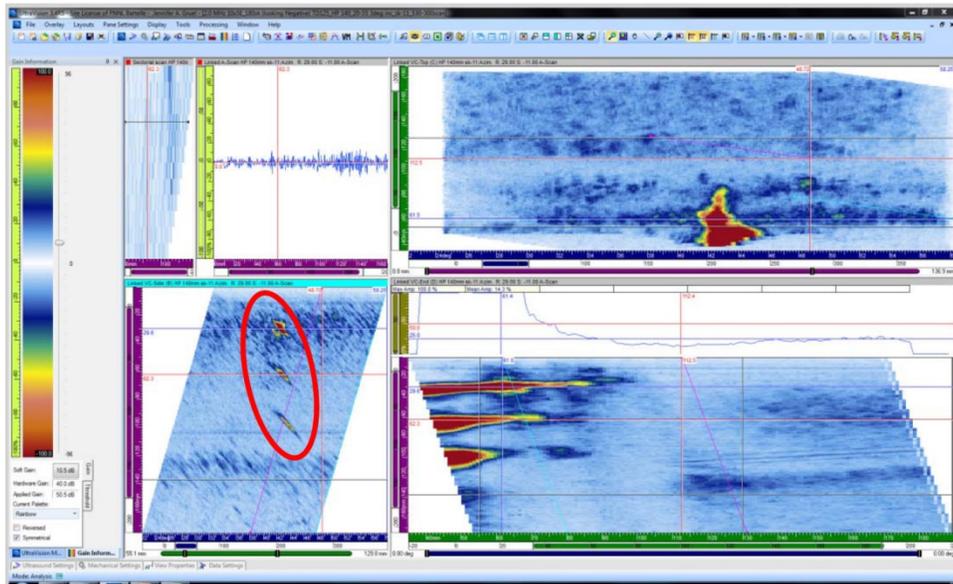
Figure E.8. CCW, Skew 11, Reduced Gain. Three side-drilled holes are visible and circled in red.

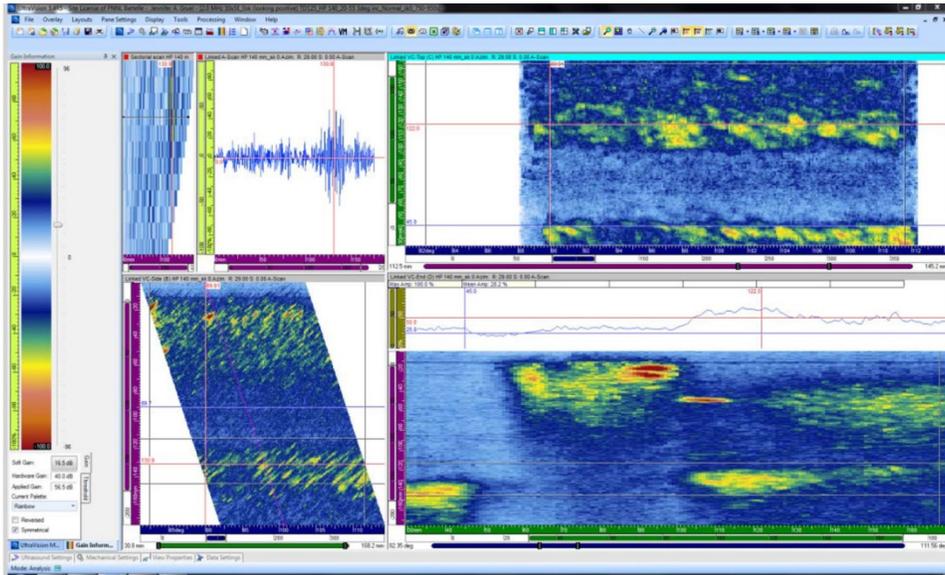
Figure E.9. CW, Skew 0, Axial Flow 2 Region. Flaw not detected.
