PNNL-22553

Final Assessment of Manual Ultrasonic Examinations Applied to Detect Flaws in Primary System Dissimilar Metal Welds at North Anna Power Station

March 2014

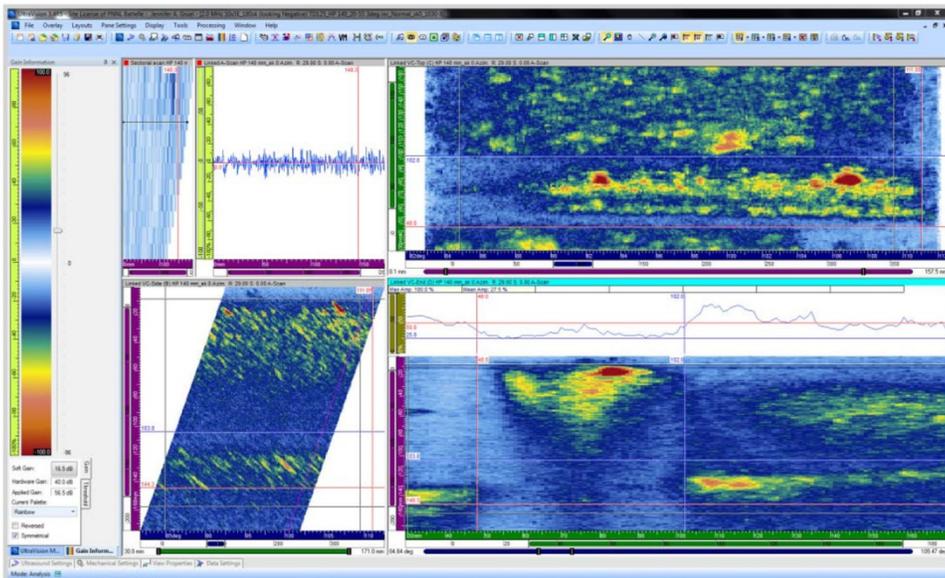
Figure E.10. CCW, Skew 0, Axial Flow 2 Region. Flaw not detected.

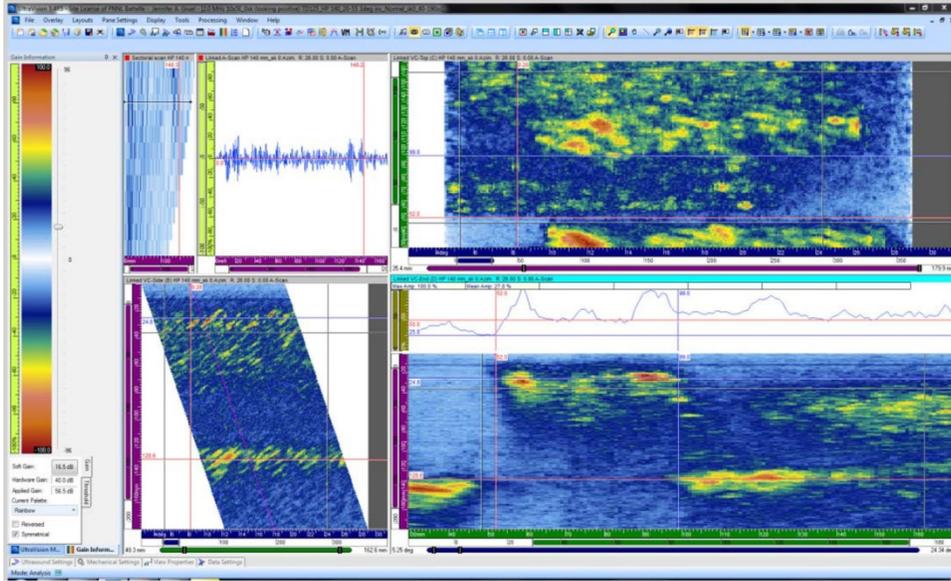
Figure E.11. CW, Skew 0, Axial Flaw 3 Region. Flaw not detected.

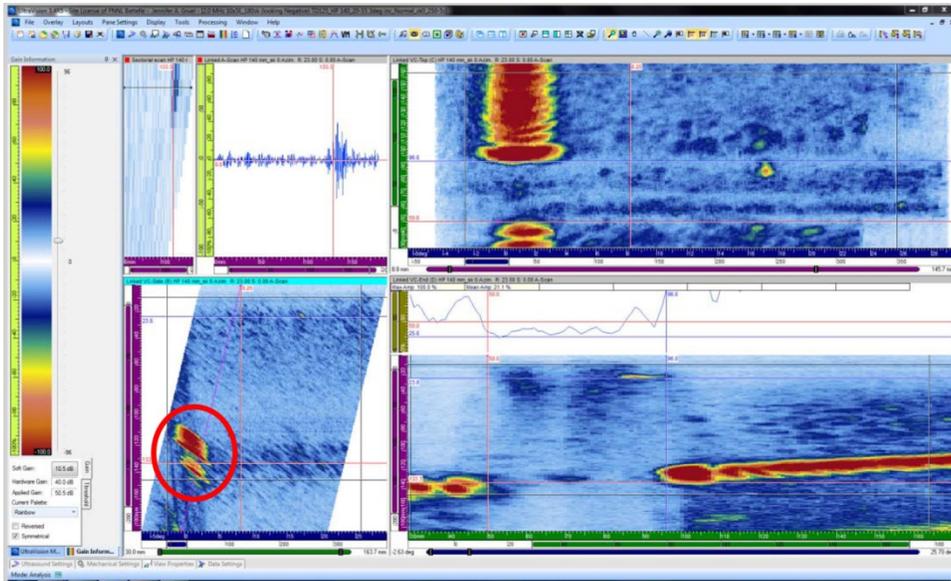
Figure E.12. CCW, Skew 0, Axial Flaw 3 Region. Flaw not detected; end-of-specimen is visible and circled in red.

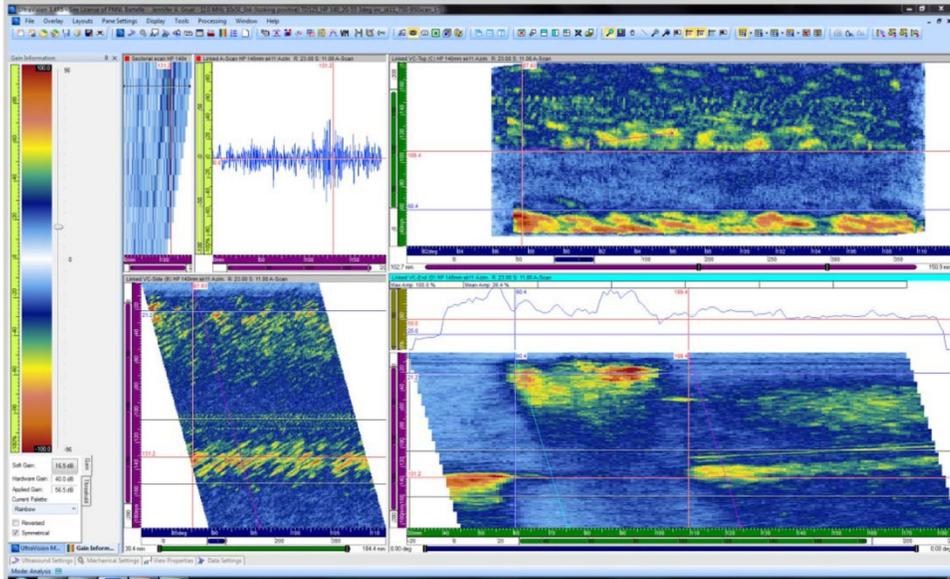
Figure E.13. CW, Skew 11, Axial Flaw 2 Region. Flaw not detected.

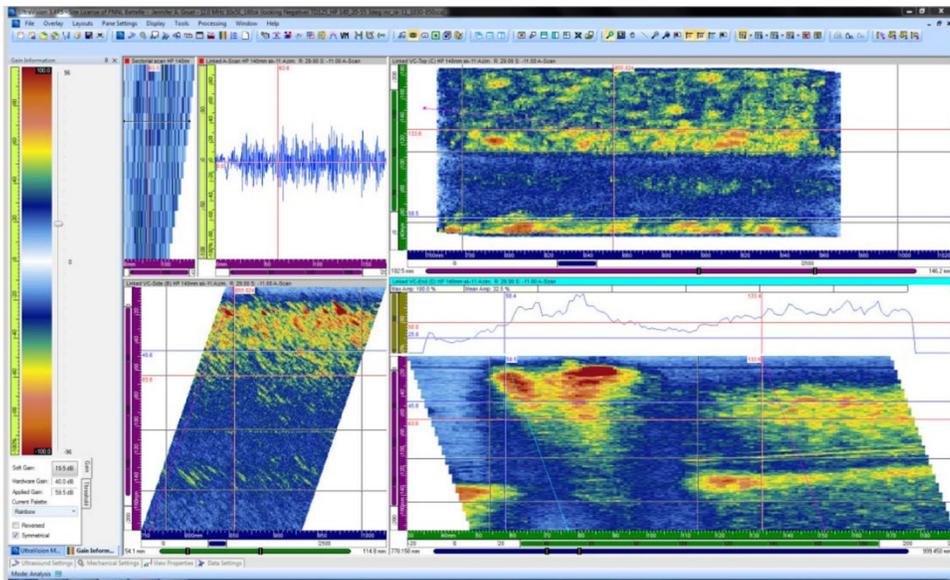
Figure E.14. CCW, Skew 11, Axial Flaw 2 Region. Flaw not detected.

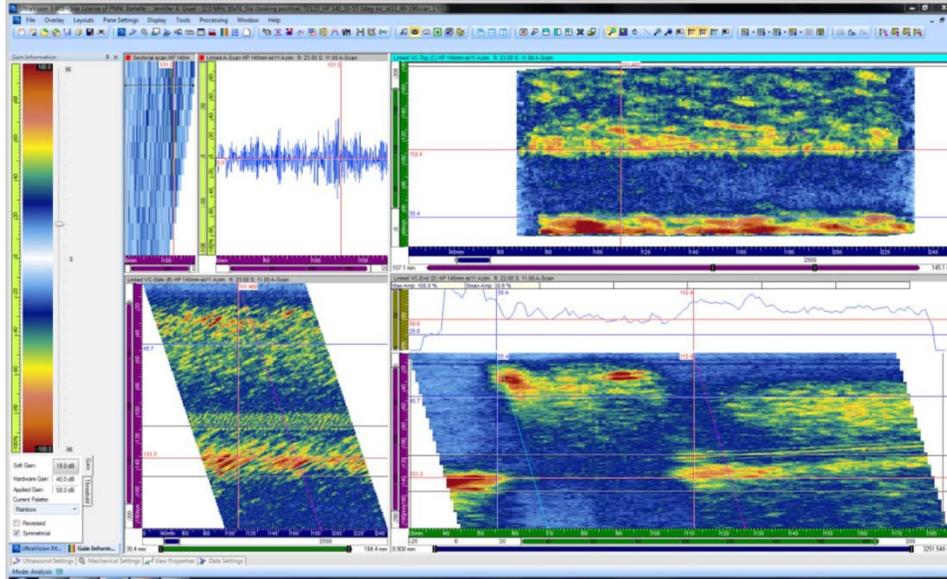
Figure E.15. CW, Skew 11, Axial Flaw 3 Region. Flaw not detected.

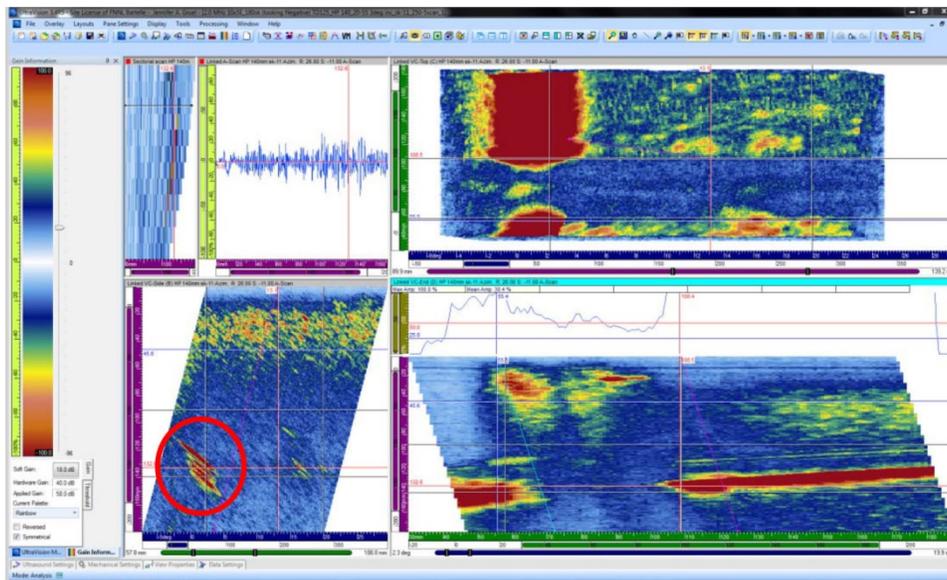
Figure E.16. CCW, Skew 11, Axial Flaw 3 Region. Flaw not detected; end-of-specimen is visible and circled in red.

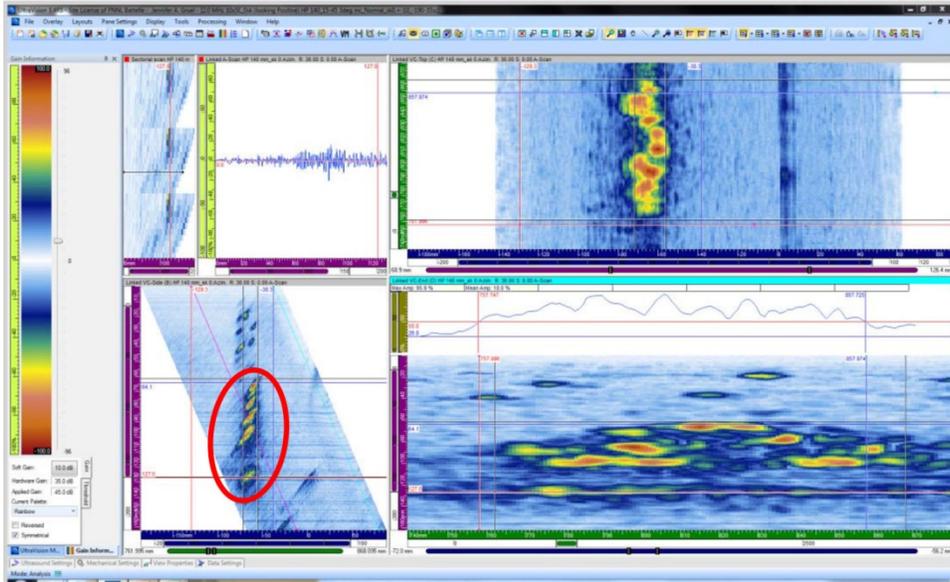
Figure E.17. DM-05 Flaw 2 Circled in Red

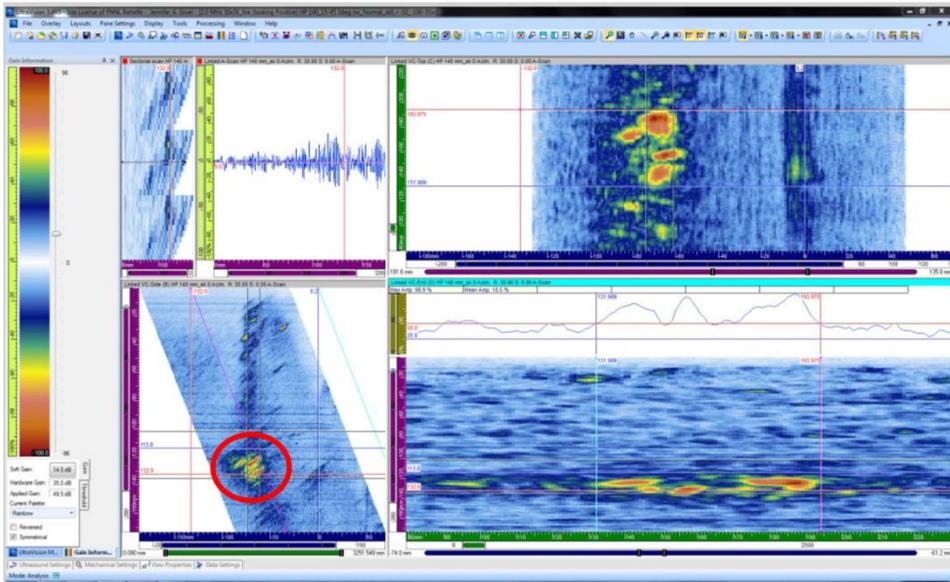
Figure E.18. DM-05 Flaw 3 Circled in Red

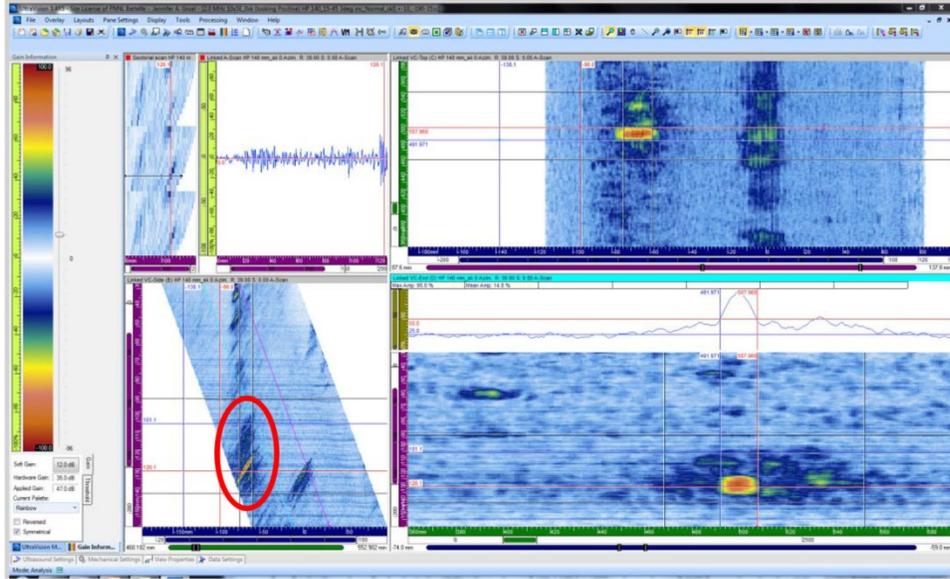
Figure E.19. DM-05 Flaw 4 Circled in Red

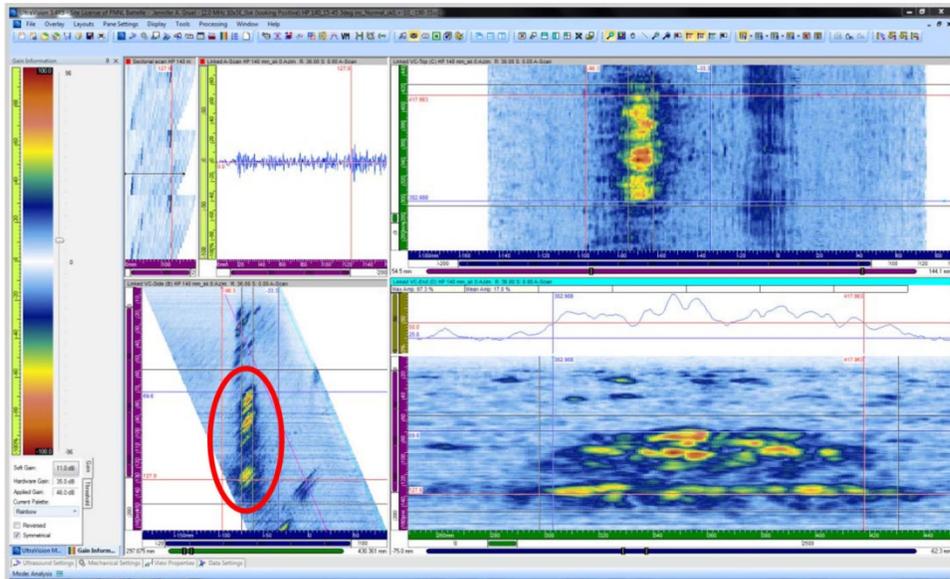
Figure E.20. DM-10 Flaw 1 Circled in Red

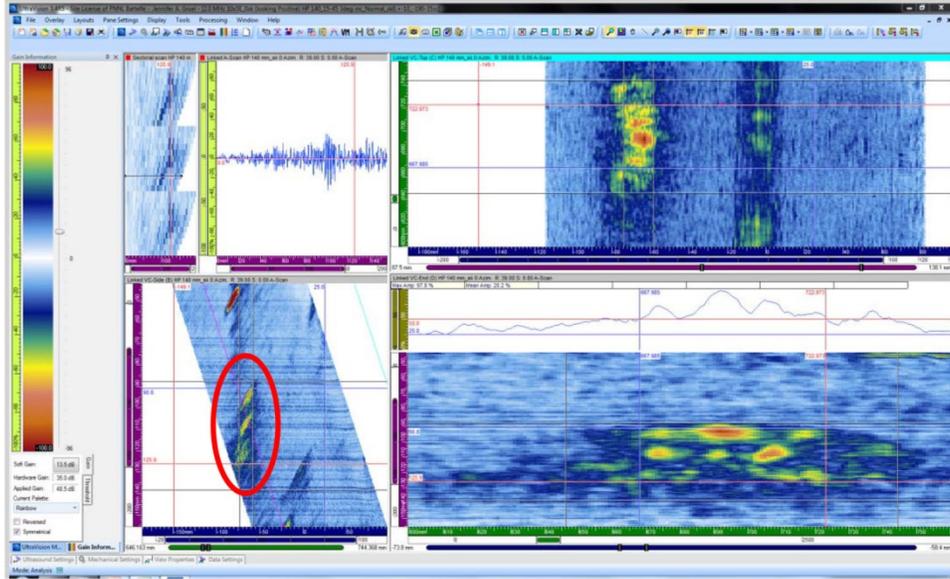
Figure E.21. DM-10 Flaw 4 Circled in Red

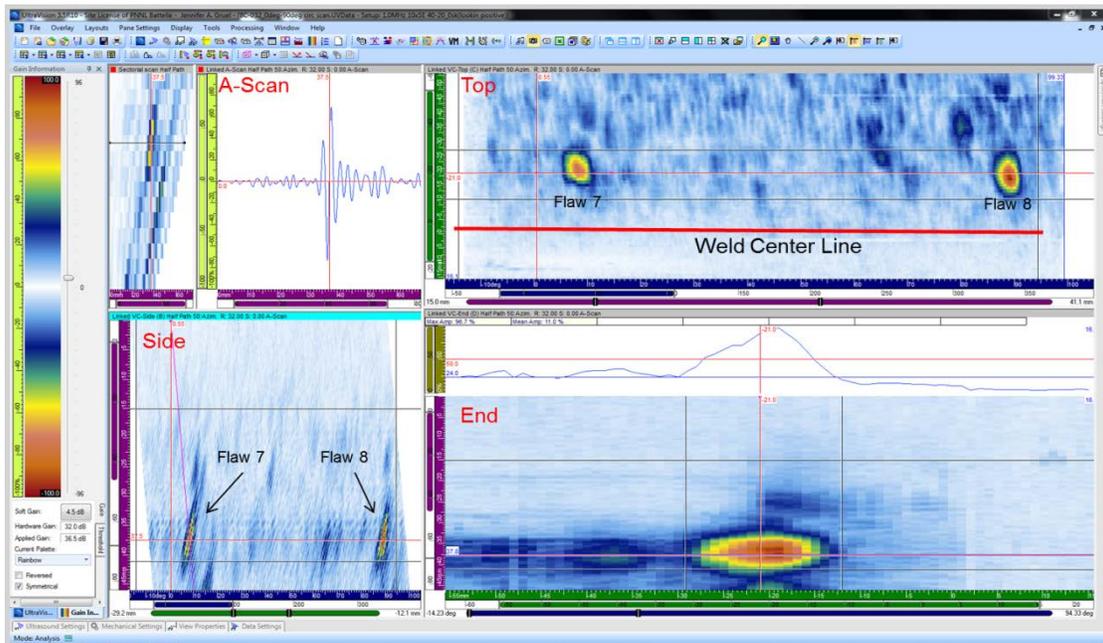
Figure F.9. 8C-036 Quadrant #1: Detection of Axially Orientated Flaws #7 and #8

Circumferential scan quadrant #1 of 8C-036 extended from approximately -10 degrees to 100 degrees in length from the reference '0' position and contained both axially oriented flaws (for reference, flaw numbers 7 and 8). Figure F.9 shows the PA-UT data for quadrant #1 at an inspection angle of 32 degrees (43 -degree impingement angle). The selected angle resulted with the largest response from both flaws and established the applied gain setting to be 36.5 dB for subsequent analyses. Flaws #7 and #8 were easily detected (indicated by the black arrows) at the true-state locations of 9 and 90 degrees circumferentially in the scan axis and adjacent to the weld (in the weld/butter region) in the top and side views. Signal-to-noise ratio (SNR) values for flaw #7 and #8 were 21.7 and 23.0 dB, respectively. Note: The data layout format will remain consistent for the remainder of the section.

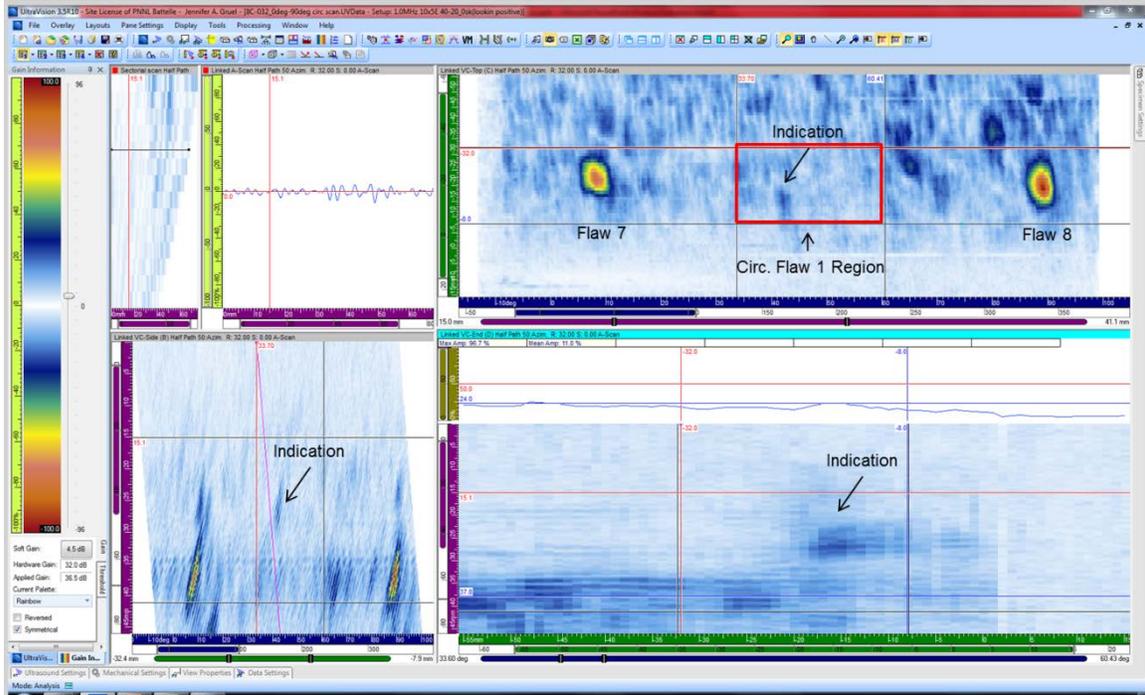
Figure F.10. 8C-036 Circumferential Flaw #1 Region Boxed in Red

In addition to the two axially orientated flaws, quadrant #1 contained the 58% through-wall circumferentially oriented flaw #1 between scan locations of 33.7 and 60.3 degrees circumferentially. The flaw #1 region of interested is boxed in red and shown in Figure F.10. At the same 32 -degree inspection angle and applied gain settings, a mid-wall indication was identified and highlighted by the black arrows in the figure. Figure F.11 shows a mid-wall gate applied excluding ID responses, and sensitivity was increased displaying the through-wall extents of flaws #7 and #8 as well as the indication in the circumferential flaw region (boxed in red). Here it is shown that the indication is located closer to the weld center line and is detected with a SNR of 12.9 dB.

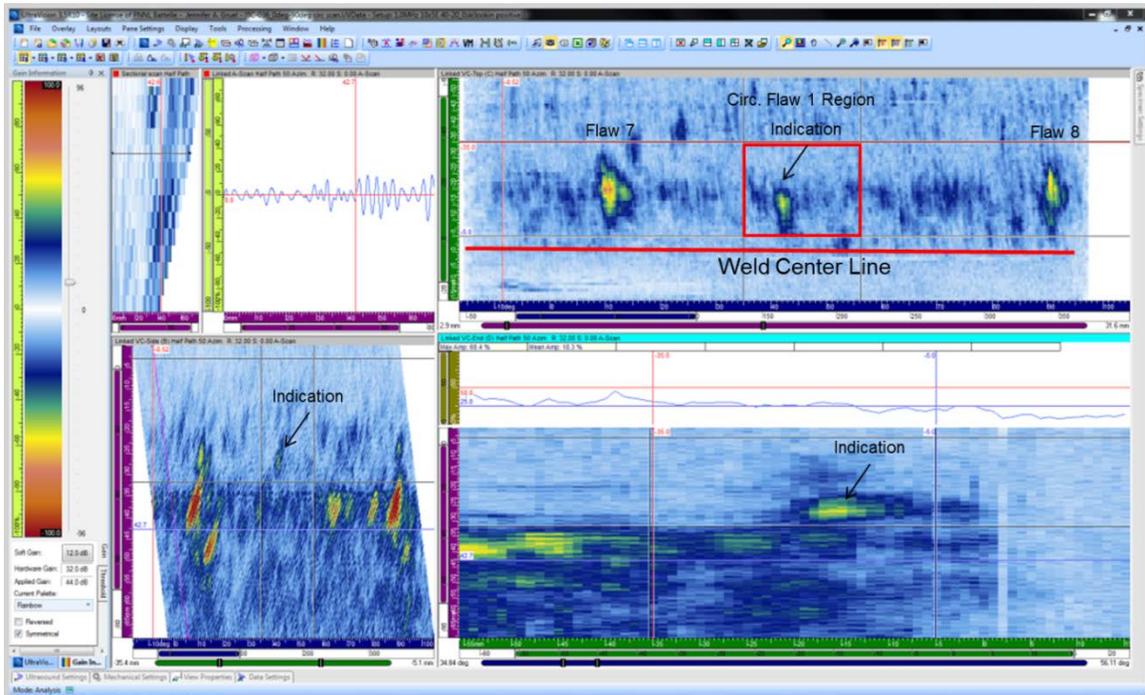
Figure F.11. 8C-036 Circumferential Flaw #1 Region Boxed in Red. Mid wall data gates are applied.

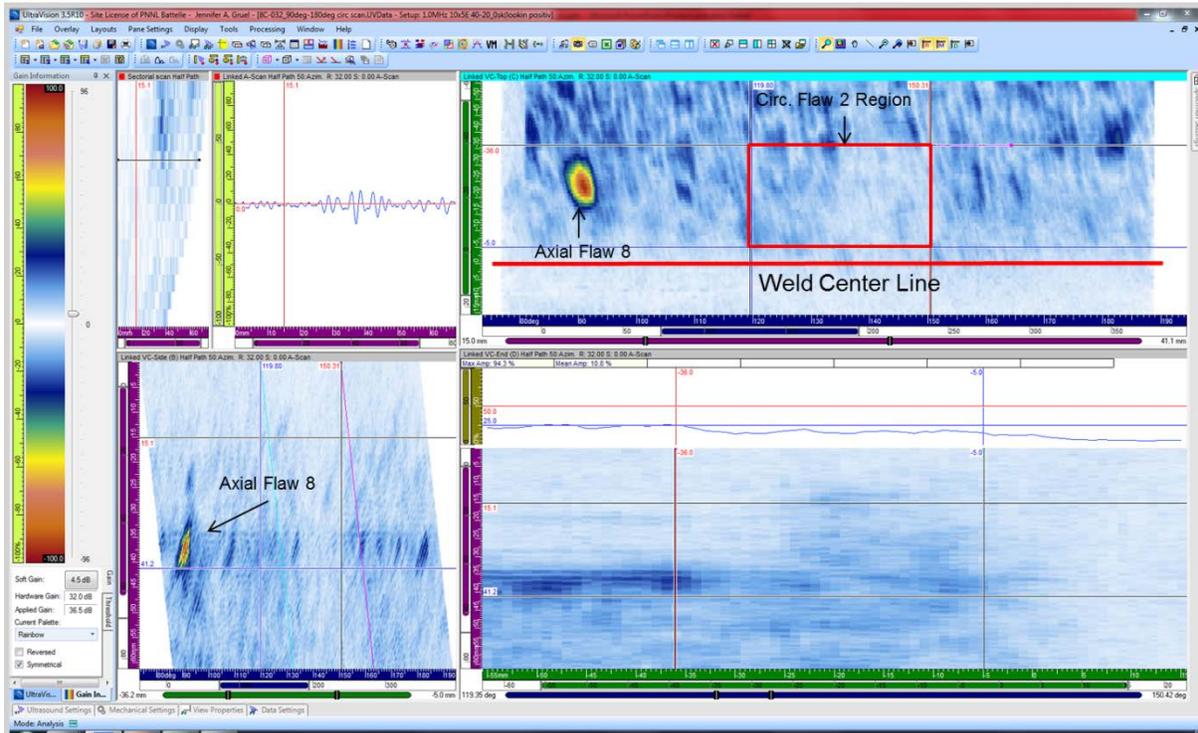
Subsequently, quadrants #2, #3, and #4 of the 8C-036 DMW component were analyzed. Figures F.12, F.13, and F.14 show data screenshots highlighting the circumferential flow regions of interest boxed in red. In addition, the axial flaws are indicated where applicable. Quadrants #2, #3, and #4 did not show any discernable indications above background noise in the regions of circumferentially oriented flaws.

Figure F.12. 8C-036 Circumferential Flaw #2 Region Boxed in Red. No indications.

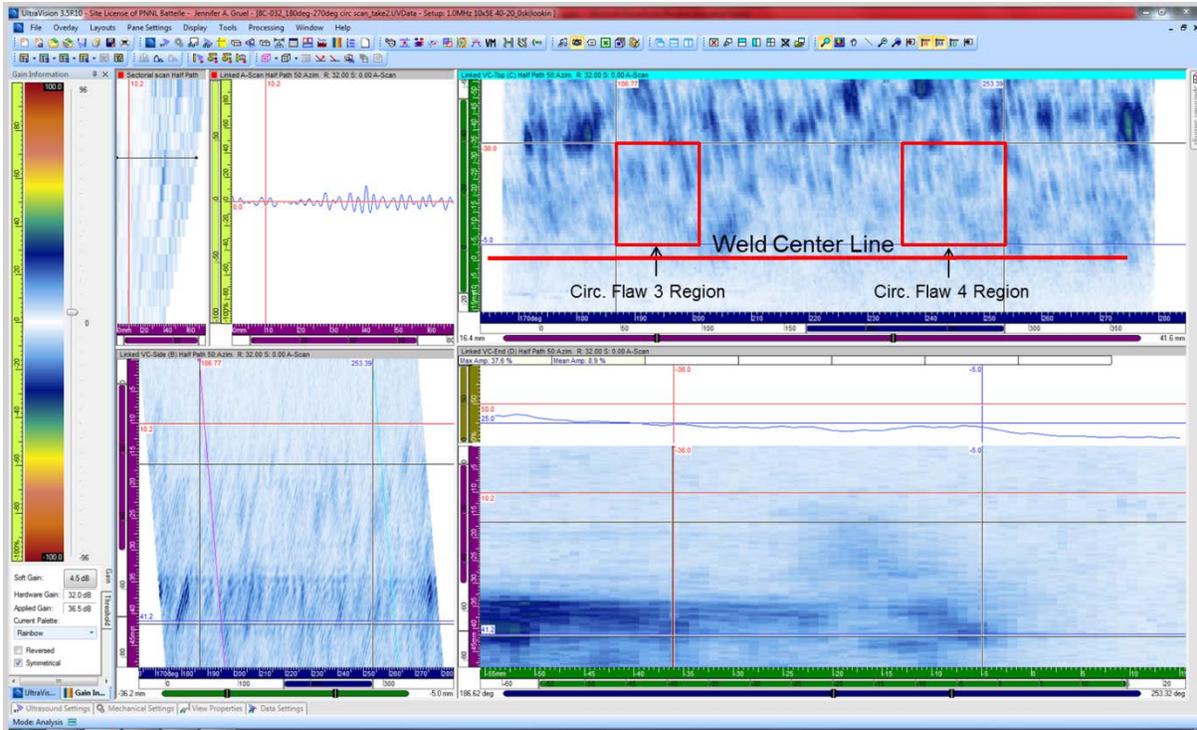
Figure F.13. 8C-036 Circumferential Flaw #3 and #4 Region Boxed in Red. No indications.

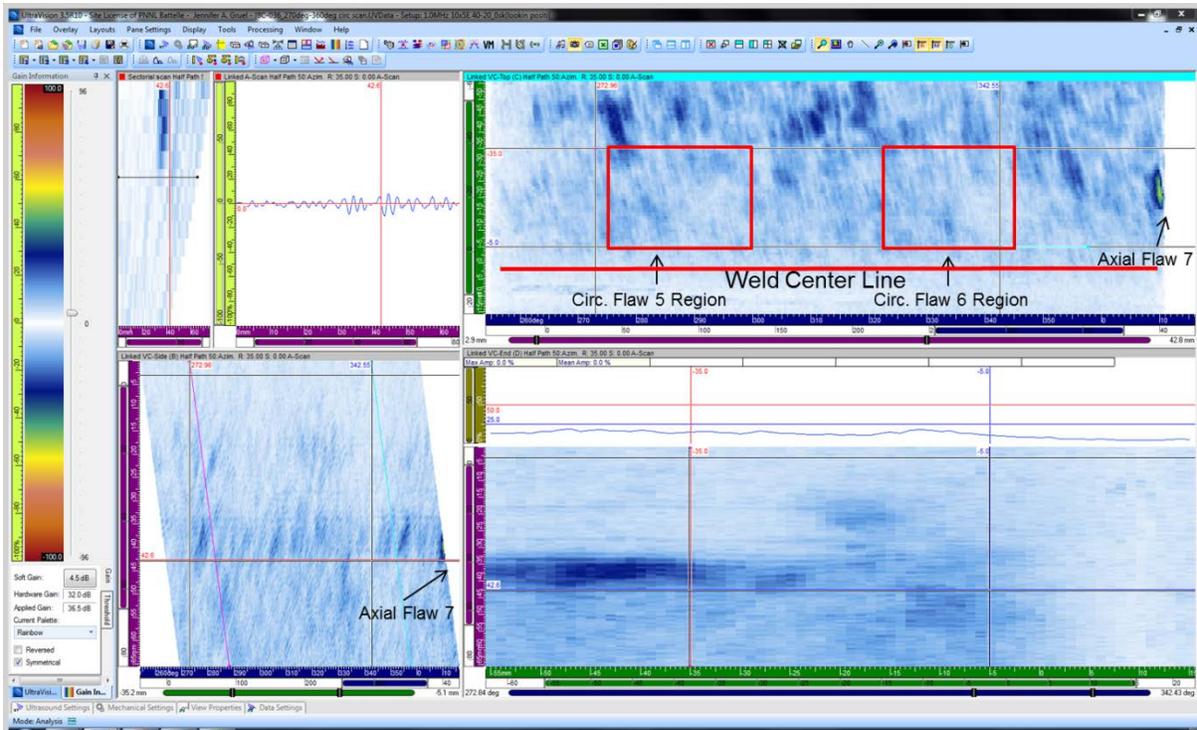
Figure F.14. 8C-036 Circumferential Flaw #5 and #6 Region Boxed in Red. No indications.

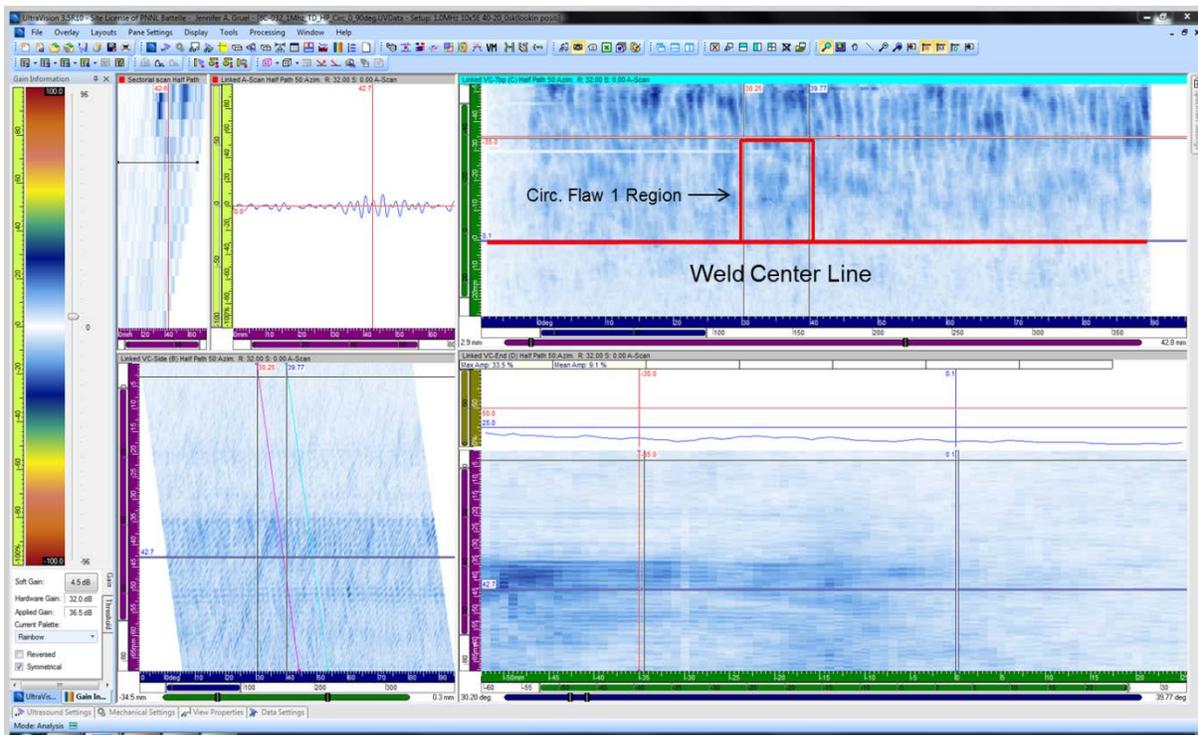
Circumferential scans were also performed on the 8C-032 DMW component in quadrant fashion with reference to the '0' position stamped on the specimen. The 8C-032 component only contains implanted circumferential flaws. For calibration purposes, a sensitivity setting of 36.5 dB at a 32-degree inspection angle was applied to all 8C-032 data—as established from the axial flaw responses #7 and #8 in the 8C-036 component. The red boxed region in Figure F.15 illustrates the circumferential flaw #1 region in quadrant #1 that extends from 30.2 to 39.8 degrees circumferentially. No indications above background noise are detected in this region.

Figure F.15. 8C-032 Circumferential Flaw #1 Region Boxed in Red. No indications.

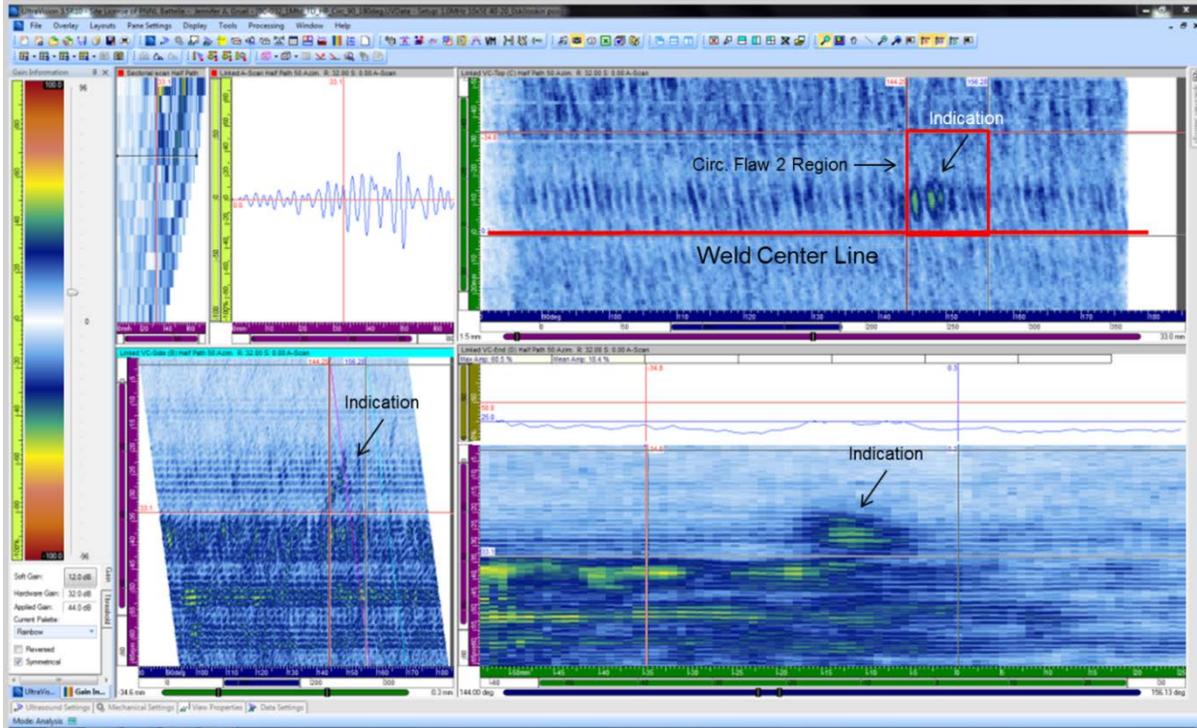
The quadrant #2 scan of the 8C-032 specimen contains circumferential flaw #2 between 144 and 156 degrees circumferentially. An indication above background noise levels was detected in the mid-wall region of circumferential flaw #2. The mid-wall gated view of the data is shown in Figure F.16 with increased sensitivity. The indication was detected with a SNR of 9.5 dB.

Figure F.16. 8C-032 Circumferential Flaw #2 Region Boxed in Red. Mid-wall data gates are applied.

Considering the ten opportunities for detection of circumferential-flaw-related indications, only two regions of circumferential flaw locations presented indications above background noise from each DMW component. Circumferential flaw #1 region in 8C-036 contained an implanted TFC that was 58% through-wall and extended 26.6 degrees in the circumferential axis. This flaw also was specified to have a 30-degree tilt away from the weld with respect to radial. The detectable mid-wall indication from this flaw region had a SNR of 12.9 dB. The second indication was found in the circumferential flaw #2 region of 8C-032. Similarly, this was a 40% through-wall implanted TFC with a radial tilt of 19 degrees. This flaw was detected in the mid-wall region with a SNR of 9.5 dB.

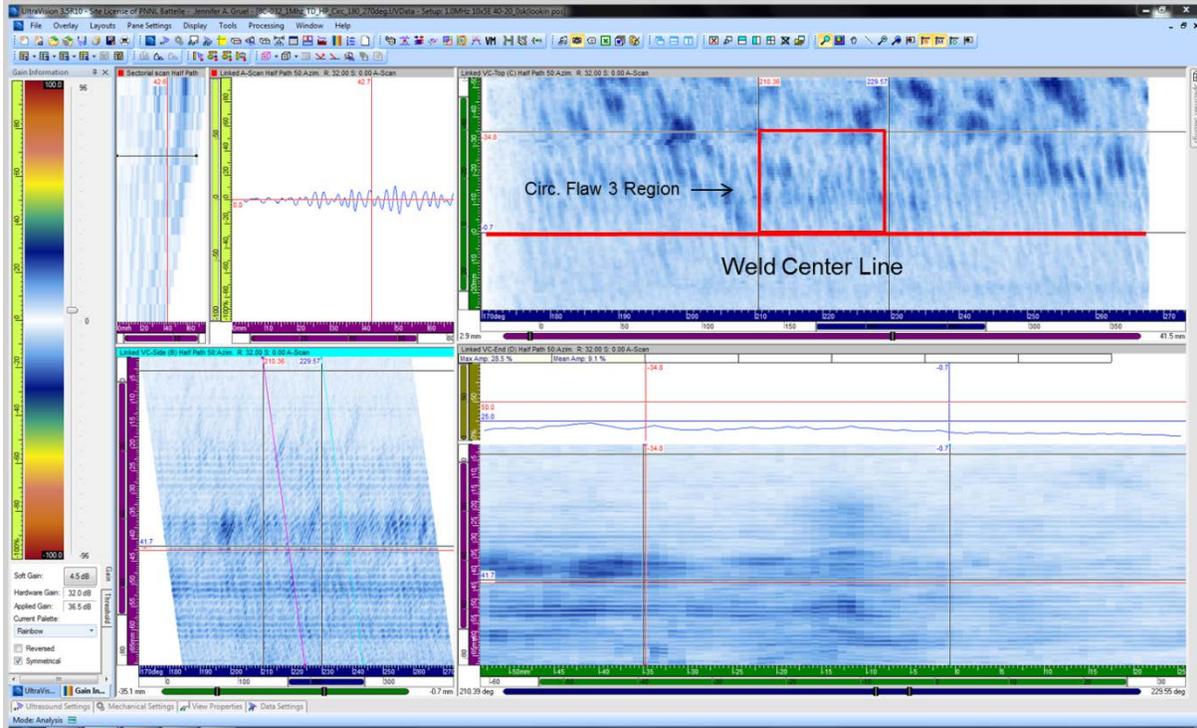
Quadrants #3 and #4 of 8C-032 containing circumferential flaws #3 and #4, respectively, were also fully evaluated for detection of indications in the flawed regions. Figures F.17 and F.18 show data from each quadrant with the circumferential flaw regions boxed in red. Neither quadrant had indications above noise levels.

Figure F.17. 8C-032 Circumferential Flaw #3 Region Boxed in Red. No indications.

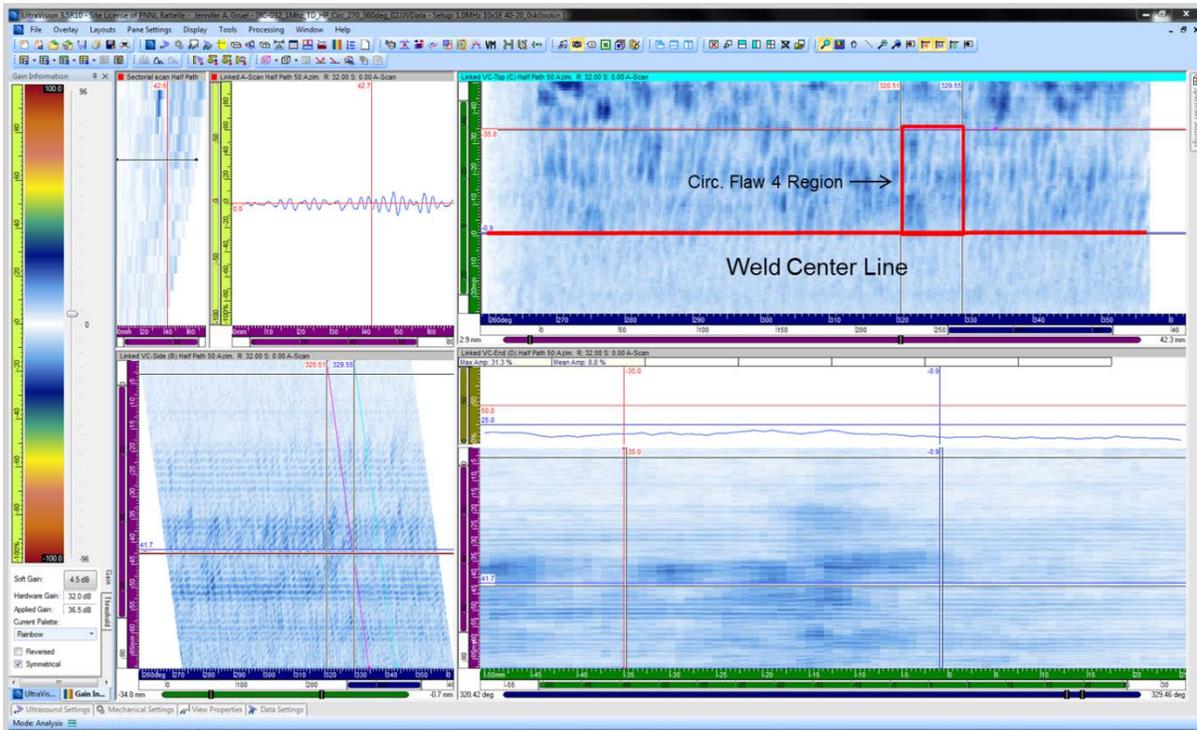
Figure F.18. 8C-032 Circumferential Flaw #4 Region Boxed in Red. No indications.
