**Pacific Northwest
National Laboratory**

Independent Review of Tank 241-AY-101 Fitness for Service

February 2003

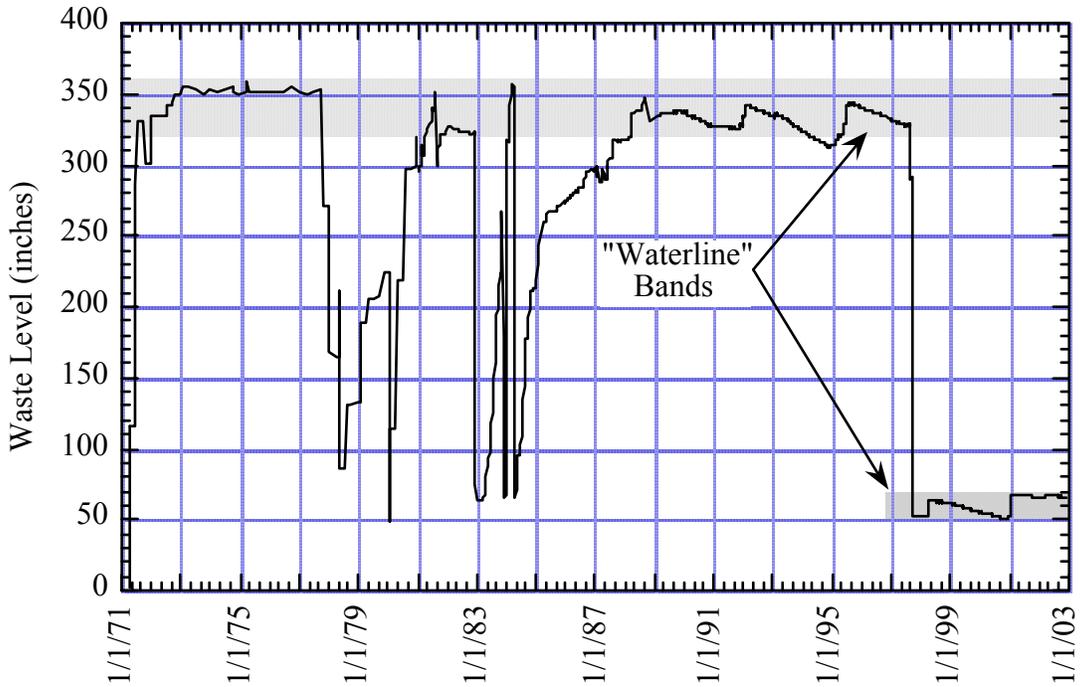
Figure A.3. AY-101 Waste Level History

The waste level history for AY-101 since it was put into service in 1971 is shown in Figure A.3. The waste levels prior to 1981 were derived from the fill history. The two shaded bands in the figure indicate regions where the waste level remained for relatively long periods. These regions are loosely termed “waterlines” or “beach lines” from the similarity between the tank and a natural body of water. The water lines are more clearly visible on the distribution of cumulative time-at-level given in Figure A.4. The waste level spent 17 years in the primary “waterline” band between 318 and 362 inches and 5.6 years in a secondary, more recent band between 50 and 69 inches.
