**Pacific Northwest
National Laboratory**

**Ultrasonic Examination of Double-Shell
Tank 241-AP-101 Examination
Completed March 2003**

AF Pardini
GJ Posakony

April 2003

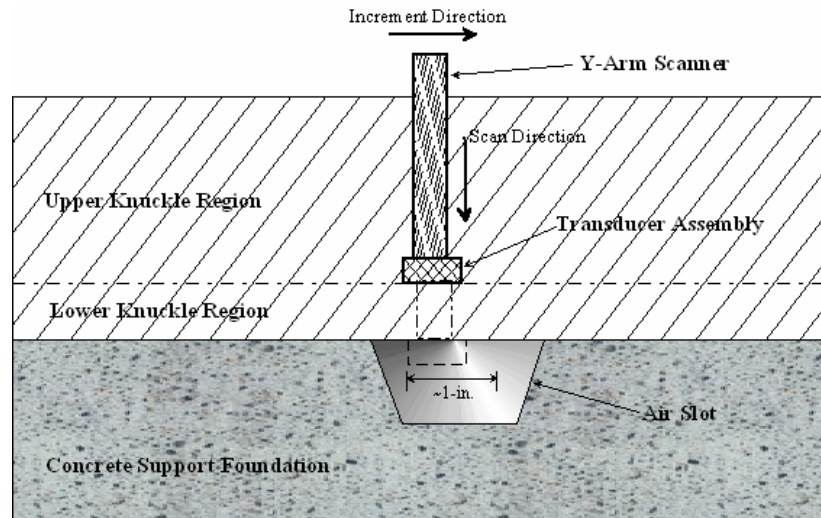
Figure 3.5. Lower Knuckle Examination in Air Slot Regions (End View)

Additional Y-arm scanning was done on areas that were accessible in the air slots that extend under the tank in the concrete support foundation. Figure 3.5 provides an end view (looking down the air slot) and Figure 3.6 provides a side view (looking along the circumference of the tank) of the examination of the lower knuckle in the region of the air slots.

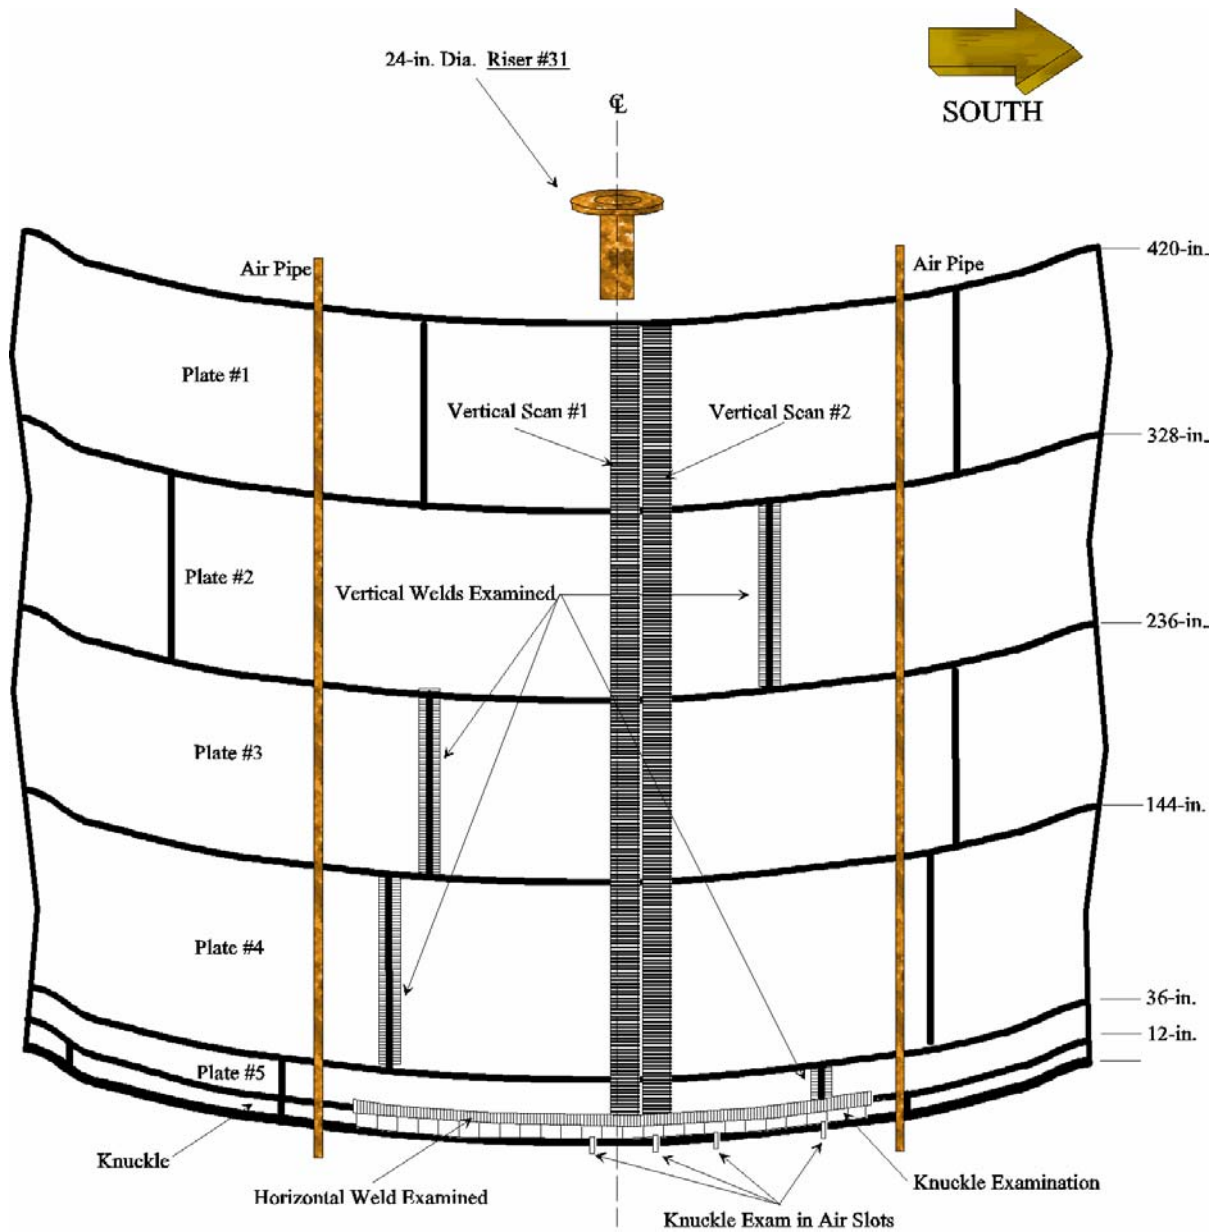
Figure 4.2. Sketch of Scan Paths on Tank 241-AP-101

Two 15-in.-wide scan paths were performed on Plates #1, #2, #3, #4, and #5. The plates were examined for wall thinning, pitting, and cracks oriented vertically on the primary tank wall. There were no areas that exceeded the reportable level of 10% of the nominal thickness. No pitting or vertical crack-like indications were detected in Plate #1, #2, #3, #4, or #5.

The HAZs of vertical welds in Plates #2, #3, #4, and #5 were examined for wall thinning, pitting and cracks oriented either perpendicular or parallel to the weld. There were no areas that exceeded the reportable level of 10% of the nominal thickness. No pitting or crack-like indications were detected in the weld areas in Plate #2, #3, #4, or #5.

The HAZ of the horizontal weld between Plate #5 and the tank knuckle was examined for wall thinning, pitting and cracks oriented either perpendicular or parallel to the weld. There were no areas that exceeded the reportable level of 10% of the nominal thickness. No pitting or crack-like indications were detected in the weld areas on Plate #5 side or on the knuckle side of the horizontal weld.

Figure 4.2 describes the areas on the primary wall of Tank 241-AP-101 that were ultrasonically examined. Two 15-in.-wide vertical scan paths were performed on Plates #1, #2, #3, #4, and #5 below the entrance to Riser 31. Vertical weld HAZ examinations were done on Plates #2, #3, #4, and #5, and the horizontal weld HAZ examination was done on the transition Plate #5 to knuckle weld. The upper portion of the knuckle was examined as well as four areas that extended down to the lower knuckle weld in the air slot regions.
