**Pacific Northwest
National Laboratory**

Ultrasonic Examination of Double-Shell Tank 241-AP-104 Examination Completed February 2005

A.F. Pardini
G.J. Posakony

March 2005

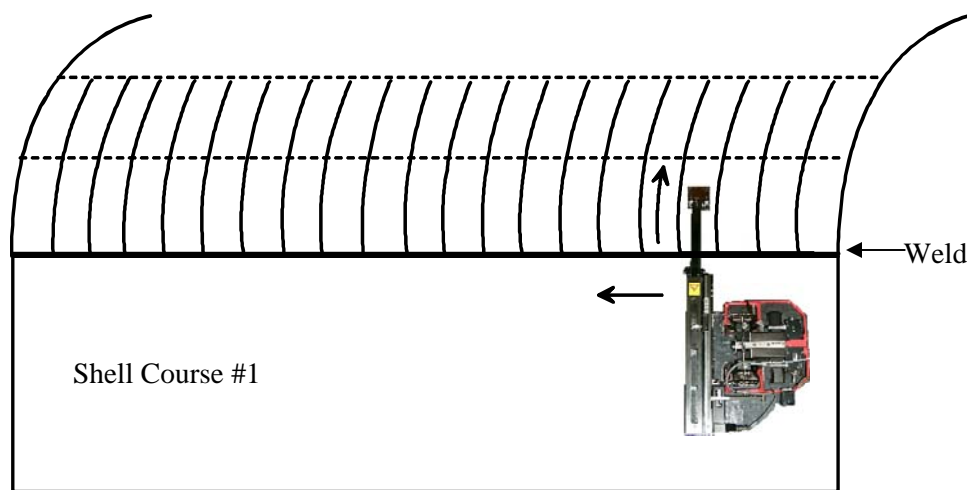
Figure 3.2. Scanning of the Primary Tank Upper Knuckle

Figure 3.2 shows the area of the section of the upper knuckle examined using the Y-arm fixture. With the transducer positioned 1-in. above the shell course #1 to knuckle weld, the scanning bridge was set to scan the transducer upward a distance of approximately 12-in. in 0.035-in steps (or as set by the operator). Upon completion of the scan, the crawler was indexed circumferentially 0.035-in. (or as set by the operator) and the scan upward is repeated to obtain a pixel size 0.035-in. x 0.035-in. (or as set by the operator). Approximately 15-ft. was scanned in the circumferential direction for this 1st scan. The crawler and scanner were repositioned to scan an additional 12-in. above the first scan. This 2nd scan was also approximately 15-ft. in the circumferential direction.

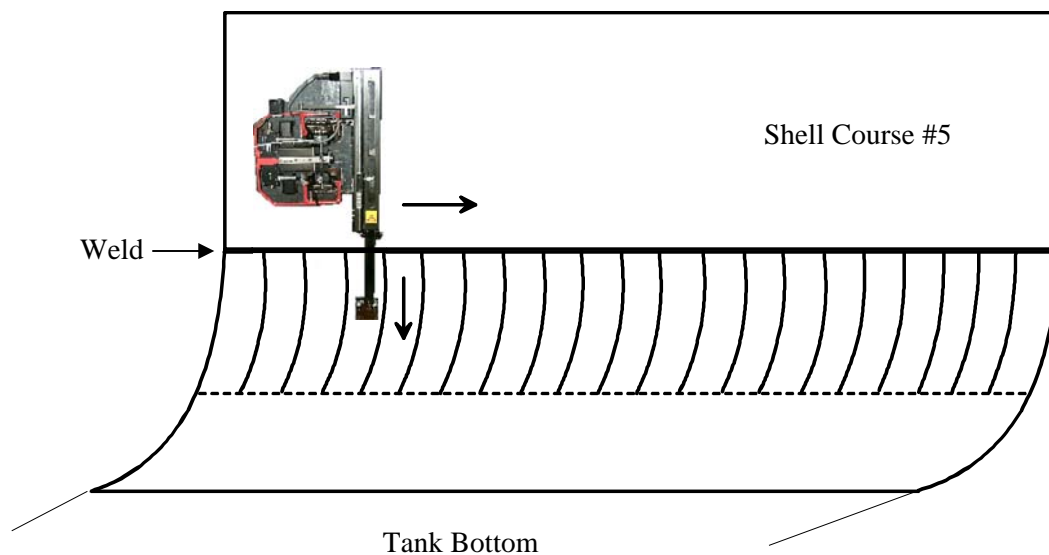
Figure 3.3. Scanning of the Secondary Tank Lower Knuckle

Figure 3.3 shows the area of the section of the lower knuckle examined using the Y-arm fixture. With the transducer positioned 1-in. below the shell course #5 to knuckle weld, the scanning bridge was set to scan the transducer downward a distance of approximately 12-in. in 0.035-in steps (or as set by the operator). Upon completion of the scan, the crawler was indexed circumferentially 0.035-in. (or as set by the operator) and the scan downward is repeated to obtain a pixel size 0.035-in. x 0.035-in. (or as set by the operator). Approximately 20-ft. was scanned in the circumferential direction. It should be noted that the Y-arm fixture was designed to examine the primary tank knuckle and is made with a spring steel arm which is curved for the primary knuckle. Application on the secondary knuckle bends the spring steel arm away from its normal operational angle creating a slight error in radial position. This radial position error was accounted for in the UT data report.
