**Pacific Northwest
National Laboratory**

**Ultrasonic Examination of
Double-Shell Tank 241-AY-102
Examination Completed January 2007**

May 2007

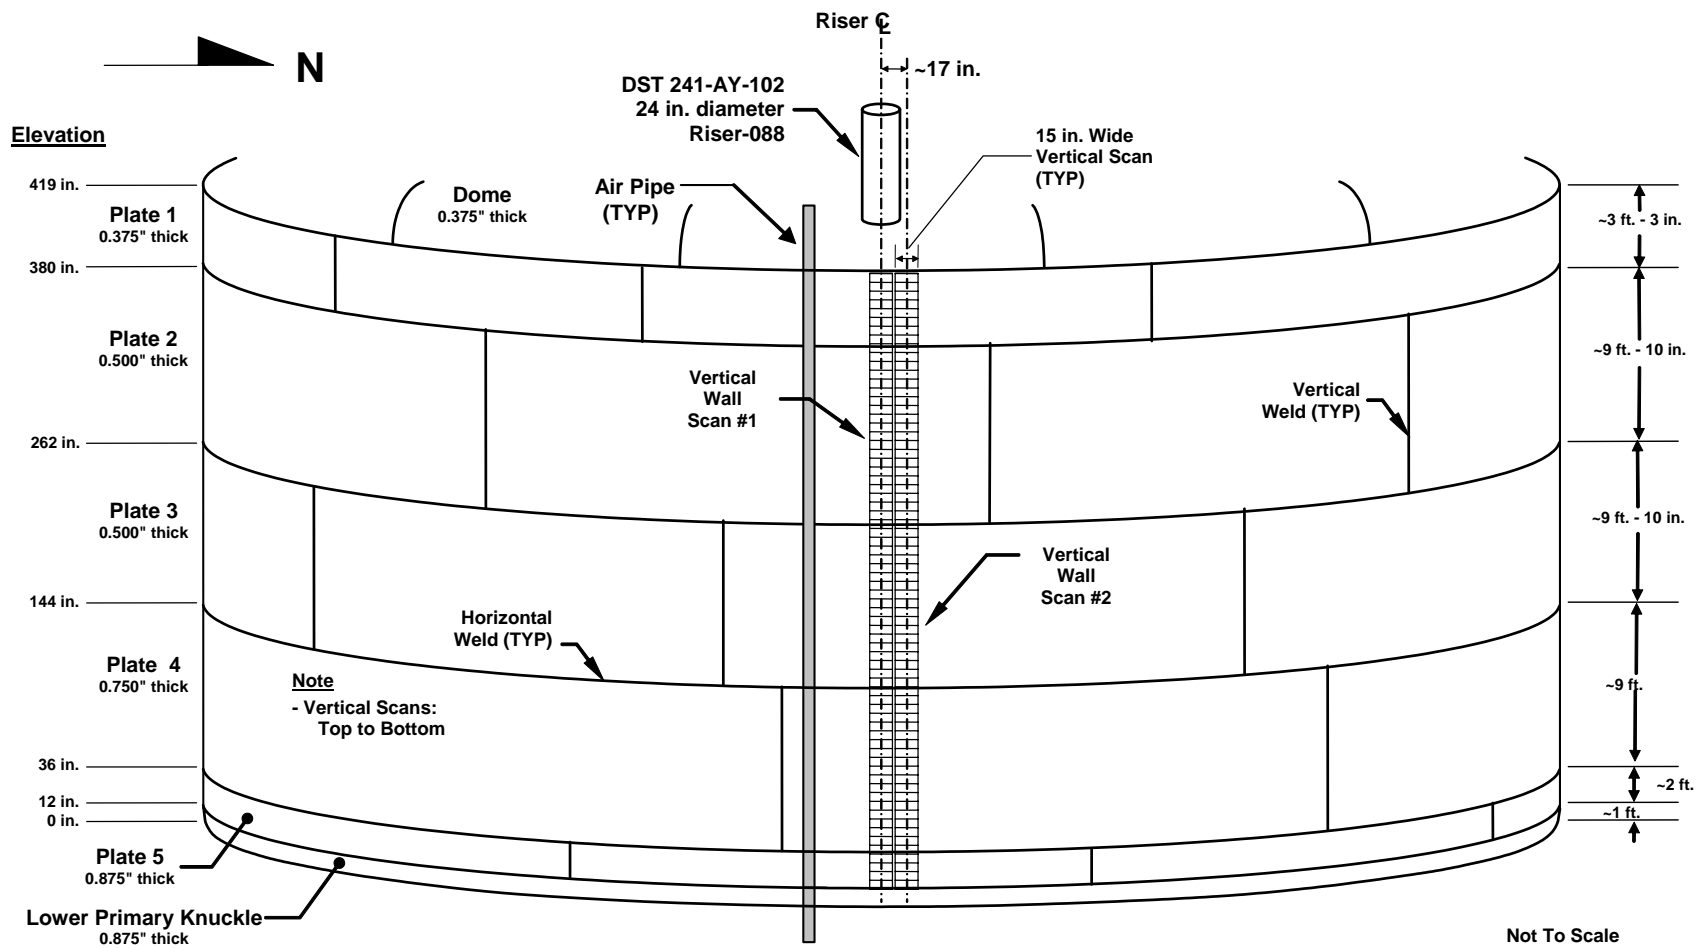
Figure 4.2. Sketch of Scan Paths on 241-AY-102 Primary Tank from Riser 88

Figure 4.2 describes the areas on the primary wall of Tank 241-AY-102 that were ultrasonically examined from Riser 88 located on the east side of the tank. Two 15-in.-wide vertical scan paths were performed on Plates #1, #2, #3, #4, and #5 below the entrance to Riser 88.

Two 15-in.-wide vertical scan paths were performed on Plates #1, #2, #3, #4, and #5 from Riser 88. The plates were examined for wall thinning, pitting, and cracks oriented vertically on the primary tank wall.

- The nominal thickness of Plate #1 is 0.375-in. and the minimum thickness in this area was 0.359-in. Plate #1 results indicate no areas that exceed the minimum thinning reportable level of 10% of the nominal thickness. No pitting or vertical crack-like indications were detected in Plate #1.

- The nominal thickness of Plate #2 is 0.500-in. and the minimum thickness in this area was 0.457-in. Plate #2 results indicate no areas that exceed the minimum thinning reportable level of 10% of the nominal thickness. No pitting or vertical crack-like indications were detected in Plate #2.

- The nominal thickness of Plate #3 is 0.500-in. Plate #3 results indicate three areas that exceed the minimum thinning reportable level of 10% of the nominal thickness. However, these three areas (with remaining ligament of 0.403-in., 0.440-in., and 0.441-in.) were analyzed by the UT Level III and were considered pit-like and therefore do not exceed the reportable pitting level of 25% of the nominal thickness. No vertical crack-like indications were detected in Plate #3.

- The nominal thickness of Plate #4 is 0.750-in. Plate #4 results indicate two areas that exceed the minimum thinning reportable level of 10% of the nominal thickness. However, these two areas (with remaining ligament of 0.646-in., and 0.666-in.) were analyzed by the UT Level III and were considered pit-like and therefore do not exceed the reportable pitting level of 25% of the nominal thickness. No vertical crack-like indications were detected in Plate #4.

- The nominal thickness of Plate #5 is 0.875-in. Plate #5 results indicate one area that exceeded the minimum thinning reportable level of 10% of the nominal thickness. However, this one area (with remaining ligament of 0.783-in.) was analyzed by the UT Level III and was considered pit-like and therefore does not exceed the reportable pitting level of 25% of the nominal thickness. No vertical crack-like indications were detected in Plate #5.

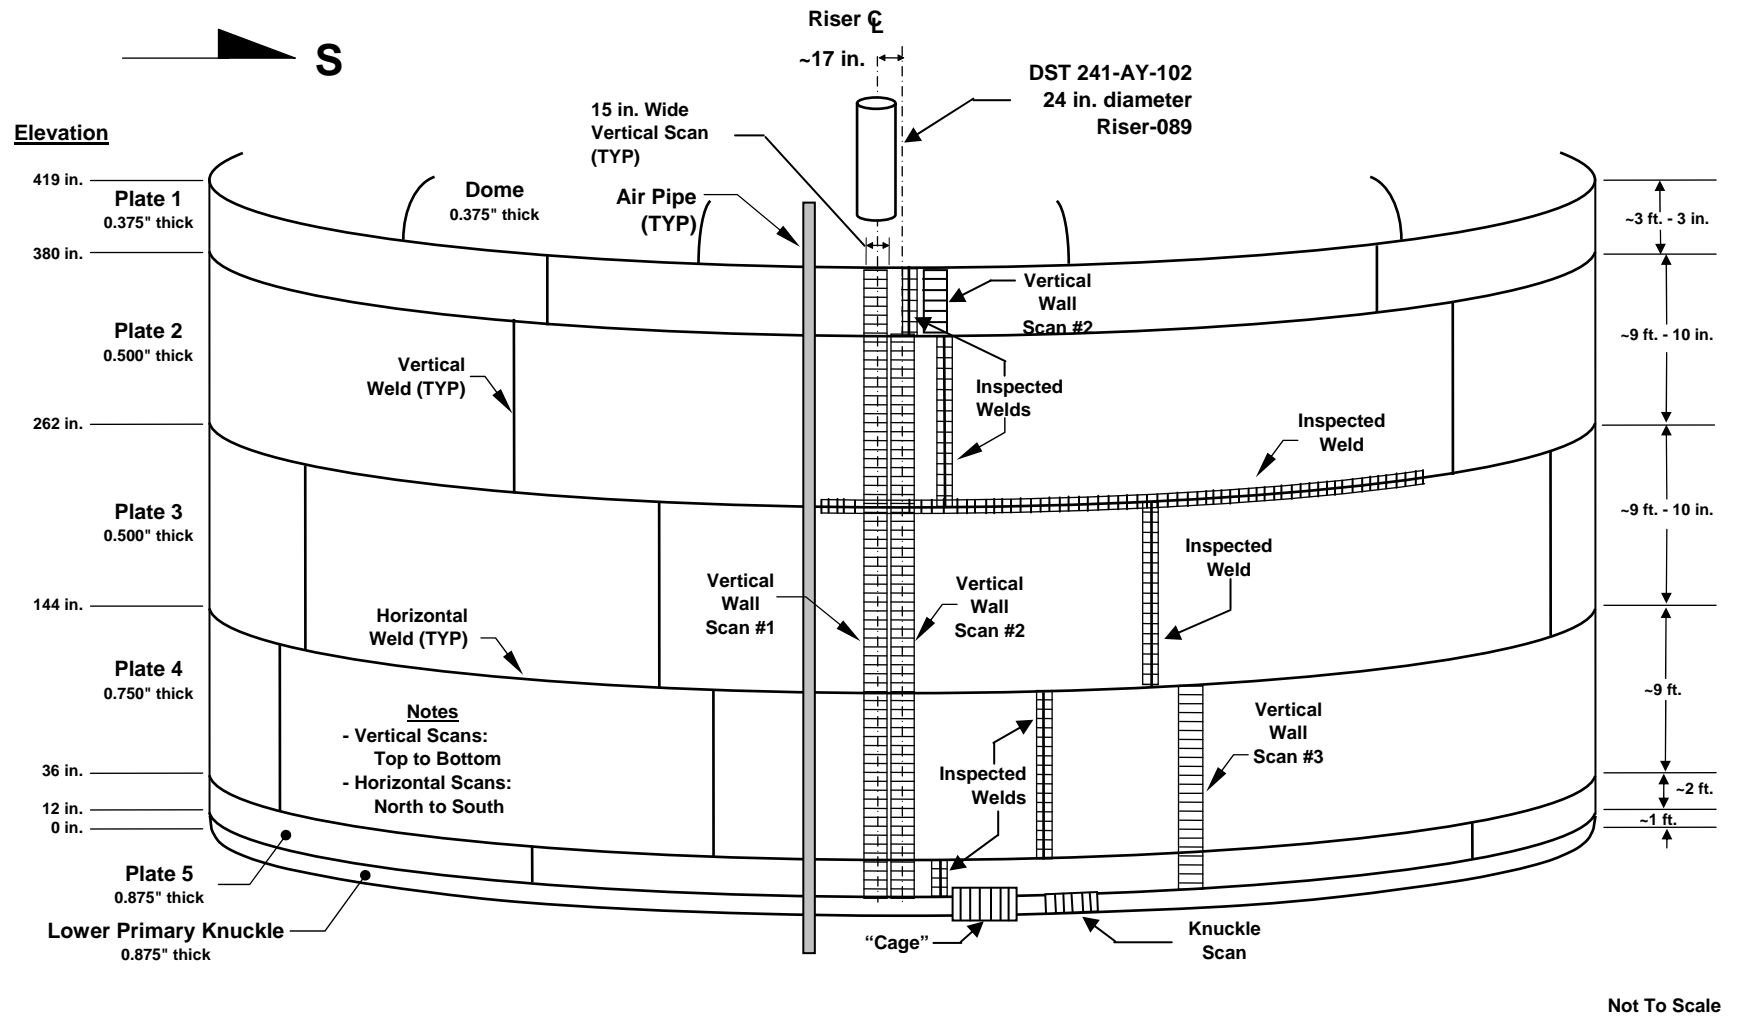
Figure 4.3. Sketch of Scan Paths on Tank 241-AY-102 Primary Tank from Riser 89

Figure 4.3 describes the areas on the primary wall of Tank 241-AY-102 that were ultrasonically examined from Riser 89 located on the west side of the tank. Two 15-in.-wide vertical scan paths were performed on Plates #1, #2, #3, #4, and #5 below the entrance to Riser 89 an additional short scan on Plates #4 and #5 was performed just south of these two. Vertical weld HAZ examinations were done on Plates #1, #2, #3, #4, and #5, and the horizontal weld HAZ examination was done on the Plate #2 to Plate #3 weld. A short section of the knuckle was also scanned from Riser 89.
