# Ultrasonic Examination of Double-Shell Tank 241-AZ-101 Examination Completed July 2007

AF Pardini DR Weier

August 2007

Pacific Northwest National Laboratory Richland, Washington 99352

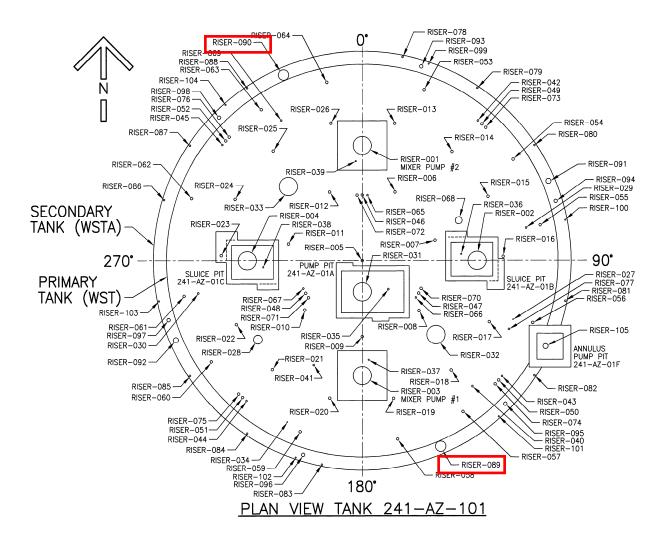
Figure 4.1. UT of Tank 241-AZ-101 Riser 89 and Riser 90

Tank 241-AZ-101 is located in the Hanford 200 East area in AZ Tank Farm. The crawler and associated scanner that hold the transducers were lowered into the 24-in. risers located on the south side (Riser 89) and on the north side (Riser 90) of 241-AZ-101. Figure 4.1 provides a graphic of the location of the risers.
