Technical Letter Report

**Preliminary Assessment of NDE
Methods on Inspection of HDPE
Butt Fusion Piping Joints for
Lack of Fusion**

JCN N6398, Task 2D

May 2008

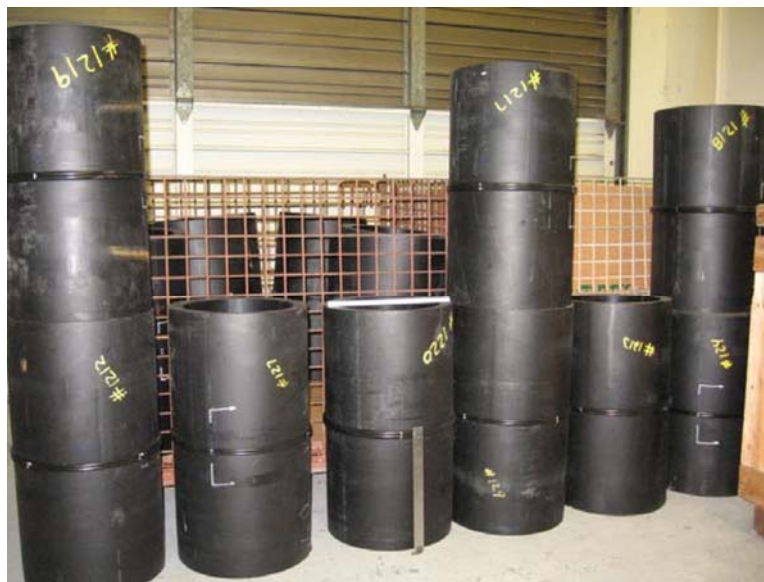
Figure 2.1. Several of the Butt Welded 3408 Pipes are Shown with 12-inch (30.5-cm) Scales on the Center Pipe, One in the Horizontal Direction and One in the Vertical. The pipe assemblies are approximately 2 feet (61 cm) long.

James Craig at McElroy was contracted to heat fuse a series of butt welds in 3408 pipe containing a variety of kissing bond-LOF conditions. This kissing bond or LOF is characterized by contact in the joint between the two compressed surfaces, but there are no or a reduction in the number of molecular ties across the interface. This bond could also be defined as the perfect contact between two surfaces which transmit no shear stress so it is lacking in strength (Brotherhood et al. 2003). Six fusion conditions were selected with the parameters shown in Table 2.3. Four pipes at each condition were made. The sixth condition is the ideal or control condition and is fused according to the ASTM F2620 Procedure (ASTM F2620-06). The other five conditions are expected to produce LOF in the pipe welds. Several of the pipes are shown in Figure 2.1. Each welded section is approximately 2 feet (61 cm) long.

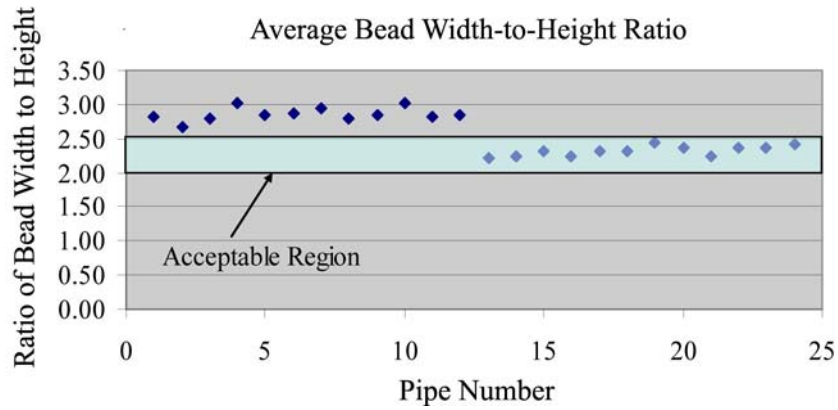
Figure 3.3. Bead Width-to-Height Ratio Comparison for the 24 Fused Pipes

The left and right weld bead widths, total width, and left and right bead heights were measured for the 24 fused pipes at eight positions around the pipe or approximately every 45 degrees. Figure 3.2 shows from left to right, two profiles taken from one pipe in each of the six fusion conditions. The top profile was taken at 0 degree, the print line of the pipe, and the lower profile at 135 degrees. Notice that the beads in conditions 1–3 are smaller than the beads fused with conditions 4–6. The average difference in left and right bead width and height was 0.67 and 0.34 mm, respectively, with no apparent correlation between the good four welds and the other welds expected to contain LOF. Also calculated was the average bead width-to-height ratio, which should be in the 2 to $2\frac{1}{2}$ range. Figure 3.3 shows the results for this calculation for each of the 24 pipes. Joints fused with fusion pressure during the heat cycle, conditions 1–3, were out of bounds in the width-to-height ratio and the beads were smaller in these joints as already mentioned. With fusion pressure during the heat cycle, the weld bead width was approximately 15 percent smaller and the bead height 32 percent smaller than a bead with a normal heat cycle.

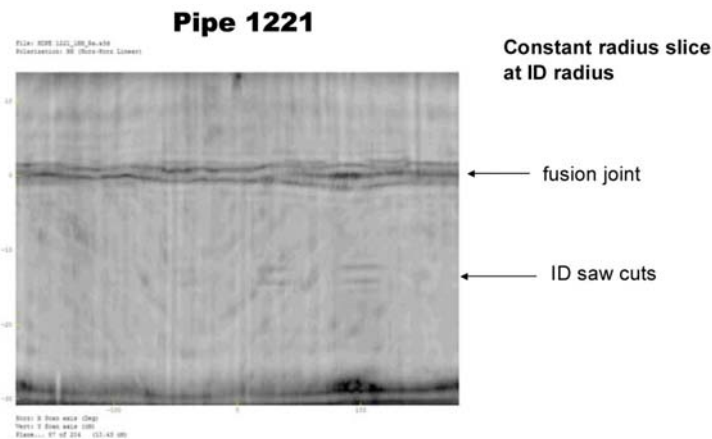
Figure 3.6. Typical U-Band Image Slice at the ID Surface

A U-Band transceiver (40–60 GHz) was implemented because of the need for higher lateral imaging resolution. This system provided for a more promising scenario due to the much higher illumination frequency and higher bandwidth. Figure 3.6 shows a characteristic image slice of one of the pipe samples. The fusion joint is readily seen. However, any defect features are obscured by the outside bead and the geometry of the illumination.

The method of displaying the image of the ID surface showed promise as it shows the shadow of the material variations.

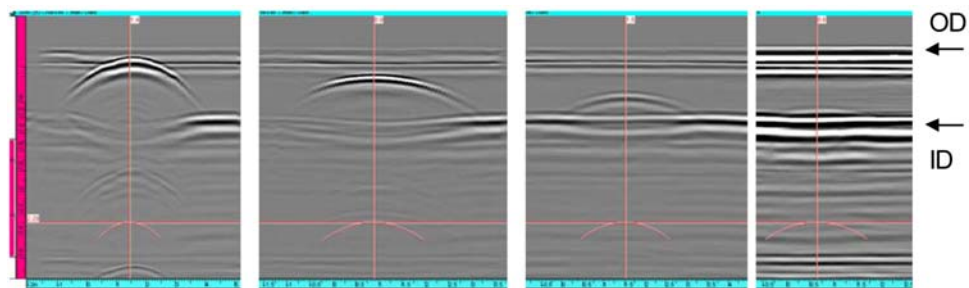
Figure 3.12. PNNL TOFD Results from Four ID-Connected Sawcuts. From left to right the through-wall depths are 75, 50, 25, and 10%.

Responses from the ID sawcuts acquired at 52 dB of hard gain and no additional soft gain are shown in Figure 3.12 for the 75, 50, 25, and 10 percent through-wall deep flaws. These sawcuts were placed in the base material. The 5 percent deep notch was not detected. Note that the deeper two flaws are saturated and greater in response than the lateral wave. The 25 percent deep sawcut is 5 dB lower in amplitude and the 10 percent deep notch is 18 dB lower than full scale at the base gain level of 52 dB. The time or depth (vertical direction) window shown in these sawcut images extends beyond the ID or back wall echo. This allows viewing of mode-converted signals (longitudinal to shear) that can add additional information to the material inspection. This is an area for further investigation.

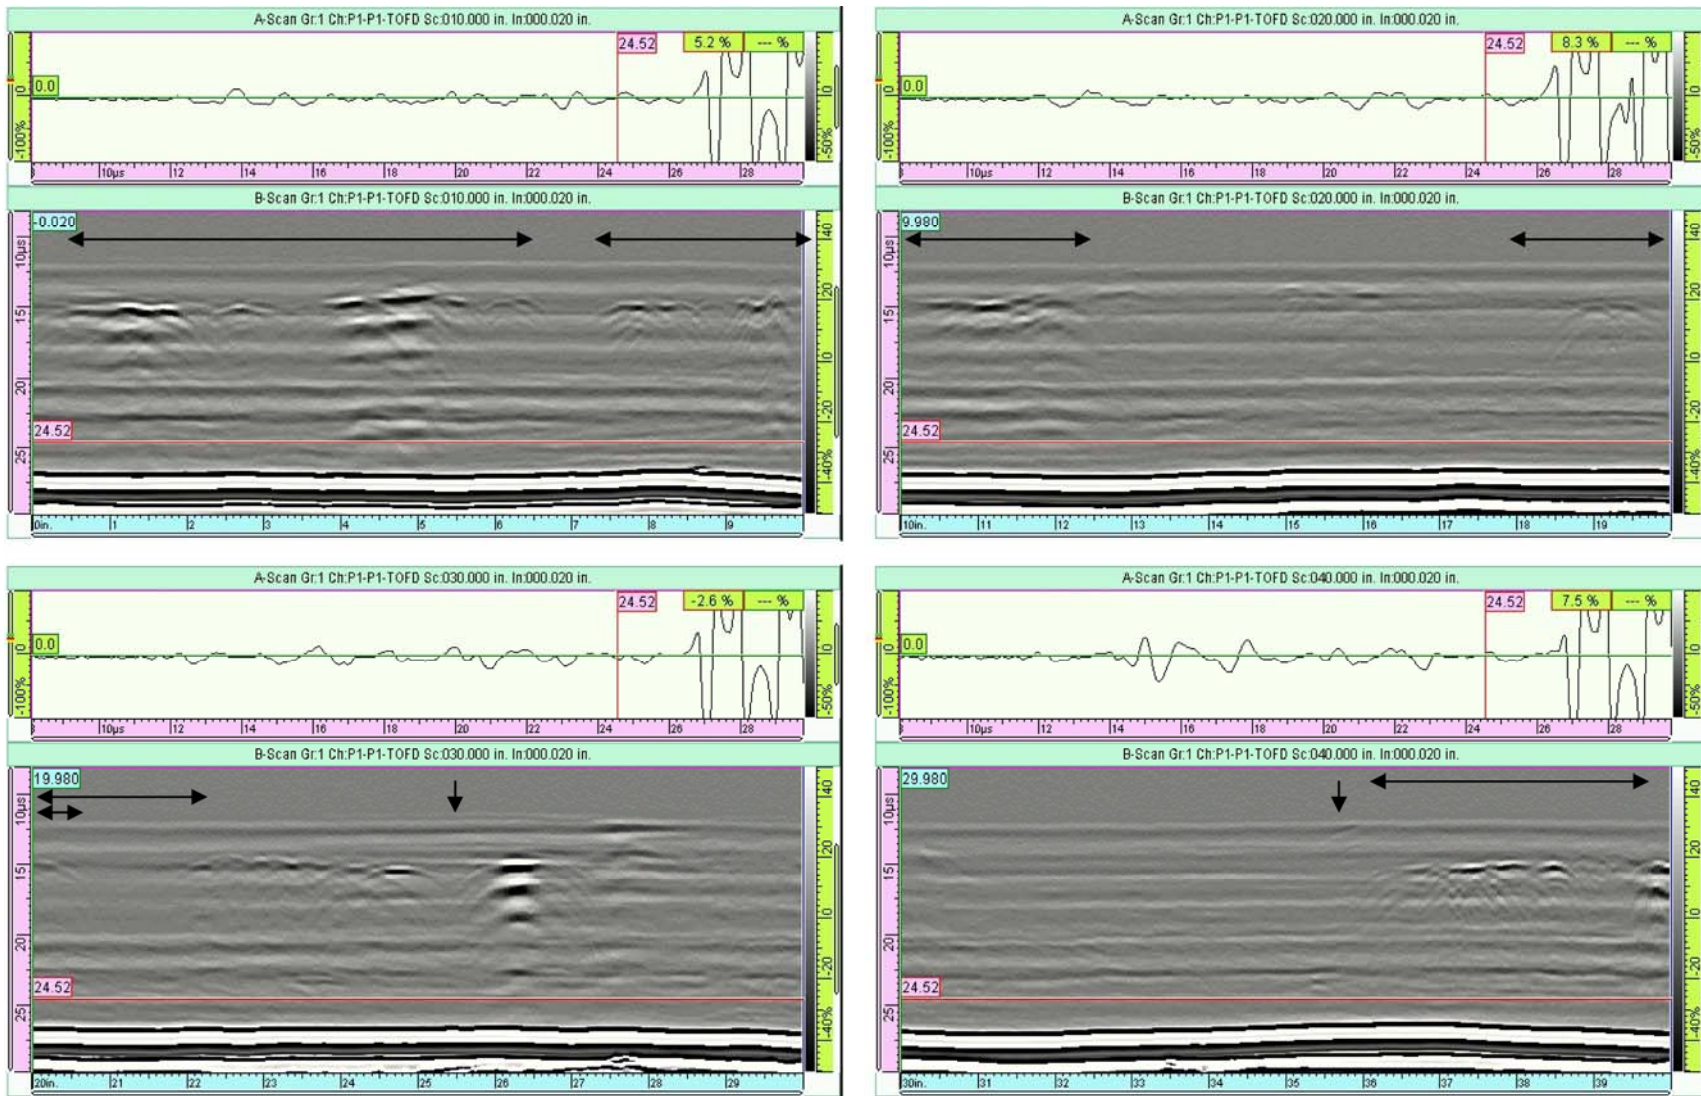
Figure B.5. HDPE Pipe 125, Condition 2

The worst-case condition for pipe fusion, out of the McElroy batch of 24 test assemblies, and the one most likely to produce LOF was condition 2 with fusion pressure during the heat cycle and a 20-second open/close time. One of these pipes was examined with TOFD by PNNL showing results comparable to those presented by Fluor/NDT Innovations, Inc. The data are shown in Figure 3.13 and Figure 3.14 for the four pipe quadrants, with the PNNL data shown in the top of each figure and the Fluor/NDT Innovations, Inc. data at the bottom of each figure. Notice that the PNNL data show the mode-converted signals beyond the longitudinal-wave back wall (ID) echo. The time window was extended to include the slower mode-converted signals with the thought that this additional data would enhance the detection of defects. The Fluor/NDT Innovations, Inc. data images are cropped at the ID and additionally do not have the saturated OD lateral wave signal seen in most TOFD images and in the PNNL data. This results in a cleaner looking image and should provide better near-surface sensitivity to flaws. Fluor/NDT Innovations, Inc. data is also much more sensitive, due most likely to their patented processing of the raw data. Regardless, in this data comparison flaw indications are identified at similar locations by both PNNL and Fluor/NDT Innovations, Inc. Each quadrant represents approximately 10 inches (25.4 cm) of pipe circumference.

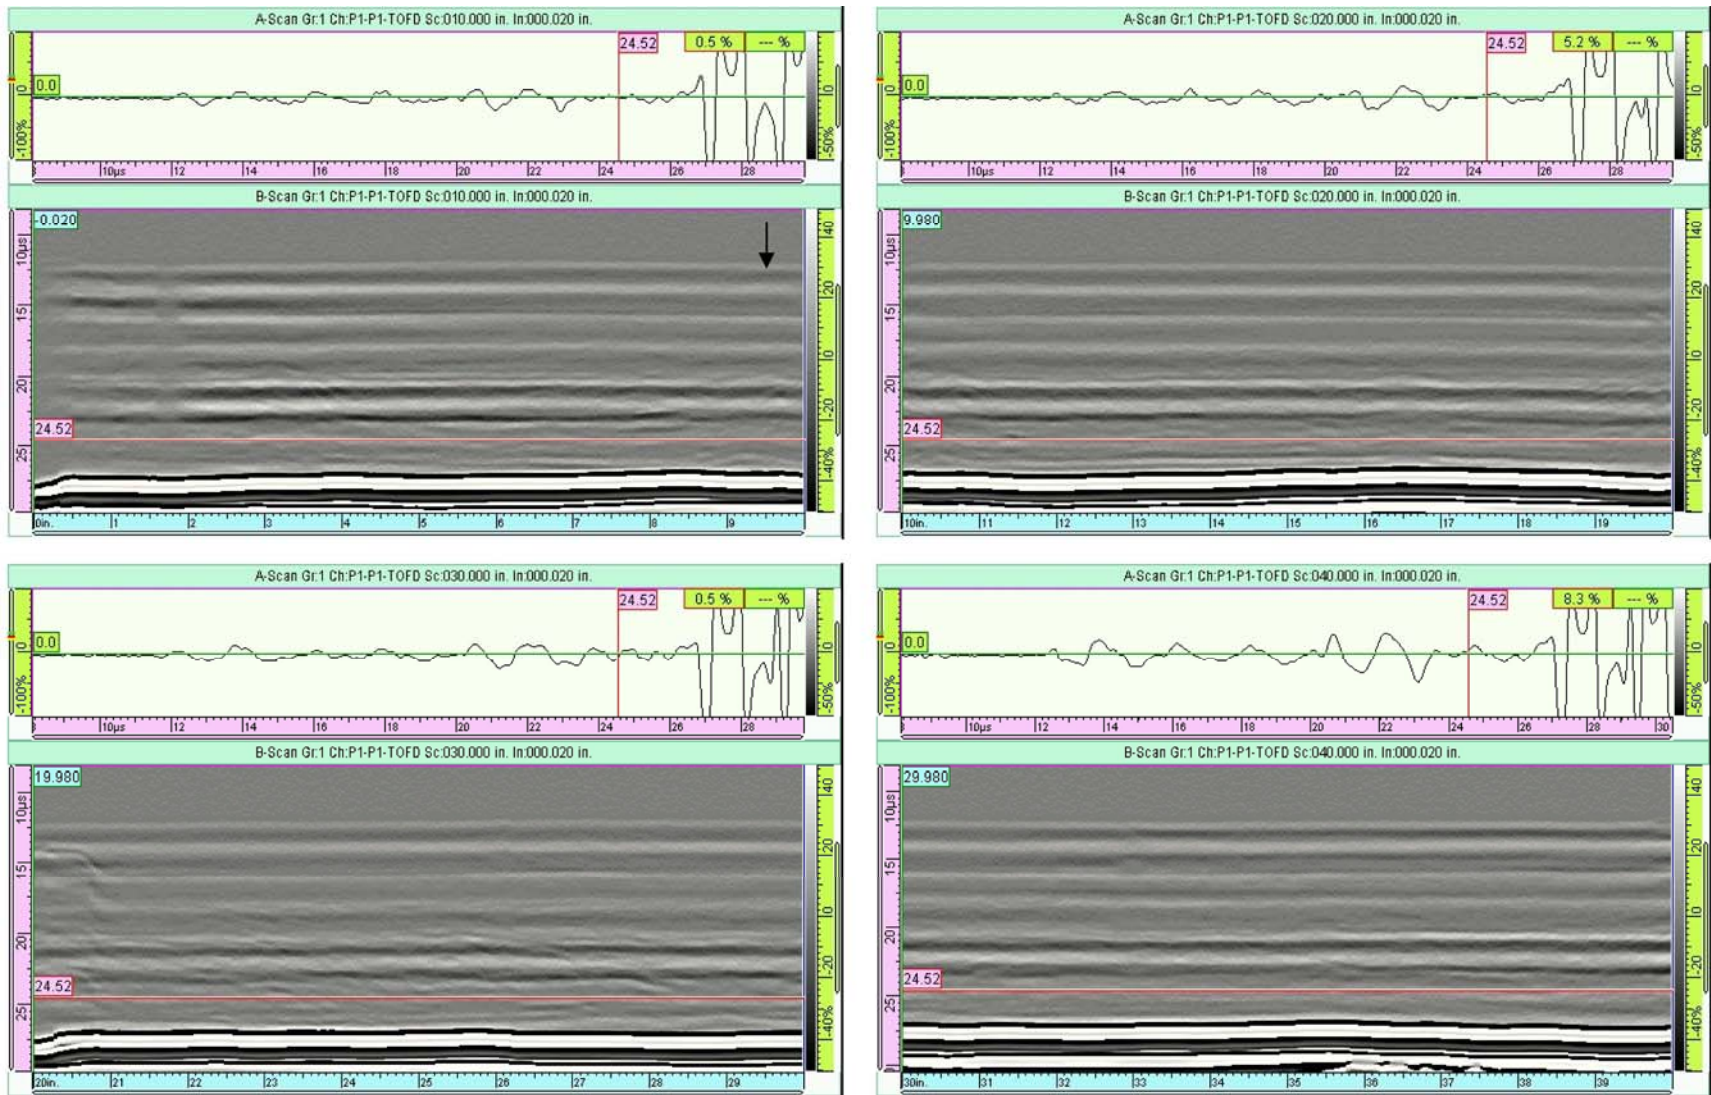
Figure B.24. HDPE Pipe 1224, Condition 6

For comparison a piece of a reportedly good weld was also evaluated. TOFD and PA ultrasonic examinations showed no indications in quadrant four of pipe 1224 at 3 to 4 inches (7.6–10.2 cm). This area was cut out and sectioned. Figure 4.7 shows a slice from this weld at approximately 3.4 inch (8.6 cm). As in pipe 125, streaks of light material due to uneven mixing with the dark carbon black pipe material are evident and make a lack-of-fusion detection from the slice difficult or impossible. The pipe surface after slicing appears to be a better indicator of the weld condition. Figure 4.8 shows the cut surface with no evidence of lack of fusion in the fusion zone.
