PNNL-18747

Evaluation of Fish Passage Conditions for Juvenile Salmonids Using Sensor Fish at Detroit Dam, Oregon

Final Report

January 2010

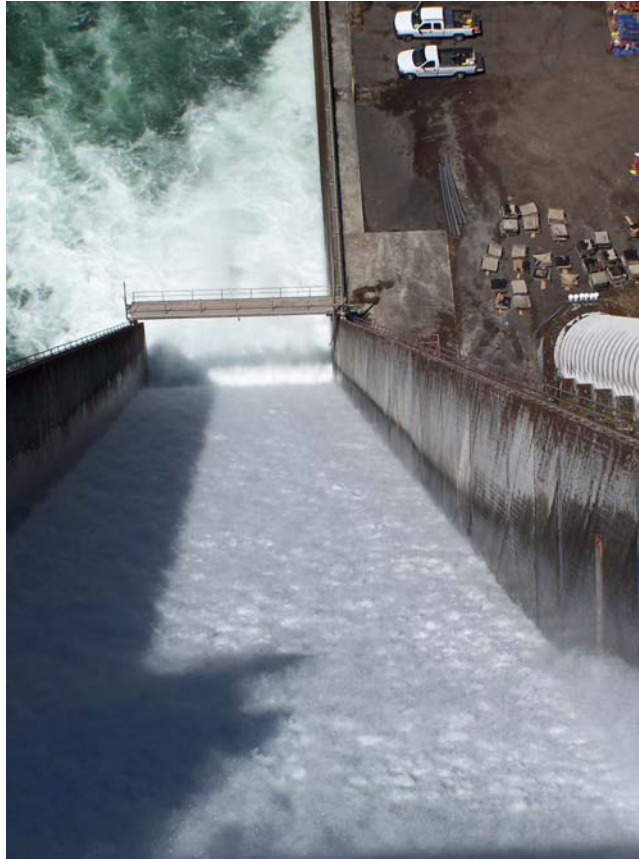
The height and slope of the spillway chute contribute to deleterious exposure conditions observed during the study. Detroit Dam, completed in 1953, is slowly deteriorating due to age. The concrete surface of the spillway is rough from weathering (Figure 4.1), and the descending flow is irregular (Figure 4.2).

Figure 4.2. Spillbay 6 at Detroit Dam showing turbulent flow created on the rough spillway chute.

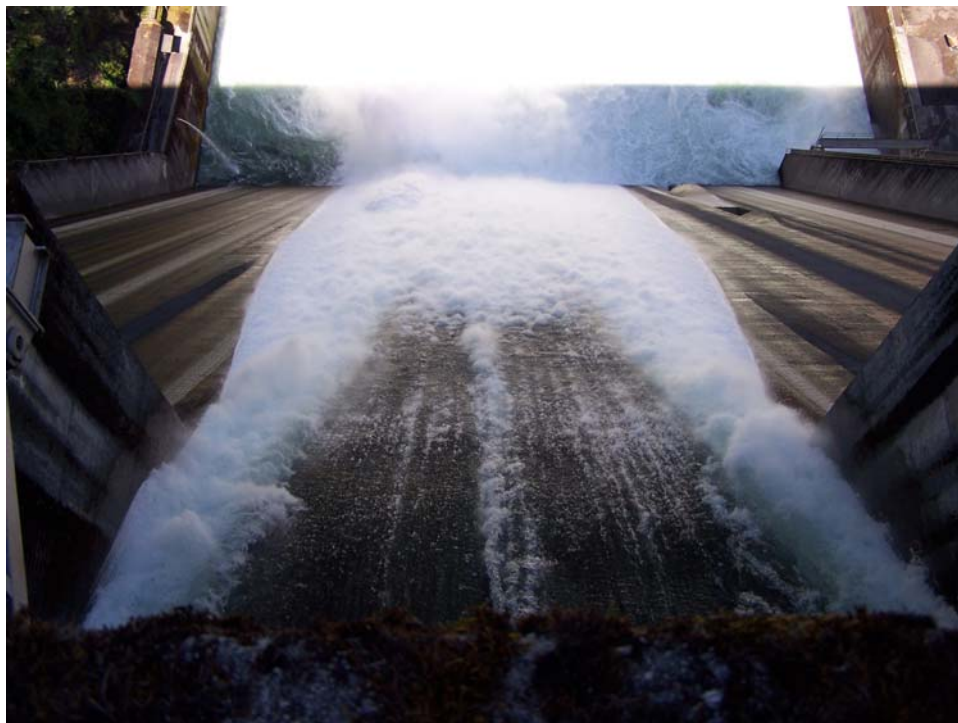
Spillbay 3 has no guidewalls, allowing the spill flow to thin and spread into the adjoining spillbays (Figure 4.3). Flow velocities exceed 150 ft/s before plunging into the stilling basin, often to depths of over 30 ft, at times striking rocks or other unidentified objects.

Figure 4.3. Flow through Spillbay 3 spreads to adjoining spillbays.
