# **Ultrasonic Phased Array Assessment of the Interference Fit and Leak Path of the North Anna Unit 2 Control Rod Drive Mechanism Nozzle 63 with Destructive Validation**

Manuscript Completed: July 2012

S. L. Crawford, A. D. Cinson, P. J. MacFarlan, B. D. Hanson,  
R. A. Mathews

Pacific Northwest National Laboratory  
P.O. Box 999  
Richland, WA 99352

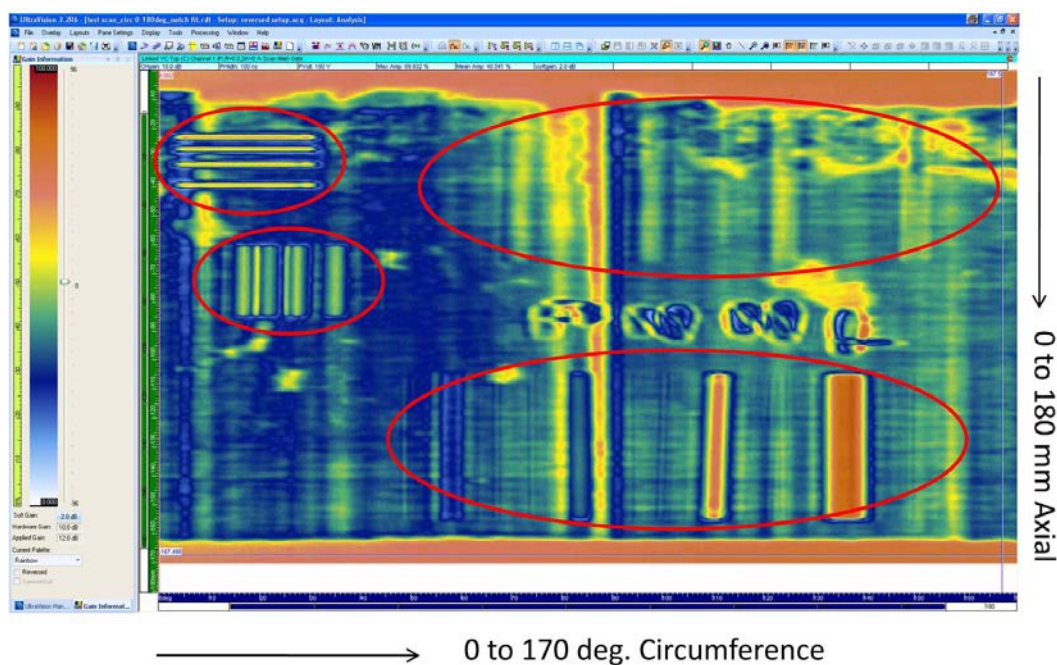
The machined notches in the Alloy 600 tube of the CRDM nozzle mockup simulated air gaps between the penetration and the RPV head that could arise from cracking of the penetration. The notched area shown in Figure 4.4 was scanned over approximately a 0 to 170 degree range in the circumferential direction (horizontal axis) and 0 to 180 mm (7.1 in.) in the axial direction (vertical axis) with the data image shown in Figure 4.10. This top view, plan view, or C-scan image shows the resolution notches in the upper-left portion of the image. The variable depth and width notches are also seen as well as the letters “PNNL.” The color scale is displayed on the left with lowest amplitudes at the bottom represented by white and the highest amplitude at the top of the color bar represented by red. In this pulse-echo data, the low amplitude signals (blue and green) indicate good transmission or low reflection of the ultrasonic energy at the interface of the tube to the low-alloy steel. Conversely, the high-amplitude signals

(yellow and red) represent poor transmission or large reflection at the interface. A large reflected signal would be generated at a tube-to-air interface as would be seen above and below the interference fit region or in the presence of a notch with large enough dimensions. The system gain level was selected to produce a strong but not saturated response from the largest notch. A full-screen height (FSH) value of approximately 97%, from a possible range of 0 to 100%, is ideal and allows for mapping of the ultrasonic responses over the entire system dynamic range.

**Figure 4.10 Top View, Plan View, or C-scan Ultrasonic Image of the Upper Interference Fit Region Containing Calibration Notches in the Alloy 600 Tube. Calibration notches are circled.**

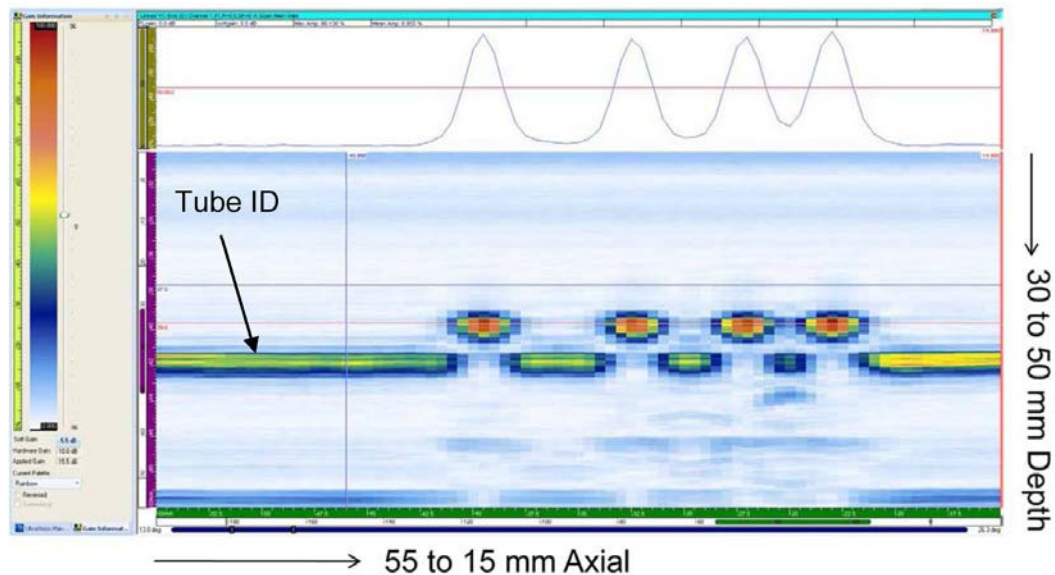
The data analysis software allowed electronic gating of signals in the time or depth dimension as well as positional dimensions Z and theta (axial and circumferential, respectively). The axial resolution notches were first gated or selected for analysis. An enlarged D-scan end view, as depicted in Figure 4.11 was used to measure the center-to-center spacing of the notches. This image was taken as viewed from the left edge of the image in Figure 4.10 and depicts depth into the material (along the sound path) in the vertical axis and the scanner index or nozzle axial direction in the horizontal axis. From this end view, an “echodynamic” curve or profile was generated along the red horizontal line drawn through the responses from the notches, and was plotted above the image. The measured notch widths, from left to right, as measured at the half-amplitude points, were 2.0, 2.0, 2.5, and 2.5 mm (0.08, 0.08, 0.10, and 0.10 in.), respectively. This represents only 4 or 5 pixels with each pixel equal to 0.5 mm (0.02 in.). The actual notch widths were 2.08, 2.06, 2.16, and 2.11 mm (0.082, 0.081, 0.085, and 0.083 in.), respectively. Notch depths were measured as 2.06, 2.06, 2.03, and 2.03 mm (0.081, 0.081, 0.080, and 0.080 in.), respectively. Actual depths were 2.06, 1.95, 2.00, and 2.00 mm (0.081,

0.077, 0.079, and 0.079 in.), respectively. The data suggested that gaps created by cracks as small as approximately 1 mm (0.04 in.) in depth could be accurately sized. Also, the notches could be clearly distinguished from each other, providing an indication of lateral probe resolution in the nozzle axial direction. In this set of notches, the actual center-to-center separations were 7.11, 5.08, and 4.06 mm (0.28, 0.20, and 0.16 in.), respectively. The measurements from the ultrasonic data gave separations of 7.0, 5.5, and 4.0 mm (0.28, 0.22, and 0.16 in.), respectively. These highly correlated data values and the data image indicated that an axial resolution of better than 4.0 mm (0.16 in.) was achievable.

**Figure 4.11 D-scan End View of the Axial Resolution Notches in the Alloy 600 Tube**

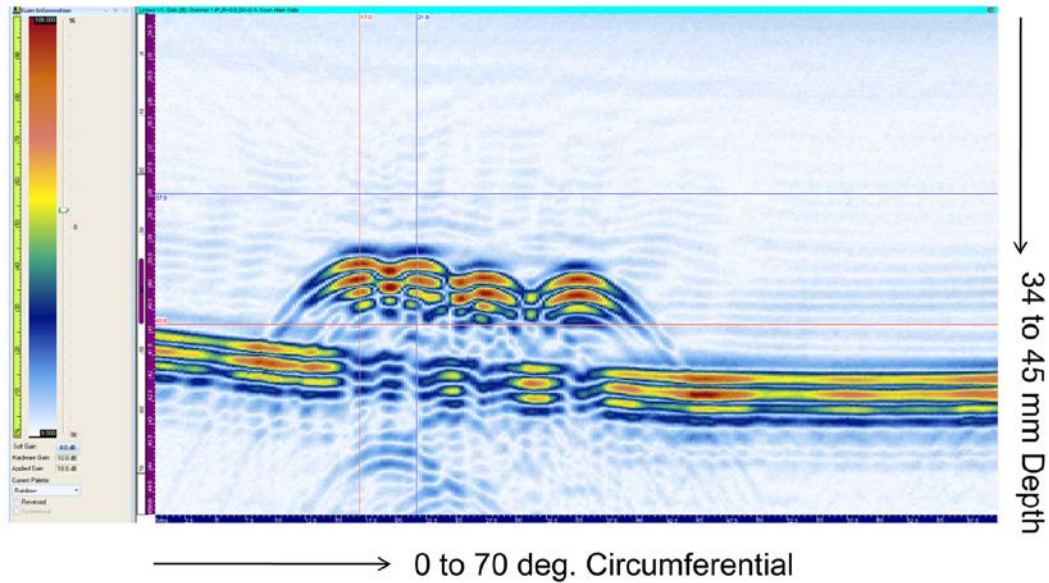
The gated circumferential resolution notch set is shown in Figure 4.12. This image was taken as viewed from the bottom edge in Figure 4.10. Notice that the closely spaced two notches on the left are overlapping but they are still resolvable. Peak-to-peak values gave measured notch separations of 4.36, 5.18, and 6.82 mm (0.17, 0.20, and 0.27 in.), respectively. The actual separations were 4.06, 5.08, and 7.11 mm (0.16, 0.20, and 0.28 in.), respectively. This is greater error than was observed for the axial direction. This test demonstrated a circumferential probe resolution of approximately 4.4 mm (0.17 in.).

**Figure 4.12 B-scan Side View of the Circumferential Resolution Notches in the Alloy 600 Tube**

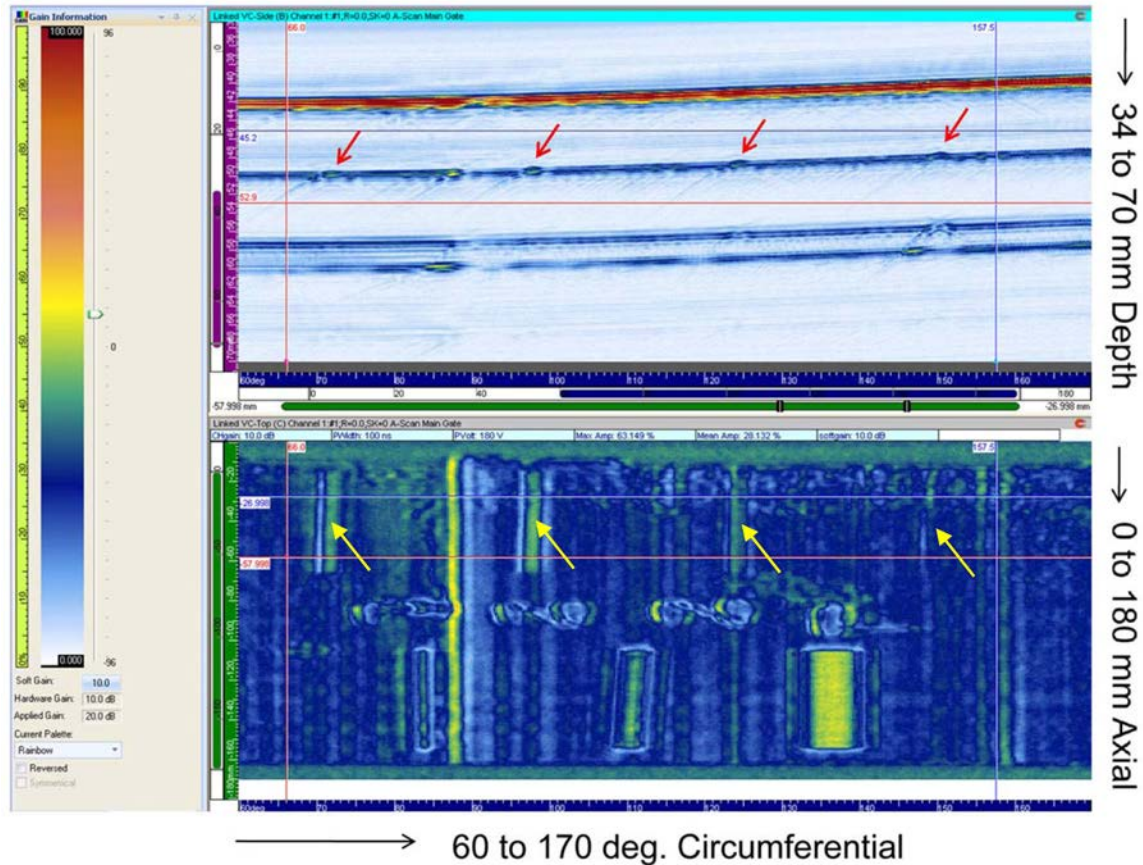
The set of notches in the upper right portion of the scanned image in Figure 4.10 varied in depth but had constant width. These very shallow notches were recognized because their shape and location were known, but they could have been missed based on amplitude response alone. Machining marks on the tube as well as variations in the interference fit produced a non-uniform background response for the fit region, complicating the detection. The center-to-center separations of these notches as ultrasonically measured were 23.84, 24.29, and 23.61 mm (0.939, 0.956, and 0.930 in.), respectively, whereas the actual spacing was 25.4 mm (1.0 in.) between each notch. Notch depth information was not discernible in the first interference fit echo, but the second echo gave some indication of a notch tip as noted by the red arrows in the upper part of Figure 4.13. This image represents the B-scan side view of the data while the lower image is a C-scan top view. A higher inspection frequency could have better resolved the small depth variations in these notches. The current second-echo ultrasonic data showed an approximate depth of 0.15 mm (0.006 in.) for all four notches, whereas the actual depths were 0.028, 0.051, 0.76, and 0.13 mm (0.001, 0.002, 0.003, and 0.005 in.), respectively. While these very shallow notches each presented a discontinuity that was ultrasonically detected, their depths were below the system depth or range resolution. For a greater than 50% bandwidth probe, the range resolution is on the order of one wavelength, which in Alloy 600 is approximately 1.1 mm (0.043 in.) at a 5-MHz inspection frequency.

**Figure 4.13** The Second Echo is Gated in the Side View Image in the Top of Figure with the Horizontal Lines. The corresponding C-scan top view is displayed in the bottom image. This second echo captures a disturbance in the back-wall echo showing some depth information, noted by the red arrows at top. The yellow arrows note the depth-varying notches.

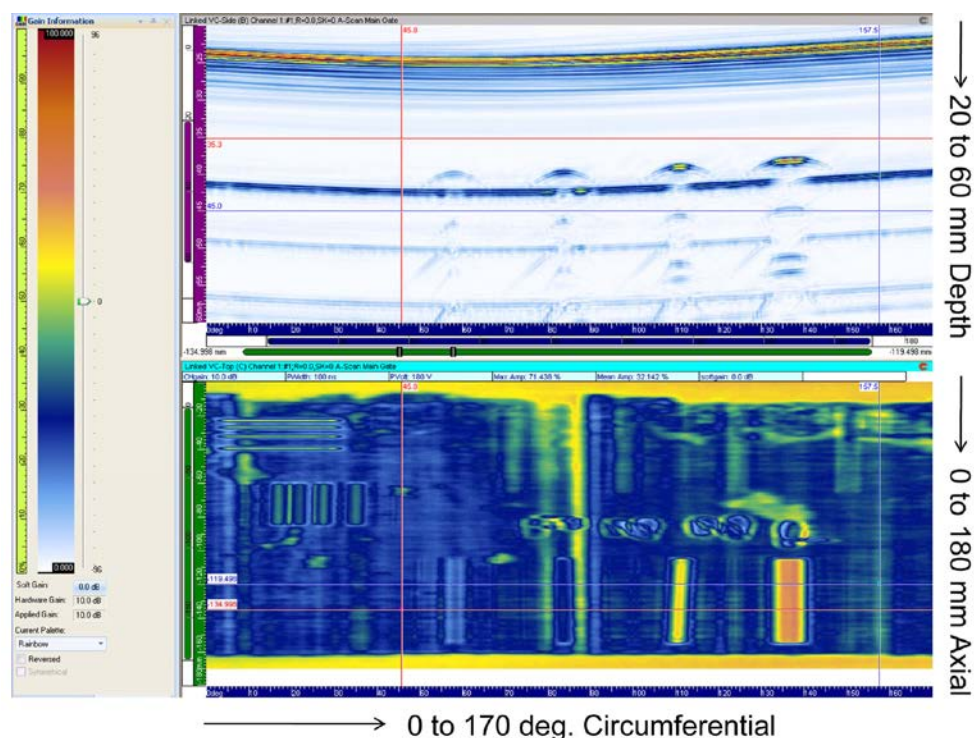
The final set of notches contained width variations and are shown in Figure 4.14. These notches were ultrasonically measured with depths of 2.2, 2.5, 2.7, and 2.9 mm (0.09, 0.10, 0.11, and 0.11 in.), respectively, left to right in the image, while the actual depth was 2.53 mm (0.10 in.) for all notches. The measured center-to-center spacings were 23.1, 24.8, and 23.8 mm (0.91, 0.98, and 0.94 in.), respectively, while actual spacings were all 24.5 mm (1.00 in.). Finally, the widths of the notches were measured in two ways. The first method used the width of the upper part of the notch response, and the second method used the width of the loss of back-wall signal. The loss of back-wall signal technique was more accurate with measured widths of 3.91, 3.36, 5.00, and 8.82 mm (0.099, 0.126, 0.154, and 0.298 in.), respectively. Actual widths were 0.80, 1.61, 3.24, and 6.42 mm (0.031, 0.063, 0.127, and 0.253 in.), respectively. When measured from the second ultrasonic back-wall echo, the loss of signal measurements gave notch widths of 1.36, 2.73, 3.82, and 7.00 mm (0.054, 0.107, 0.150, and 0.276 in.), which were closer to the actual values. The probe spot size when focused at the interference fit, or 15 mm (0.59 in.) into the Alloy 600, was modeled at  $1.2 \times 1.2$  mm ( $0.047 \times$

0.047 in.) at the  $-6$  dB points. Notch width sizing values are typically oversized by the probe spot size so these measured width values were well within the error expected with this probe.

**Figure 4.14 B-scan Side View on Top and C-scan Plan View on Bottom of the Width Varying Notches in the Inconel Tube**

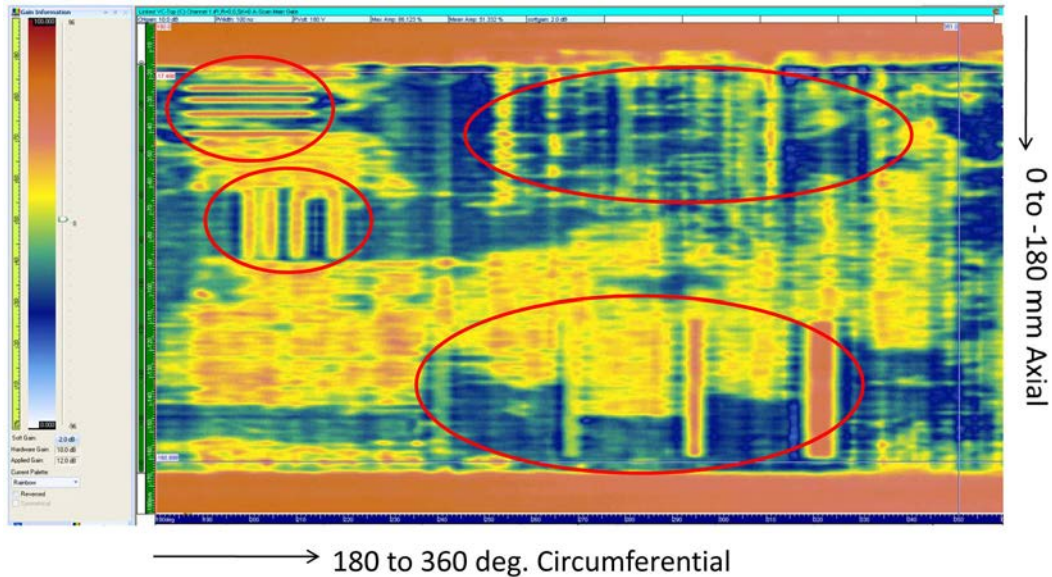
**Figure 4.15 C-scan Plan View of the Notches in the Low-Alloy Steel from the First Ultrasonic Echo. The calibration notches are circled.**

The axial resolution notches in the top left of Figure 4.15 were resolved, but the lower notch was on the edge of a high-amplitude region. The measured center-to-center spacings were 3.90, 4.58, and 6.88 mm (0.15, 0.18, and 0.27 in.), respectively, while actual spacings were 4.06, 5.08, and 7.11 mm (0.16, 0.20, and 0.28 in.), respectively. Axial resolution was therefore approximately 4 mm (0.16 in.) or better.

Measurements from the circumferential resolution notch pattern showed center-to-center spacings of 3.82, 5.00, and 7.54 mm (0.15, 0.20, and 0.30 in.), respectively, with actual spacings of 4.06, 5.08, and 7.11 mm (0.16, 0.20, and 0.28 in.). Circumferential resolution was also approximately 4 mm (0.16 in.) or better.

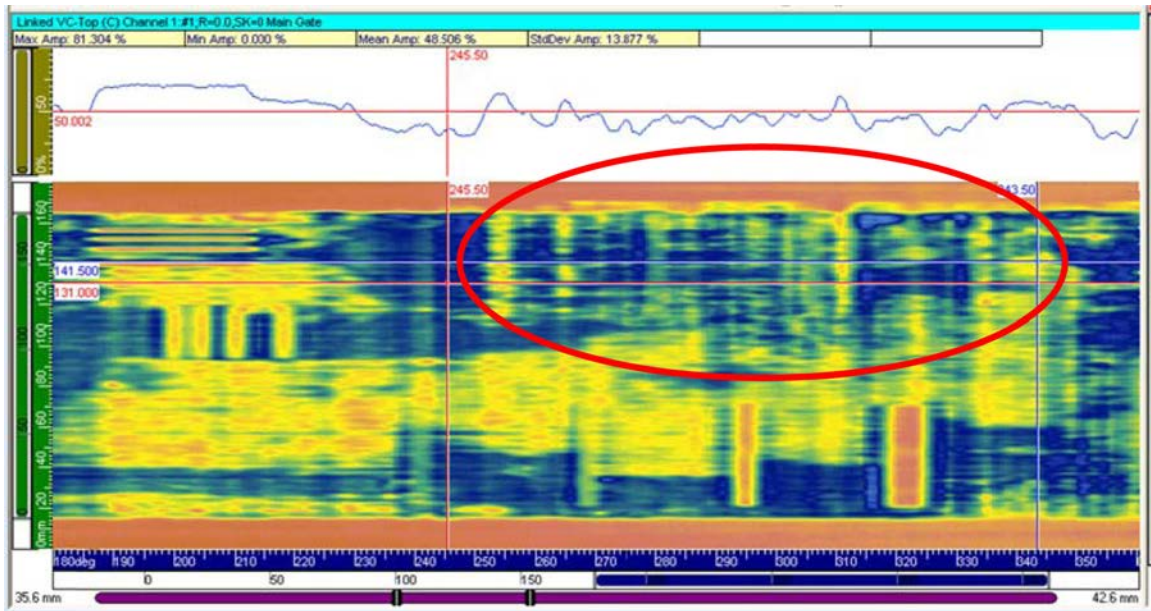
The variable depth notches in the top right of Figure 4.15 were detected but depths could not be measured. First and second echo images are shown in Figures 4.16 and 4.17, respectively. Center-to-center spacing was ultrasonically measured at 23.9, 22.4, and 24.4 mm (0.94, 0.88, and 0.96 in.), respectively, with an actual spacing of 25.4 mm (1.00 in.) for all notches.

**Figure 4.16 C-scan Plan View of the Depth Notches in Low-Alloy Steel, Circled on the Upper Right. This image was acquired from the first ultrasonic echo.**

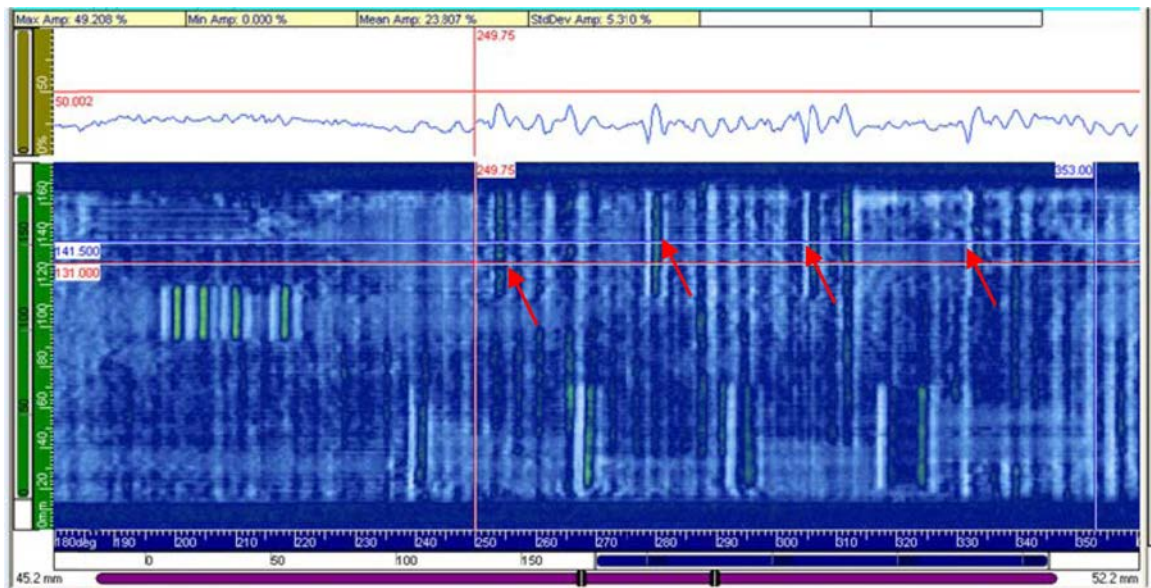
**Figure 4.17 C-scan Plan View of the Depth Notches in Low-Alloy Steel, Noted by Red Arrows on the Upper Right. This image was acquired from the second ultrasonic echo.**

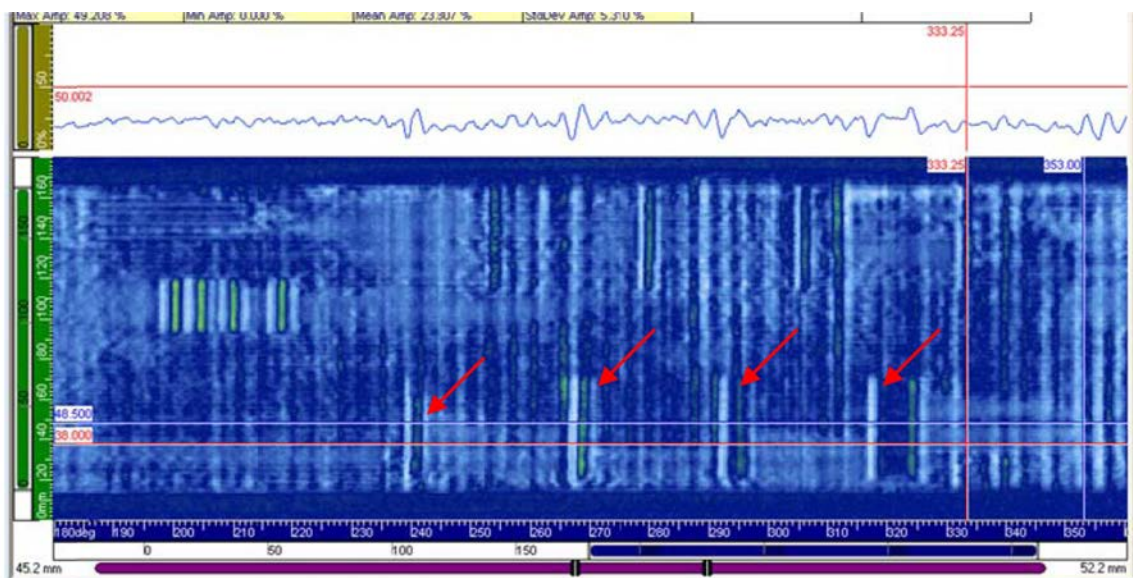
The set of notches with variable widths is shown in Figure 4.18 with the notches marked by red arrows at the bottom of the image. This image represents the second echo. The center-to-center spacing measurements were 25.4, 23.2, and 25.0 mm (1.00, 0.91, and 0.98 in.),

respectively, left to right, with actual spacing of 25.4 mm (1.00 in.). Measured notch width values were 1.82, 2.27, 4.27, and 6.82 mm (0.072, 0.089, 0.168, and 0.268 in.), respectively, with actual values of 0.80, 1.59, 3.18, and 6.39 mm (0.032, 0.062, 0.13, and 0.25 in.), respectively. The notch widths were also measured from the first echo (refer to Figure 4.15, a first ultrasonic echo image) with slightly poorer results.

**Figure 4.18 C-scan Plan View of the Width Notches in Low-Alloy Steel, Noted by Red Arrows on the Bottom. This image was acquired from the second ultrasonic echo.**

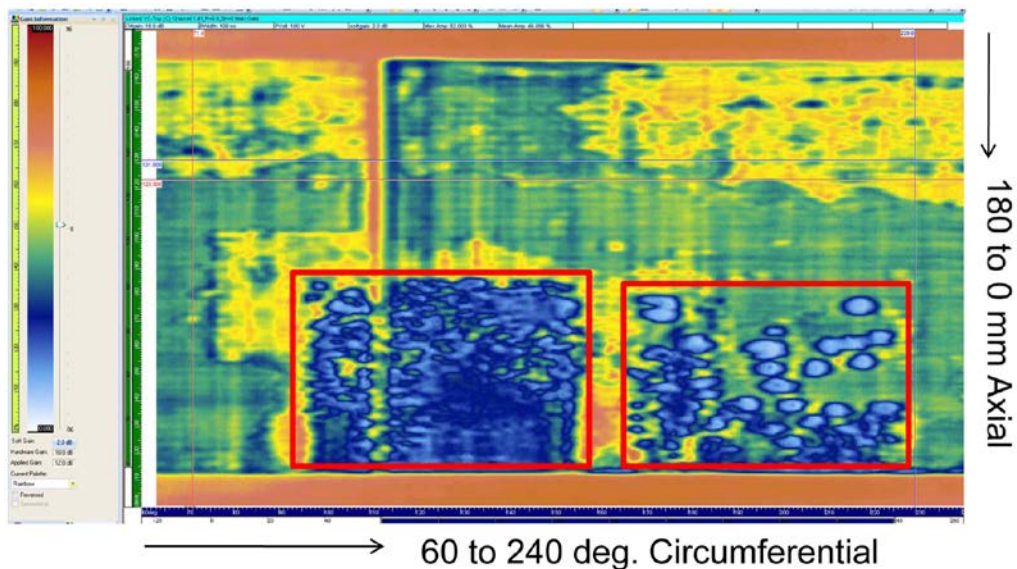
The top view, C-scan images from the mockup with boric acid deposits in the interference fit region between the tube and low-alloy steel block are displayed in Figures 4.19 and 4.20. The first image represents the 60 to 240 degree circumferential region and the second image represents the 240 to 60 degree circumferential region, both as captured by the first echo. The boric acid regions were readily detected as lower amplitude response relative to regions with no boric acid and are outlined with red boxes. Again, notice machining marks and non-uniformity in the interference fit response. The snake path scratched into a boric acid region as visually

shown in Figure 4.3 was not evident in the ultrasonic data. Likely, the pattern was not preserved during the mockup assembly.

**Figure 4.19 C-scan Plan View of the Boric Acid Deposits, Boxed in Red, in the Lower Interference Fit Region. The horizontal axis represents the circumferential range of 60–240 degrees. This image is from the first ultrasonic echo.**

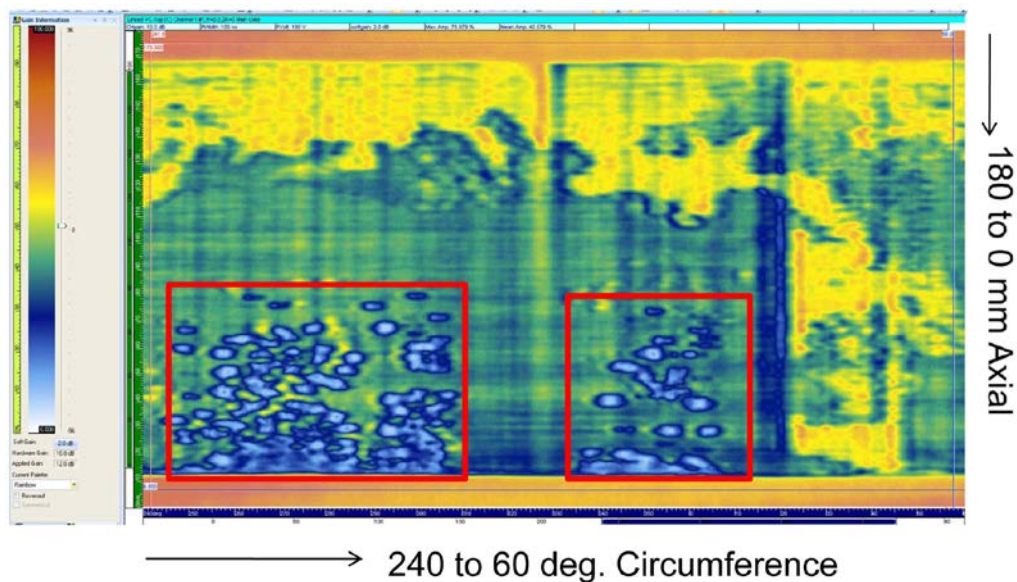
**Figure 4.20 C-scan Plan View of the Boric Acid Deposits, Boxed in Red, in the Lower Interference Fit Region. The horizontal axis represents the circumferential range of 240–60 degrees. This image is from the first ultrasonic echo.**

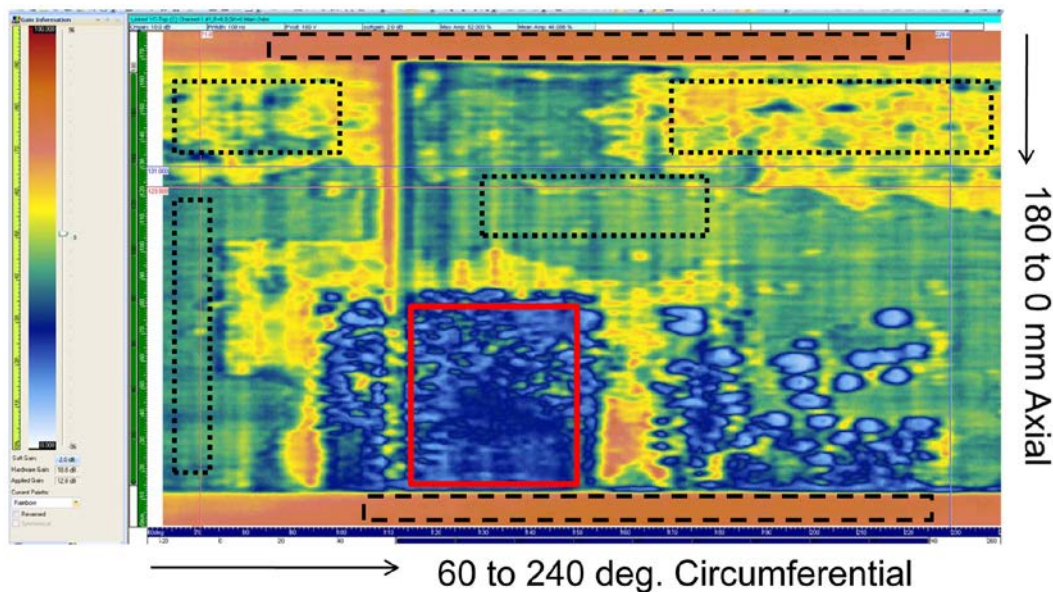
**Figure 4.21 The Interference Fit Region Containing Boric Acid is Subdivided into Three Regions. The red box represents the presence of boric acid in the interference fit region, the black dashed boxes represent the tube-to-air interface region, and the black dotted boxes represent the nominal interference fit region.**

The data images were analyzed with a total image gain of 12 dB. This represented 10 dB of hard gain applied during acquisition and 2 dB of soft gain applied during analysis. The mean responses from the nominal interference fit regions without boric acid deposits between the tube and low-alloy steel block were in the range of 40 to 55 percent of FSH. This range of values

was due to the variability in the fit itself, likely caused by out-of-roundness of the tube or hole in the block. Some regions of the fit were tight, giving lower reflected amplitude and more transmitted energy. This condition is represented by the green color in Figure 4.21. Other regions of the nominal fit with no boric acid showed higher reflected energy indicating less intimate contact, thus less transmitted energy, and this state is represented by the yellow-to-orange colors in Figure 4.21. Machining marks were evident and also lead to response variability. Additionally, the Alloy 600 tubes are known to have hard spots, which could transmit or scatter ultrasonic energy differently than the nominal material. The mean responses of the interference fit regions with boric acid deposits between the tube and low-alloy steel block were in the range of 24 to 30 percent range of FSH. This shows more energy transmitted (less reflected) through the interference fit region with the presence of boric acid than in the regions without boric acid. The boric acid crystals filled gaps in the fit and efficiently coupled the ultrasonic energy from the tube into the low-alloy steel material. Finally, the mean responses of the tube-to-air regions above or below the interference fit were 60 to 75 percent of FSH, demonstrating greater reflectance of energy compared to the interference fit. In summary, these data from the mockup showed that the ultrasonic system could distinguish the condition of the interference fit, whether the nominal state, with boric acid deposits, or an air gap, by their mean ultrasonic response.

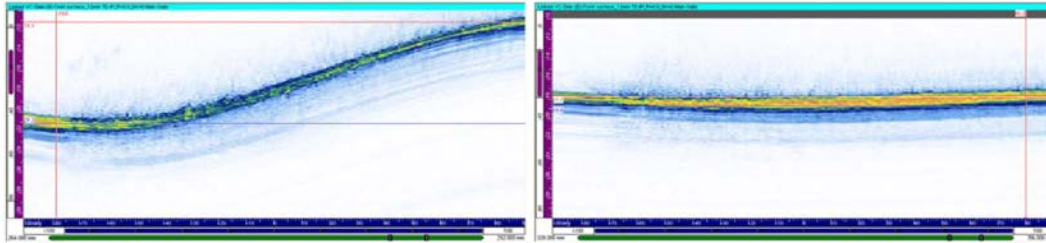
Before the start of a scan, the probe was manually lowered to the bottom of the interference fit region and the data were collected while indexing the probe upwards. Two data channels were recorded during acquisition—one with a focus at the front surface (1 mm or 0.04 in. within the Alloy 600 material) and the other focused at the interference fit interface (15 mm or 0.59 in. within the Alloy 600 material). The front surface reflection represented the interface between the water inside the tube and the Alloy 600 tube inner diameter (ID), and provided an indication of the surface condition of the tube. This data would reveal bubbles, pitting, and other surface anomalies, if present. The second data channel recorded the reflection from the interface between outer diameter (OD) of the Alloy 600 tube and the low-alloy steel RPV head material, and represented the interference fit region. The first coarse scan data showed the need to laterally adjust the scanner to more accurately center the phased-array probe in the nozzle. Results from data acquired towards the top of the tube before and after centering the scanner are displayed in Figure 5.1. The horizontal axes in each image represent a circumferential distance from  $-90$  to  $+90$  degrees. The vertical axes represent approximately 20 mm (0.79 in.) of travel in depth or distance from the probe. Before centering the scanner, the front surface signal travel or difference from high to low point was measured at 10 mm (0.39 in.) on the left

**Figure 5.1 Alloy 600 Tube ID Response Before (left) and After (right) Centering the Scanner on the Nozzle. The horizontal axis represents approximately 180 degree and the vertical axis 20 mm (0.79 in.).**

image. After centering, the signal travel was only 1 mm (0.04 in.) with the data displayed on the right of Figure 5.1. In addition to showing that the probe was centered, the coarse scans also verified that the areas of interest were captured in the data file.

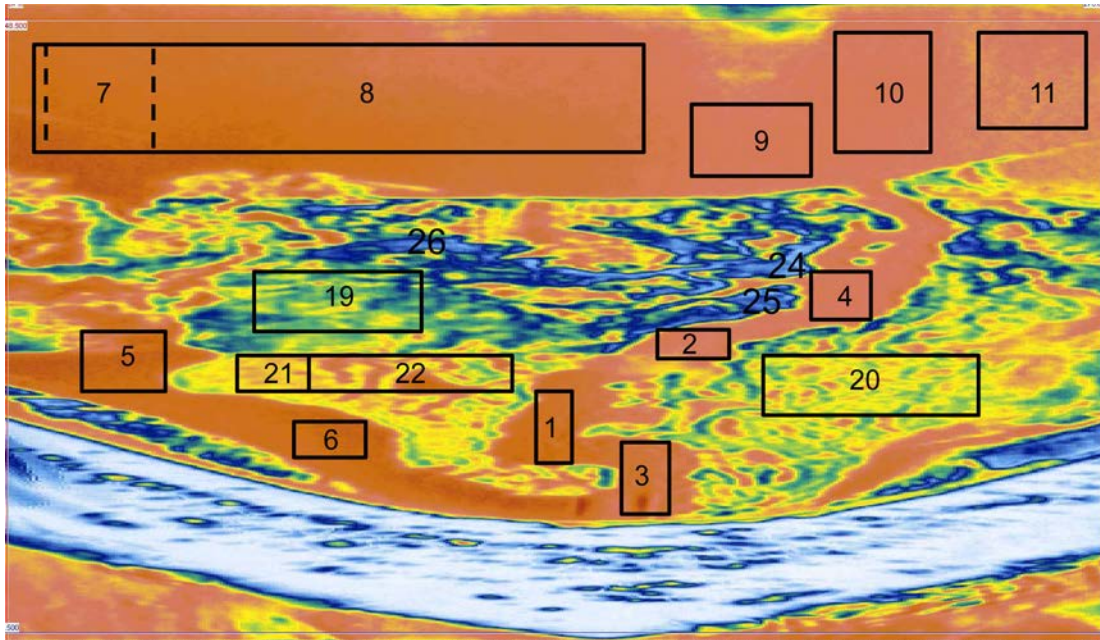
Based on the results from the mockup, the image in Figure 5.3 was interpreted to suggest that regions of nominal interference fit between the nozzle penetration and the RPV head would appear green or yellow, that boric acid deposits would appear as blue, and leakage paths and regions above or below the interference fit would appear orange. An analysis was performed to compare the amplitude responses for the Nozzle 63 interference fit to those of the mockup. The first such analysis was conducted on the 90 to 270 degree data acquired after the first brushing. The image was segregated into regions as depicted in Figure 5.4. The peak and mean amplitude responses were measured in each boxed region. Regions 1 through 6 are suspected air gaps or leakage paths in the interference fit between the penetration and RPV head. Regions 7 through 11 represent the response from the tube-to-air interface above the interference fit. The nominal interference fit and lower counter bore areas are represented by regions 19 through 22 while regions 24 through 26 represent the interference fit with suspected boric acid present between the penetration and the RPV head. The same procedure was used on the -90 to +90 degree data with the numbered boxed regions shown in Figure 5.5. Next, the mean amplitudes within each boxed region were plotted with results in Figure 5.6. The

suspected leakage path and tube-to-air responses all were in the range of 60 percent of FSH and greater. The regions with suspected boric acid deposits had mean amplitudes 25 percent and below. Finally, the interference fit/counter bore region mean amplitudes were in the 41 to 58 percent range. A proposed segregation of the regions is denoted by the orange, green, and blue colored zones in the plot. A 30 percent mean amplitude or less was thought to indicate the presence of boric acid in the interference fit while greater than 60 percent was thought to represent an air gap and possible leakage path if connected all the way through (top to bottom) the interference fit.

**Figure 5.4 Interference Fit Data Image After First Brushing. The horizontal axis represents approximately 90 to 270 degrees. The vertical axis represents 360 mm (14.17 in.). Boxed regions were used in an amplitude analysis.**

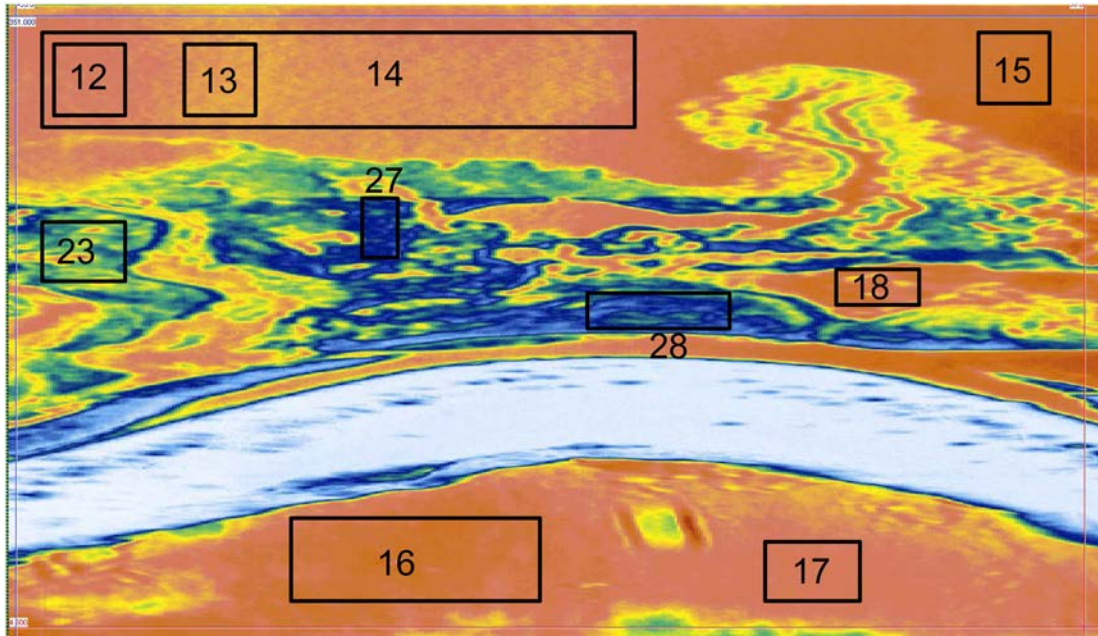
**Figure 5.5 Interference Fit Data Image After First Brushing.** The horizontal axis represents approximately  $-90$  to  $+90$  degrees. The vertical axis represents 360 mm (14.17 in.). Boxed regions were used in an amplitude analysis.

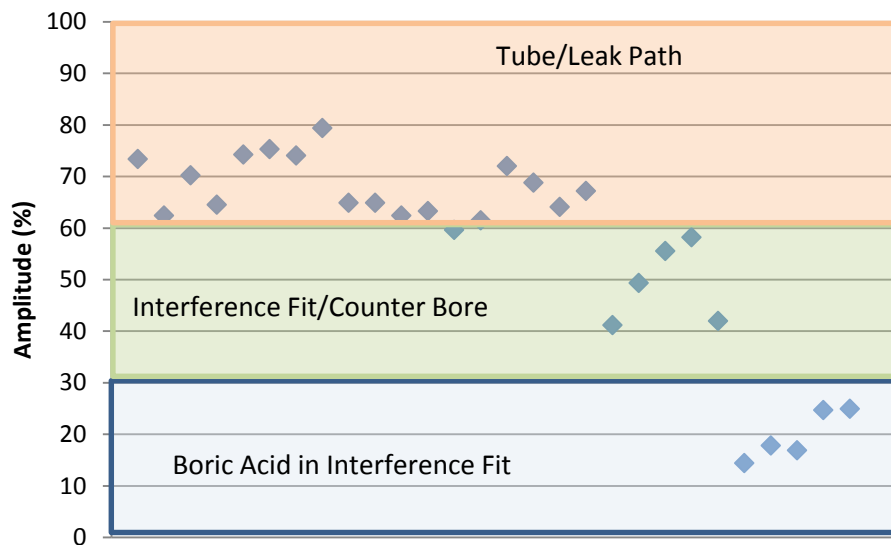
**Figure 5.6 Mean Amplitude Response from the Regions Indicated in Figures 5.4 and 5.5**

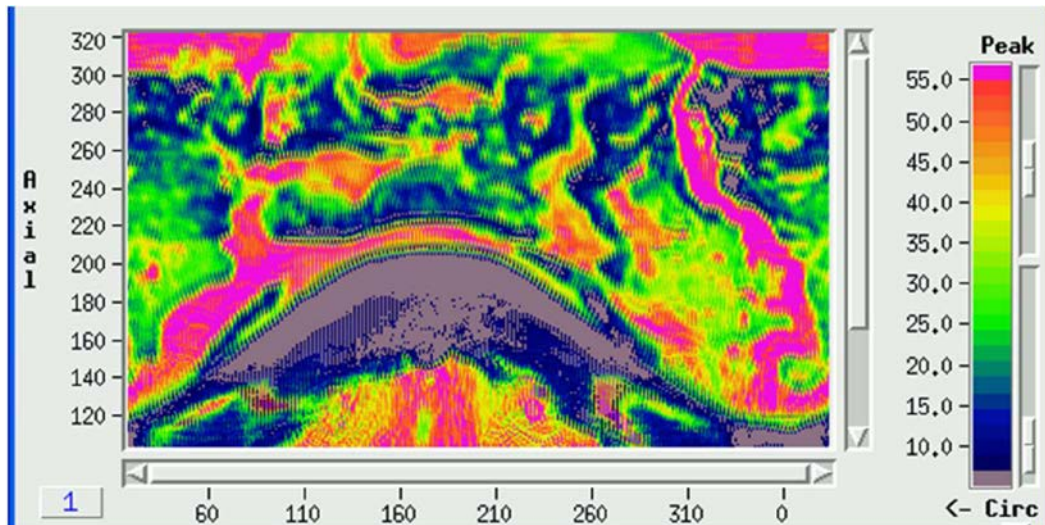
The Figure 5.8 image can be compared to the PNNL's laboratory results in Figure 5.3. Both data sets were acquired with probes having nominal center frequencies of 5 MHz and they show the main leak path as a high-amplitude signal. In the WesDyne data, this is represented by the magenta color. Both data images capture other partial leak paths and show similar areas of high and low reflectivity. Although these field data sets were acquired in 2002 and a technique

demonstration requirement did not come into effect until 2008, there have been only minor changes to the technique. The field procedure requires a minimum of a 51-mm (2-in.) scan above the weld, observation of a “river bed” pattern, and a nominal 2 dB difference in amplitude between the leak path response and the background.

**Figure 5.8** Ultrasonic Data from Nozzle 63 as Obtained by WesDyne International. The image was acquired with a 5-MHz probe. The horizontal axis represents the nozzle circumference in units of degrees. The vertical axis represents the nozzle axis in units of millimeters.

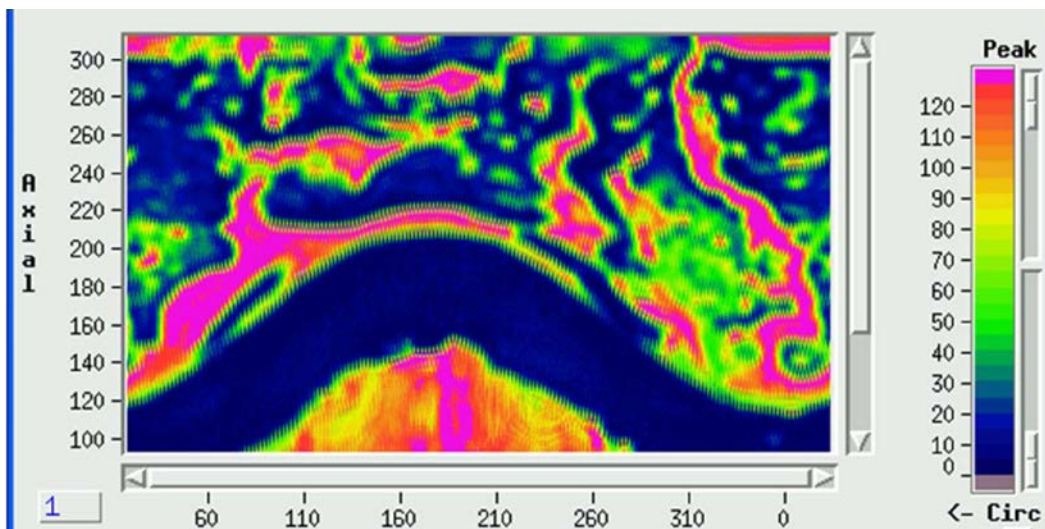
**Figure 5.9** Ultrasonic Data from Nozzle 63 as Obtained by WesDyne International. The image was acquired with a 2.25-MHz probe. The horizontal axis represents the nozzle circumference in units of degrees. The vertical axis represents the nozzle axis in units of millimeters.

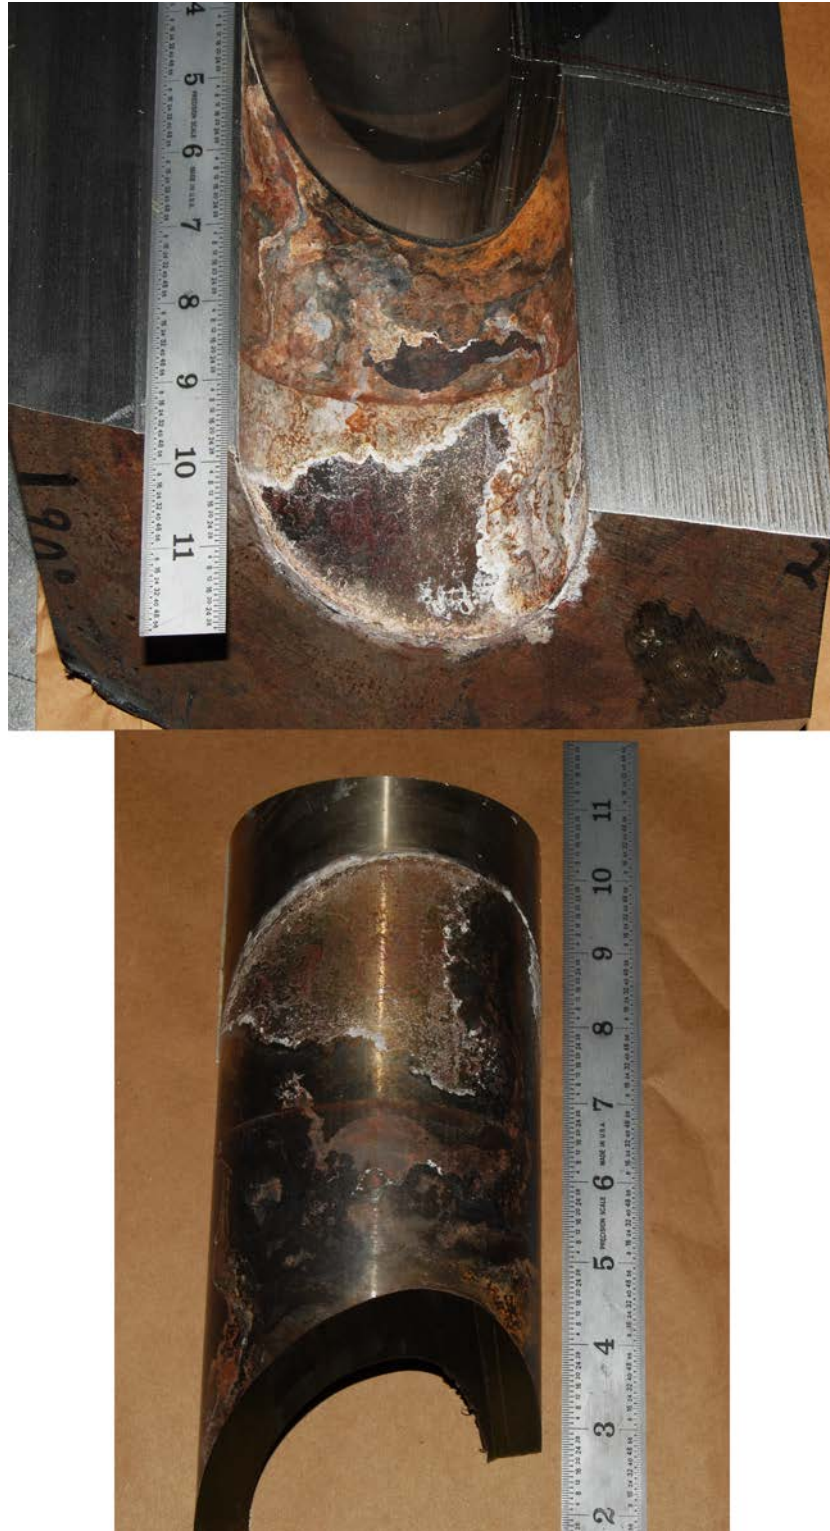
The cutting continued until the entire nozzle was separated from the J-groove weld region as pictured in Figure 6.4. At this point, the nozzle region above the weld was freely released from the RPV head material. Removal of the nozzle exposed the annulus region of the high-side section as shown in Figure 6.5. A Nikon D40x camera was used to acquire high-resolution photographic documentation of the annulus region. A subsequent cut was conducted on the low-side section to expose its annulus region containing the primary leak path (Figure 6.6). The nozzle freely released from this portion as well.

**Figure 6.5 Exposed RPV Head and Nozzle from High Side Section**

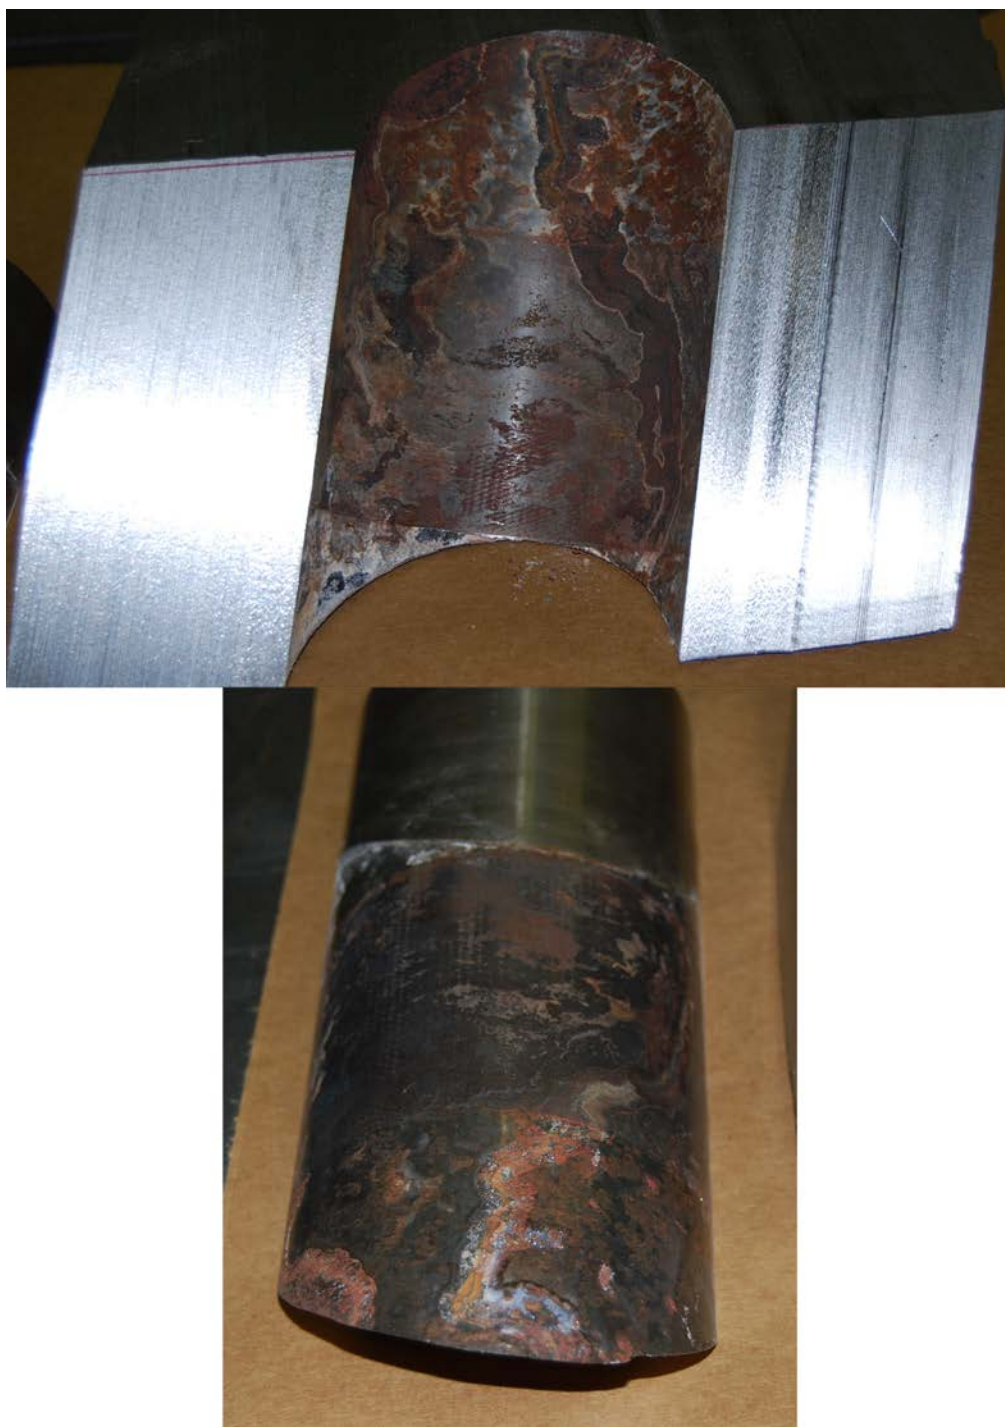
**Figure 6.6 Exposed RPV Head and Nozzle from Low-Side Section**

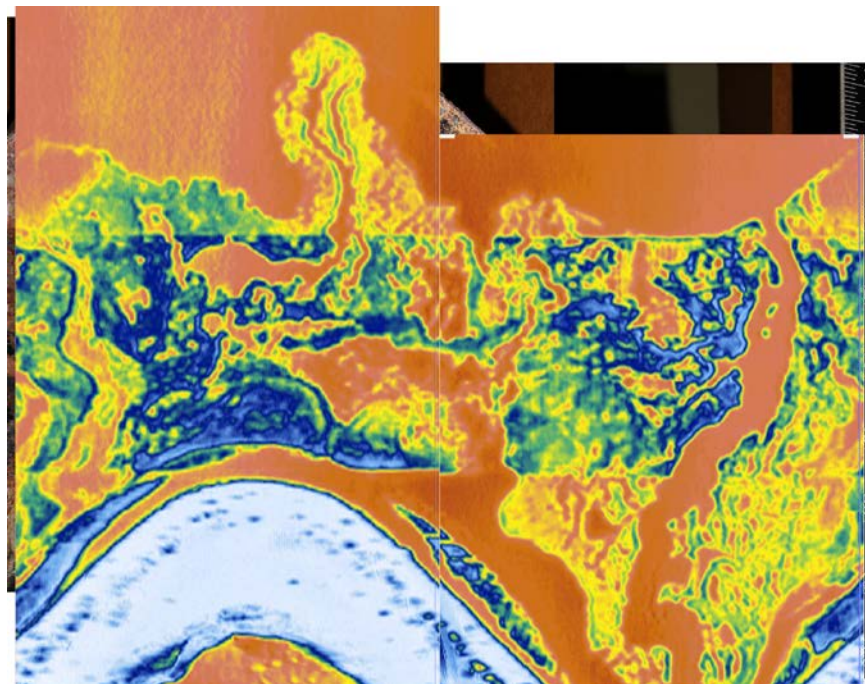
Similarly, the exposed reactor pressure vessel (RPV) head was photographed and the stitched image is displayed in Figure 7.2. The main leak path and other features seen in the ultrasonic images are clearly evident. Boric acid deposits are visible in white and corrosion products in the rust color. The interference fit region is evident in the photograph and is marked with the red line. For comparison, the ultrasonic data image with the same aspect ratio as the photograph is displayed in Figure 7.3. The ultrasonic image was stretched to best fit the visual data but the match is not perfect due to the curved surfaces. Nevertheless, the ultrasonic features well match the features seen visually on the RPV head annulus. Clearly, the main leak path and other partial leak paths are evident and well imaged.

**Figure 7.3 Ultrasonic Data Stretched to Best Match the RPV Head Photograph**

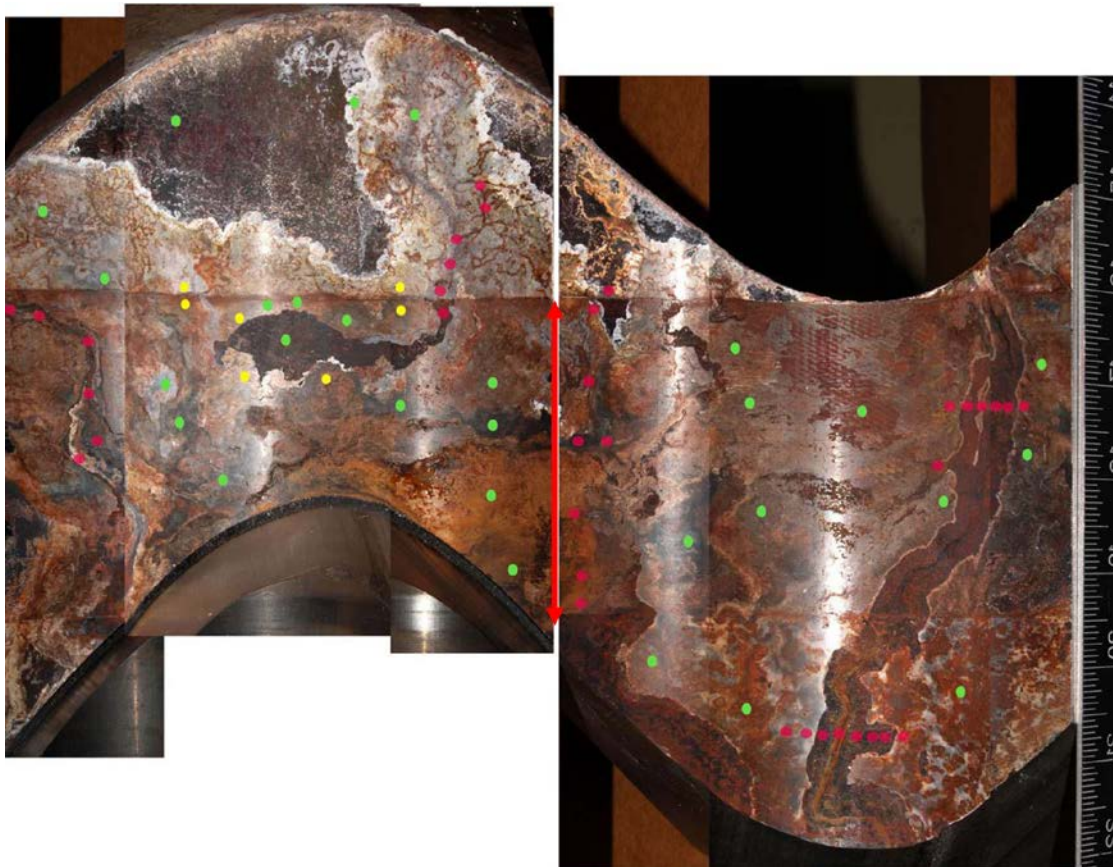
and U.S. Nuclear Regulatory Commission (NRC) personnel and are displayed in Figure 8.1 for the photographed uphill and downhill halves of the RPV head. The red dots represent what appear to be leak paths or bare metal regions. The green dots represent areas with different reflectivity in the photo and differing ultrasonic response. Lastly, the yellow dots represented additional points of interest including two pairs of points on either side of the upper interference fit border.

**Figure 8.1 Photograph of the RPV Head Material with Boric Acid Measurement Points. The interference fit region is marked by the red line.**
