# **Ultrasonic Phased Array Assessment of the Interference Fit and Leak Path of the North Anna Unit 2 Control Rod Drive Mechanism Nozzle 63 with Destructive Validation**

Manuscript Completed: July 2012

S. L. Crawford, A. D. Cinson, P. J. MacFarlan, B. D. Hanson,  
R. A. Mathews

Pacific Northwest National Laboratory  
P.O. Box 999  
Richland, WA 99352

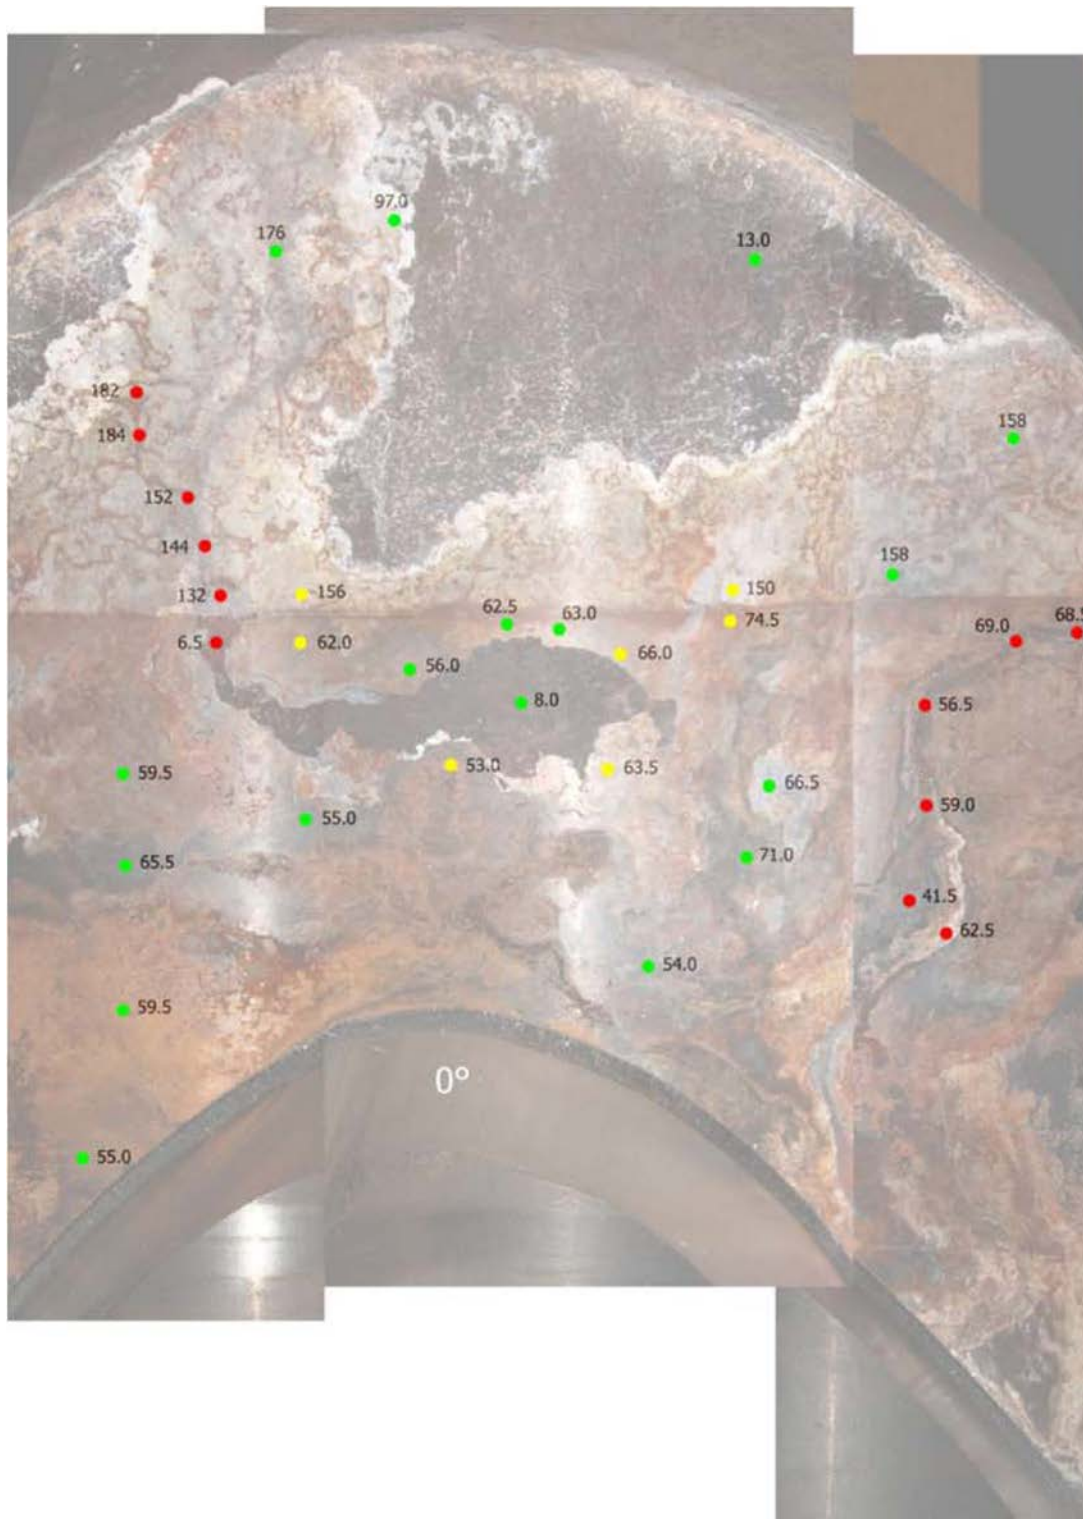
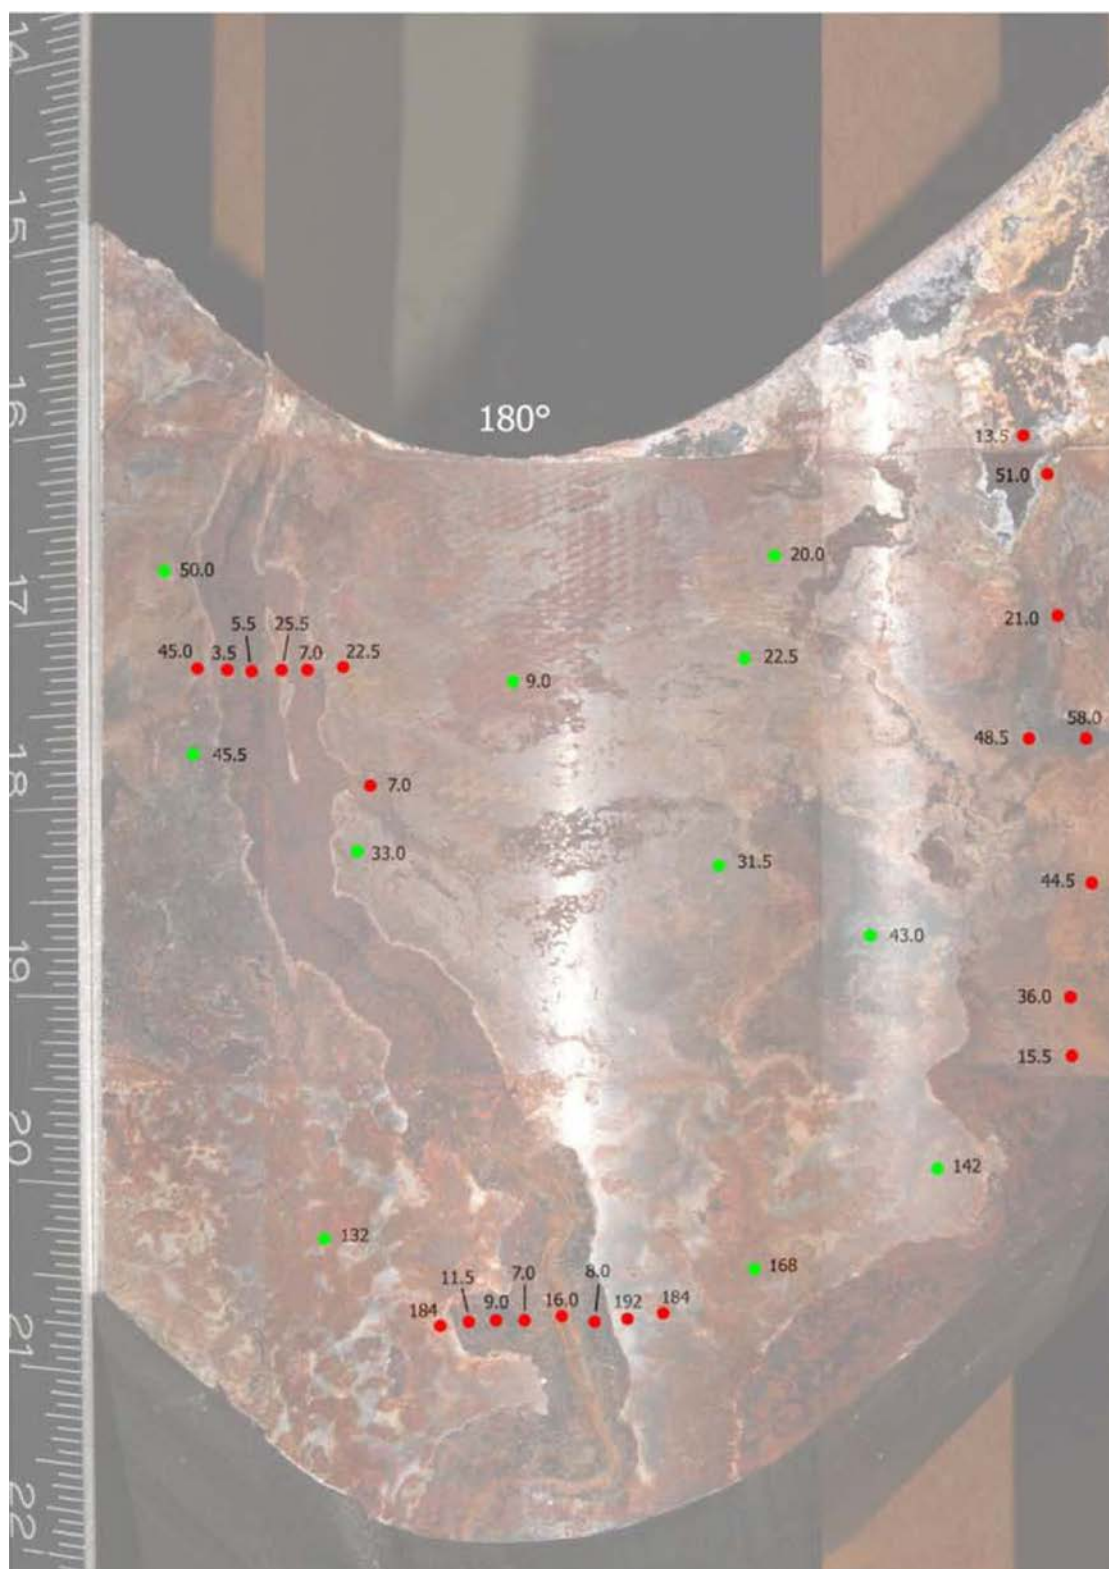
Each of the 70 data points was numbered and the boric acid measurements were entered into a spreadsheet. The thickness measurements in microns are displayed adjacent to the data points in Figure 8.2. Some general observations were:

- 3) The leak path and what appear as bare metal or nearly bare metal locations have a thin surface layer of corrosion deposits rather than visible boric acid deposits, with corrosion deposit thicknesses of 16 microns (0.63 mils) or less. These are thinner than the measured boric acid deposits inside or outside the span of the interference fit.

Figure 8.2 Boric Acid Deposit Thickness Values in Microns

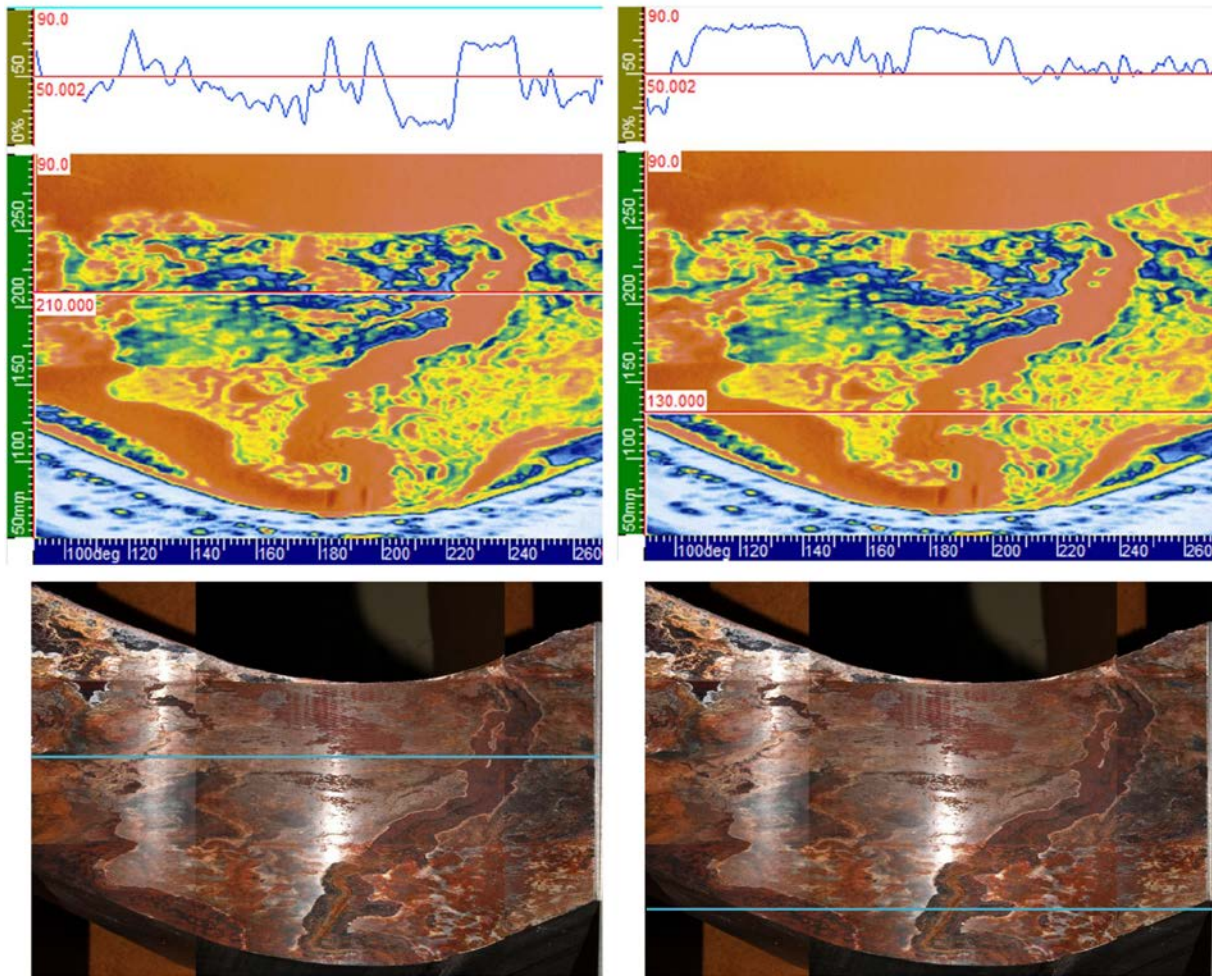
The relationship between the ultrasonic response values and eddy current (EC) thickness values was explored in more detail. As demonstrated in the mockup evaluation, the large-amplitude ultrasonic data represents an air gap in the interference fit between the penetration and the RPV head. These data regions are represented by the color orange in the rainbow color bar previously shown in Figure 5.3, for example. Two horizontal profiles that display ultrasonic amplitude variations along the selected measurement line in the image are shown in Figure 8.3. The left side displays a profile taken along the red horizontal line located in the interference fit region marked on the ultrasonic image. Clearly the high ultrasonic response is evident across the main leak path and then the response falls off on either side, of the leak path. The left side drop off is more severe in the profile and is associated with the blue color in the image, while the right side drop off is moderate and is associated with the yellow color in the image. The right side displays a profile taken along the red horizontal line in the ultrasonic image below the interference fit. The profile as well as the data image, again, shows a high-amplitude ultrasonic response for the leak path regions with signal drop off on both sides of the leak paths. At this axial position in the annulus, the drop off is smaller than that observed in the data from within the interference fit on the left. For comparison, the exposed interference fit region at the low-alloy steel surface is displayed in the lower portion of the figure with the blue lines corresponding to the profile locations.

The inherent characteristic of a leak path ultrasonic response, as confirmed by visual examination of the interference fit, is a high-amplitude response that vertically traverses the entire interference fit (I fit) region. The primary leak path deposit layer measurements obtained with the eddy current probe further show that within the leak path there will be an absence of deposits and therefore an air gap between the nozzle penetration and RPV head. This inverse relationship between the deposit thickness and the amplitude of the ultrasonic response is represented in Figures 8.4 and 8.5. Eddy current layer thickness data obtained at the red points horizontally spanning the primary leak path in Figure 8.1 are plotted as boric acid (BA) data in blue diamonds, realizing that these are boric acid and corrosion layer values. The corresponding ultrasonic data at those same points are plotted as ultrasonic test (UT) data in red squares. Figure 8.4 represents data obtained in the interference fit region and Figure 8.5 represents data outside of the interference fit from the primary leak path points, red in Figure 8.1. In each figure below, the leak path boundary is noted by two black horizontal lines. Both figures show that leak path data points are represented by this characteristic high ultrasonic response (above 70%) and low boric acid or corrosion layer thickness (approximately below 20 microns [0.79 mils]). More specifically, the BA or corrosion layer thickness within the interference fit is below 7 microns (0.28 mils) with the exception of the data point acquired at the island position in the main leak path. Here a larger thickness value of 25.5 microns (1.0 mils) was measured. Similarly, for data outside of the interference fit but still in the primary leak path, the layer thickness values were below 12 microns (0.47 mils) except for the data point at the

**Figure 8.3 Ultrasonic Response Profile at Top, Acquired Along the Red Horizontal Line in the Middle Image. The left image profile is in the interference fit and the right image profile is outside of the interference fit. Lower photographic images show the exposed interference fit on the low-alloy steel surface.**

rust-colored streak in the middle at 16 microns (0.63 mils). Moving outside of the leak path, the ultrasonic response drops and the BA/corrosion layer increases. Within the interference fit, Figure 8.4, this increase in BA/corrosion layer thickness is much smaller as can be expected. The interference fit region has little to no gap between the nozzle and RPV head but this condition is variable throughout the fit (Hunt and Fleming 2002). Boric acid presence in this region would likely be a thin layer and more compacted as noted by the low (blue-colored) ultrasonic response. Outside of the interference fit, the BA/corrosion layer increases more dramatically on either side of the main leak path, to nominally 185 microns (7.28 mils). A wider gap was present in the annulus region outside of the interference fit due to a machined counter bore (refer to Figure 1.1). The data suggest that this gap fills with boric acid. Note that the ultrasonic response shows a smaller drop on either side of the leak path possibly indicating that the boric acid was less compacted in this region.

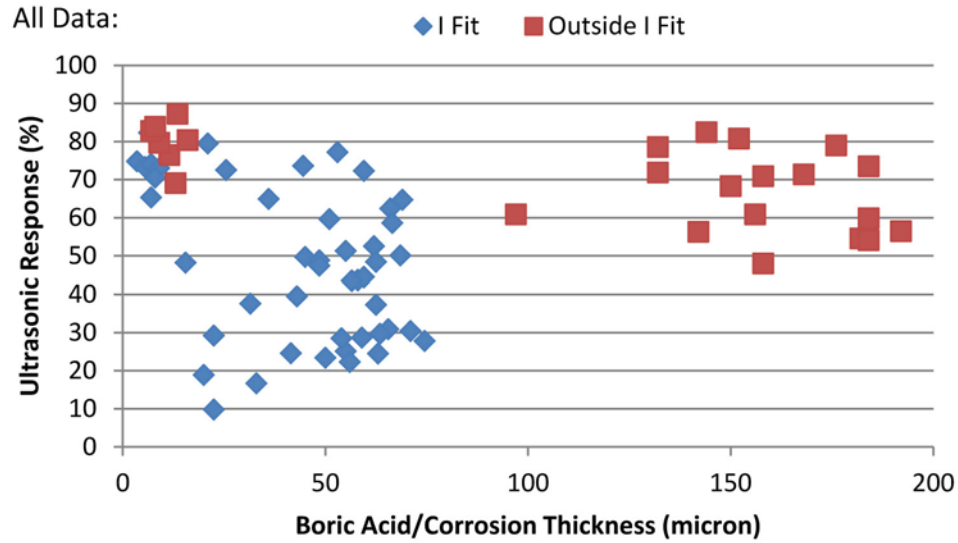
Lastly, an attempt was made to correlate the ultrasonic and eddy current measurements at all 70 data points. In this analysis, the data points were segregated as within the interference fit region or outside of the interference fit region. Initially, all of the points were plotted with results shown in Figure 8.6. Points with high ultrasonic response and low BA or corrosion deposit thickness, upper left, are primarily associated with the main leak path region and represent areas where any potential deposits are flushed out and not allowed to remain. In addition to the primary leak path, other partial leak paths and regions that visually appear as bare metal were

**Figure 8.6 Comparison of Ultrasonic Response and Boric Acid/Corrosion Layer Thickness at all 70 Acquired Data Points**

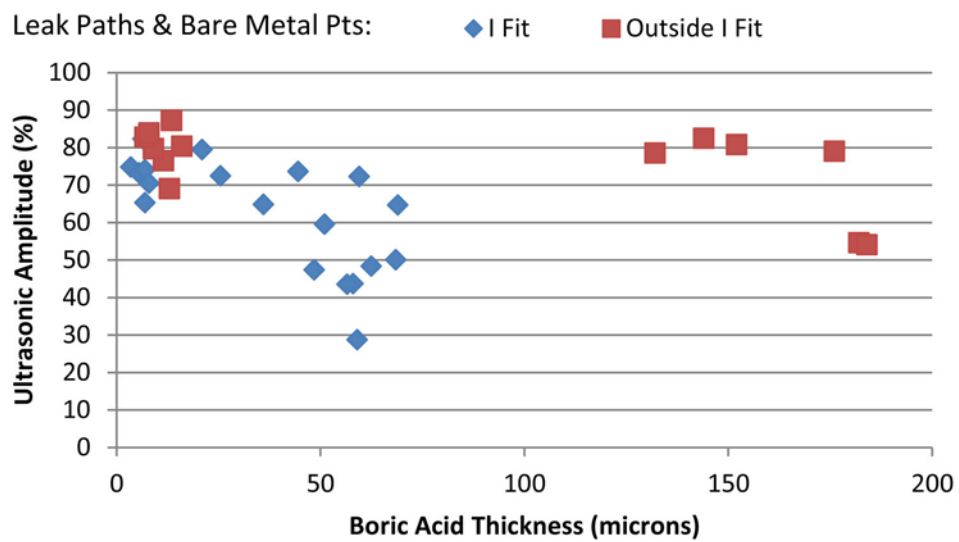
identified. All of these leak path and bare metal points are plotted in Figure 8.7. These points represent a likely gap in the annulus between the nozzle penetration and the RPV head, noted by the high ultrasonic response. The primary leak path points from both within and without the interference fit are represented in the upper left portion of the graph as exhibiting high ultrasonic responses and minimal layer deposit thicknesses. The interference fit data in the middle, represented by approximately a 40- to 70-micron (1.58- to 2.76-mils)-thick deposit and 45 to 75 percent UT response, corresponds to the possible secondary leak path points. Finally, the data outside the interference fit in the upper right portion of the graph represent the points in the plume above the interference fit. These points are located on a suspected secondary leak path that exits the interference fit and extends upward into the annulus. The ultrasonic responses along this “plume leak path” are high, 55 to 83 percent. The boric acid values are also high, 132 to 182 microns (5.20 to 7.17 mils). It is likely that the boric acid was able to collect in this upper annulus flow channel due to the wider gap in the presence of a counter bore and an assumed low flow rate. The remaining points (70 original points except for the leak path and bare metal points) are plotted in Figure 8.8. An ultrasonic amplitude level of approximately 50 percent divides the data, with lesser values taken from locations within the interference fit and greater values taken from locations outside the interference fit region. For this nozzle, the BA or corrosion deposit thickness values in the interference fit are less than 75 microns (3.0 mils), and outside the interference fit are greater than 130 microns (5.12 mils). The outlier point at the center of the graph, with a layer thickness of 97 microns (3.82 mils) in Figure 8.8, was obtained at a location where there is a noticeable boric acid deposit on the nozzle side. The thickness of this deposit, though not quantitatively known, would increase the layer thickness value moving the point to the right and likely in the range of the other “Outside I Fit” data points. The other outlier point (EC value of 9 microns [0.35 mils] and UT value of 73%) is from the interference fit data and was obtained at a rust-colored region so it was not included in the bare metal points. This outlier is also possibly explained by positional registration error of the data points. Nevertheless, data trends are evident. While the numerical values are specific to Nozzle 63, these trends are expected to be applicable for upper head penetrations in general. A summary of the Nozzle 63 results follows.

- Leak paths
  - a. High UT response, >60%
  - b. Minimal boric acid/corrosion layer EC measurement, <16 microns (0.63 mils)
- Outside the leak path
  - a. Inside the interference fit region
    - i. UT response <50%
    - ii. EC measurement low, 15–75 microns (0.59–3.0 mils)
  - b. Outside the interference fit region
    - i. UT response >50%
    - ii. EC measurement larger, 130–190 microns (5.12–7.48 mils)

**Figure 8.7 Comparison of Ultrasonic Response and Boric Acid/Corrosion Layer Thickness at the Leak Path and Bare Metal Data Points**

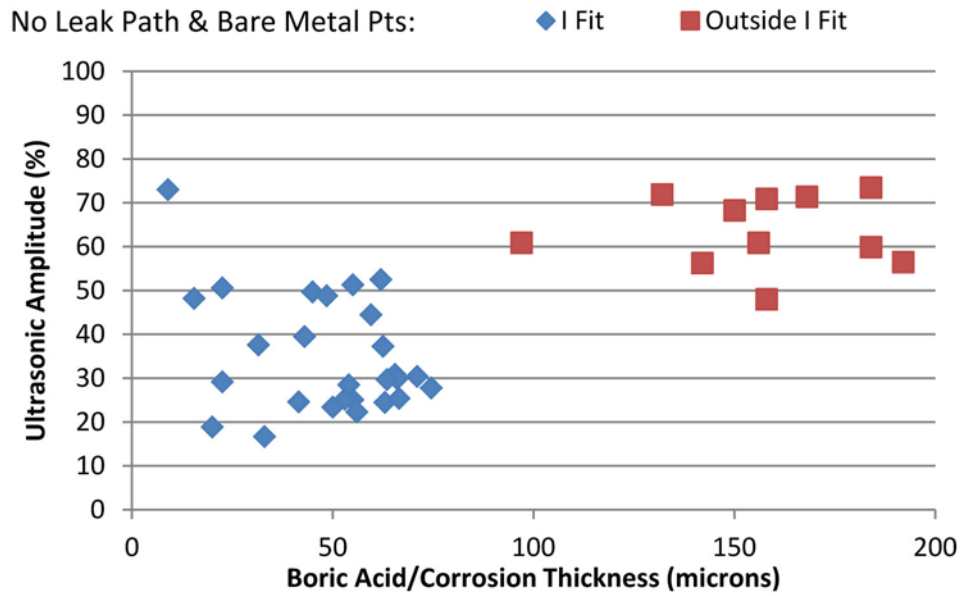
**Figure 8.8 Comparison of Ultrasonic Response and Boric Acid/Corrosion Layer Thickness at Data Points Not in the Leak Paths Nor at Bare Metal Points**

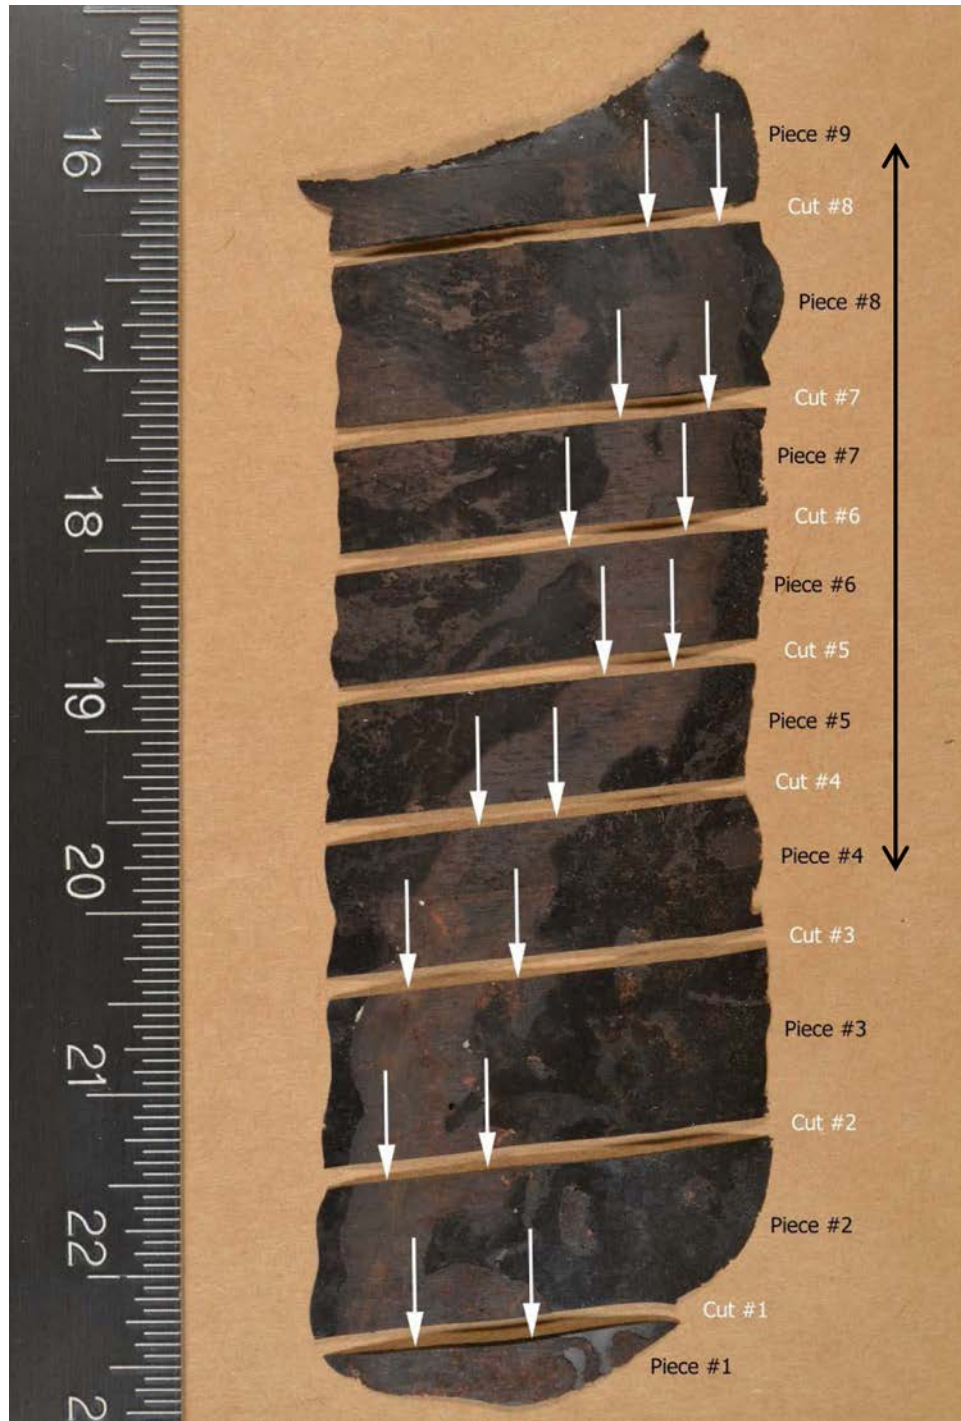
To evaluate the surface condition of the leakage path for evidence of loss of material from corrosion, the replicated surfaces from Figure 8.10 were viewed with a stereomicroscope. As shown in Figures 8.11 and 8.12, machining marks were observed on the replicated surfaces indicating minimal corrosion, erosion, or wastage throughout the leak path region, likely indicating a relatively low leakage flow rate during plant operation. Figure 8.11 shows replica pieces 2 and 3 in the main leak path in the region below the interference fit. Both pieces show double streaks from corrosion product staining but no or minimal actual corrosion or wastage. The machining marks are intact across the images. The transition from below the interference

**Figure 8.10 Leak Path Replica with Cuts and Pieces Identified. The interference fit region is noted with the black line and is contained in pieces 4 through 9.**

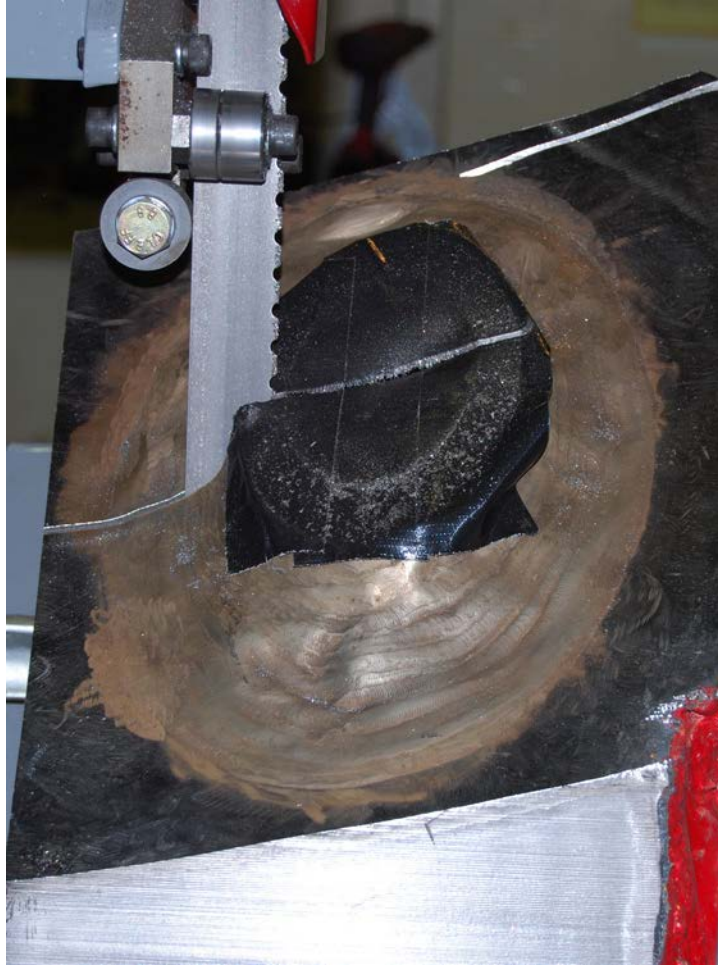
Dissection cutting began with the coarse-toothed blade. The cut progressed for approximately 20 minutes until an unidentified 'hard spot' was reached at the outer edge of the Alloy 600 nozzle region and stopped the cutting progression. A slower feed rate with a faster blade speed was attempted, but did not traverse the hard spot. The cause of the hard spot was not fully investigated, but a likely cause was from a cold-worked region of material within the heat-affected zone of the J groove weld adjacent to the nozzle outer diameter (OD). The coarse-cut blade was exchanged with a fine-toothed cutting blade and the cut was attempted again without success. Finally, the carbide blade was employed to abrasively grind through the hard spot. This blade required a greatly reduced feed rate, thus lengthened the cutting time. Further, the kerf of the carbide blade was thicker than the cutting blades, requiring the cut to be restarted at the initial cut path. The carbide grit abrasive blade is shown in Figure C.4. The cut through this hard spot required approximately 2 hours to complete.

**Figure C.4 Abrasive Carbide Blade Progressing Through the Hard Spot**

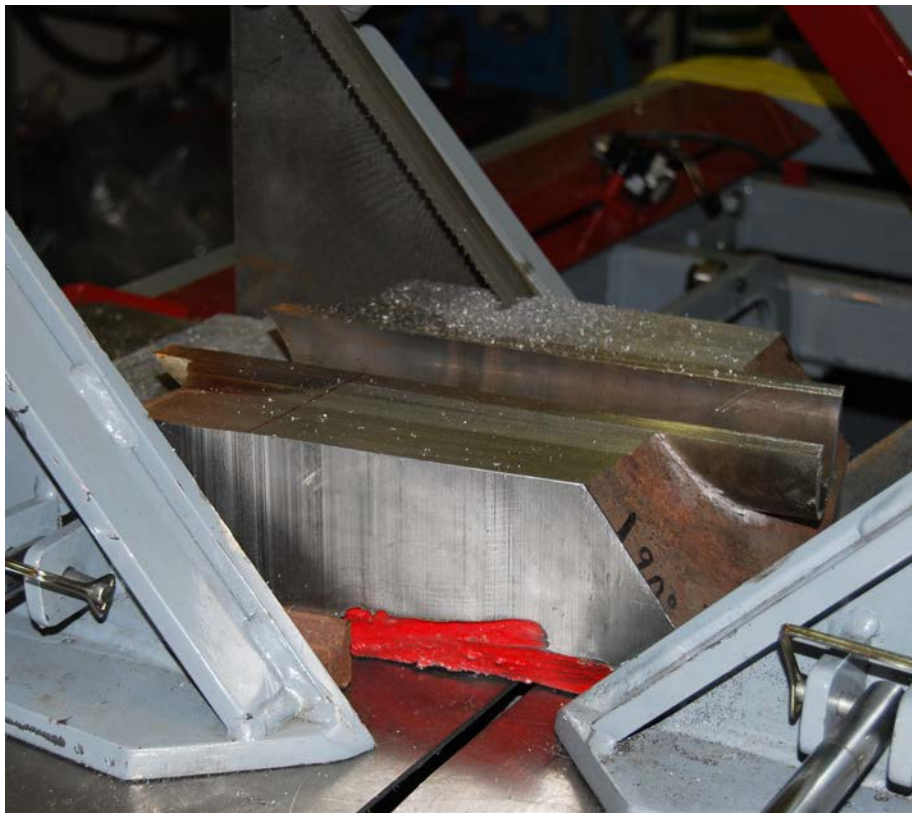
**Figure C.7 J-groove Weld Cut on the High Side**

The cut to remove the J-groove weld was made 6.35 mm (0.25 in.) above the butter/triple point region in the reactor pressure vessel (RPV) head as seen in Figure C.6. The high or uphill side half-portion was selected for the first cutting. As previously stated, the 'high' side has several potential leak paths whereas the 'low' or downhill side had the primary leak path as identified in the ultrasonic data. The specimen was secured and the band saw tilted to an approximate 43-degree angle to match the angle between the nozzle and head as shown in Figure C.7. Cutting at this angle maximized the annulus region that was exposed while keeping the weld and butter regions intact for future evaluation. As the cut was designed to pass only through the low-alloy RPV material, the fine toothed cutting blade was selected for use. During the J-groove weld removal cut, another hard spot was encountered near the outside of the nozzle. Attempts were made to continue cutting with the fine-toothed blade until abrasive wear on one side of the blade resulted in the cut veering away from the desired cut line. Blades were exchanged and the carbide blade was used to cut through the hard spot and also to finish the cut. Before the cut broke through the inside of the tube, a vacuum equipped with a high-efficiency particulate air (HEPA) filter was added to collect and capture any radioactive oxide particles that were discharged from the cut as pictured in Figure C.8.

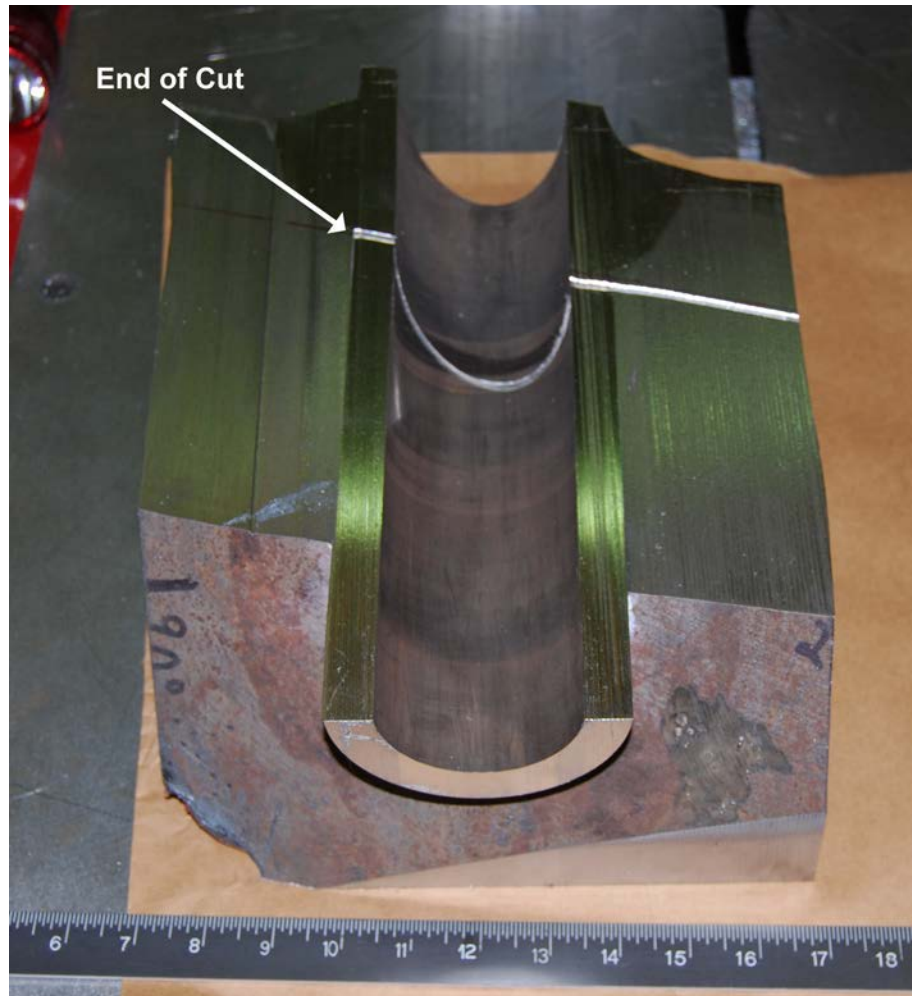
**Figure C.9 End of J-groove Weld Removal Cut**

The cutting continued until the entire nozzle was separated from the J-groove weld region as pictured in Figure C.9. At this point, the nozzle region above the weld was freely released from the RPV head material. Removal of the nozzle exposed the annulus region of the high-side section as shown in Figure C.10. At this point all available blades were exhausted. Replacement blades were ordered to finish the cut and complete removal of the J-groove weld region. A Nikon D40x camera was used to acquire high-resolution photographic documentation of the annulus region. This activity was provided by B&W. A subsequent cut was conducted on the low-side section to expose its annulus region containing the primary leak path (Figure C.11). The nozzle freely released from this portion as well.
