Long-Term Evaluation of SSL Field Performance in Select Interior Projects

February 2017

Pacific Northwest National
Laboratory

Prepared in support of the DOE Solid-State Lighting Technology GATEWAY Program

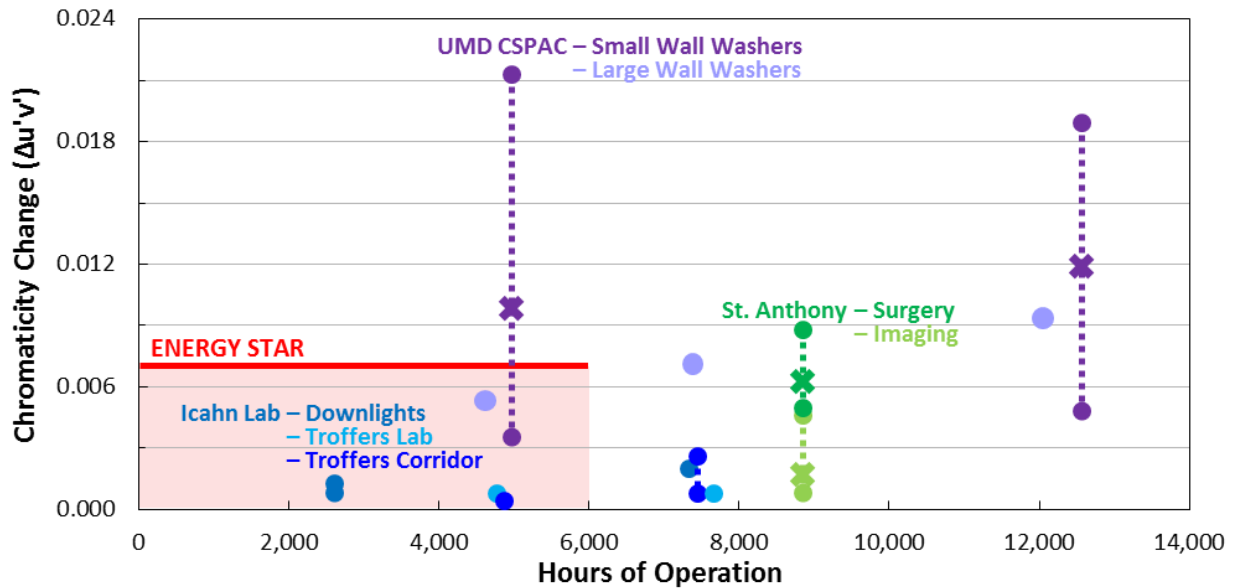
Figure ES-1. Overall chromaticity change for UMD CSPAC wall washer retrofit kits, Icahn Lab troffer and downlight retrofit kits, and St. Anthony replacement lamps based on the hours of operation at the time the measurements were collected. The average chromaticity change is marked by an X, while the minimum and maximum values are marked with circles, connected by a dotted line. If the range in performance is small, the average may not be marked and the circles may overlap.

For all measurement times, each site has measurement points that are below the red horizontal line in Figure ES-1, indicating the chromaticity change is less than the ENERGY STAR standard of 0.007. (This standard was used as a reference for comparison; the product manufacturers did not necessarily claim that their products met this standard.) The retrofit products in UMD's CSPAC exhibited substantially greater color shift than the other products; most of the measurement points are above the 0.007 line. After the third round of measurements (at least 12,000 hours of operation), the small wall washer products had an average $\Delta u'v'$ value of 0.0118 compared to the initial set of measurements. Although the chromaticity shift measured for the LED retrofit kits at the UMD's CSPAC was greater than expected, the fact that the products have operated for more than 17,000 hours without any required maintenance satisfied the project goals for the university. The incumbent halogen lamp system would have required numerous lamp replacements during the same period, with much greater energy use.

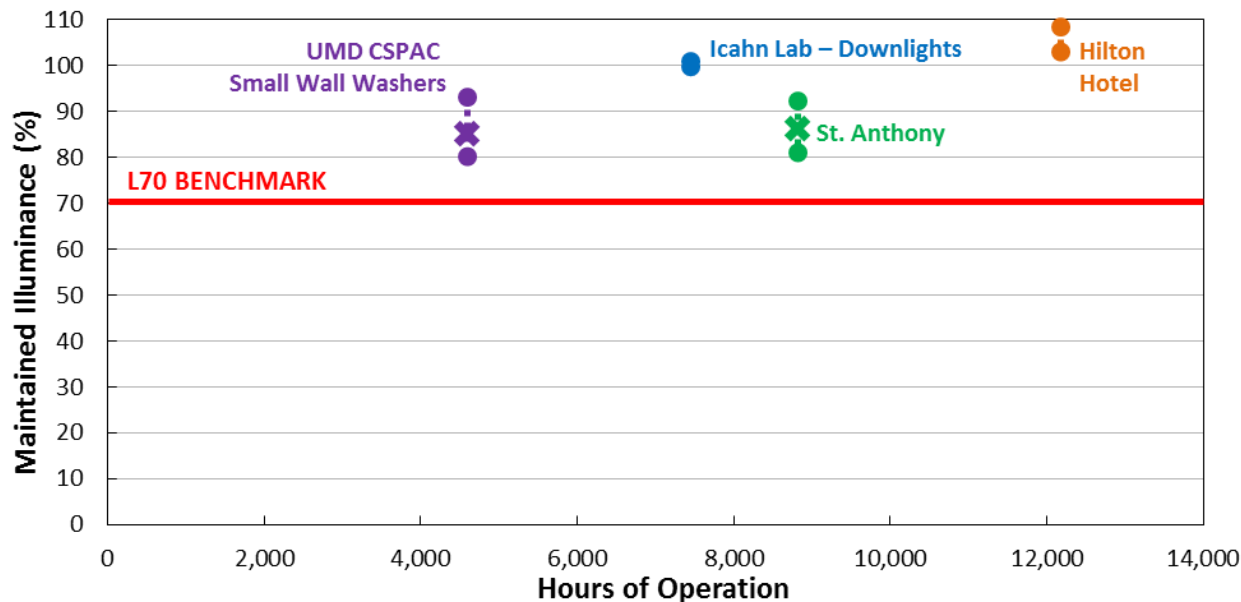
Figure ES-2 shows the overall maintained illuminance for each of the sites based on the estimated hours of operation at the time measurements were collected. At the Hilton Hotel, the LED downlights provided sufficient lighting to satisfy IES task requirements after both sets of measurements, and all maintained illuminance values were significantly greater than the benchmark 70%; in fact, all of the values increased. In comparison to other downlight options, CFLs typically have a 10,000 hour rated life; thus, at least half of the lamps would have been expected to be replaced within the first 12,100 hours of data. At the Icahn Lab, illuminance levels after 7,400 hours of operation were also the same if not slightly greater than the initial levels with a maintained uniformity ratio. The average illuminance for the integral LED lamps at St. Anthony Hospital decreased but still met the relevant IES requirements after 8,800 hours. While the illuminance produced by the retrofit kits installed in

UMD’s CSPAC decreased, it remained above 70% of initial after an estimated 5,000 operating hours. Although additional illuminance data was not collected, after 17,000 hours of operation only one of the 135 modules may need to be replaced, whereas the incumbent halogen lamps with a 1,500 hours rated life would have been replaced 11 times within the first 17,000 hours. Thus, from an energy and maintenance savings standpoint, the conversion was worthwhile.

Figure ES-2. Overall maintained illuminance for the Hilton Hotel new downlights, UMD CSPAC wall washer retrofit kits, Icahn Lab downlight retrofit kits, and St. Anthony replacement lamps based on the hours of operation at the time the measurements were collected. The average maintained illuminance percentage is marked by an X, while the minimum and maximum values are marked with circles, connected by a dotted line. If the range in performance is small, the average may not be marked and the circles may overlap.

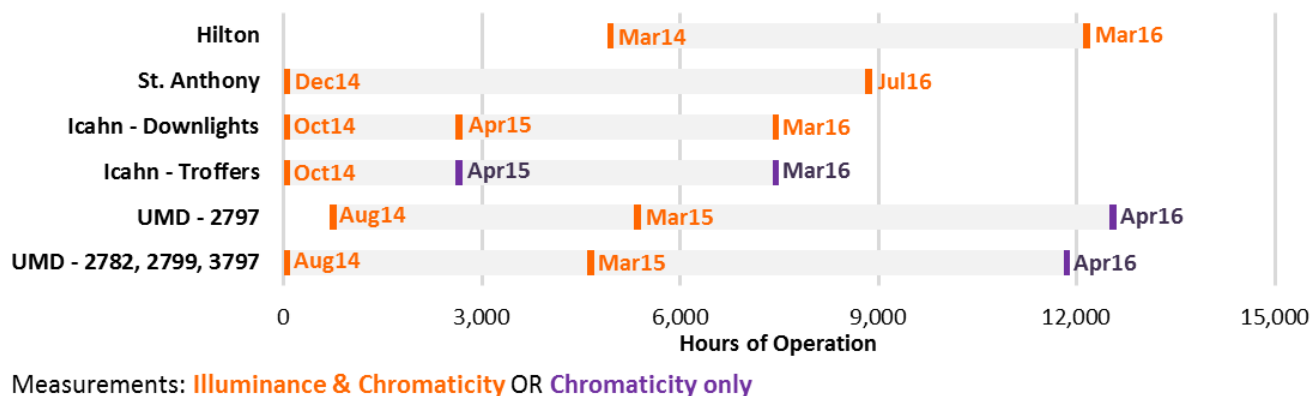
Figure 1. Timeline of data collection. Hours of operation are delineated for each set of measurements at each site. An orange bar indicates that both illuminance and chromaticity were measured, whereas a purple bar indicates that only chromaticity was measured. The date of each measurement is shown adjacent to each bar. For Icahn, the two product types are differentiated (downlights versus troffers), whereas for UMD, the installation locations are distinguished (2797 versus 2782, 2799, and 3797).

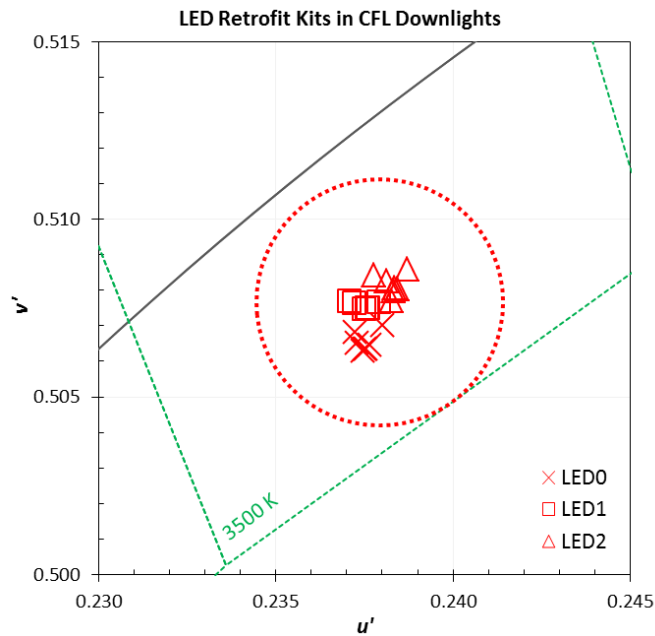
The average CCT changed from 3496 K initially to 3454 K after 7,400 operating hours, and the average D_{uv} changed from -0.0036 to -0.0030. These changes in CCT and D_{uv} are very small, likely within the measurement uncertainty, and would probably not be noticed by most building occupants. The $\Delta u'v'$ values were, on average, 0.0010 after 2,600 hours and 0.0018 after 7,400 hours, confirming that the color properties have remained stable. Figure 3 shows the u' and v' chromaticity coordinates of the seven downlights at each of the three measurement times. The graph illustrates that the chromaticity changes are small.

Figure 3. Chromaticity coordinates for the LED downlight retrofit kits in the Icahn Lab plotted on 1976 CIE uniform color space (UCS) (u', v') chromaticity diagram with MacAdam ellipses. The diagram shows the coordinates for the seven measured downlights at each of the three measurement times, in relationship to the ANSI bin for 3,500 K products. The circle has a radius of 0.0035 in the (u', v') chromaticity diagram to approximate a 3.5-step MacAdam ellipse, where the step size refers to the distance from the center of the ellipse to the perimeter. The circle is centered on the average u' and v' coordinates. The tight clustering of the chromaticity coordinates at each of the measurement times shows that all products remained fairly well grouped.

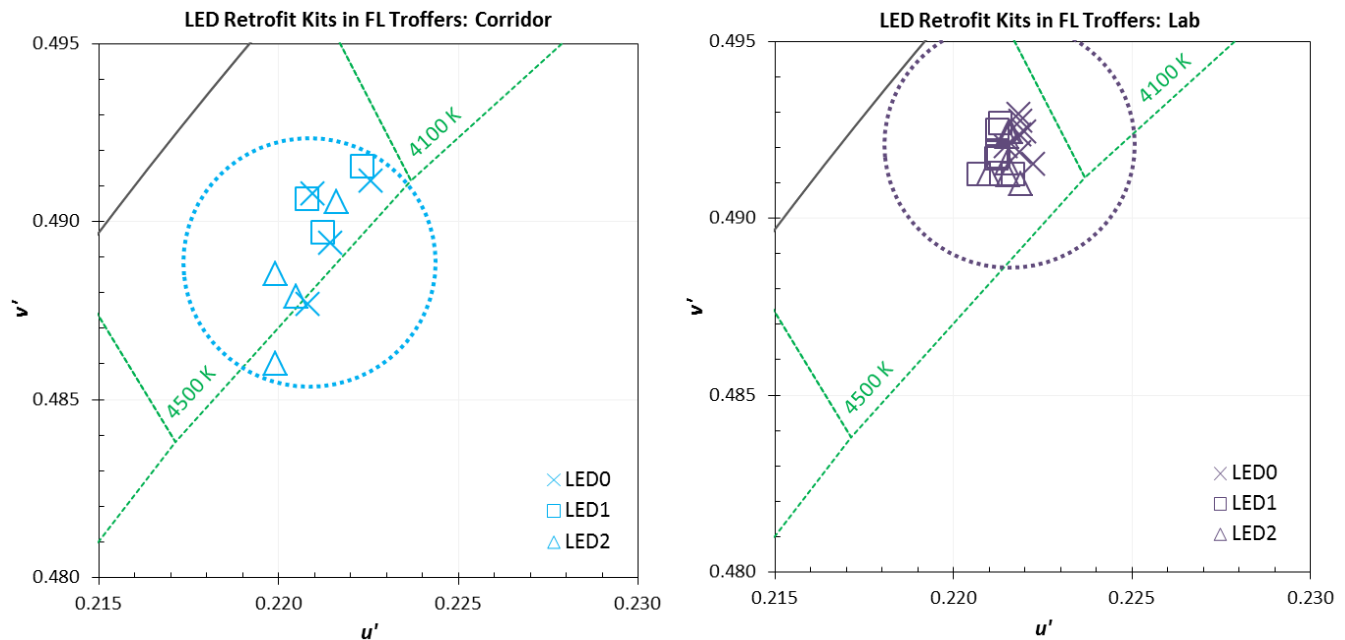
Figure 4 illustrates the shift in chromaticity for the troffer retrofit kits in the corridor luminaires (left) and the lab luminaires (right). The $\Delta u'v'$ values for both sets of fixtures after 7,400 hours were below the ENERGY STAR specification of 0.007, but there was a greater shift in chromaticity for the corridor luminaires.

Figure 4. Chromaticity coordinates for the LED troffer retrofit kits in the Icahn Lab plotted on 1976 CIE uniform color space (UCS) (u', v') chromaticity diagram with MacAdam ellipses. The diagram on the left shows the coordinates for the corridor luminaires at each of the three measurement times, while the diagram on the right is for the lab luminaires. The circles have a radius of 0.0035 in the (u', v') chromaticity diagram to approximate a 3.5-step MacAdam ellipse, where the step size refers to the distance from the center of the ellipse to the perimeter. The circles are centered on the average u' and v' coordinates for each set of measurements. The circles indicate that for both sets of luminaires, the shift in chromaticity is within seven steps. The lab hours are assumed to be less than those in the corridor, which could explain the more tightly grouped performance in the diagram on the right.

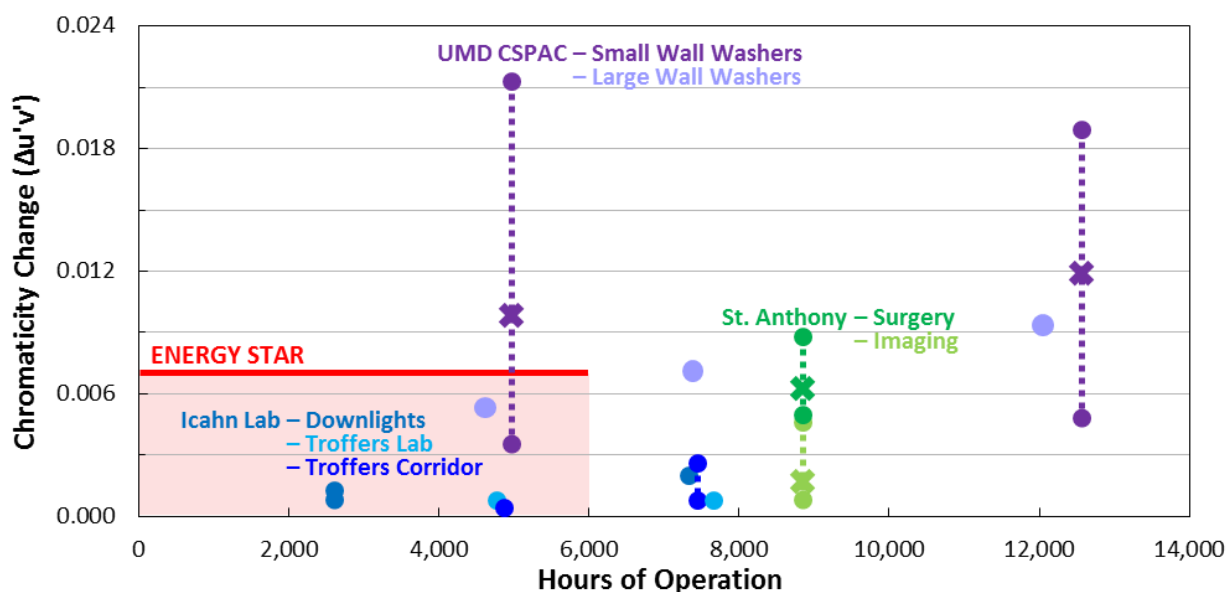
Figure 9 shows the range in chromaticity change ($\Delta u'v'$) for each site based on the estimated hours of operation at the time measurements were taken. Although the data collected for the downlights at the Hilton Hotel did not allow the calculation of the $\Delta u'v'$ values, these products showed very little change in their CCT, CRI, and R_9 values after more than 12,000 hours of use. The retrofit kits installed in the downlights and troffers at the Icahn Lab similarly show stable color performance after 7,400 hours; the downlight retrofit kits had an average $\Delta u'v'$ of 0.0018 while the troffer retrofit kits installed in the lab fixtures had an average $\Delta u'v'$ of 0.0007, almost one-third less than the corridor fixtures (average $\Delta u'v'$ of 0.0018) given the reduced hours of operation. After 8,800 hours of use, the integral LED lamps used at St. Anthony had $\Delta u'v'$ values of 0.0062 (surgery waiting area) and 0.0017 (imaging changing rooms) on average. Similar to the Icahn troffers, the downlights in the changing rooms are assumed to operate for fewer hours than those in the surgery waiting area.

Figure 9. Overall chromaticity change for UMD CSPAC wall washer retrofit kits, Icahn Lab troffer and downlight retrofit kits, and St. Anthony replacement lamps based on the hours of operation at the time the measurements were collected. The average chromaticity change is marked by an X, while the minimum and maximum values are marked with circles, connected by a dotted line. If the range in performance is small, the average may not be marked and the circles may overlap.

For all measurement times, each site has measurement points that are below the red horizontal line in Figure 9, indicating the chromaticity change is less than the ENERGY STAR standard of 0.007. The ENERGY STAR criterion is perhaps the only defined criterion for chromaticity shift. It is a reasonable starting point, but may not be strict enough to ensure very high-quality lighting, especially since the lifetimes of LED products routinely far exceed 6,000 hours. This level of difference is readily noticeable in many interior lighting settings, if two lamps with that level of difference are viewed simultaneously and in relative proximity. However, if all the lamps in a room undergo a change of that magnitude—and in the same direction—over the course of several years, the occupants may not detect that the lighting has changed, at least not until one or more of the lamps is replaced.

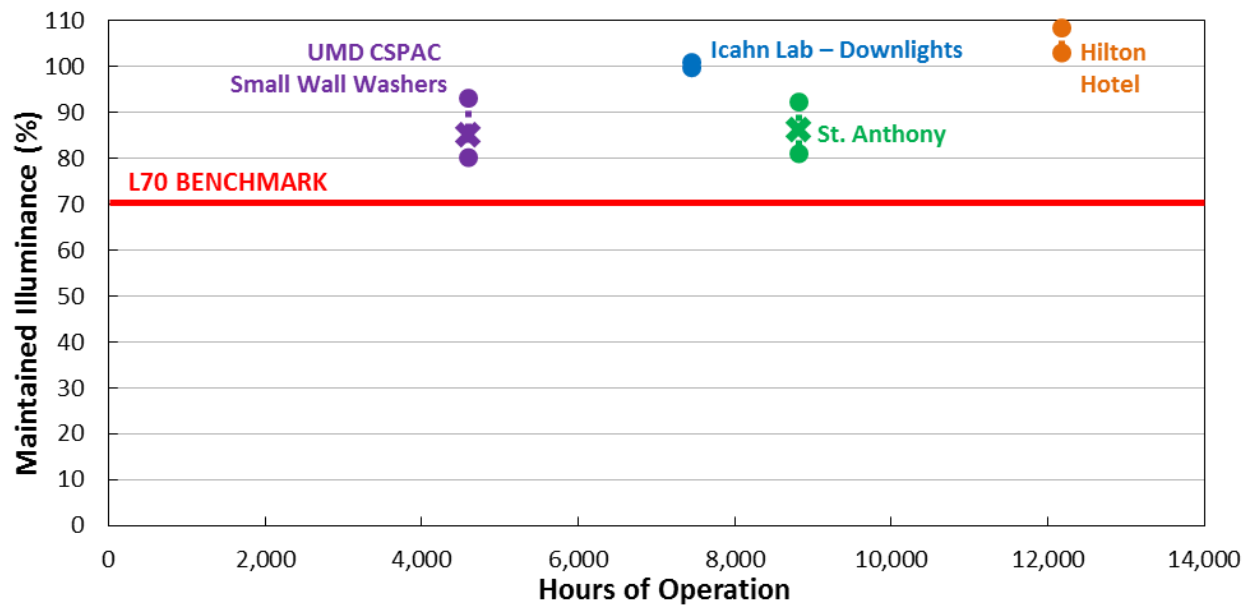
Figure 10 shows the overall maintained illuminance for each of the sites based on the hours of operation at the time measurements were collected. At the Hilton Hotel, the LED downlights provided sufficient lighting to satisfy IES task requirements after both sets of measurements; all maintained illuminance values were significantly greater than the benchmark 70%; in fact, all of the values increased. In comparison to other downlight options, CFLs typically have a 10,000 hour rated life; thus, at least half the lamps would have been expected to be replaced within the first 12,100 hours of data. At the Icahn Lab, illuminance levels after 7,400 hours of operation were also greater than the initial levels with a maintained uniformity ratio.²¹ The average illuminance for the integral LED lamps at St. Anthony Hospital also still met the relevant IES requirements after 8,800 hours.²² While the retrofit kits installed in UMD's CSPAC varied in performance, the illuminance was above 70% of initial after an estimated 5,000 operating hours.²³ Although additional illuminance data was not collected, after 17,000 hours of operation only one of the 135 modules may need to be replaced, whereas the incumbent halogen lamps with a 1,500 hours rated life would have been replaced 11 times within the first 17,000 hours. Thus, from an energy and maintenance savings standpoint, the conversion was worthwhile.

Figure 10. Overall maintained illuminance for the Hilton Hotel new downlights, UMD CSPAC wall washer retrofit kits, Icahn Lab downlight retrofit kits, and St. Anthony replacement lamps based on the hours of operation at the time the measurements were collected. The average maintained illuminance percentage is marked by an X, while the minimum and maximum values are marked with circles, connected by a dotted line. If the range in performance is small, the average may not be marked and the circles may overlap.
