# NDE of Novel Materials (CFRP)

**Muthu Elen, Nicholas Conway, Aaron Diaz**  
Pacific Northwest National Laboratory

**Summary Deliverable through FY24**

Prepared for the U.S. Nuclear Regulatory Commission  
Office of Nuclear Regulatory Research  
Under Contract DE-AC05-76RL01830  
Master Interagency Agreement: A2307-031-089-048662  
Task Order Number: 31310024S0062

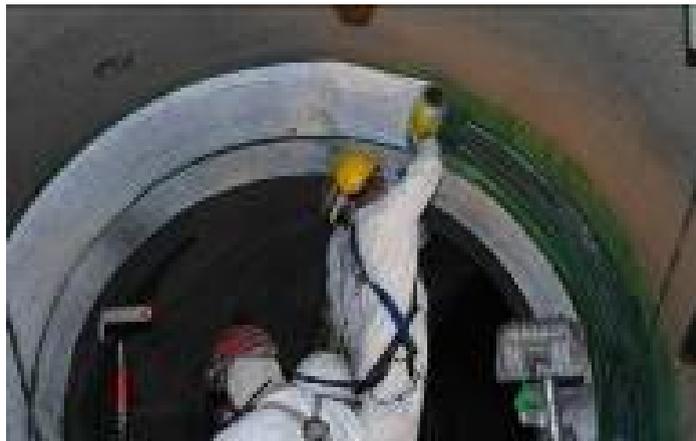
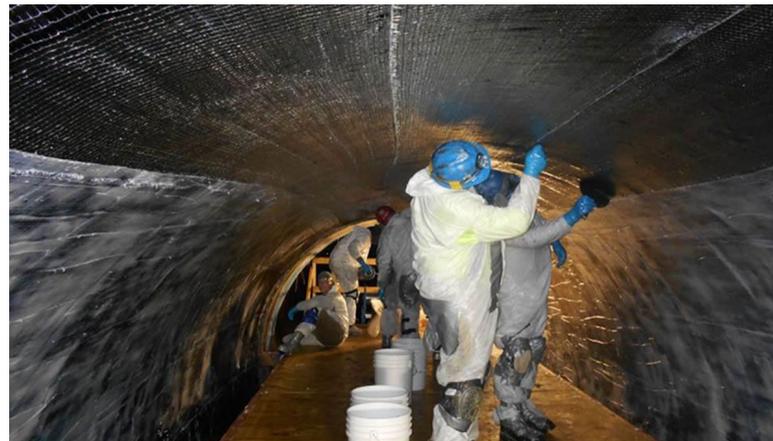
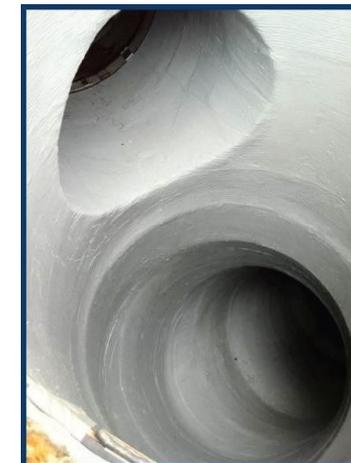
- CFRP repairs have been performed in NPPs for several non-safety-related piping systems
- Examples:
  - A) Repair and strengthening of 700 linear feet of 10-ft-diameter PCCP concrete pipe with CFRP at San Juan Generating Station in Farmington, NM, performed in 2007 by QuakeWrap Inc.
  - B) 57 linear feet of 144-in.-diameter PCCP pipeline repairs at Hope Creek Nuclear Generating Station, NJ, by Structural Technologies
  - C) 84-in.-diameter cement mortar lined steel piping at Brunswick NPP, Southport, NC, by Fyfe Company and Fibrwrap<sup>®</sup> Construction

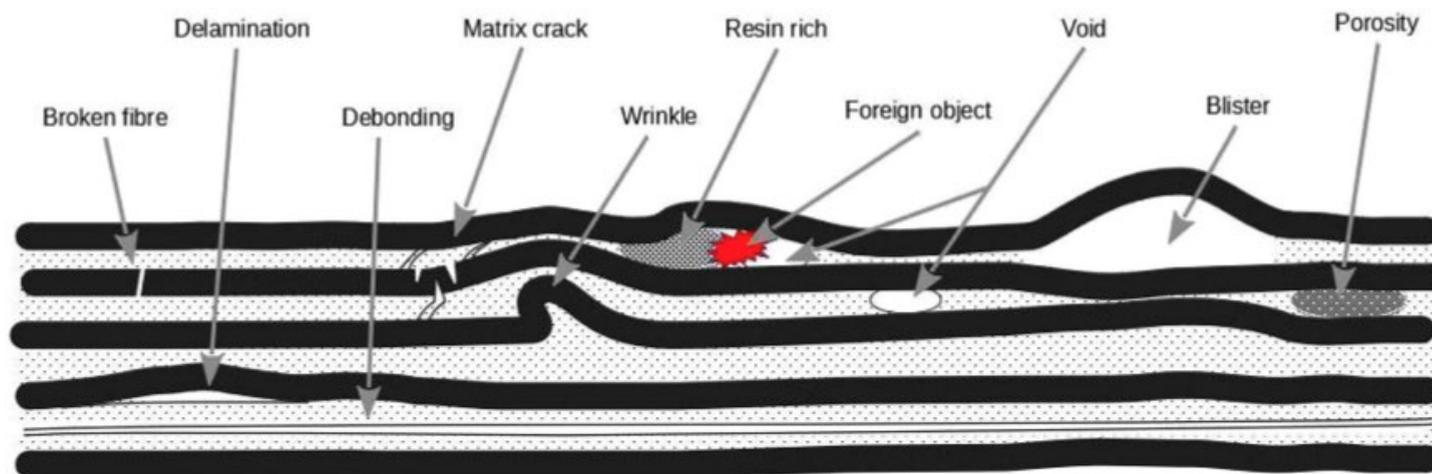
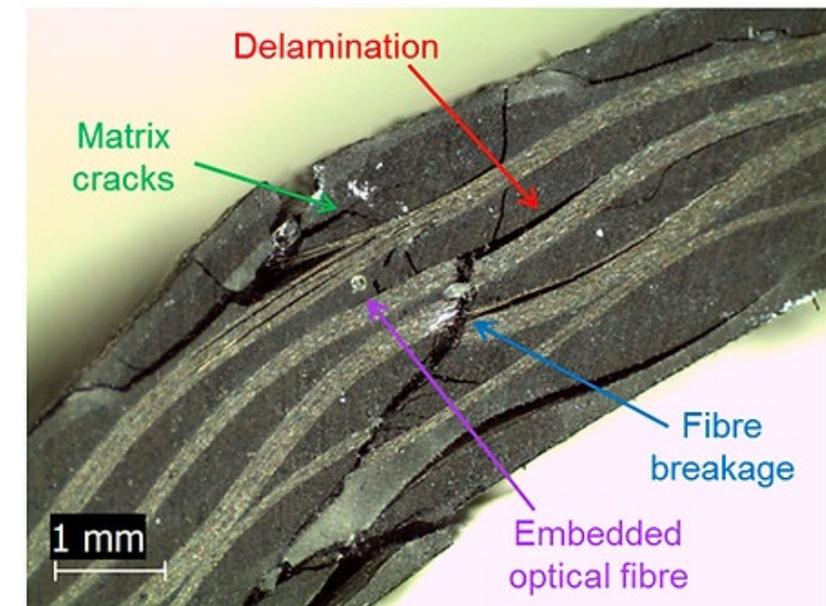
The most common defects during the manufacturing process and service life of fiber reinforced composites fabricated by hand-layup process are delamination, debonding, matrix cracks, wrinkles, resin-rich areas, voids, porosity, and fiber breakage.

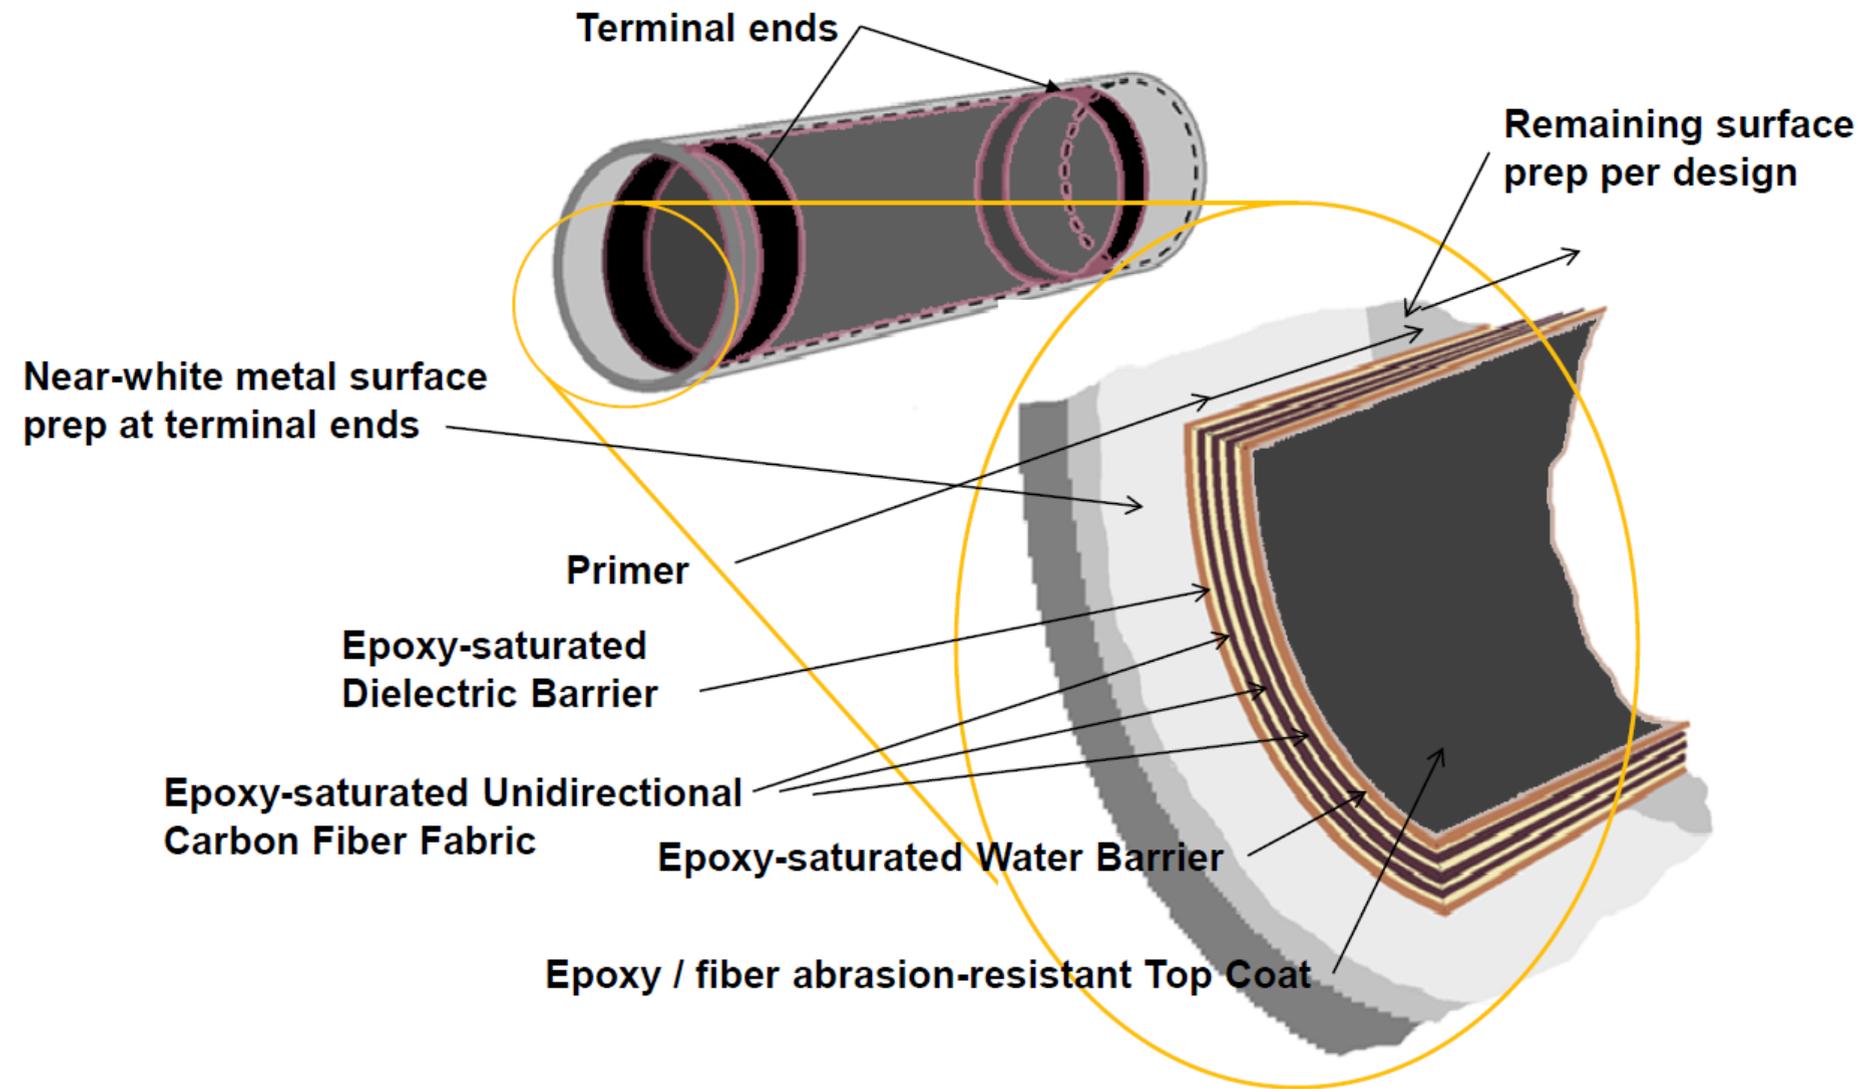
Figure on “CFRP Repair” from ML20014E606, Jim O Sullivan, “Code Case N-871-1 Status Update,” NRC Technical Exchange meeting, 2020

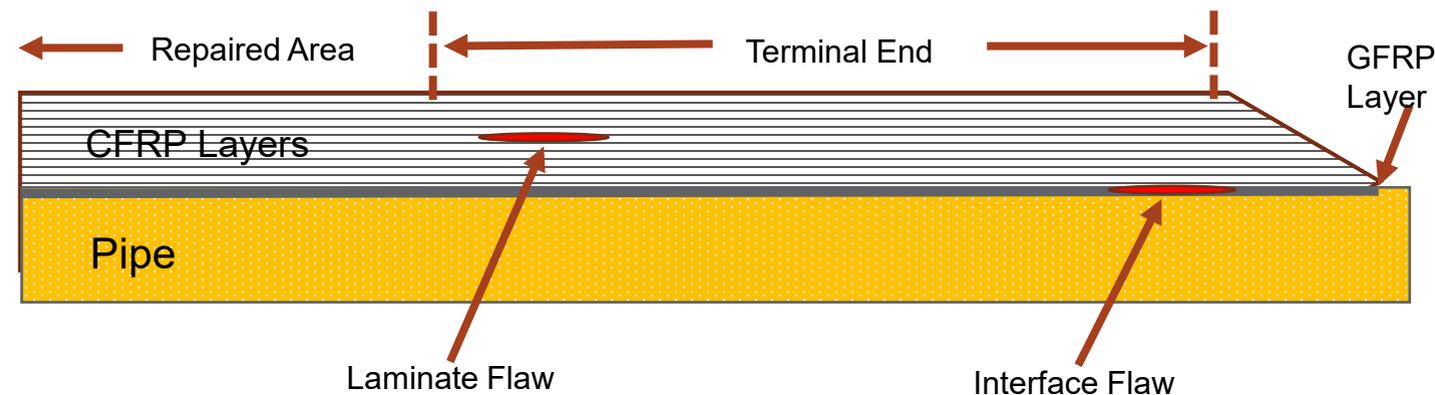
- The most critical examinations are:
  - The substrate at the terminal end under the composite
  - The bond between the substrate and composite
  - The integrity of the underlying substrate at the terminal end and the composite to metal bond is critical for load transfer
  - If terminal end fails to retain structural integrity or the bond fails, it is reasonable to expect that the repair will fail to function as intended
- The second-most critical examinations are for laminar flaws (voids or delaminations) within the composite laminate itself

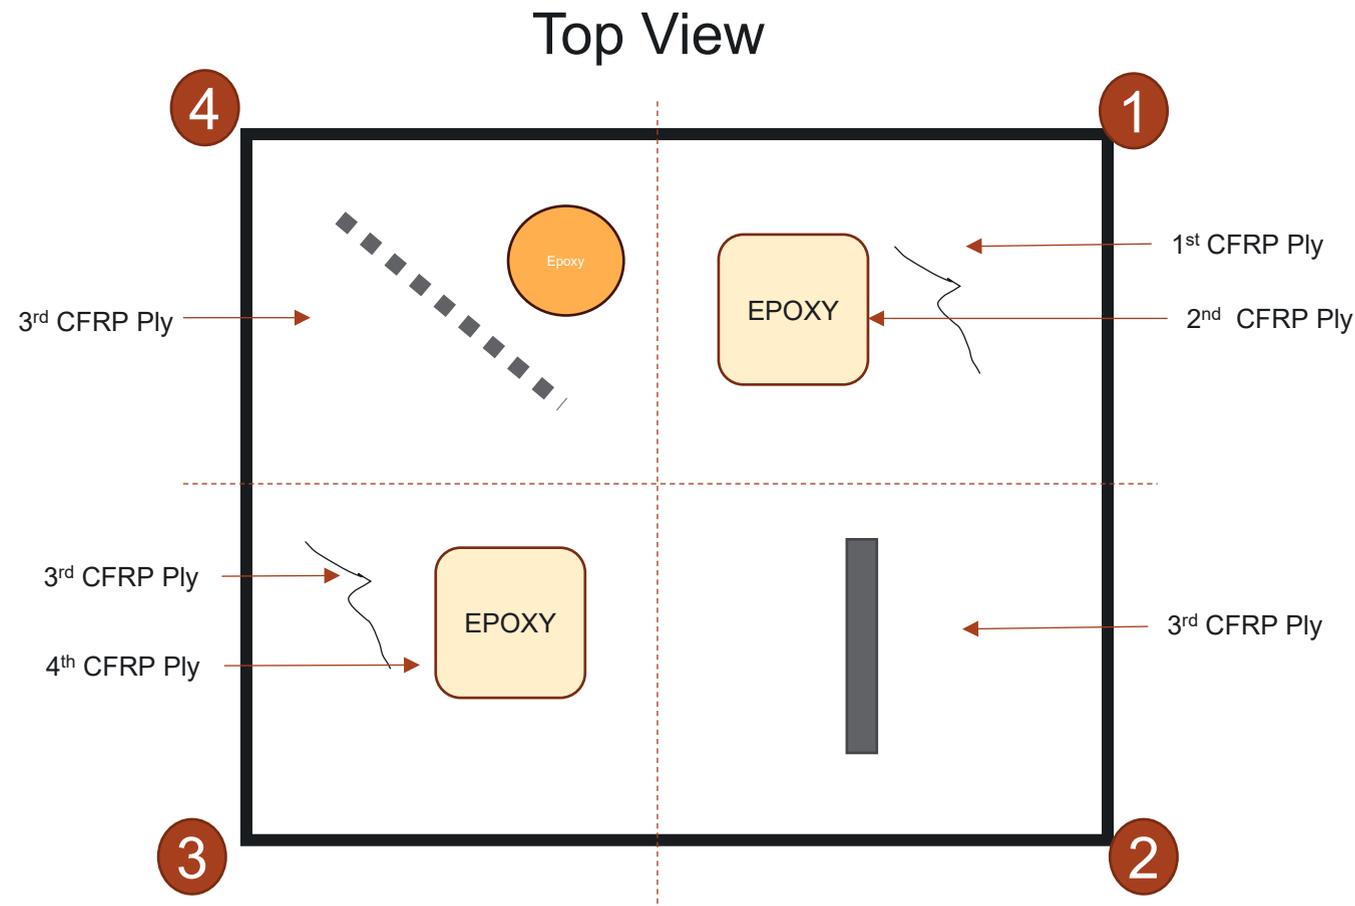
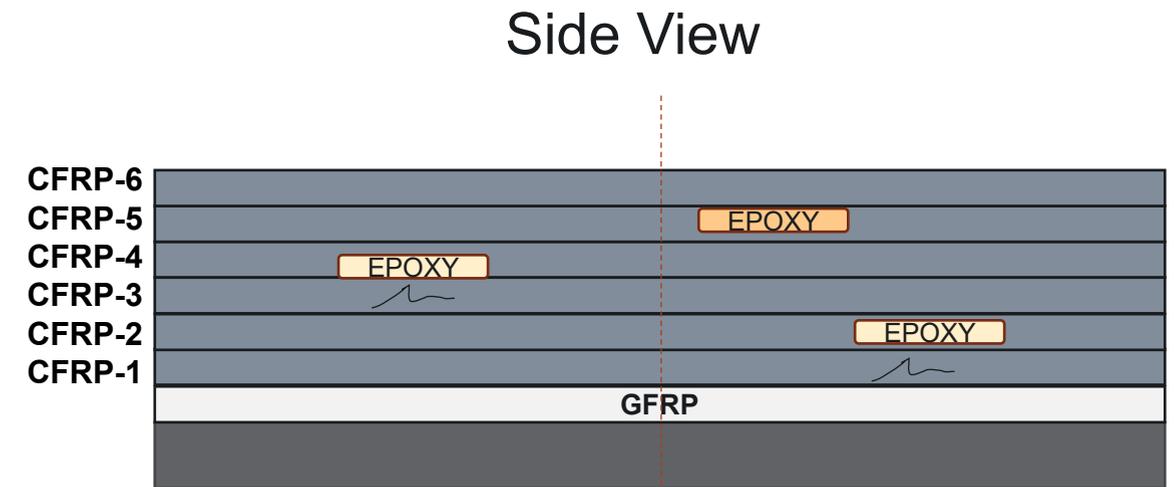
# CFRP Mockup: Generic Design

*\*Putty and Topcoat are not shown*

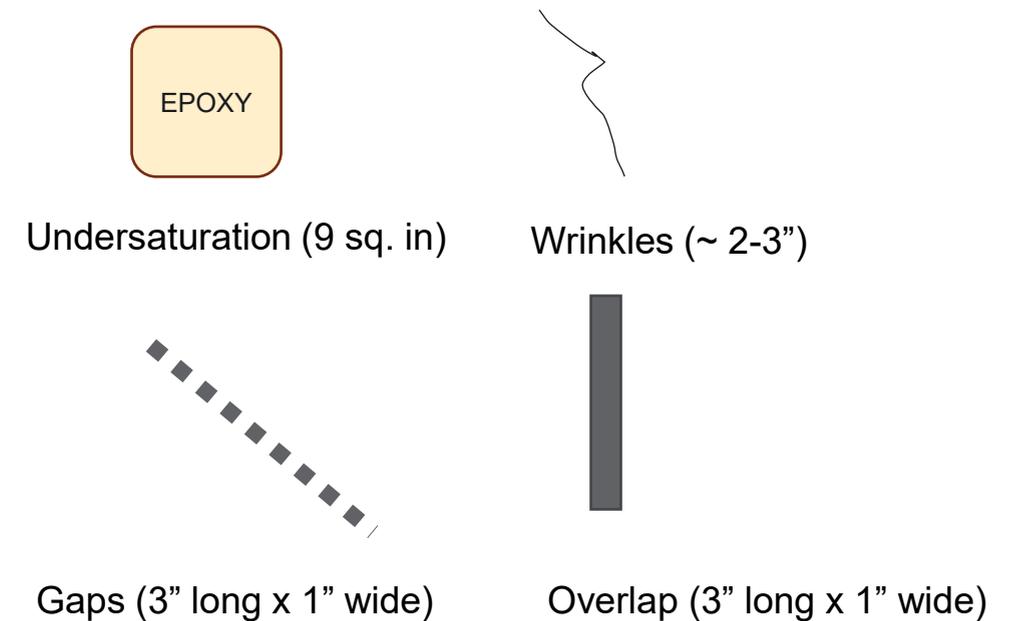
Undersaturation of Epoxy (9 sq. in) – 1<sup>st</sup> quadrant of 2<sup>nd</sup> CFRP Ply, 3<sup>rd</sup> quadrant of 4<sup>th</sup> CFRP Ply  
 Undersaturation of Epoxy (3 sq. in) - 4<sup>th</sup> quadrant of 5<sup>th</sup> CFRP Ply  
 Wrinkles – 1<sup>st</sup> quadrant of 1<sup>st</sup> CFRP, 2<sup>nd</sup> quadrant of 3<sup>rd</sup> CFRP, 3<sup>rd</sup> quadrant of 5<sup>th</sup> CFRP  
 Gaps – 4<sup>th</sup> quadrant of 3<sup>rd</sup> CFRP Ply  
 Overlap - 2<sup>nd</sup> quadrant of 3<sup>rd</sup> CFRP Ply

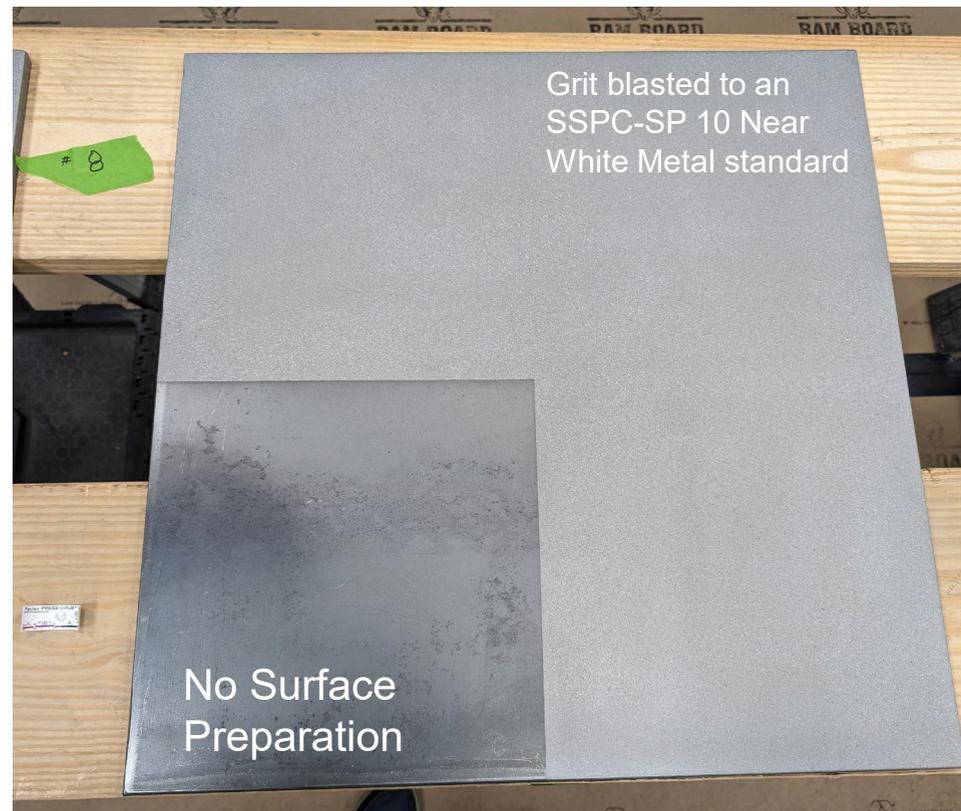
**Plate 8**

- #8 with a different surface preparation, as described in the figure
- #3 with 1 layer of glass fiber fabric, with 10.3% thickened epoxy underneath, applied at 0.031-in. thickness
- #6 with 1 layer of glass fiber fabric, with 10.3% thickened epoxy underneath it, applied at 0.125-in. thickness

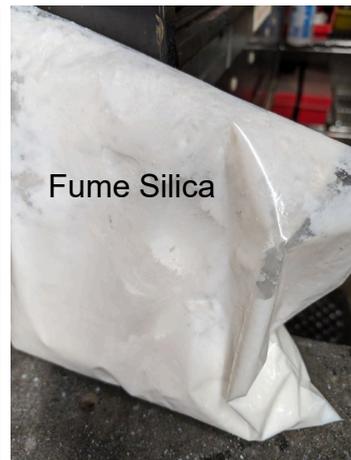
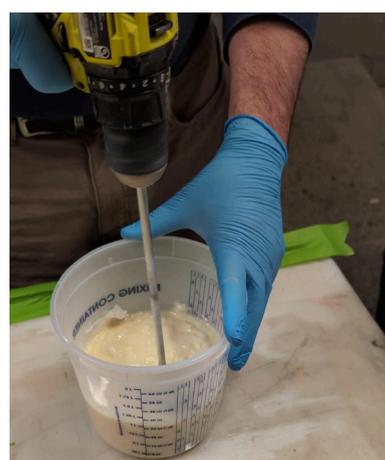
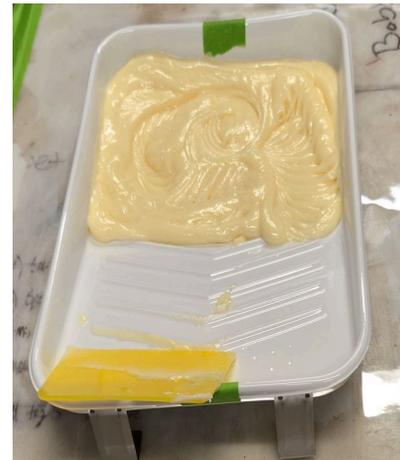
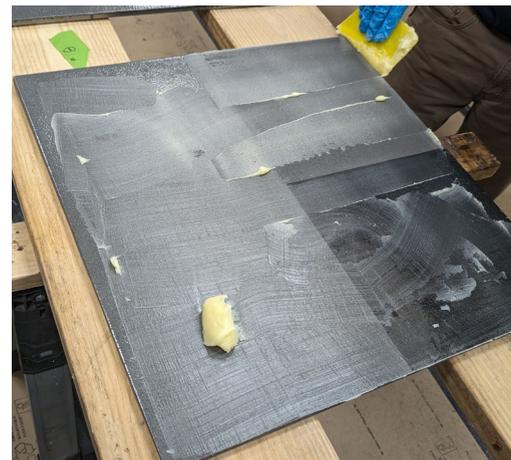
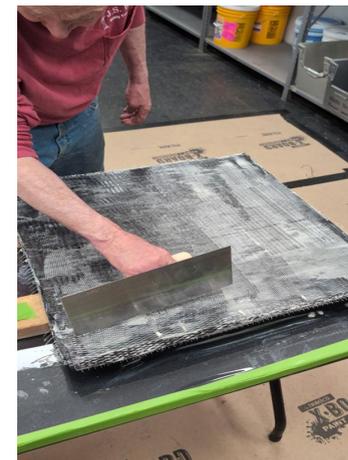
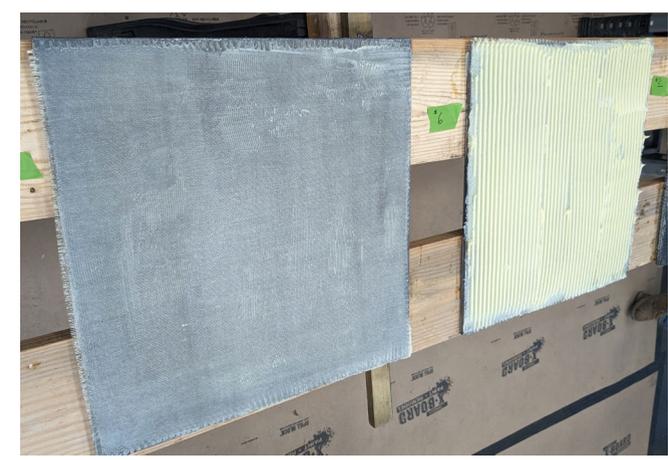
## Step 2 : Preparation and Application of Putty

**Steps 2, 3, 4 are repeated for each CFRP or GFRP layer as per the design**

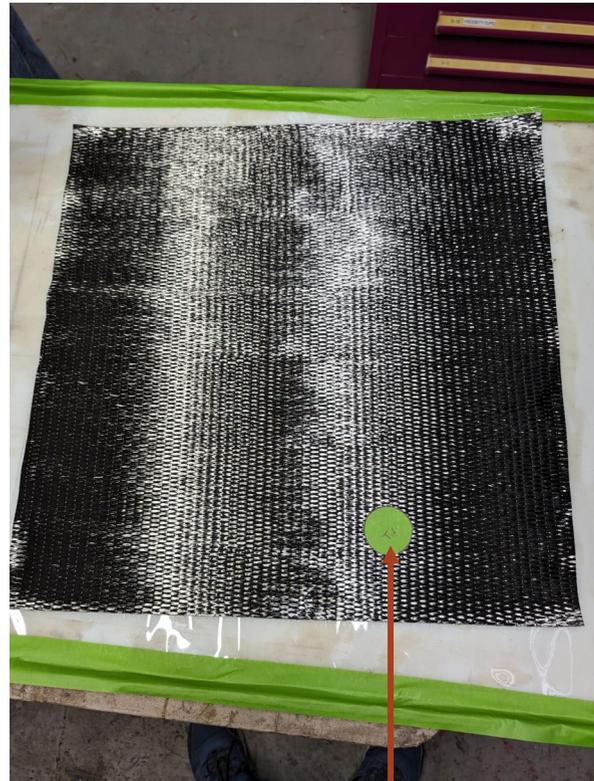
Dry Spot

## Placement of Defects

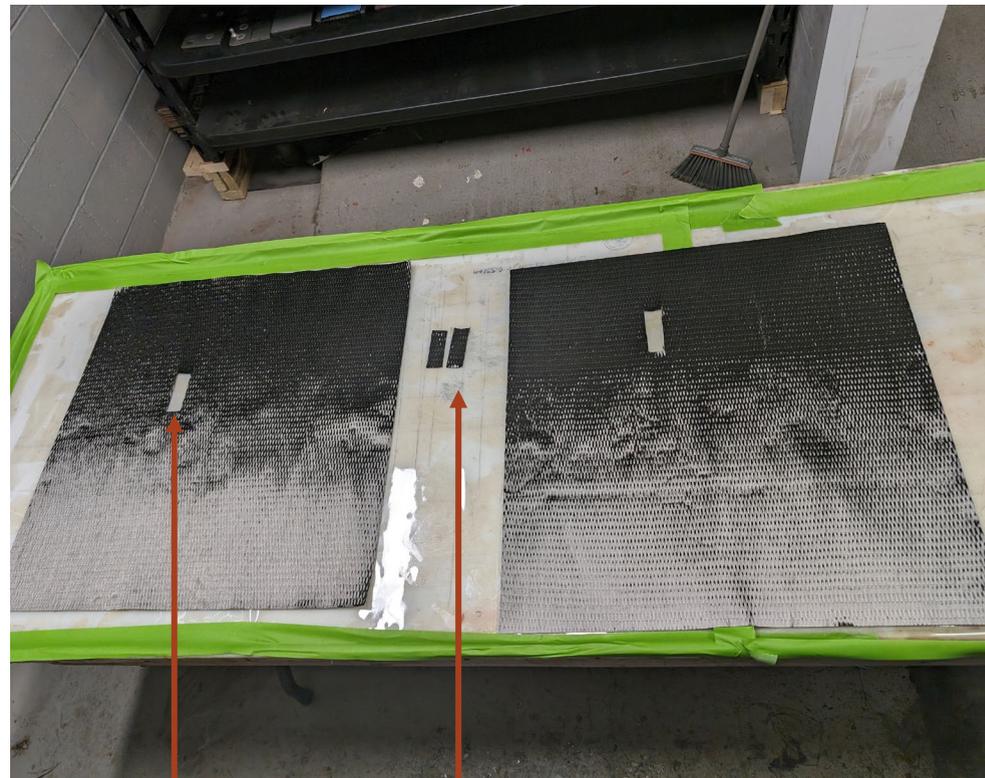
Gap

Fabric for  
Overlap

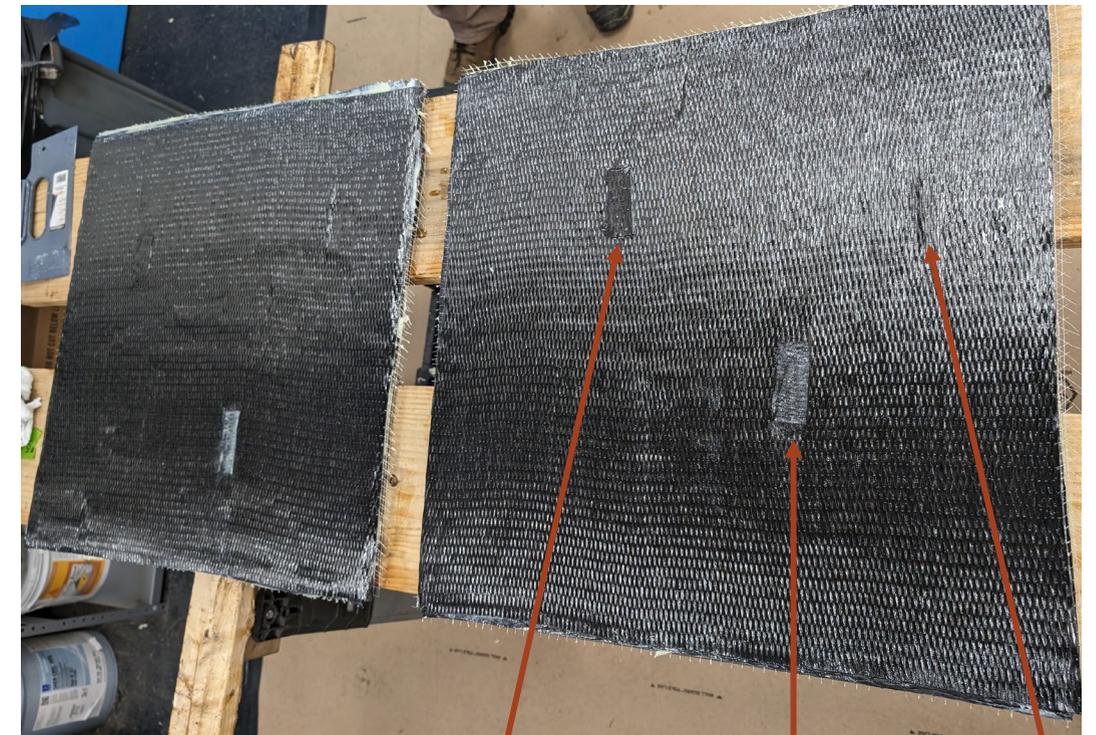
Overlap

Gap

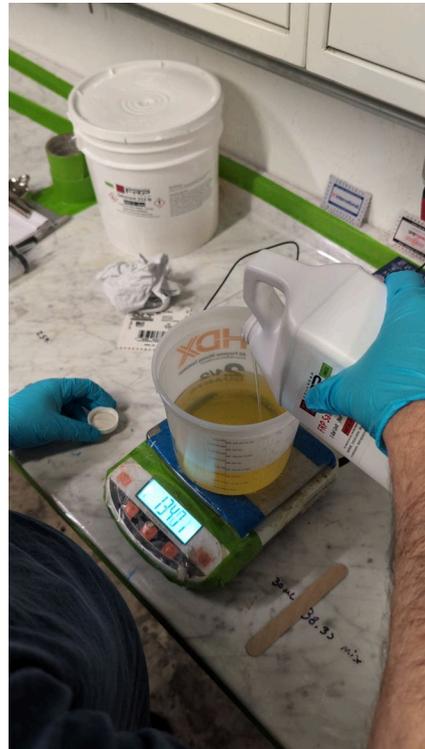
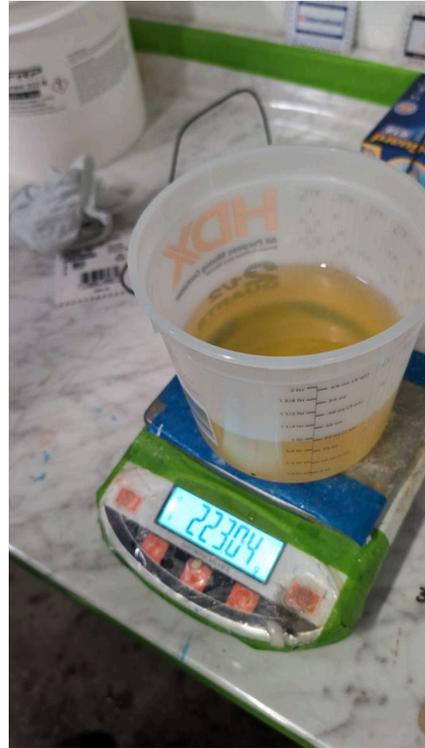
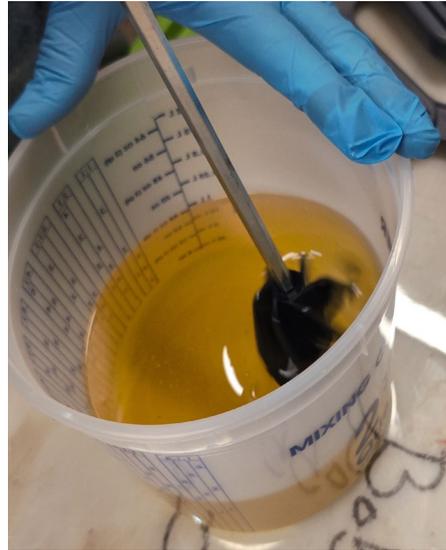
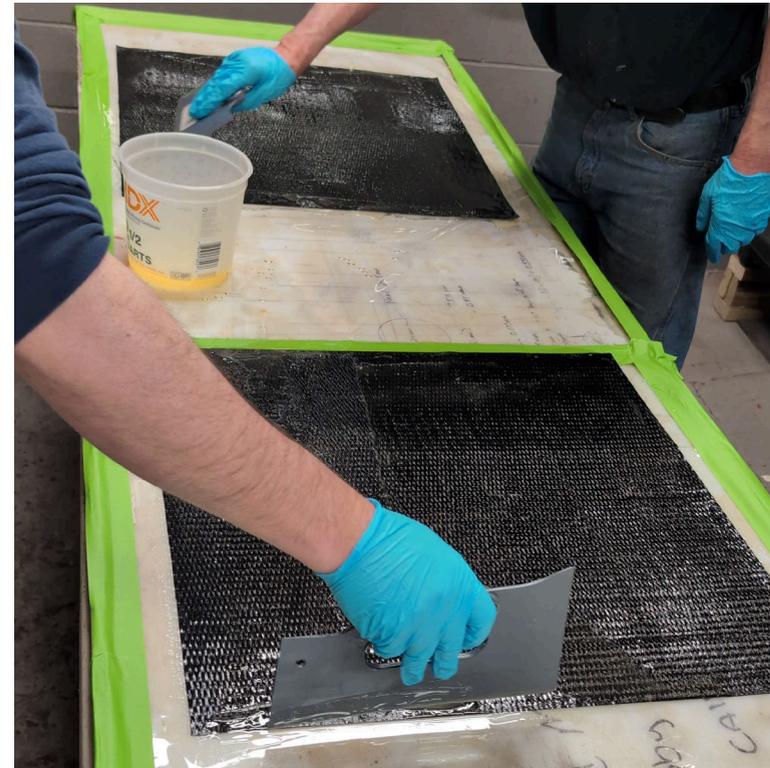
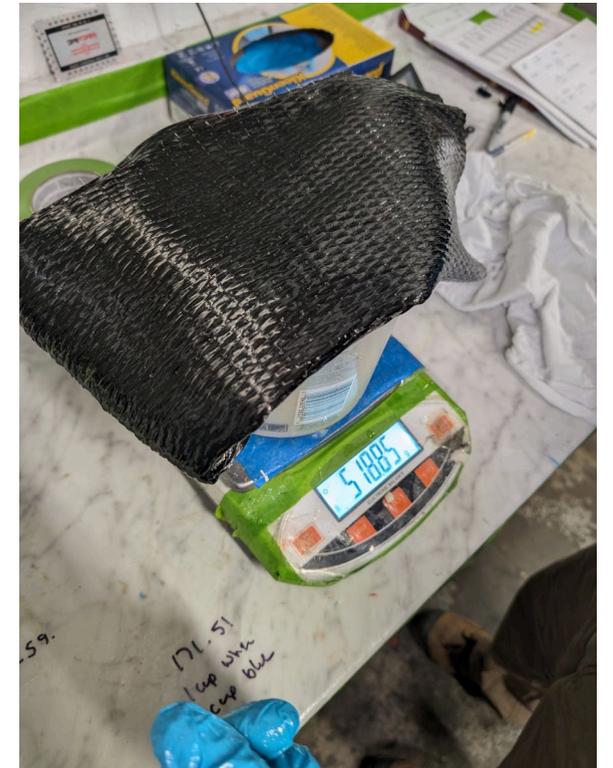
# CFRP Mockup Fabrication: Fabric Saturation

The fabrics were saturated manually (by hand). The resin was mixed in appropriate ratios as per the manufacturer's recommendations, weighed, and applied to the fabrics. The resin-impregnated fabrics were weighed again to ensure and achieve the correct fiber-volume ratio required as per the installer's specifications.

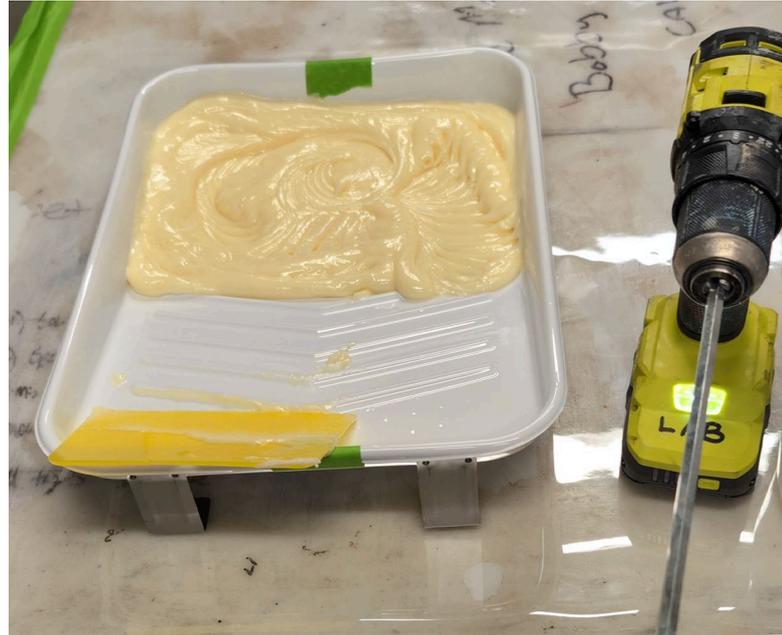
Mixed putty

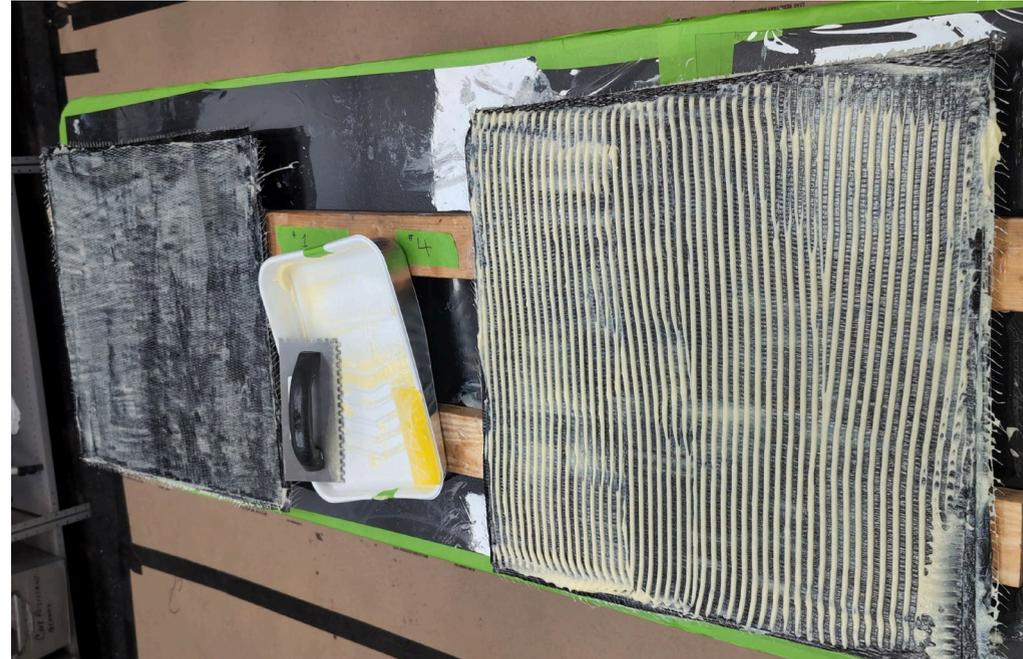
Applied putty at 0.031 in. and 0.125 in. thickness on CF layer

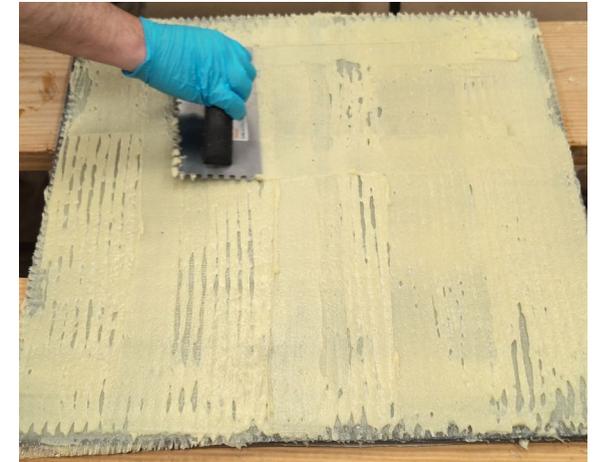
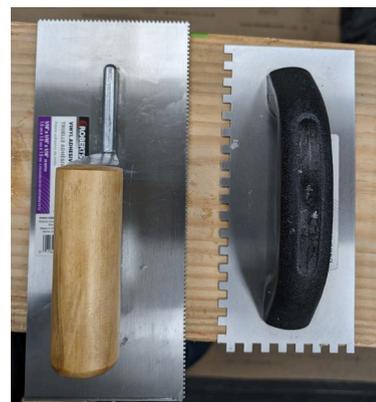
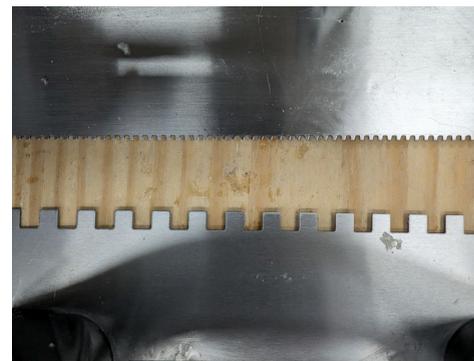
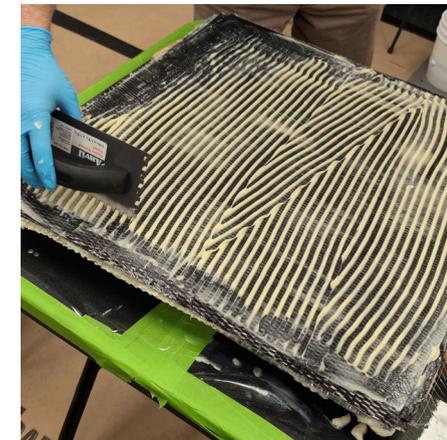
Trowels used to maintain the thickness of putty

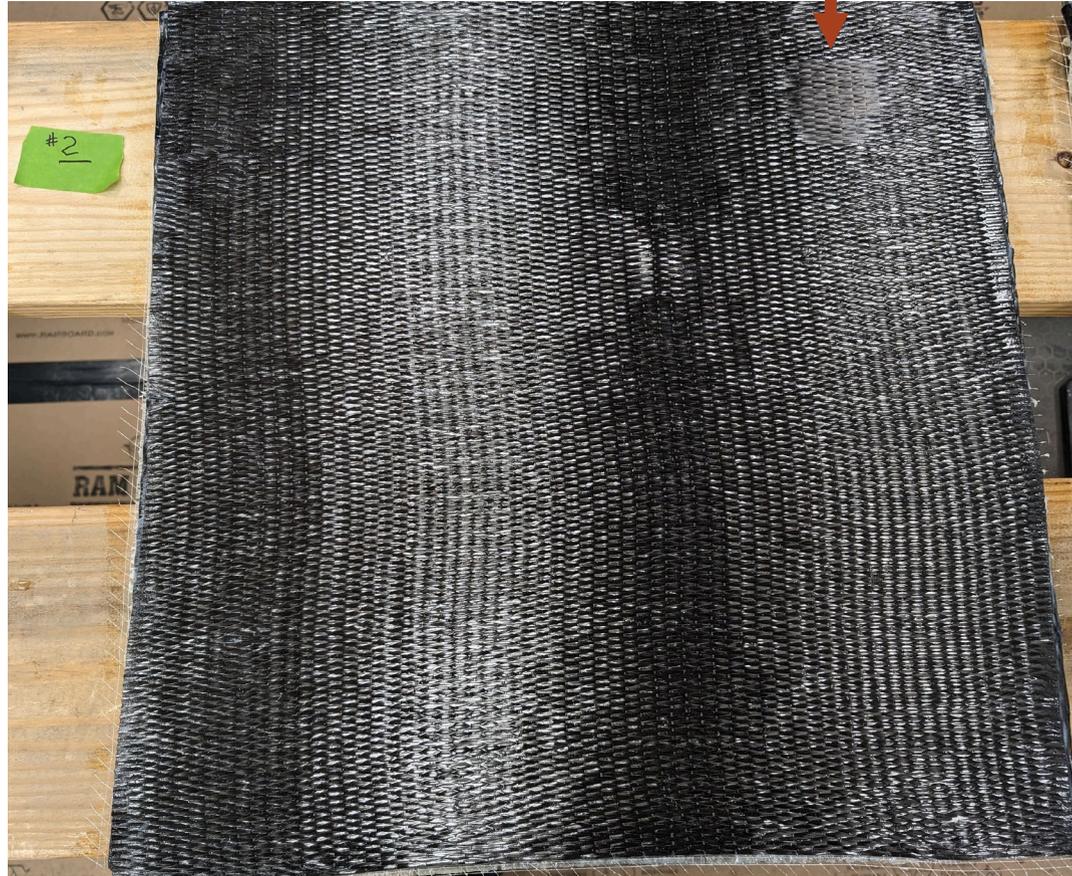
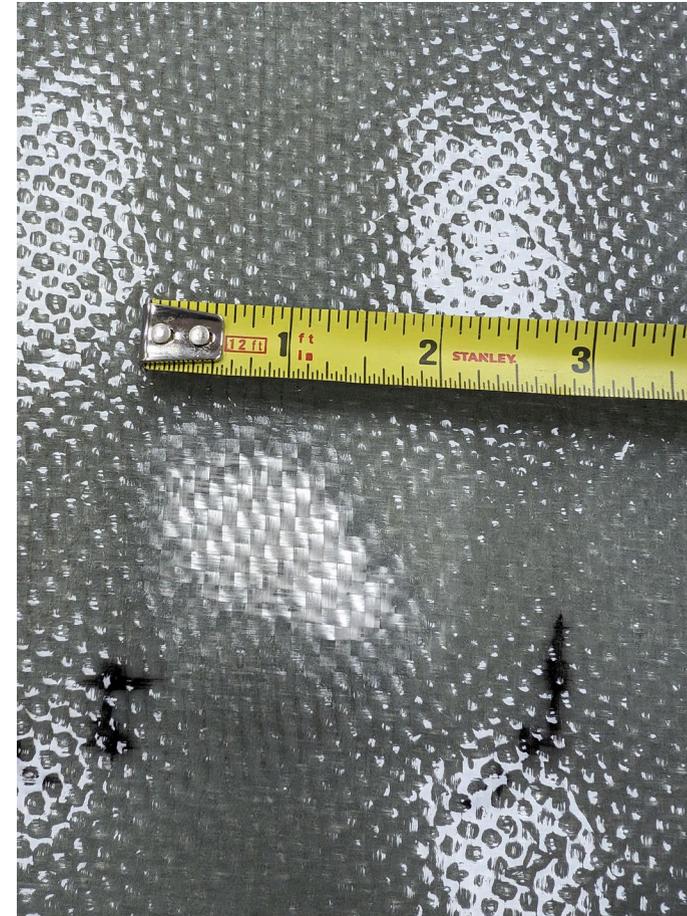
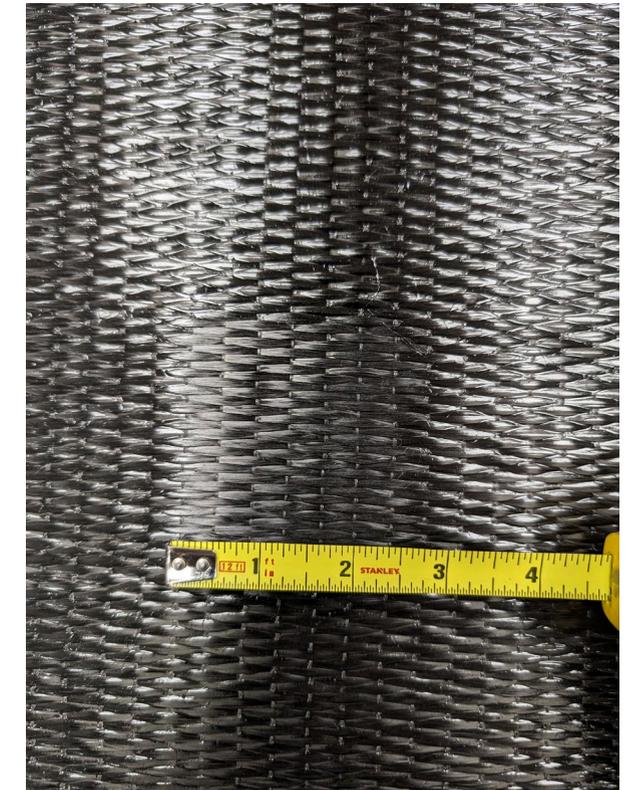
# CFRP Mockup Fabrication: Planned vs. Actual Defect Size

The above figures show the undersaturated epoxy spots. These dry spots were planned to be 3 in. × 3 in. squares, but due to the resin saturation the dry spot size decreased to be between ~2 in. to 2.5 in. in both dimensions

- As per the test plan, 3 in. × 3 in. square flaw was planned; however, due to resin saturation from the edge of the planned defect location, the size of the dry spot was reduced to ~2 in. × 2 in. square flaw

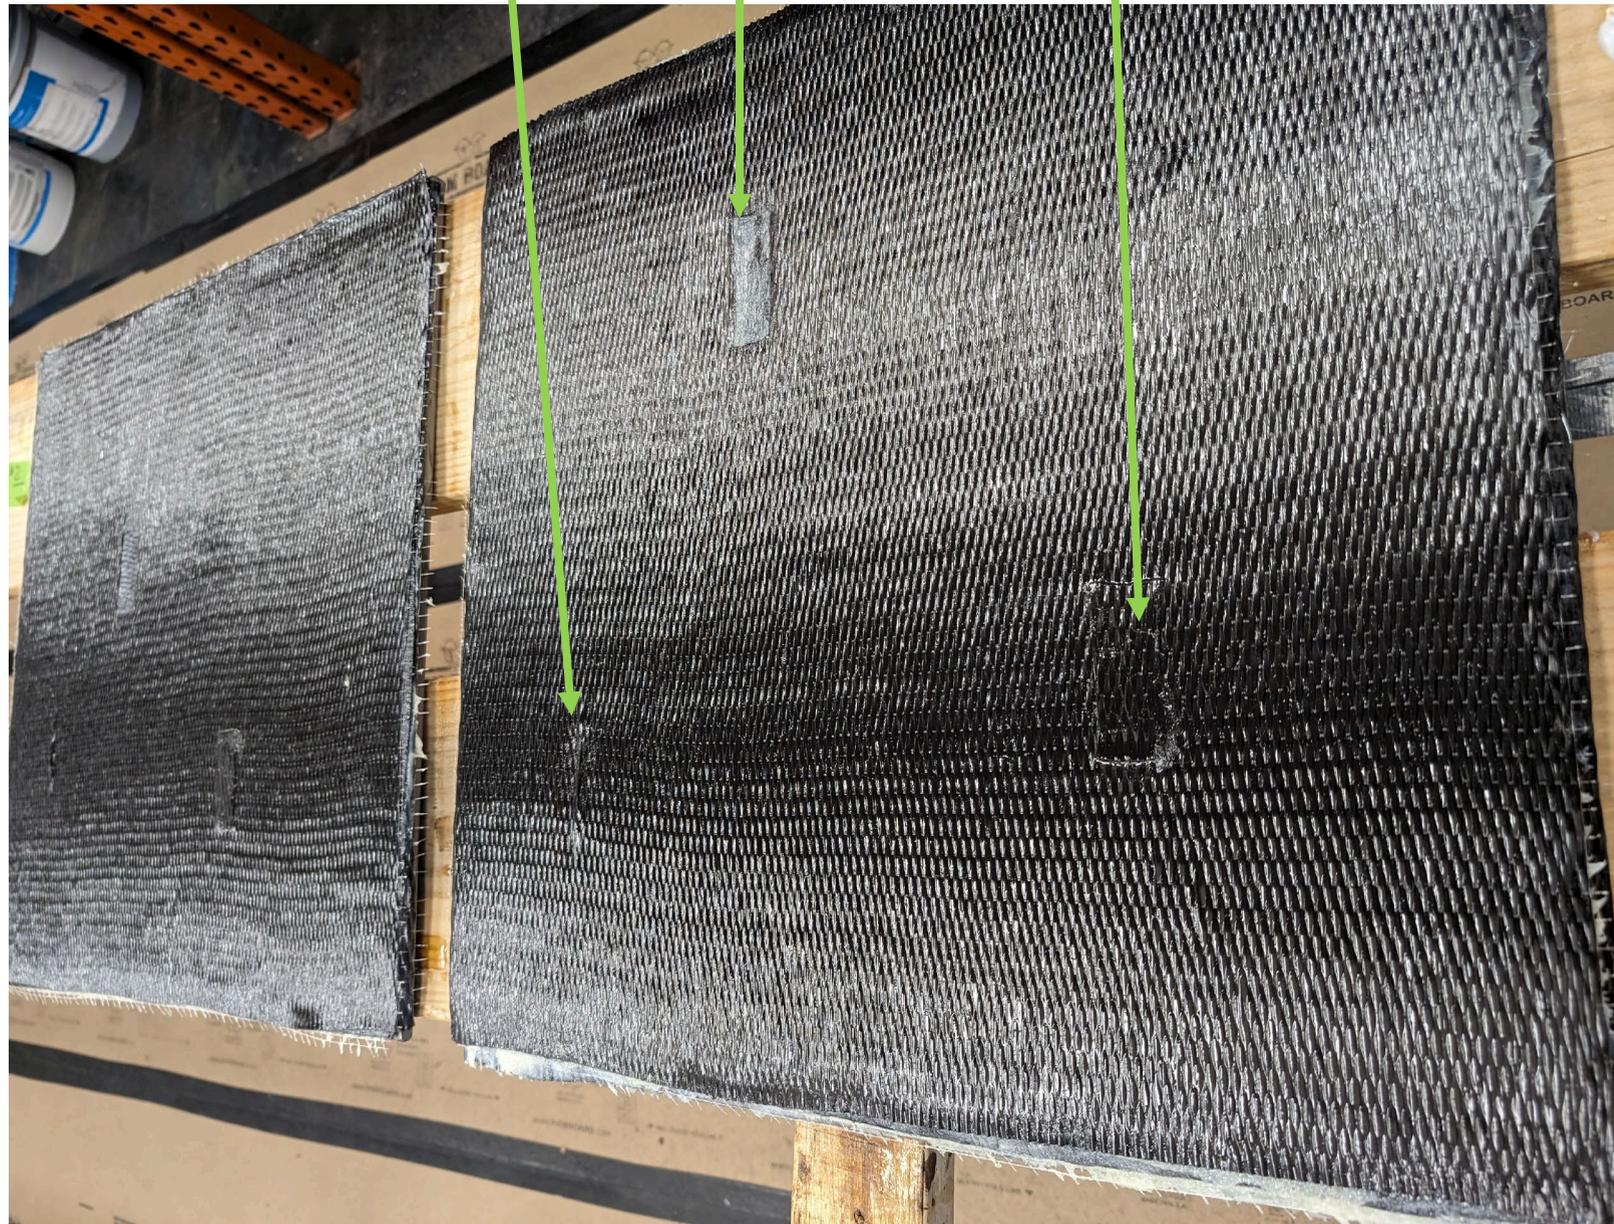
# CFRP Mockup Fabrication: Other Defects

gap

overlap

This figure shows an overlap in the 2<sup>nd</sup> quadrant, a wrinkle in the 3<sup>rd</sup> quadrant, and a gap in the 4<sup>th</sup> quadrant on the 3<sup>rd</sup> CFRP ply

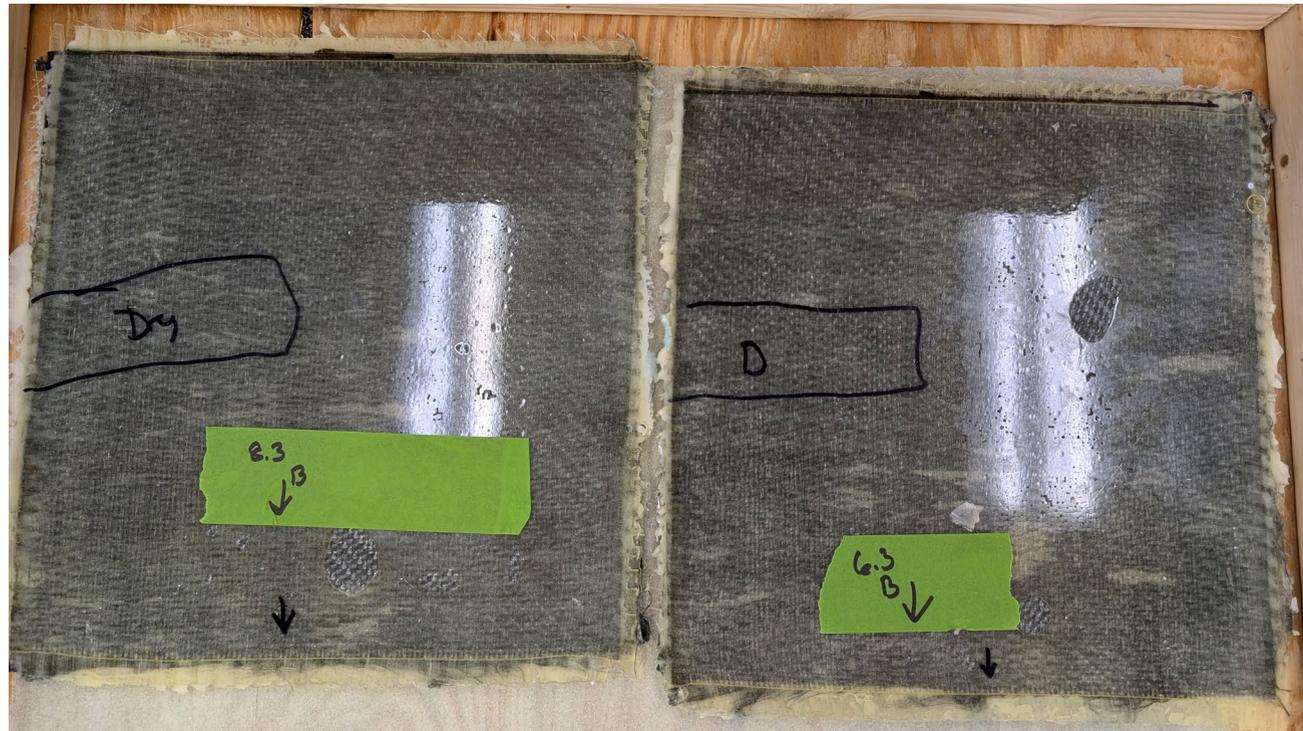
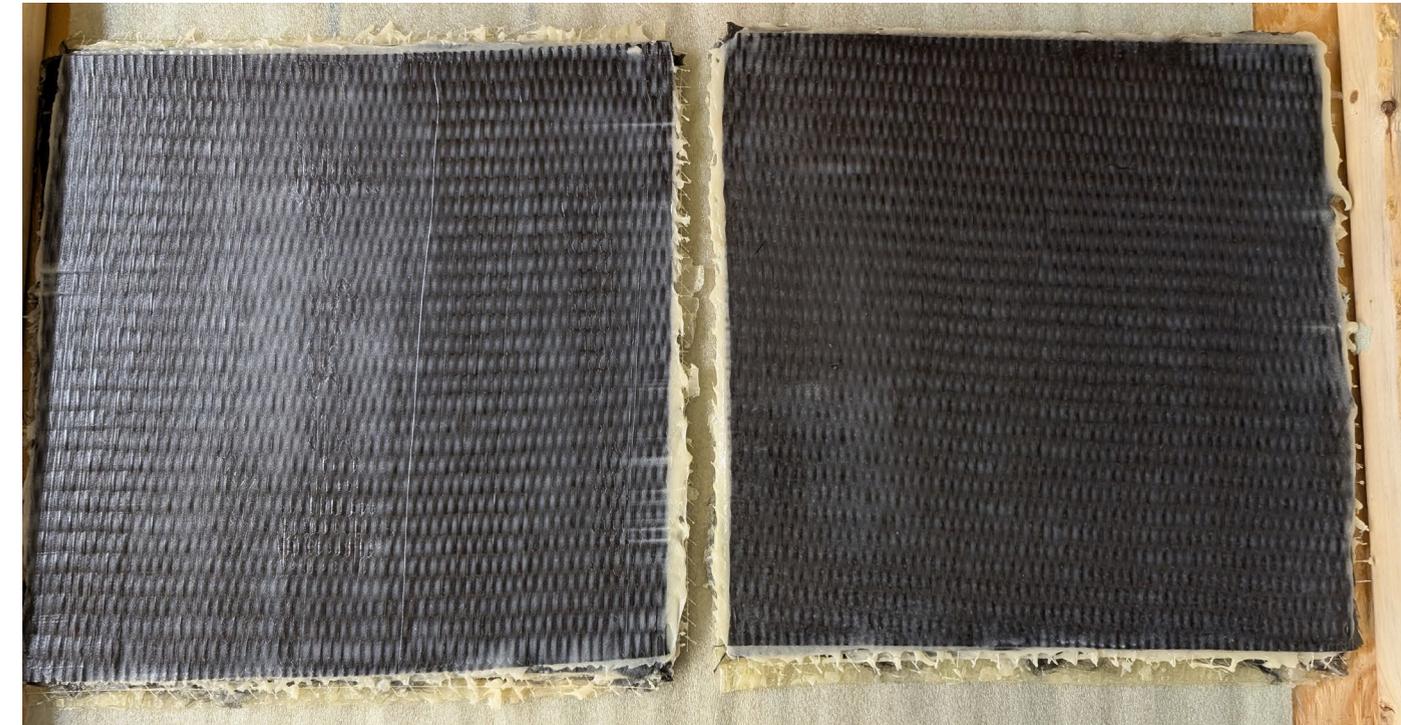
# CFRP Panels (No Metal Substrate)

- Two composite panels of 12 in. × 12 in. with no substrate were also fabricated with 6.3% and 8.3% amounts of putty
- Same layup sequence as CFRP plate mockups (1 layer GFRP + 6 layer CFRP)
- On the third CFRP ply, a dry spot defect was induced on one-half of the panel
- Putty was smoothed to a uniform thickness on these plates (0.031-in. thickness)

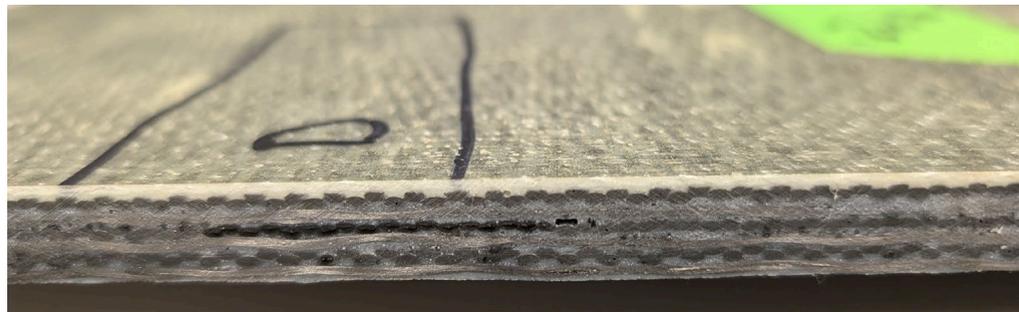
The CFRP panels were cut into smaller coupons to examine the dry spot region and application of putty

**CFRP panel with 6.3 % putty**

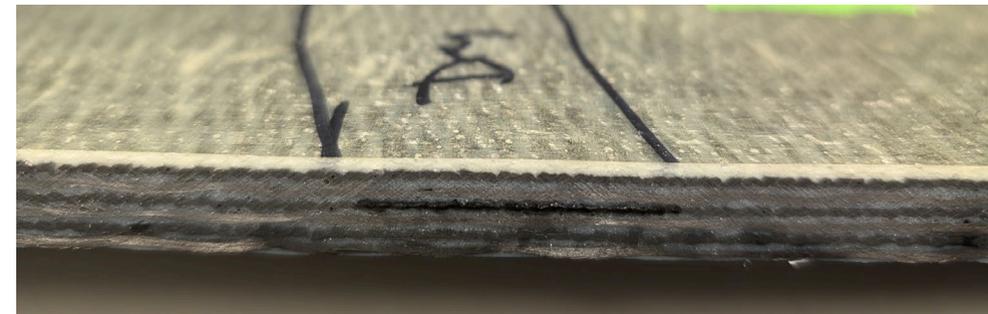
**CFRP panel with 8.3 % putty**
