# NDE of Novel Materials (CFRP)

**Muthu Elen, Nicholas Conway, Aaron Diaz**  
Pacific Northwest National Laboratory

**Summary Deliverable through FY24**

Prepared for the U.S. Nuclear Regulatory Commission  
Office of Nuclear Regulatory Research  
Under Contract DE-AC05-76RL01830  
Master Interagency Agreement: A2307-031-089-048662  
Task Order Number: 31310024S0062

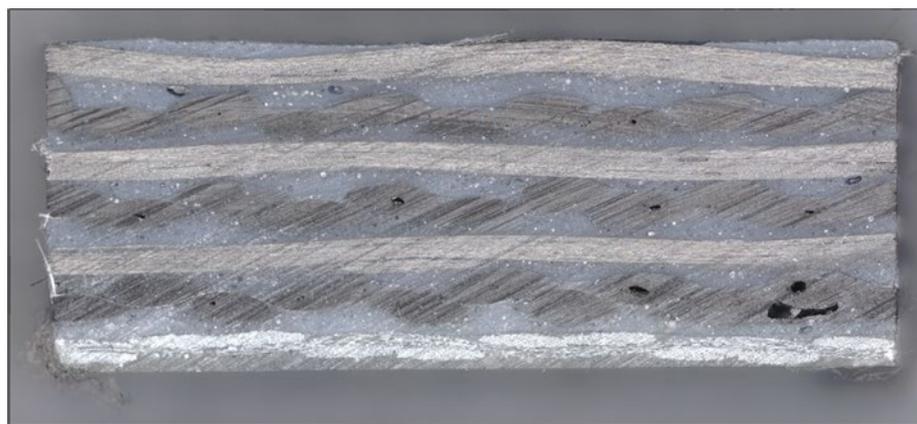
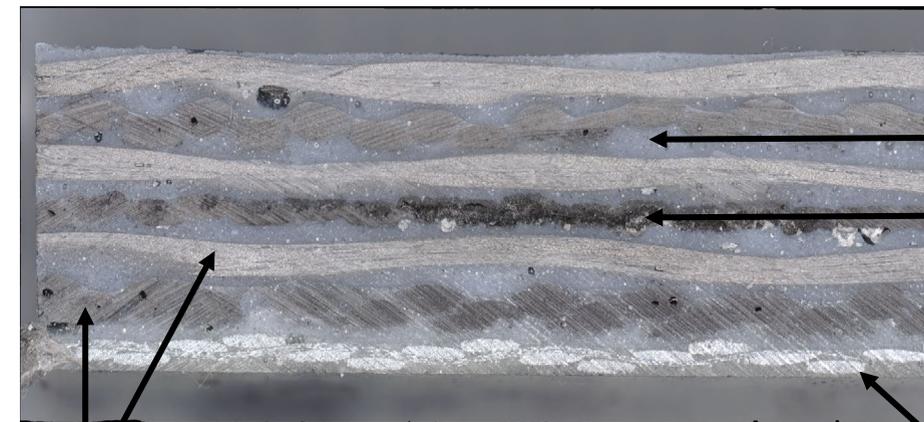
Optical microscope scans of cross-sections of 8.3% panel – without and with dry spot

Putty

Dry Spot

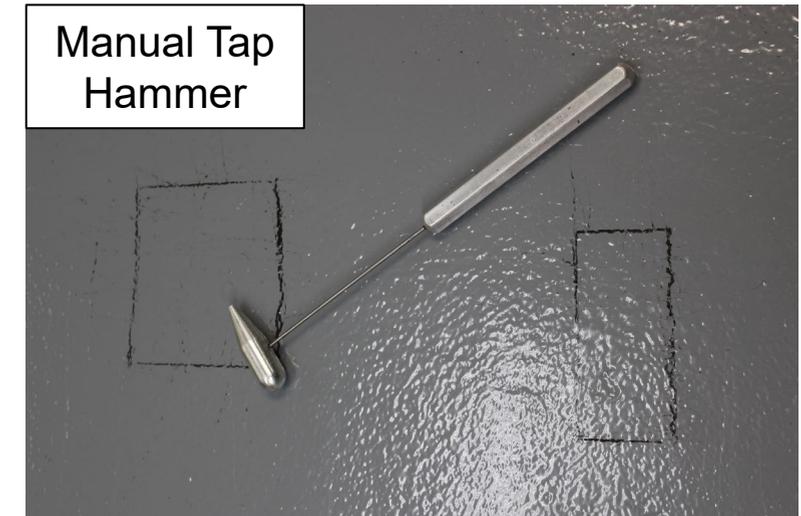
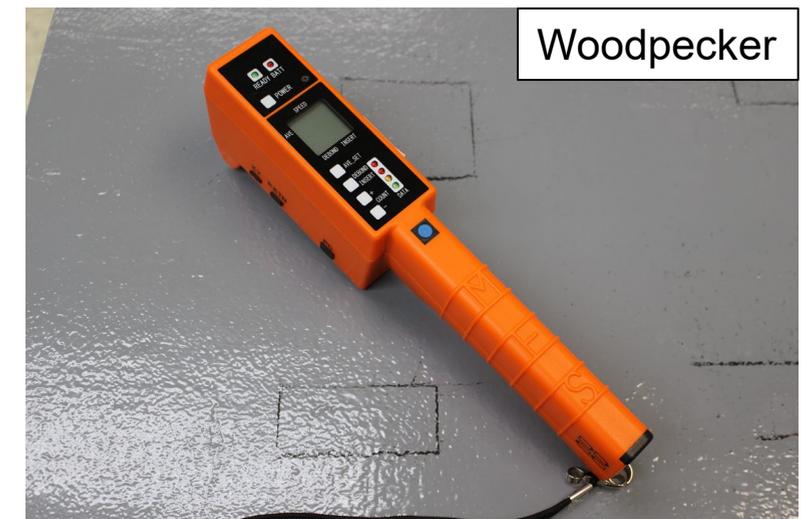
# Data Collection: Tap Testing Hardware

- Manual tap testing (MTT)
  - Aerospace tap hammer
  - Low-cost
  - Easily deployable
  - Requires trained inspector to interpret audible responses for flaw identification
- Automated tap testing (ATT)
  - Woodpecker WP-632AM-R
  - Uses a ratio of the response to a reference “good” location the operator collects to identify flawed regions
    - ✓ Not dependent on an individual’s hearing abilities
  - Records measurements (but not position)
  - Designed for inspection of thin laminates

- The ATT system (632 AM-R) had difficulties providing consistent responses
  - The system is designed for thin ( $\leq 4$  mm or 0.16 in.) laminates such as those used in aerospace

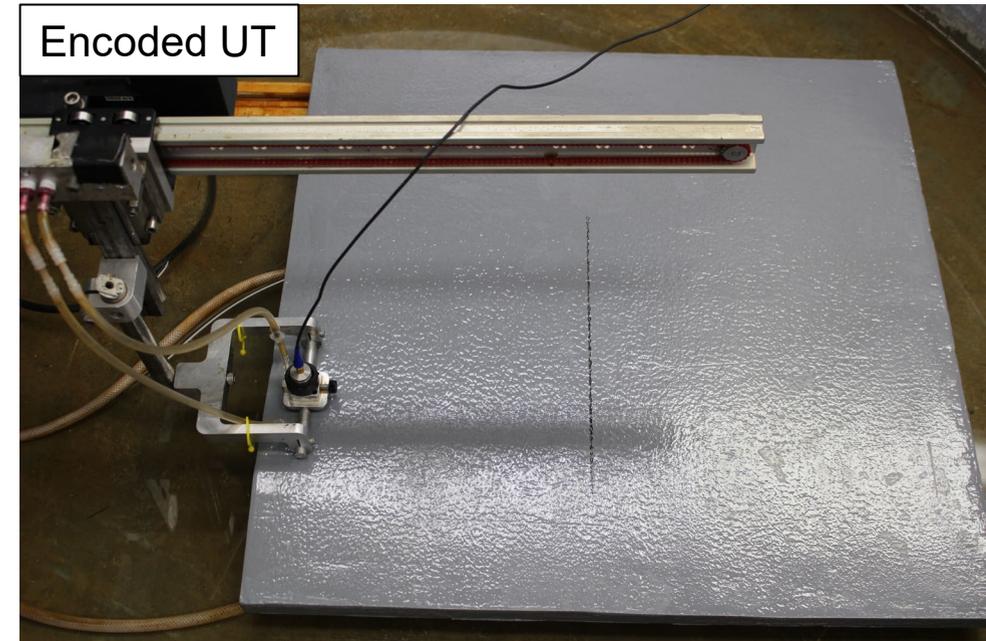
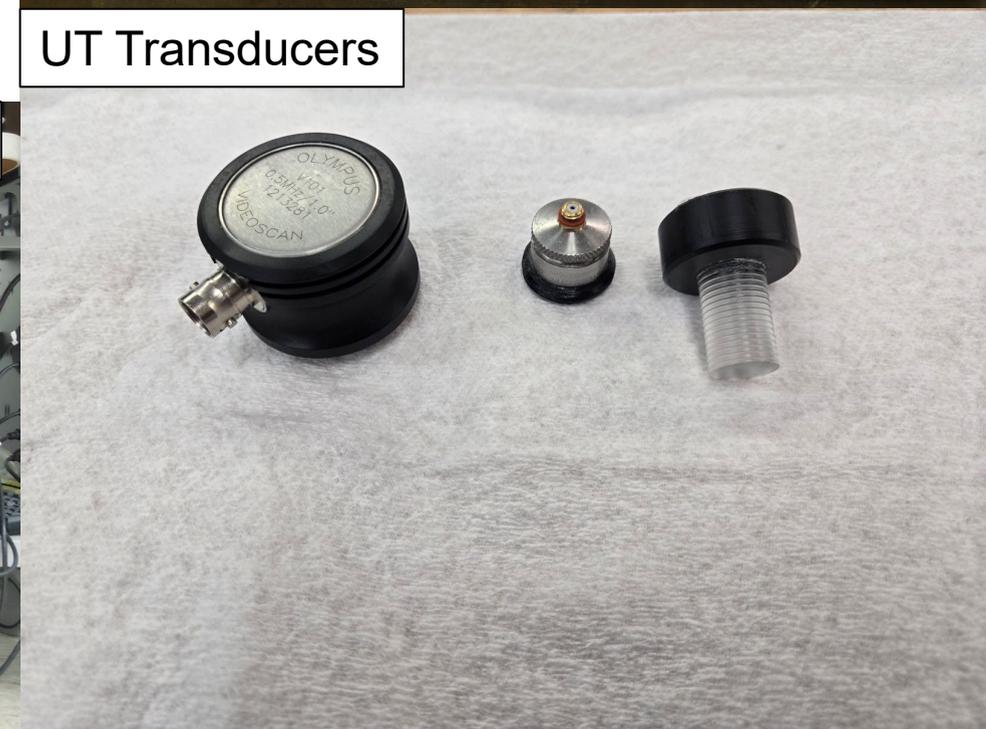
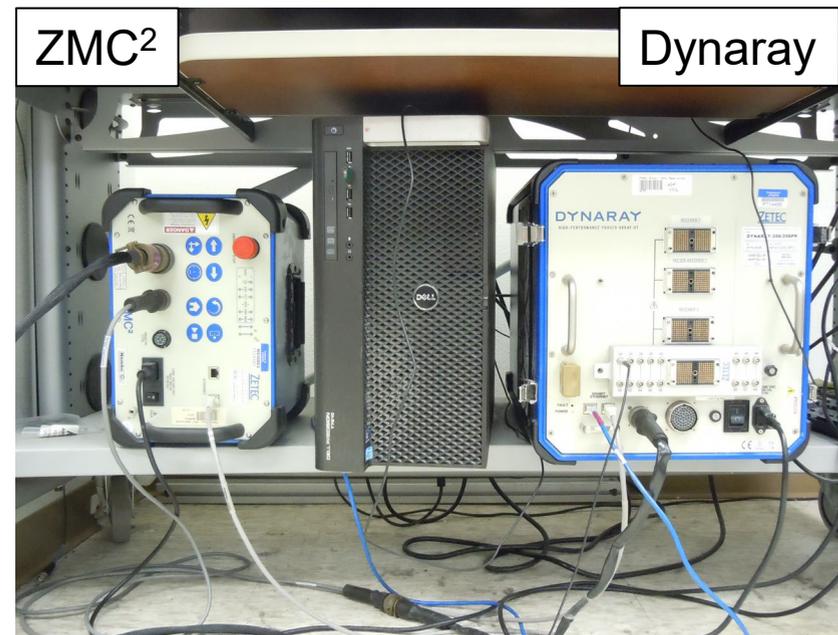
# Data Collection: UT Hardware

- Encoded/Automated pulse-echo ultrasonic testing (PE-UT) method
  - Zetec DYNARAY w/ ZMC<sup>2</sup> (UV3, 2.5-mm scan/step increment)
  - Olympus V101 (0.5 MHz, 1.0-in. diameter) and Krautkramer 389-057-070 BMC (1 MHz, 0.5-in. diameter w/ 1-in. Rexolite delay line)
    - Frequencies are chosen based on preliminary testing
    - Normal beam (i.e., 0-degree incident angle)
    - Contact probe
    - Pulse-echo
  - Volumetric inspection
  - Widely accepted
  - Couplant: Ultragel

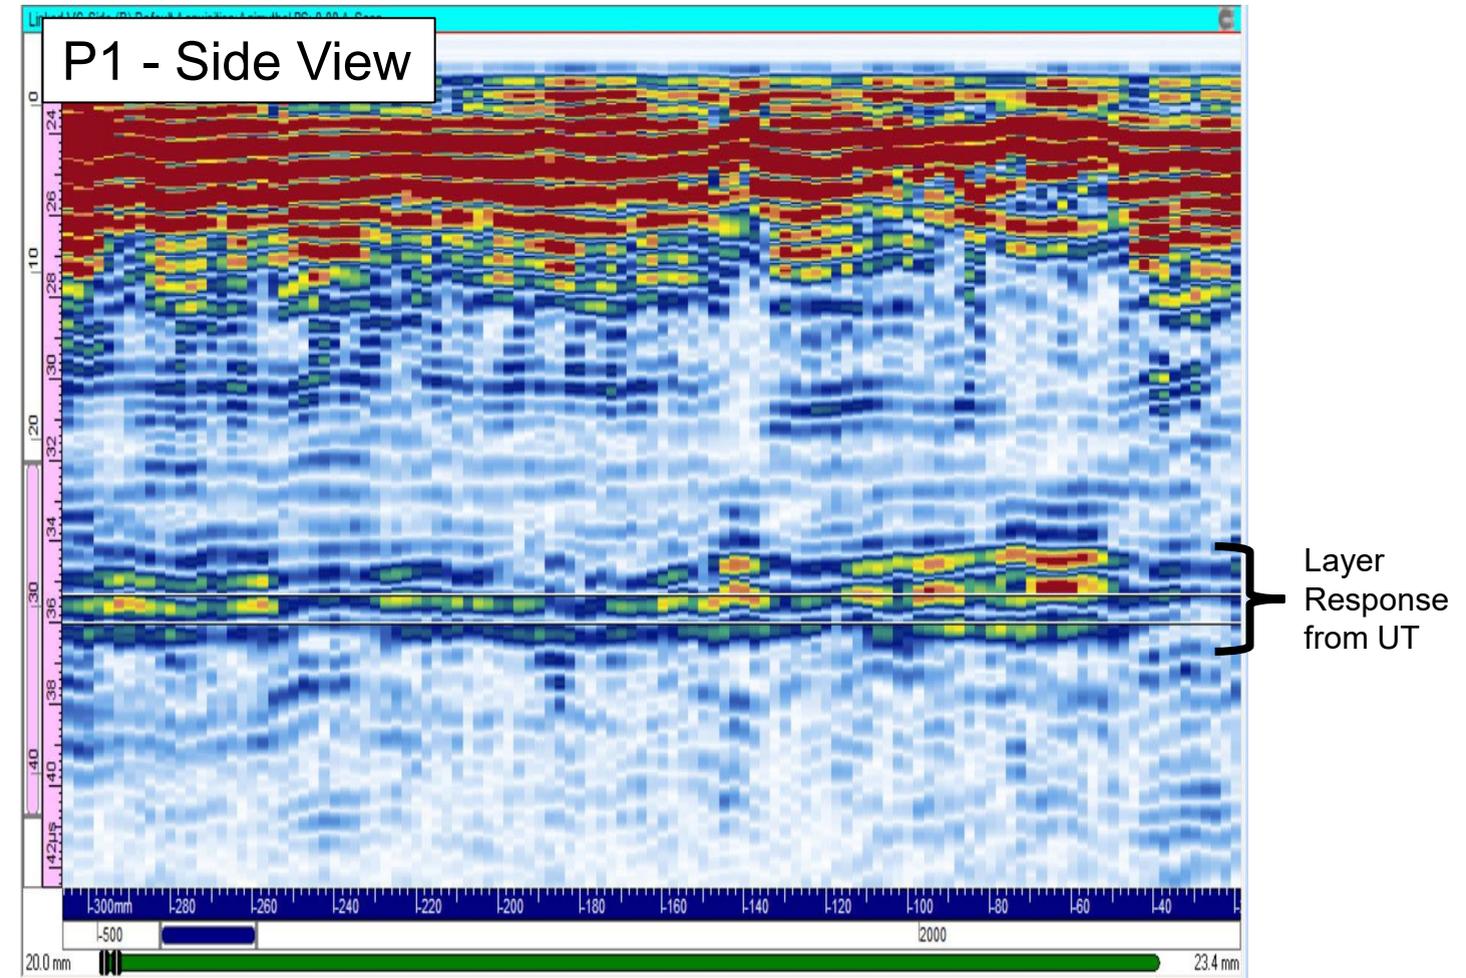
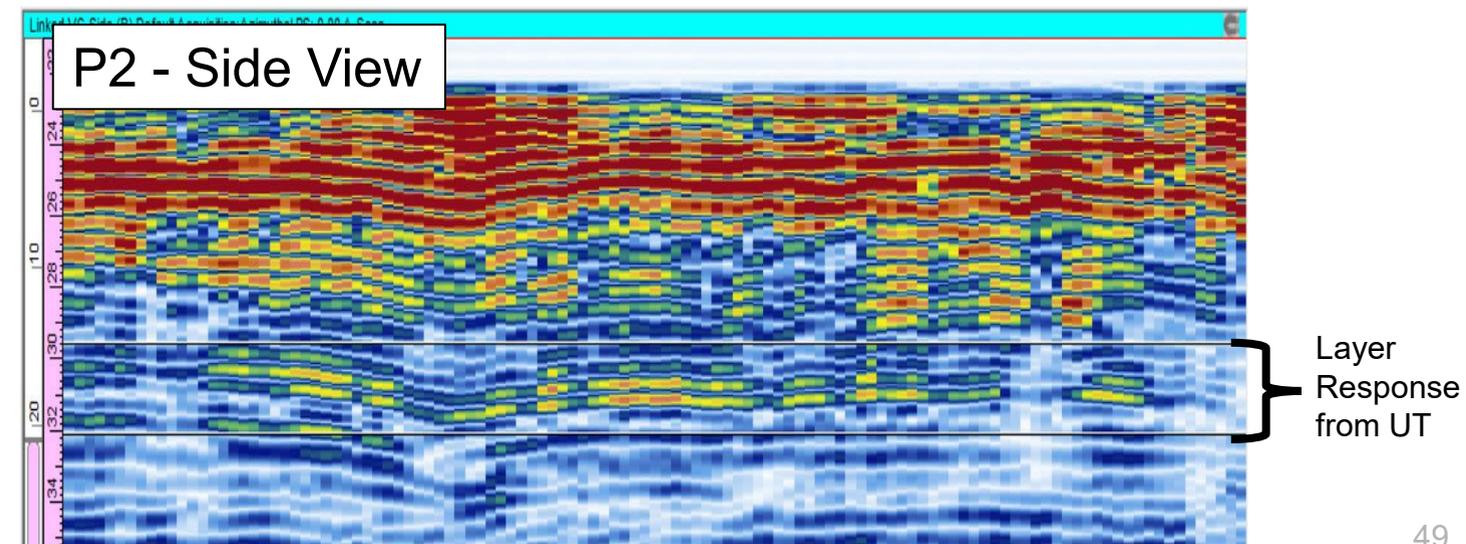
# UT Observations

- Due to the nature of alternating layers of fabric, epoxy, and putty, layers visible in the UT are not flat/planar responses
  - Changes in layer thicknesses can compound distortion seen in UT images
  - Gating individual regions or layers is difficult due to time variation
  - Examples of layer responses seen in the UT data are highlighted

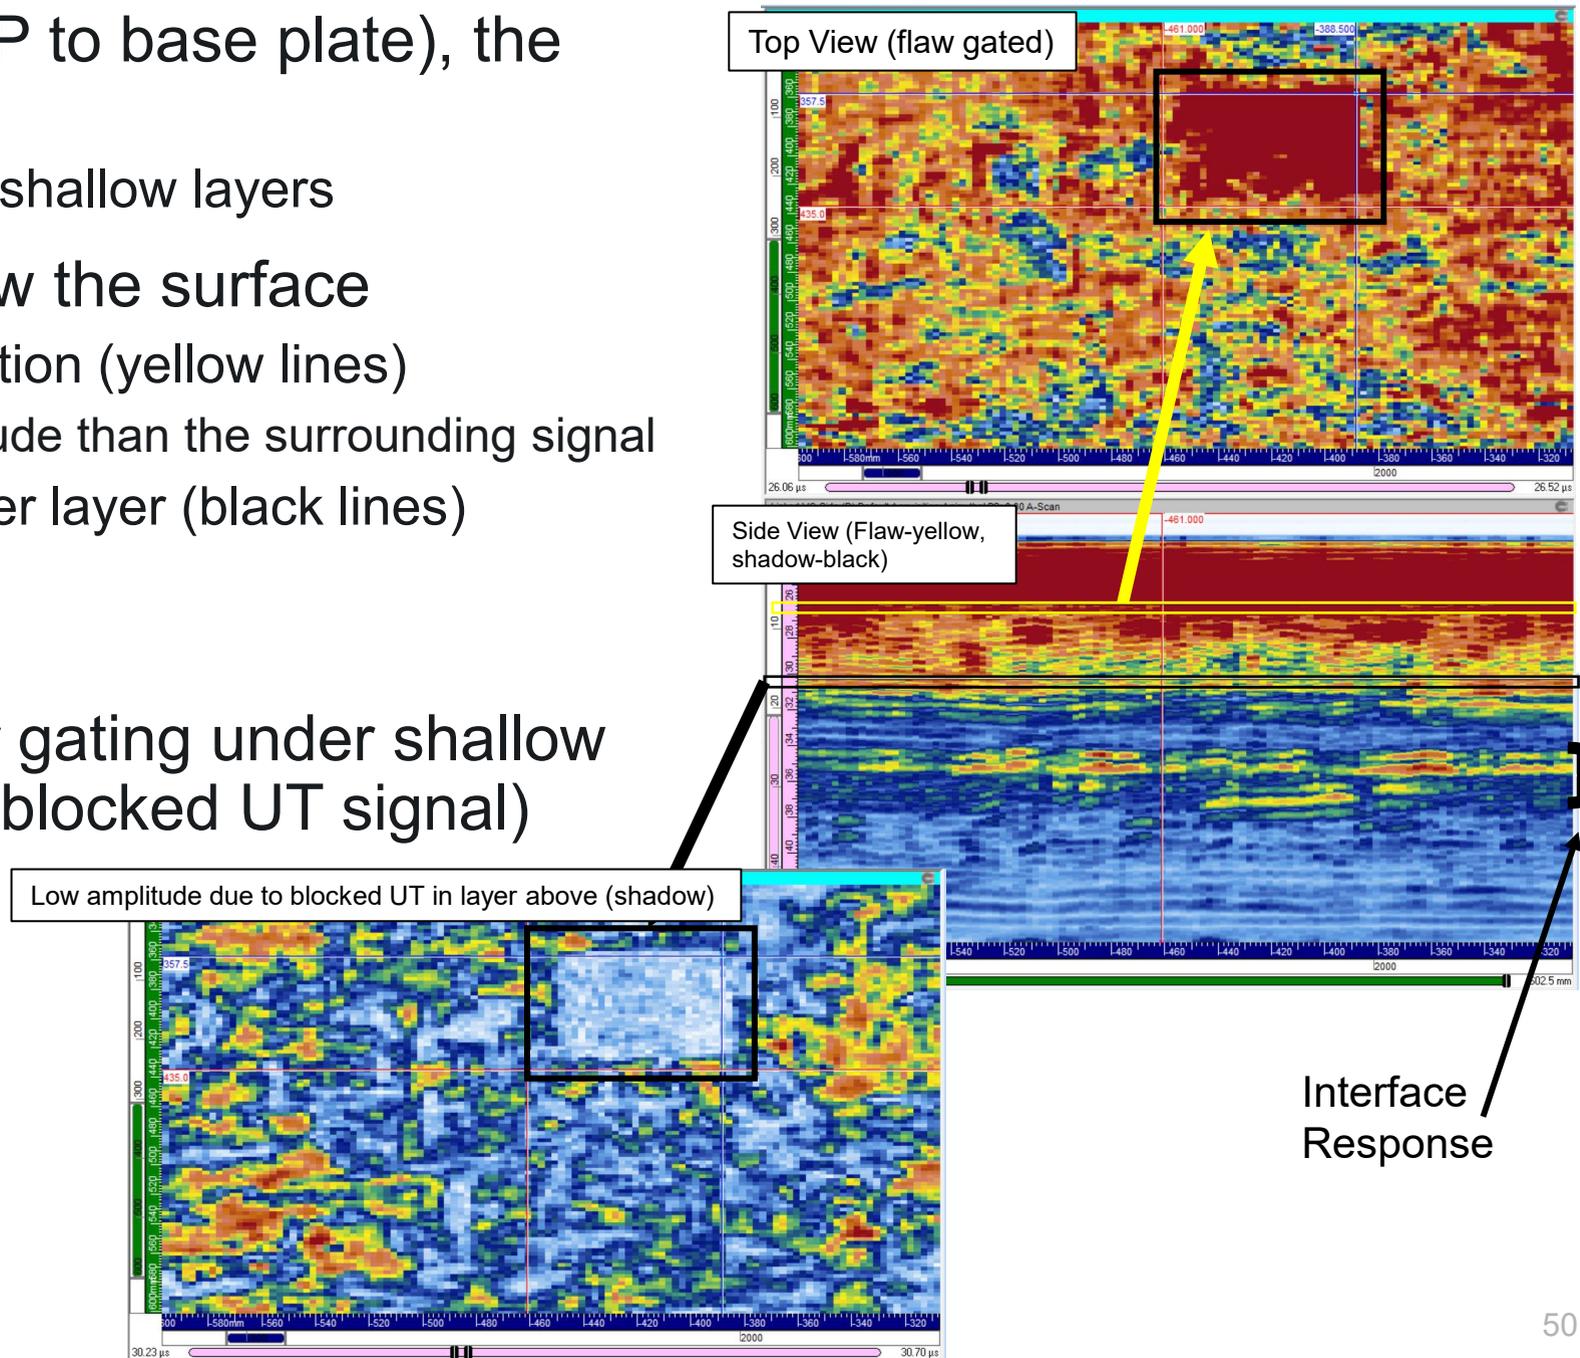
# UT Observations (cont.)

- To capture the interface response (CFRP to base plate), the gain was increased substantially
  - Surface saturation drowns out some of the shallow layers
- Images show a dry spot two layers below the surface
  - Top image is gated based on the layer location (yellow lines)
    - Response from the defect is higher amplitude than the surrounding signal
  - Lower image is based on gating on a deeper layer (black lines)
    - Lack of signal penetration due to dry spot
    - Shadow under the defect
- The lower image shows the potential for gating under shallow flaws for detection via the flaw shadow (blocked UT signal)

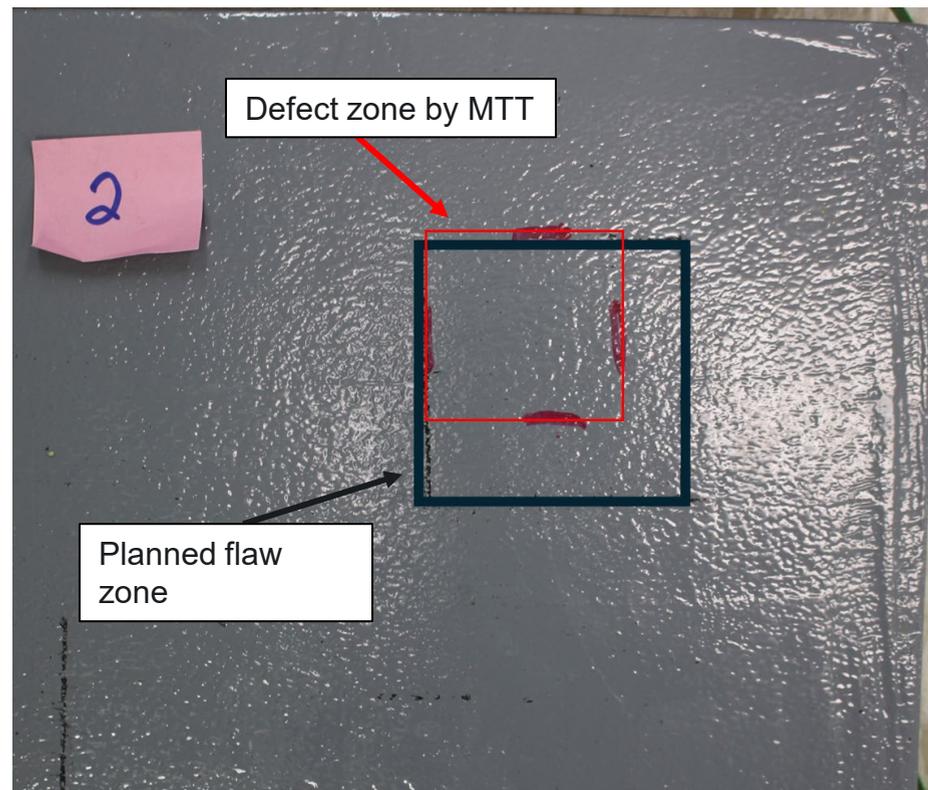
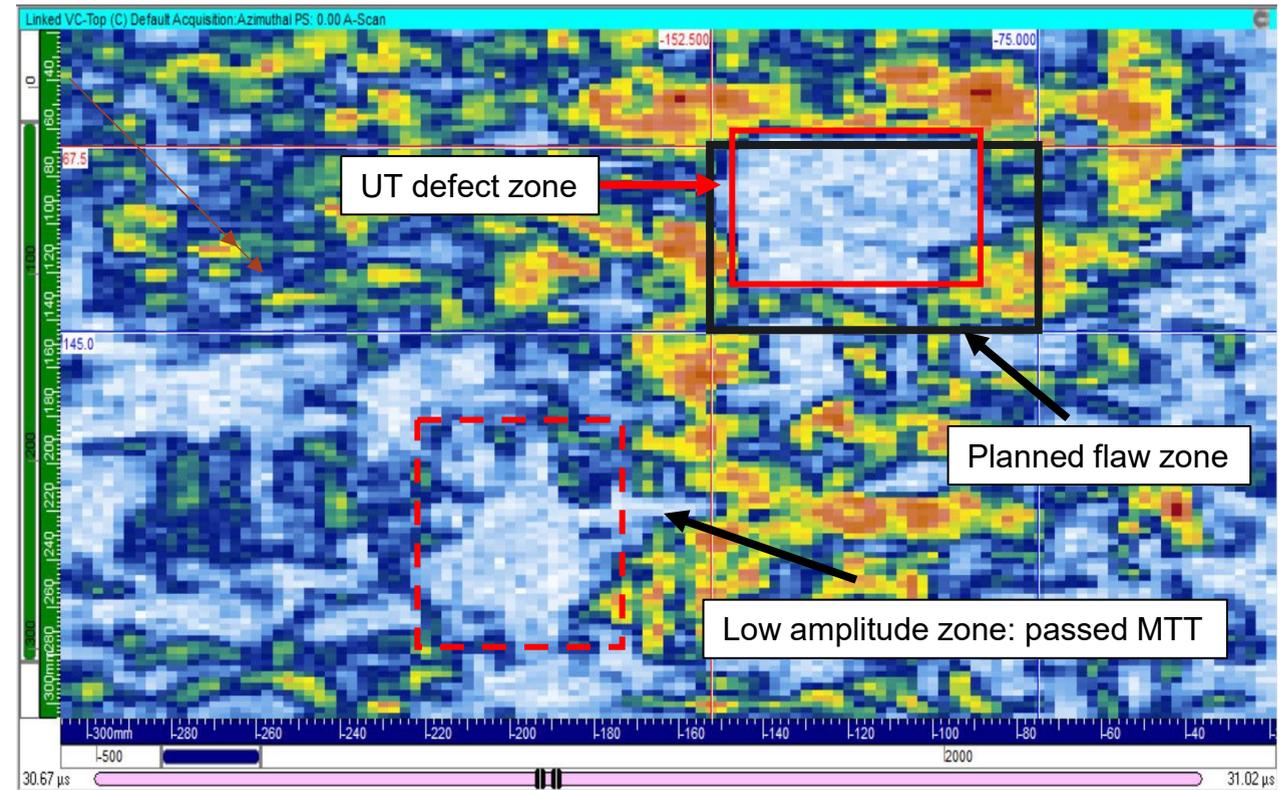
# Plate #2 – Q1 Dry Spot Indications

- Defect is located in the second layer of carbon fiber applied
  - ~2/3 of the way through the CFRP
- Dry spot detected by both MTT and UT inspection
  - Indications reported had similar locations and sizes for both techniques
  - UT indication is gated behind layer #2 to show a lack of signal penetration
- True-state dimensions are not necessarily accurate
  - Size and location were defined as the plates were being fabricated
  - Epoxy may have flowed and distorted the true size of the defect during curing

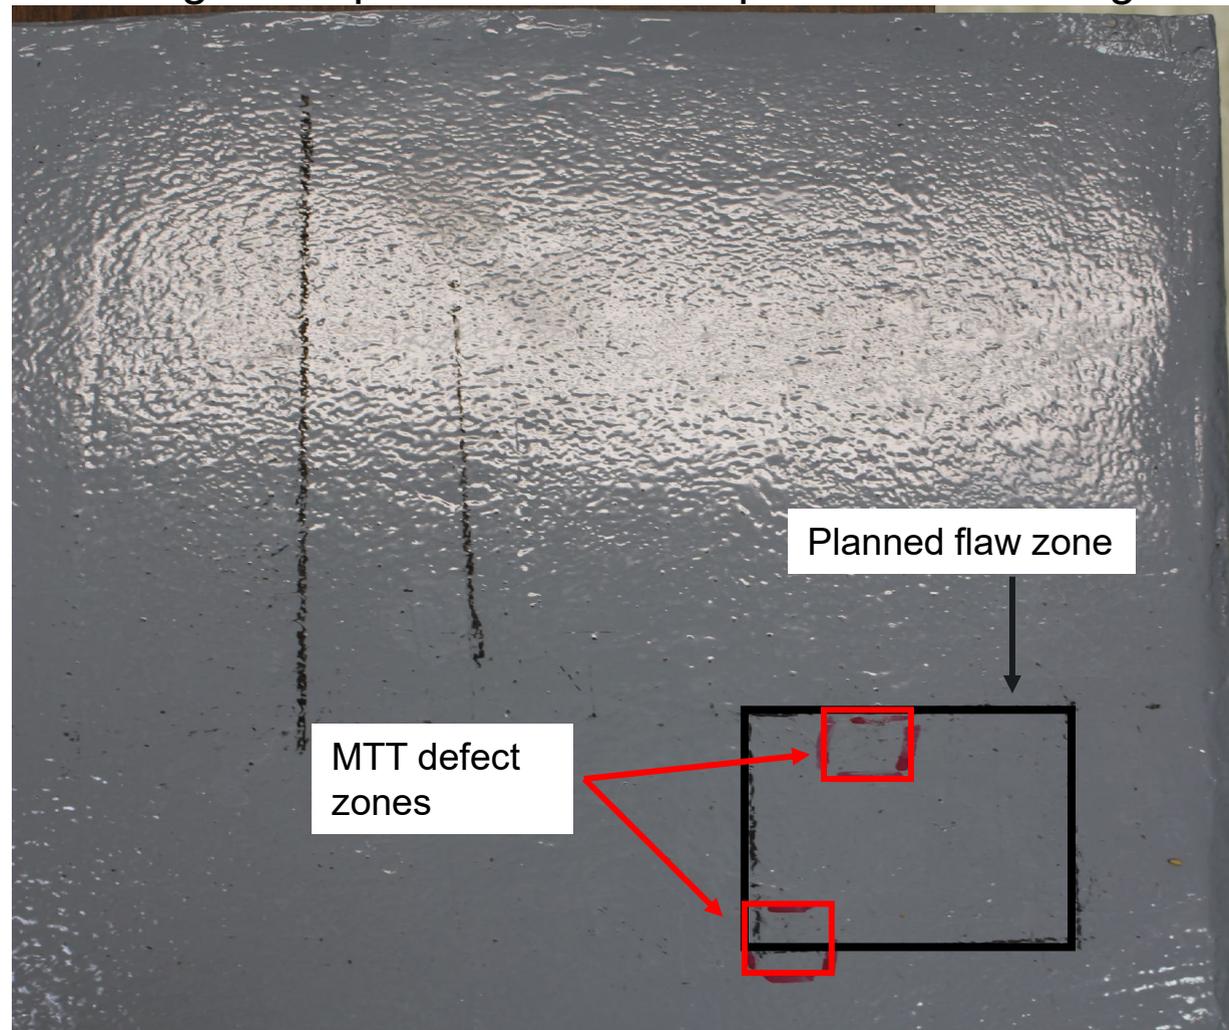
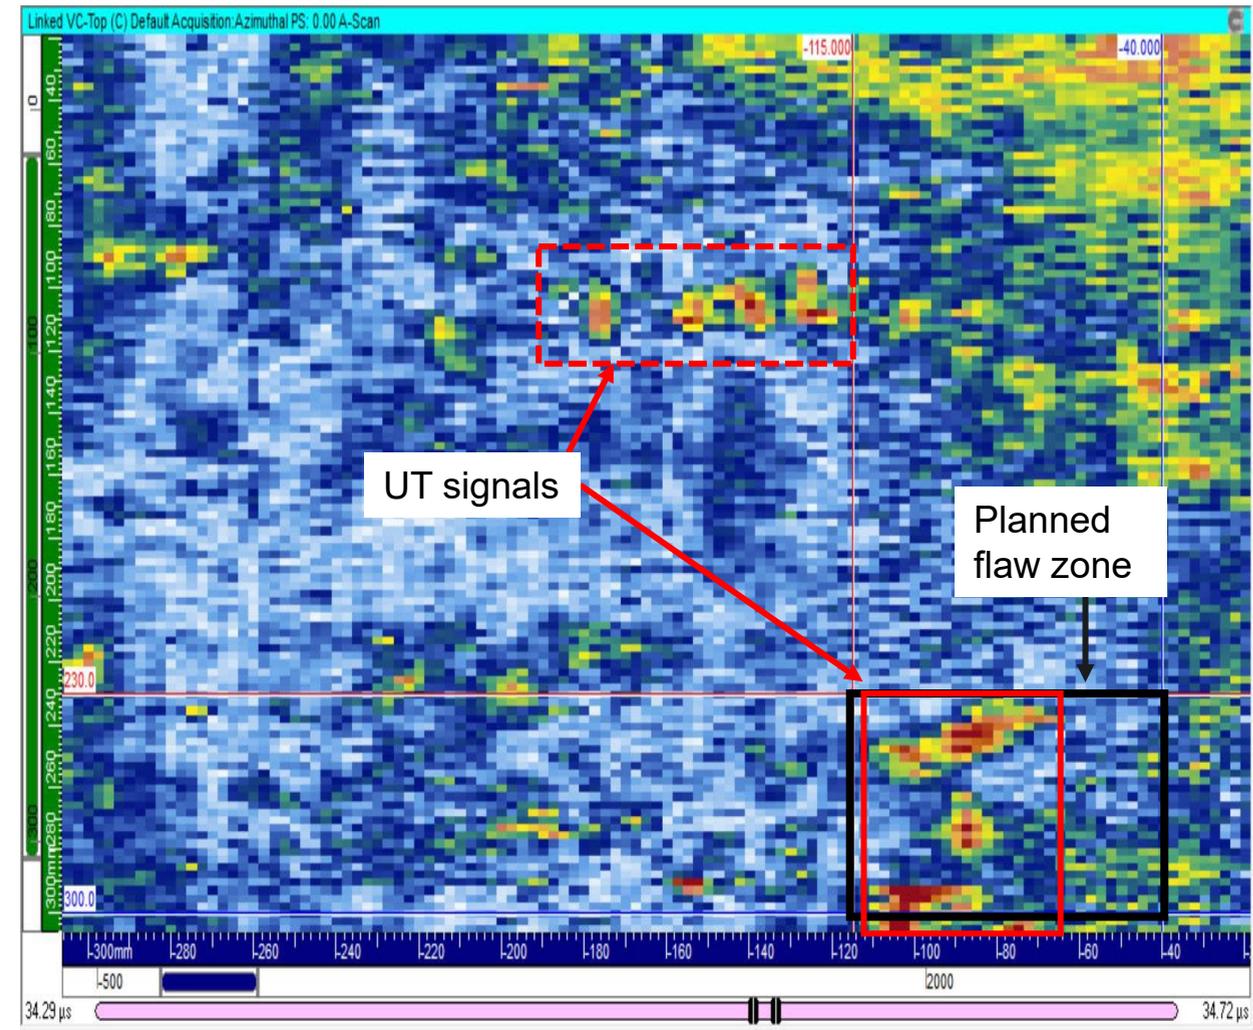
# Plate #4 – Q1 Dry Spot Indications

- Defect is located in the second layer of carbon fiber applied
- Recorded as “no detection” for UT
  - UT response lacked continuity across a majority of the flawed region (solid red box highlight a few discrete indications)
  - Presence of other signals outside of planned flaw fabrication region with comparable magnitude nearby (highlighted in red dashed box)
- UT signal responses within the planned defect region were similar in location to MTT detections

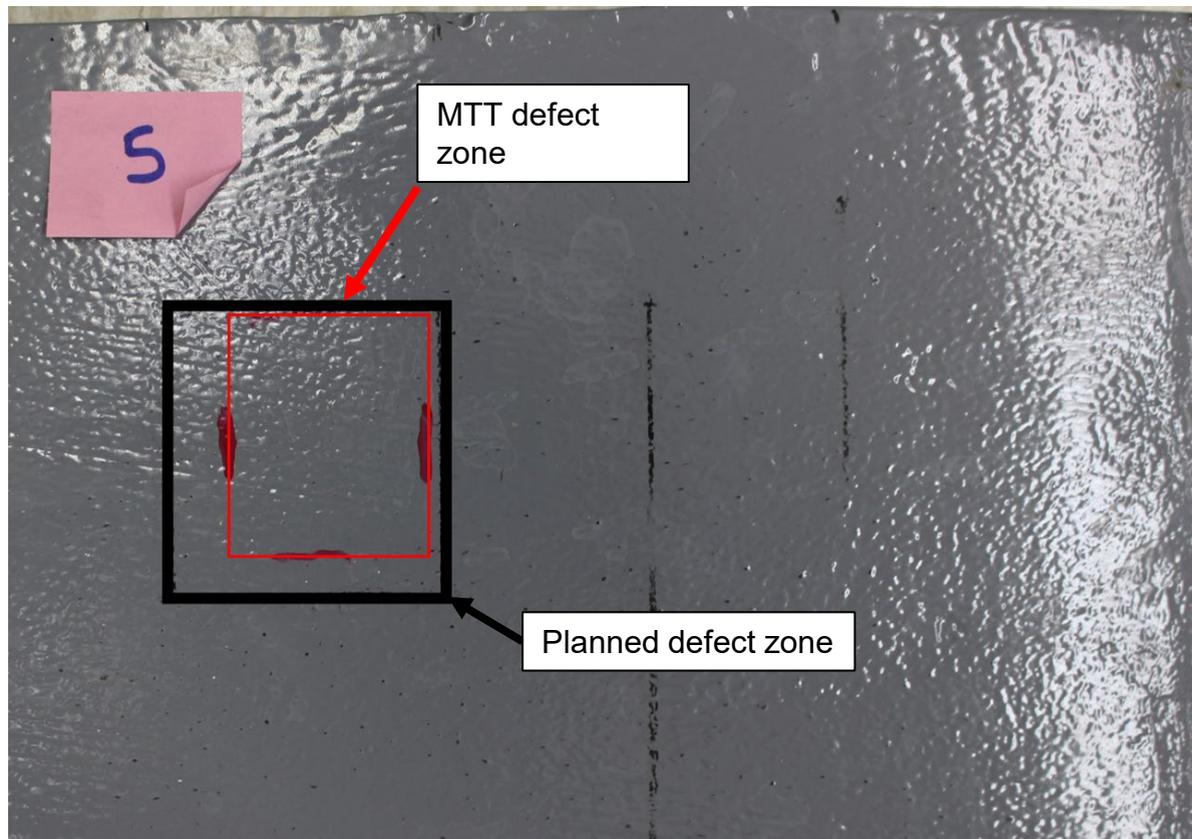
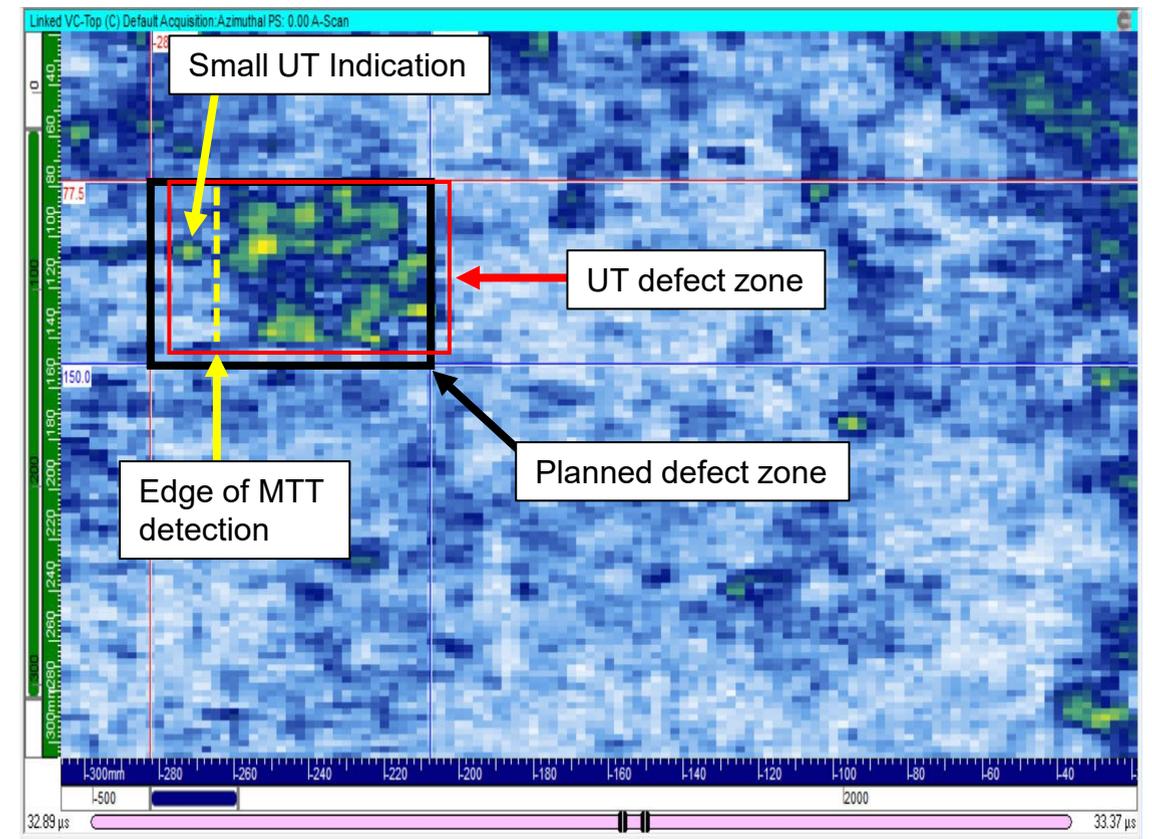
# Plate #5 - Q1 Dry Spot Indications

- Defect is located in the 2<sup>nd</sup> layer of carbon fiber applied
- Dry spot detected by both MTT and UT inspection
  - Indications reported were similar location and size for both techniques
  - Gated UT signal has low surrounding noise
- Small indication on the left edge of the UT detection may have just been missed by MTT
  - Small response which can easily be missed without an encoded data record
