PNNL-20019

Demonstration Assessment of Light-Emitting Diode (LED) Retrofit Lamps at Intercontinental Hotel in San Francisco, CA

N Miller

November 2010

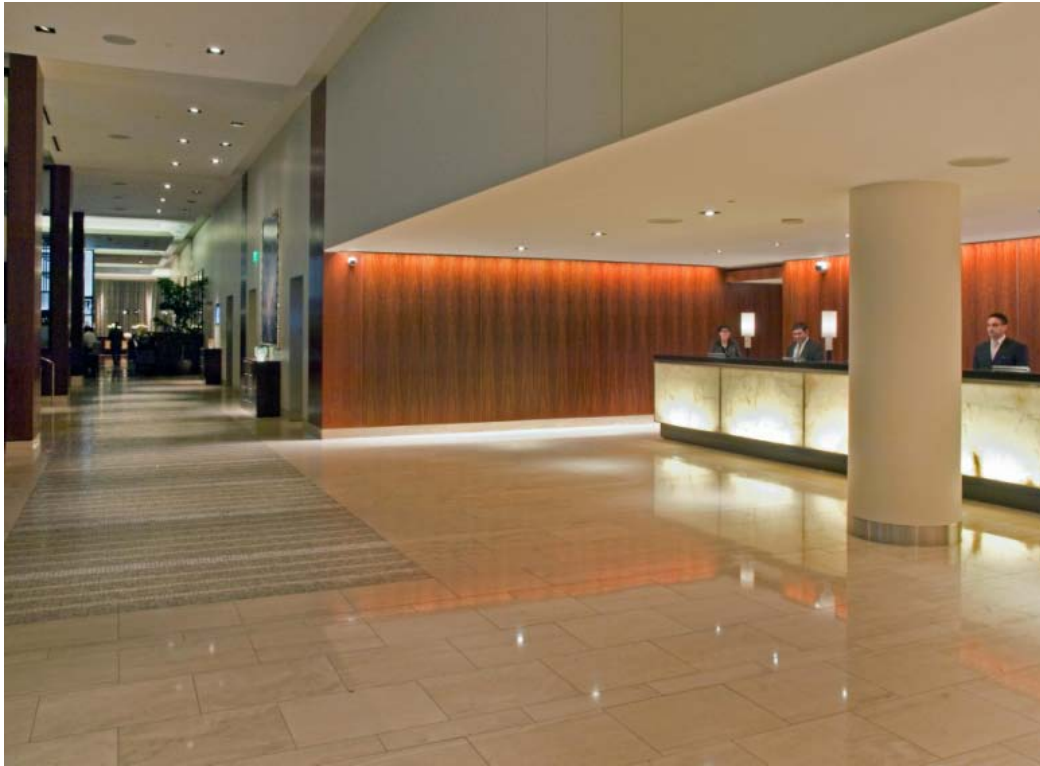
Figure 1.2. Photo of InterContinental Hotel Lobby Registration Desk Area with LED Replacement Lamps. www.kenricephoto.com

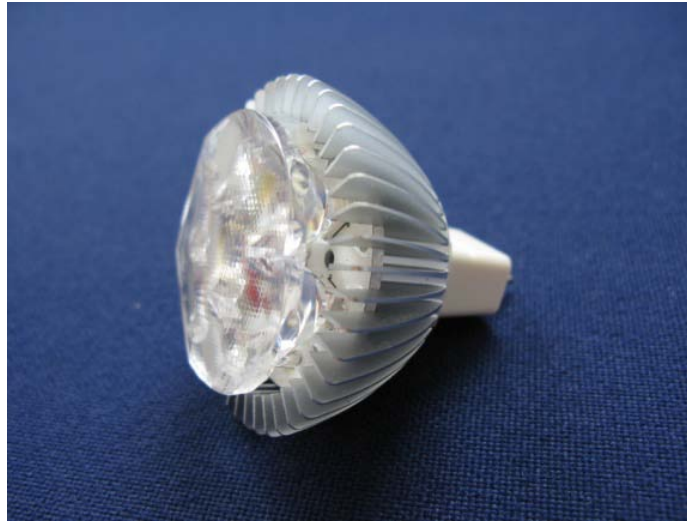
Figure 2.1. CRS Electronics 6W LED MR16 Lamp

The track was powered through a triac incandescent dimmer, so the team was able to observe the lamp behavior under dimming. All but the CRS lamp exhibited erratic behavior when dimmed, either dimming unevenly, shutting off below a set dimming point, or producing noticeable flicker. The CRS lamp dimmed smoothly, down to a very low level (measured at less than 10% output) before switching off, appearing to maintain color quality throughout the range.

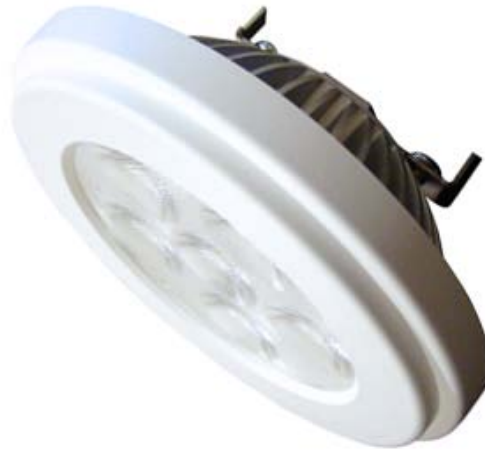
Figure 2.2. Con-Tech 10W LED AR111 Lamp

The two-story lobby space uses 75W AR111 halogen lamps because they deliver high intensity narrow beams that create visually dramatic patterns of light and shadow. Only one brand of lamps was submitted as replacements for this lamp type, a 10W LED AR111, 25° or 40° Flood distribution, warm (3000K) or neutral white (4000K) color. Participants preferred the warm color for this application, liked the color quality, but observed that the reported beam spread did not correspond to the submitted photometric report. (The actual beam spreads are 16° and 25°, respectively.) Although the intensity of light wasn't equivalent to the CBCP of the 75W AR111 halogen lamps used in the hotel lobby, the team

decided to try the narrower lamp to illuminate the lobby curtains. The color is somewhat cooler than the incumbent 3000K AR111 lamps (appearing pinkish from an increased blue content), but the new interior designer on the project expressed an interest in a cooler-color light for the lobby, so that could have been an advantage.

A single 10W AR111 nominal 25° (actual 16°) LED lamp was installed in the 20' tall ceiling to produce a splash of light on the gray sheer curtains. The team was impressed with the intensity of the light beam in application, and liked the color quality and lack of perceptible flicker. However, the light was cooler (pinker) than the halogen it replaced and shifted the color emphasis in the space from gold to silver. Other fixtures in the center of the room used higher wattage halogen AR111s that could not be matched in intensity by this LED lamp. To avoid mismatched lamp colors in this lobby, this area was eliminated from the final demonstration.

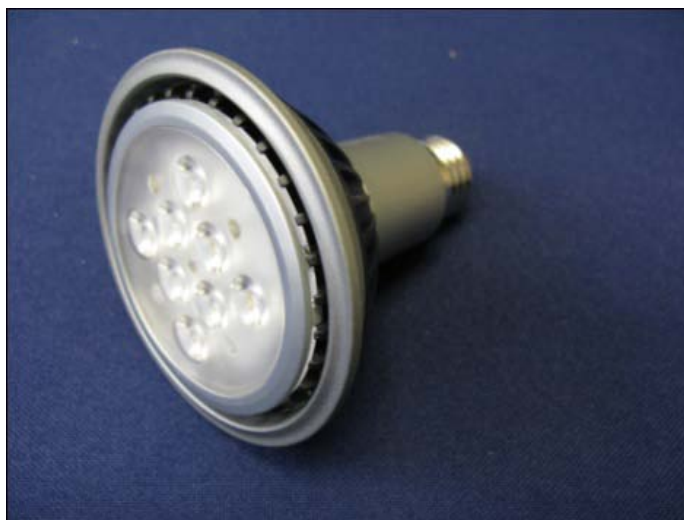
Figure 2.3. Philips 10W LED PAR30 Lamp

The request for samples of this lamp type had been sent out only a week before the Round 1 evaluation, so none of the lamps had arrived by the time the team evaluation took place. PNNL provided three samples of 10W LED PAR30 shortneck lamps separately. Their performance was not equivalent to the light output of the 75W PAR30 halogen lamps installed in conference level hotel corridors, but the team thought they might work as replacements for PAR30 lamps installed in conference room emergency lighting downlights. (Two downlights per conference room operate at full output, 24/7, as emergency lighting.) Unfortunately, they did not physically fit into the downlights. The team decided to try them in Registration Desk area downlights, along with other LED PAR30 lamps when they arrived.

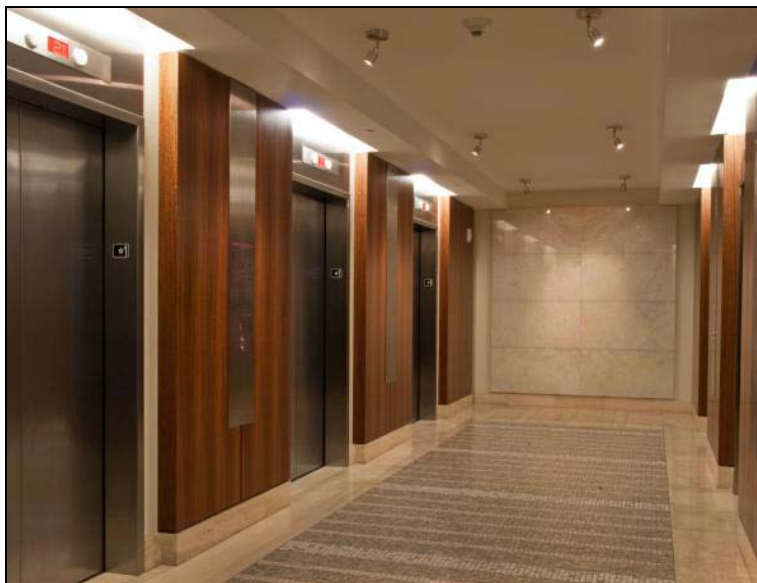
Figure 2.5. 1st Floor Elevator Lobby - Halogen Lamping (Dimmed). www.kenricephoto.com

Higher illumination levels and improved uniformity are among the benefits immediately visible from the LED products on the first floor (Registration Desk Area and Elevator Lobby), when compared to the halogen lighting that had been routinely dimmed to very low levels.

Halogen lamps in the “before” condition of the registration desk and 1st floor elevator lobby areas were dimmed from “35” (PAR30 lamps) to “65”, “75”, or “80” (MR16 lamps), so measured light output is expected to range from roughly 10 to 65% of rated light output. (Reference: 9th Edition IES Lighting Handbook, Figure 27-4, Square Law Curve. Also see Footnote 4.) Table 3.1 below summarizes the illuminance values measured with the same Minolta TL-1 meter for both the halogen “Before” and LED “after” conditions.

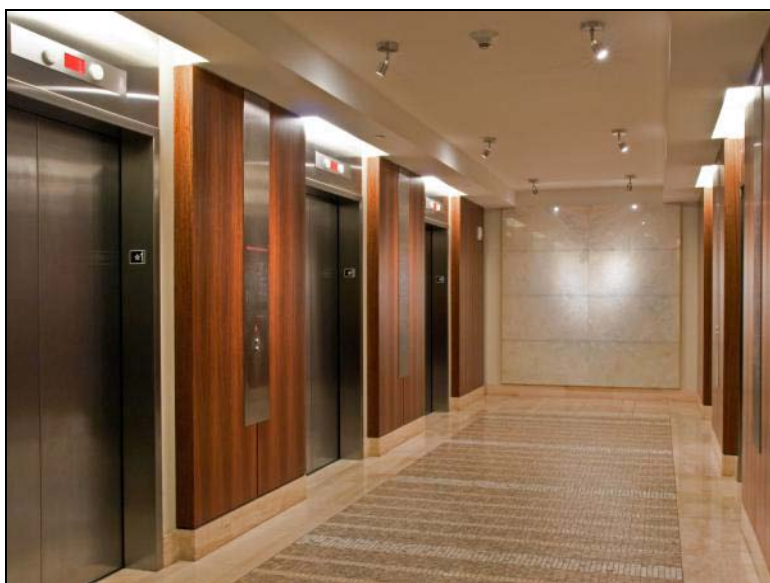
Figure 2.7. 1st Floor Elevator Lobby - LED Lamping (Undimmed). www.kenricephoto.com

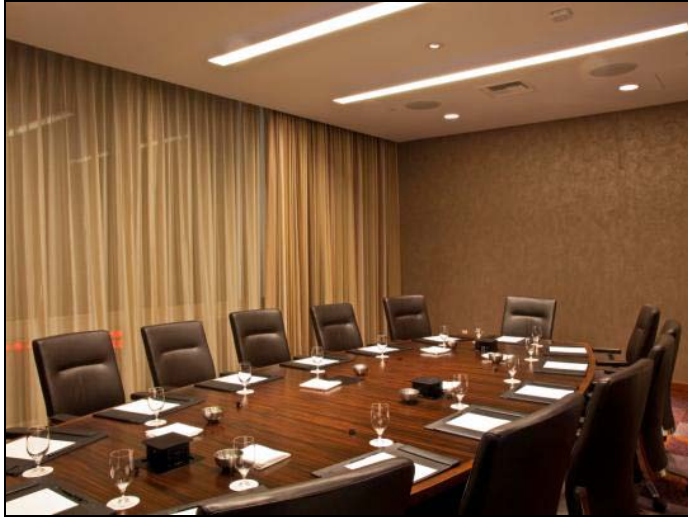
Figure 2.9. Conference room lighting with halogen downlights at far end.
www.kenricephoto.com

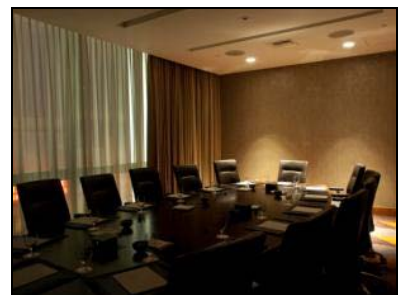
Figure 2.12. Conference room emergency lighting only – LED.
www.kenricephoto.com

The 7th and 8th floor elevator lobbies and guest floor corridor lighting had no dimming control, so the halogen lamps were delivering full output when the measurements were taken, as were the emergency-circuit downlights in the Conference Rooms. Table 3.2 below summarizes the illuminance values measured with the Minolta TL-1 meter for both the halogen “Before” and LED “after” conditions.

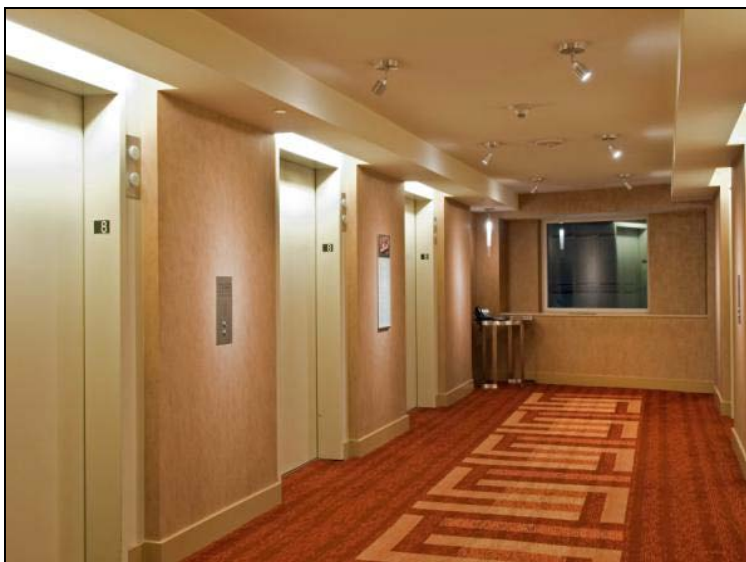
Figure 2.18. 8th Floor Elevator Lobby - LED Lamping.
www.kenricephoto.com

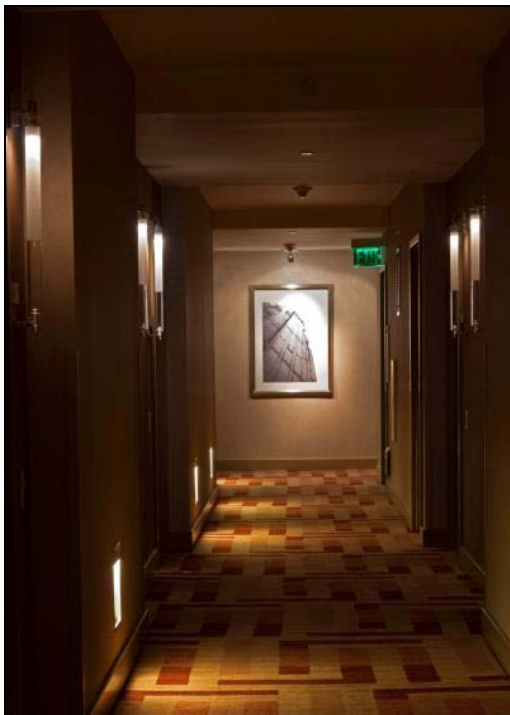
Figure 2.19. Guest Corridor Artwork Lighting (Halogen).
www.kenricephoto.com

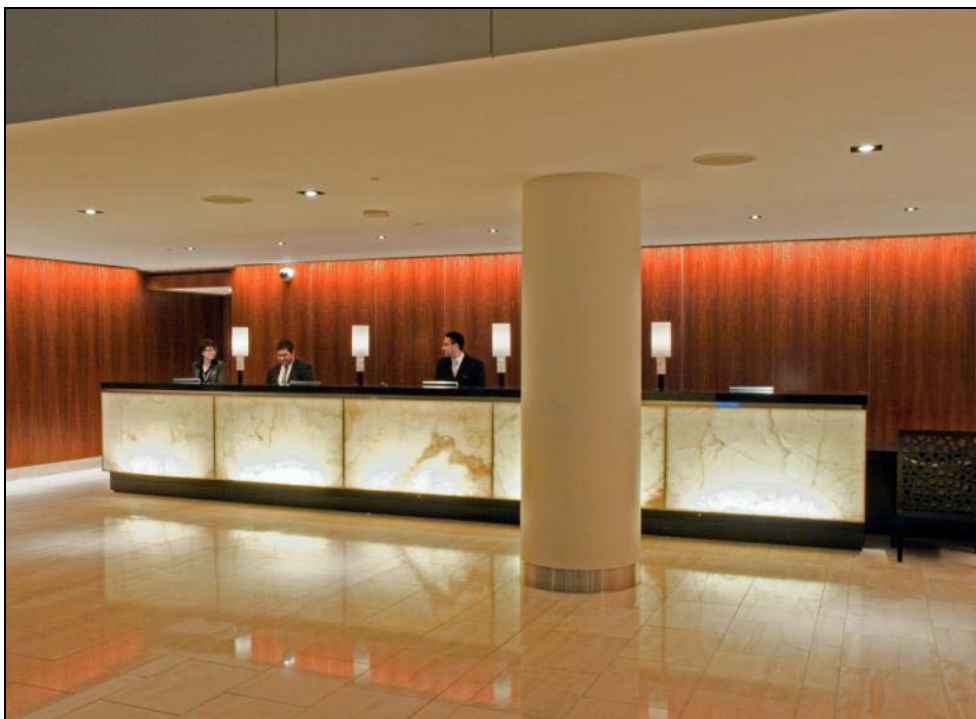
Figure 2.25. Registration Desk area with LED accent and wall-grazing (onyx panels are backlighting with fluorescent lamps, and the pedestal lights use incandescent lamps). www.kenricephoto.com

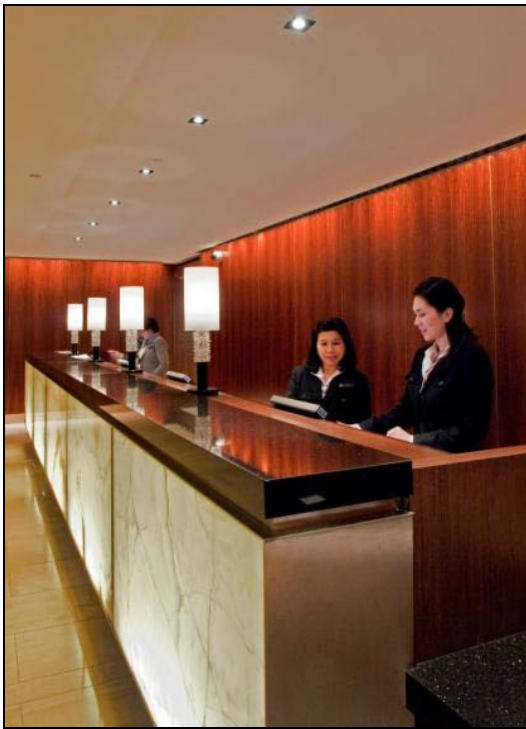
Figure 2.26. Registration Desk area counter showing overhead halogen accent lights. www.kenricephoto.com

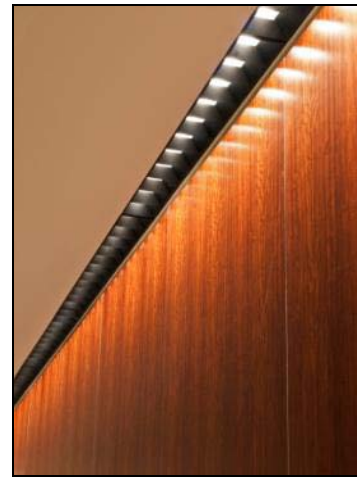
Figure 2.27. Closeup of wall grazing lighting (LED).
www.kenricephoto.com

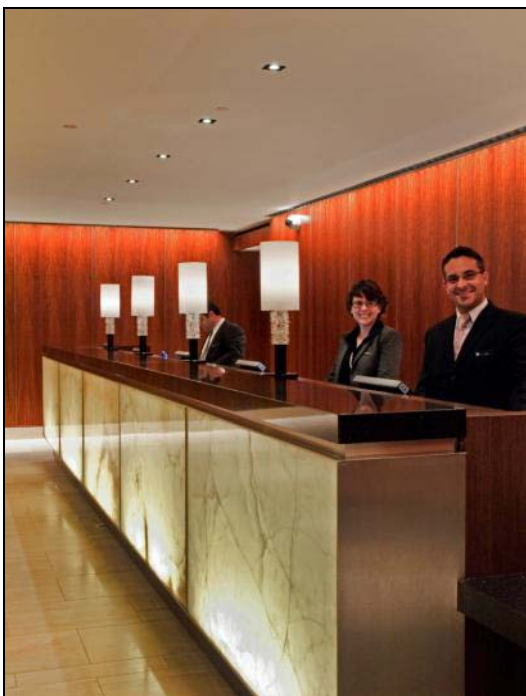
Figure 2.29. Registration Desk area counter showing overhead accent lights with LED replacement lamps. www.kenricephoto.com

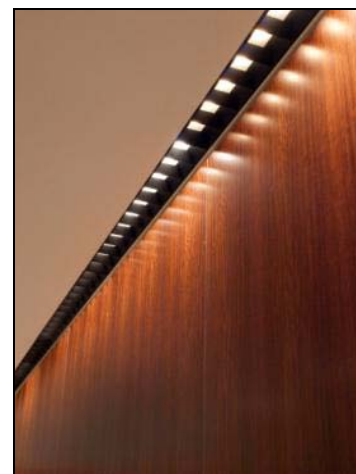
Figure 2.28. Closeup of wall grazing lighting (Halogen).
www.kenricephoto.com
