PNNL-21033

# **Geomagnetic Storms and Long-Term Impacts on Power Systems**

H Kirkham JE Dagle MA Elizondo YV Makarov JG DeSteese R Diao

December 2011

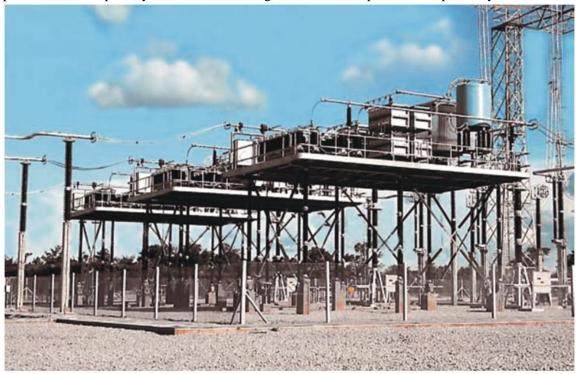
**Figure 8**. Series Capacitor for a Three-Phase High Voltage Power System. The capacitors (and associated communications and control equipment) are mounted on insulated platforms

The electrical characteristics of an overhead power transmission line include a series inductance and a shunt capacitance, both of which are distributed along its length. The series inductance, which increases with line length, effectively limits the amount of power that can flow through the conductor. Properly engineered series capacitors can offset this series inductance, and can enhance the power-carrying capacity of the line. The decision to install series capacitors is made when the benefit of this increased power transfer capability offsets the cost. Figure 8 shows a representative power system installation.
