Electropolishing of a Full-Sized U-10Mo Plate

December 2022

PACIFIC NORTHWEST NATIONAL LABORATORY
operated by
BATTELLE
for the
UNITED STATES DEPARTMENT OF ENERGY
under Contract DE-AC05-76RL01830

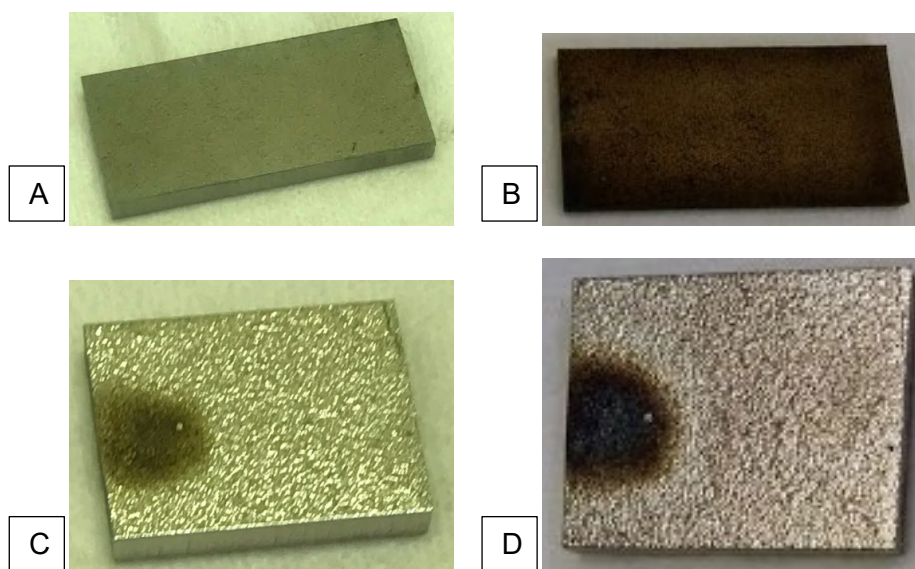
Figure 1. Images from electropolishing LEU-10Mo Center Foils (Shimskey et al. 2019)

- A) LEU-10Mo ingot directly following electropolishing in 30% HNO_3 .
 B) Sample from A) **following 17 days of storage** in plastic bag in fume hood.
 C) LEU-10Mo ingot directly following electropolishing in 30% H_2SO_4 .
 D) Sample from C) **following 30 days of storage** in plastic bag in fume hood.

- Anodization of surface was visible at the location of where the electrode contact was made (Figure 1c) but could be minimized by how the potential of the power supply was ramped up and down.
- Nickel and platinum plated electrodes were utilized for the testing and both experienced corrosion and found as contamination in the electrolyte solutions, including copper and iron (nickel coated screw on the anode) and copper (underneath the platinum coated cathode).

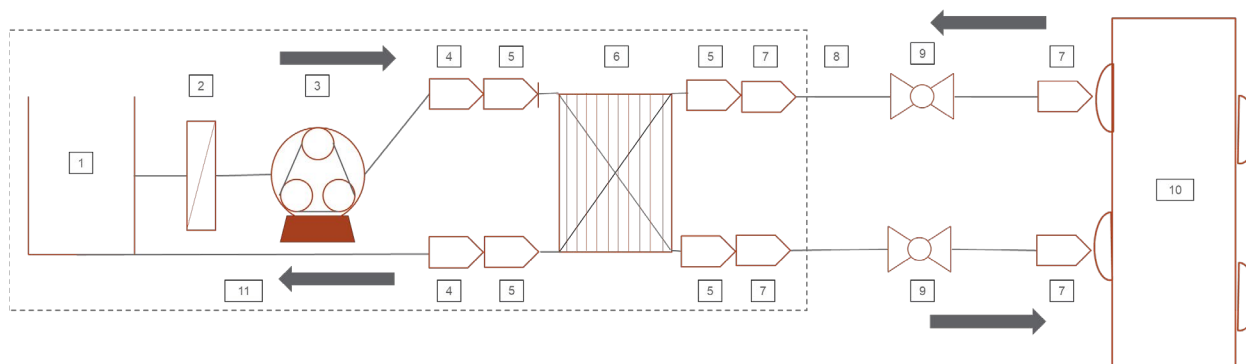
Figure 12. The electropolishing solution cooling system diagram

Note: The components contained within the dashed line are found in the fume hood contamination area

Initial shakedown testing found significant generation of heat produced from this process electropolishing DU-10Mo roughly 20 times larger than was previously tested. To maintain the temperature between 25-35°C, an external cooling circulating system was added to the system (Figure 12 and Table 2). The polishing vessel was connected to a variable drive peristaltic pump to circulate the sulfuric acid solution through a two-pass stainless steel heat exchanger. Cooling water flowing through a closed loop external chiller flowed through the other side of the heat exchanger and removed heat effectively from the electrolyte solution.

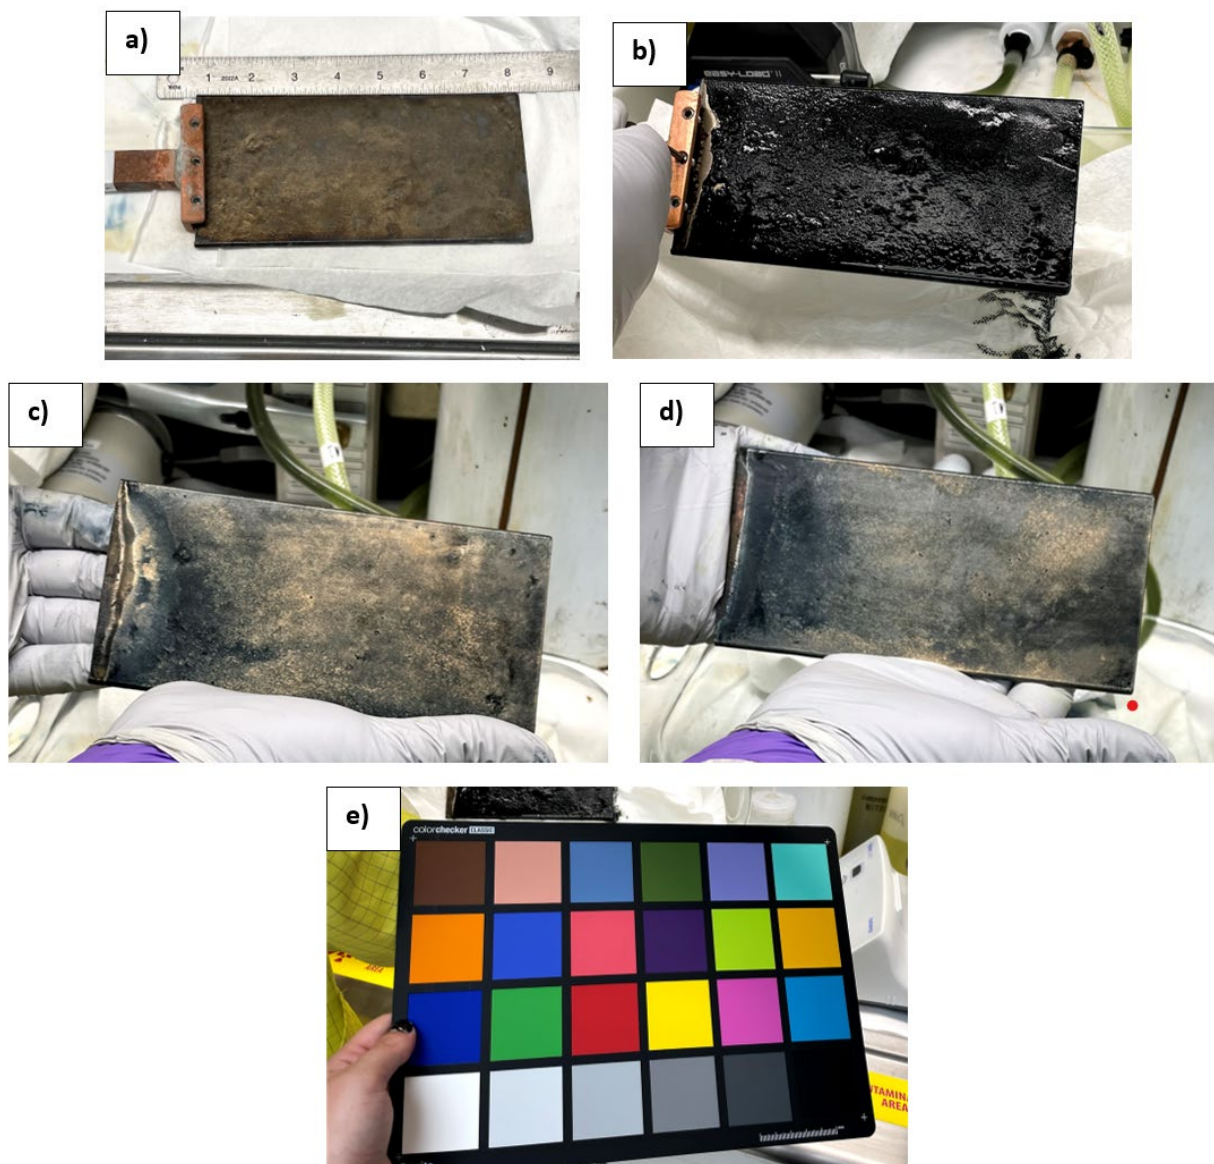
Figure 16. The DU-10Mo plate throughout the first electroplating process

- The plate before electroplating.
- The plate immediately after polishing and before rinsing. A blue/black film appeared on the surface during the polishing process.
- Side 1 of the plate following polishing and rinsing. There were sections with dark blue and copper coloration and the plate was smoother to the touch.
- Side 2 of the plate following polishing and rinsing. There were sections with dark blue and copper coloration and the plate was smoother to the touch.
- A color chart for comparison purposes

The first electropolish was ran using the test parameters listed in Table 5 and images of the plate before and after polishing are found in Figure 16. The acid solution turned blue after 3 minutes, and a blue/black film formed on the plate during the polishing process (Figure 16b). While a dilute blue water film was observed on the surface during small scale polishing, this type of film was not experienced with small scale testing or considered an issue (Shimskey et al. 2019).

Once the plate was removed from the acid solution, the film was rinsed off with deionized water, and rinsed again with ethanol, and allowed to dry. After rinsing, the surface was free of smut and oxide with a bare metal surface. However, the metal surface finish was tinted with both blue and gold colors (Figure 16c and Figure 16d). This implied that the surface was either re-oxidized with water during the removal of the film with water, or the surface was anodized with a stable oxide from the applied voltage similar to what was seen where the electrode contact was made on the small-scale test pieces shown in Figure 1c. Over time, the surface of the plate did not re-oxidize like the nitric acid cleaning, so the high voltage experienced during the test (7.6 V) likely caused anodization. Reducing the distance between the working and tool electrodes as well as finding better methods to connect to the working piece would reduce the total voltage applied.

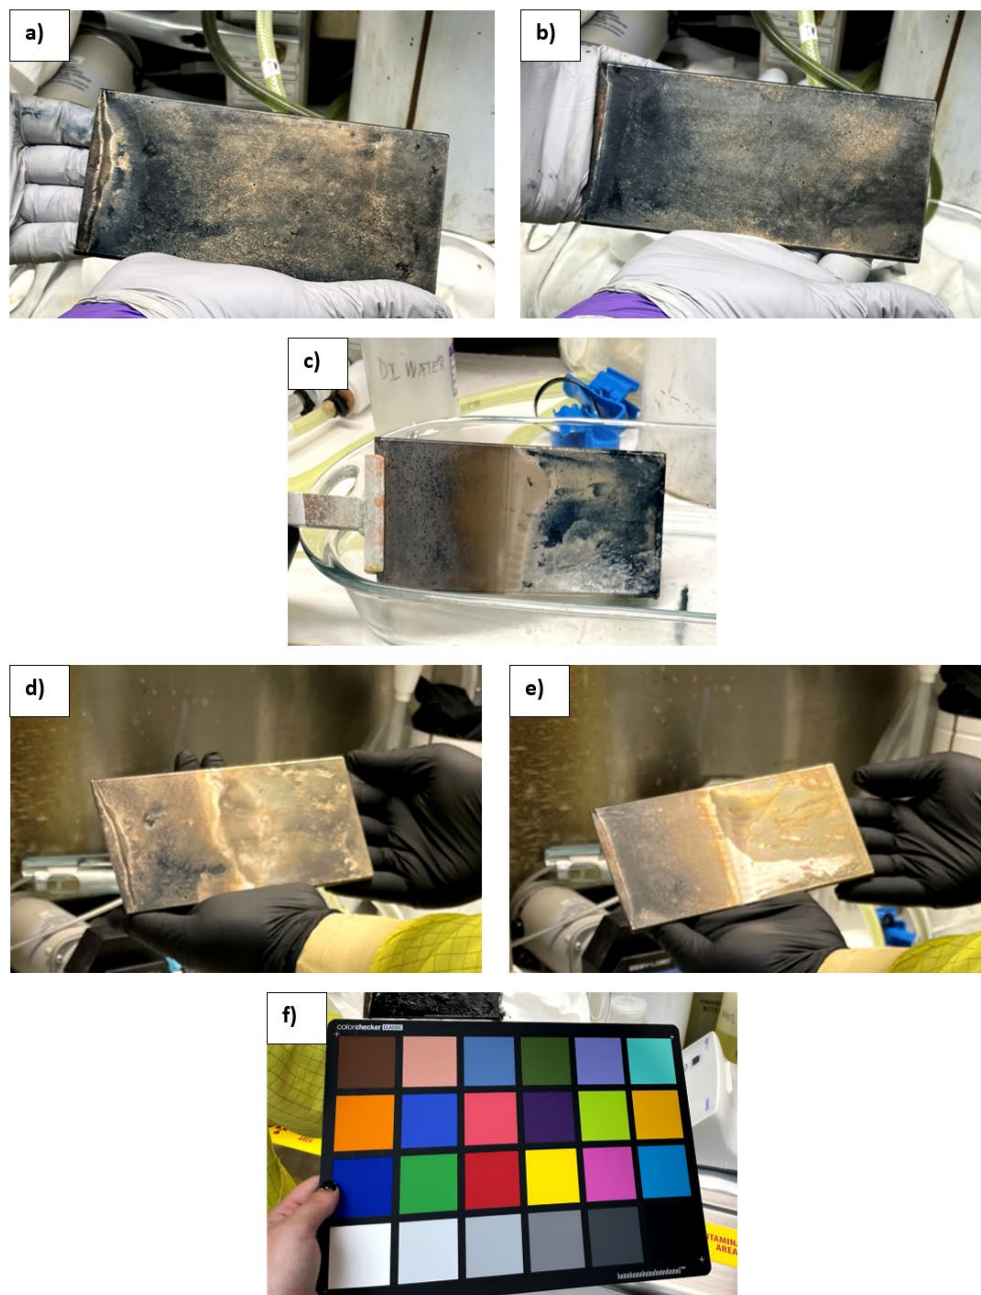
Figure 18. The U-10Mo plate throughout the second electropolishing process

- a) Side 1 of the plate prior to polishing. The surface was smooth with sections of blue and copper coloration.
- b) Side 2 of the plate prior to polishing. The surface was smooth with sections of blue and copper coloration.
- c) The plate after polishing and before rinsing. A dark blue film, likely uranyl sulfate, formed on the surface during the polish. The acid solution (not shown) also turned blue approximately 03:00 minutes into the polish
- d) Side 1 of the plate after polishing and rinsing. The surface is a smoother, shinier, copper color.
- e) Side 2 of the plate after polishing and rinsing. The surface is a smoother, shinier, copper color
- f) A color chart for comparison purposes

The polishing solution changed to a blue/black color at between 4-5 minutes and a dark blue/green film was present on the surface afterwards (Figure 18c). A dilute solution (0.2M) solution of sulfuric acid was initially used to remove the film from the polished piece. This solution easily redissolved this film into solution allowing the use of less DI water to rinse the surface clean. The newly electropolished surface was tinted a light gold color and lighter than the blue-gold color of the previous surface (Figure 18d and Figure 18e).

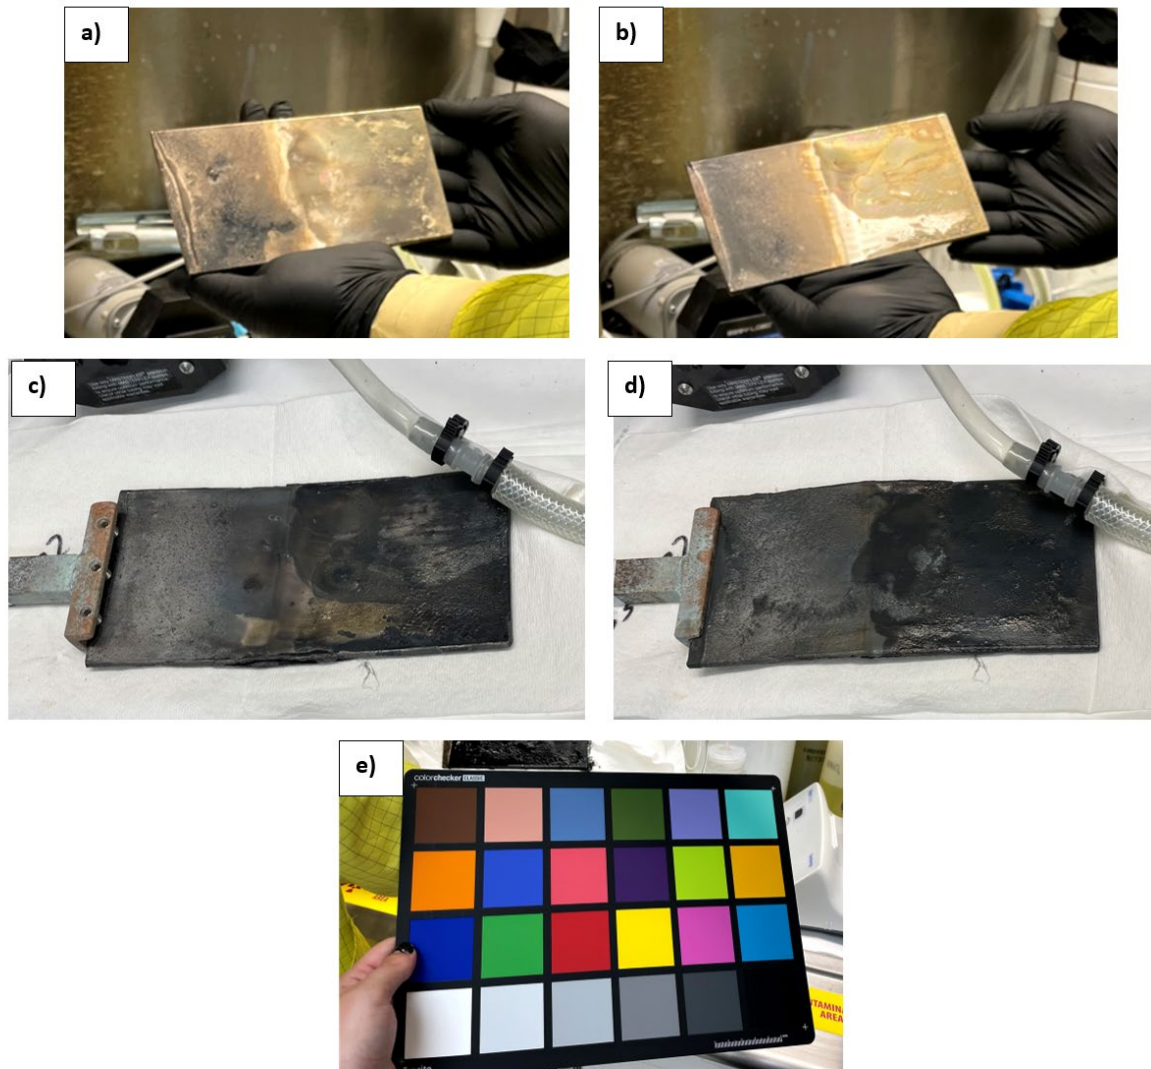
Figure 21. The U-10Mo plate before and after homogenization

- Side 1 of the plate prior to homogenization. The surface is smooth with a shiny copper color.
- Side 2 of the plate prior to homogenization. The surface is smooth with a shiny copper color.
- Side 1 of the plate following homogenization. The surface was gray and more matte with a rougher surface. There is also a slight bend in the plate due to a hole becoming apparent during homogenization.
- Side 2 of the plate following homogenization. The surface was gray and more matte with a rougher surface. There is also a slight bend in the plate due to a hole becoming apparent during homogenization.
- A color chart for comparison purposes

The U-10Mo plate before and after homogenization is shown in Figure 21 and the surface was re-analyzed by LCM afterwards (Figure 22). The average surface roughness increased following homogenization. Variability of surface roughness measurements also increased when compared to the pre-homogenization surface.

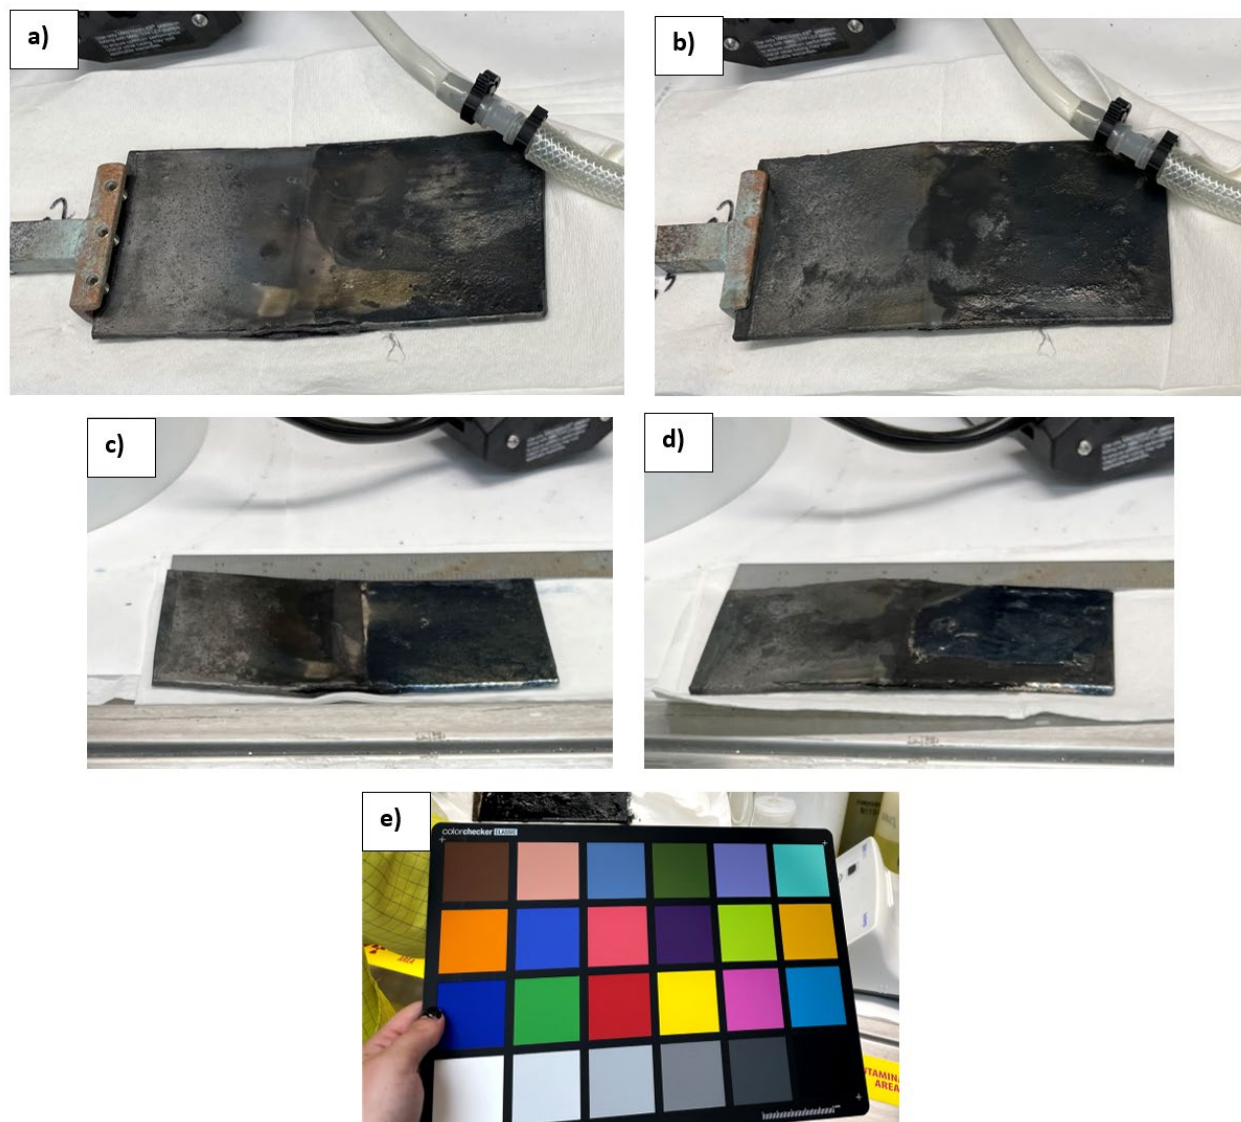
Figure 23. The U-10Mo plate throughout the post-homogenization electropolish

- a) Side 1 of the plate prior to polishing. The surface is rough, matte, and dark grey.
- b) Side 2 of the plate prior to polishing. The surface is rough, matte, and dark grey.
- c) Side 1 of the plate after the post-homogenization electropolish. The plate had a rough and shiny surface with majority blue coloration.
- d) Side 2 of the plate after the post-homogenization electropolish. The plate had a rough and shiny surface with majority blue coloration.
- e) A color chart for comparison purposes.

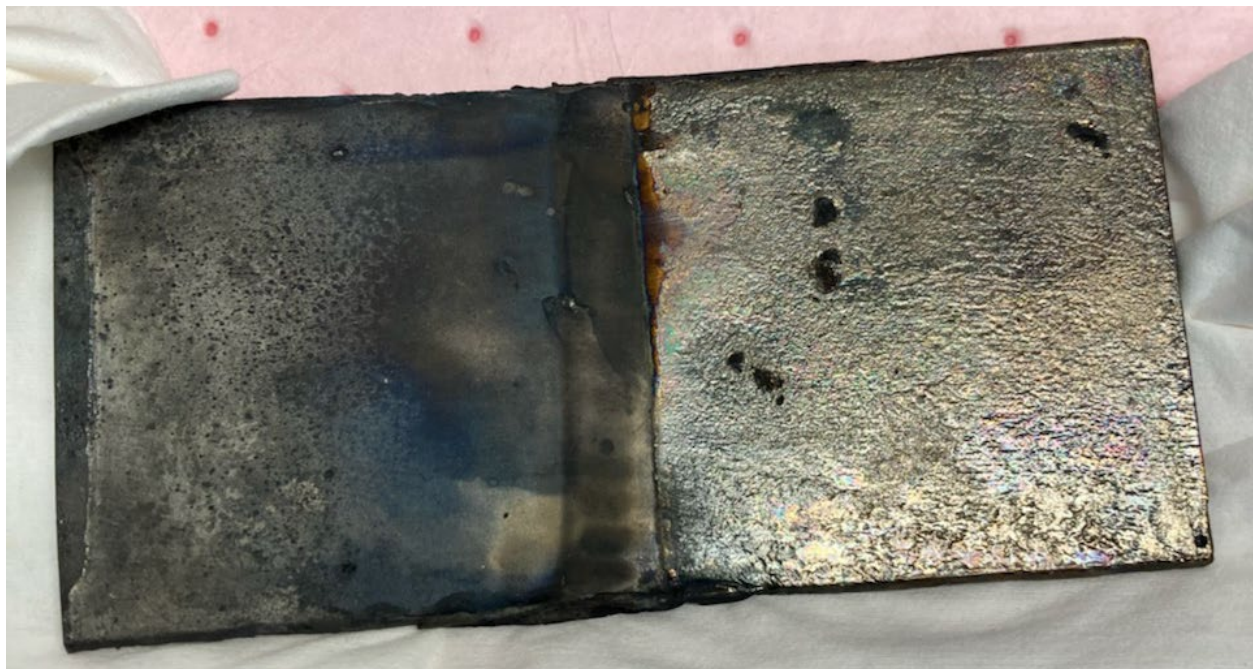
Figure 28. The U-10Mo plate before and after each step of the electropolishing process

Figure 28. The U-10Mo plate before and after each step of the electropolishing process..... 30

Overall, the use of electropolishing was able to smooth the surface of the cast DU-10Mo plate. Images of the plate following each step of the process are shown in Figure 28. The surface became shinier and smoother following the first two polishes; however, it became dull and rough following homogenization and was only slightly improved following a single final polish, suggesting that more effort to reduce the surface roughness should occur after homogenization than before. However, the ability for the electropolish to reduce oxidation was still observed in all test cases, with the surface of the annealed DU-10Mo that was electropolished still free of oxidation after 9 months (Figure 29).

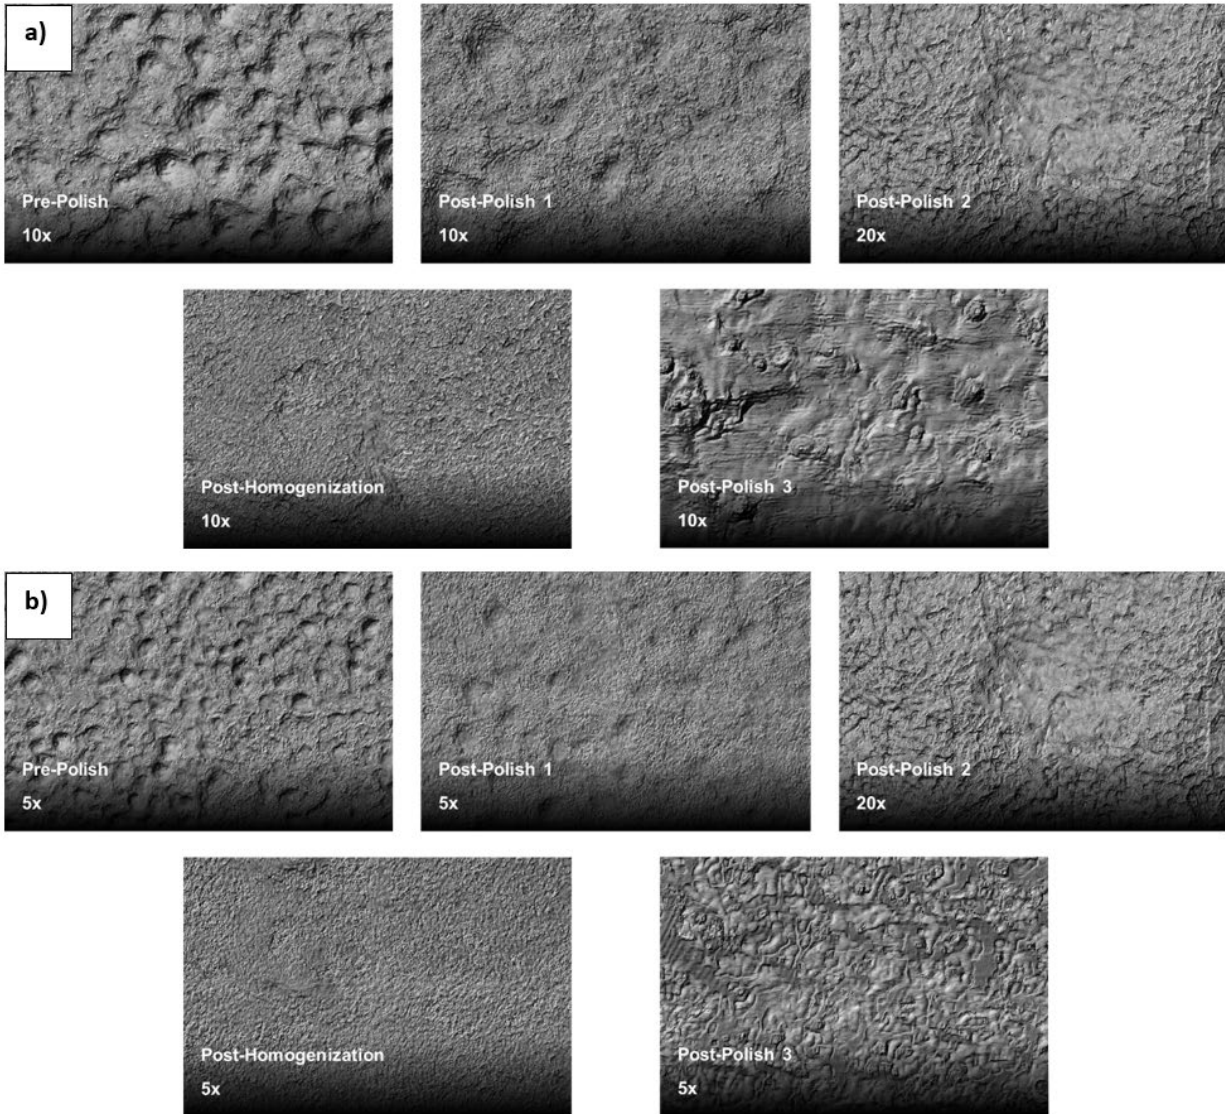
Figure A.5. The a) 10x magnification and b) 5x magnification C-DIC images for the Bottom Right section of Side 1 of the U-10Mo plate before and after two polishes, a homogenization step, and a third polish. The Post-Polish 2 images were taken at the 20x magnification and will not be used for visual comparison purposes. The surface roughness appeared to slightly increase between homogenization and the final polish. This is supported by the numerical data.

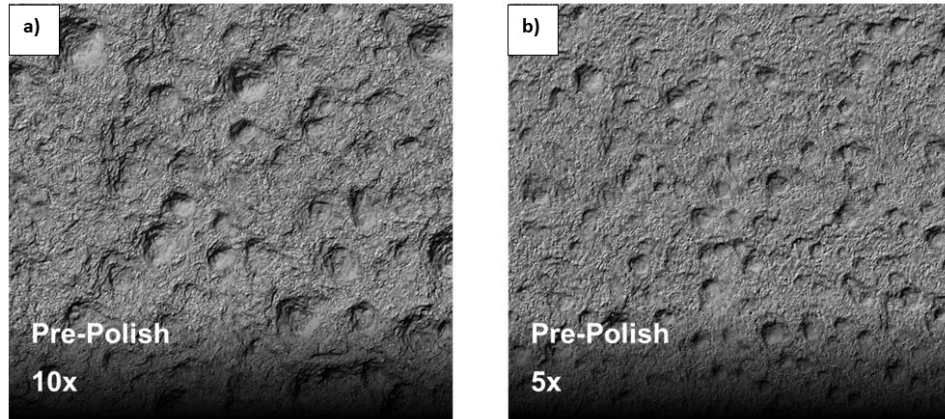
Figure A.7. The a) 10x magnification and b) 5x magnification C-DIC images of the Middle Right section of Side 1 of the U-10Mo plate prior to electropolishing.

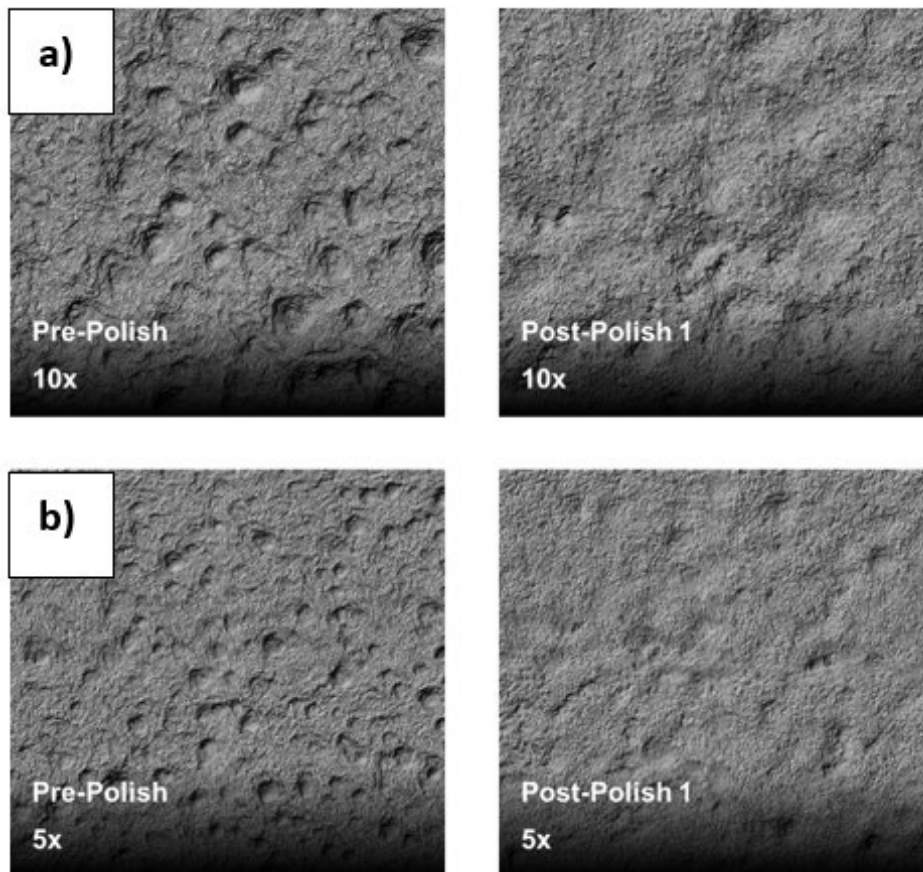
Figure A.8. The a) 10x magnification and b) 5x magnification C-DIC images of the Middle Right section of Side 1 of the U-10Mo plate before and after electropolishing. The surface roughness appeared to decrease following the first polish. This is corroborated by the numerical surface roughness data.

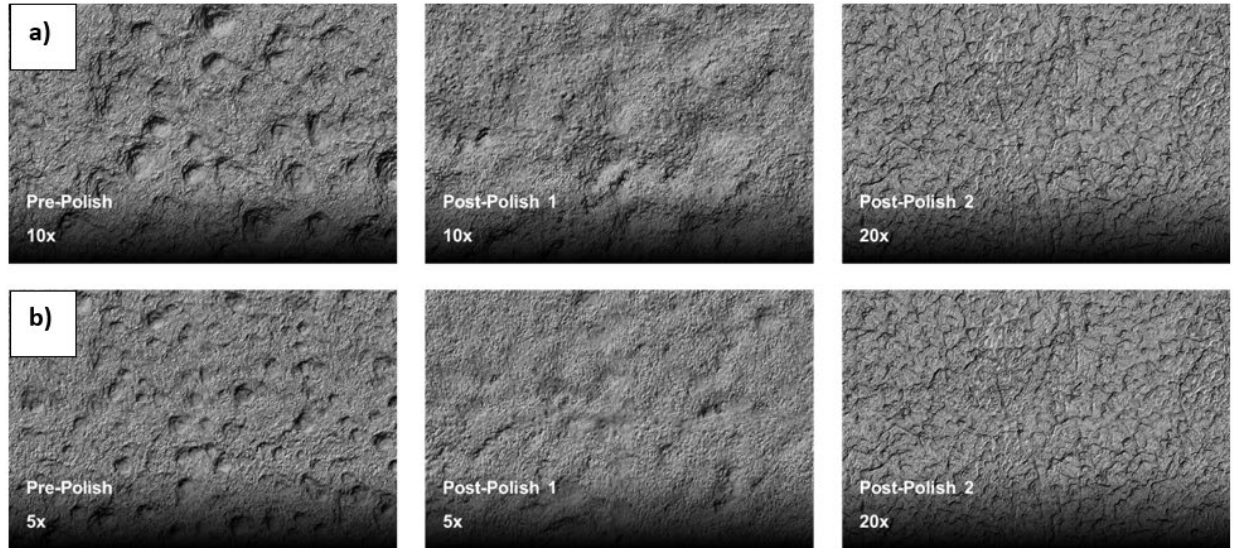
Figure A.9. The a) 10x magnification and b) 5x magnification C-DIC images of the Middle Right section of Side 1 of the U-10Mo plate before and after two electropolishes. The Post-Polish 2 images were taken at the 20x magnification and will not be used for comparison purposes; however, the numerical data indicates a decrease in surface roughness.

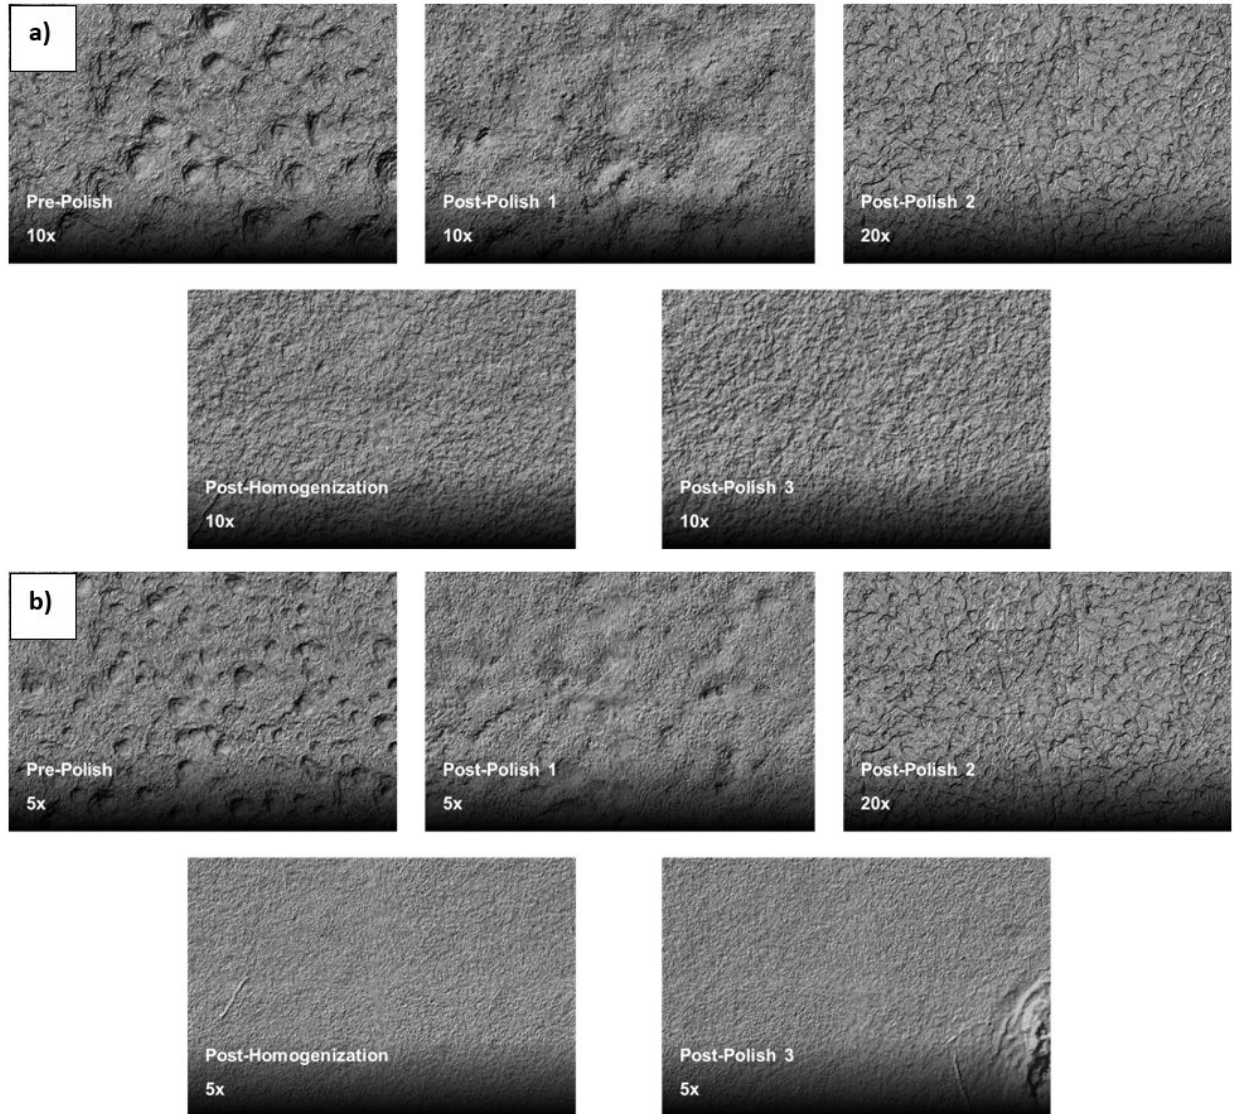
Figure A.11. The a) 10x magnification and b) 5x magnification C-DIC images for the Middle Right section of Side 1 of the U-10Mo plate before and after two electropolishes, homogenization, and a third electropolish. The Post-Polish 2 images were taken at the 20x magnification and will not be used for comparison purposes. The surface of the plate remained unchanged after the final polish, which is supported by the numerical data.

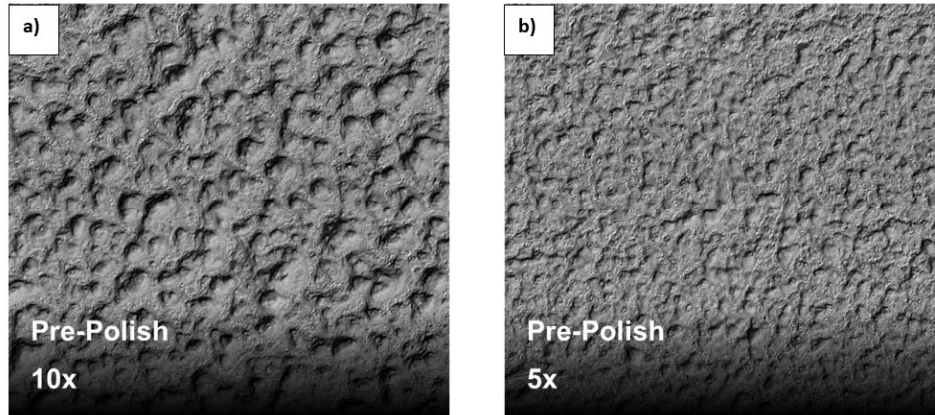
Figure A.13. The a) 10x magnification and b) 5x magnification C-DIC images for the Bottom Left section of Side 2 of the U-10Mo plate prior to electropolishing.

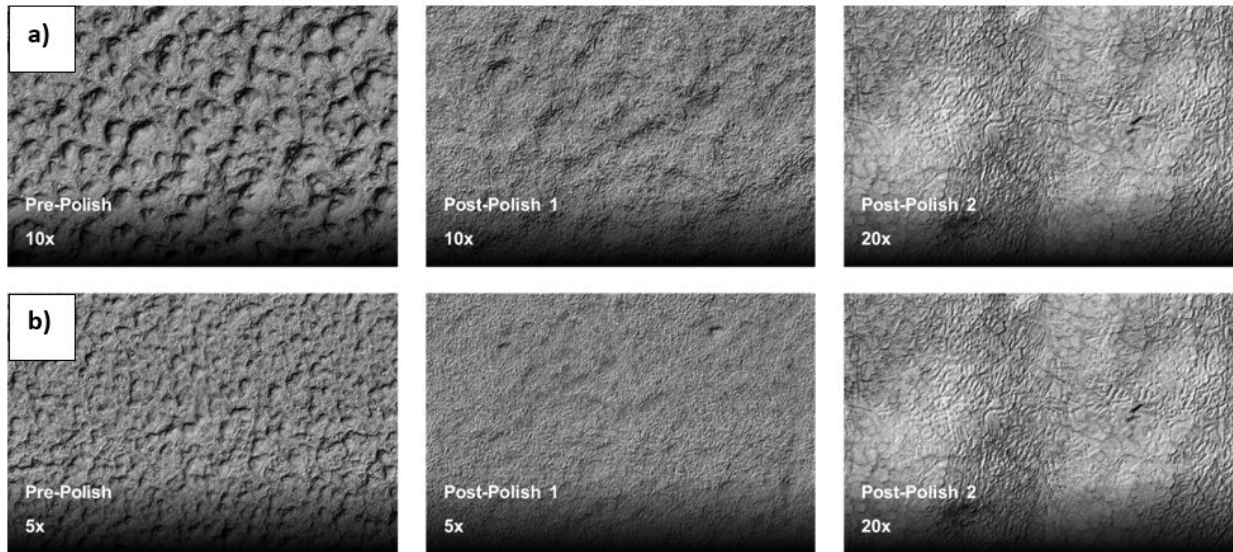
Figure A.15. The a) 10x magnification and b) 5x magnification C-DIC images of the Bottom Left section of Side 2 of the U-10Mo plate before and after two electropolishes. The Post-Polish 2 images were taken at the 20x magnification and will not be used for visual comparison purposes; however, numerical data indicates that the surface roughness decreased following the second polish.

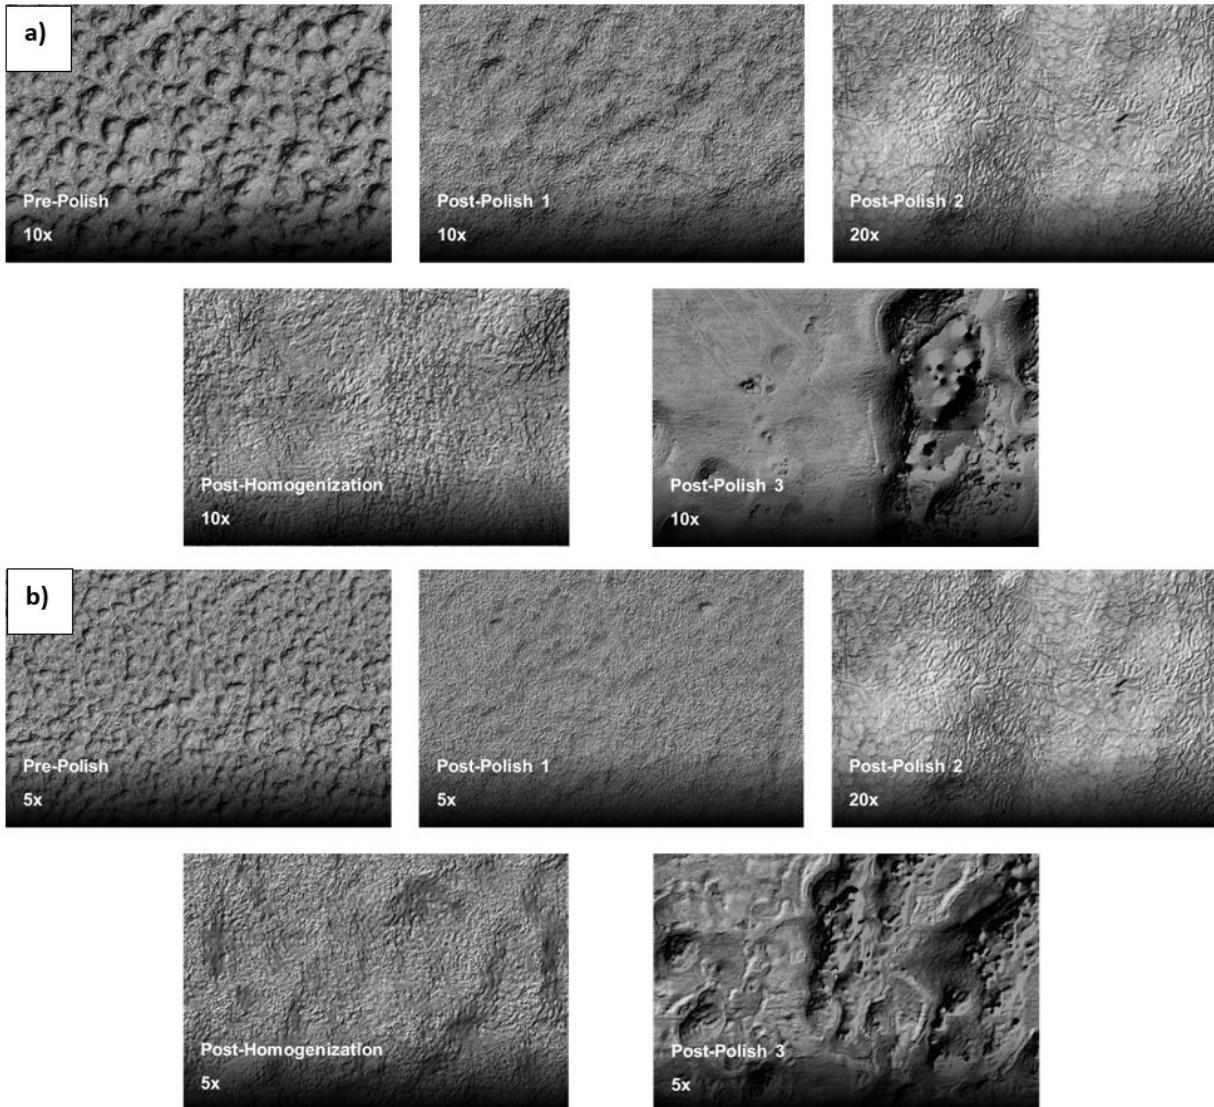
Figure A.17. The a) 10x magnification and b) 5x magnification C-DIC images before and after two electropolishes, homogenization, and a third polish for the Bottom Left section of Side 2 of the U-10Mo plate. The Post-Polish 2 images were taken at 20x and will not be used for visual comparison purposes. The surface of the plate appears rougher following the third polish. This observation is supported by the numerical data.

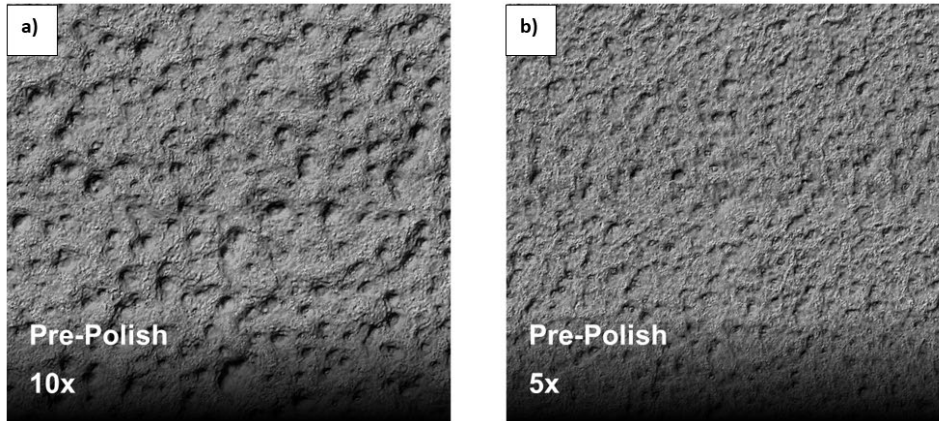
Figure A.18. The a) 10x magnification and b) 5x magnification C-DIC images for the Middle Left section of Side 2 of the U-10Mo plate prior to electropolishing.

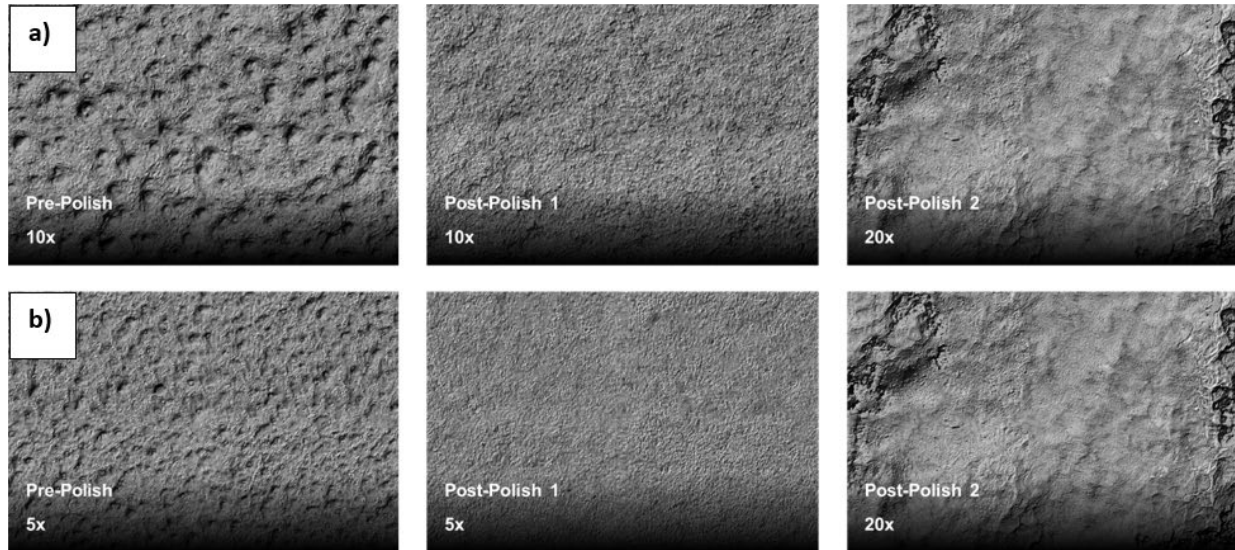
Figure A.20. The a) 10x magnification and b) 5x magnification C-DIC images before and after two electropolishes for the Middle Left section of Side 2 of the U-10Mo plate. The Post-Polish 2 images were taken at the 20x magnification and will not be used for visual comparison purposes; however, the numerical surface roughness data indicates a decrease in surface roughness following the second electropolish.

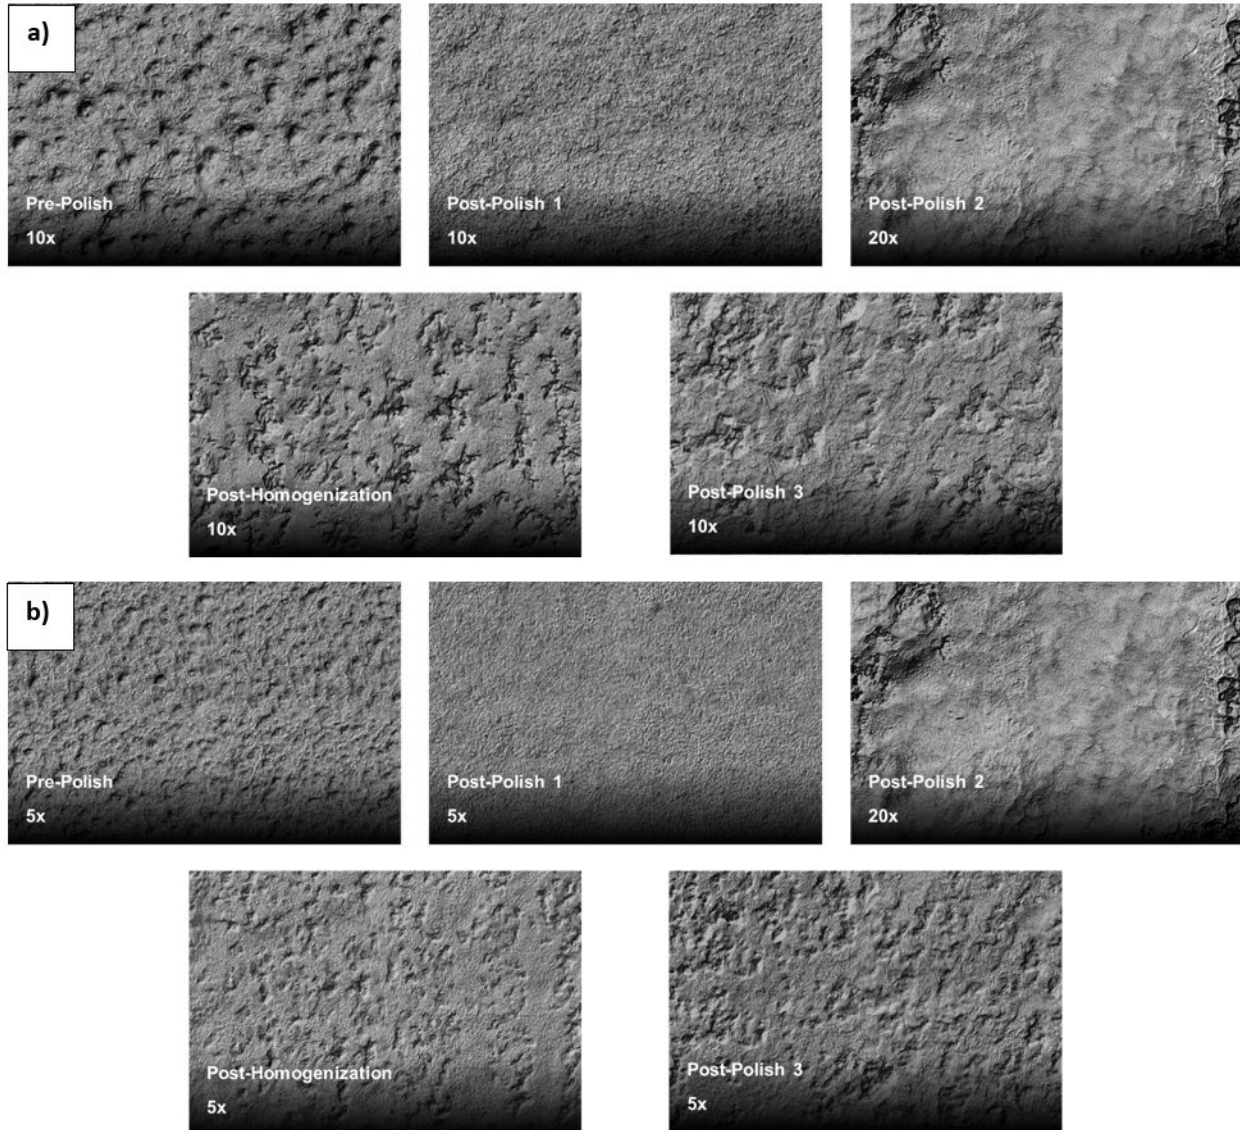
Figure A.22. The a) 10x magnification and b) 5x magnification C-DIC images before and after two electropolishes, homogenization, and a third electropolish for the Middle Left section of Side 2 of the U-10Mo plate. The Post-Polish 2 images were taken at the 20x magnification and will not be used for visual comparison purposes. The surface of the plate following the third polish appeared similar to that of the plate after homogenization. This observation is supported by the numerical data.

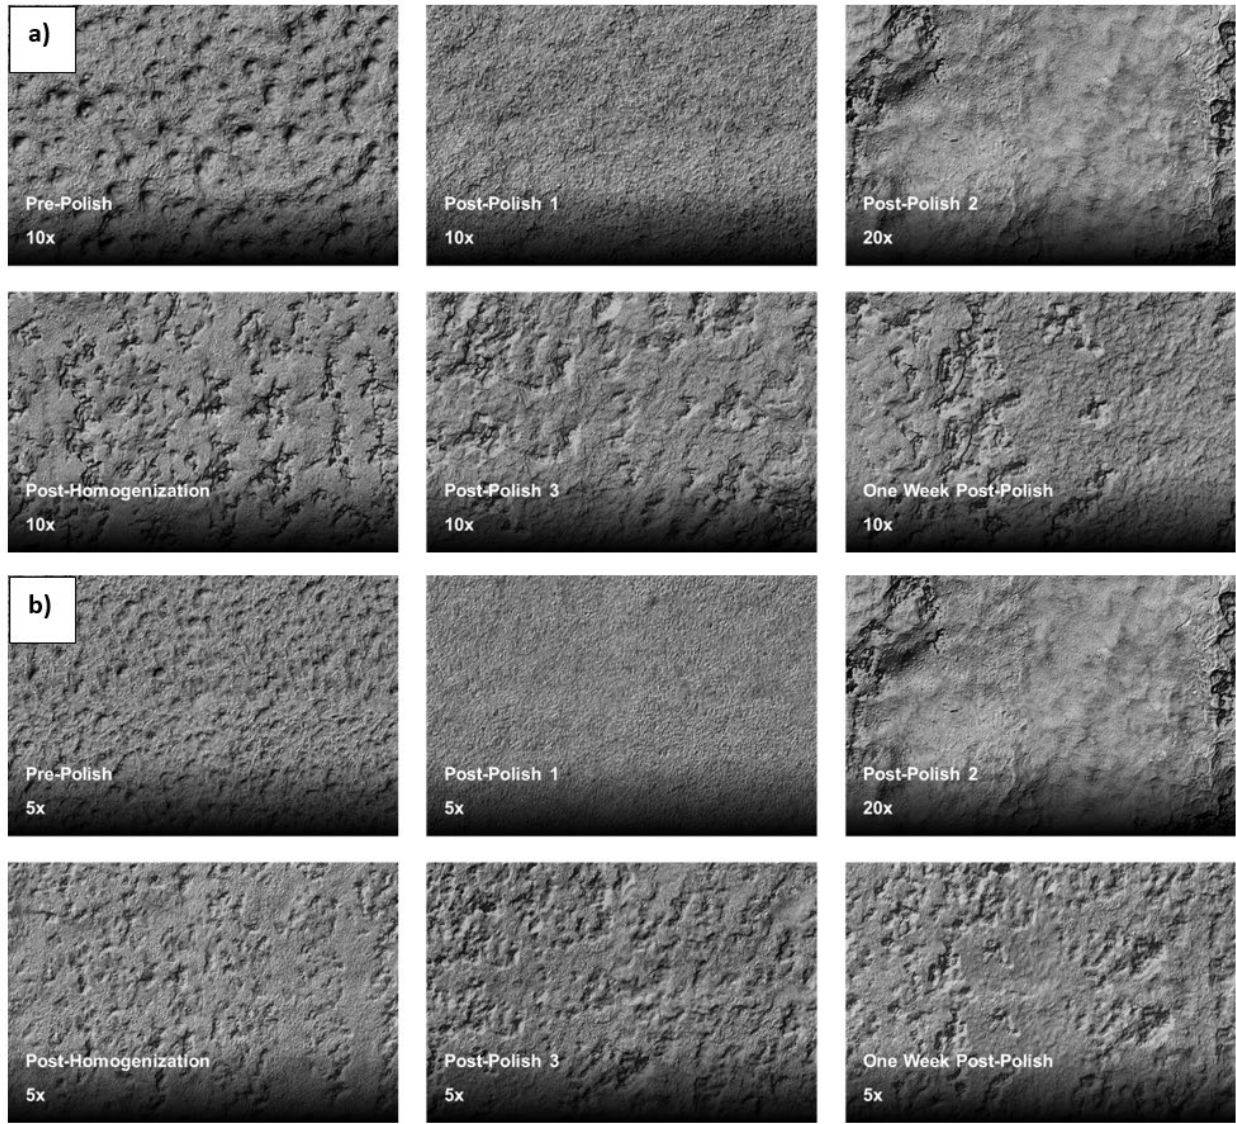
Figure A.23. The a) 10x magnification and b) 5x magnification C-DIC images for the Middle Left section of Side 2 of the U-10Mo plate throughout the electropolishing process and one week after the final polish. The Post-Polish 2 images were taken at the 20x magnification and will not be used for visual comparison purposes. The surface roughness appears unchanged one week after polishing. This is corroborated by the surface roughness data.

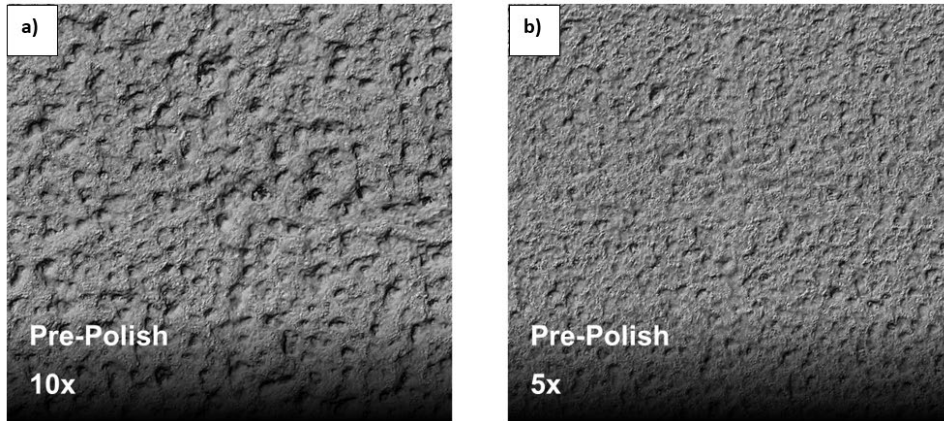
Figure A.24. The a) 10x magnification and b) 5x magnification C-DIC images for the Bottom Right section of Side 2 of the U-10Mo plate prior to electropolishing.
