Electropolishing of a Full-Sized U-10Mo Plate

December 2022

PACIFIC NORTHWEST NATIONAL LABORATORY
operated by
BATTELLE
for the
UNITED STATES DEPARTMENT OF ENERGY
under Contract DE-AC05-76RL01830

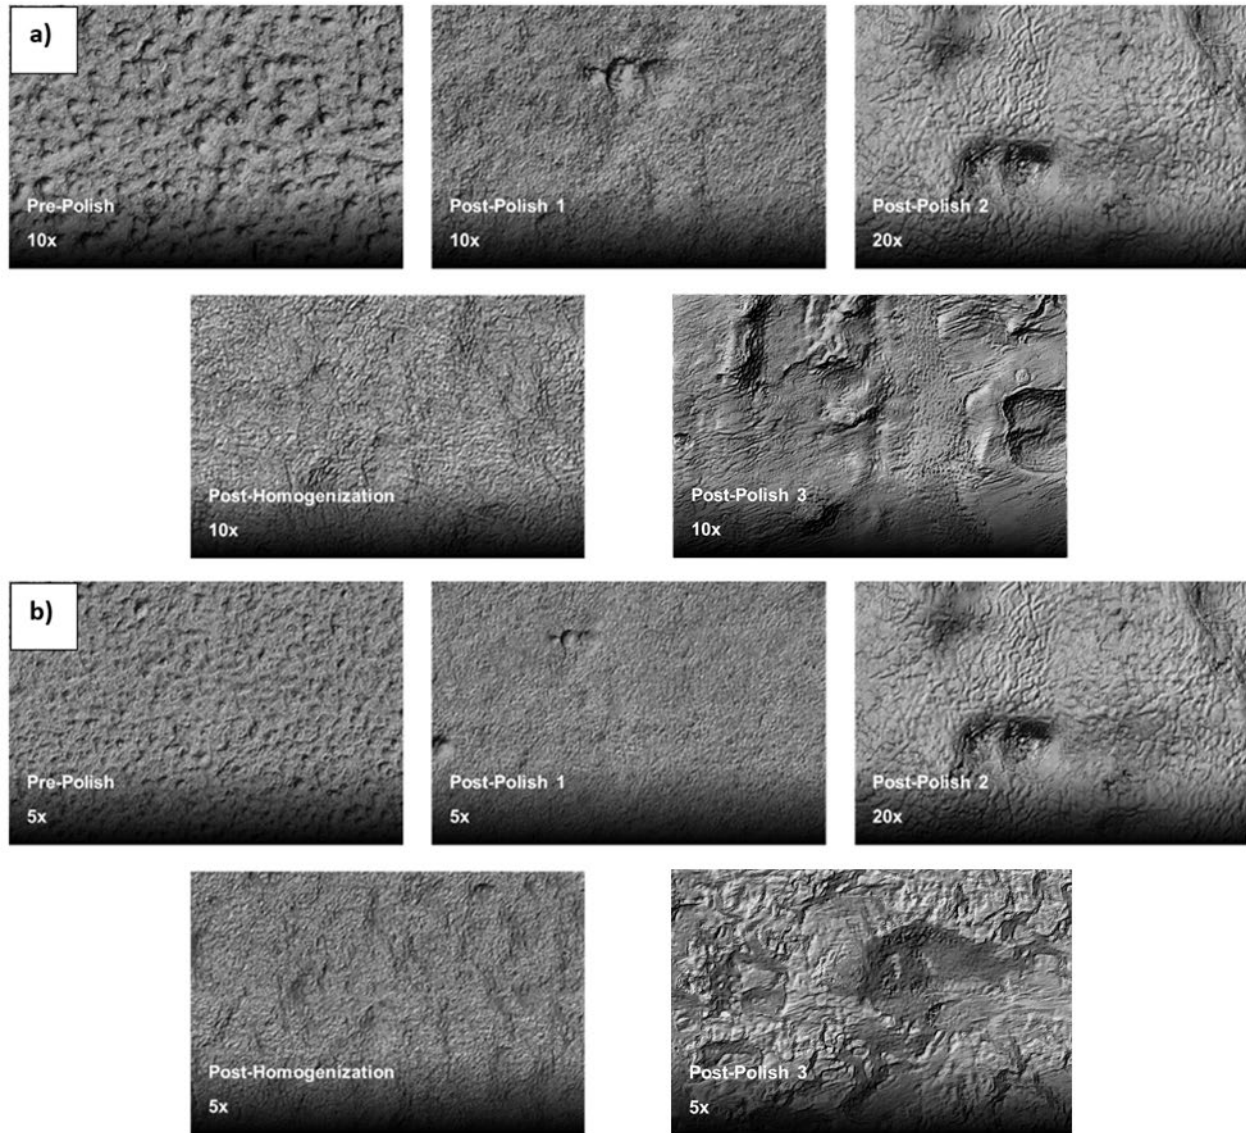
Figure A.28. The a) 10x magnification and b) 5x magnification C-DIC images before and after two polishes, homogenization, and a third polish for the Bottom Right section of Side 2 of the U-10Mo plate. The Post-Polish 2 images were taken at the 20x magnification and will not be used for visual comparison purposes. The surface roughness of the plate visually increased following the third polish. This observation is supported by the numerical surface roughness data.

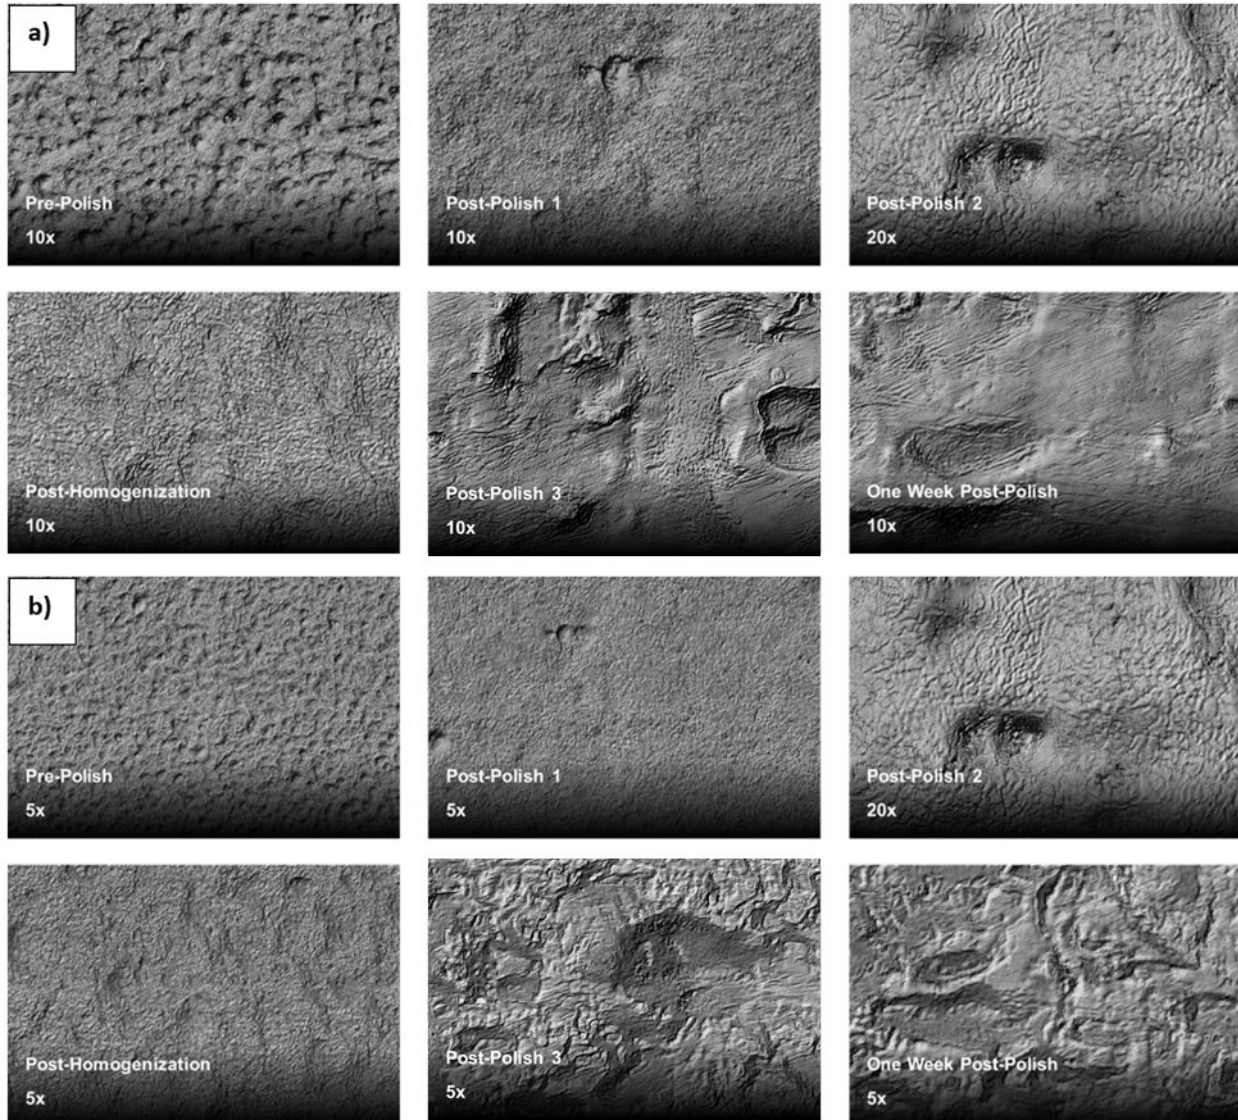
Figure A.29. The a) 10x magnification and b) 5x magnification C-DIC images throughout the polishing process and one week after the final polish for the Bottom Right section of Side 2 of the U-10Mo plate. The Post-Polish 2 images were taken at the 20x magnification and will not be used for visual comparison purposes. The surface roughness of the plate remained relatively unchanged one week after polishing. This is supported by the numerical data.

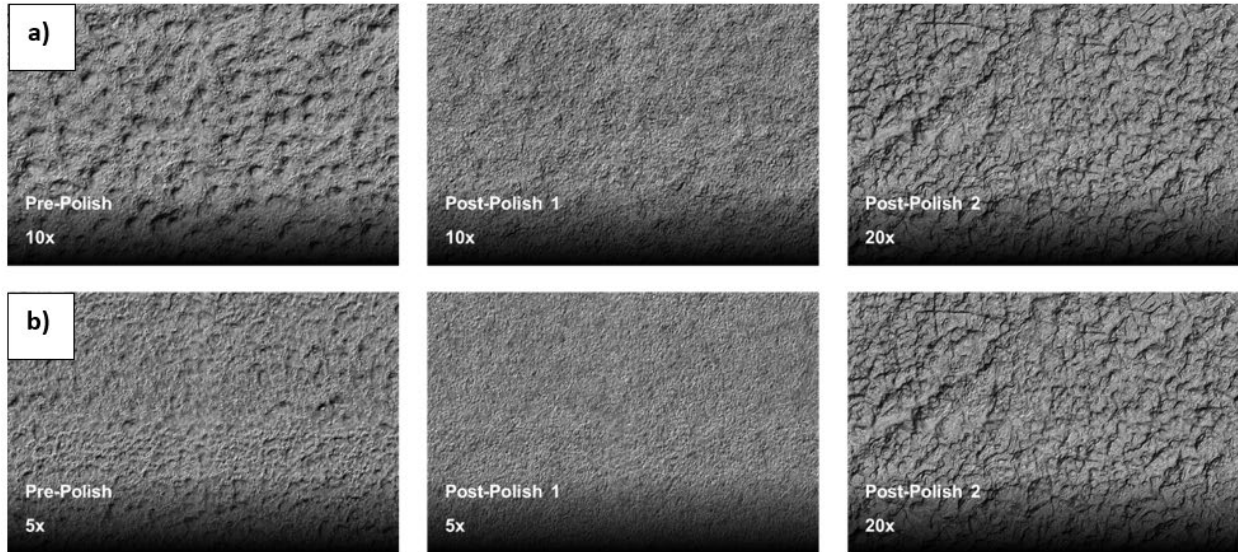
Figure A.32. The a) 10x magnification and b) 5x magnification C-DIC images for the Middle Right section of Side 2 of the U-10Mo plate before and after two electropolishes. The Post-Polish 2 images were taken at the 20x magnification and will not be used for comparison purposes; however, the numerical data indicates a decrease in surface roughness following the second polish.

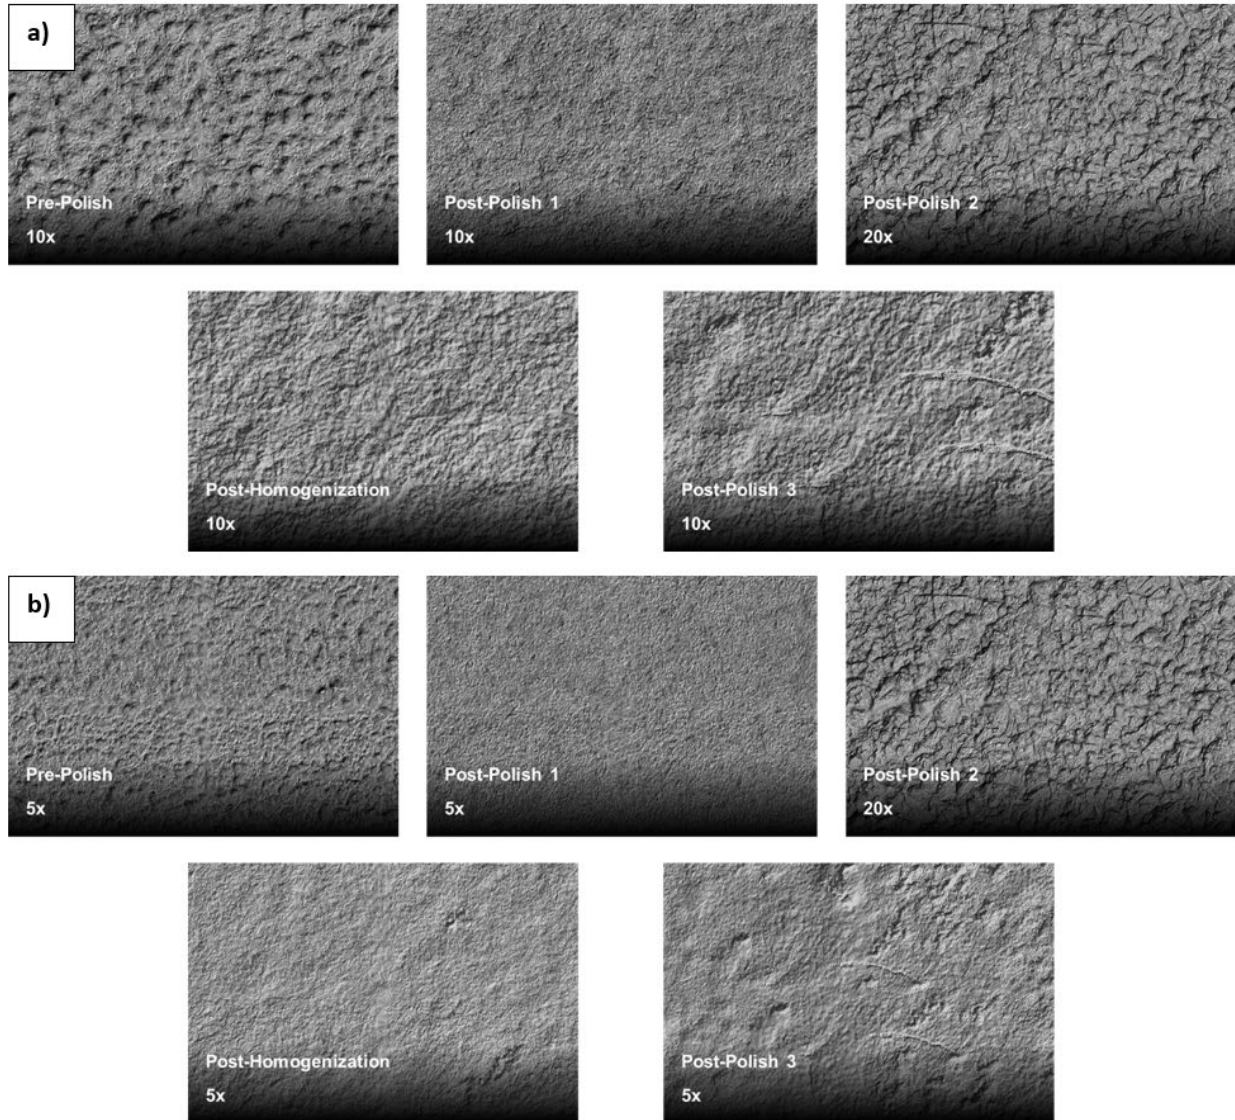
Figure A.34. The a) 10x magnification and b) 5x magnification C-DIC images for the Middle Right section of Side 2 of the U-10Mo plate before and after two polishes, homogenization, and a third polish. The Post-Polish 2 images were taken at the 20x magnification and will not be used for visual comparison purposes. The surface of the plate following the third polish was visually rougher than that of the plate following homogenization. This is corroborated by the numerical data.

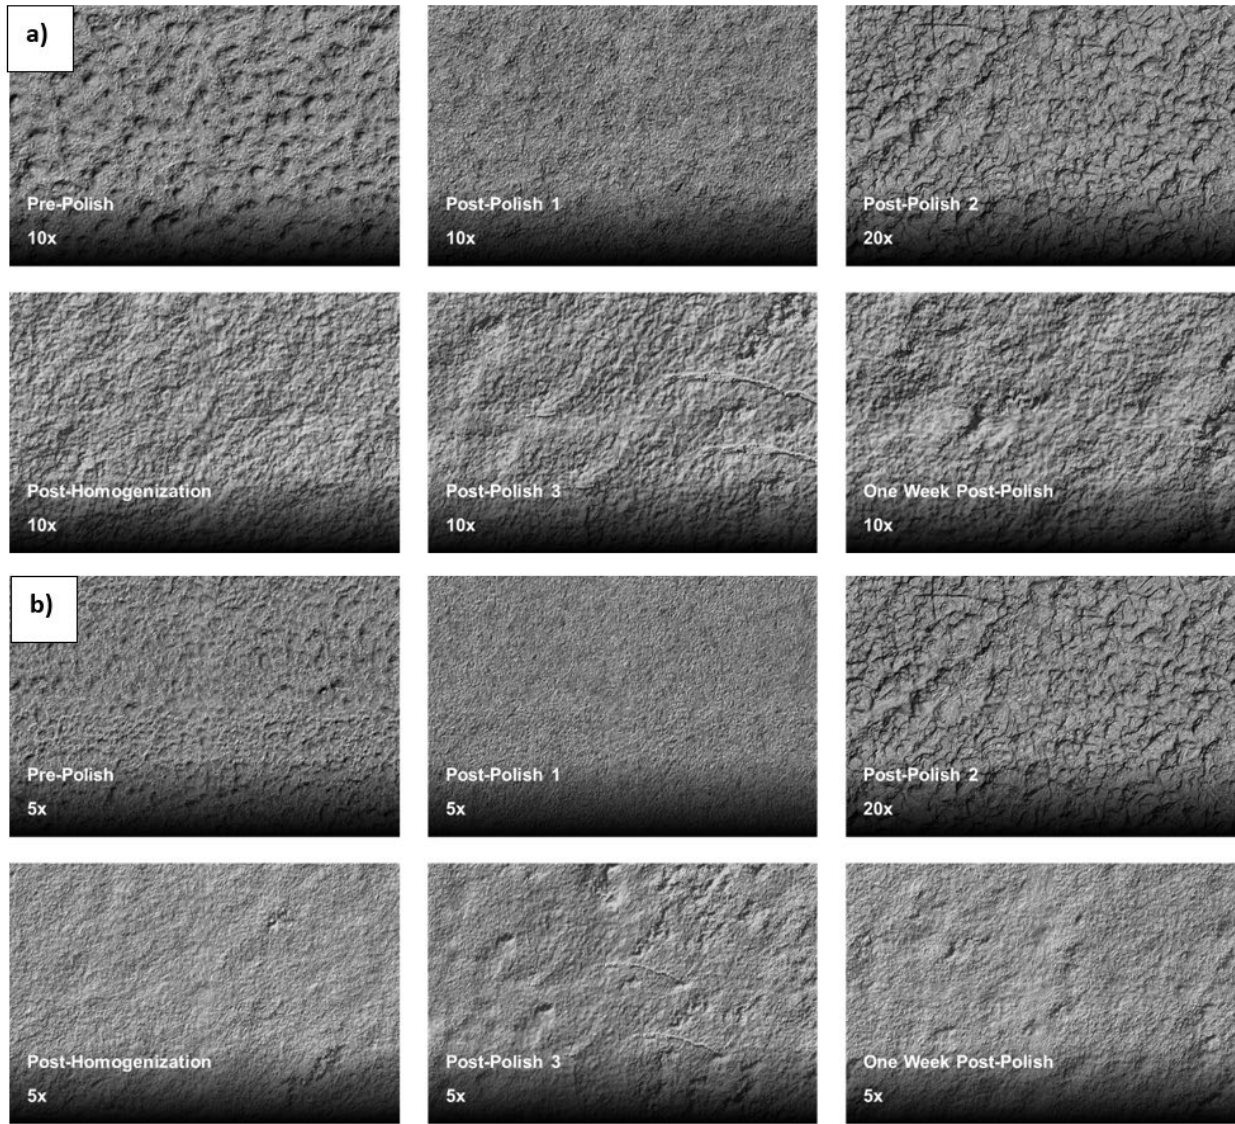
Figure A.35. The a) 10x magnification and b) 5x magnification C-DIC images of the Middle Right section of Side 2 of the U-10Mo plate throughout the polishing process and one week following the final polish. The Post-Polish 2 images were taken at the 20x magnification and will not be used for comparison purposes. The surface of the plate remained relatively unchanged one week after the final polish. This observation is supported by the numerical data.
