# Light Water Reactor Sustainability Program

## Survey of Aging and Monitoring Concerns for Cables and Splices Due to Cable Repair and Replacement

# **Survey of Aging and Monitoring Concerns for Cables and Splices Due to Cable Repair and Replacement**

**M.P. Spencer, M. Elen, and L.S. Fifield  
Pacific Northwest National Laboratory**

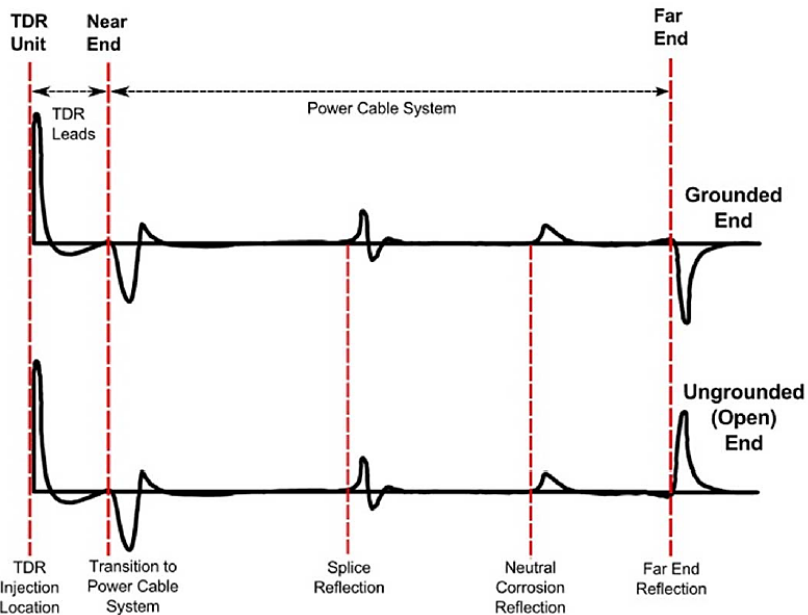
Figure 4-4. Typical test plot of TDR applied to a cable with a splice (Hernandez-Mejia 2016). The effect of grounding the cable is also shown.

TDR measures reflections of a stepped or impulse signal along a single conductor to detect and locate any changes in the conductor or insulation impedance. A TDR pulse is usually less than 10 volts and is primarily in the higher frequency range ( $> 1$  kHz), so the pulse has little or no effect on low frequency signals or on 50/60 Hz power excitation. TDR transmits an incident signal into the conductor and listens for signal reflections. If the conductor is a uniform impedance network and is terminated to a matching impedance, then there will be no reflections and the transmitted signal will be completely absorbed at the far end by the termination. Instead, if there are impedance variations such as a short or open circuit at the cable end, a damaged or reduced cross-sectional area, or a splice with a higher resistance along the conductor, then some fraction of the incident signal will be reflected to the source. The polarity of the reflection contains information about the reflector. An open cable end will reflect “in-phase” with the excitation and a short will reflect as an inverted signal. This reflected signal is measured at a point in time on the TDR instrument that is proportional to the signal propagation velocity in the cable and the distance along the cable, thereby allowing assessment of the location of any reflector observed. The amplitude of the reflected signal coupled with the inherent cable attenuation characteristics also allows an estimate of the magnitude of the impedance change. An example TDR plot is shown in Figure 4-4.

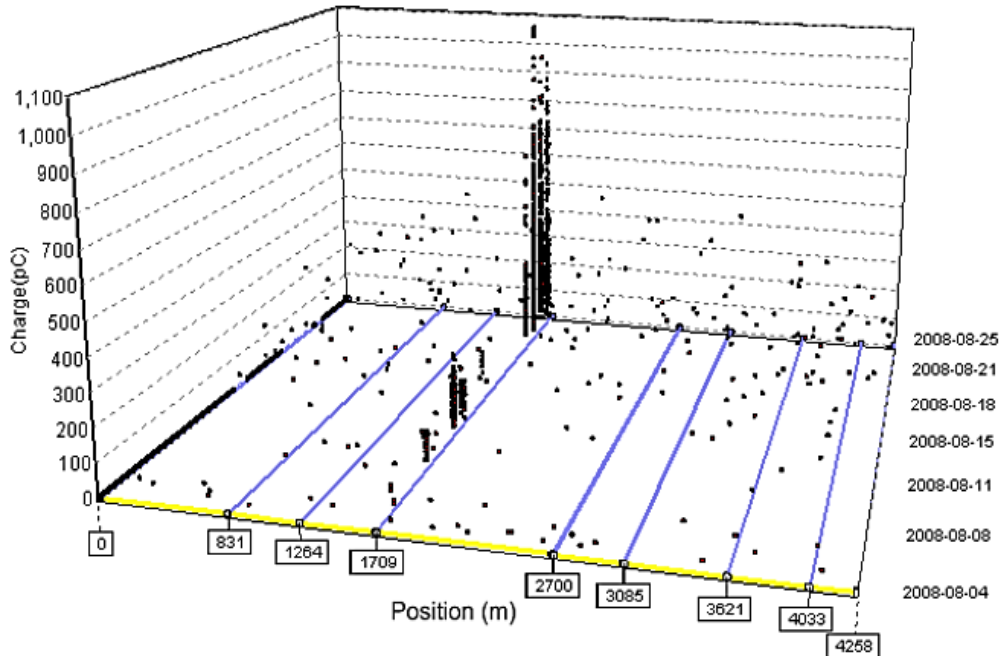
Figure 4-6. 3D plot of online developing PDs in a flawed joint with a crimped connector running hot at 1678 m (Cuppen, Steennis, and van der Wielen 2010).

PD are electrical discharges that can take place in gaseous inclusions, which may accidentally occur in solid insulation. PDs do not bridge the whole insulation (i.e., they do not extend from conductor to ground) but can lead to material failure. A PD takes place in a nanosecond and causes high-frequency currents, which are measurable by PD detection equipment. After a discharge, both positive and negative charges are deposited on the surfaces of the voids or tree channels. These charges change the localized electric field, thereby controlling the time when the next PD will take place along with changes in the applied sinusoidal voltage. The net result is a pattern of PDs of various magnitudes, repetition rates, and phase angles relative to the applied voltage. During testing in which the voltage is slowly raised, the voltage at which discharges are observed in each cycle are known as the PD inception voltage. On decreasing the voltage slowly from above the PD inception voltage value, the voltage at which PD ceases to occur is referred to as the PD extinction voltage. PD will often become intermittent before complete extinction occurs. Because of the deposition of charges on the surfaces of the voids caused by PD, the PD extinction voltage can theoretically be as low as 50 percent of the inception voltage. In practice, the difference is between 10 and 25 percent. To ensure that a cable is discharge-free at the operating voltage, it is necessary to test for PD at levels up to twice the operating voltage. Decreases in the PD inception voltage are an indication of significant degradation of the insulation material. A cable that has PD at operating voltage or within 1.5 times the operating voltage is generally significantly deteriorated and may fail in the near future. Cables that have no significant PD at levels up to twice the operating voltage have no immediate expectation of failure from PD and will operate satisfactorily for a significant period of time. An example PD plot is shown in Figure 4-6.

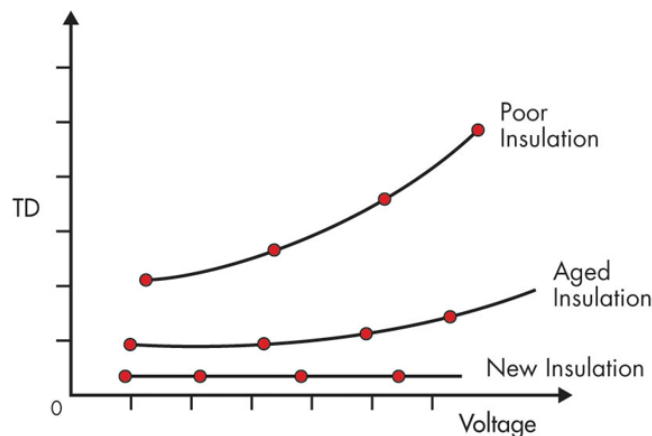
Figure 4-8. Typical tan delta response for an aged or degraded cable (Youngblood 2020).

The tan delta technique or  $\tan \delta$  can be derived from one of the four Maxwell equations, which relates the magnetic field intensity to the electric field intensity. The tangent of the angle  $\delta$  between the imaginary and real portion of permittivity is the ratio of two vector quantities and is also a measure of the ratio of energy from the applied electric field that is stored in a specific material to the amount dissipated or lost. This quantity is also known as the loss tangent. The cable to be tested must be de-energized and each end disconnected and isolated. Using a very low frequency (0.1 to 1 Hz), a test voltage is applied to the cable while the  $\tan \delta$  controller takes measurements. Typically, the applied test voltage is raised in steps, with measurements first taken up to the normal line-to-ground operating voltage. If the  $\tan \delta$  numbers indicate a good cable system, the test voltage is raised up to one and a half or two times the ground operating voltage. The  $\tan \delta$  numbers at the higher voltages are then compared to those at lower voltages and an analysis is made. Tan delta testing is becoming widely used in NPPs—particularly for medium-voltage shielded cable. Such tests have been shown to be particularly sensitive to water tree degradation in medium-voltage cables. A typical  $\tan \delta$  plot is shown in Figure 4-8.

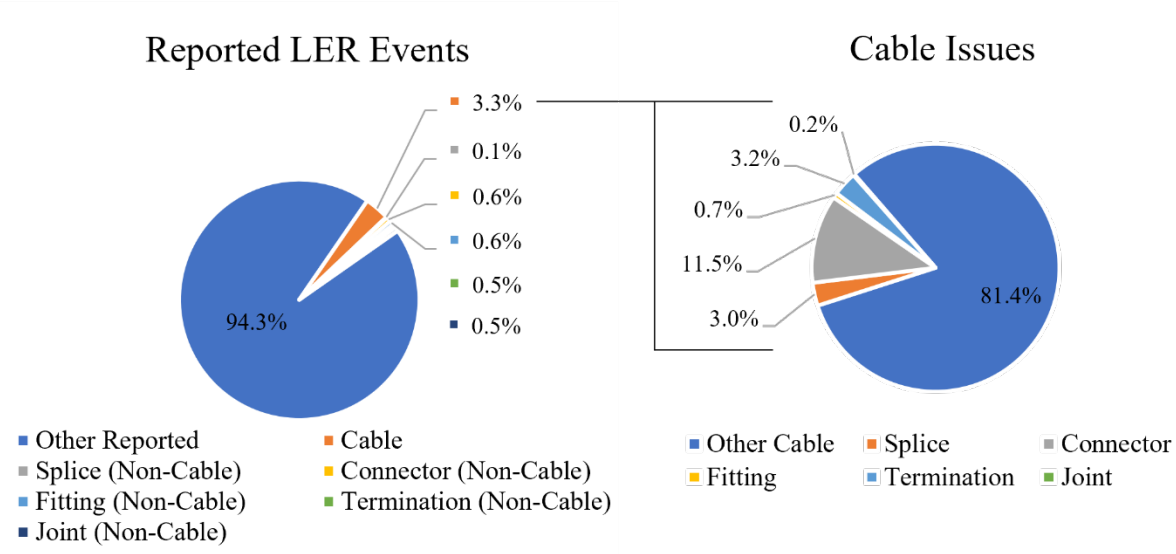
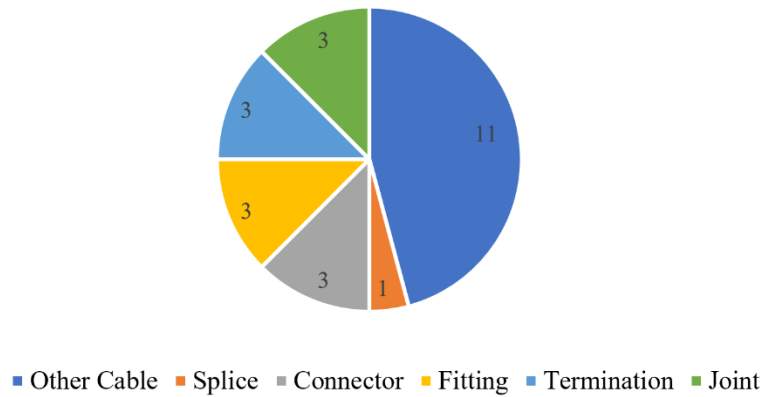
Average Cable Issues per Year Since 2000

Figure 5-1. (Top) reported LER events for cables, splices, and other components and (bottom) the average number of reported issues since 2000.

All reported LER events for cables, splices, connectors, fittings, terminations, and joints are shown in Figure 5-1; the events for non-cable associated components (i.e., *cable* or *cables* was not included in the title or abstract of the event) were estimated by subtracting the combined cable and component events [e.g., *(Cable OR Cables) AND (Splice OR Splices)*] from the reported LER events for the component alone (e.g., *Splice OR Splices*). In addition, cable events including the components are also reported in Figure 5-1. From the figure, of all LER events, approximately 3.3% are cable related. In addition, most cable events (approximately 81%) were not keyword-associated with splices, connectors, fittings, terminations, or joints. Of the events that correspond to the components of interest, approximately 12% were due to connectors, 3% were due to terminations, 3% were due to splices, 1% were due to fittings, and less than 1% were due to joints.

To evaluate trending of the events, the events per year are shown in Figure 5-1 and Figure 5-2. As shown in the figures, reported events peaked shortly after recording of LER events begun. Specifically, it is hypothesized that due to new LER reporting requirements around 1980, a significant increase in reportable events occurred as NPP operators moved to ensure they were meeting regulations. Thus, to evaluate events without bias of initial reporting, and since the last published NRC report on splices was conducted in 2002 (see Table 14), reported events since 2000 are also shown. Since 2000, reported events for cable splices, connectors, fittings, terminations, and joints were nearly constant with reported splice events at approximately one per year. Interestingly, reported cable events overall seem to have reduced over the 2019 to 2022 timeframe, potentially due to COVID restrictions.

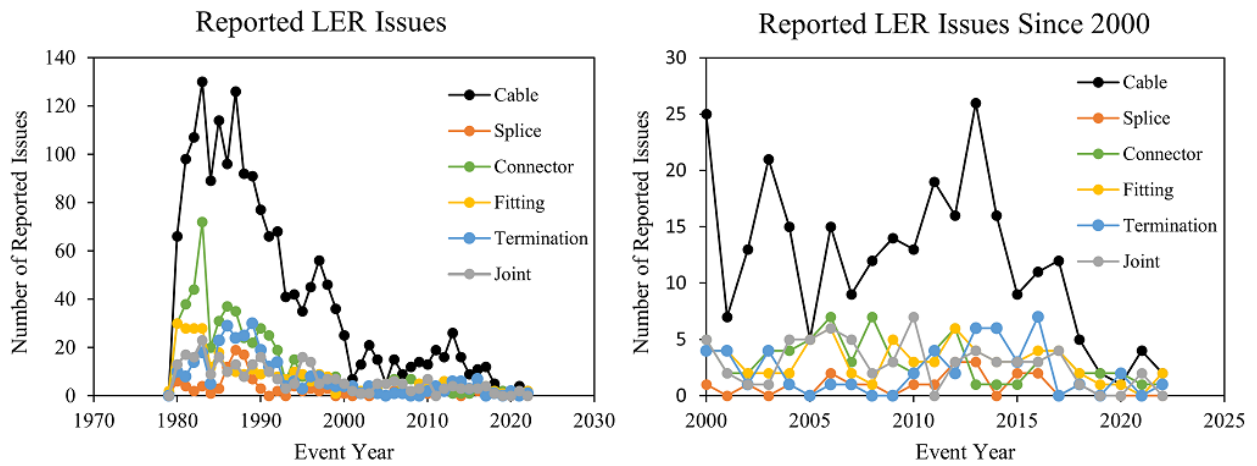
Figure 5-2. Reported LER cable events against event year.

Reported splice and termination LER events are shown in Figure 5-3. Contrary to the other components shown in Figure 5-2, splice and termination events demonstrated a peak near 1988. It is hypothesized that this was due to new reporting requirements for splices (i.e., non-qualified splices were upgraded to qualified splices) (NRC 1987).

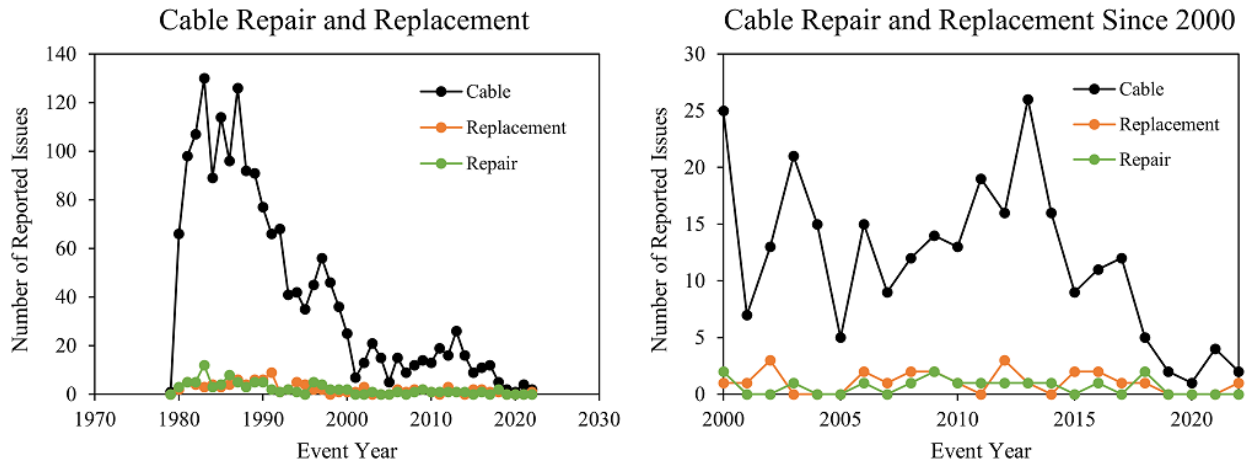
Figure 5-5. Reported LER cable repair and replacement events against event year.

LER events related to cable repair or replacement are shown in Figure 5-4 and Figure 5-5. From the former figure, approximately 5.4% and 5.1% of cable events are correlated to cable replacement or repair, respectively. In addition, since 2000, cable replacement has been approximately 50% more common than cable repair, which is within expectations as cables have historically been replaced, as opposed to repaired, when issues were observed (IAEA 2012). In addition, replacement can effectively assist with NPP life extension as many of the cable types of interest have been EQ tested and newer cables can supply improved performance, such as flame retardancy, halogen-free materials, and reduced degradation.

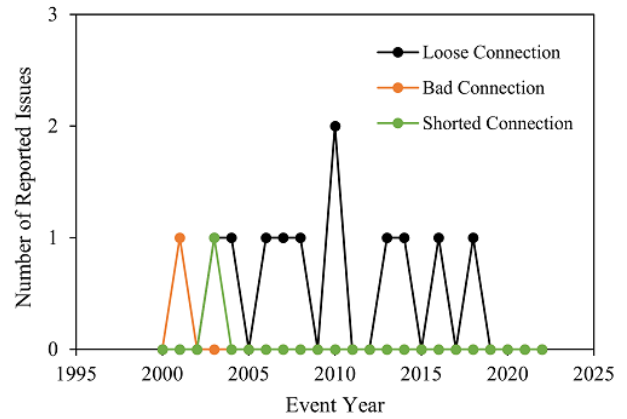
The results for the additional search terms are shown in Figure 5-6. Of the investigated events, a majority of them (approximately 94%) were related to loose connections. A loose connection may occur due to workmanship but may also occur due to thermal cycling (Gazdzinski et al. 1996). More specifically, thermal cycling will lead to expansion and contraction of the components and may lead to issues with contact pressure and correspondingly contact between interfaces. Such thermal fatigue may eventually cause failure of the splice or component through ingress of moisture, for example. In addition to thermal cycling, vibration may also lead to loosening connections and interface issues, particularly over 30 to 40 years. Based upon these events, thermal cycling fatigue and vibration are of potential concern for long-term aging of splices but are not currently considered in cable and splice EQ (IEEE 2015).

Figure 5-6. (Top) reported LER cable connection events and (bottom) events reported against event year.

- *(Cable OR Cables) AND “Loose Connection”* [54 events]
- *(Cable OR Cables) AND “Bad Connection”* [2 events]
- *(Cable OR Cables) AND “Shorted Connected”* [1 event]

2. Common-cause failure for evaluated cable events of interest was observed to primarily be associated with loose connections, which may manifest associated with workmanship issues, thermal cycling, and/or vibration. However, both thermal cycling fatigue and vibration (non-seismic) are not currently included in EQ of cables and splices.
